**DRAFT** Summary Report

**Wetland and Stream Channel Restoration at the Arcata Redwood Co. Mill B site**

**Davison Creek Trailhead**

**A Redwood National and State Parks, ISTEa joint**

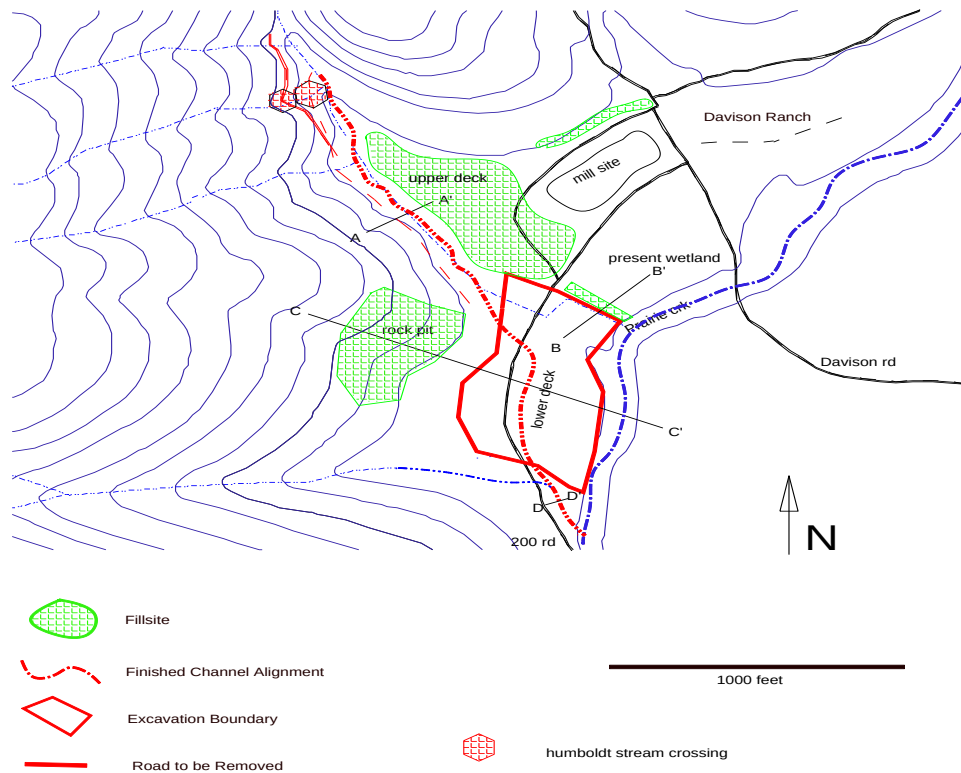
Figure 1. Plan Map for wetland and stream channel restoration as built.

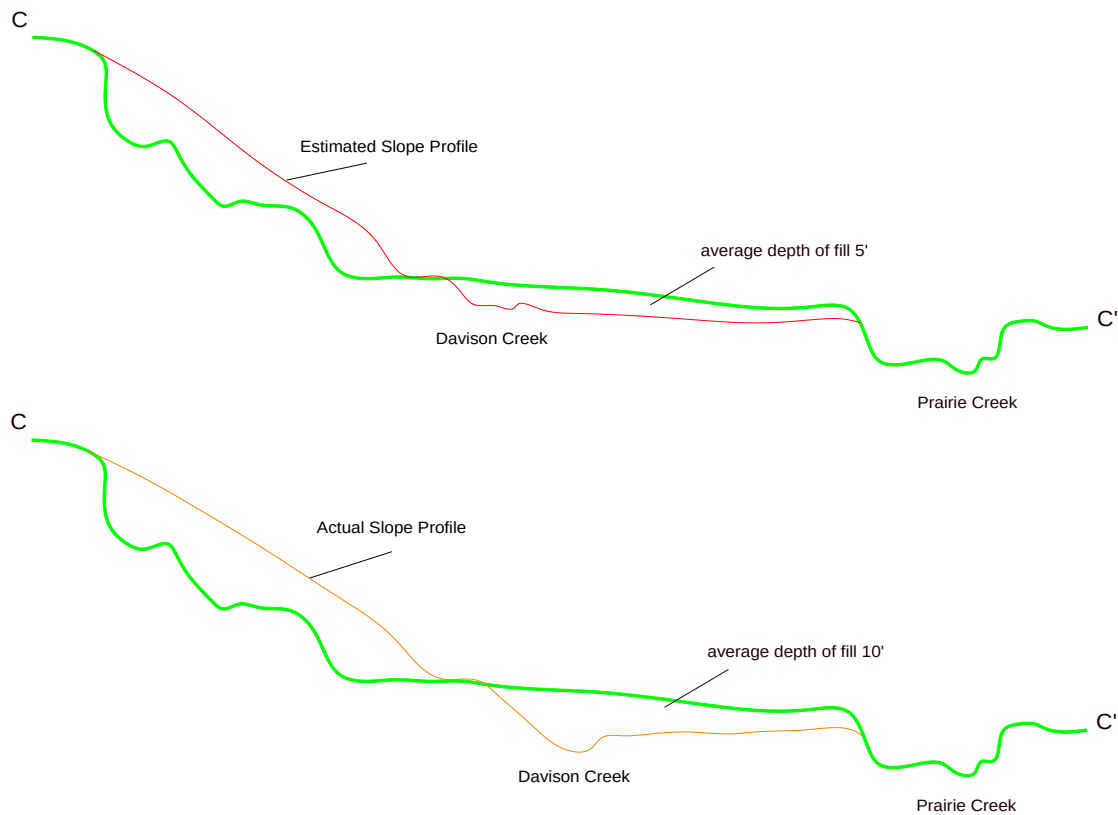
Figure 2. Alteration in slope / wetland profile at cross section C C’.

The restored reach of Davison Creek morphology varied slightly from that described in the BA plan, cross section C. The anticipated channel form, identified in early test pit assessments, showed a prominent natural levee associated with the wetland interface of Davison Creek. However, the final exhumed channel had either a subtle levee or no levee at all (figure 2).

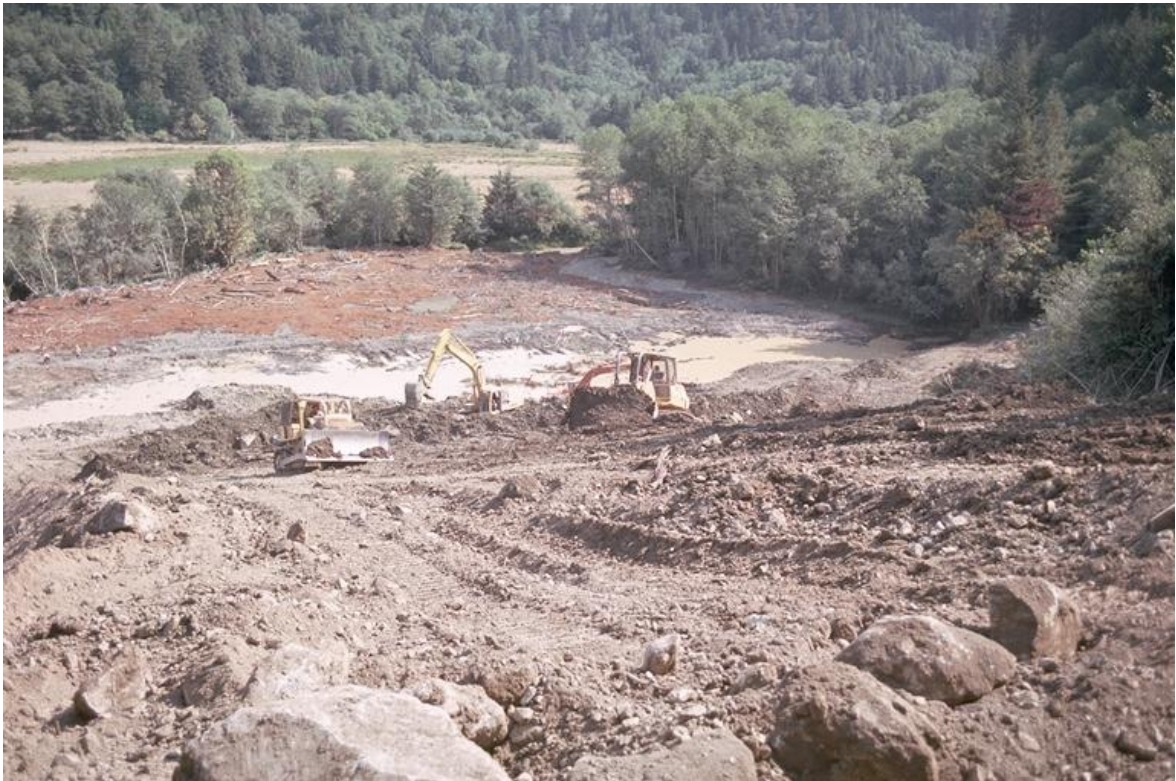
Estimates of production were based upon past work in RNSP. Road removal work performed in 1998 on the M-Line had average production rates of 100 yd<sup>3</sup> per hour in rougher terrain with similar push distances. Since the dozer had a relatively flat and straight push to the fill site, a rate higher than that on the M-Line was expected. Therefore, initial estimates for the dozers production were 125 yd<sup>3</sup> per hour. However, the fill contained an abundance of (2 to 10 feet in diameter) rock and this reduced dozer production to less than 50 yd<sup>3</sup> per hour.

Photo 2. Rocks in foreground (averaged 18 to 48 inches in diameter), frequently encountered during excavation.

The presence of the rock also plagued the end hauling process. The original plan had the dump trucks spread the fill on the parking lot area in eight to 10 inch lifts, minimizing the need for mechanical spreading and utilizing repeated truck traffic for maximum compaction. Typically, 50% the truck loads would contain a rock two to four feet in diameter, making it impossible to spread thin lifts. An alternative plan to dump in piles and spread fill by other means was quickly adopted.

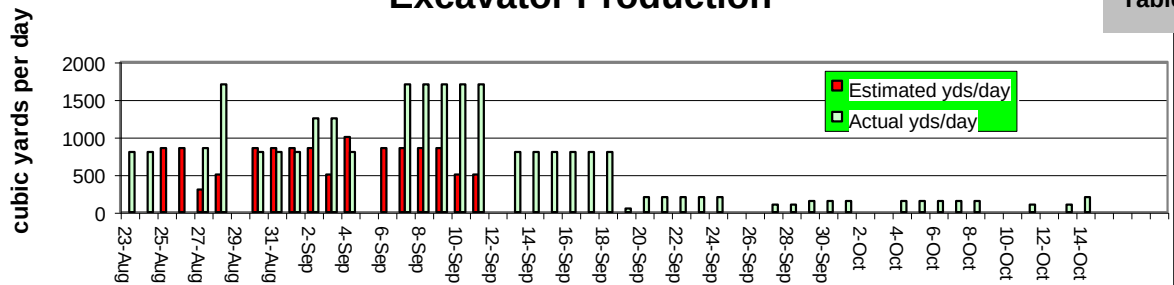
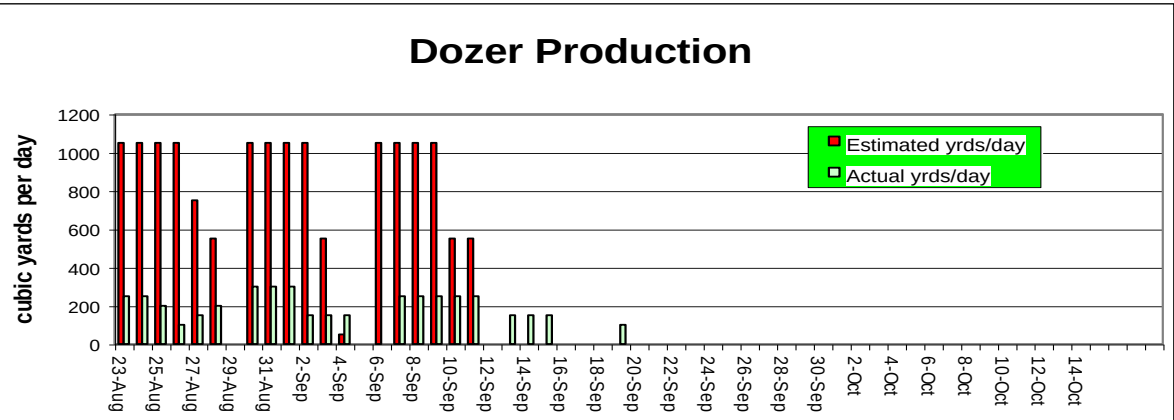
Figure 3. Estimated and actual production (yd<sup>3</sup>/day) for excavator(s) and dozer(s). The dozer production was significantly reduced due the abundance of large rocks in the fill, requiring increased production from the excavator(s). Dozer ‘production’ is absent after implementation of the MMP since the excavators were generating all the fill. Production is determined by which machine generates fill to be moved and does not relate to how fill was delivered to fillsite once mobilized.

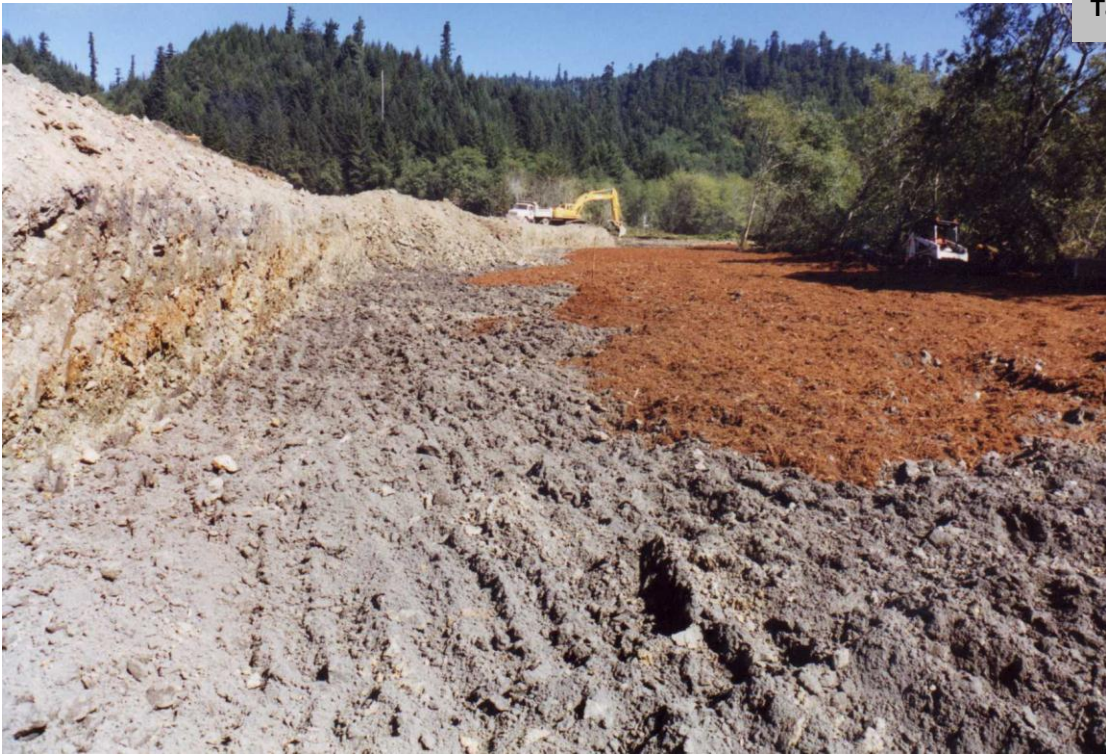
The pre-existing morphology of the buried wetland was easily interpretable during excavation. The wetland soils were intact and composed of silt, fine and coarse sands relative to their proximity to Prairie Creek. The deck fill was consistently of a different nature, providing an obvious contact with the buried original soil (see photo 4.). Subtle depressions of a foot or more in the wetland surface were identifiable and replicable. Restoration of the original morphology was easier than anticipated, but blending that morphology with areas that were not being restored was a continuous challenge.

Photo 4. Original wetland soil surface contrasted with imported deck fill.

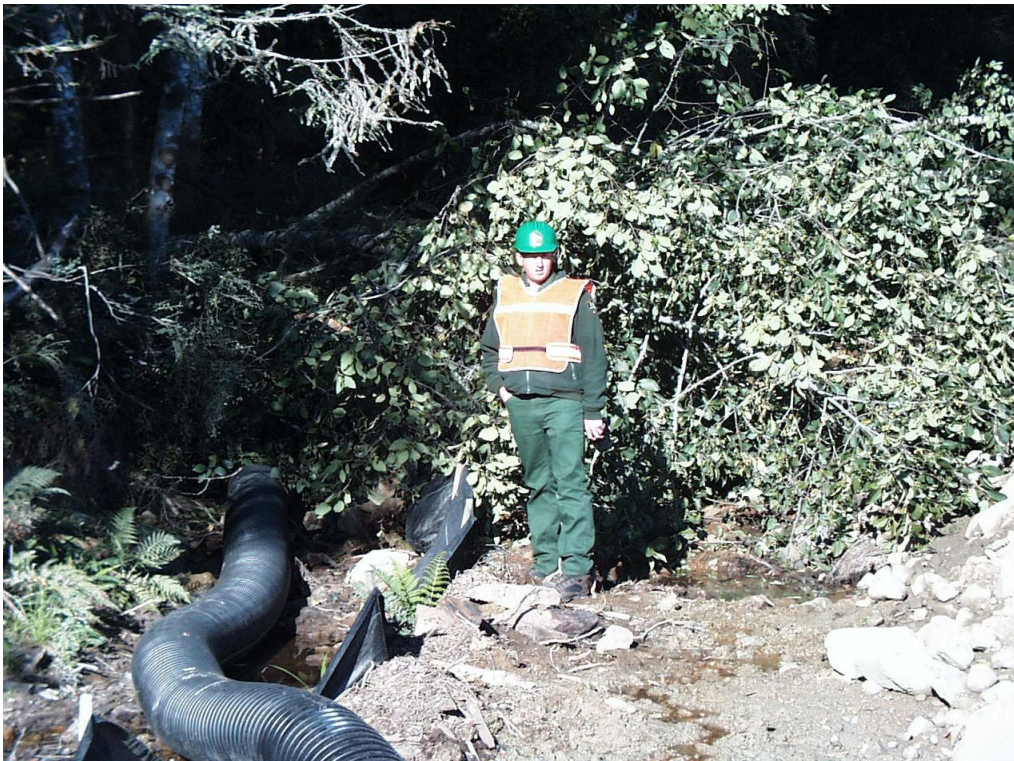
Photo 5. Inlet of diversion pipe with designer / builder (Dave Anderson, Fisheries Biologist).

The drop in production caused by the excessive moisture in the fill and the threat of turbid water entering Prairie Creek instigated the development of a Muck Management Plan (MMP). The MMP entailed pumping of the impoundment, installing a new diversion culvert and procuring additional equipment. The high turbidity of the impounded water required that it not be allowed to flow directly into Prairie Creek. Water from the impoundment was pumped across Prairie Creek to the middle of the eastern wetland to allow for ground percolation. A new, relatively water tight, diversion pipe was installed upstream of the culvert on Davison Creek and additional equipment was contracted.

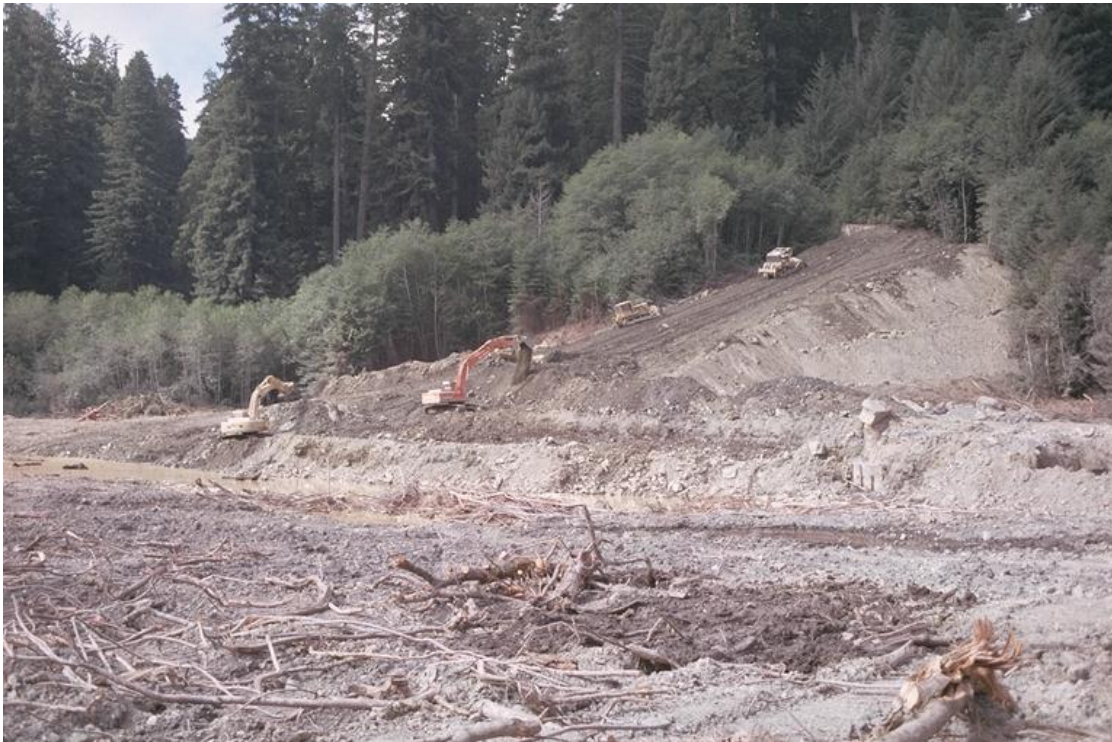
The morphology of the restored wetland and the interception of ground water caused the wetland to collect water. The pond was typically one to two feet in depth along the lower edge of the fill slope. Excavation along the pond produced liquefied soil and sticky mud (herein referred to as muck).

When the moisture content of the excavated material increases, it becomes harder to push with a dozer (dozers are typically the most efficient way to move dirt short distances). Moisture tends to cause material to stick to the blade (especially when pushing uphill) and greatly reduces traction (getting stuck usually happens when muck is present). One strategy for dealing with excessively moist material is to blend or mix with dry material. To do this, an additional excavator was rented and used to repeatedly pile muck (a

Photo 6. Multiple bailing effort to mix muck with dry fill. Note ponded water at base of excavation.

procedure referred to as multiple bailing). In this fashion, we were able to incorporate enough dry fill into the muck that it eventually became pushable again (typically after the third bailing effort). Multiple bailing greatly reduces production rates (typically to 10 - 15 yd<sup>3</sup>s per hour). Consequently, in order to meet deadlines, more equipment is required. The drop in production can be seen in the production chart (fig 3.).

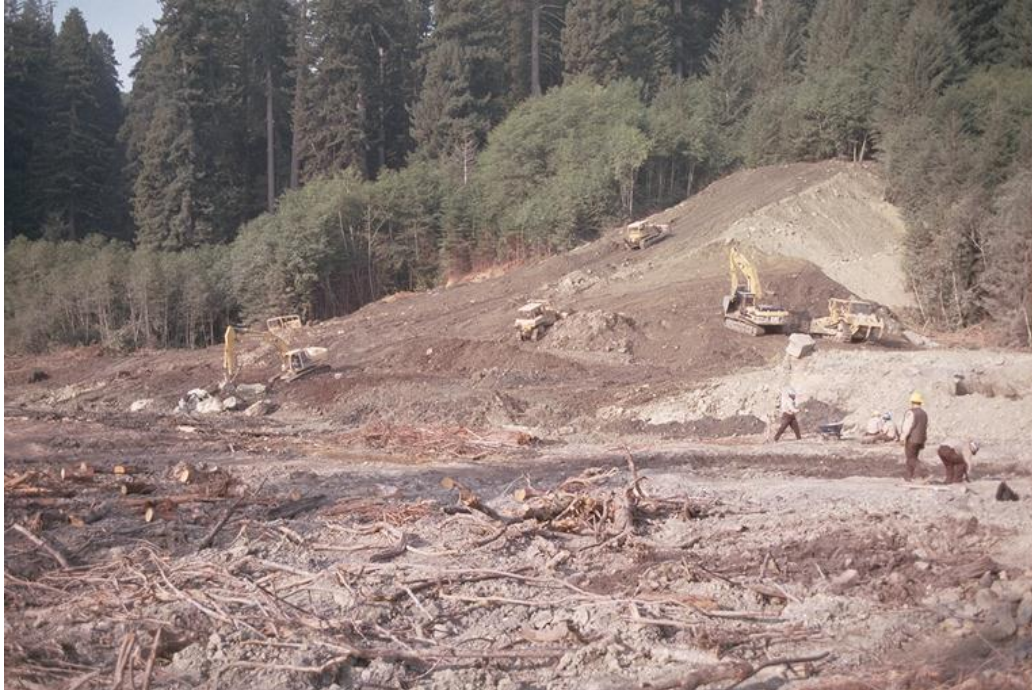
During the final portion of deck removal, eleven Large, Formidable Rocks (LFR's) were uncovered. The LFR's were schist boulders, eight to 10 feet in diameter that had been blown out of quarry pit in the initial phase of deck construction (personal communication, Robert Miller). The boulders had been too big to move easily, therefore simply rolled down from the quarry and left in the stream channel at the base of the ridge.

Photo 7. Large, Formidable Rocks (LFR's) at base of slope. Both excavators were required to move the boulders.

Initially, there was little hope that we would be able to remove the LFR's. Neither 230 or the 330 excavator could move the boulders. An attempt to locate a licensed blaster was made, but the window of opportunity to access the LFR's was short. One LFR was split using expanding clay. The expansion process required one day for drilling and placing the clay and another 24 hours or more to actually split the boulder. The excavator operators (Paul Harris, RNP and Roger Henslee, Z Logging LLC) figured out a methodology using both excavators, side by side, that allowed them to pull the LFR's onto the deck surface. Once a LFR was on the deck, a D8 could roll the LFR to a more appropriate burial location. Removal of the LFR's required a total of one and a half days for both excavators, and a half day for a D8.

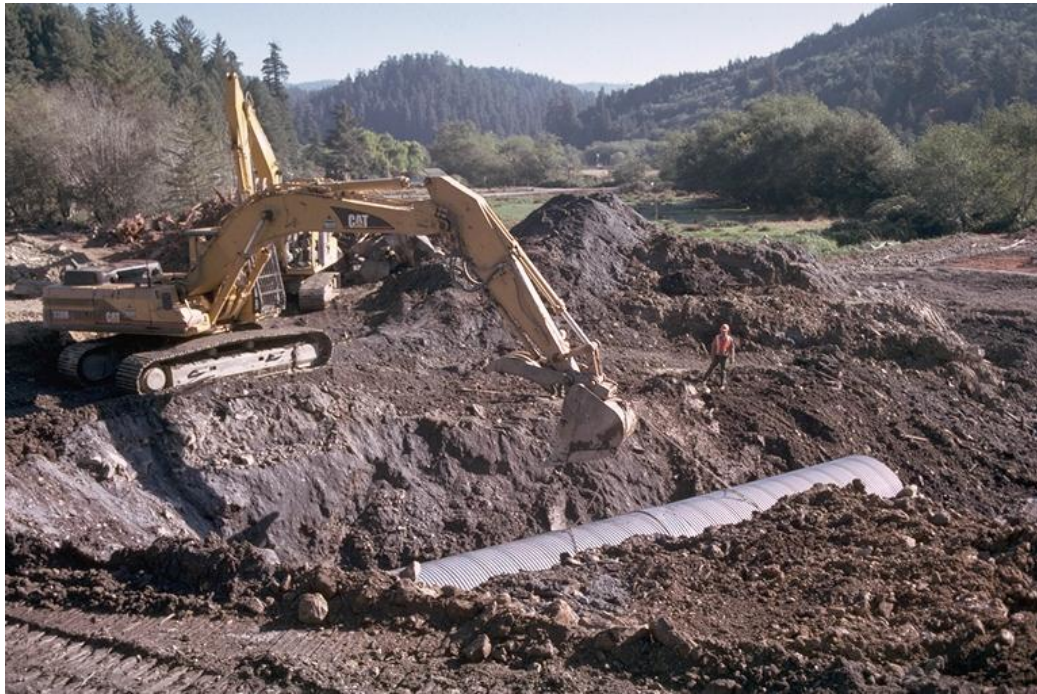
Photo 8. Installing new culvert for Davison Creek. Eight foot diameter culvert was buried half way, allowing channel bed to migrate vertically and horizontally.

An eight-foot diameter culvert was installed for crossing the 200 Road over Davison Creek. The culvert was buried three to four feet deep, allowing channel bed materials to be consistent between upstream and down stream reaches – much as they would through a pipe arch or bridge. Installation entailed digging a bed for the culvert below original grade, back filling with salvaged gravel from old culvert, and restoring channel grade within culvert from stockpiled channel bed material.

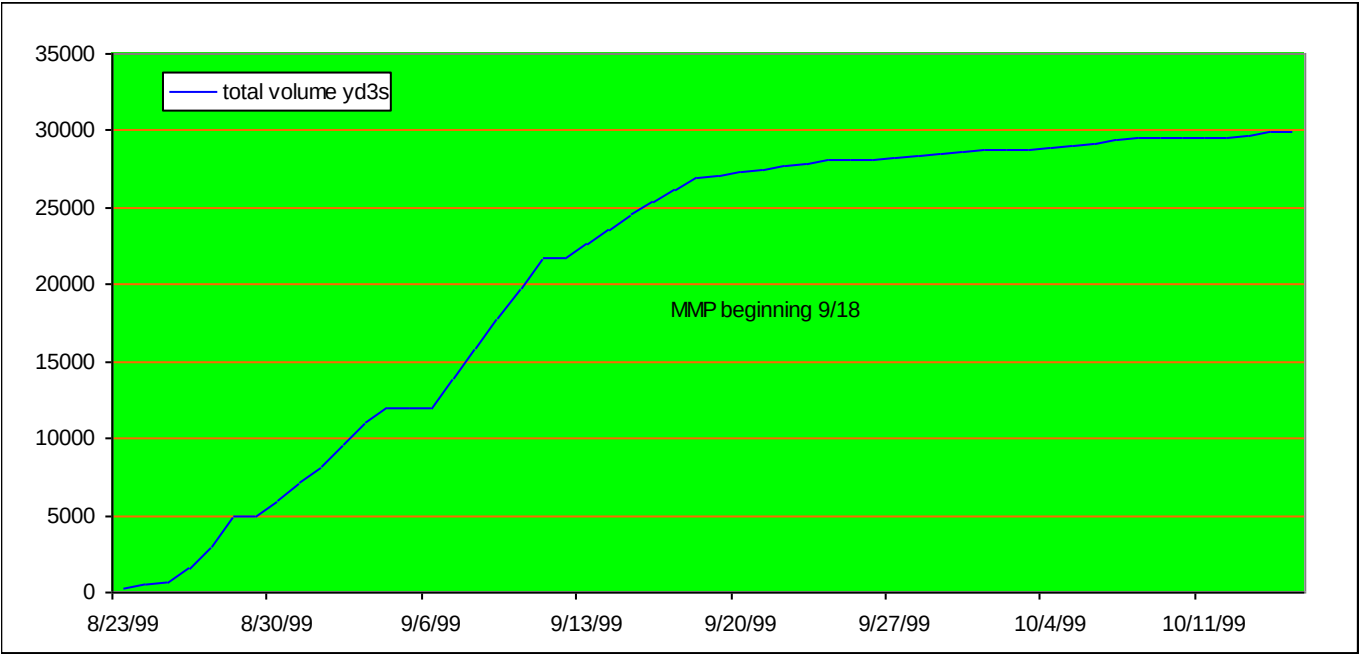
Overall production graph based on total volume (cubic yards) of fill excavated per day. Rate of fill excavated declines as the Muck Management Plan (MMP) becomes necessary.

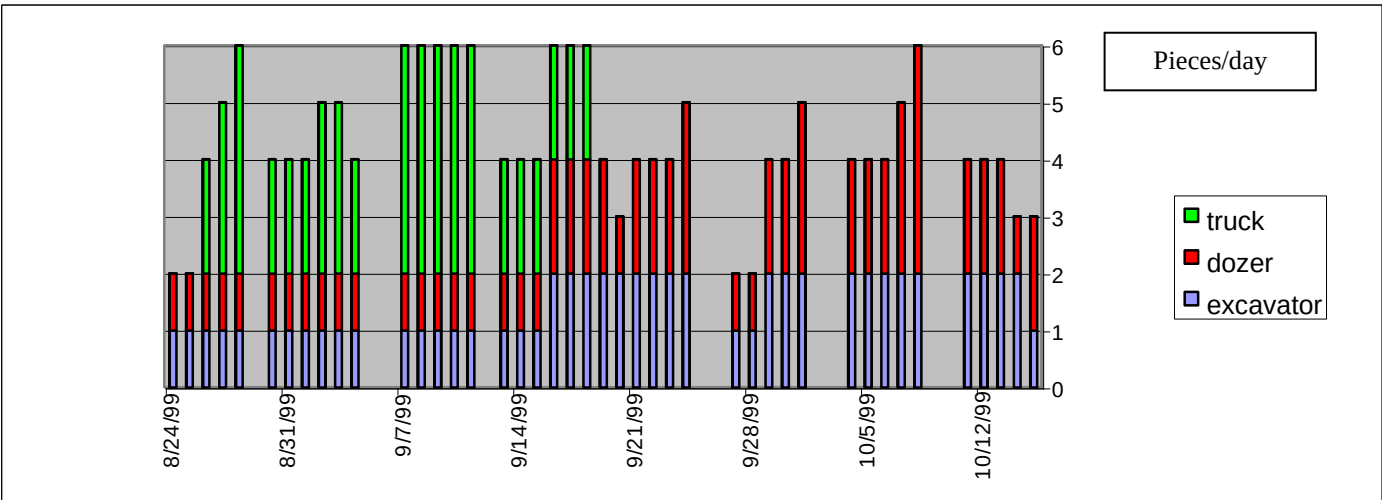
Amount of equipment working on site. Contrast with cumulative volume chart; as MMP develops, more heavy equipment to move less volume.

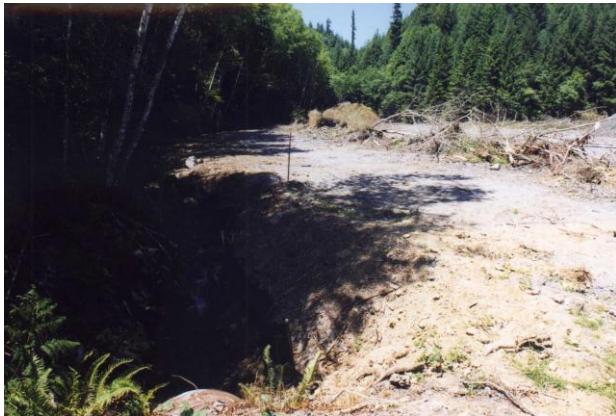
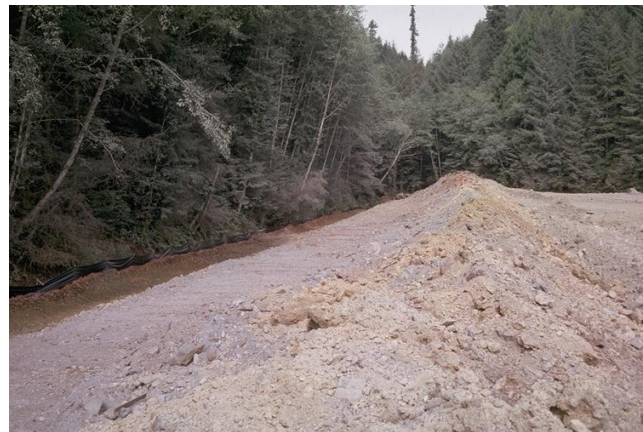
Upper Davison Creek along developed area

Before

After widening

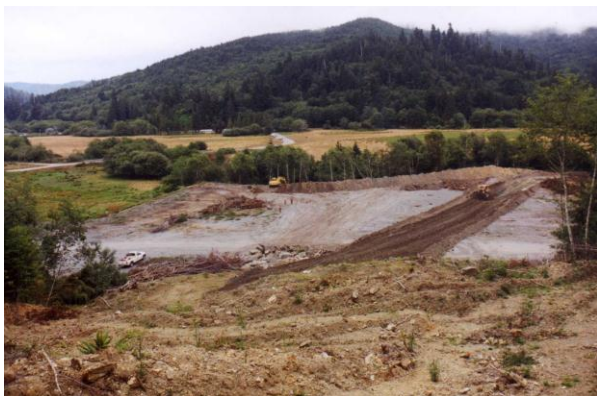
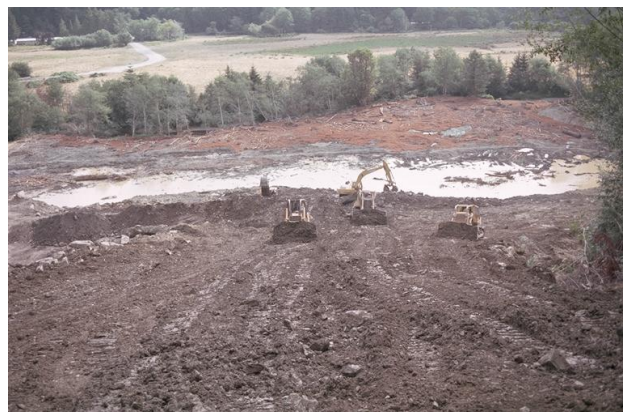
Looking down the lower deck from the top of the rock pit

August 24, 1999

October 7, 1999
