National Park Service
Cultural Landscapes Inventory
2003

Tassi Ranch
Grand Canyon-Parashant National Monument

CULTURAL LANDSCAPES INVENTORY (CLI) PROGRAM
2008 Condition Assessment Update for:

CONDITION ASSESSMENT: **FAIR**

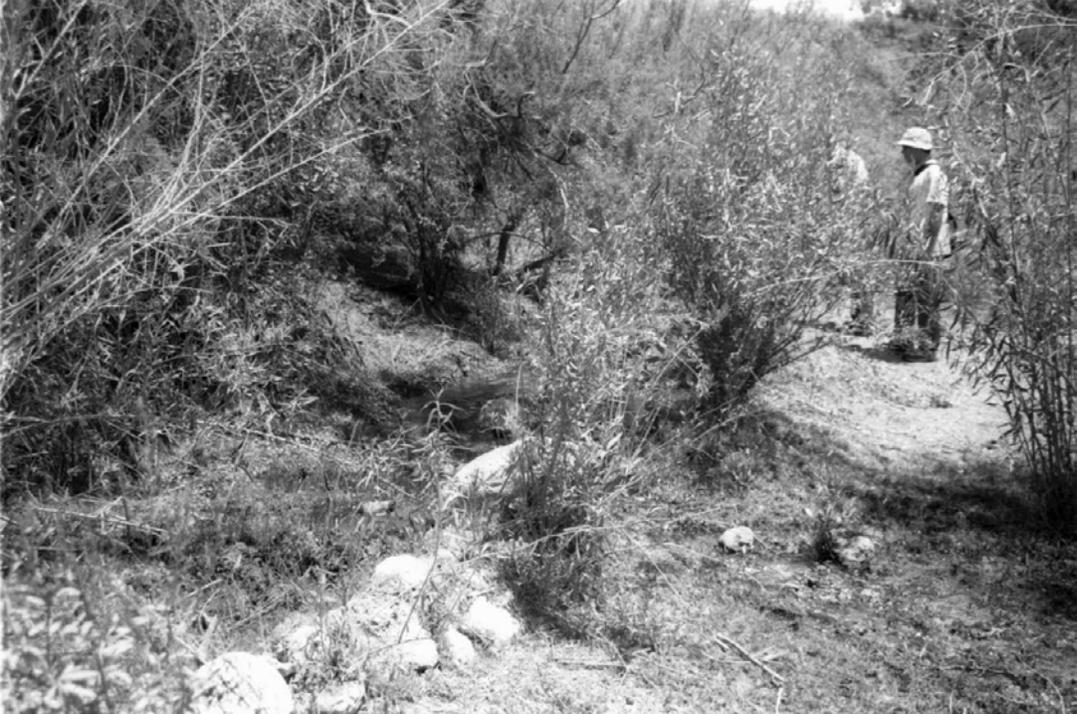
Vegetation #1: Willow and arrowweed thickets growing along the irrigation ditch above the ranch house. (CLI, PARA-N-0001-05, 2002)

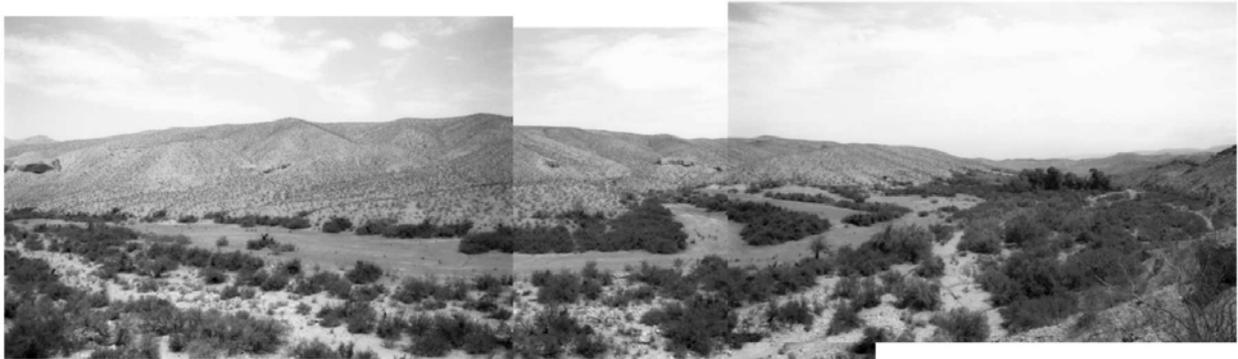
In the agricultural field area of the ranch, catclaw-mesquite thickets have sprouted within distinct areas. These thickets are sharply bordered by the irrigation ditches, suggesting that they may be the result of formerly fallow areas, the last areas to be regularly watered, or the most heavily fertilized areas of the ranch (see photo, Vegetation #2). These thickets, along with those found along the wash and irrigation ditches are non-historic and do not contribute to the landscape's significance.

Vegetation #2: Overview of the agricultural fields, with catclaw and mesquite thickets between irrigation ditches. (CLI, PARA-N-0001-1/2/3, 2002)

The irrigation ditches at Tassi periodically breach their walls and cause the spring waters to run downhill, damaging structures and creating mesquite thickets. The berms should be regularly monitored to prevent further damage to the ditches and the historic features located downslope. Monitoring would also further prevent the growth of additional mesquite/catclaw/willow thickets.

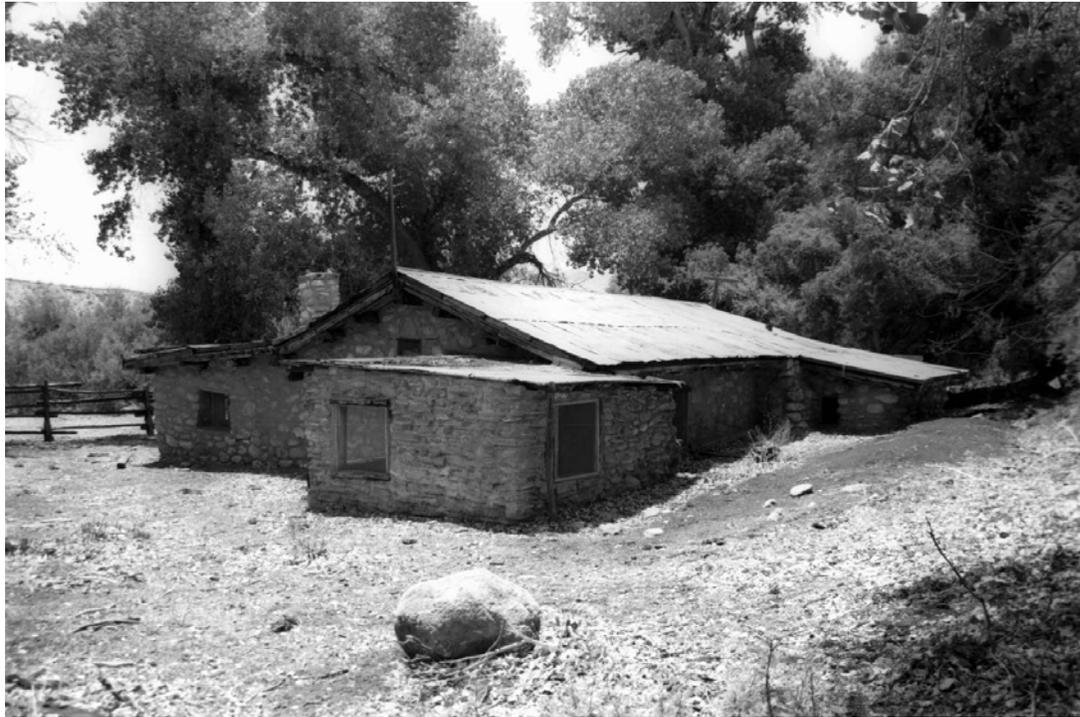
Although cottonwoods were present at the site in 1917 (Belshaw 1980, 108), the alignment of the trees across the front of the present house and barn suggests that both the trees and structures may have been installed at the same time (ca. 1939). This would date the trees to the historic period. The majority of the trees are mature and approaching senescence, although a number of suckers or seedlings are present. Many have large limb failures, and others show evidence of advanced wood decay (Swartzell 2001, 1). One naturally occurring willow by the cistern and one cottonwood south of the corrals were cut down leaving only tall trunks, to be used as "wildlife trees" during stabilization efforts in 2002. A number of other trees were trimmed to reduce hazards at the site (Jones, 2002).

Vegetation #3: Cottonwood trees providing shade over the ranch house. (CLI, PARA-N-0001-24, 2002)

In 2001 an arborist inspected the specimen trees and found that the majority of the trees were approaching senescence and that a number posed immediate threats of collapse and/or limb failure. The following year some trees were stabilized and others were reduced to "wildlife" trees. Periodic inspections of the cottonwoods should be continued, and regular consultation with an arborist should be done in order to protect the trees, and consequently the buildings and structures at Tassi.

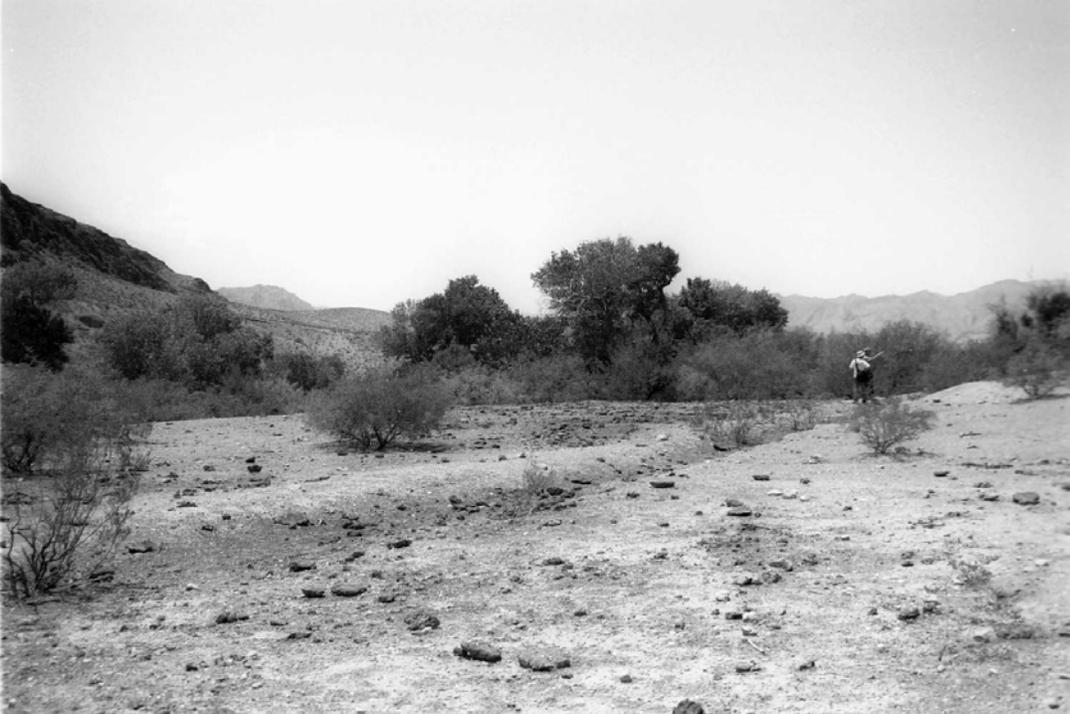
Topography #1: Irrigation ditch near the agricultural fields. (CLI, PARA-N-0001-06, 2002)

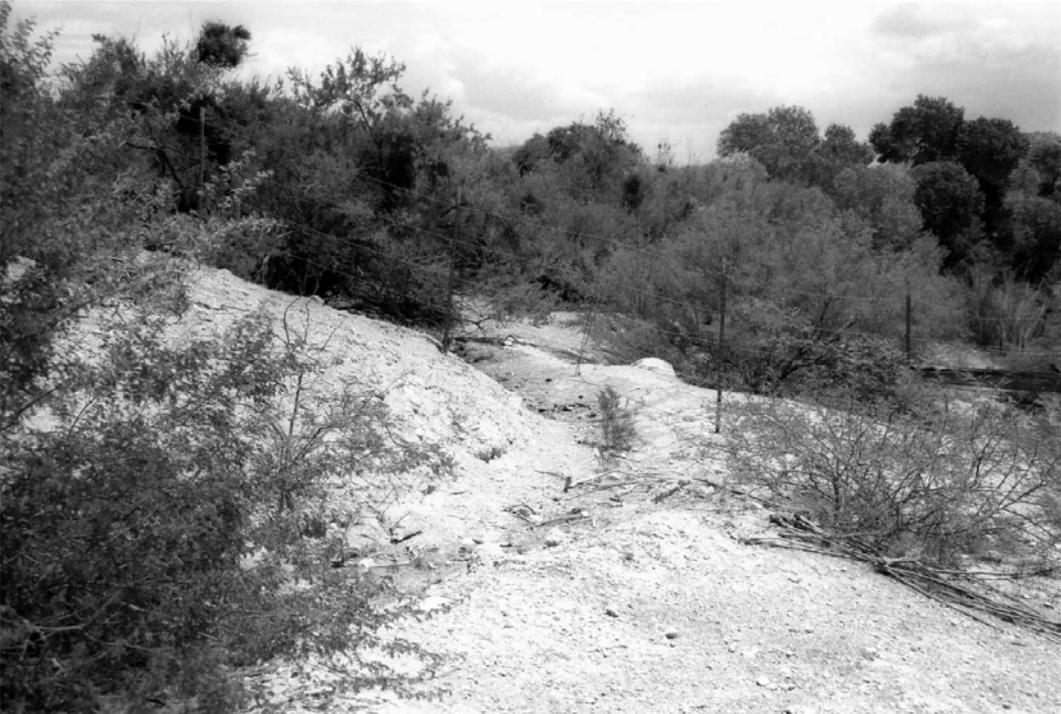
Topography #2: A portion of the main irrigation ditch between the spring heads and the holding pond. (CLI, PARA-N-0001-08, 2002)

If the ditch were to be repaired, the resulting flow would promote the growth of the arrowweed/willow thicket from the spring to the west holding pond. This would increase damage to the ditch from root systems. Further, repairing the ditch would cut off the water supply to the mesquite thicket to the south and destroy the bird habitat there.

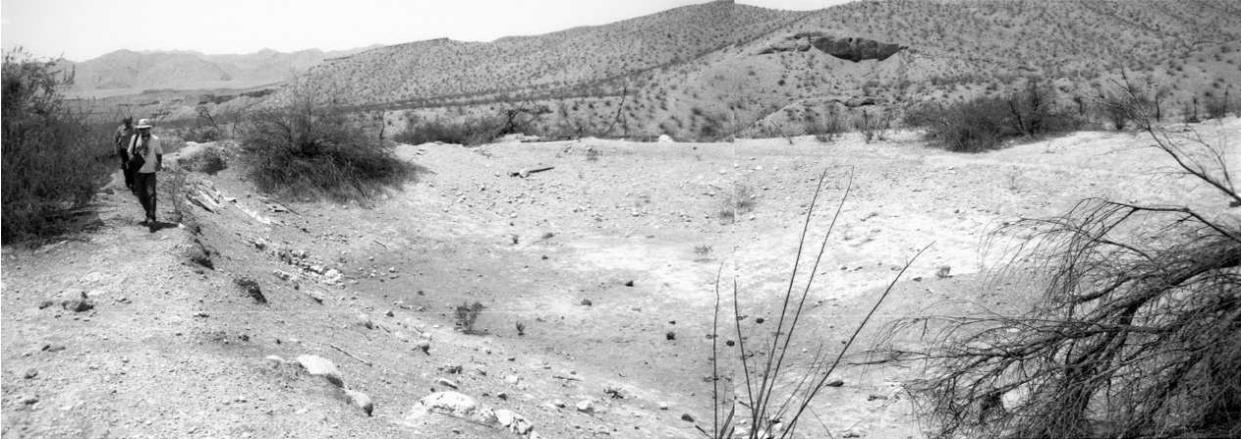
Taking advantage of the upslope spring locations, Ed Yates' irrigation system stocked two holding ponds, now dry, with water from the two primary spring locations. The east holding pond is the smaller of the two, and is located in the pasture above the house. Roughly circular in configuration, the pond has a diameter of sixteen feet. It was likely used to water cattle, as there are no ditches running from it to the surrounding pasture. A single feeder ditch runs to the pond from an unidentified point to the east, and a second, unconnected ditch segment is found in the pasture below. Neither of these ditches, nor the small holding pond, appear to have been connected to a spring, or contain evidence of having water pumped to them. There may, however, be an association with the spring near cistern #2 to the east of the core area. The second and larger west holding pond, located over one thousand feet to the west, is roughly forty-five by ninety feet across (see photo, Topography #3). This pond is fed by a single major ditch that connects it to the springs above the residence to the east. Two primary irrigation ditches leave the holding pond's south and west sides, and in turn branch into numerous ditches running downslope to the south, creating the agricultural field divisions below. A collapsed culvert is at the base of the pond's south side. Within the agricultural fields, furrows can still be seen running downslope from the ditches. These undulations in the surface topography are slight but are significant remnants of the agricultural land use at Tassi Ranch.

Topography #3: The west holding pond. (CLI, PARA-N-0001-11/12, 2002)

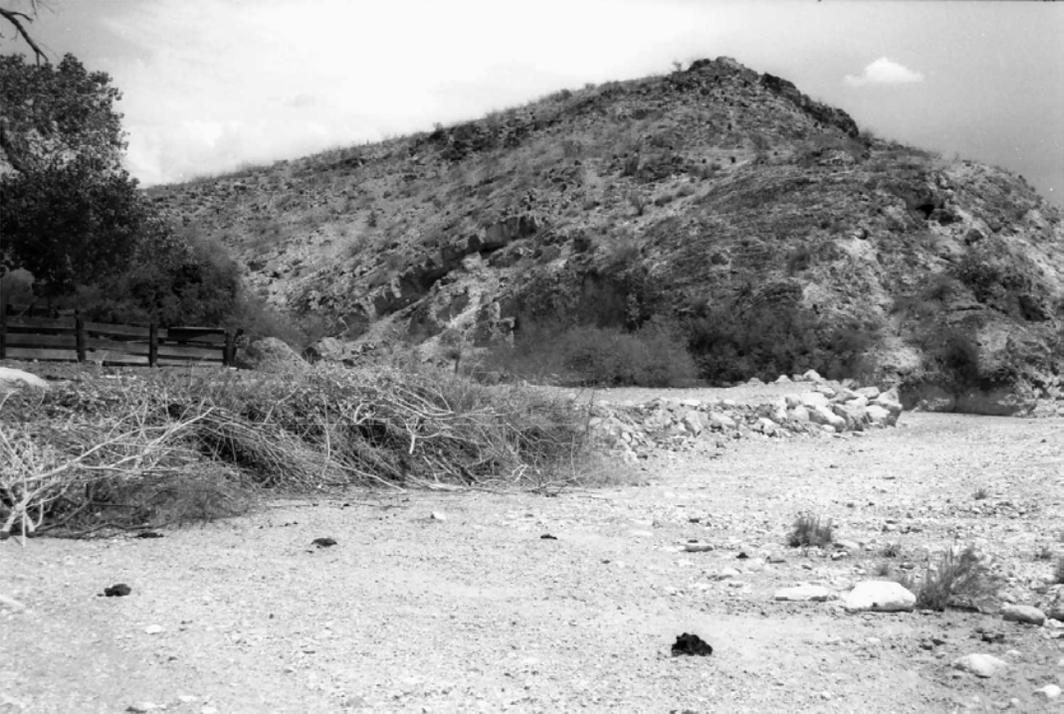
Following a major flood event in 2000, a large level area in front of the core ranch area was eroded away. That year, the NPS constructed a boulder retaining wall along Pigeon Wash and re-graded the fill behind it to match the existing configuration. The topographical area is a contributing feature of the landscape (see photo, Topography #4).

Topography #4: Graded area in front of ranch house, with non-contributing boulder wall along Pigeon Wash. (CLI, PARA-N-0001-15, 2002)

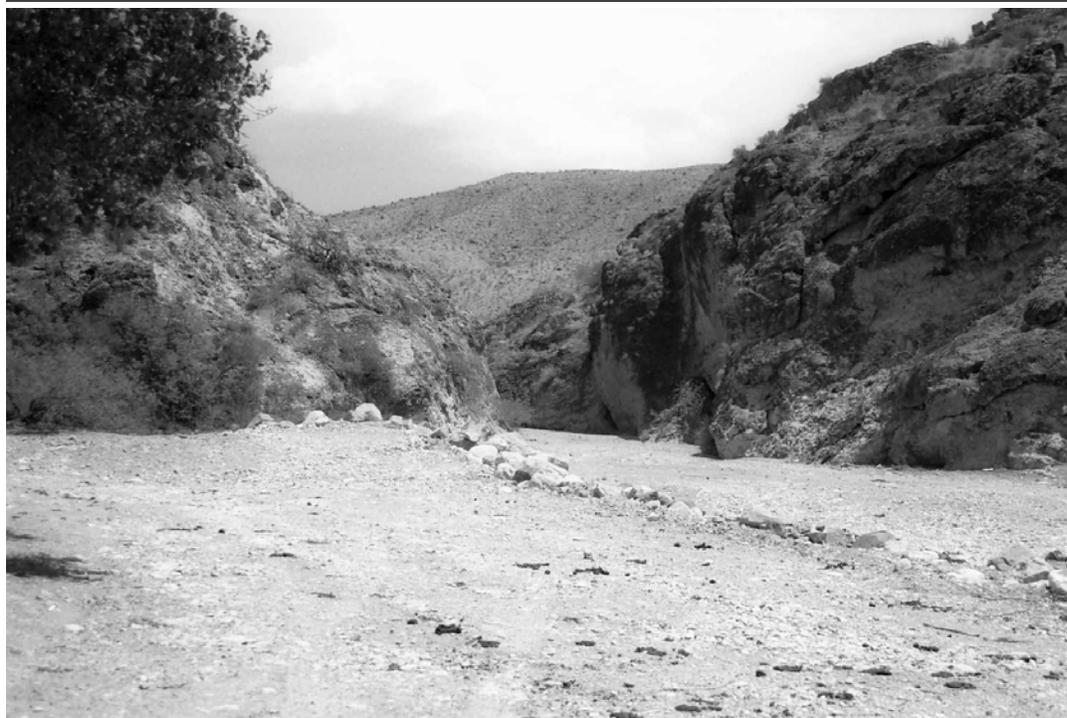
*Circulation #1: Entrance to Tassi Wash, Mohave County Route 149, with Mohave County Route 152 in foreground.
(CLI, PARA-N-0001-16, 2002)*

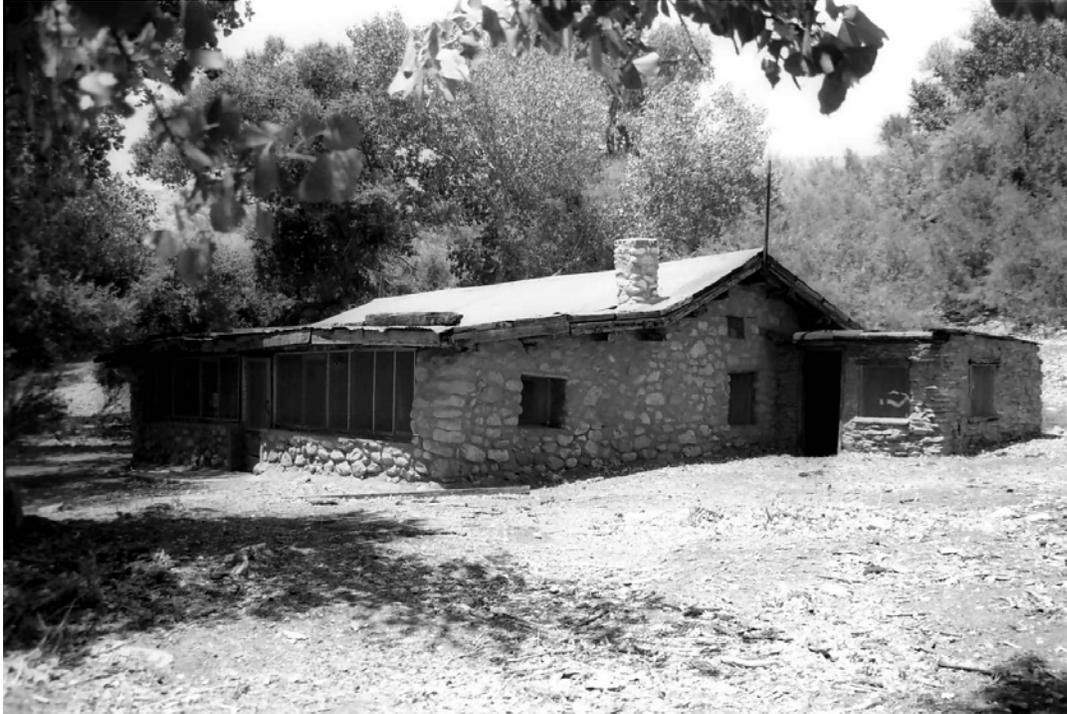
Buildings and Structures #1: The ranch house constructed of river stones and surrounded by cottonwoods. (CLI, PARA-N-0001-25, 2002)

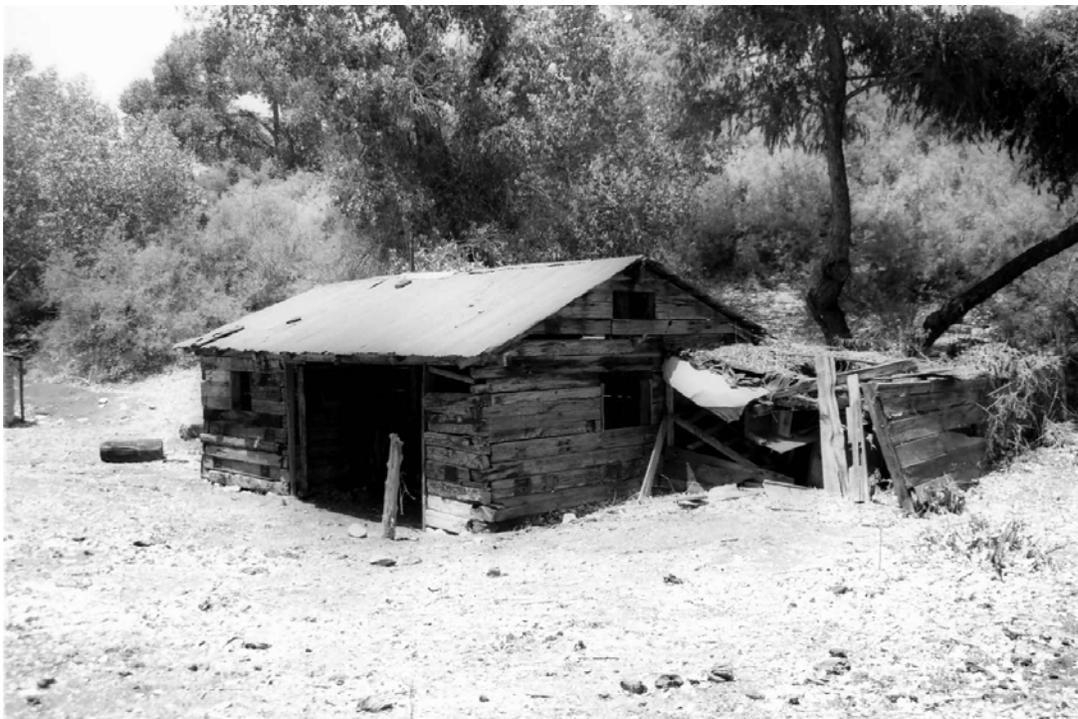
Located 66 feet to the east of the ranch house, this two-room building is constructed of stacked railroad ties with lapped ends, and a corrugated metal roof (see photo, Buildings and Structures #2). The building sits on a foundation of river stones. One large, primary opening faces south into a large open work area adjoining the corrals. A collapsed chicken coop is attached to the east end.

Buildings and Structures #2: The barn constructed with salvaged railroad ties. Note collapsed chicken coop. (CLI, PARA-N-0001-22, 2002)

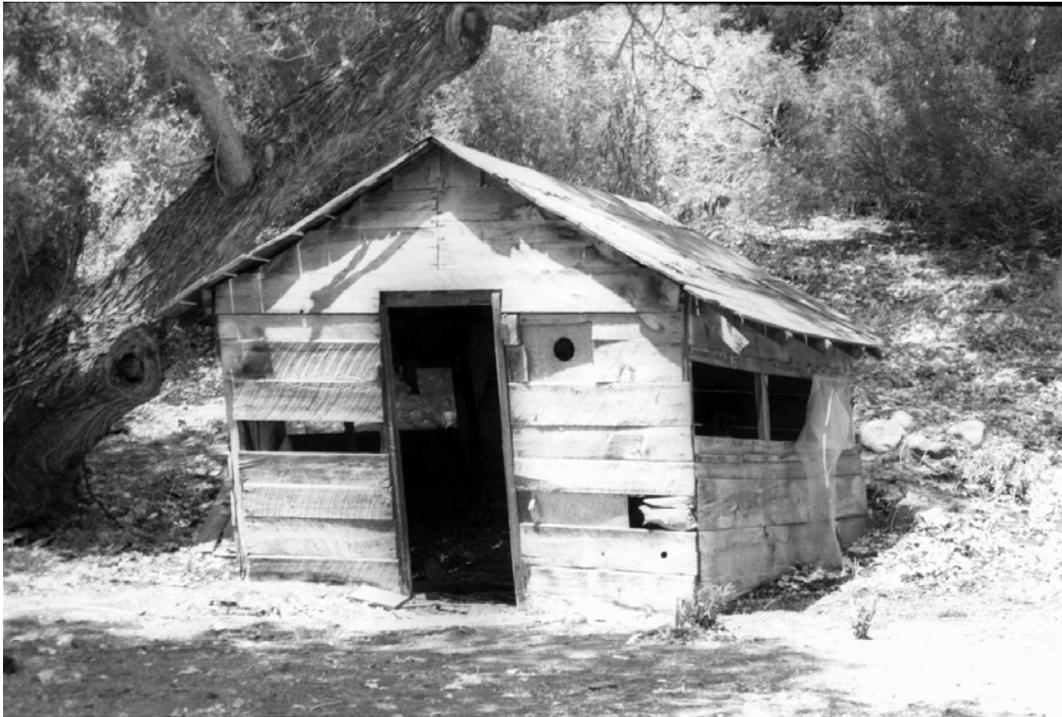
Buildings and Structures #3: The shed, constructed of milled lumber. (CLI, PARA-N-0001-28, 2002)

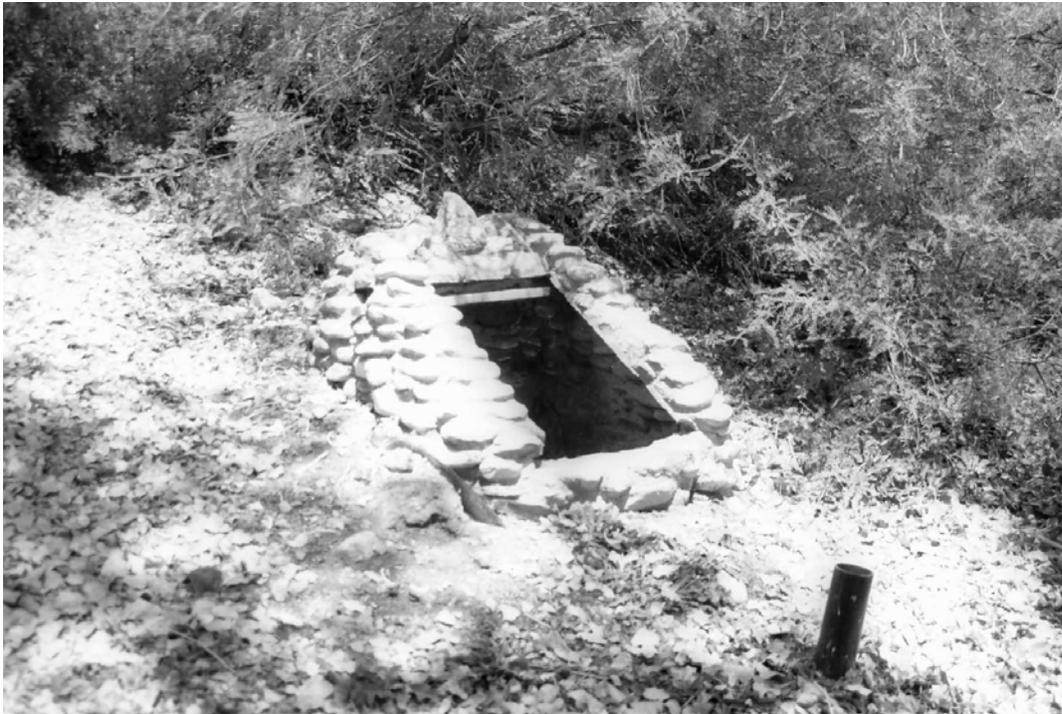
Buildings and Structures #4: Cistern #1 constructed of river stones. (CLI, PARA-N-0001-0023, 2002)

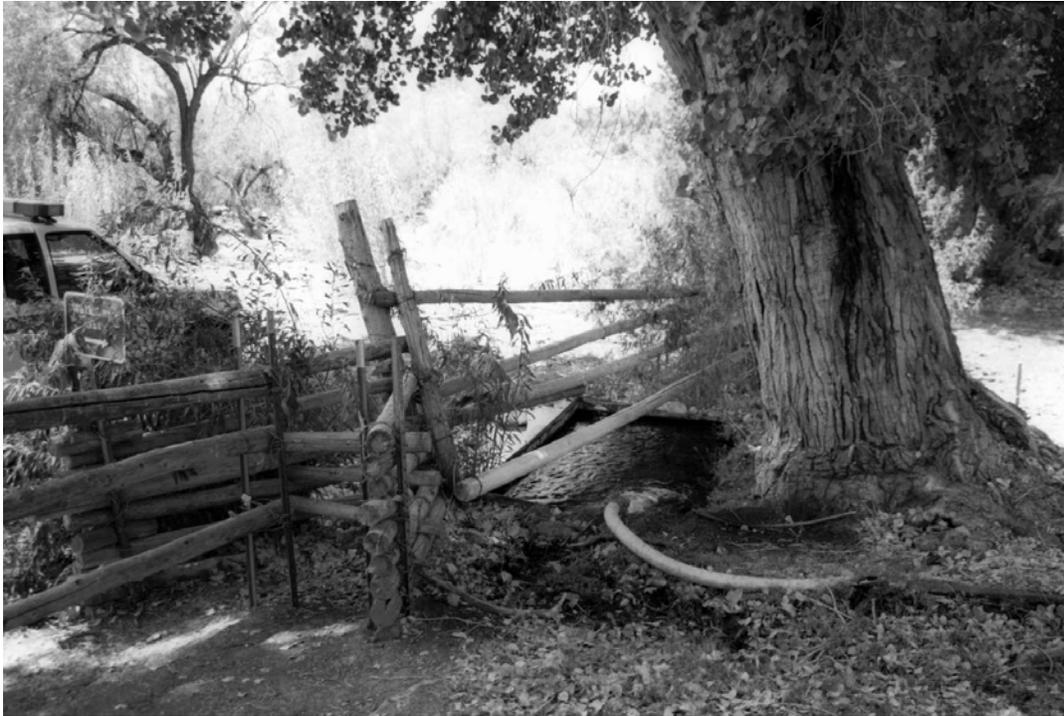
Small Scale Features #1: Metal stock tank at southern fenceline. (CLI, PARA-N-0001-27, 2002)

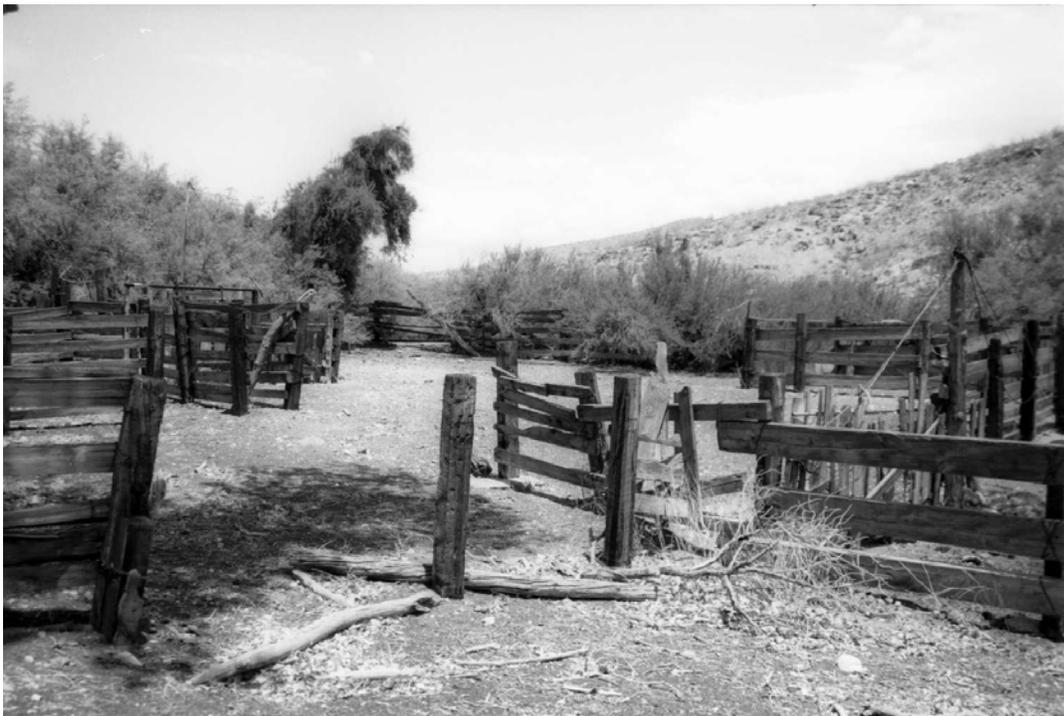
The corrals are at the eastern edge of the ranch complex. Constructed of salvaged lumber, railroad ties, and other materials, the corrals are divided into ten pens and a central chute (see photos, Small Scale Features #3 and #4). Gates in the corrals exit west toward the barn and south toward the road, allowing access from work and transportation areas.

Small Scale Features #2: Interior of corrals, note railroad tie posts. (CLI, PARA-N-0001-18, 2002)

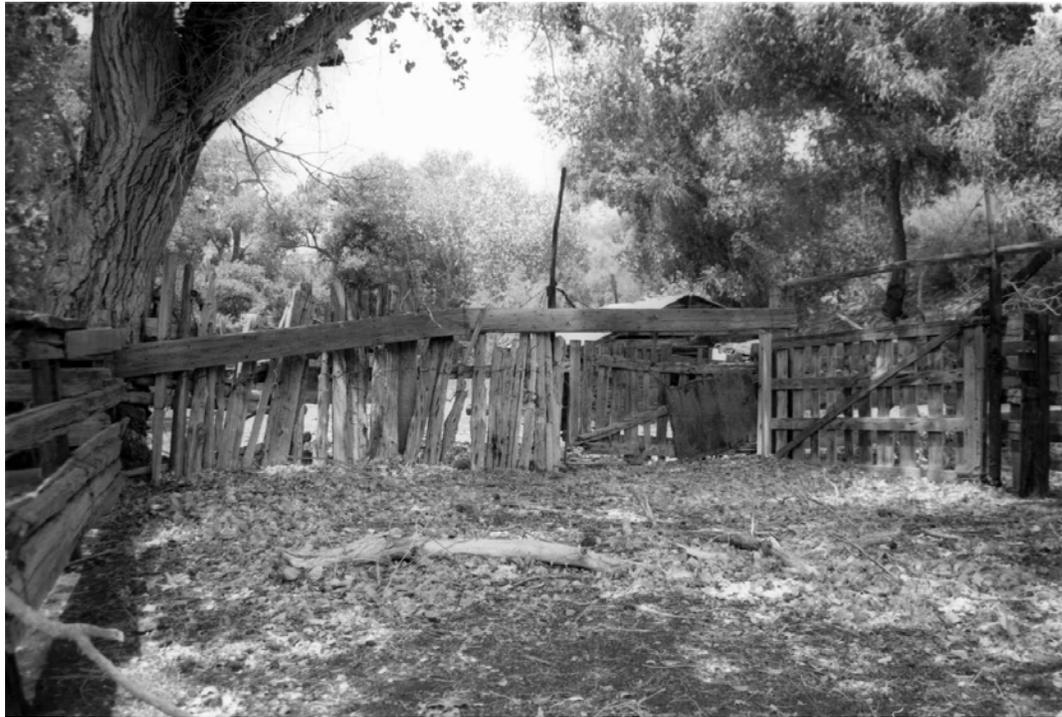
Small Scale Features #3: Detail of corral construction, note railroad ties, milled lumber, and unmilled posts used for fencing material. (CLI, PARA-N-0001-19, 2002)
