Cultural Landscape Inventory Level II:
Tower House Historic District
Whiskeytown – Shasta – Trinity National Recreation Area

MANAGEMENT CATEGORY B: **Should be preserved and maintained**

CONDITION ASSESSMENT: **Fair**

**CAMDEN HOUSE HISTORIC DISTRICT
(Tower House Historic District)
WHISKEYTOWN NATIONAL RECREATION AREA**

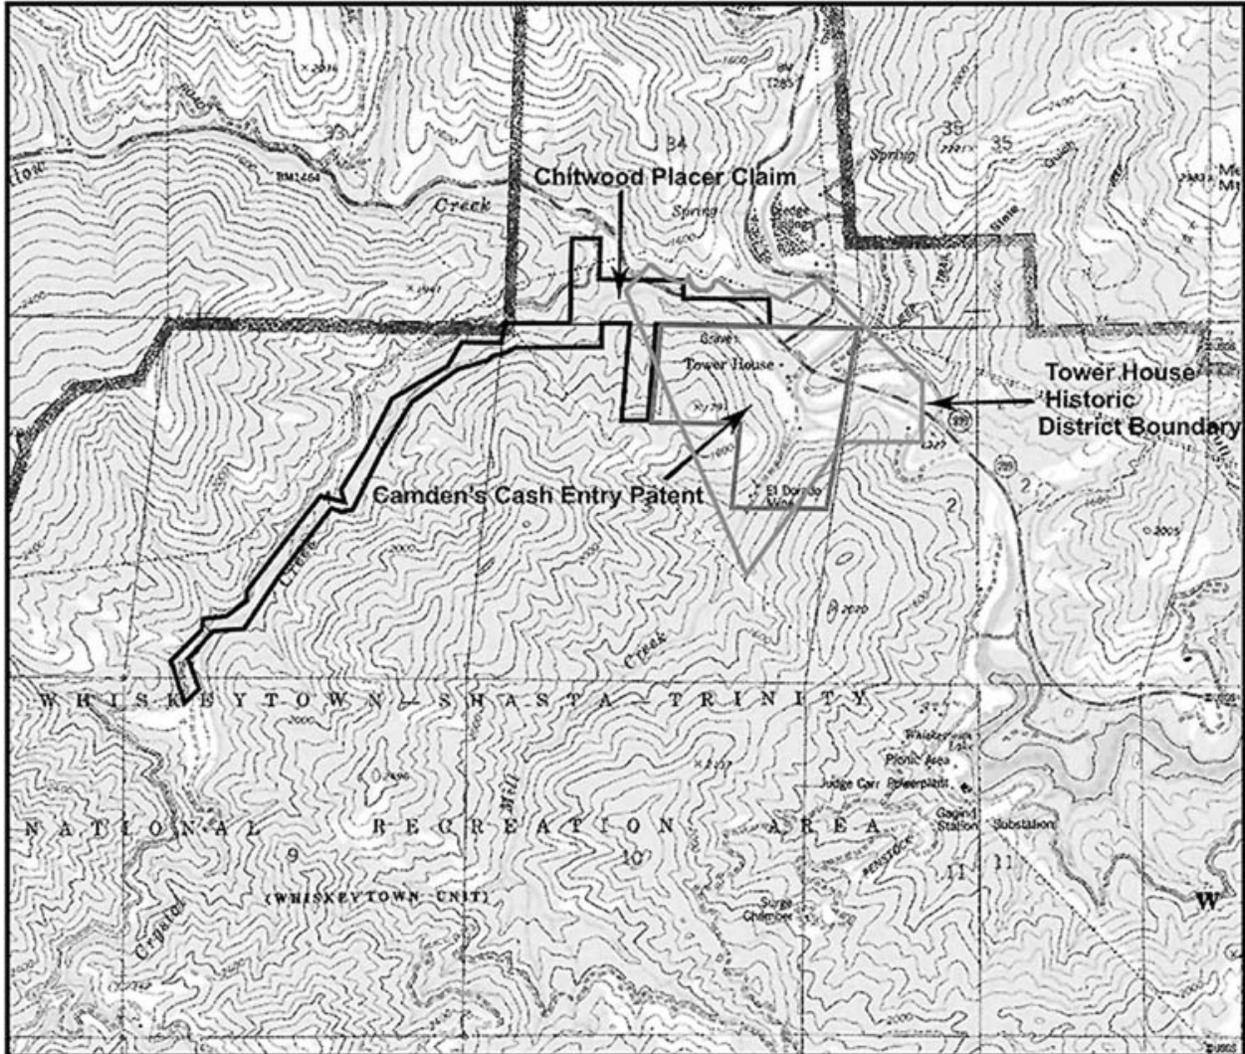
Boundary Map: The original Tower House Historic District boundary and the boundaries of the Camden's claims, the proposed boundary lines for Camden House Historic District.

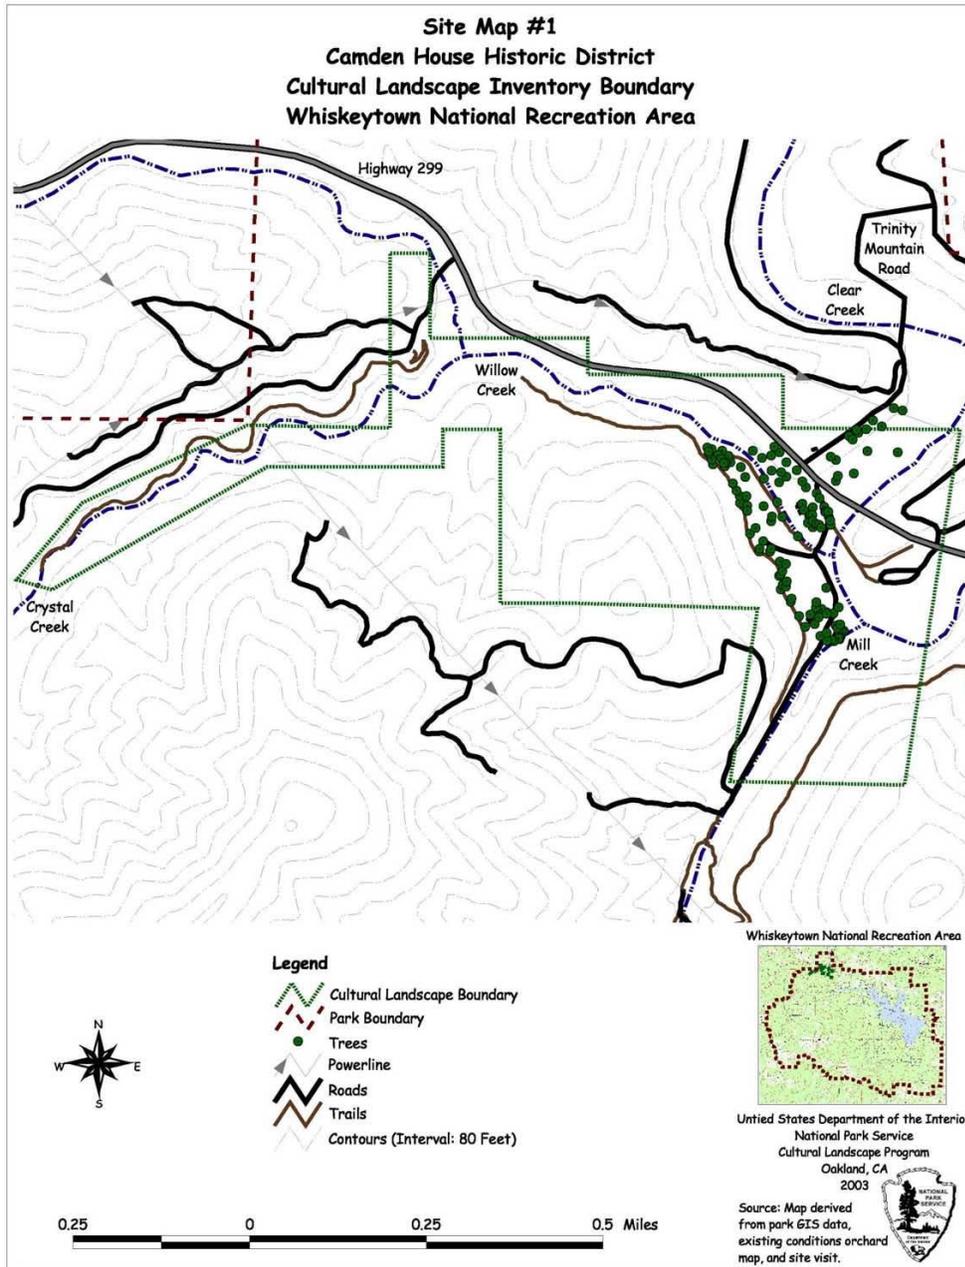
Site Map #1: Depicts the Cultural Landscape Inventory boundary has been amended based on additional information regarding land ownership patterns. (See Appendix for full size map.)

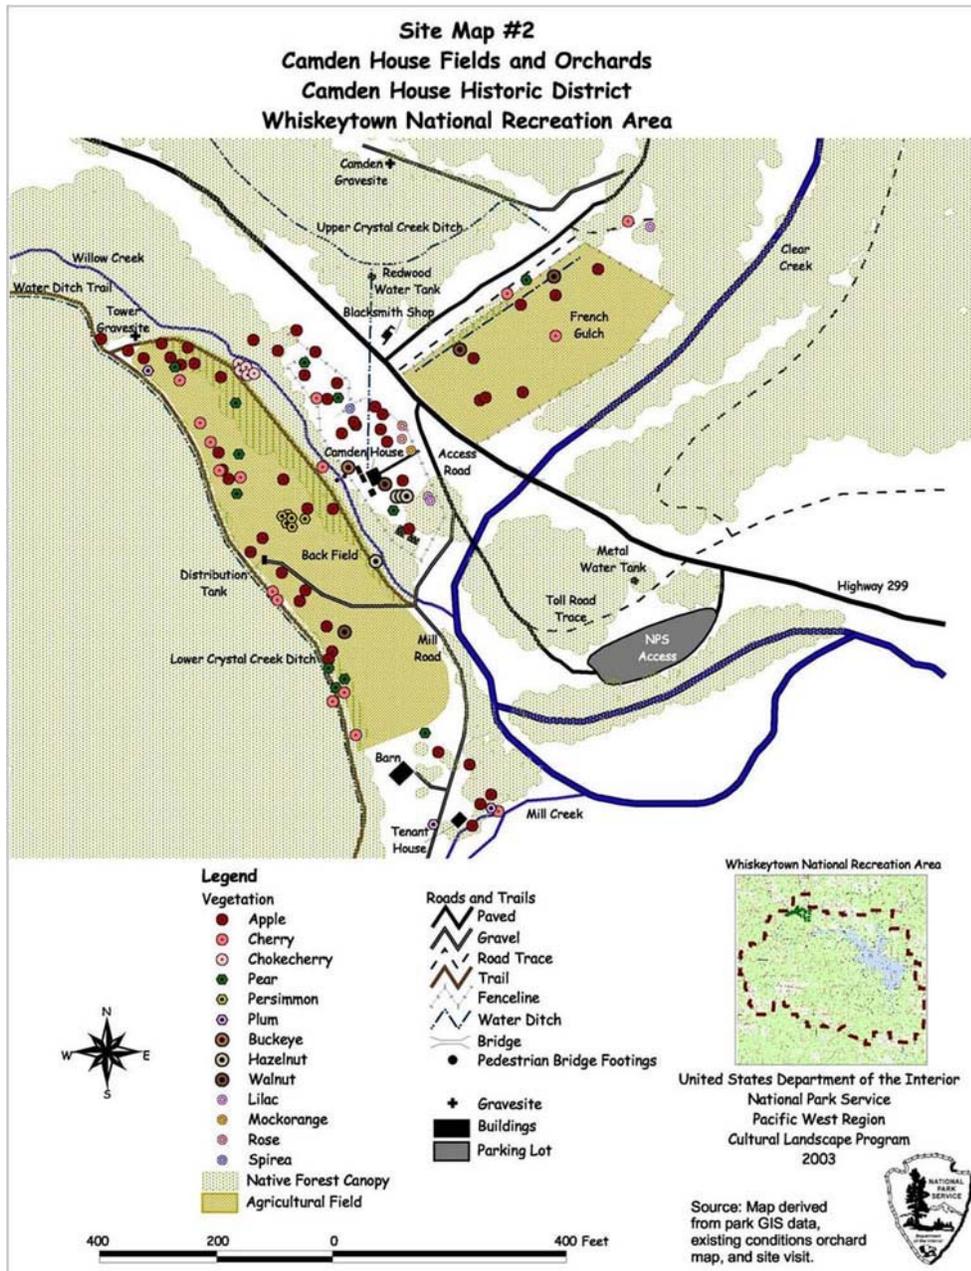
Site Map #2: The fields and orchards within the core developed area of the Camden House Historic District. (See Appendix for full size map.)

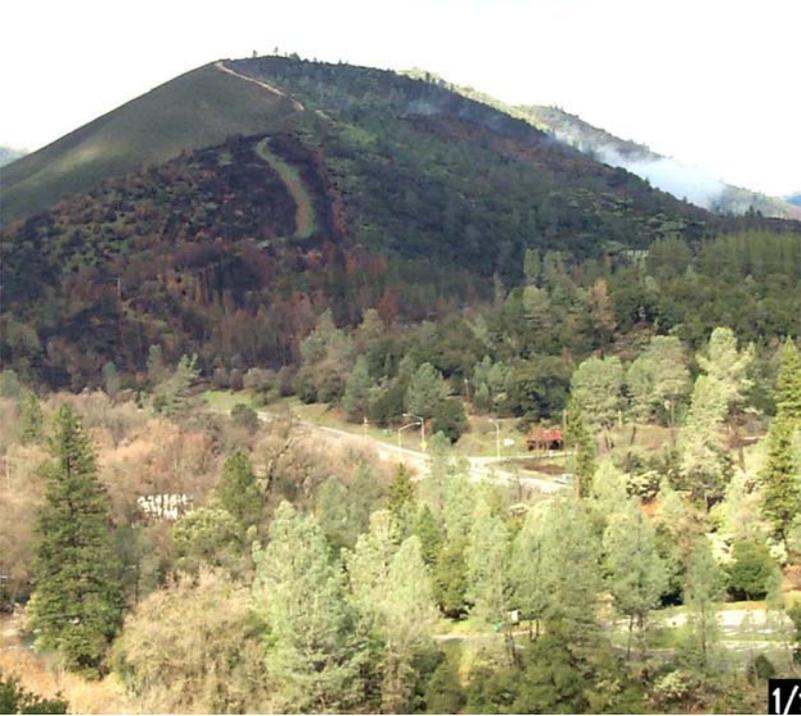
Natural Systems and Features #2: Photograph of the Camden House Historic District looking northwest. (Steve Thede, Whiskeytown NRA, 2000)

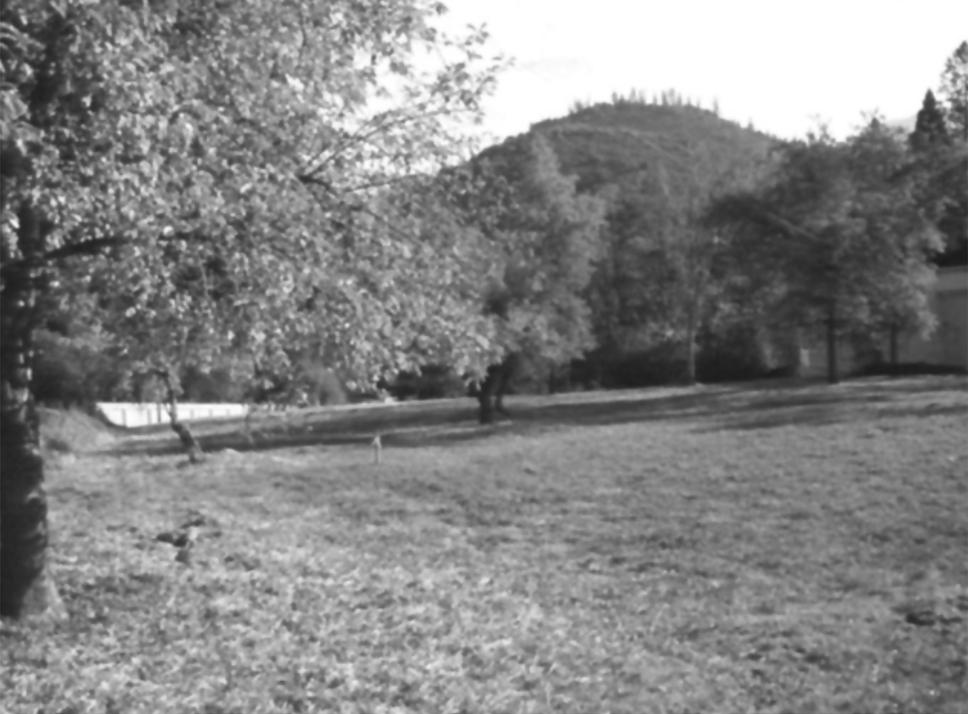
Vegetation #1: View of the historic apple trees in the Camden yard. (PWR, CLI, WHIS-S-0001-9, 2003)

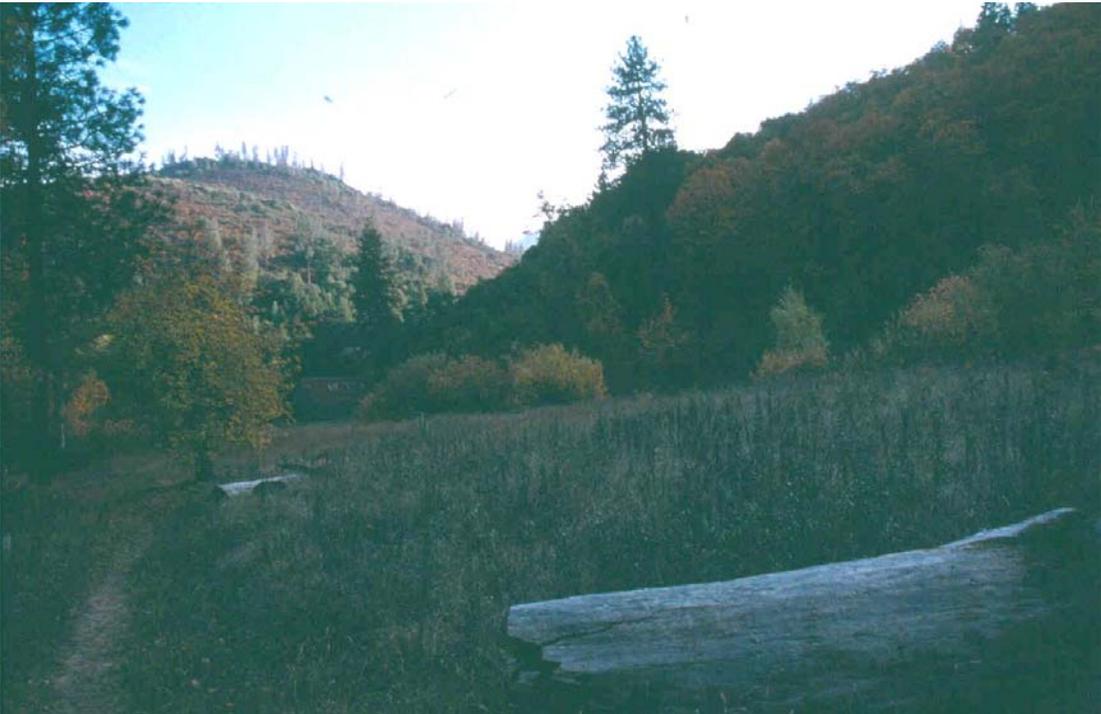
Vegetation #2: View of the Back Field looking west. (PWR, CLI, WHIS-S-0001-21, 2003)

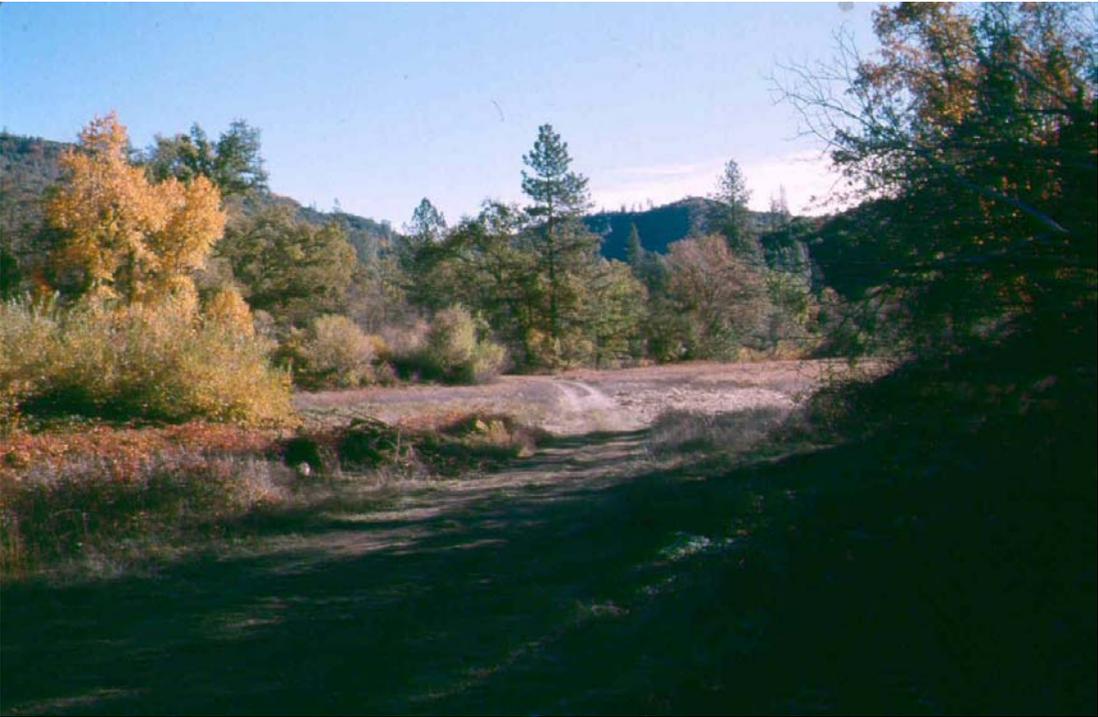
Vegetation #3: View of the Back Field from the water distribution tank. The road to the distribution tank is in the center. (PWR, CLI, WHIS-S-0002-20, 2003)

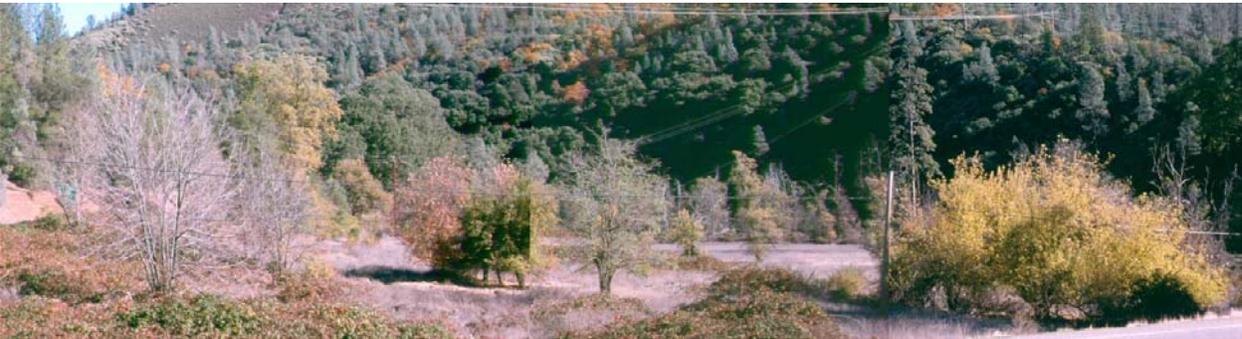
Vegetation #4: Panoramic view of the remaining historic fruit trees in French Gulch. Note the Himalayan blackberry in the foreground. (PWR, CLI, WHIS-S-0002-29, 30, 31, 2003)

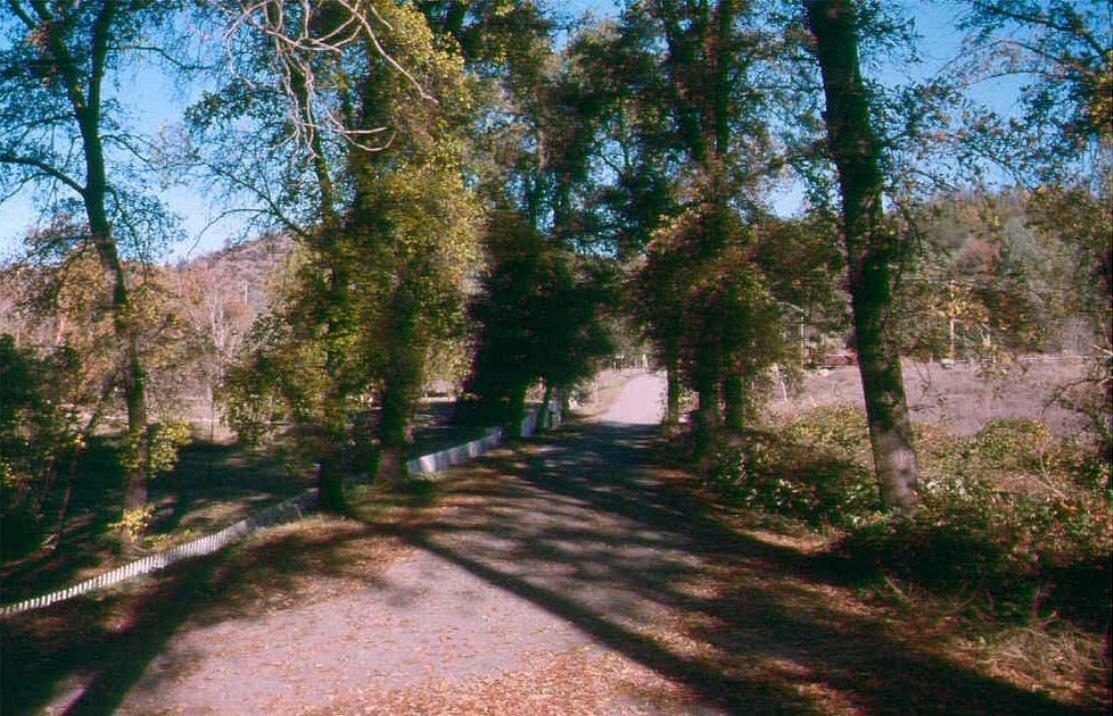
Circulation #1: View of the Service Road, or old Toll Road, facing northwest. (PWR, CLI, WHIS-S-0001-26, 2003)

The circulation systems of the site, especially those in the area south of the highway, appear to be intact. Access to the lower part of Camden's yard is in the same location as it was historically, as is the Mill Road. Both of these roads, as well as the track leading to the Tower gravesite, appear to be in their original alignments and remain unpaved. Similarly, the primary circulation features within the Camden house yard retain integrity. However, the additions of numerous modern roads and trails including Trinity Mountain Road, the road to the water distribution tank in the back field, trail to the public parking area, the transmission line maintenance road, and NPS trails detract from the historic circulation in the Camden House Historic District. Specifically, the old highway/Toll Road, which once provided Tower

and Camden with the impetus to claim the property, established the Tower House as a local transportation and communication center, and was held by the Camden years after other economic ventures in the area had been sold, has been significantly modified or lost.

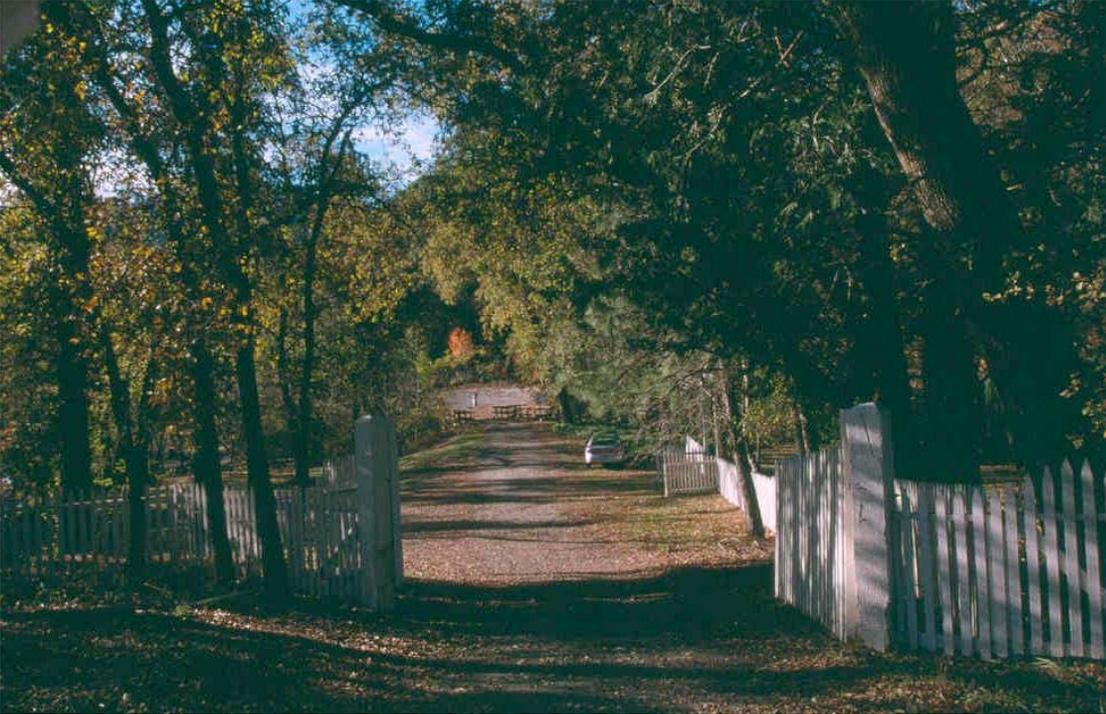
Circulation #2: View of the Mill Road facing southwest. (PWR, CLI, WHIS-S-0001-25, 2003)

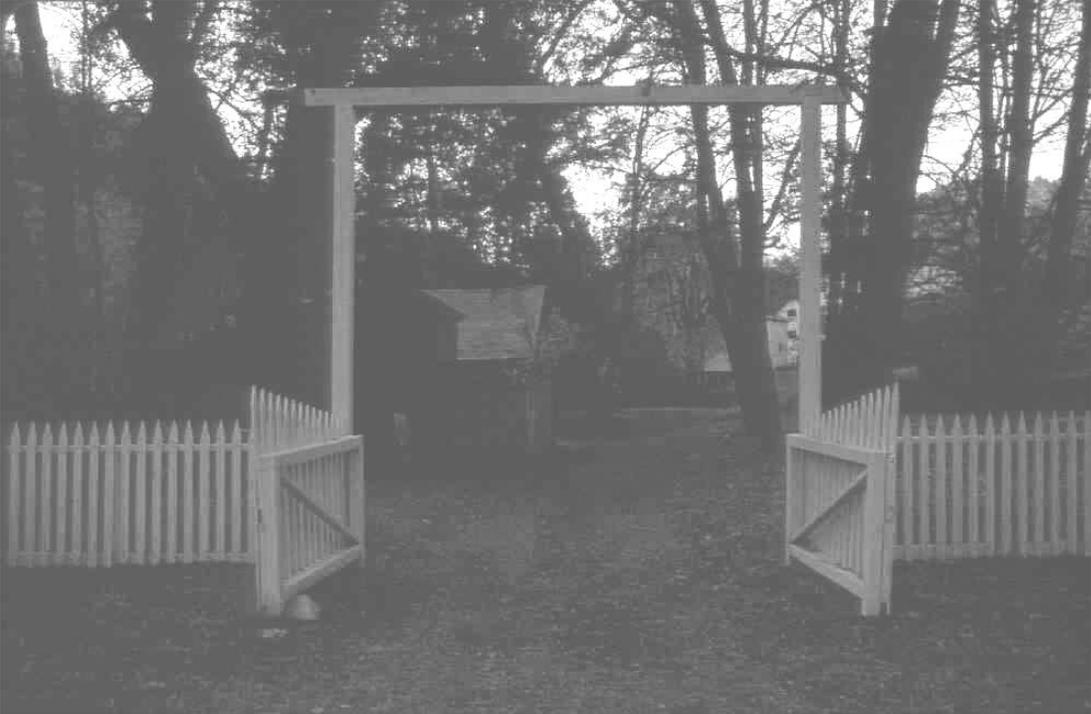
Circulation #3: View of the dirt access road into Camden yard. The garage and carriage house are on the left. (PWR, CLI, WHIS-S-0001-16, 2003)

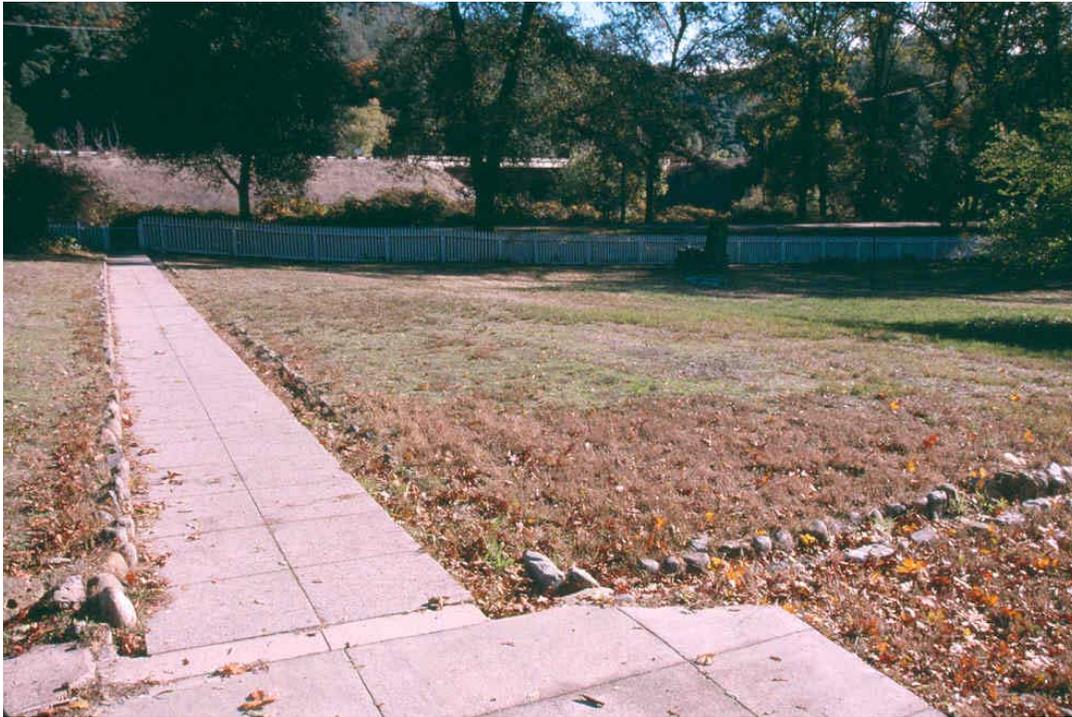
Circulation #4: View of the sidewalk to the Camden house. Note the rock-lined ditch on the right side of the walk way and the stone edging on the left side. (PWR, CLI, WHIS-S-0002-10, 2003)

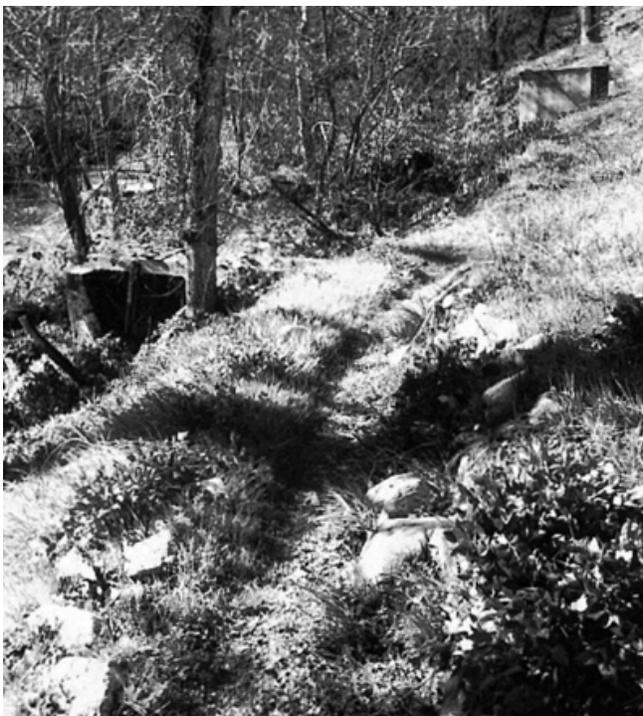
Circulation #5: View of the dirt path from the Camden house to the pedestrian bridge footing, on the left, and the concrete structure, on the right. (CLR, HRA, 1999)

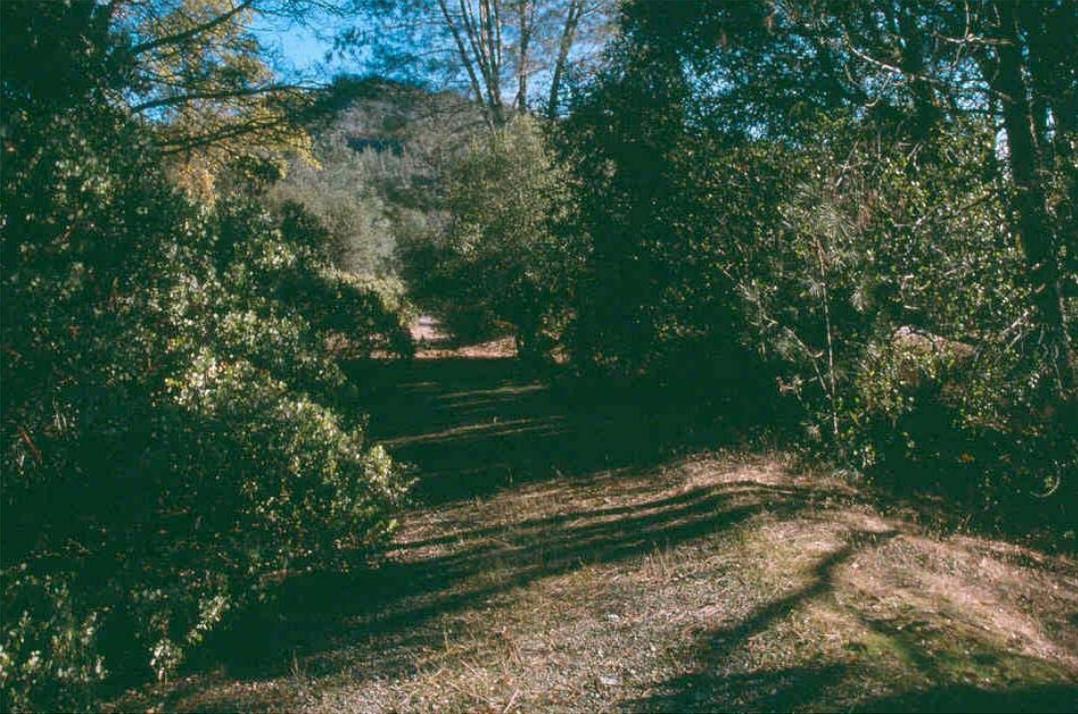
Circulation #6: View of the Toll Road trace. (PWR, CLI, WHIS-S-0001-35, 2003)

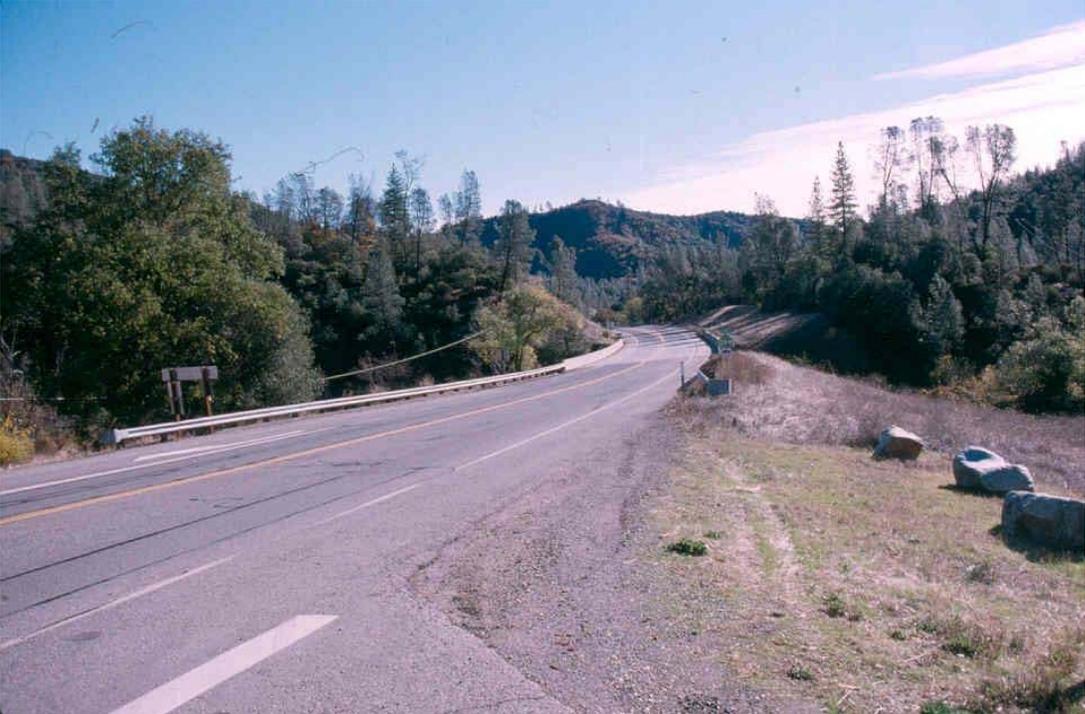
Circulation #7: View of the California State Highway 299 (non-contributing), facing east. (PWR, CLI, WHIS-S-0002-27, 2003)

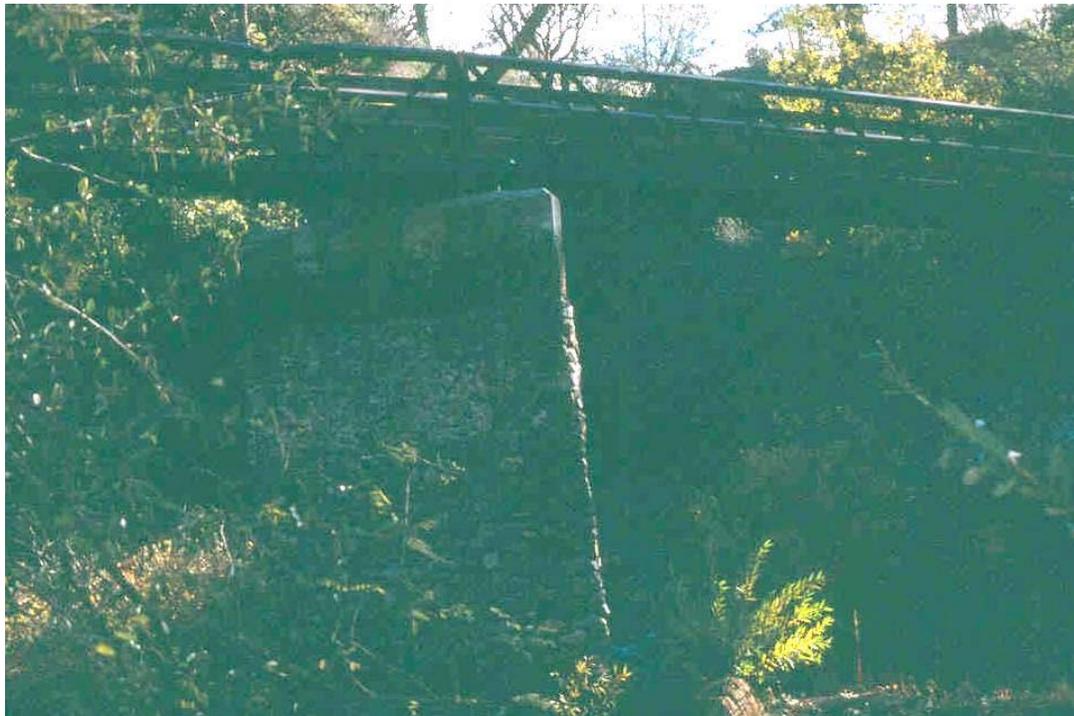
Circulation #8: View of the modern pedestrian bridge, built on historic footings connecting the NPS parking lot with the Camden house. (PWR, CLI, WHIS-S-0001-24, 2003)

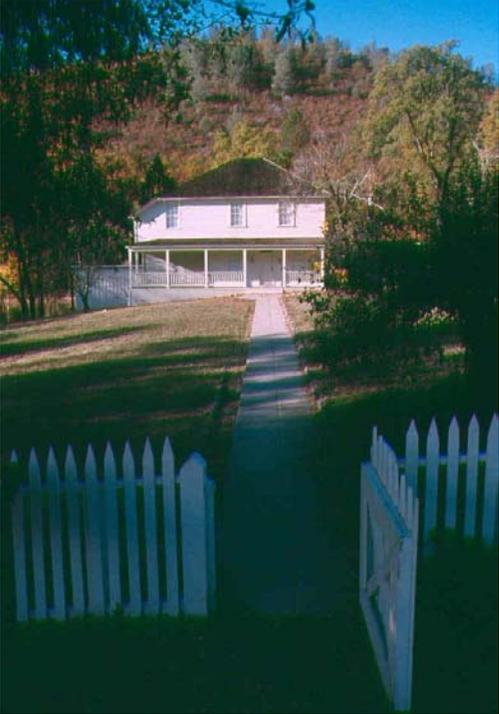
Buildings and Structures #1: View of the contributing Camden house. The wood shed is located on the left. (PWR, CLI, WHIS-S-0001-28, 2003)

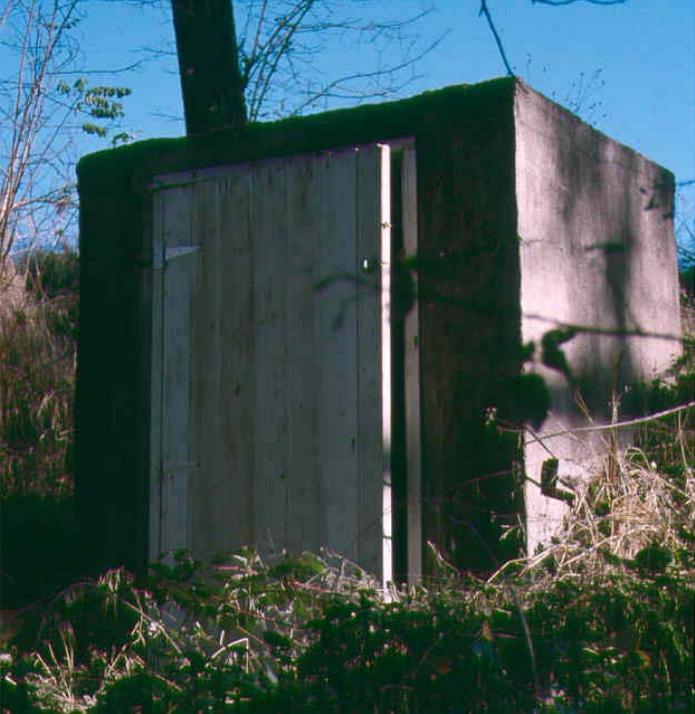
Buildings and Structures #2: View of the contributing chlorinator tank northwest of the Camden house. (PWR, CLI, WHIS-S-0002-9, 2003)

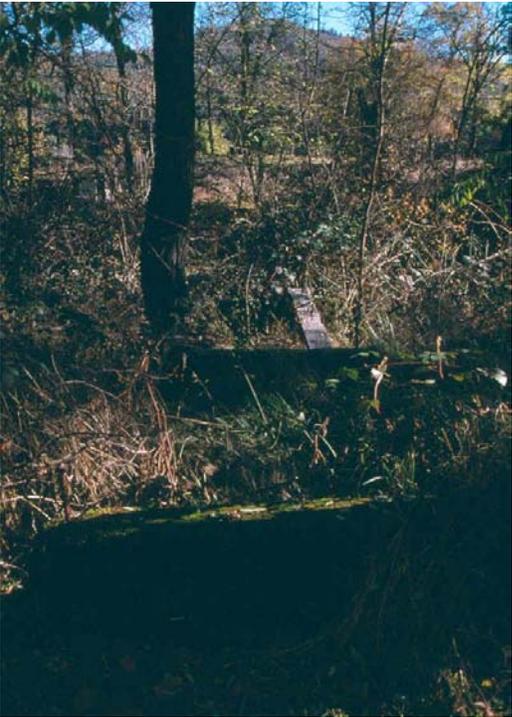
Buildings and Structures #3: View of the contributing pedestrian bridge footings over Willow Creek. (PWR, CLI, WHIS-S-0002-22, 2003)

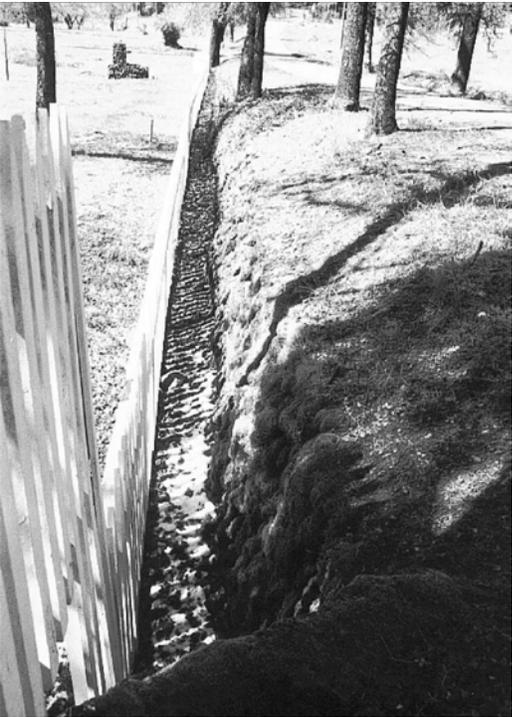
Buildings and Structures #4: View of the contributing retaining wall that supports the Service Road, or old Toll Road, and the picket fence around the Camden yard. (CLR, HRA, 1999)

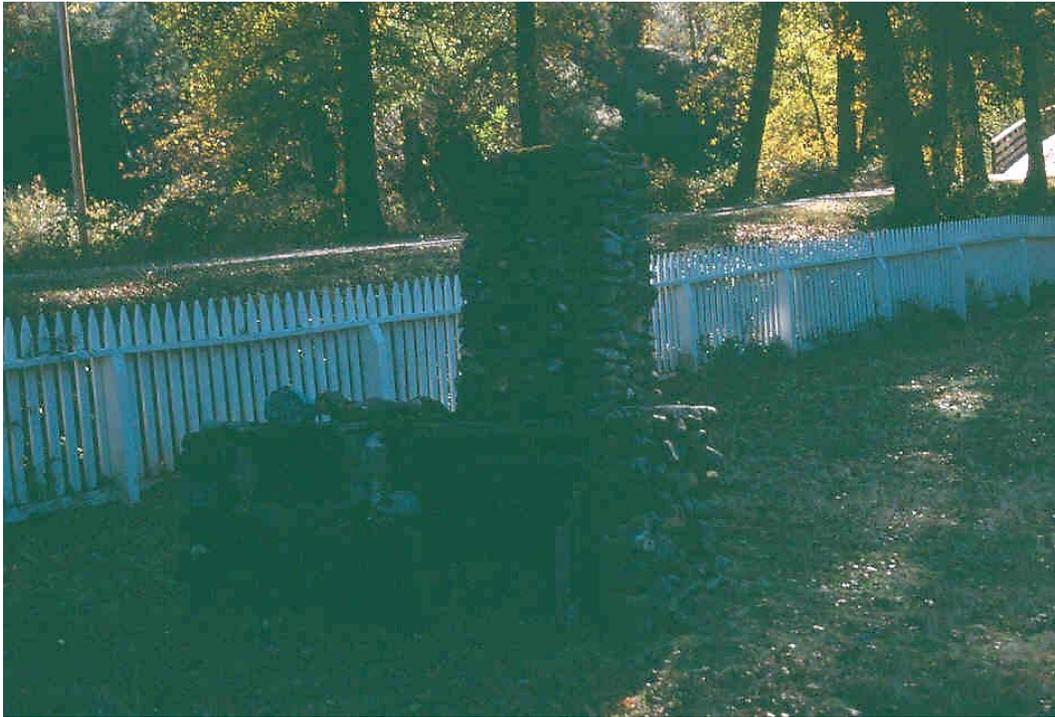
Buildings and Structures #5: View of the contributing stone barbecue in the Camden yard. (PWR, CLI, WHIS-S-0001-30, 2003)

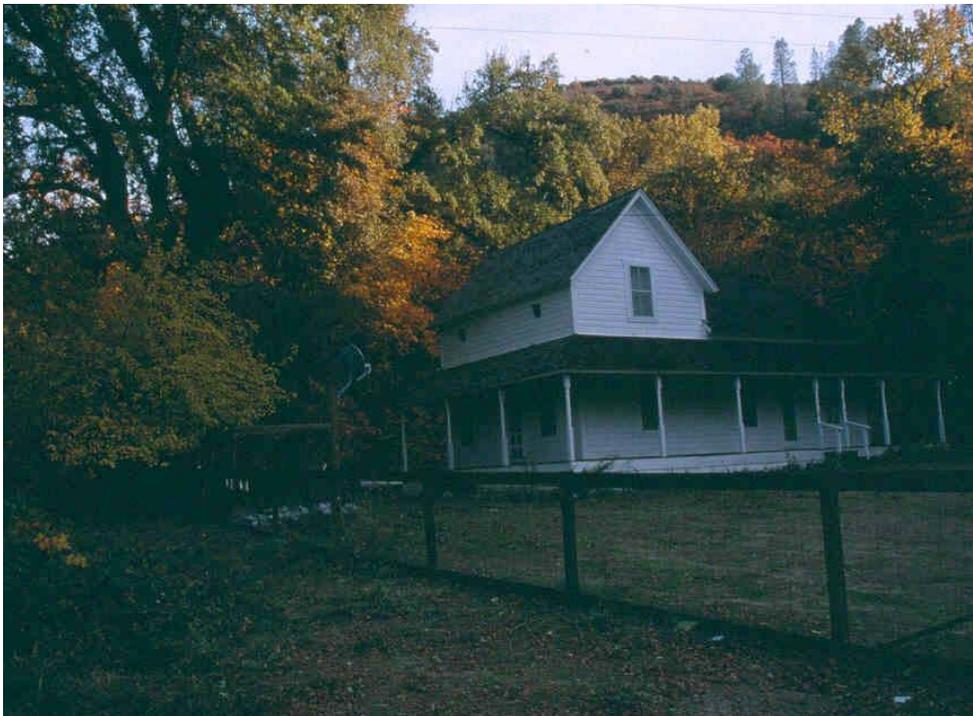
Buildings and Structures #6: View of the contributing tenant house and modern fence. (PWR, CLI, WHIS-S-0001-17, 2003)

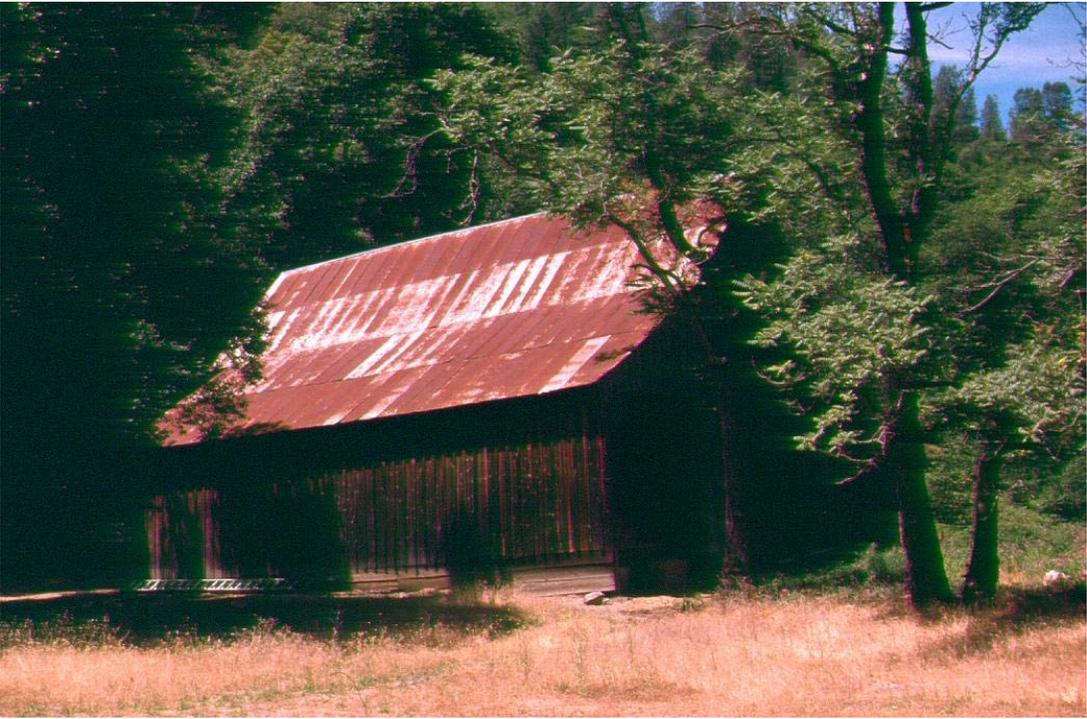
Buildings and Structures #7: View of the contributing tenant house barn. (CLR, HRA, 1999)

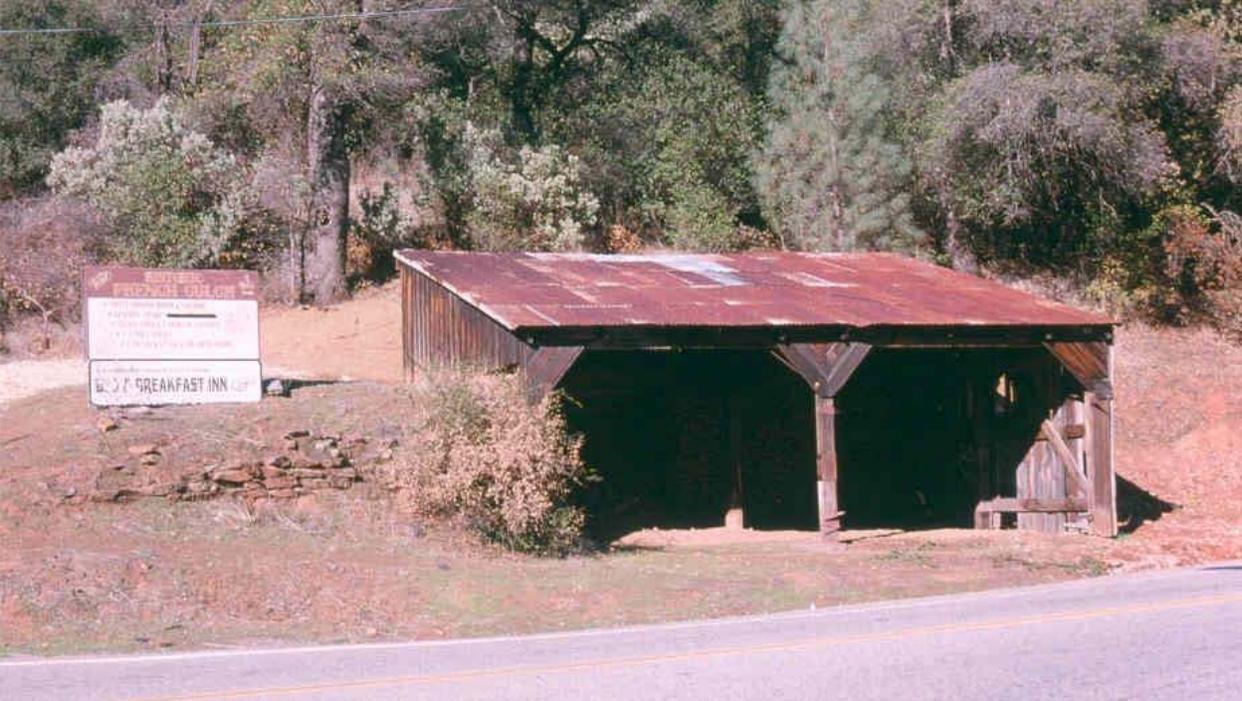
Buildings and Structures #8: View of the historic blacksmith shop foundation and the non-contributing cowshed and a hotel sign to French Gulch. (PWR, CLI, WHIS-S-0002-32, 2003)

2003 AD	Stabilized	In February 2003, orchard stabilization project is started. Fruit tree scion wood is collected and deadwood is pruned.
2003 AD	Stabilized	The blacksmith shop foundation is stabilized.

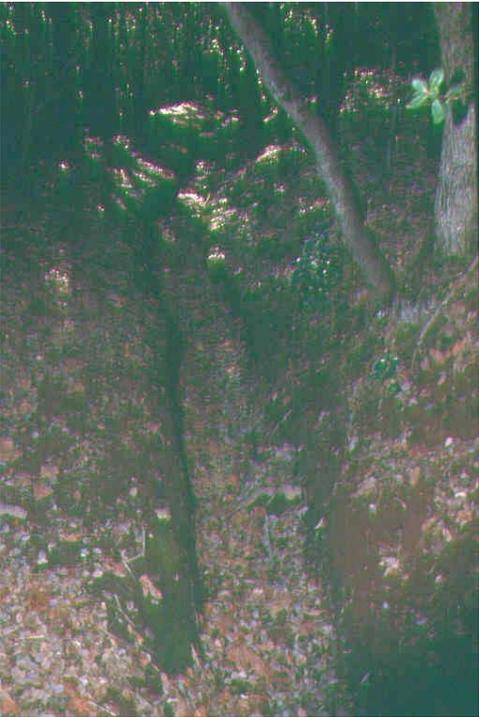
Buildings and Structures #9: Example of the contributing water ditches found as part of the water conveyance system. (PWR, CLI, WHIS-S-0002-36, 2003)

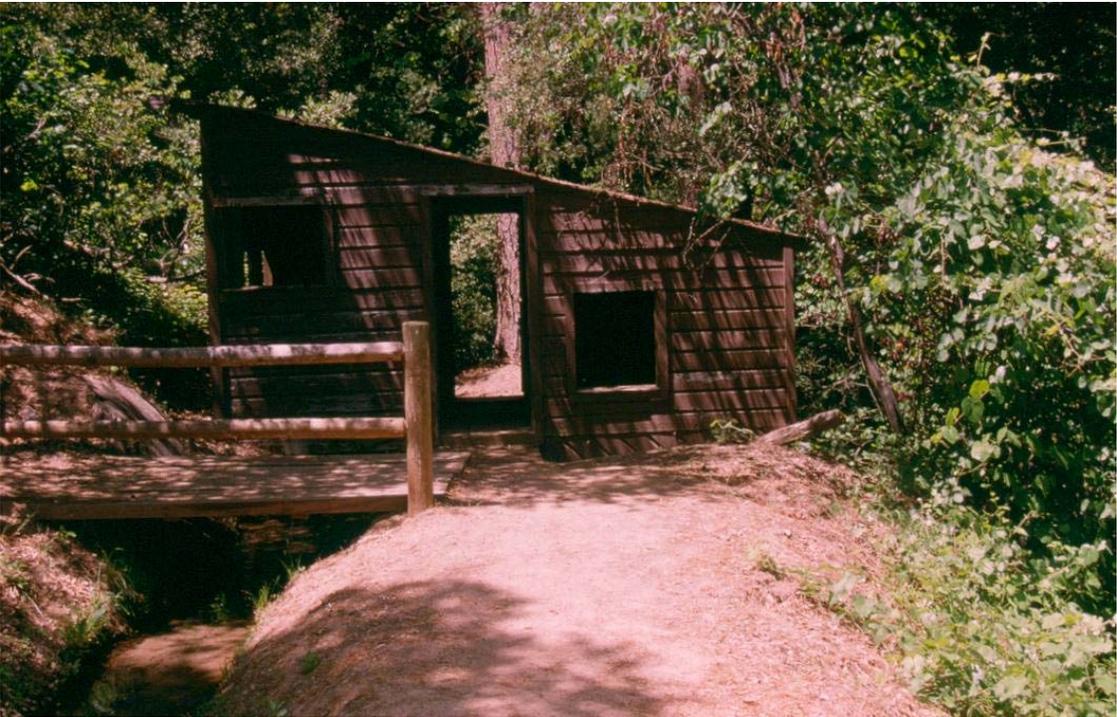
Buildings and Structures #10: View of the clean-out house along Crystal Creek Ditch. (PWR, CLI, WHIS-S-0004-??, 2004) CLR, HRA, 1999)

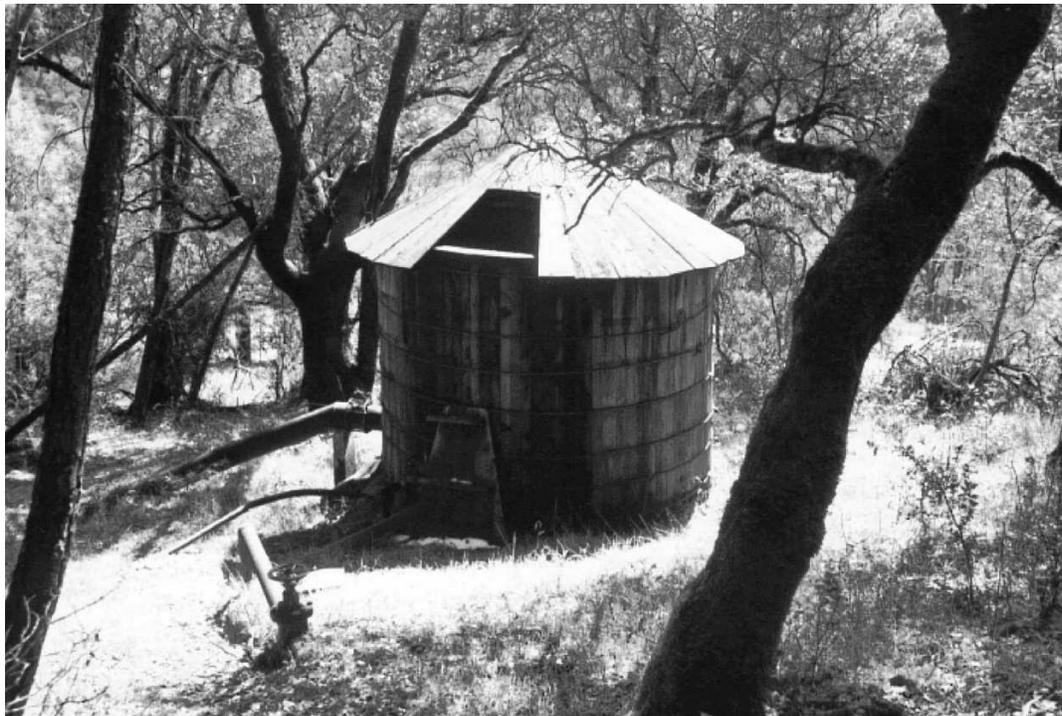
Buildings and Structures #11: View of the contributing redwood water tank. (CLR, HRA, 1999)

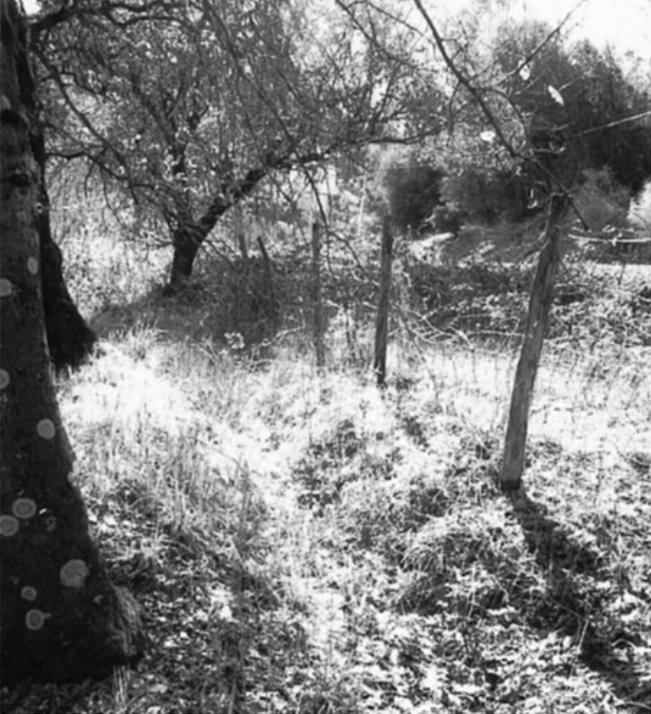
Small Scale Features #1: View of the contributing post and wire fence around French Gulch field. (CLR, HRA, 1999)

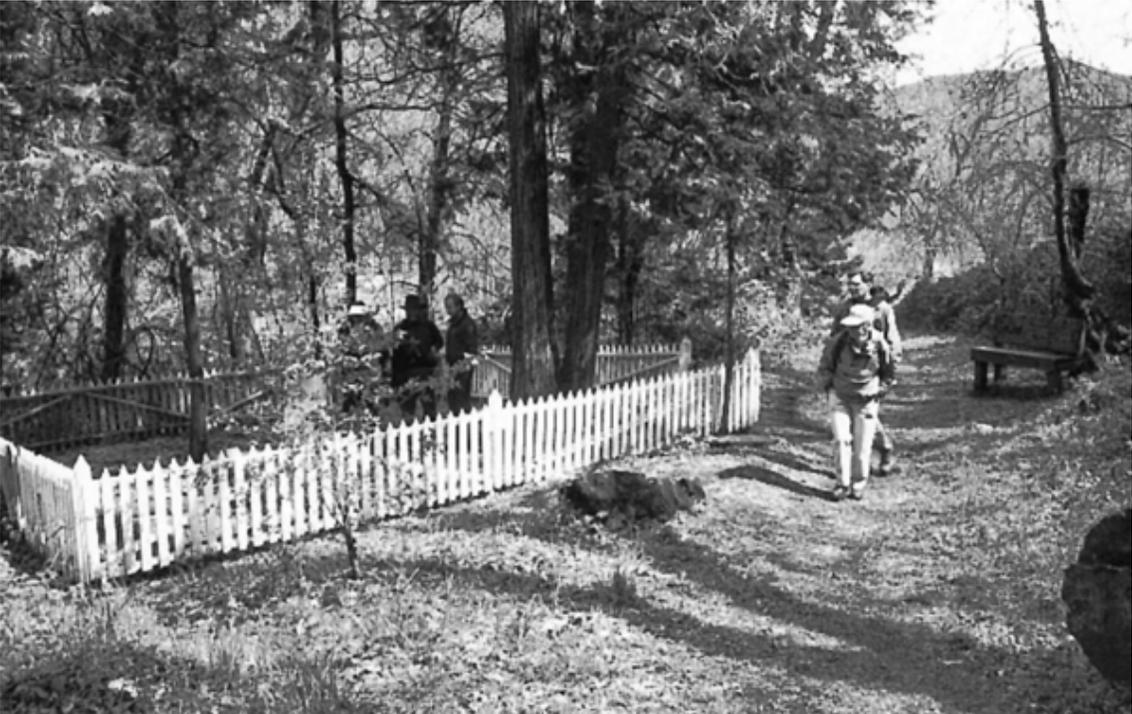
Small Scale Features #2: View of the Tower gravesite picket fence. (CLR, HRA, 1999)

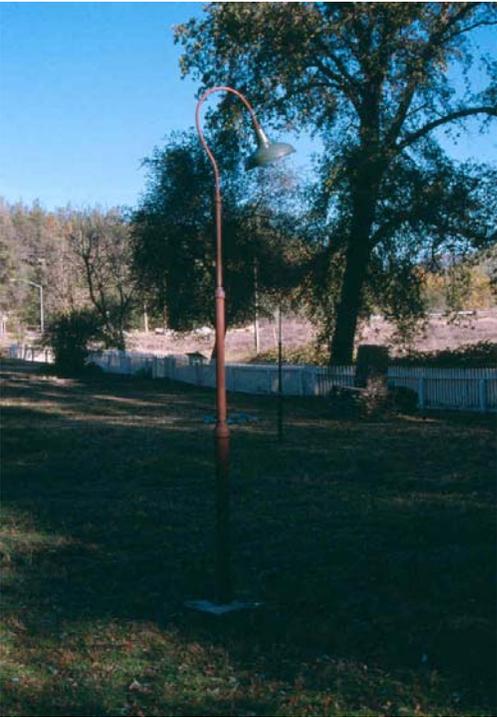
Small Scale Features #3: One of three contributing lampposts in the Camden yard and only one with a shade fixture. (PWR, CLI, WHIS-S-0001-31, 2003)
