Cultural Landscape Inventory Level II:
Tower House Historic District
Whiskeytown – Shasta – Trinity National Recreation Area

MANAGEMENT CATEGORY B: **Should be preserved and maintained**

CONDITION ASSESSMENT: **Fair**

**CAMDEN HOUSE HISTORIC DISTRICT
(Tower House Historic District)
WHISKEYTOWN NATIONAL RECREATION AREA**

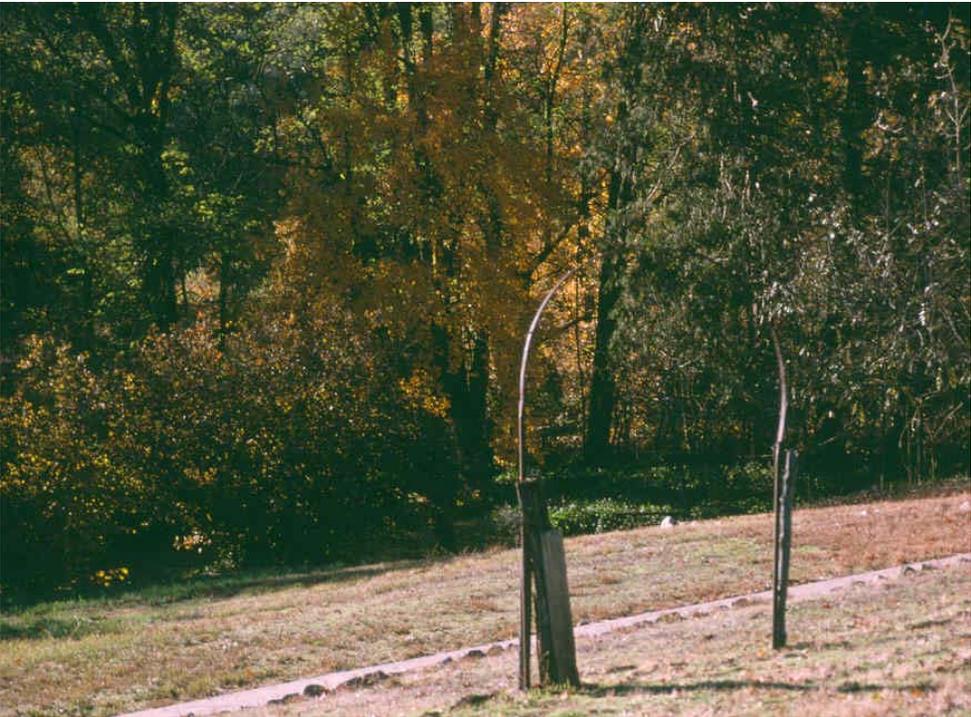
Small Scale Features #4: View of the contributing metal rose arch in the Camden yard. (PWR, CLI, WHIS-S-0001-29, 2003)
