# CULTURAL LANDSCAPE REPORT FOR ELEANOR ROOSEVELT NATIONAL HISTORIC SITE

VOLUME II: TREATMENT

HYDE PARK, NEW YORK

Olmsted Center for Landscape Preservation  
National Park Service, Boston, Massachusetts, 2013

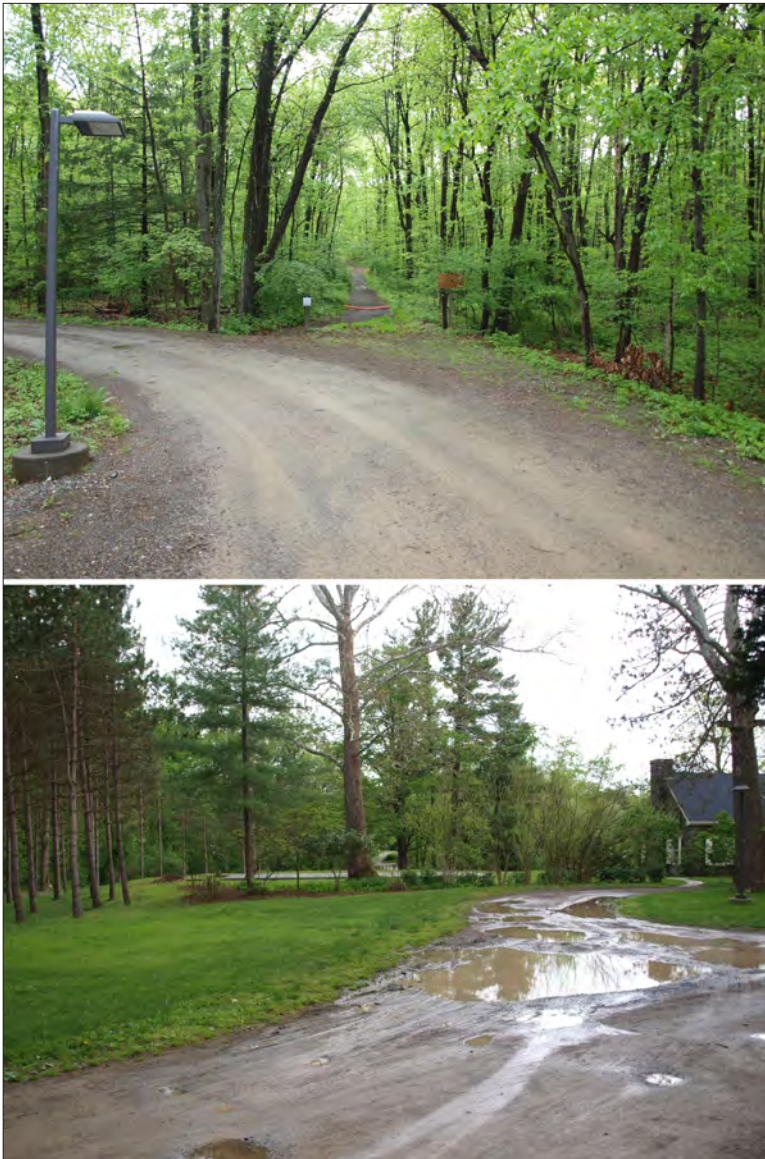
**Figure 2.5: Deteriorated condition of Val-Kill roads, showing the road to Top Cottage (Hyde Park Trail) looking east with its segmented and narrowed roadbed (top), and the loop drive at Stone Cottage, looking west with its eroded surface and edges, 2012. (SUNY ESF)**

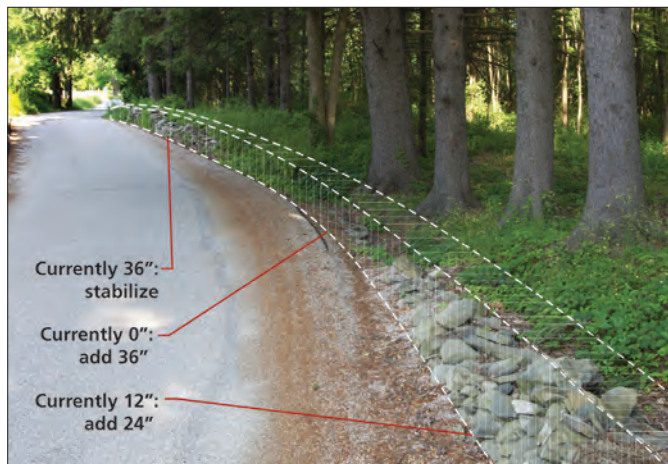
Figure 3.9. Looking west on Val-Kill Lane showing recommended treatment of the stone wall, where segments have collapsed or been buried due to raising of the roadbed. (Olmsted Center for Landscape Preservation)

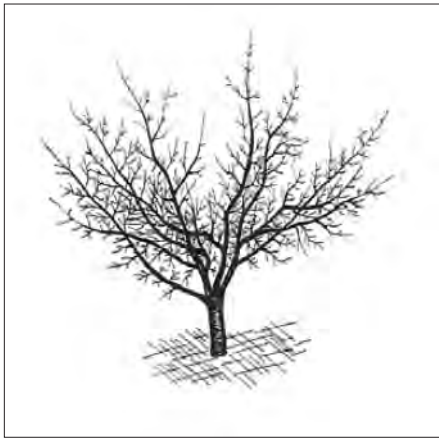
**Figure 3.11.** The open-bowl orchard tree scaffold recommended for the Val-Kill orchard trees. (Lowther, 1914, from Susan Dolan, *A Fruitful Legacy*, 2009)

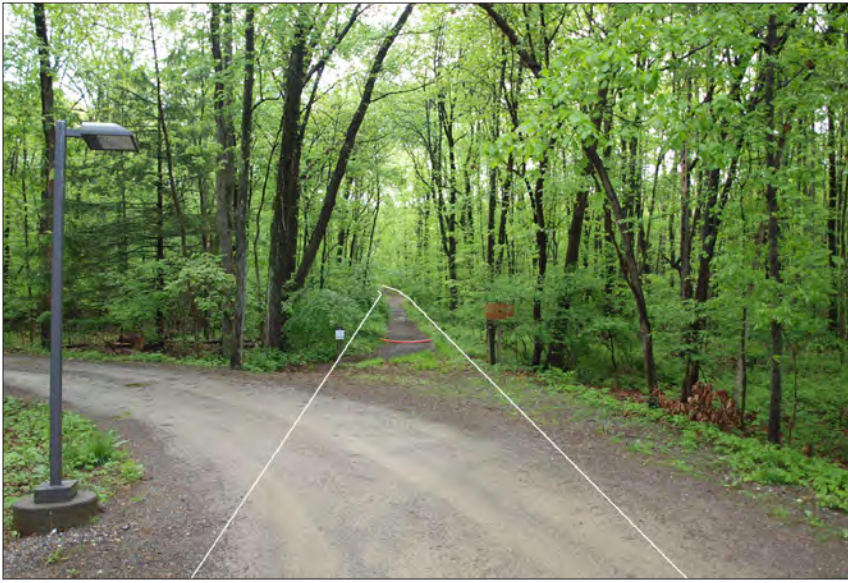
**Figure 3.18.** The road to Top Cottage looking east from the historic core showing erosion of roadbed into a narrow trail, 2012. The white lines indicate the limits of the recommended reestablished roadbed, including the section enlarged by current vehicular use. (SUNY ESF)

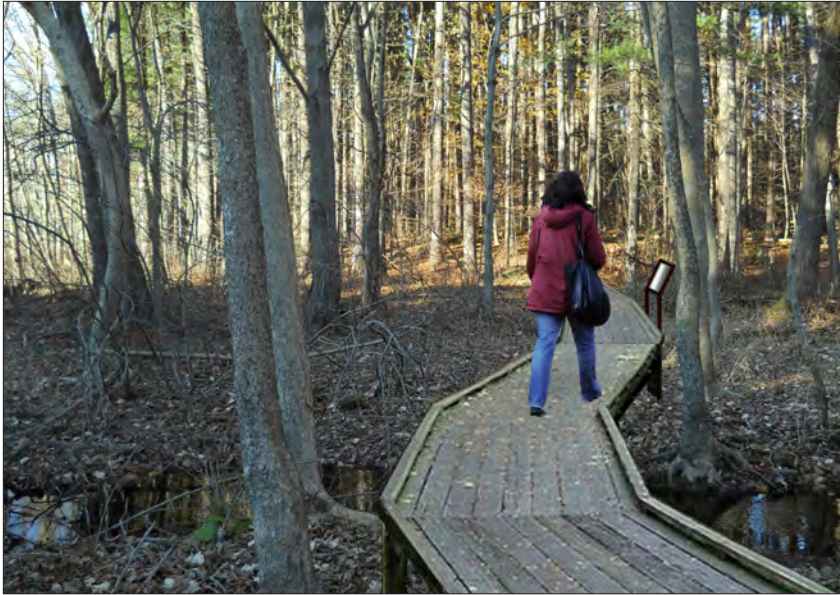
**Figure 3.24. Visual simulation of the boardwalk segment of the proposed Secret Woods interpretive trail, looking north from the historic core with the white pine plantation in the background. (Olmsted Center for Landscape Preservation)**

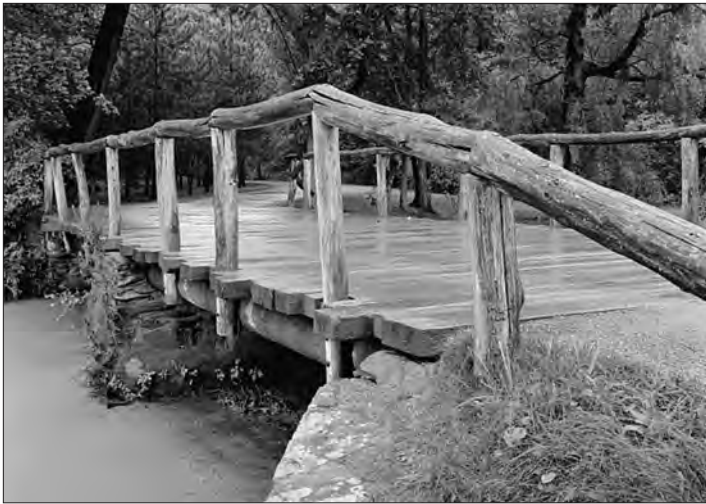
Figure 3.34. Rustic railings on the Fall Kill bridge that most likely date to the 1950s, photographed 1978. (Historic American Building Survey, NY-5666)

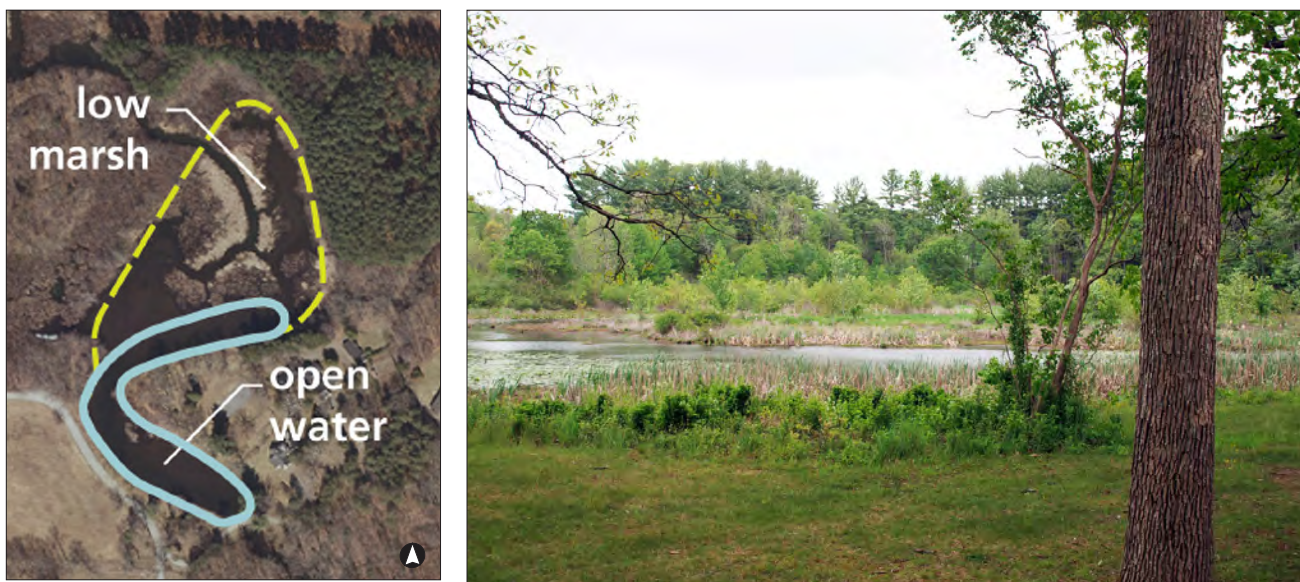
Figure 3.43 (left). Aerial photograph of Val-Kill Pond showing the later upper pond and the original ellipse or lower pond, 2009. The blue outline indicates recommended area of open water, and the yellow dashed area is recommended as open-space wetlands. (US Department of Agriculture orthoimagery, annotated by Olmsted Center for Landscape Preservation)

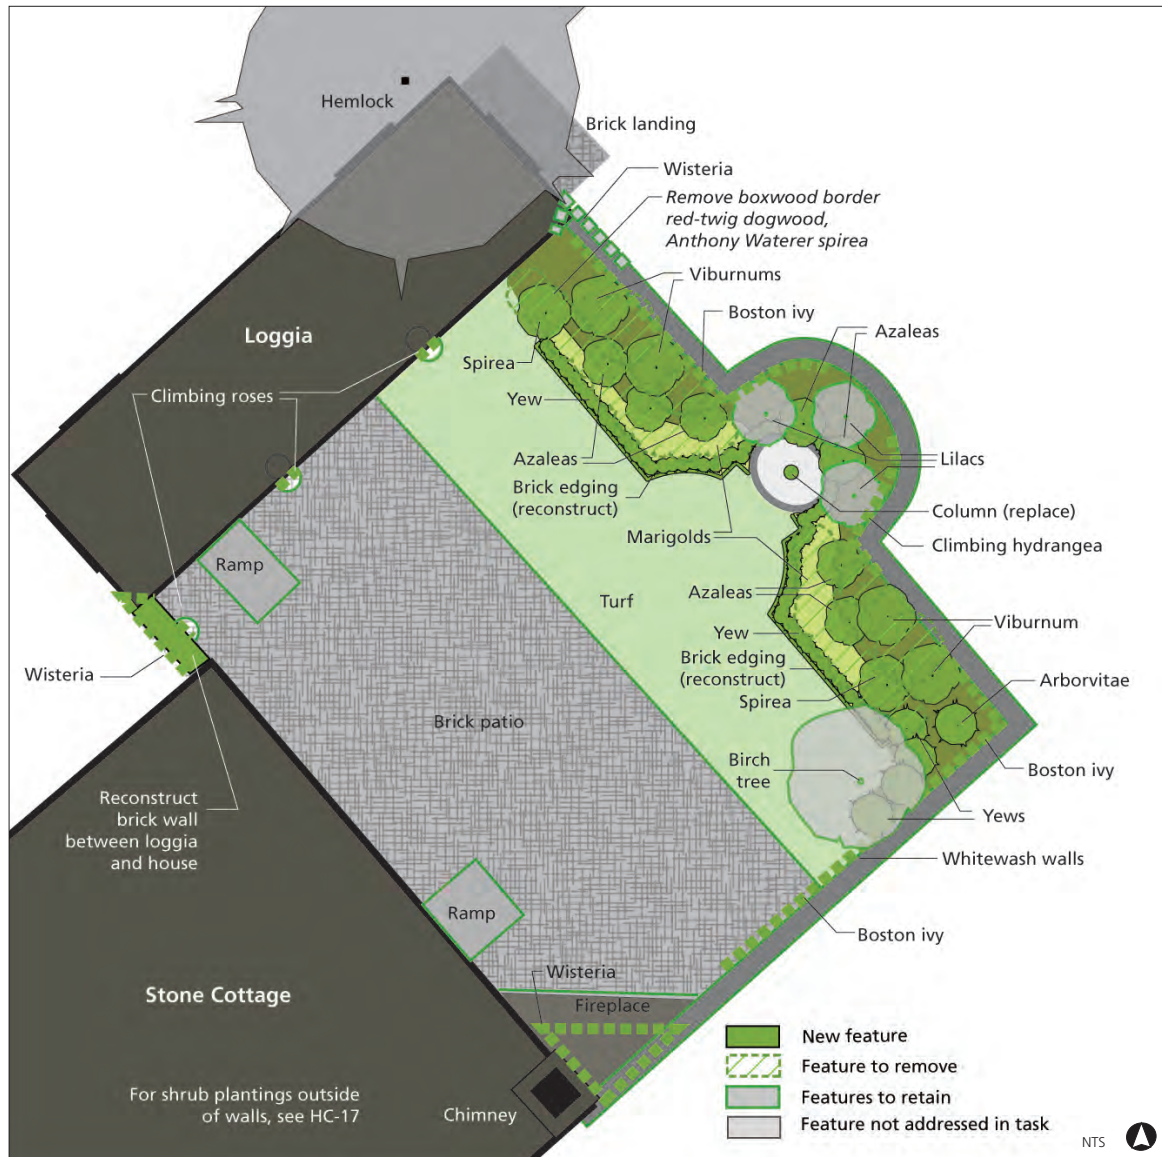
**Figure 3.68. Conceptual rehabilitation plan for the walled garden. Proposed furnishings are not shown. (SUNY ESF)**
