CARRIGAN HOUSE

LINCOLN HOME NATIONAL HISTORIC SITE

HISTORIC STRUCTURE REPORT

May 19, 2006

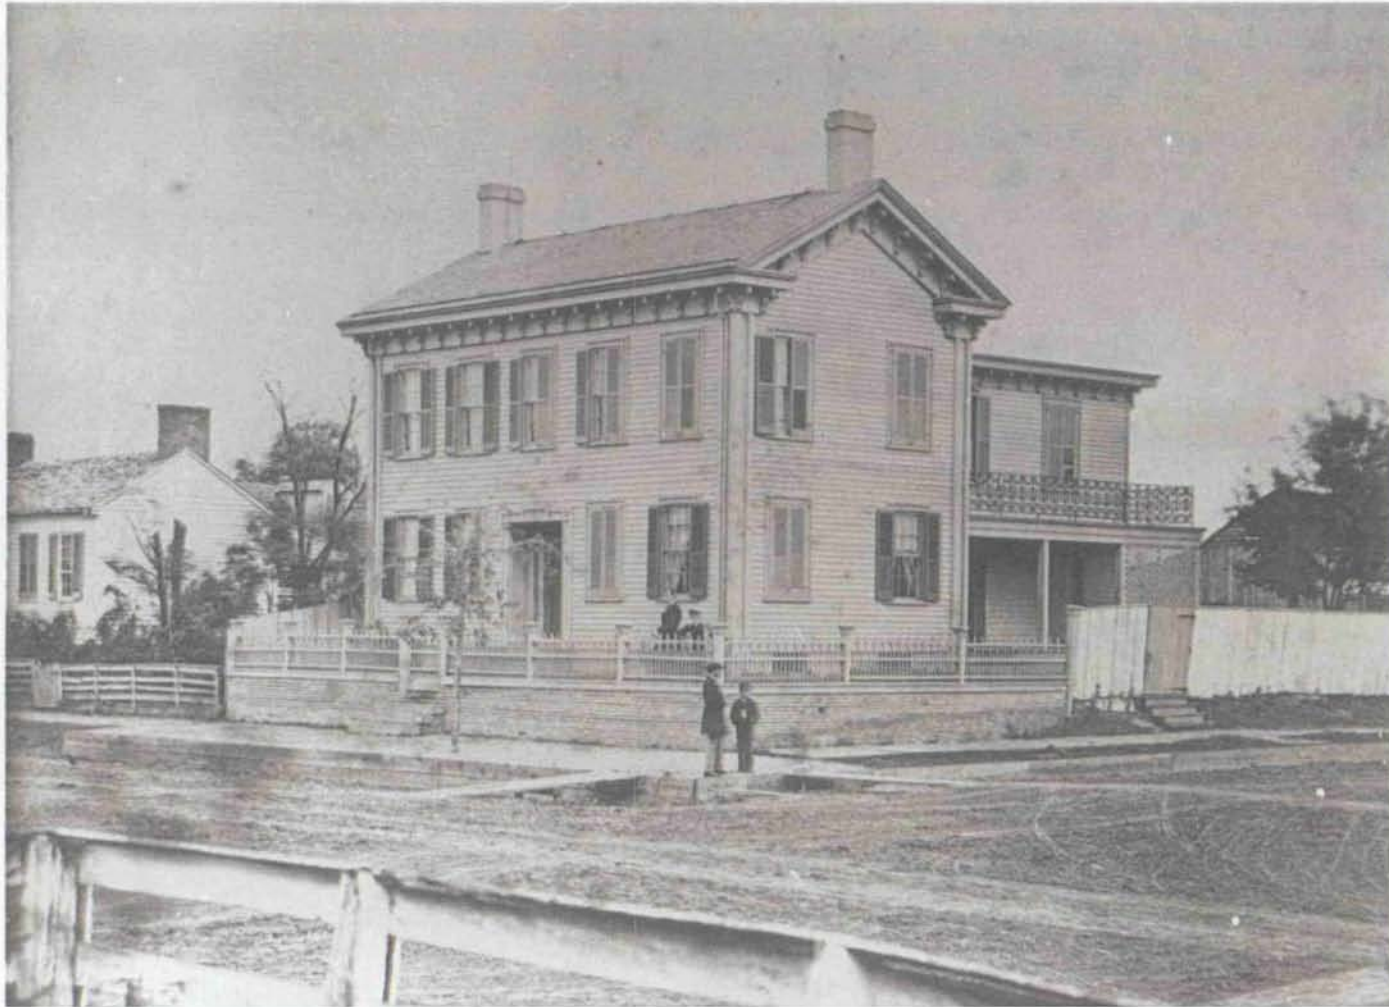
Figure 2-5: "Home of Abraham Lincoln", summer 1860. View looking northeast. A partial view of the Carrigan front facade and the roof of the ell with a gabled dormer can be seen to the left. (Courtesy The Abraham Lincoln Presidential Library)

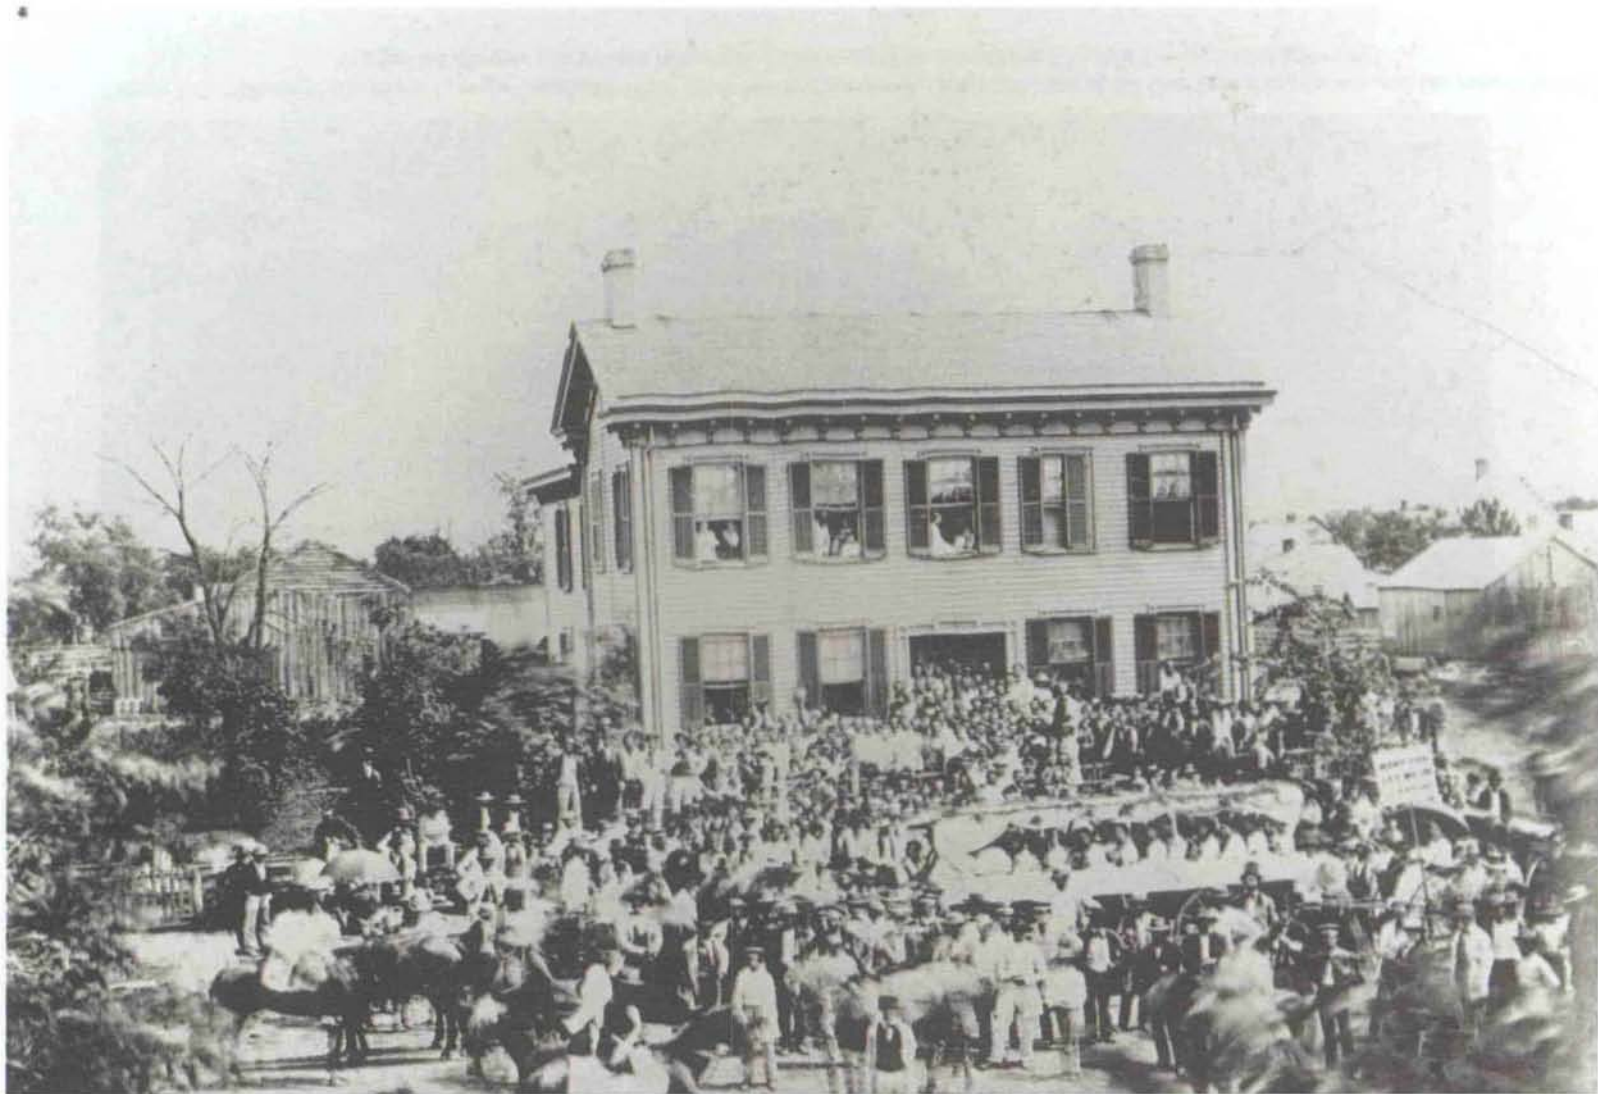
Figure 2-6: "Lincoln Home" August 8, 1860, view looking southeast; The Carrigan side yard and barn can be seen to the left. (Courtesy The Abraham Lincoln Presidential Library)

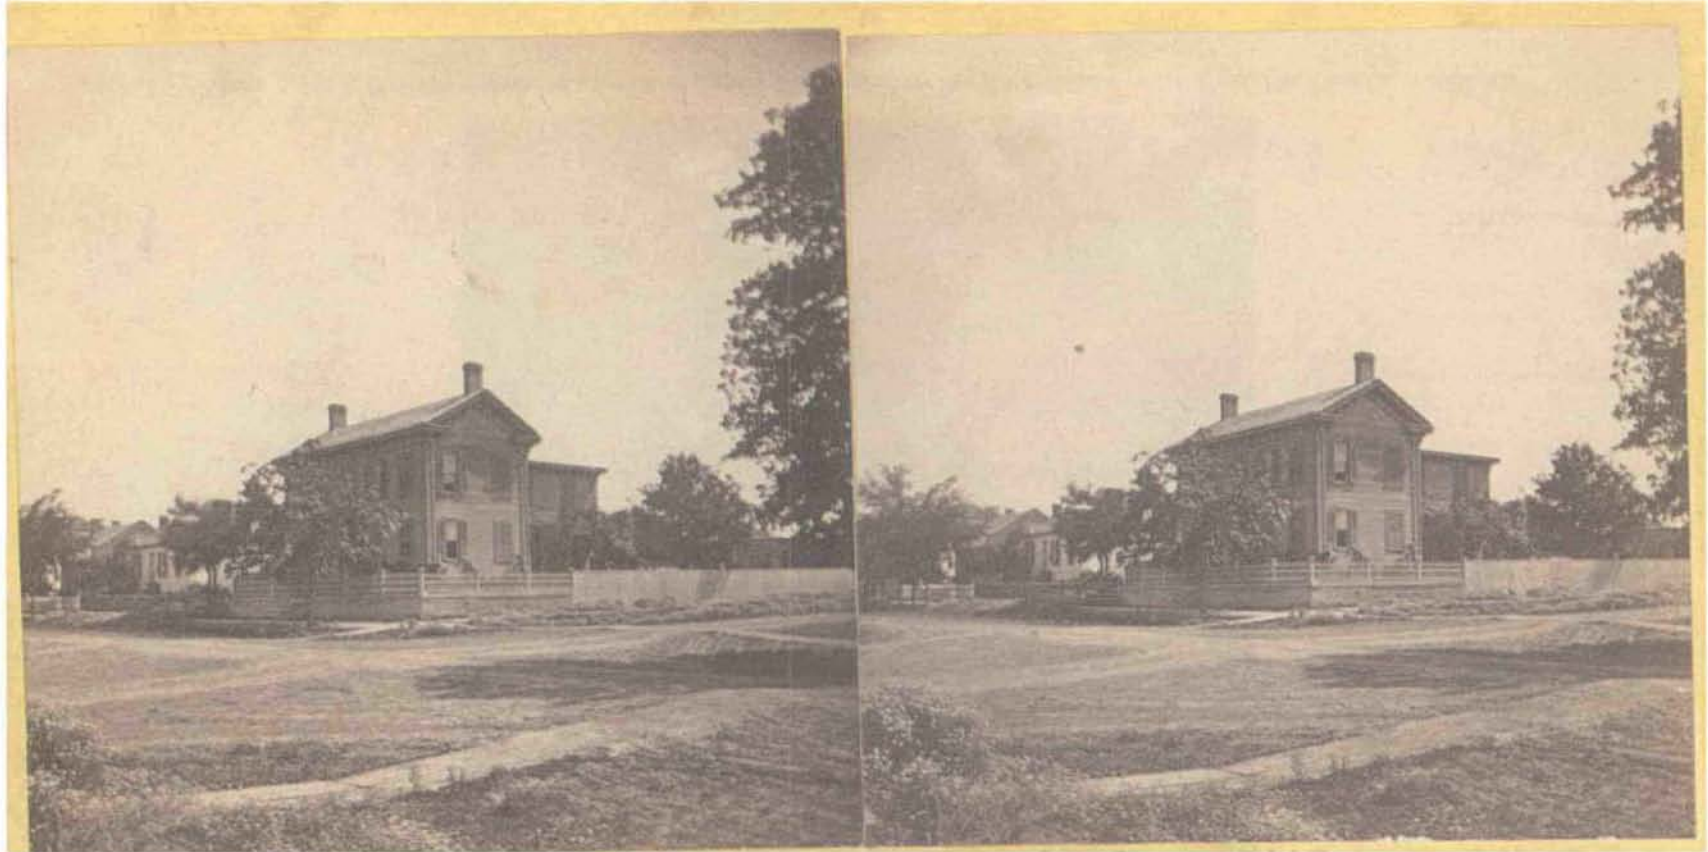
Figure 2-7: The entire front elevation of the Carrigan House can be seen in this stereograph, c.1867. (Courtesy Lincoln Home National Historic Site)

It is unclear after reviewing the deeds whether Webster or Kennett built the house. However, Webster married Emeline Barnes on May 26, 1838 and may have purchased the property and contracted to build the house as their new residence. This would explain the promissory notes and place the date of construction closer to 1839. The one-story, four bay wide, wood-frame residence had an ell to the rear, most likely built during the original phase of construction. However, the two archeological investigations that have been conducted indicate a slight jog in the foundation along the front façade. This may denote two phases of construction. Outbuildings associated with the house included a large barn (**Figure 2-6**) and a smaller one-story shed. By 1854, according to the first map of Springfield to indicate structures, the house had gained its final form (**Figures 2-7a, 2-9a, 2-19**).

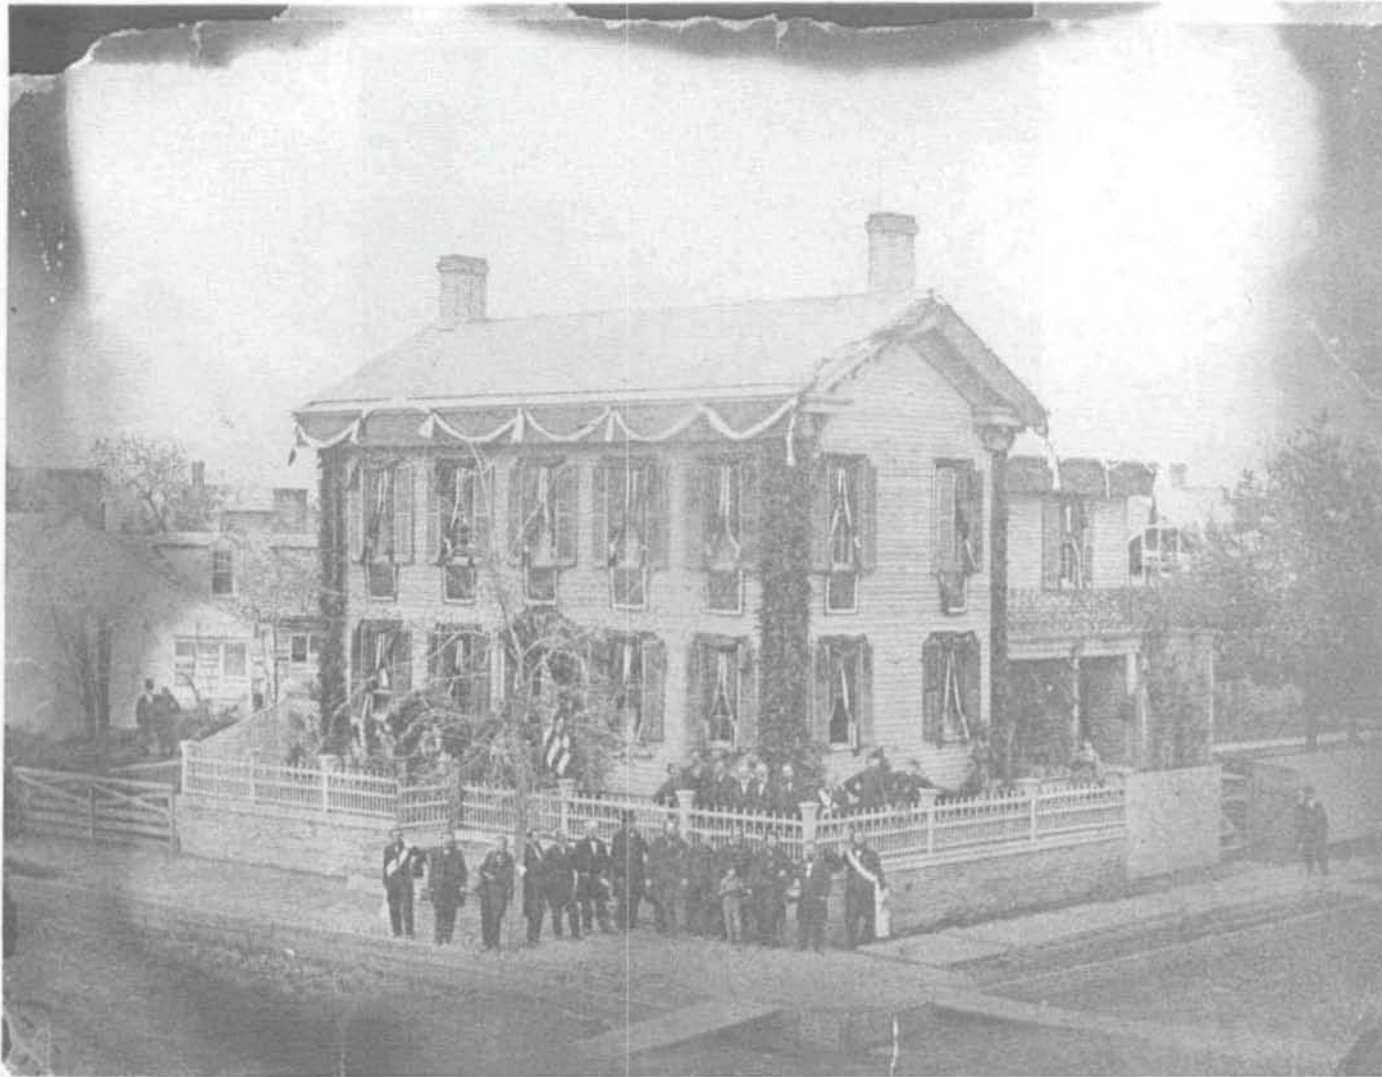
Figure 2-8: The Lincoln House dressed for mourning, 1865. View looking northeast. The rear extension to the Carrigan House can be seen to the left, including the ell with louvered porch. (Courtesy of the Abraham Lincoln Presidential Library)

Figure 2-8 and 8a: In this photograph taken in 1865, the ell can be viewed to a greater extent. Two gabled dormers can now be seen. The two dormers on the ell indicate one and one-half story construction for this portion. The windows in the dormers are six-over-six. An enclosed porch on the southeast corner of the house can also be seen. This porch and the porch on the ell are similarly enclosed with tall wooden, fixed-in-place louvers with adjustable slats. The louvers on the ell are in disrepair and missing slats. The brick chimney along the north wall of the ell can be seen for the first time.

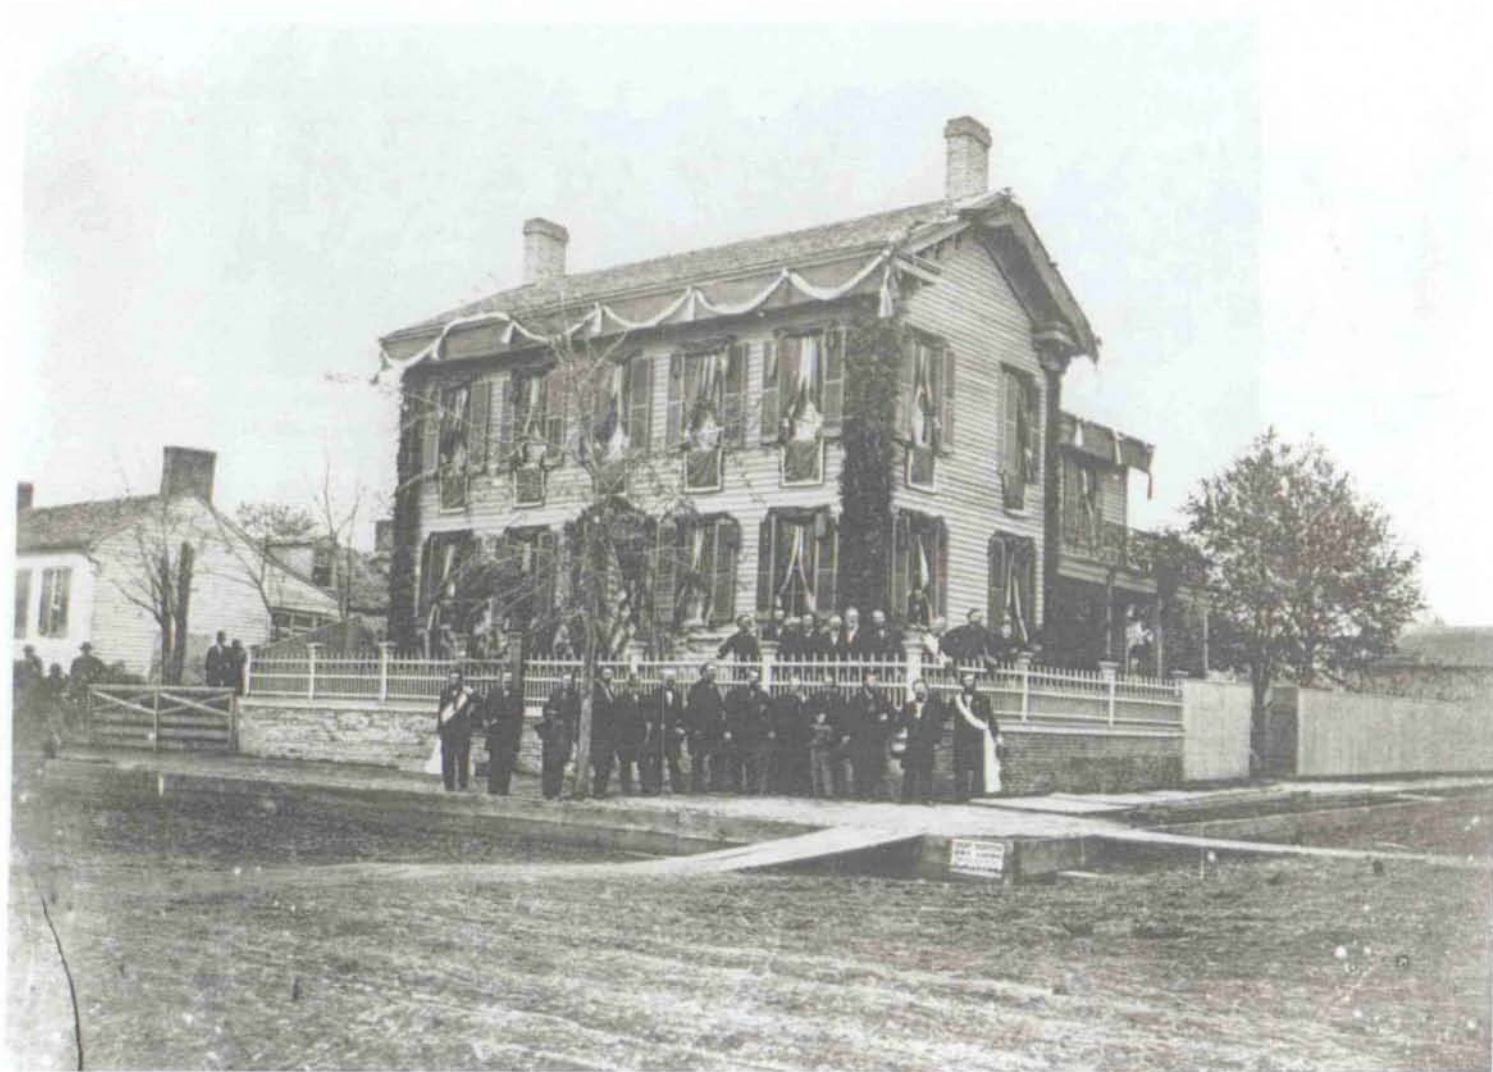
Figure 2-9: A partial view of the west and south elevations of the Carrigan House, 1865. Two dormers and a third chimney on the ell are visible. (Courtesy The Abraham Lincoln Presidential Library)

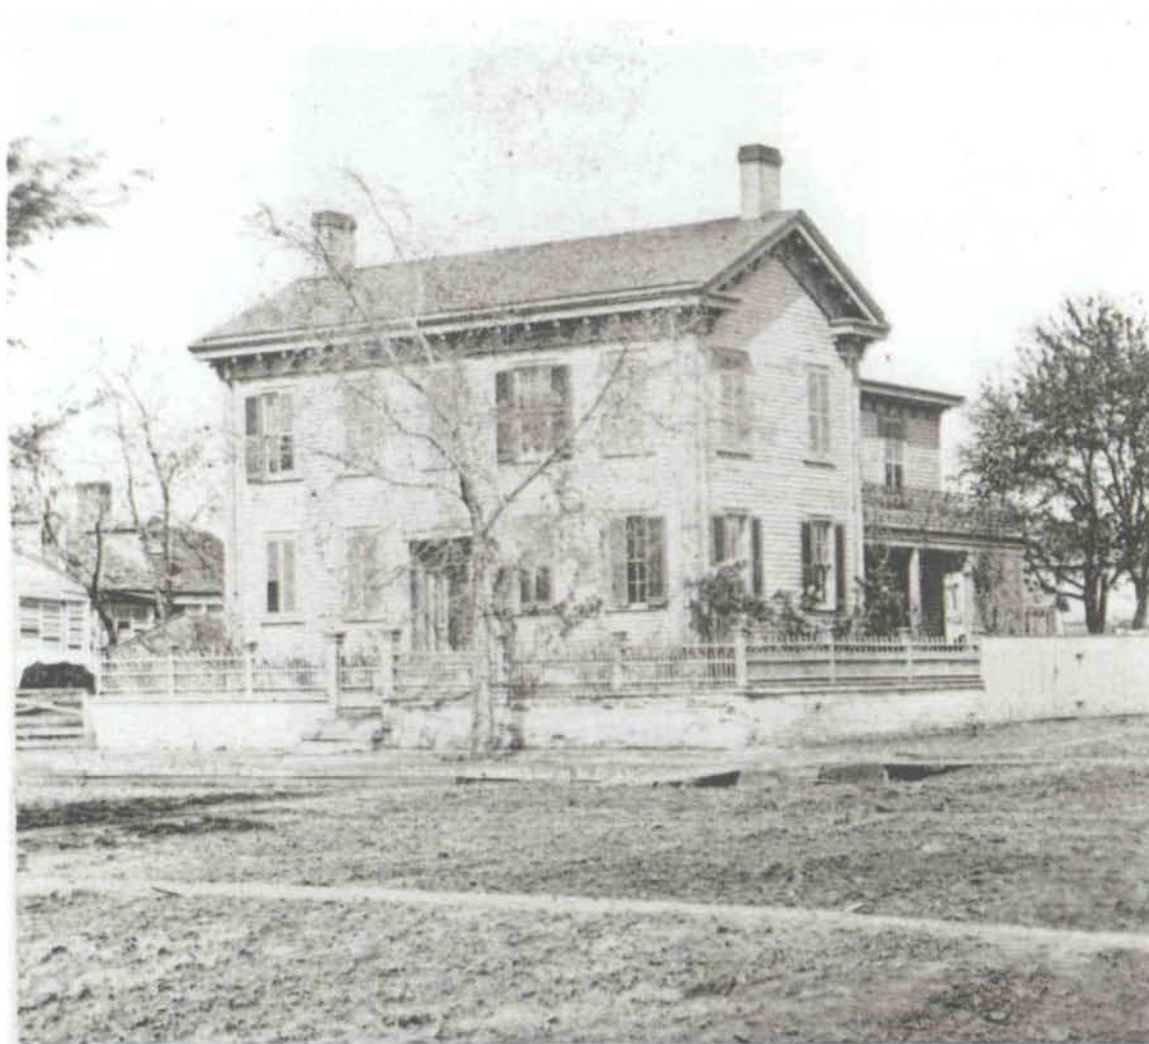
Figure 2-10: A view of the rear louvered porch and ell addition, c.1870. (Courtesy The Abraham Lincoln Presidential Library)

Figure 2-10 and 10a: This photograph provides a long view of the ell and porch structure. Two gabled dormer windows with diagonal wood siding can be seen on the roof of the ell. A fuller view of the porch is also presented. Although this photo is not dated, it was most likely taken in the 1870's due to the dilapidated condition of the porch structure. The ell's roofline is sagging in the center, above the louvered porch.

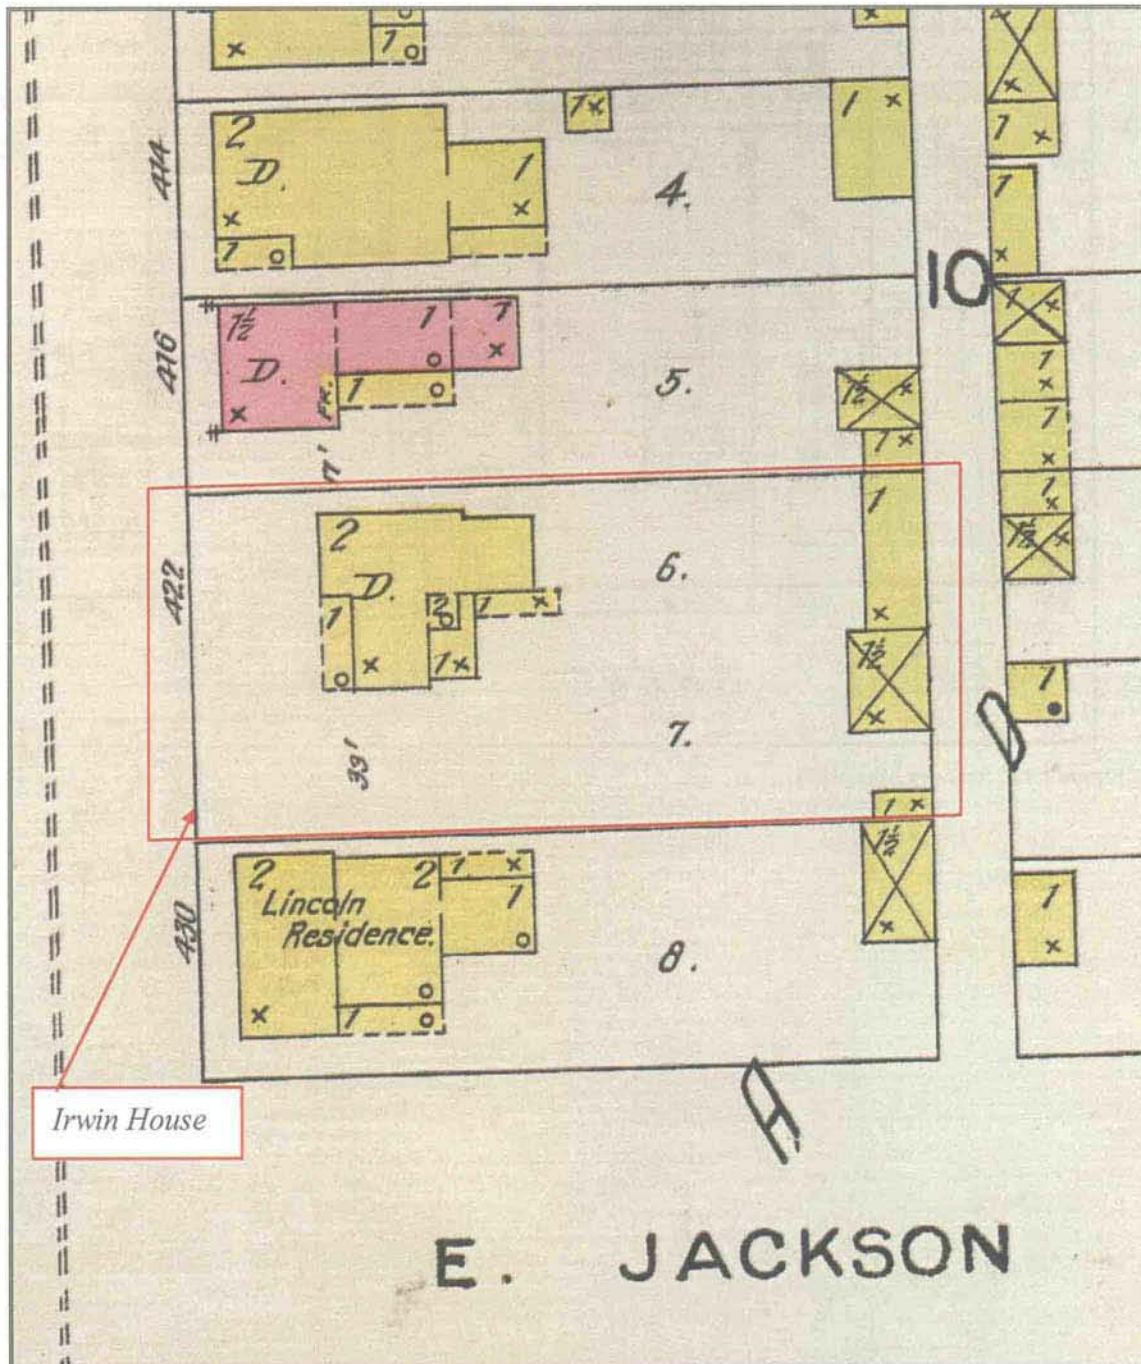
Figure 2-23: Sanborn Map, 1896. Courtesy The Lincoln Public Library, Springfield, IL.

Several changes can be seen in the 1896 map. The house address has now changed from 416 1/3 to 422. The house is now located just south of the north property line. The large two-story square shaped outbuilding that first appeared on the 1890 map is now indicated as a 1-1/2 story stable. The shape is not quite square and the smaller wood frame outbuilding is drawn smaller than in 1890.

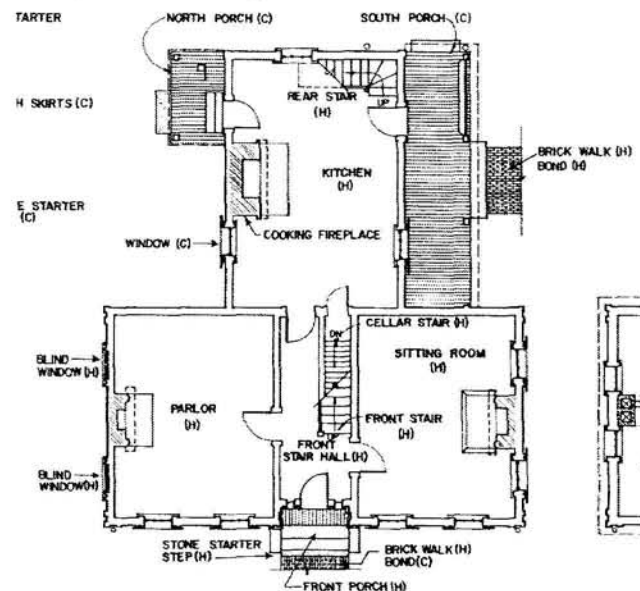
Figure 2-29: The conjectural first floor plan for the Rev. Charles Dresser/Abraham Lincoln cottage. (Historic American Buildings Survey, National Park Service, Brad McCormick, 1986.)

The Lincoln Home, as originally constructed by Charles Dresser, (**Figure 2-29**) was also similarly designed. The Lincoln cottage was a Central Passage plan built in 1839. The cottage had minor Greek Revival characteristics delineated by such details as the returned eaves and the recessed entry and small porch. The T plan shows an ell projecting from the center of the main portion of the house containing a kitchen. Chimneys were located on each end of the end-gabled dwelling.

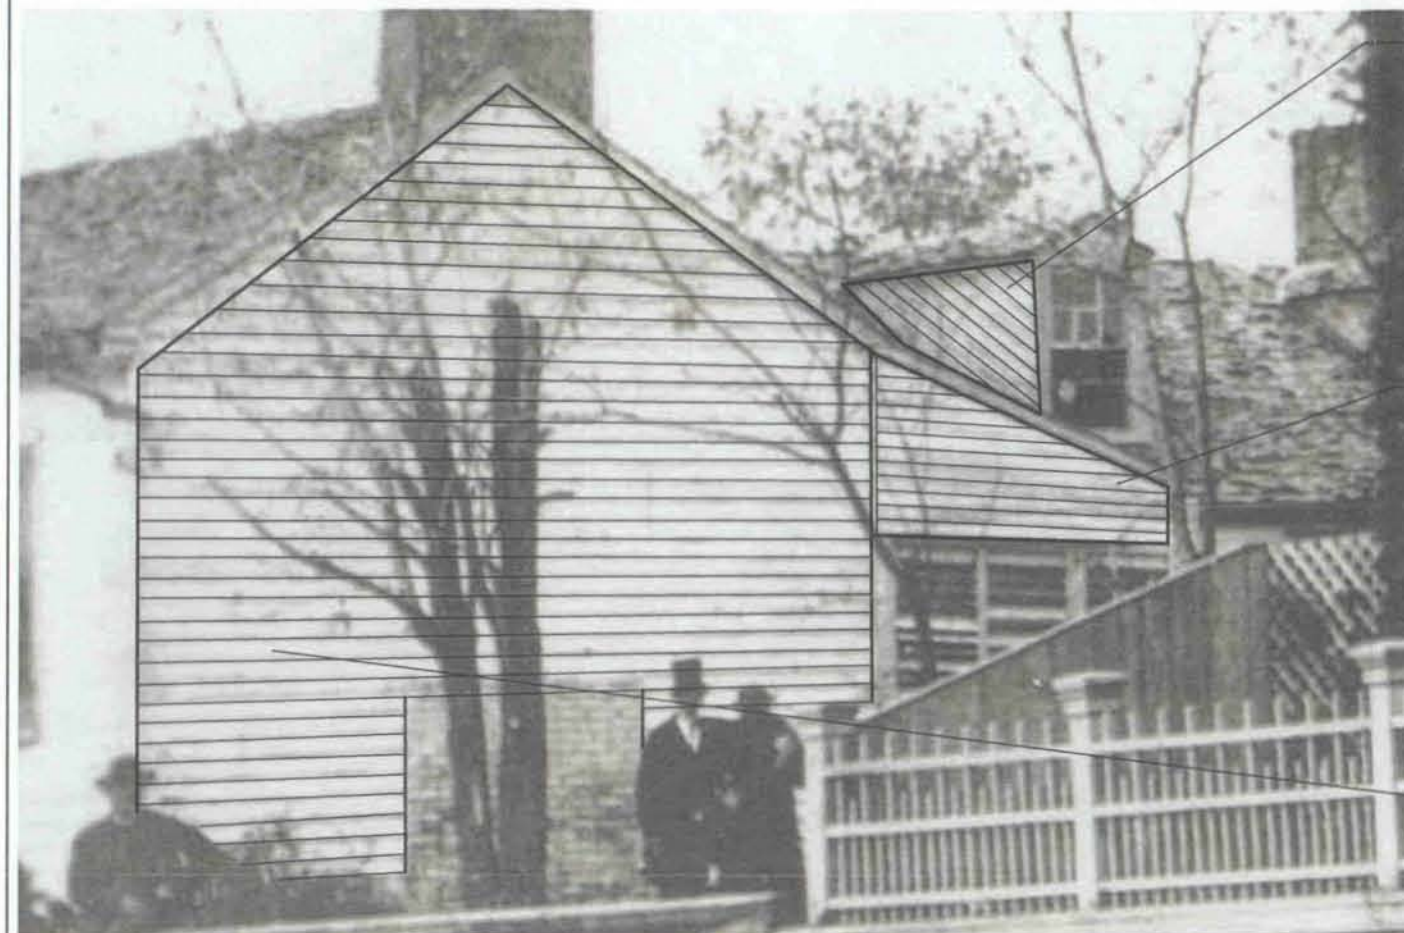
DIAGONAL SIDING ON
DORMERS WITH SIDING
COUNT OF 10

All of the roofing appears to be of the wood shingle variety where visible. There are 25 shingle courses on the western portion of the house and 35 courses at the east ell. With the slope of the roof determined in the wood clapboard analysis, this would bring the shingle exposure to around four inches.

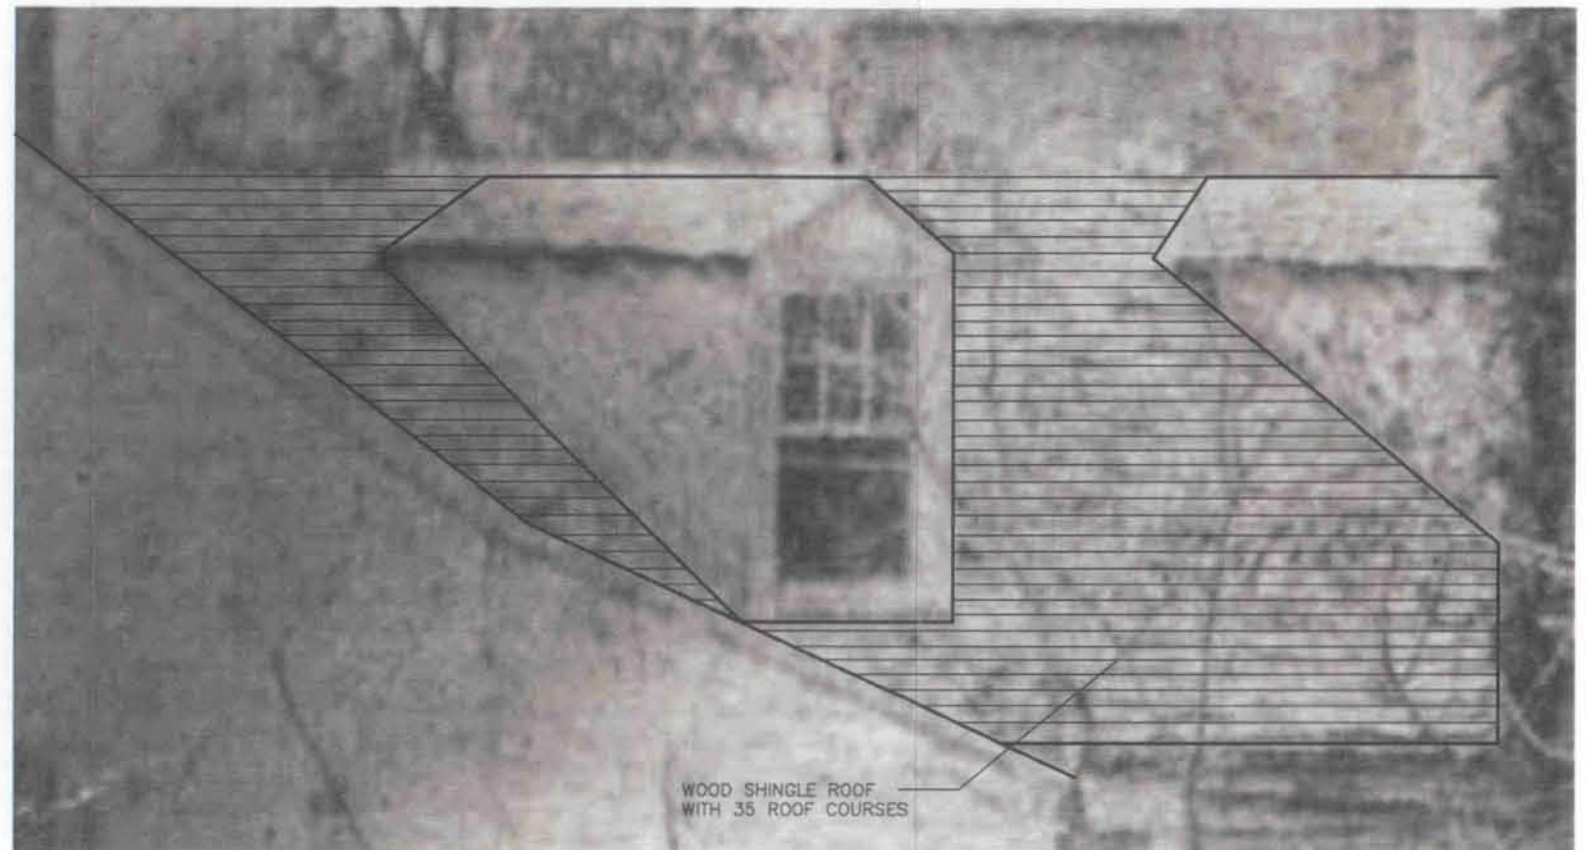
ROOFING COUNT ON ADDITION MA-2b

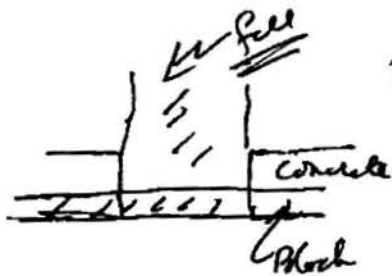
Bob holes lined with foundation (concrete) with old ground surface about 10" b.s. trench lead to opening in wall

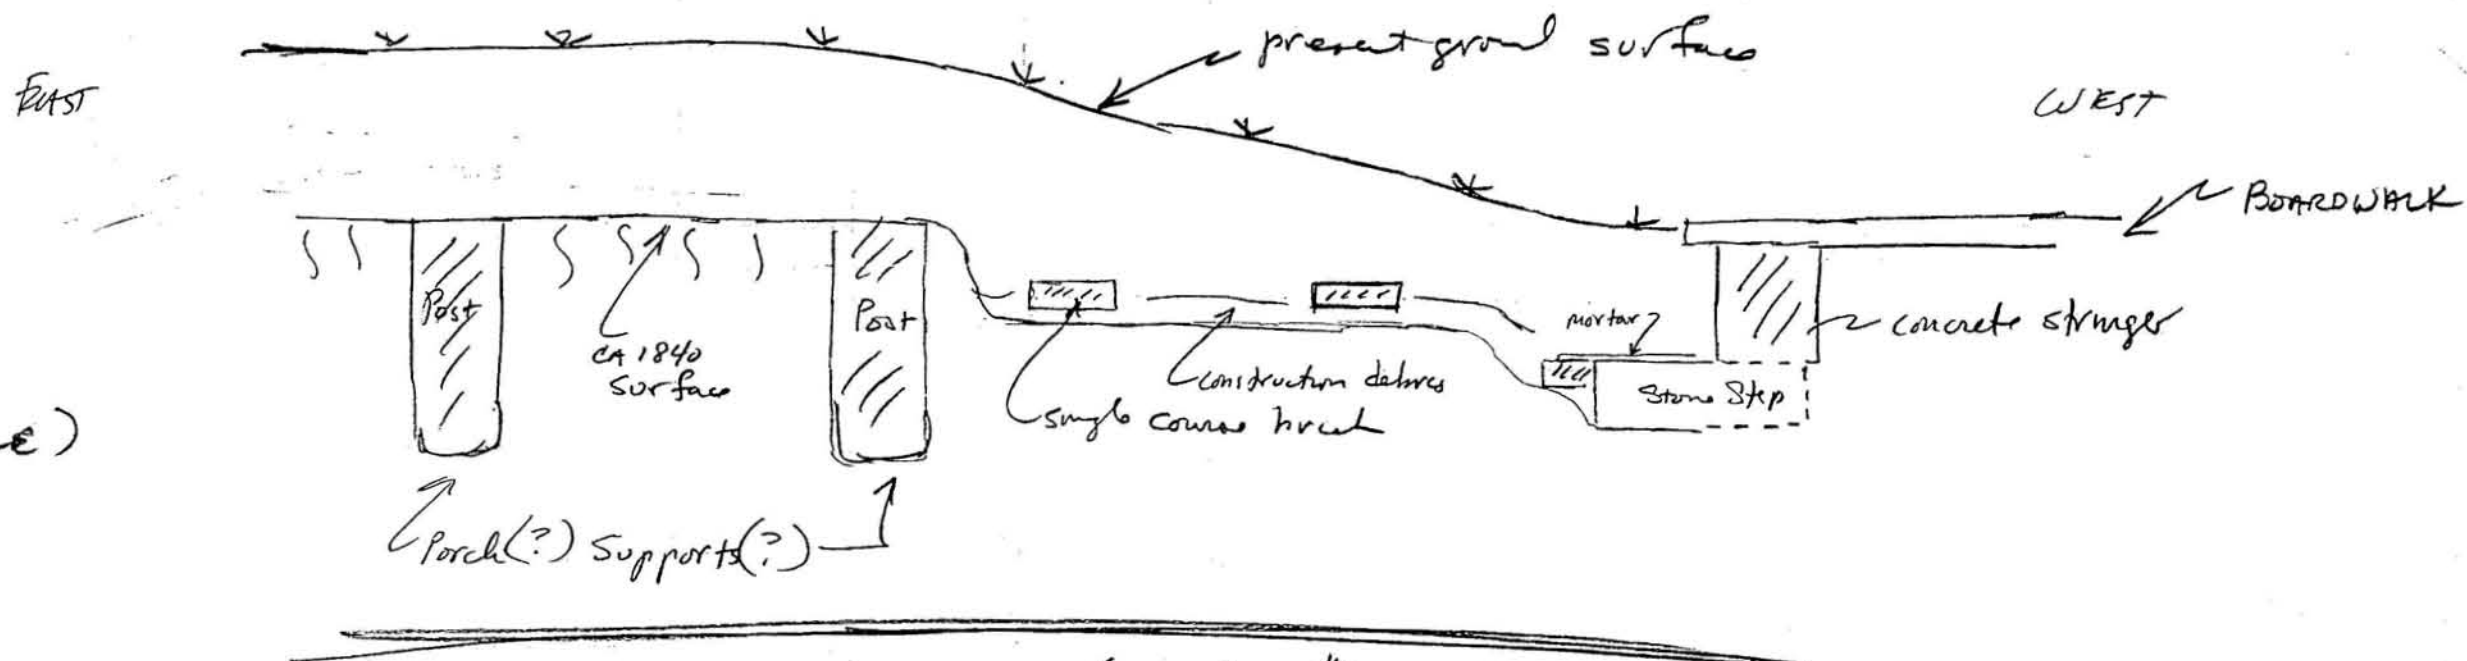
Sketch
(not to scale)

Very sketchy interpretation of relationship between "cheek wall" and brick supports. I do believe that "cheek walls" post date brick supports but this does not mean that these two represent separate components, only that the "wing walls" or "cheek walls" post date the steps.

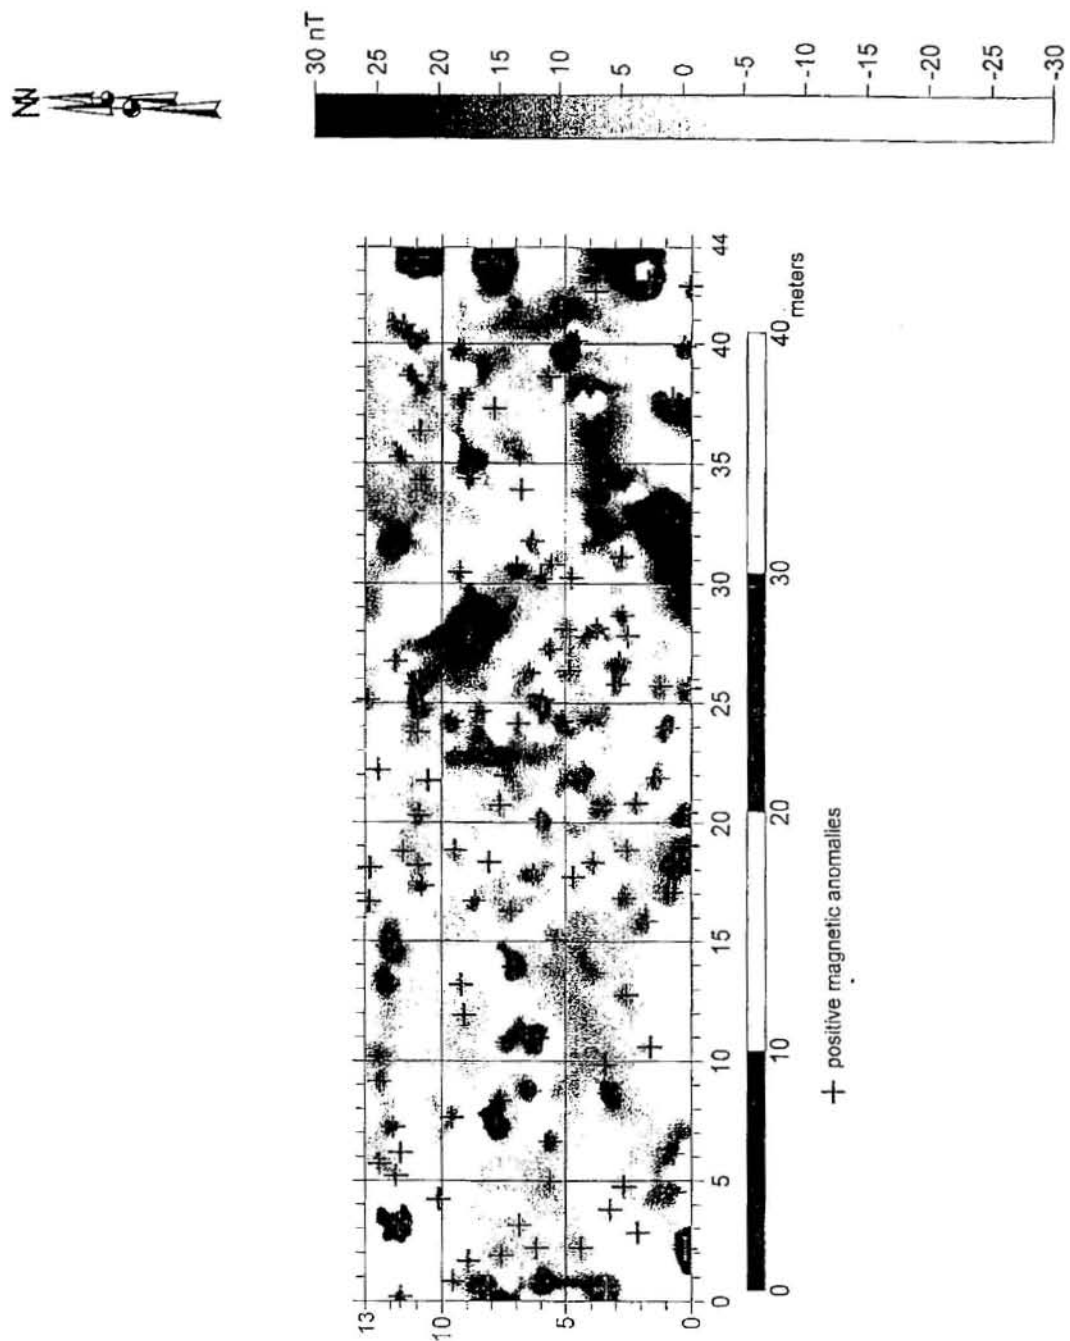
Figure 21. Interpretative map of magnetic gradient data from the Burch lot.

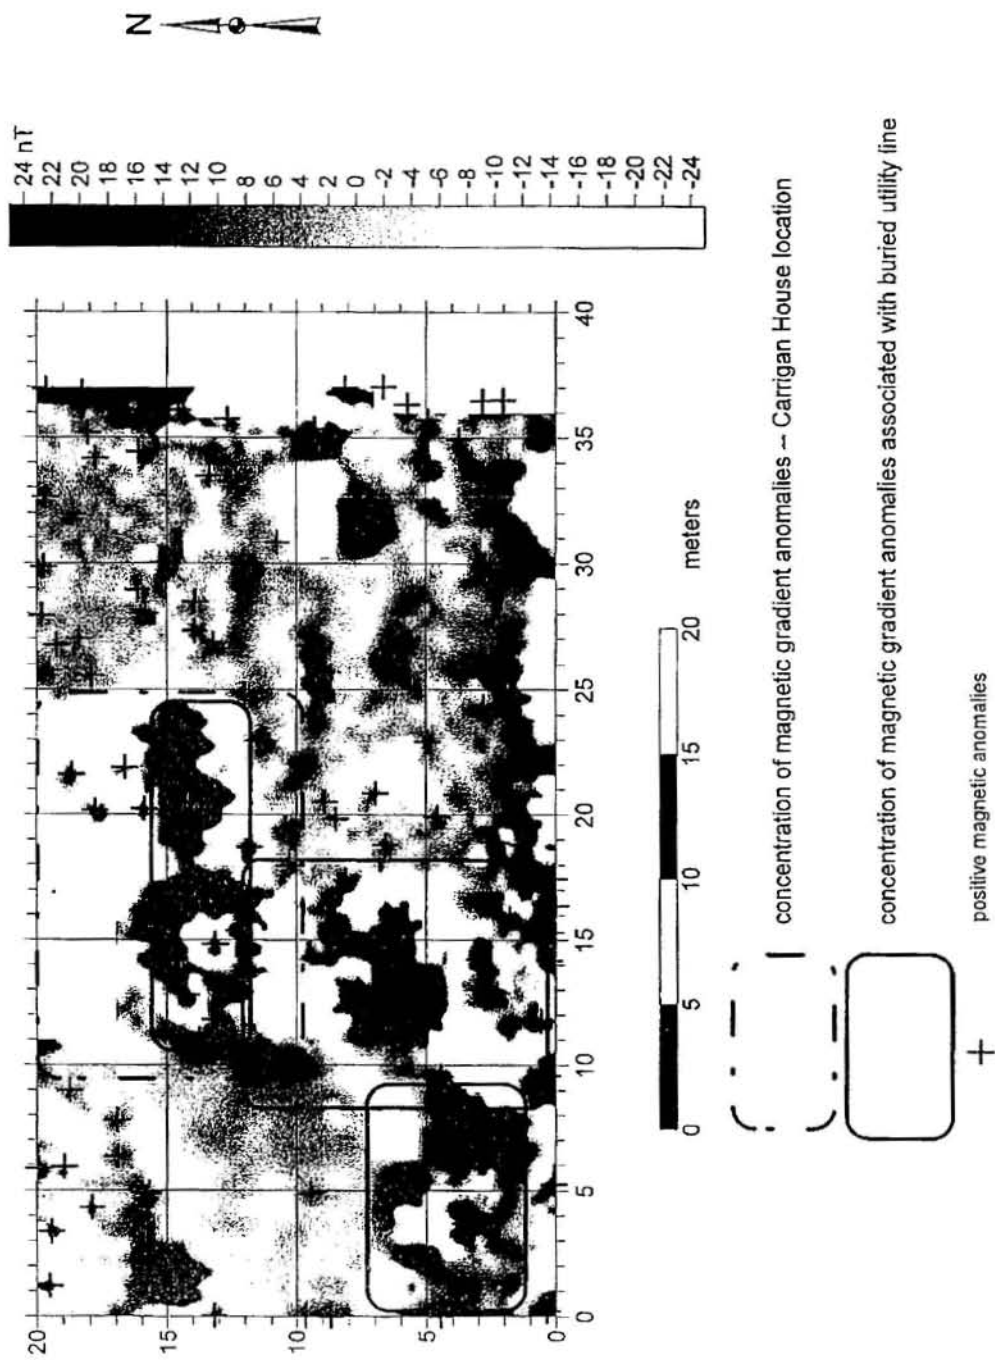
Figure 25. Interpretative map of magnetic gradient data from the Carrigan lot.

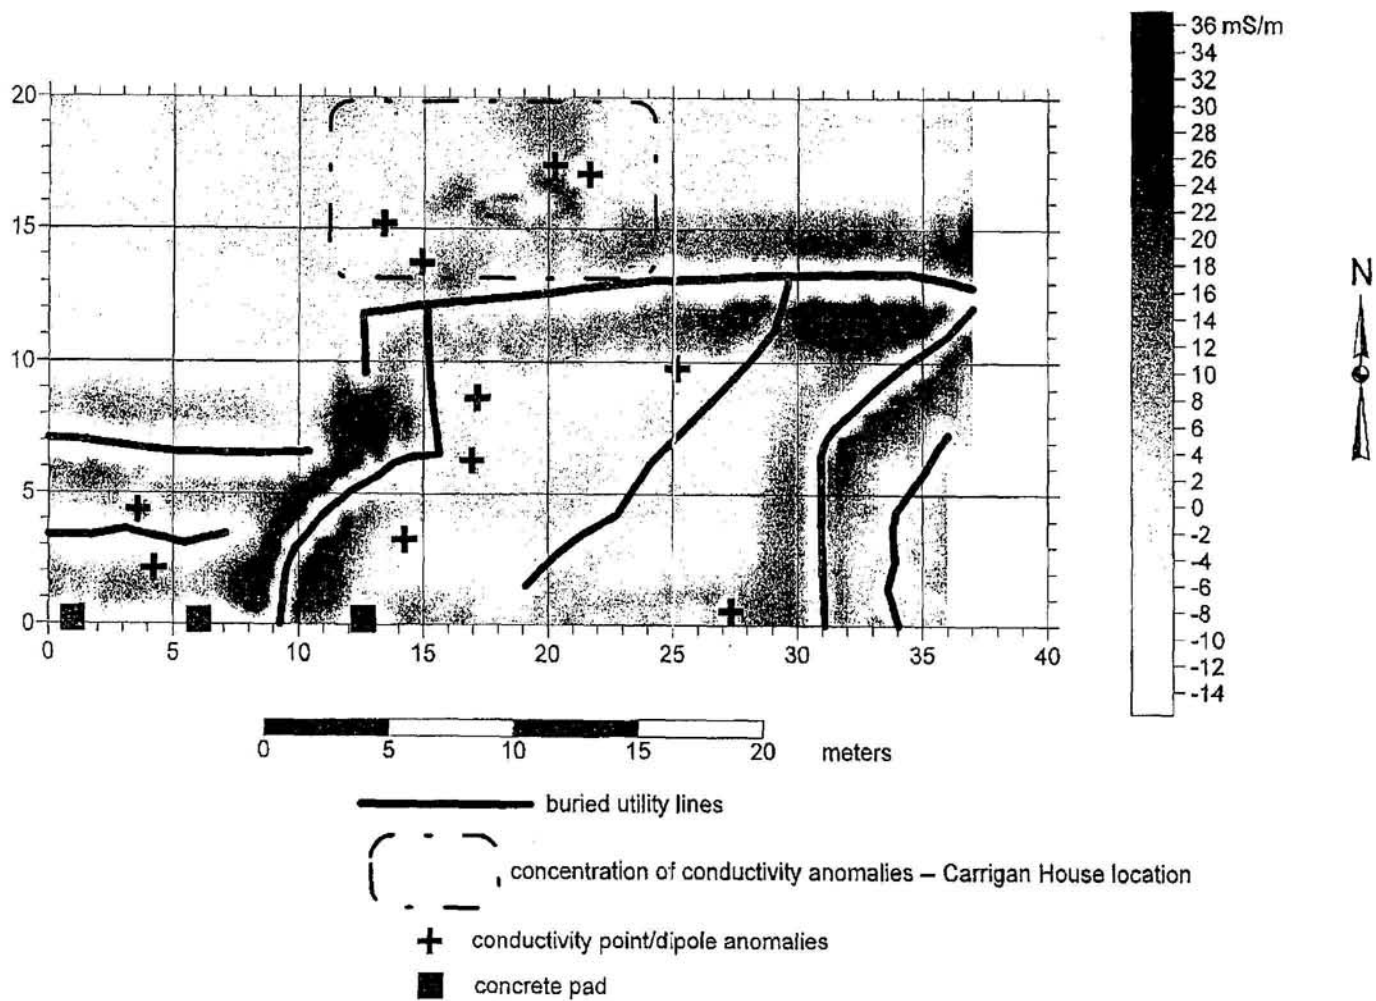
Figure 26. Interpretative map of conductivity data from the Carrigan lot.
