# CULTURAL LANDSCAPE REPORT FOR ASPET

SAINT-GAUDENS NATIONAL HISTORIC SITE

VOLUME III: TREATMENT AND RECORD OF TREATMENT

CORNISH, NEW HAMPSHIRE

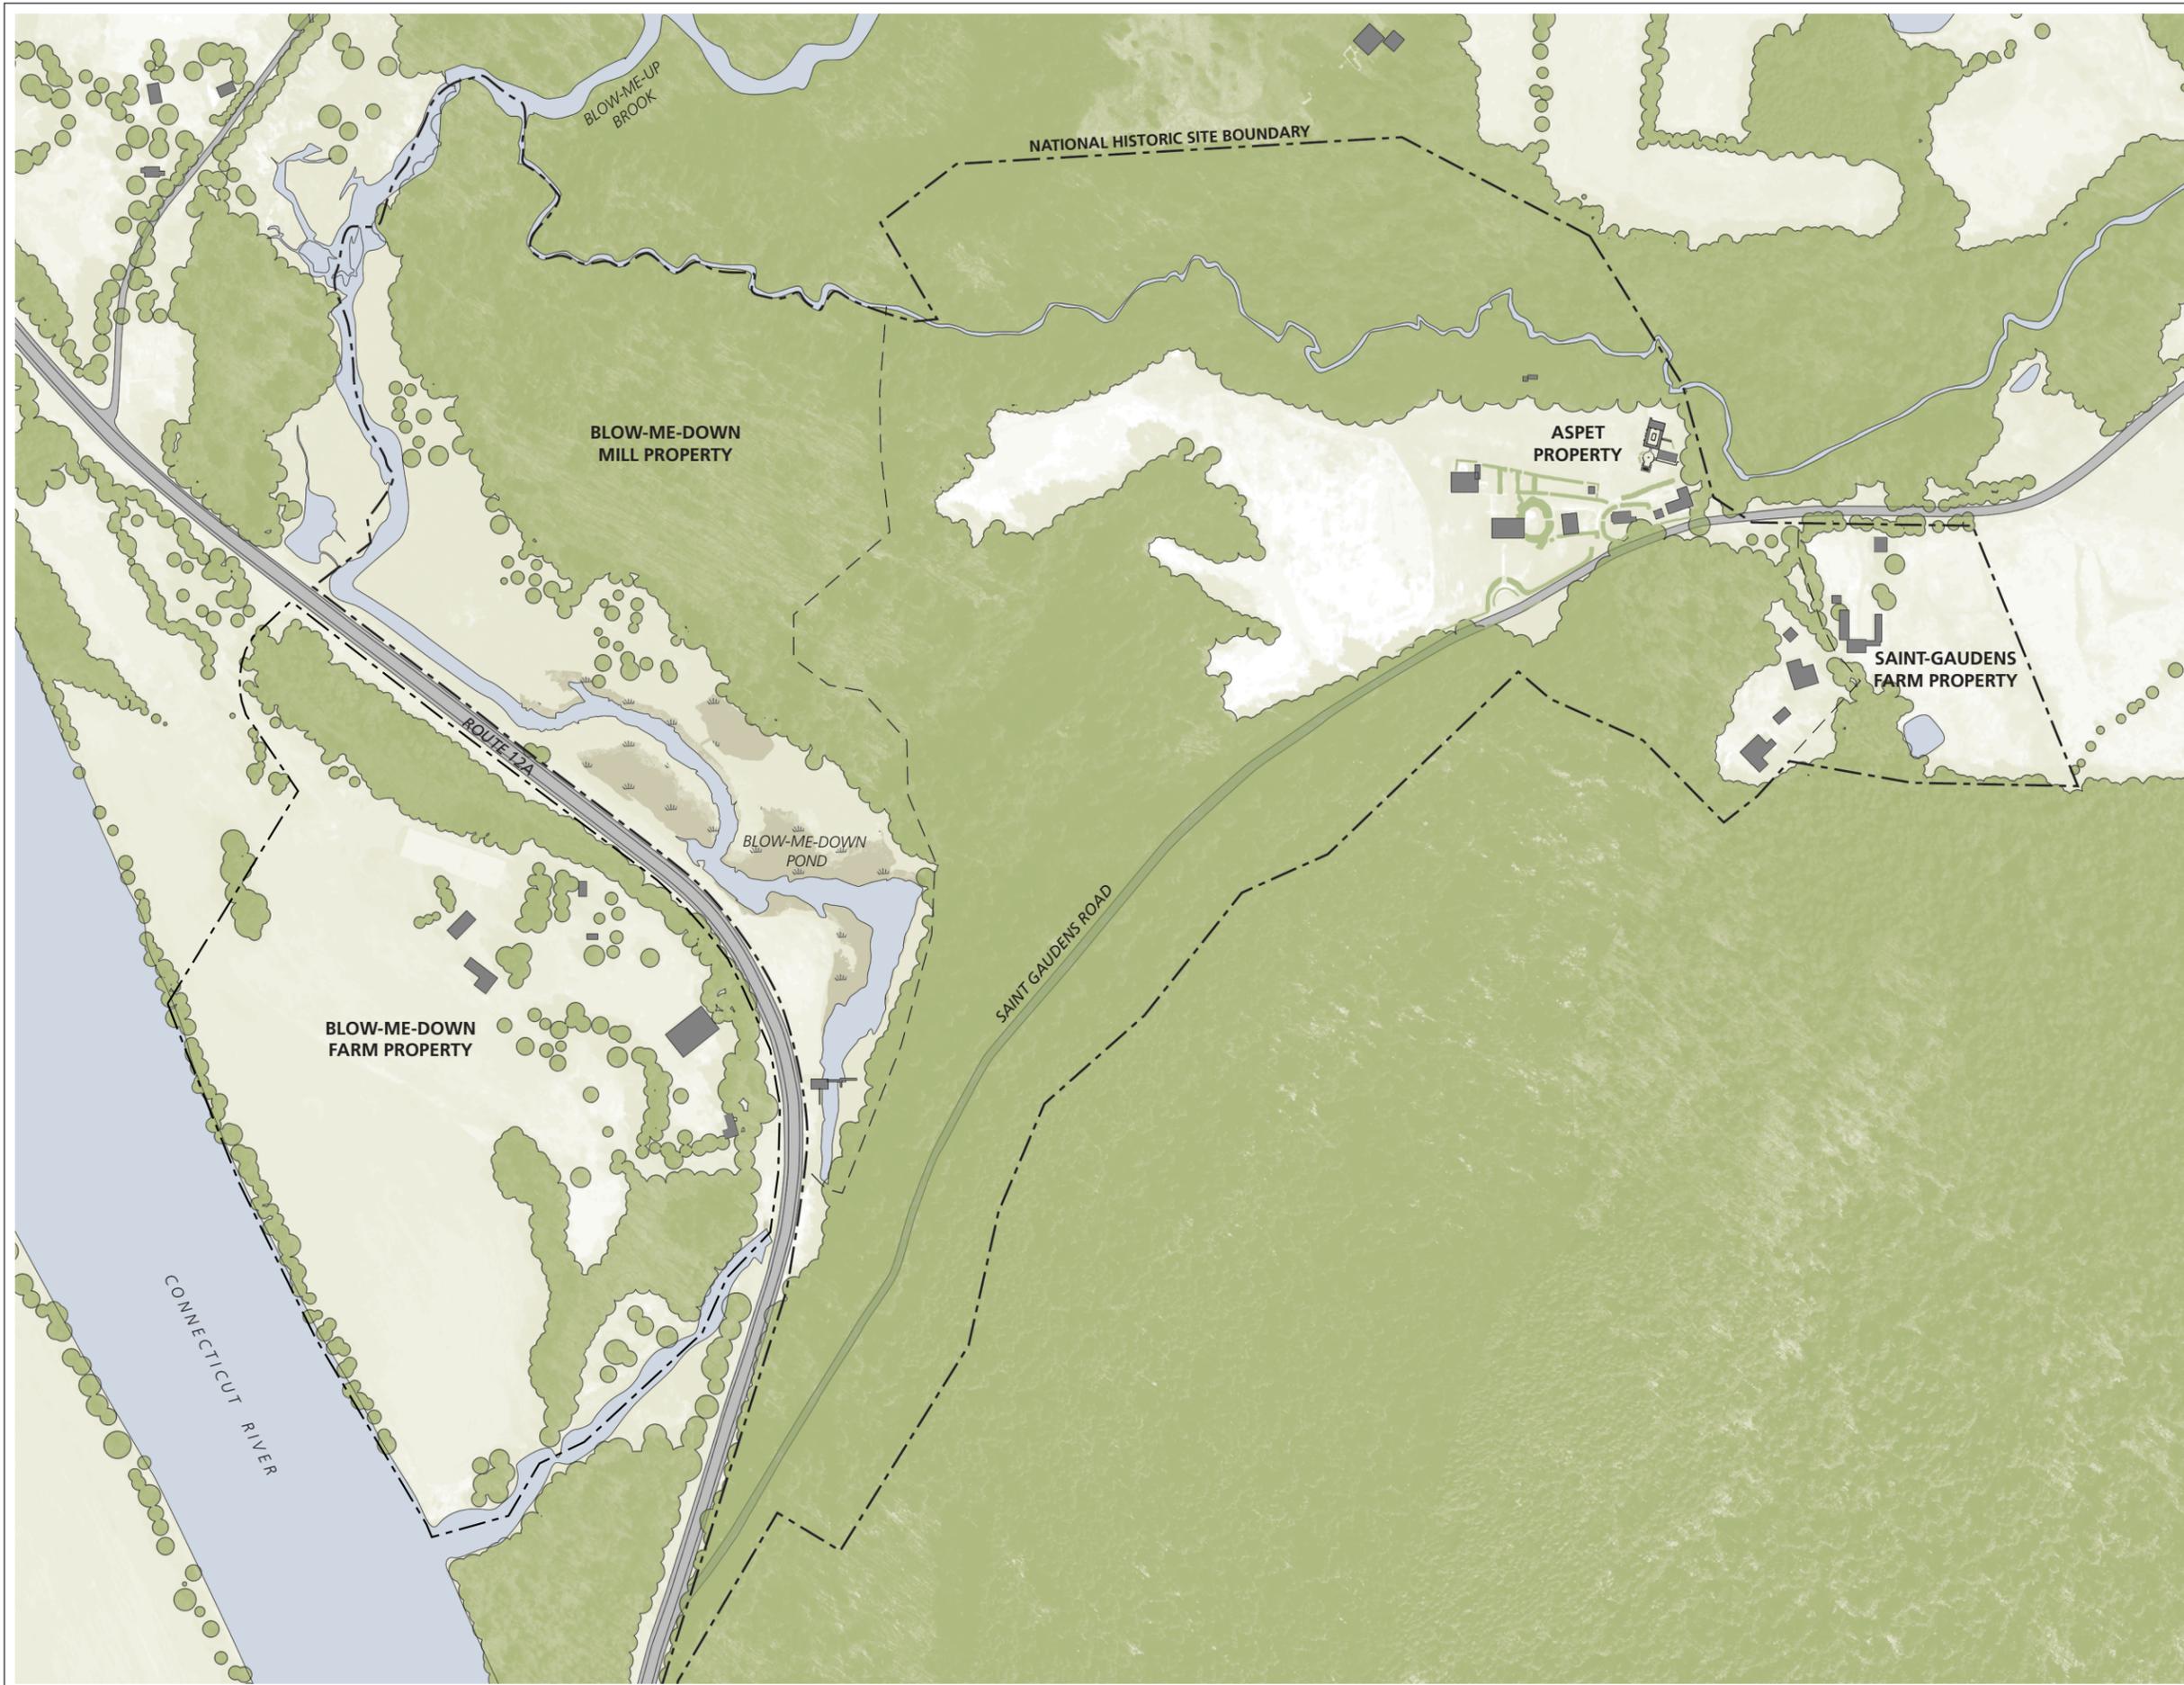
Drawing 1

### Existing Conditions Plan, 2013

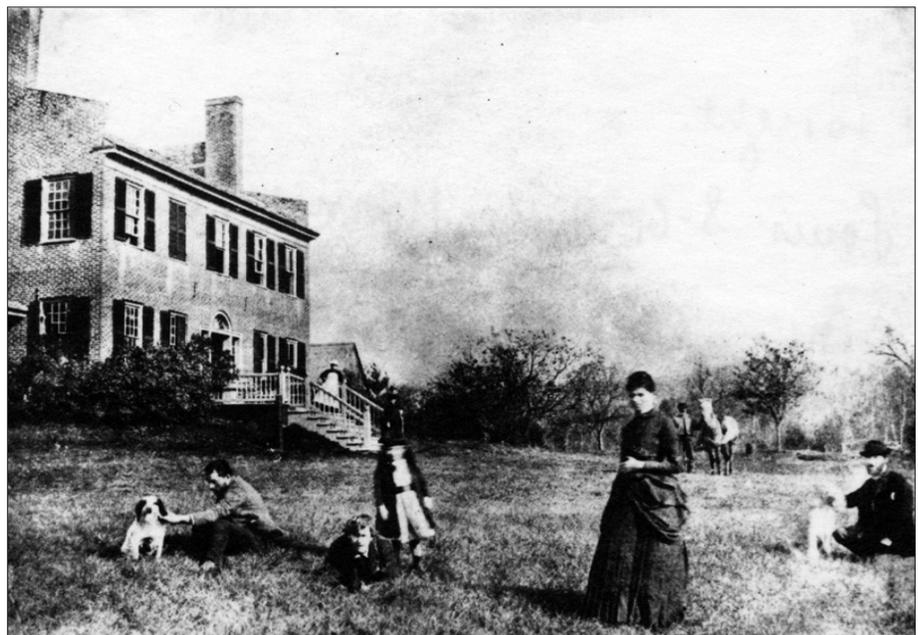
Figure 5. Saint-Gaudens family in front of "Huggin's Folly" during their first summer renting the property. Note the lilacs by the house and a row of apple trees in the background. View looking east, 1885 (SAGA 859).

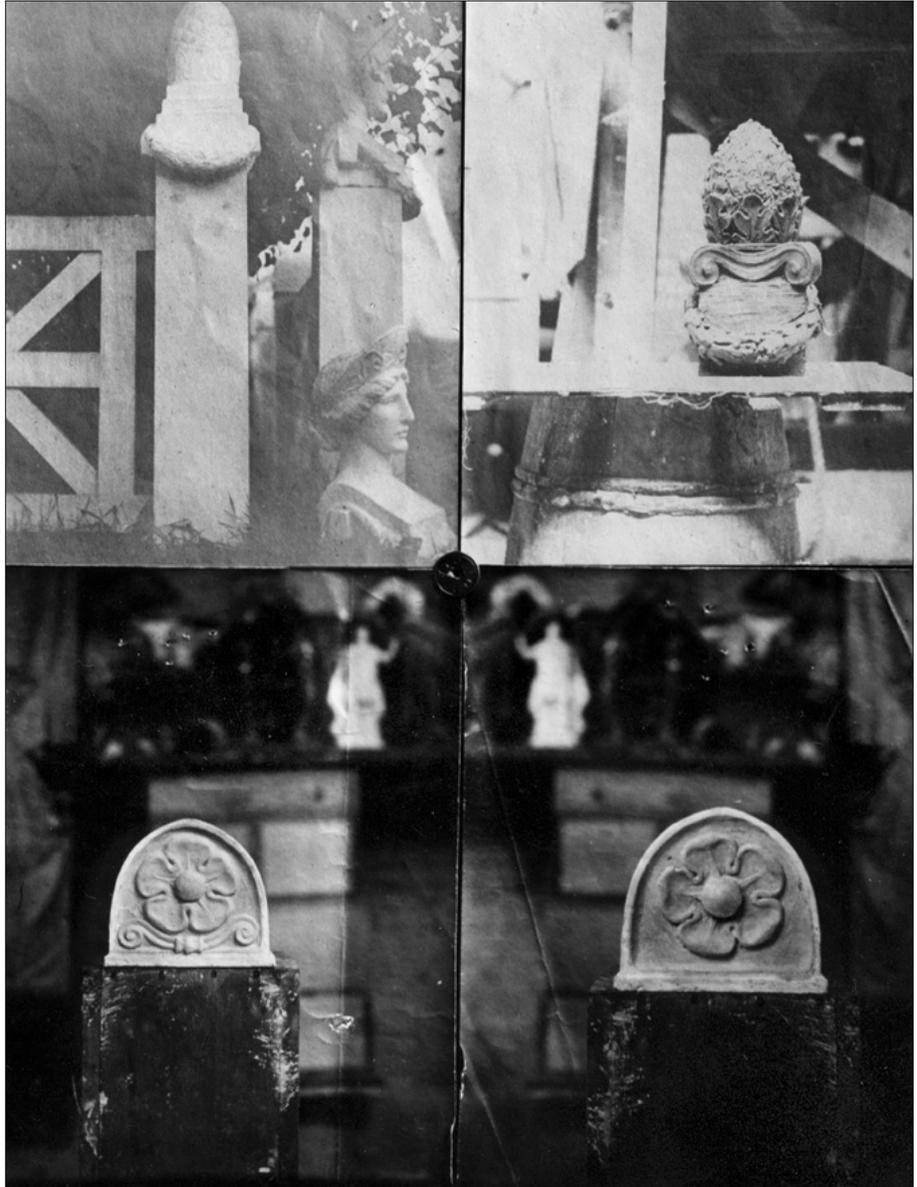
Figure 7. Details of ornamental balustrade caps. Placement of these caps is visible in Figures 6, 8, and 9, n.d. (SAGA 545).

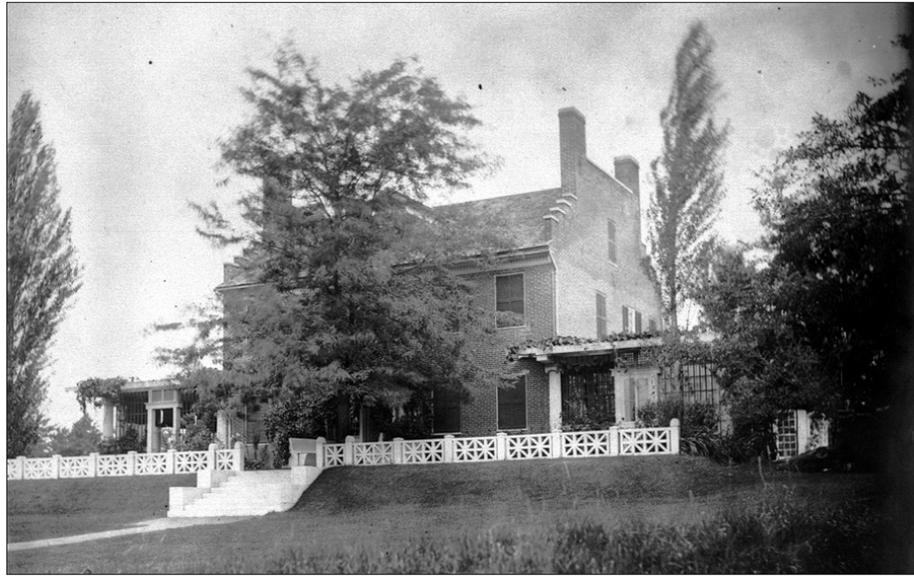
Figure 9. Mature poplars at the corners of the house are gone, with young replacements planted. A vine grows over the front entry trellis. Lilacs frame the front entry and the honeylocust is displacing a section of the balustrade. View looking northeast, c. 1965 (SAGA 3a).

Images from the 1960s to the present show minimal changes to the house main entry after the historic period, aside from the natural growth of vegetation (Figures 9 to 16). The planter box benches installed by Saint-Gaudens on either side of the front door have been replaced in-kind (see Figure 14). Flowers in containers are still placed on the cheek walls of the marble steps, a practice first recorded by a photograph taken in 1924 of the ceramic glazed planters.<sup>3</sup> The kitchen yard, seldom visited or photographed, also reflects a minimal amount of change, though the hedges have grown in height and breadth (see Figures 10 and 15).

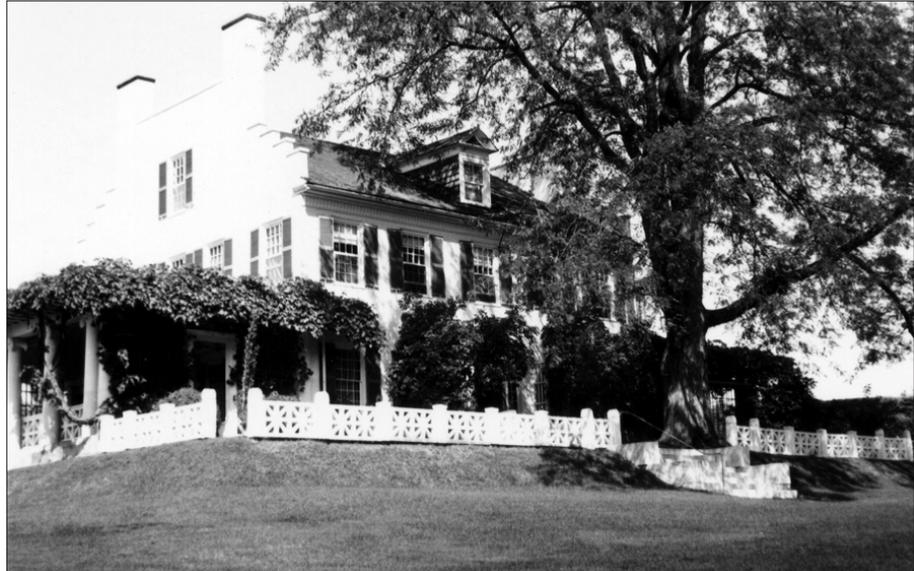
Figure 10. The kitchen entry framed by hedges. Grape vines cover the southeast porch and a small shrub, possibly a rose, grows in a bed of groundcover. View looking west, c. 1965 (HABS 104628pr).

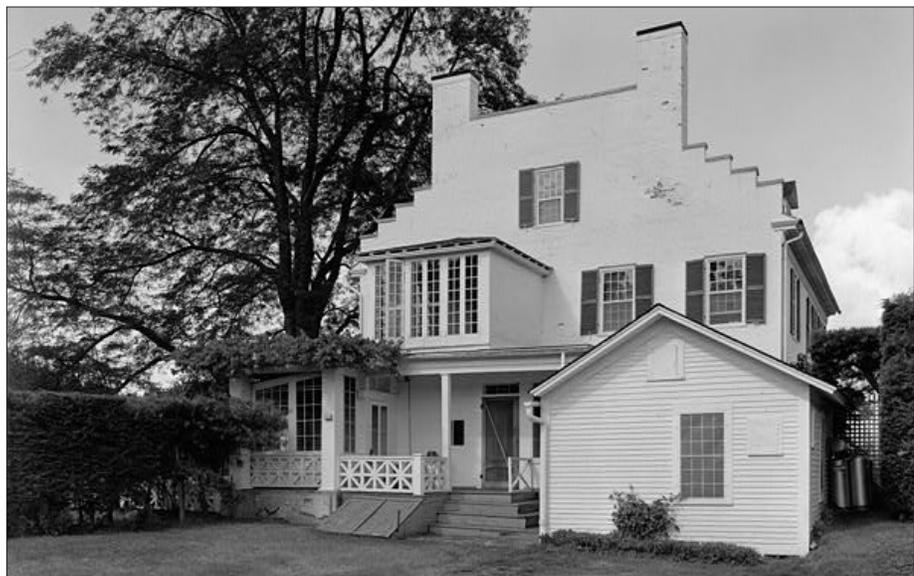
Figure 11. West Piazza and north side (back) of the Main House facing the flower garden, with newly planted poplars at both corners of the terrace, sheared round hemlocks by the piazza step, and grape vines on the trellis. A pipe railing borders the marble steps to the flower garden. View looking southeast, c. 1970 (SAGA 4b).

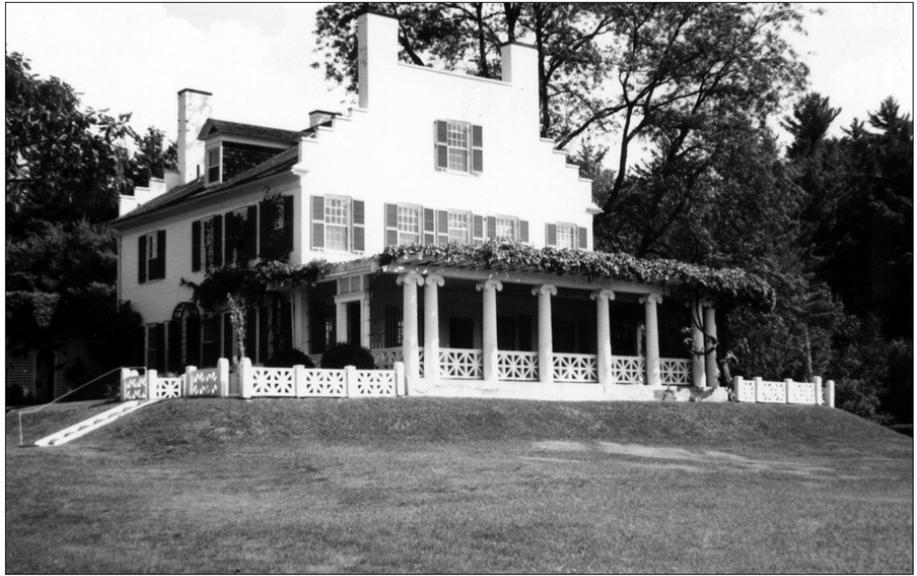
Figure 12. Entry walk to the Main House framed by the outer white pine horseshoe hedge. Replicas of historic planters on the granite steps in the foreground and on the marble steps in the background also frame the walk. A pipe rail is located to the right of the granite steps. View looking north, c. 1970 (SAGA 1240).

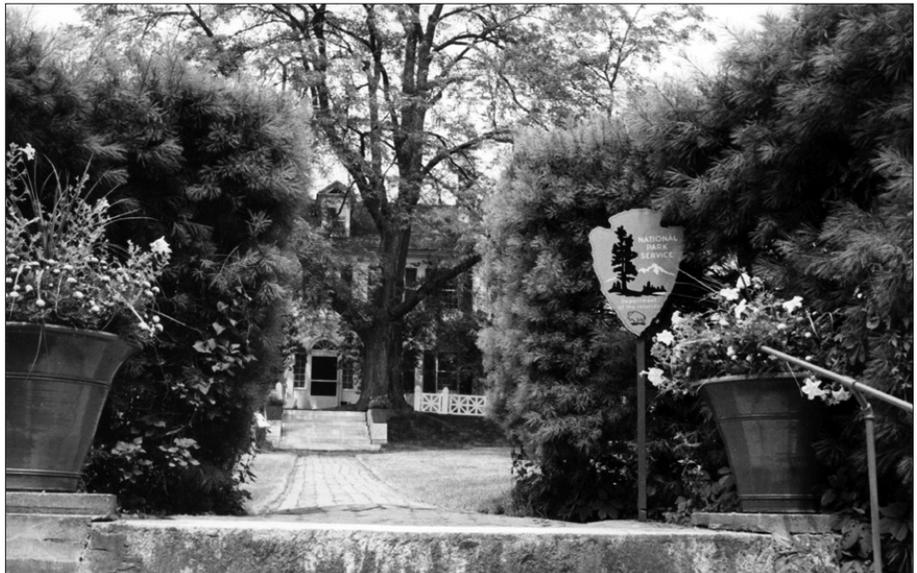
Figure 13. Main House entry, with planter benches on both sides of the entry, lilacs framing the entrance, wooden painted planters on the marble cheek walls, and an interpretive sign along the entry walk. View looking north, c. 1970 (SAGA 1d).

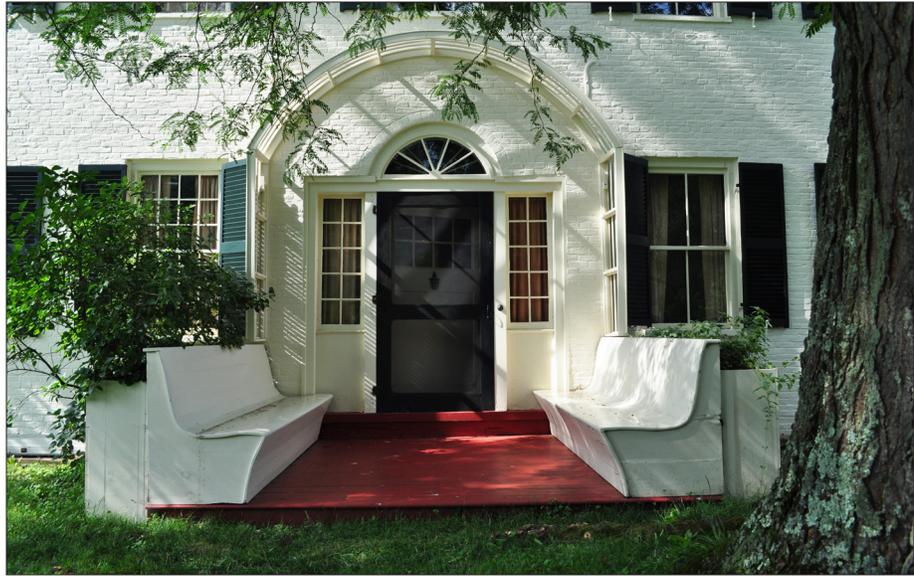
Figure 14. Main House entry showing planter boxes and wood benches. View looking north, 2013 (OCLP).

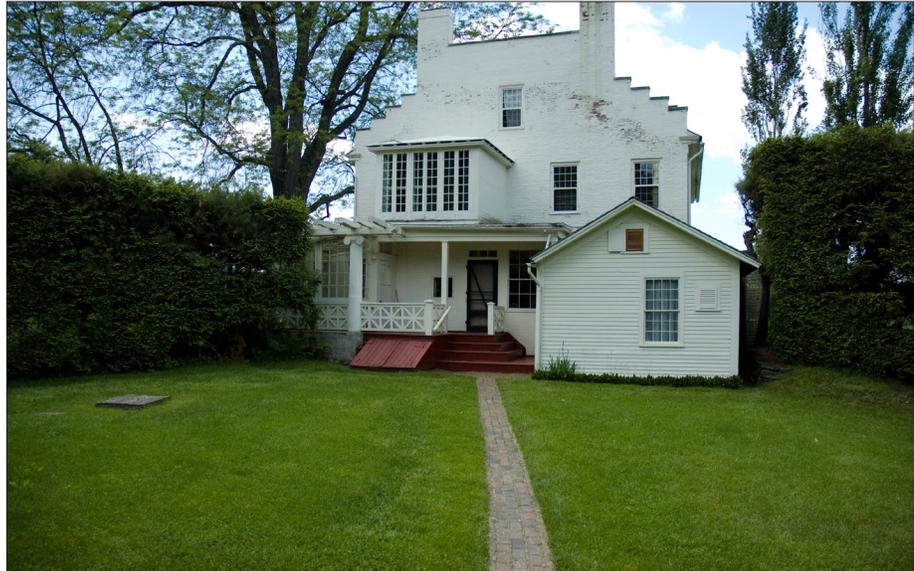
Figure 15. Main House from the kitchen yard. The space appears the same as it did in the 1960s, with the exception of growth of the hedges and loss of unidentified shrubs that grew in a bed of groundcover. View looking west, 2013 (OCLP).

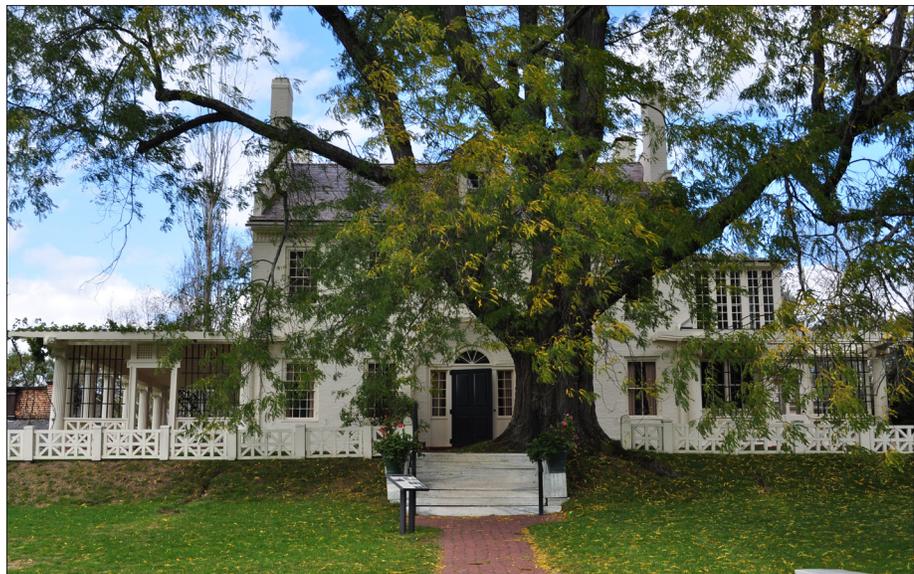
Figure 16. Main House entry showing the brick walk, marble steps, park wayside, honeylocust, and terrace balustrade. View looking north, 2012 (OCLP).

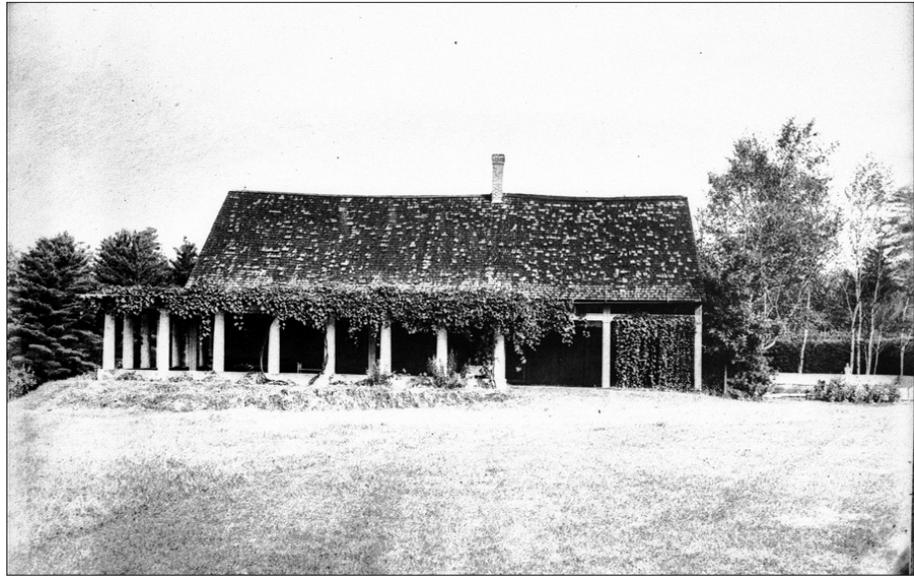
Figure 17. Hay barn/studio with pergola, grape vines, and a flower bed along the south facade. View looking north, c. 1900 (SAGA 872a).

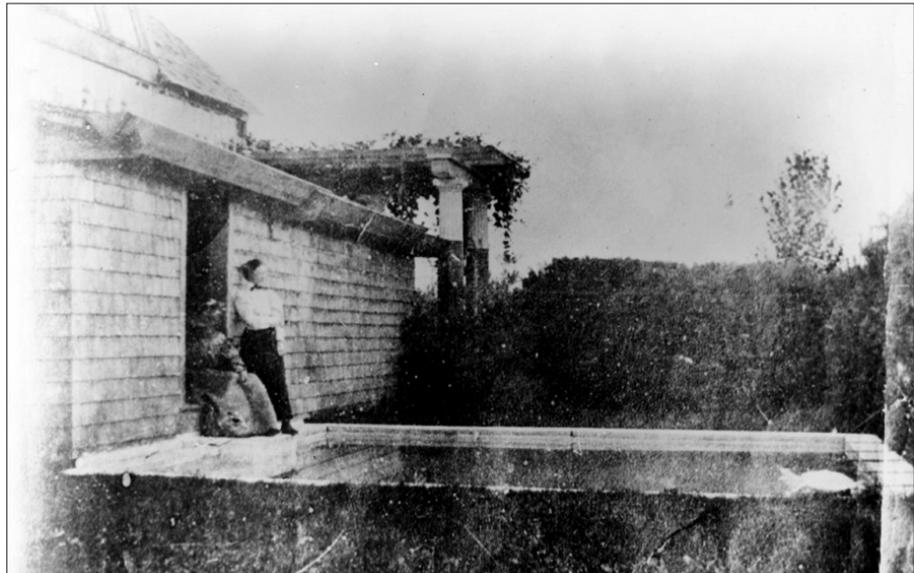
Figure 18. Plunge pool on the north side of the Little Studio, with the gold turtles on the pool coping, a white pine hedge surrounding the space, grape vines on the pergola, and a poplar at the northwest corner of the hedge. View looking west, c. 1900 (SAGA 563b).

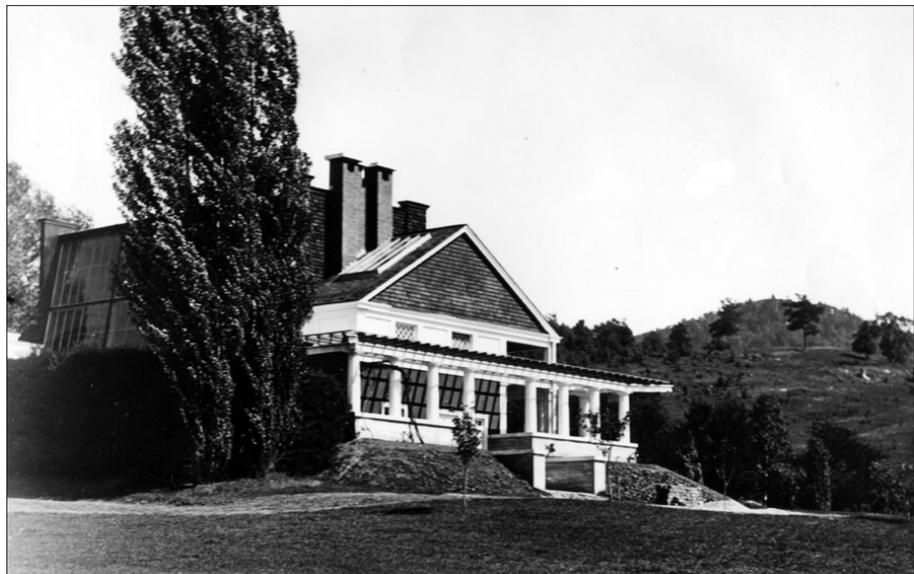
Figure 19. The newly constructed Little Studio, with a grape vine near the second column from the left, a row of young apple trees, two poplars, and a white pine hedge. The deforested Dingleton Hill is visible in the distance. View looking southeast, c. 1905 (SAGA 808).

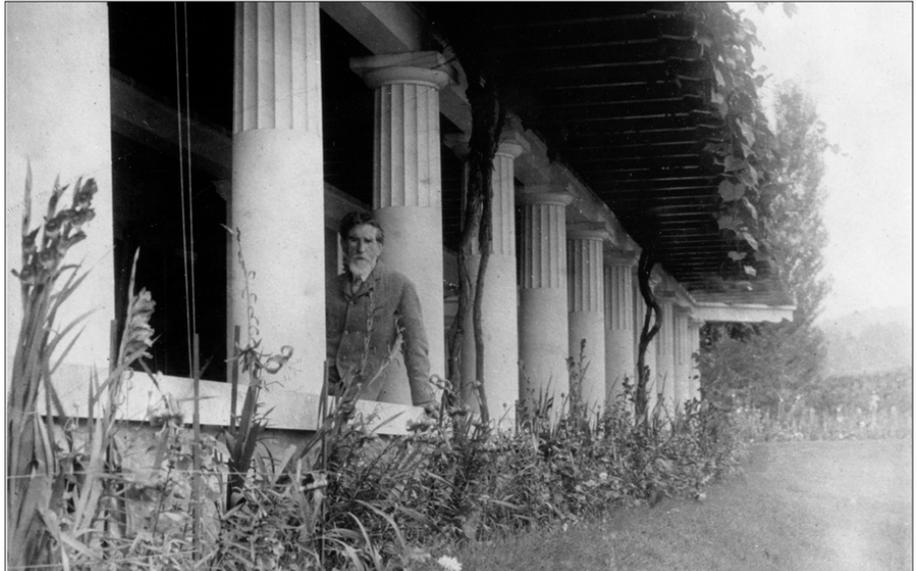
Figure 22. View of the Main House from the Little Studio pergola showing the terra-cotta jar by the pergola entrance. Several containers are visible on the upper terrace of the flower garden in the distance. View looking southeast, c. 1906 (SAGA 868).

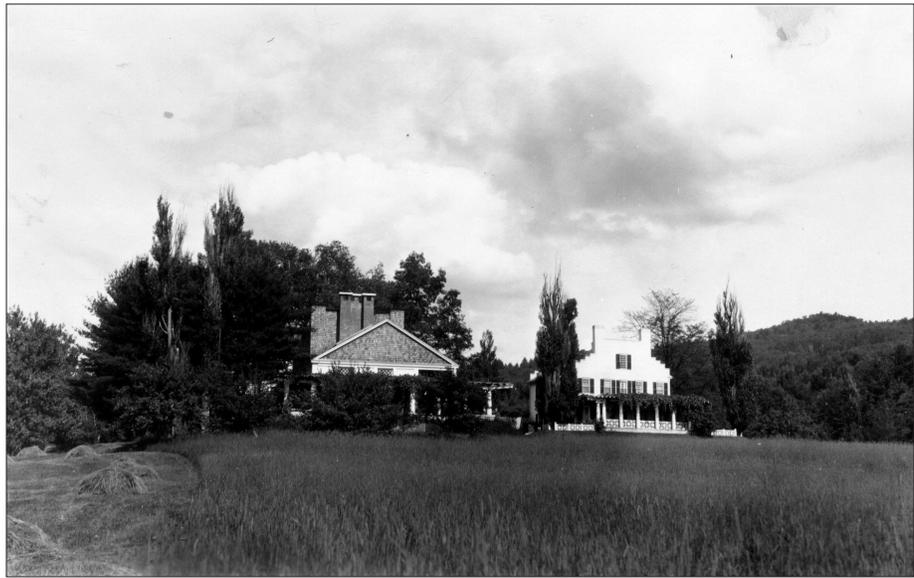
Figure 23. Aspet from the west meadow showing the Little Studio, poplars, and apple trees. View looking southeast, c. 1950 (SAGA).

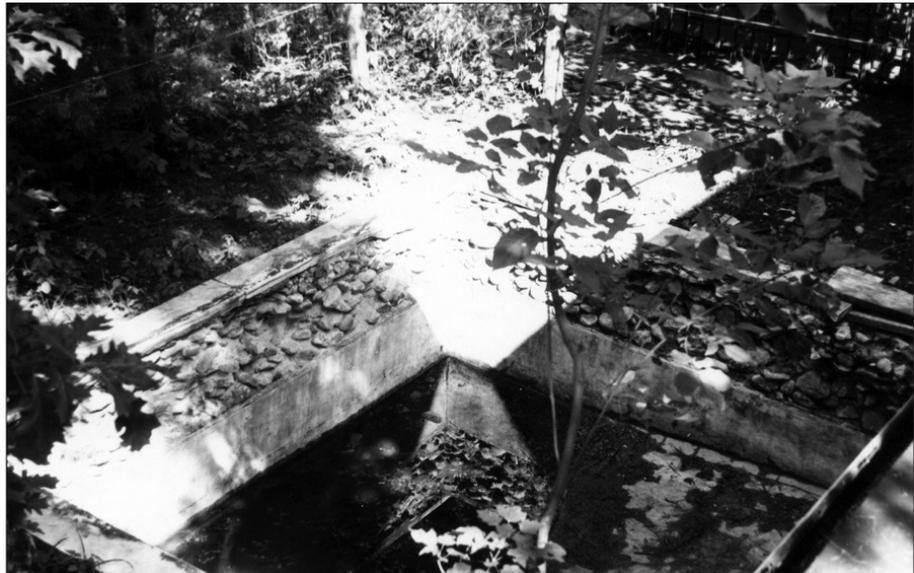
Figure 24. Little Studio plunge pool, overgrown by vegetation. View looking northeast, c. 1965 (SAGA 2c).

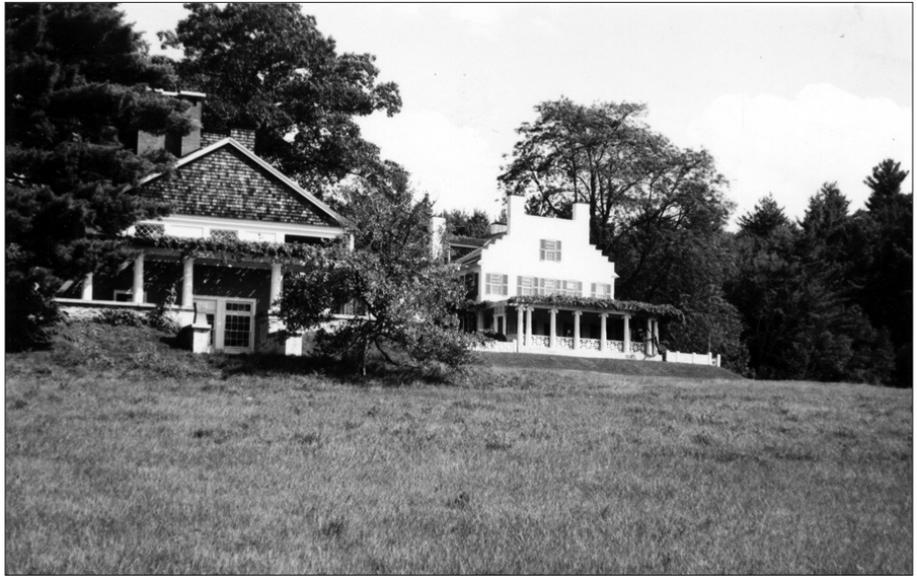
Figure 27. Brick paving and wooden benches under the Little Studio pergola. View looking east, c. 1965 (SAGA 1237).

Views from the interior of the pergola illustrate the design intent of Saint-Gaudens (see Figure 27). From within, the columns frame views to Mount Ascutney, the adjacent hills, and the Main House. Views east through the pergola entrance align with the brick path to the flower garden. A pair of terra-cotta jars, visible in historic photographs, still frame the entrance to the pergola and contribute to the Italian-inspired character of the design (see Figure 22). To the north of the Little Studio, a swimming pool remains from the historic period, though it has been filled with gravel (see Figures 18, 24, and 31). A white pine hedge and pair of poplars define the north side of the Little Studio (see Figures 18 and 19). To the west of the Little Studio a loose row of six apple trees remains from the historic period, most of which are replacements (see Figures 19, 26, and 30). To the east, near the Pan pool and birch grove, a large oak tree that was present during the historic period is gone (see Figures 25 and 29).

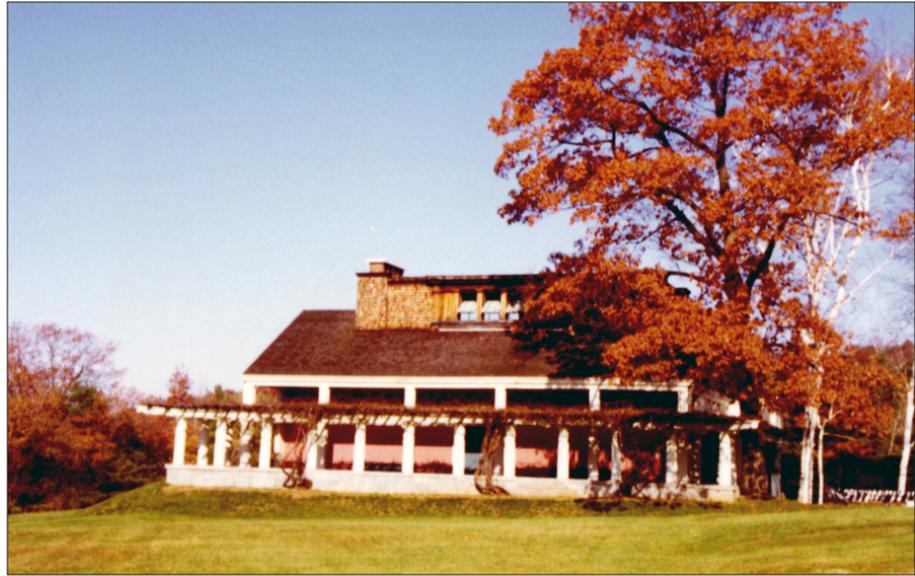
Figure 29. Little Studio prior to removal of the red oak that was leaning on the pergola. View looking north, c. 1970 (SAGA 227c).

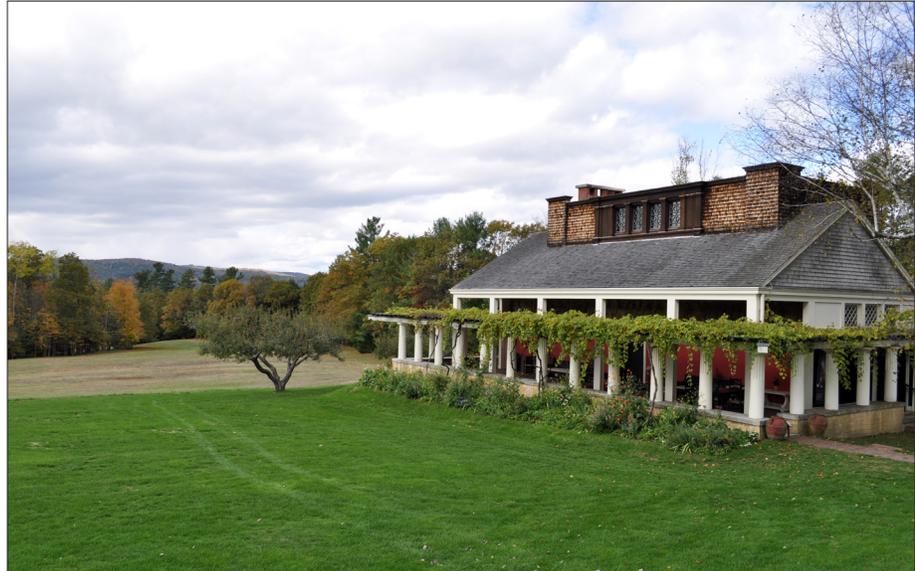
Figure 30. Little Studio, flower bed with grape vines, terra-cotta jars, and an apple tree in the distance. View looking northwest, 2012 (OCLP).

The Little Studio area includes the studio, associated pergola, south side garden bed, west side orchard trees, and north side hedge. Historically, the Little Studio was the center of activity for art commissions carried out by Saint-Gaudens and his assistants (Figures 17 to 31). During his first years on the property, the building was a hay barn. Saint-Gaudens reconfigured the building by adding a pergola structure along its south side (see Figure 17). The pergola and the grape vines trained along its south and west-facing sides continue to define the character of the building and landscape setting. Along the south side of the building, a simple garden bed runs the length of the studio and reflects Augustus and Augusta's interest in flower gardens (see Figures 21 and 30).

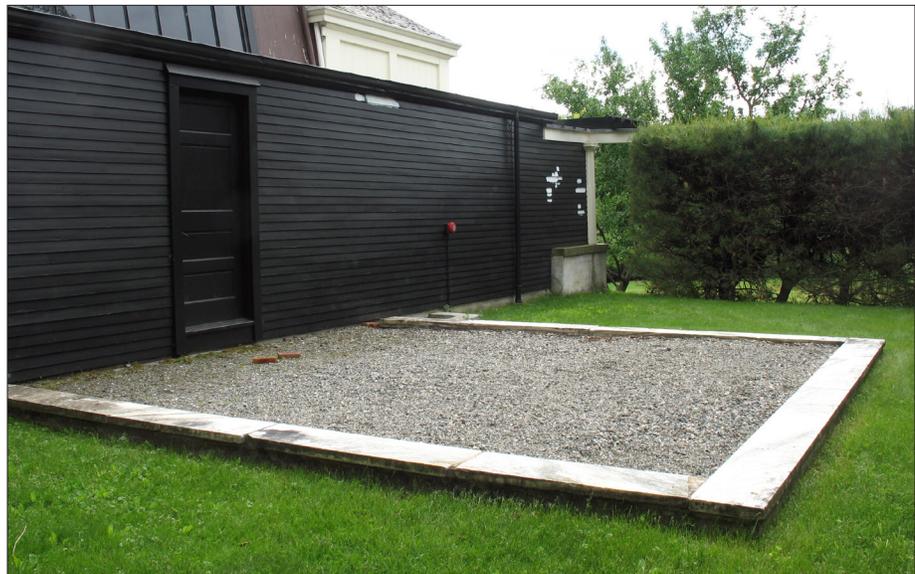
Figure 31. Plunge pool on the north side of the Little Studio, now filled with crushed stone. View looking west, 2012 (OCLP).

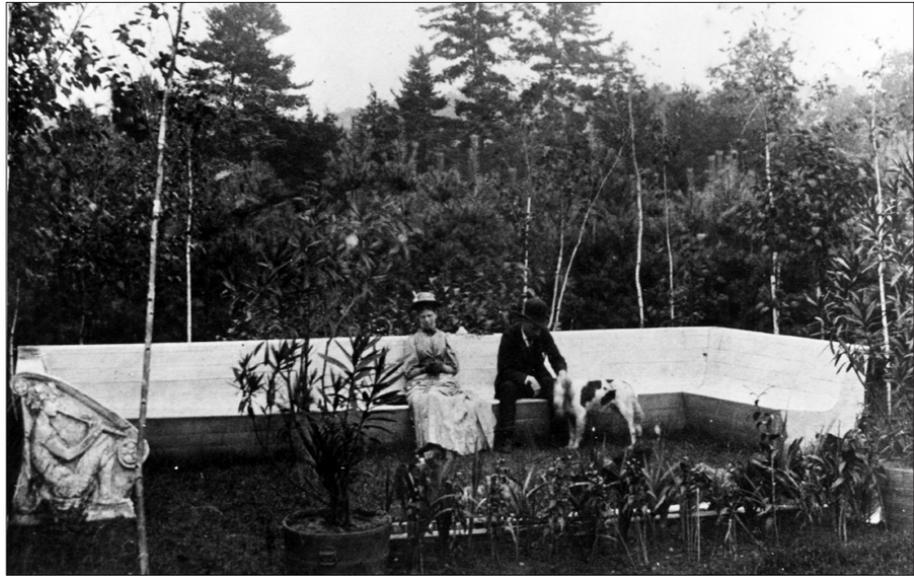
Figure 33. Pan pool and statue, with elephant ears (*Colocasia esculenta*) in the planting bed and oleanders (*Nerium oleander*) in pots. View looking south, c. 1894 (SAGA 554).

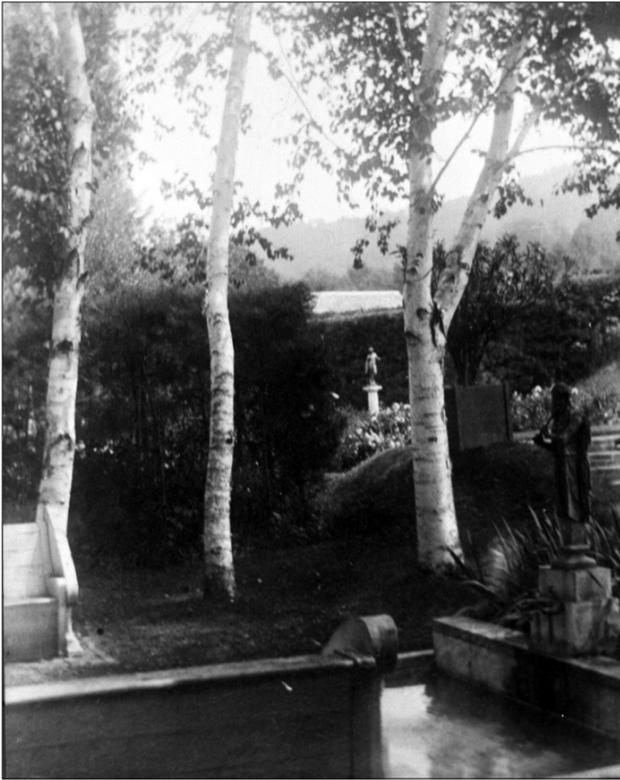
Figure 37. Pan statue, pool, and three birches in the southeast corner of the Pan Grove. The Hermes statue is visible in the distance, along with a wooden box planter containing a large shrub. View looking southeast, c. 1920s (SAGA 564).

The Pan pool and grove area is characterized as an outdoor room that is bounded by hedges to the north and east, and by the Little Studio to the west. A canopy of birches covers the space and surrounds a long bench facing the Pan statue and pool. Numerous historic photographs of the Saint-Gaudens family, pets, and guests indicate that the bench by the Pan pool was a popular gathering space (Figures 32 to 41). Several features contribute to the ambiance of the space, including the Pan statue, the distant views of Mount Ascutney to the southwest, and views of the house and flower garden terraces. Additional characteristics include the texture and color of flowers and tropical plants in the Pan pool bed, the spirited sound of water pouring from the fish fonts into the white marble pool, and the dappled shade and rustle of leaves in the birch grove. On axis with the Pan statue is the long comfortable ‘U’-shaped bench, originally installed in 1893–94, with sculptural reliefs at each end (see Figures 32 to 41). A historic photograph from the 1920s shows that the Hermes statue in the middle terrace of the flower garden could be seen from the Pan pool framed between two birches (see Figure 37). The garden hedge has since grown into the walkway and obscures this view.

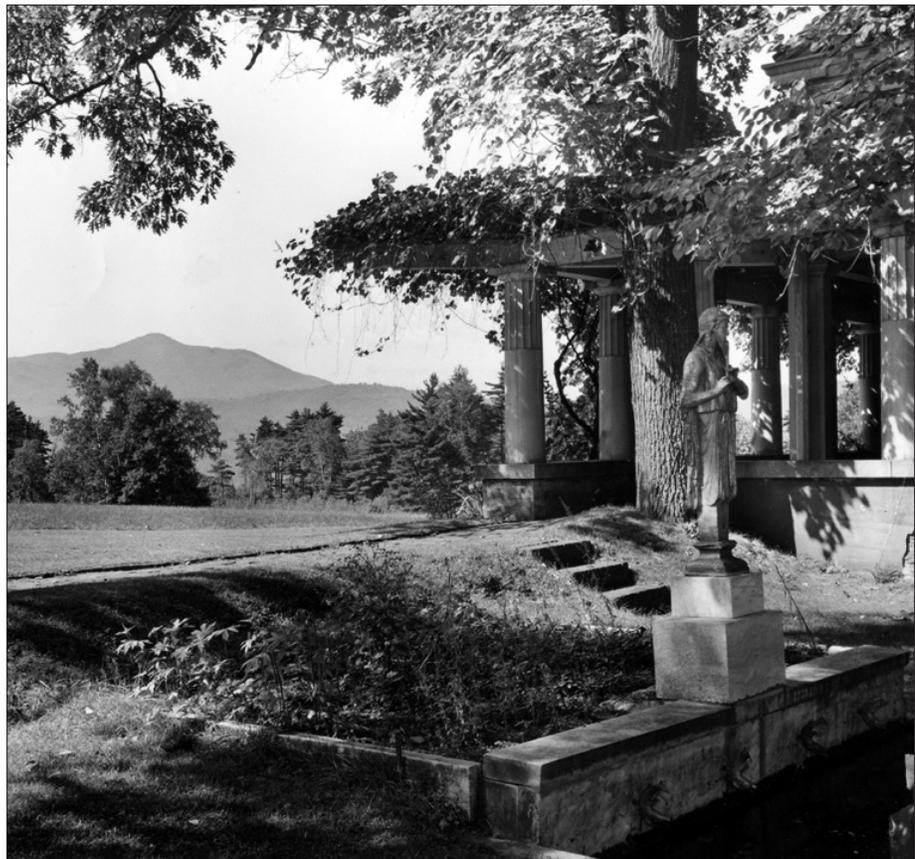
Figure 39. Pan statue and pool, with the Little Studio pergola and trunk of the red oak visible in the background. Mount Ascutney and Hunt Hill are visible in the distance. View looking southwest, 1960 (Aubrey P. Janion, SAGA 232).

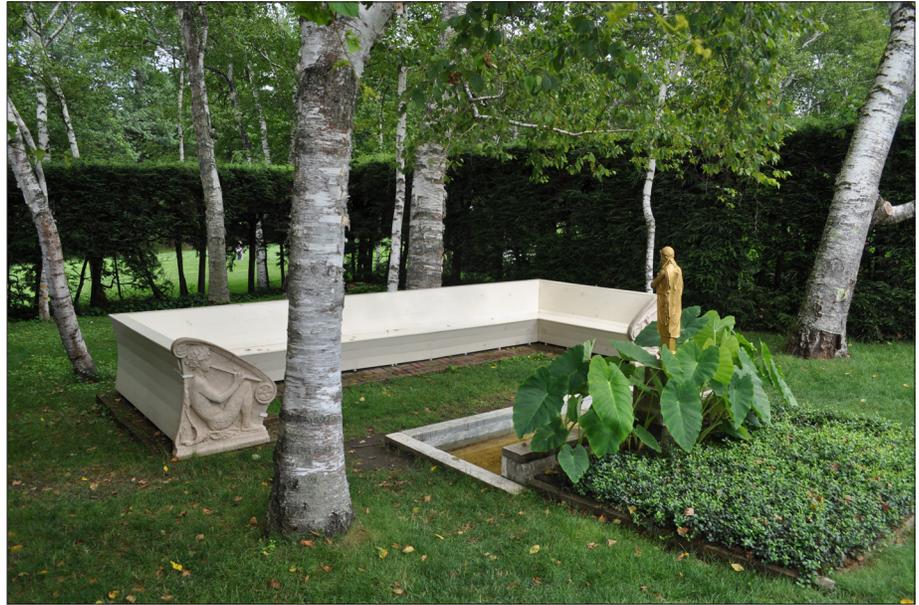
Figure 40. Pan statue, pool, and planting bed in summer with elephant ears. View looking northeast, 2013 (OCLP).

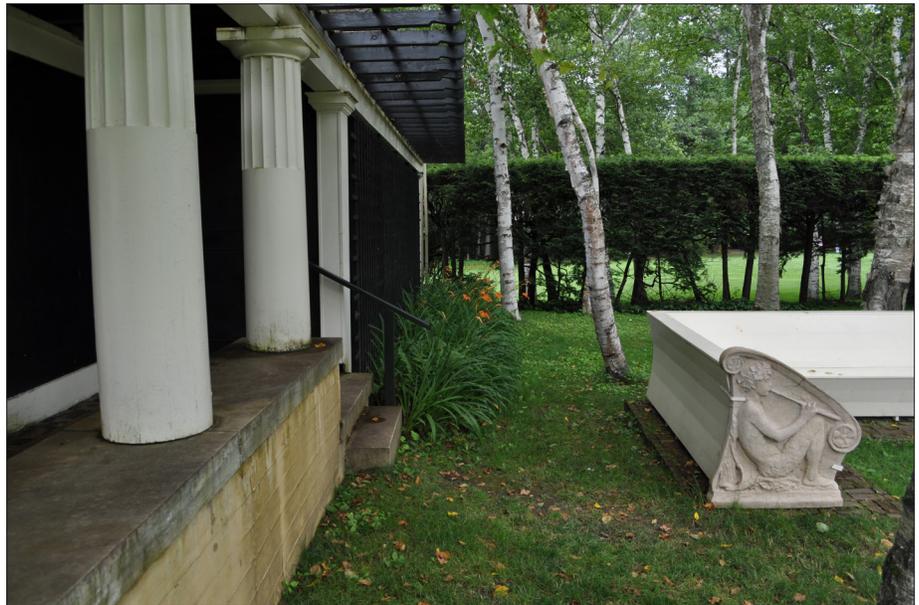
Figure 41. Western side of the Pan Grove, showing the proposed location of an accessible route from the visitor center to the Little Studio. View looking north, 2013 (OCLP).

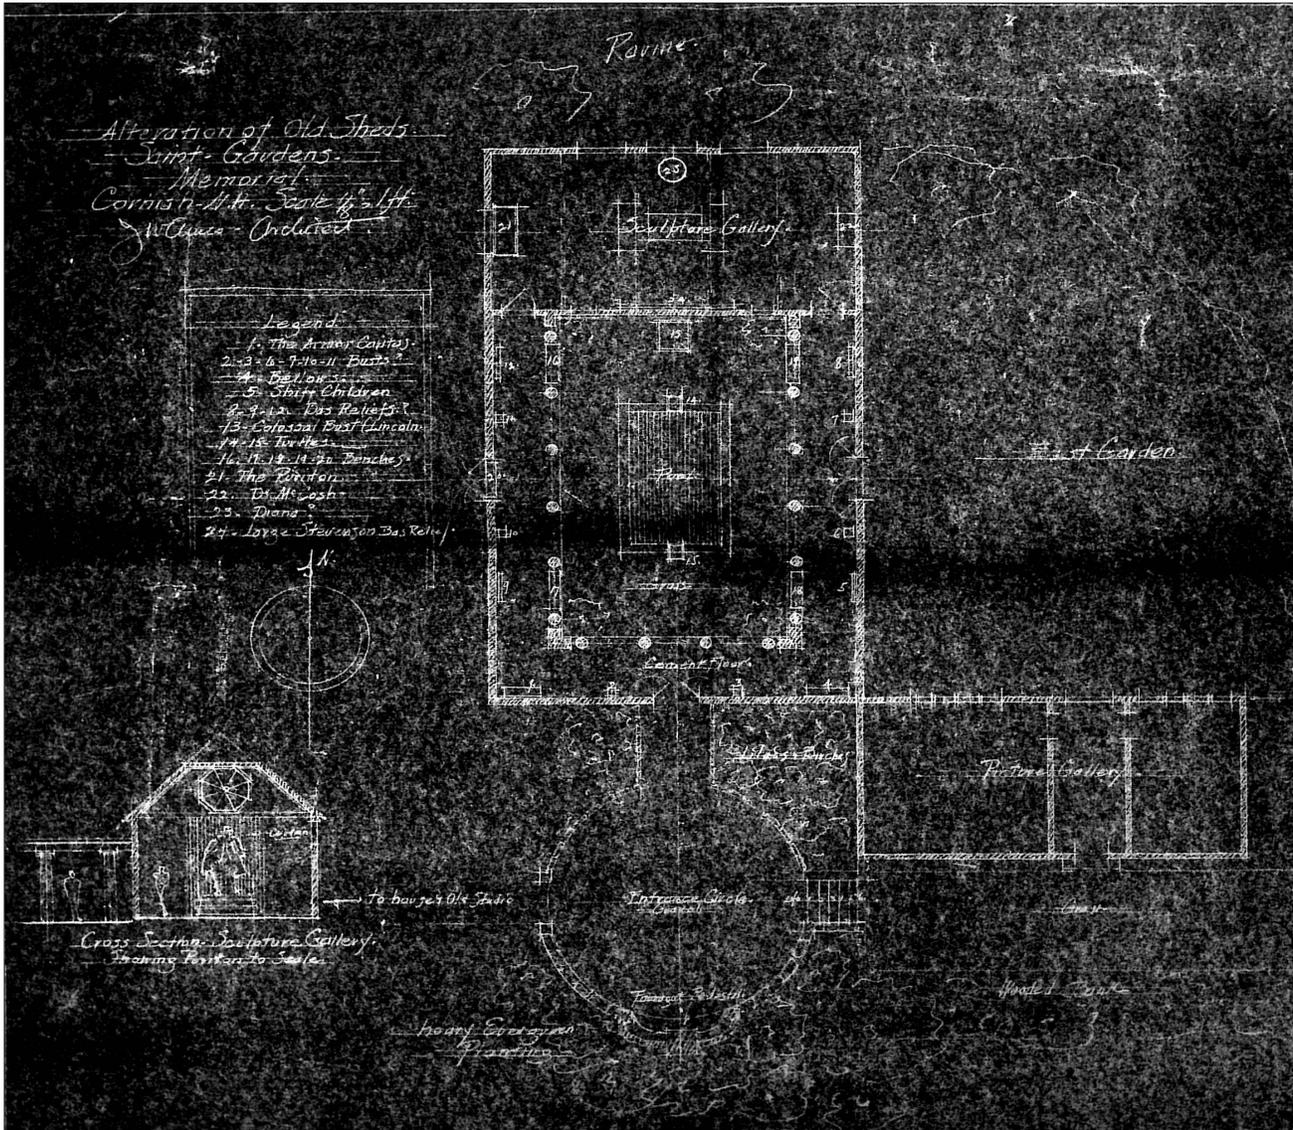
Figure 96. Plan of the New Gallery complex titled, "Alterations of Old Sheds, Saint-Gaudens Memorial" by John Worthington Ames, 1946 (Courtesy of Dartmouth College Library).

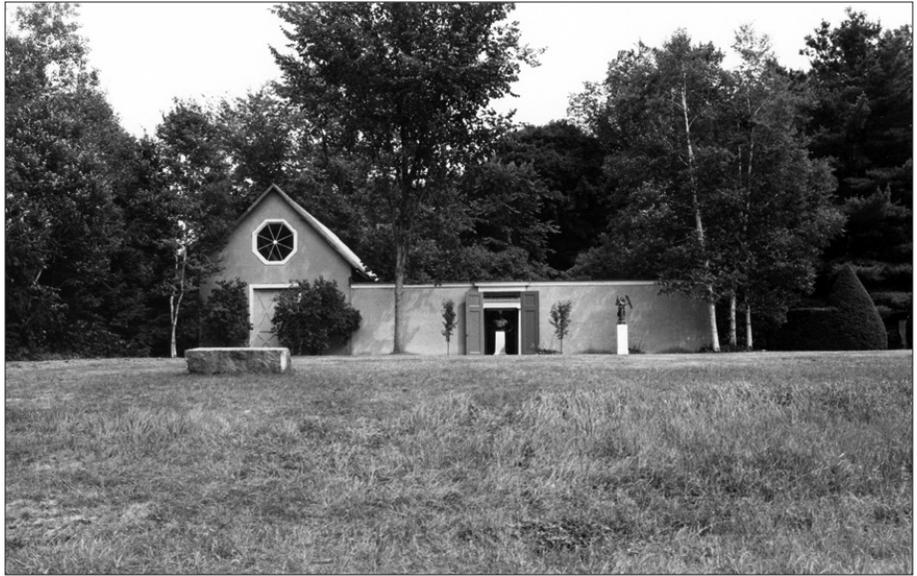
Figure 98. New Gallery, obscured by vegetation, including a birch, lilacs, and a maturing elm. View looking northeast, 1970s (SAGA 1879s).

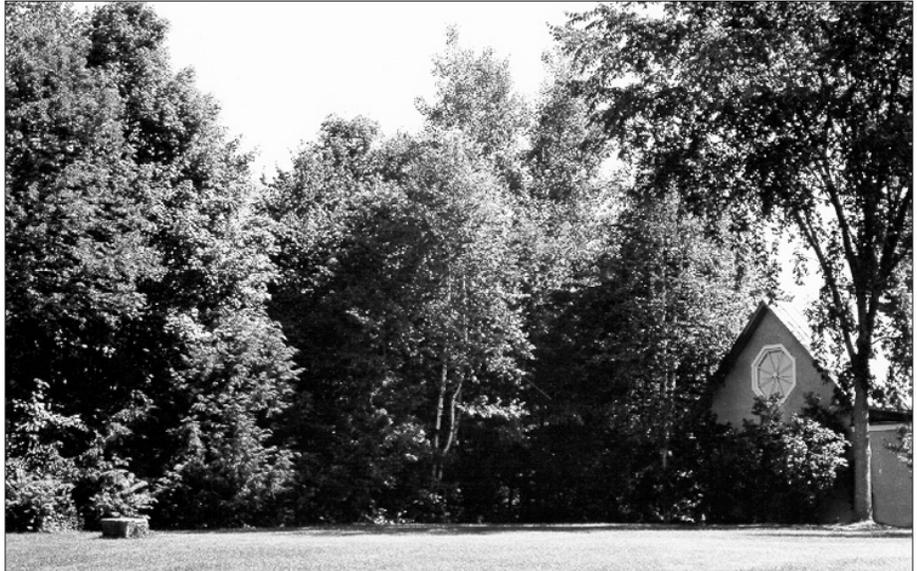
Figure 99. Farragut base flanked by mortared fieldstone walls and backed by mass of hemlocks. The bed to the left (above the wall) is possibly filled with hosta. View looking south, 1950s (SAGA 539).
