# CULTURAL LANDSCAPE REPORT FOR ASPET

SAINT-GAUDENS NATIONAL HISTORIC SITE

VOLUME III: TREATMENT AND RECORD OF TREATMENT

CORNISH, NEW HAMPSHIRE

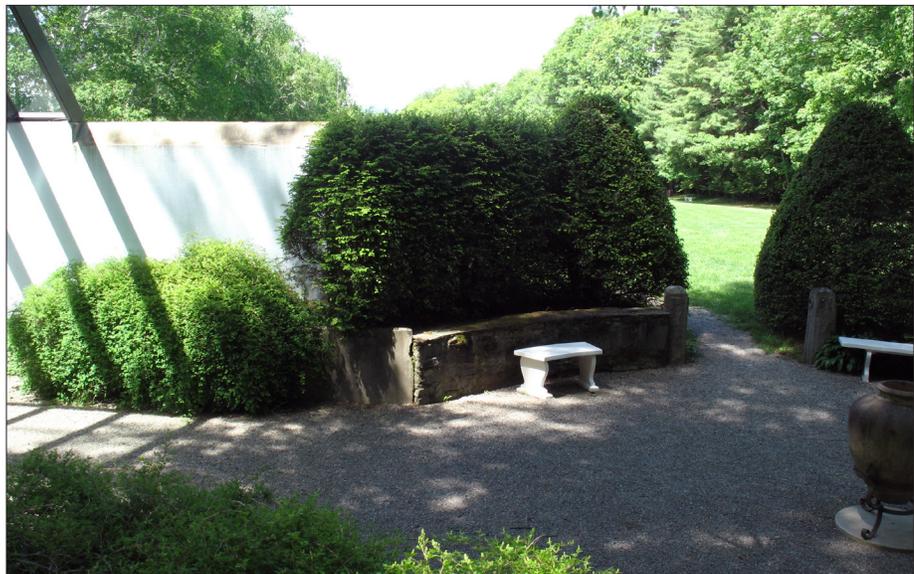
Figure 107. Farragut forecourt, showing the original elements installed in 1948—the fieldstone retaining wall, granite bollards, terra-cotta jar, and sheared hedge—and new elements installed to protect the Farragut base—the cement wall and enclosure at left. Stephanandra (left) likely dates to the addition of the enclosure in 1986. View looking west, 2009 (OCLP).

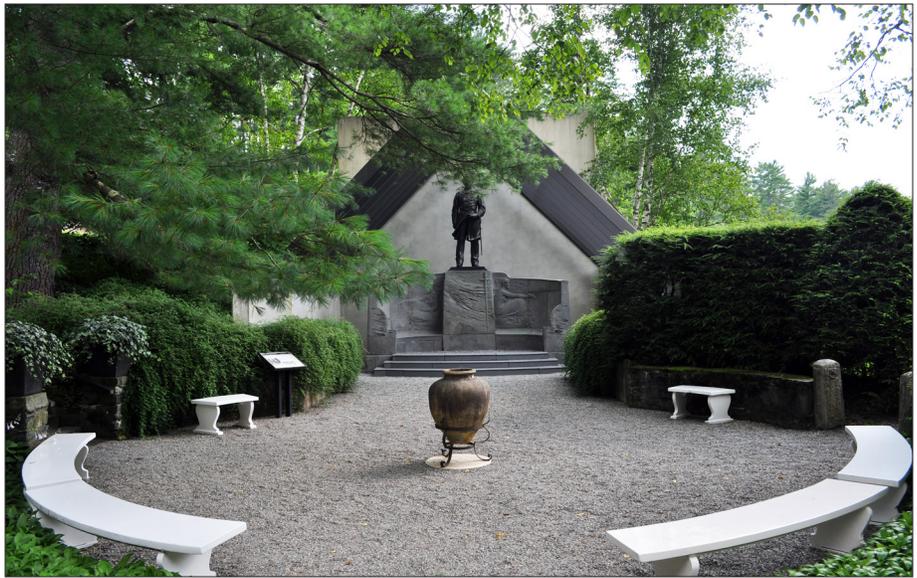
Figure 108. Faragut statue and base in the recently renovated enclosure. Branches of the mature white pine, sheared hemlocks, and cascading stephanandra reinforce the composition. View looking south, 2013 (OCLP).

The original enclosure to protect the Farragut Monument bluestone base was built in 1986. The structure was recently modified to improve light penetration and air circulation (see Figure 108). The placement and scale of the structure is compatible with the adjacent gallery buildings.

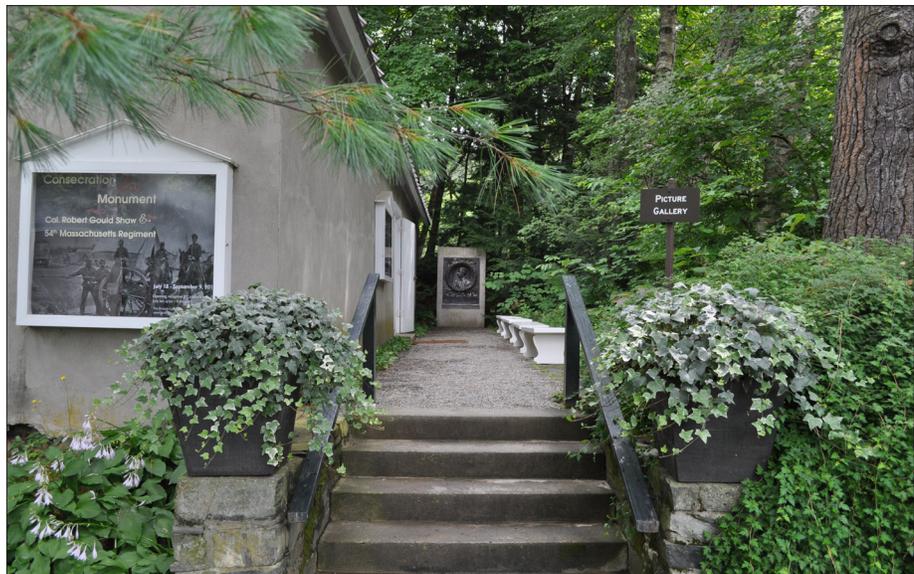
Figure 113. Square wooden planters rest on the mortared fieldstone cheek walls of the steps leading to the Picture Gallery. Stephanandra surrounds the trunk of the white pine in the background. Wooden handrail provide support on both sides of the stairs. View looking east, 2013 (OCLP).

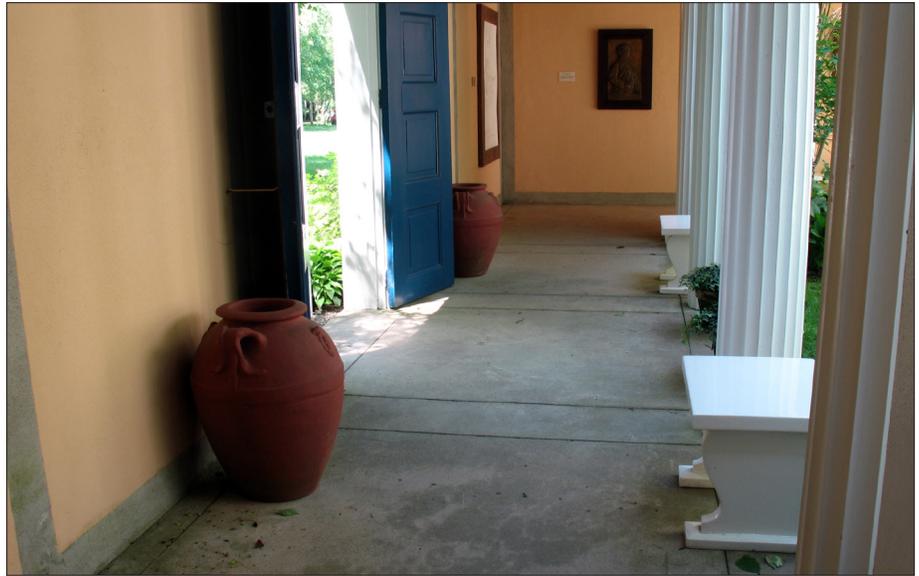
Figure 114. Terra-cotta jars by the Atrium south doors. Two short benches and two potted plants discourage visitors from walking onto the Atrium courtyard lawn. View looking west, 2012 (OCLP).

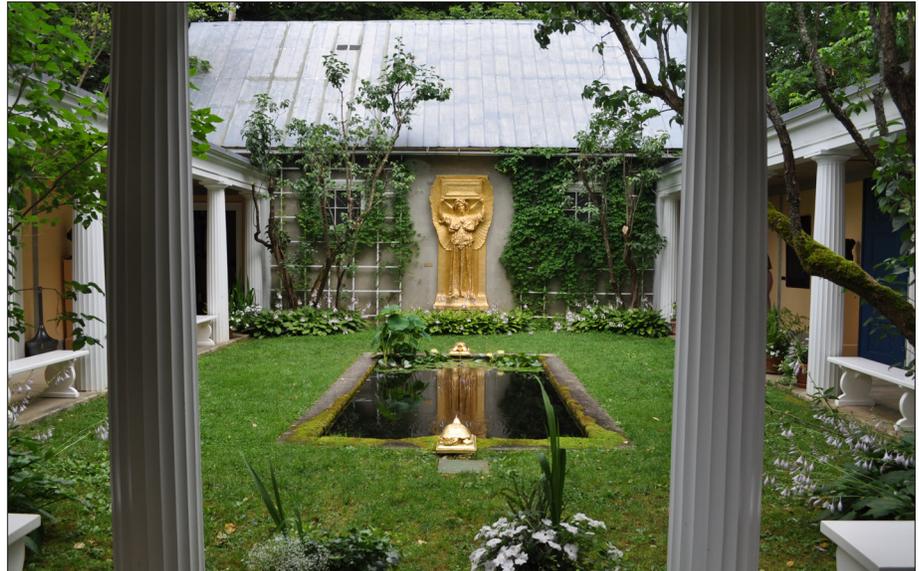
Figure 115. Amor Caritas in the Atrium courtyard, framed by akebia vines on the white trellis structure, white lilacs, and a bed of hosta. The dark pool reflects the sculpture and two gold turtles. Potted plants have been added to the perimeter of the courtyard. View looking north, 2013 (OCLP).

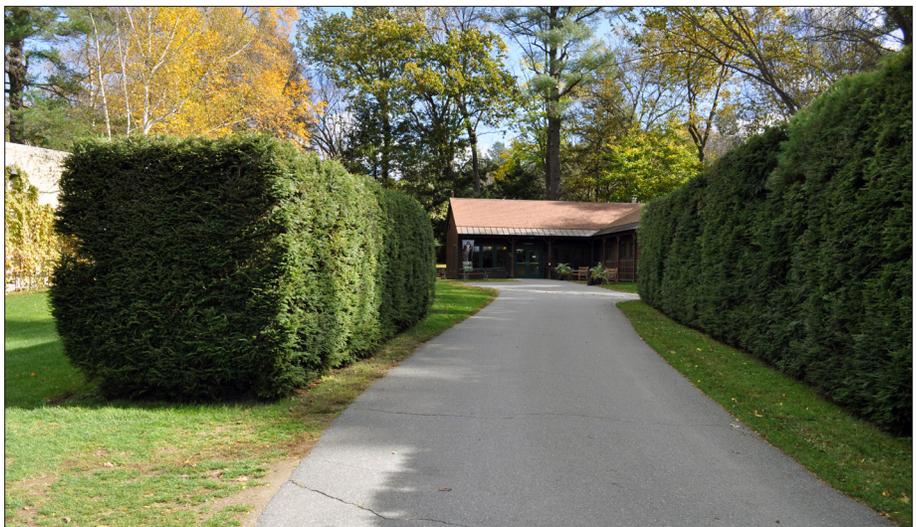
**Figure 131. Visitor center from the Caretaker's Cottage driveway. The maintenance area screening hedge is visible at left. View looking east, 2012 (OCLP).**

**East Entry Drive:** The route from the parking lot to the visitor center is about 530 feet and indirect. Once visitors walk past the kiosk, up the path, and approach the East Entry Drive, a sign at the end of the path directs them across the road. Another sign at the bend in the East Entry Drive directs them around the bend towards the building. Signs currently exist at the bend in the drive but could be consolidated (see Figures 89 and 141). Once the visitors round the bend on the driveway and pass the Caretaker’s Cottage, they should be drawn to the visitor center (see Figure 131).

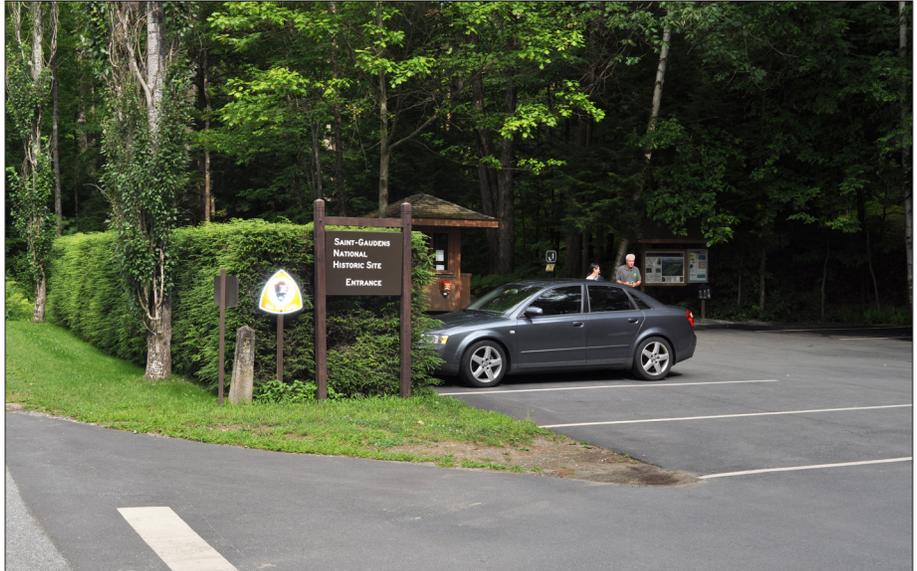
Figure 133. Visitor parking lot entry signs, hedge, bollard, poplars, and kiosk. View looking east, 2013 (OCLP).

historic period (see Figure 132). The style and location of this sign should be preserved since it contributes to the historic character of the property. A smaller sign, at the parking lot entrance, directs visitors to “Parking” (see Figure 133). This sign should be preserved. However, if a bus and overflow parking area is added, a new sign will be needed to direct cars into the visitor parking lot and buses further up Saint Gaudens Road. An option to direct visitors that mistakenly enter by the carriage turnaround is to add a sign at the top of the granite steps that directs them to the visitor center (Figure 140).

Four additional Lombardy poplars were added along the south side of Saint Gaudens Road either by the Saint-Gaudens Memorial or National Park Service.<sup>17</sup> The poplars were planted in conjunction with the hedges to accent each terminus while contrasting with the horizontal hedge line (see Figures 133 and 134).

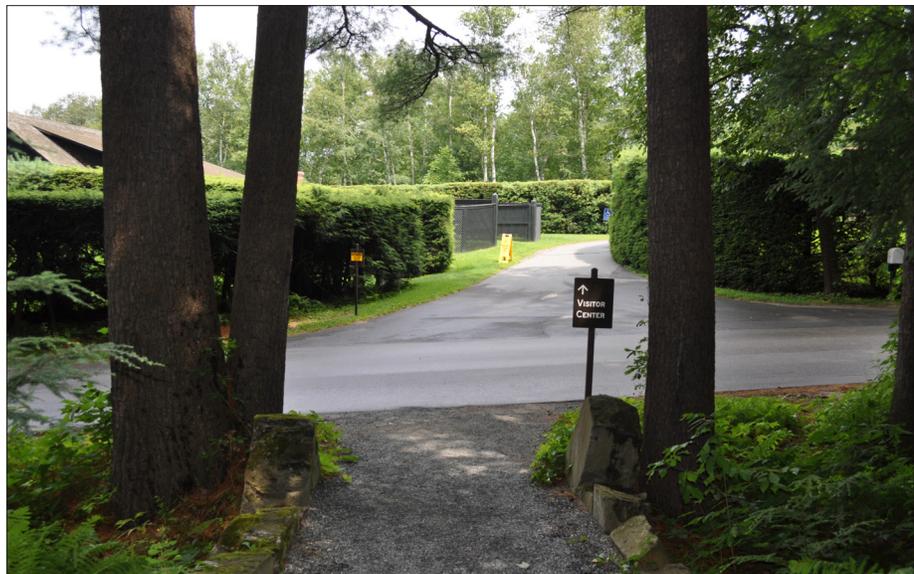
Figure 136. Information kiosk, path to visitor center, and orientation sign at the east end of the visitor parking lot. View looking east, 2013 (OCLP).

Safe pedestrian circulation is a priority for the park. To improve pedestrian safety along Saint Gaudens Road, the park constructed a woodland path between the visitor parking lot and the new visitor center in 2000 (see Figures 136 and 137). However, crossing Saint Gaudens Road is still dangerous with limited visibility and vehicles passing at high speeds on a seemingly quiet country road (see Figure 132). In addition, delivery trucks and buses turn around by backing up in front of the Caretaker's Cottage, which conflicts with the pedestrian route to the visitor center (see Figure 89).

**Parking Lot Area:** A new orientation sign at the east end of the parking lot, installed in the fall of 2006, provides a visual overview to the site (see Figure 136). Park rangers greet visitors at the parking lot contact station/information kiosk next to the new orientation sign, which includes an artistic rendering of an oblique aerial map of the property. Visitors also receive a park brochure at this location, which includes the same map on the new orientation sign.

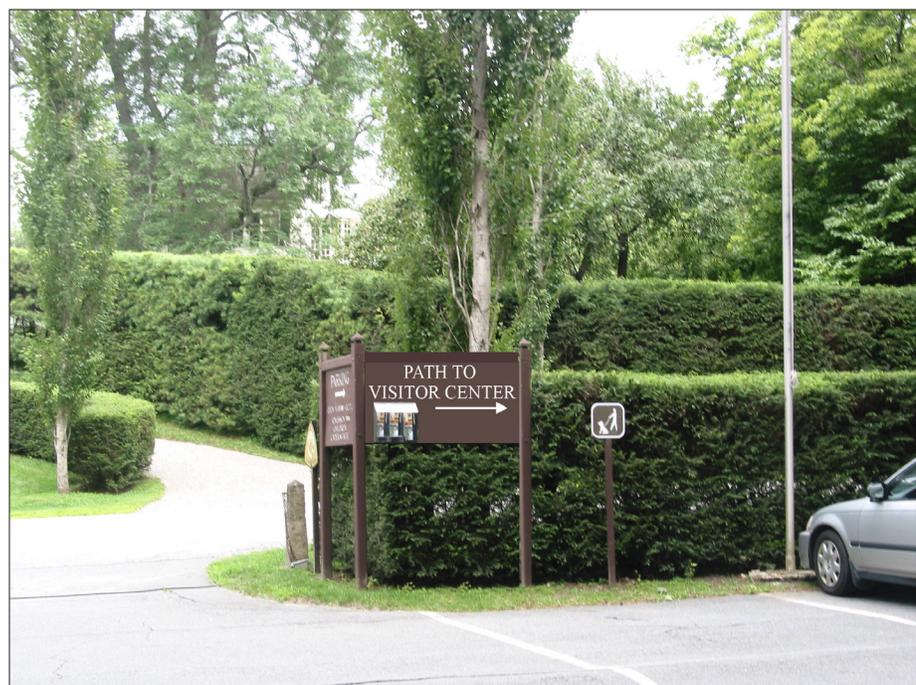
**Figure 139.** Photo simulation of a new sign at the exit of the visitor parking lot that combines park brochures with directions to the information kiosk and visitor center. Proposed view looking north, 2009 (OCLP).

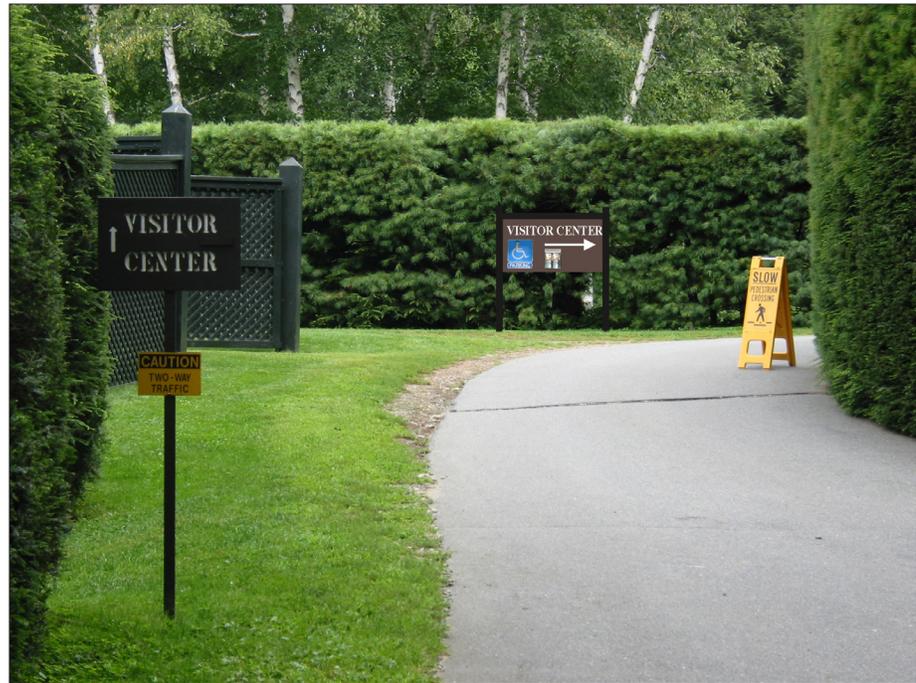
Figure 140. Photo simulation of a new sign placed just beyond the carriage turnaround to direct visitors to the visitor center. The sign is placed near the hedge so as not to obscure the view of the main house from the horseshoe hedge threshold. Proposed view looking north, 2009 (OCLP).

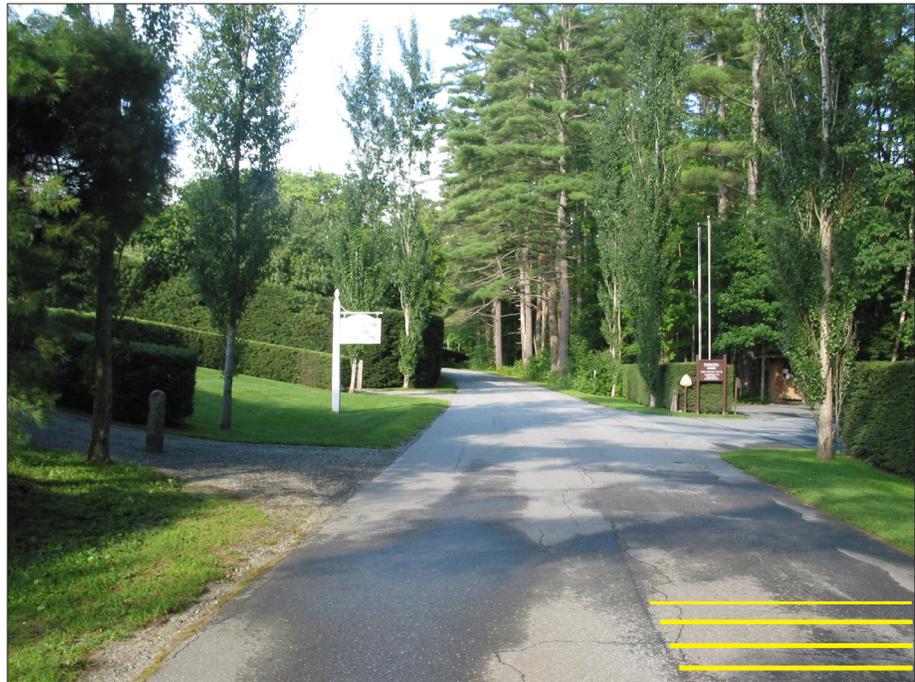
**Figure 142.** Photo simulation of rumble strips added to Saint Gaudens Road west of the visitor parking lot. Proposed view looking east, 2009 (OCLP).

**Rumble Strips:** The recommended treatment is to install rumble strips in the asphalt portion of the road thirty feet above and below the road crossings (Figures 142 and 143). Rumble strips provide a simple but effective sound warning. The sound of tires crossing over the rumble strips will alert both drivers and pedestrians of an approaching vehicle and pedestrian crossing area. The rumble strips would have the least visual intrusion on the historic landscape. Removable rumble strips could be installed on Saint Gaudens Road during the park's open season and removed during the closed season.

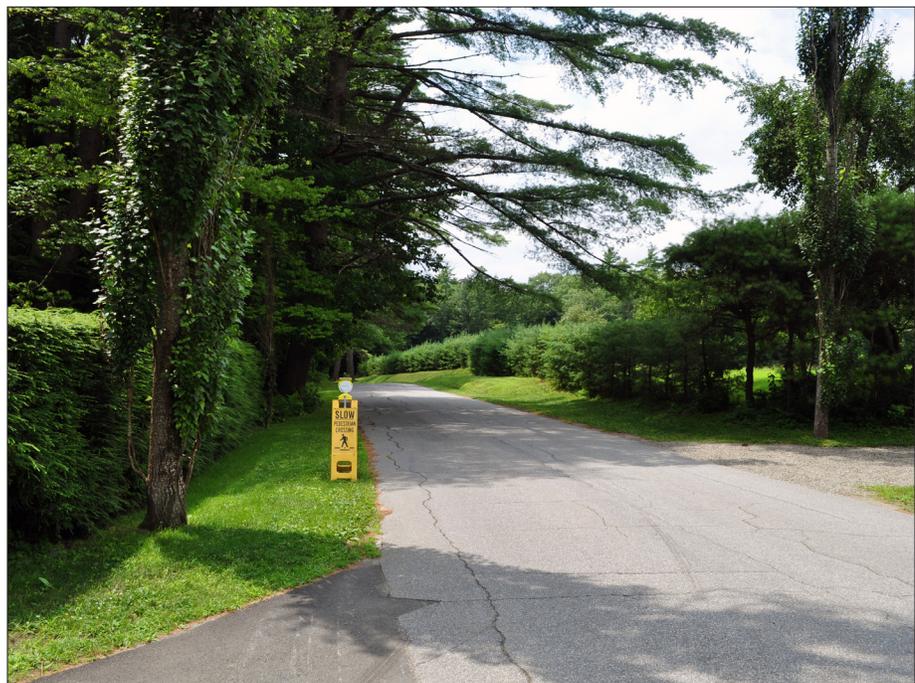
**Figure 143.** Temporary sandwich board with solar powered blinking set by Saint Gaudens Road during operating hours alerts drivers to pedestrian traffic. View looking west, 2013 (OCLP).

**Road Warning Signs:** A recommended strategy currently in use is the placement of temporary warning signs in the road when the park is open. The park currently places bright yellow warning signs along the sides of the road at the entrance to Aspet and the East Entry Drive. These bright signs serve as visual warnings for cars and pedestrians. The signs are removed when the park is closed.

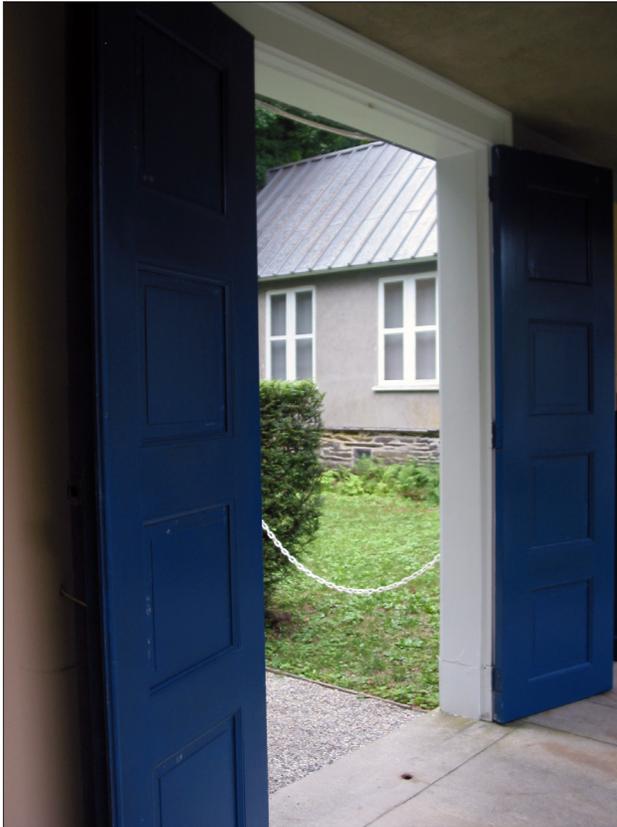
Figure 144. East Atrium doorway showing proposed location of the lower end of the accessible route from the Picture Gallery to the Atrium. The concrete floor of the Atrium would be extended six feet into the landscape to serve as a landing for the lower portion of the access ramp. View looking southeast, 2012 (OCLP).

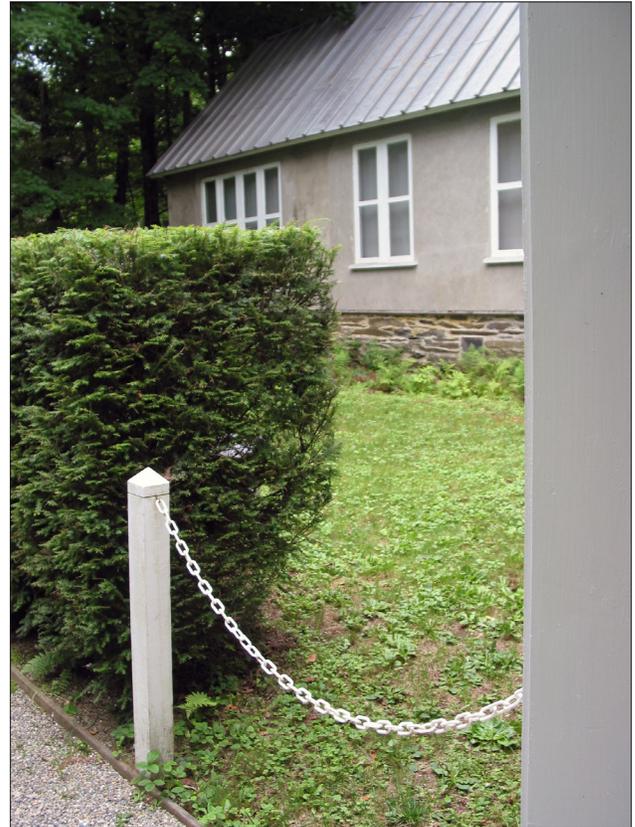
Figure 145. Outside the east Atrium doorway showing proposed location of the lower end of the access ramp. The ramp would extend through the area known as the East Garden, along the north wall of the Picture Gallery and east wall of the Atrium. View looking southeast, 2012 (OCLP).

ramp. At the northeast corner of the Picture Gallery, the ramp would continue around the east façade of the Picture Gallery to meet the existing stonedust walkway and south entrance to the building.

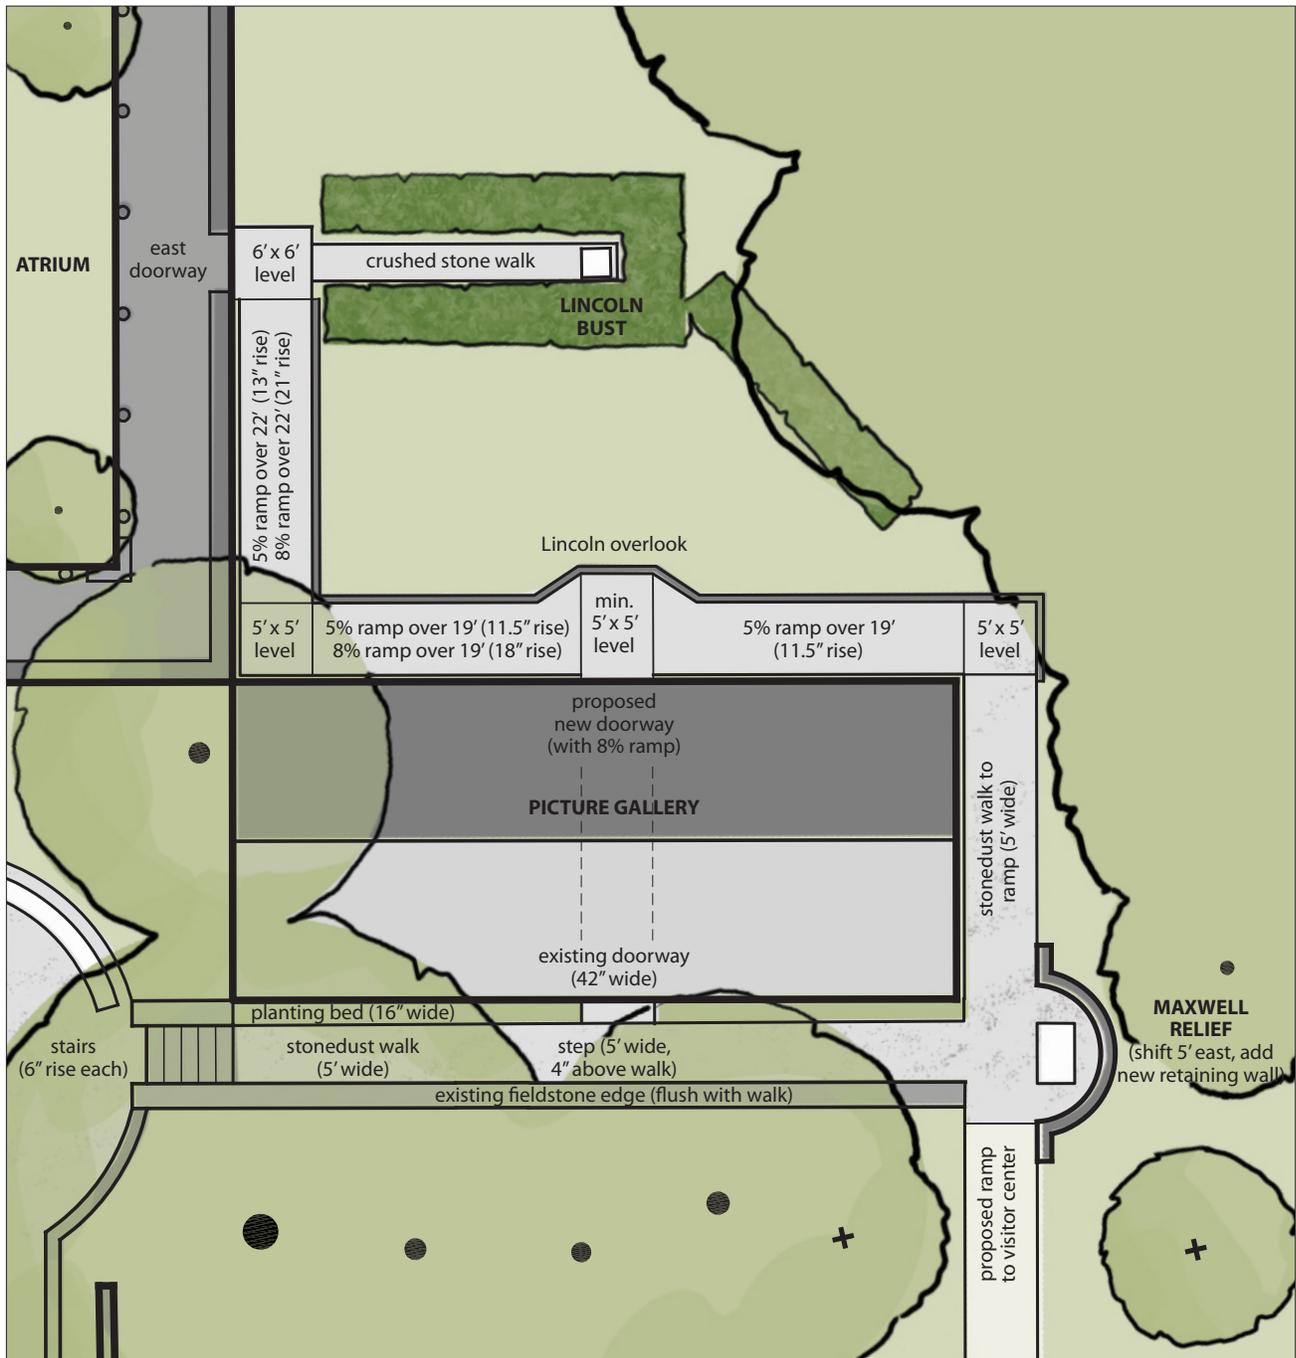
Figure 146. Plan for an universally assessable route between the Picture Gallery and Atrium. A five percent ramp would accommodate a ramp between the existing door to the Picture Gallery and the east doorway of the atrium. An eight percent ramp would be necessary if a new entrance is installed on the north side of the Picture Gallery, 2013 (OCLP).

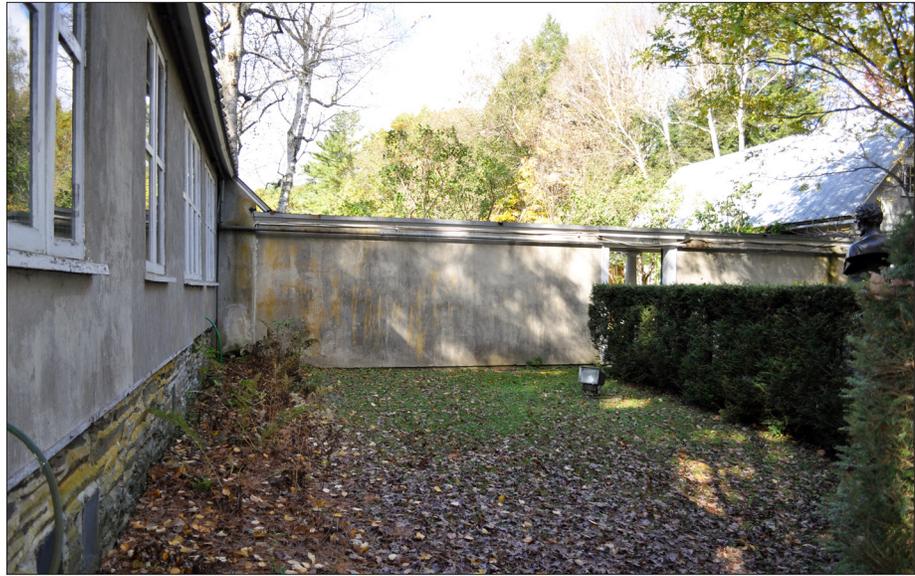
Figure 148. Picture Gallery door (left) and landing, which is four inches above grade. The Henry W. Maxwell Relief (center) will need to be shifted back five feet to allow the visitors to circulate around the building. View looking east, 2012 (OCLP).

This proposed ramp would require the relocation of the Henry W. Maxwell bas relief statue, which could be moved east (back) five feet, thereby preserving its location on axis with the Farragut forecourt (see Figure 111). The existing entrance to the Picture Gallery is sufficiently wide for universal access, with forty inches clear from door jamb to door hinge. However, there is a four inch step into the gallery, which would need to be leveled by eliminating the threshold or raising the adjacent walk (see Figure 109). If the stonedust walkway is raised, the existing fieldstone edging detail along the south side of the walk should be preserved (see Figure 148).

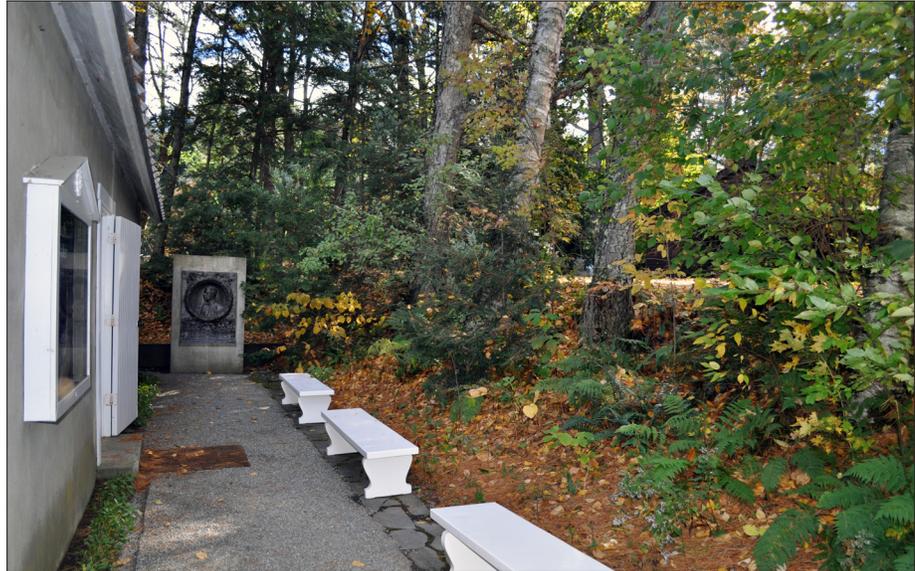
Figure 149. Faux granite base for the Henry W. Maxwell Relief from the eastern side of the Picture Gallery. The relief and base would need to be shifted five feet back (left) to allow visitors to circulate around the building. View looking north, 2012 (OCLP).

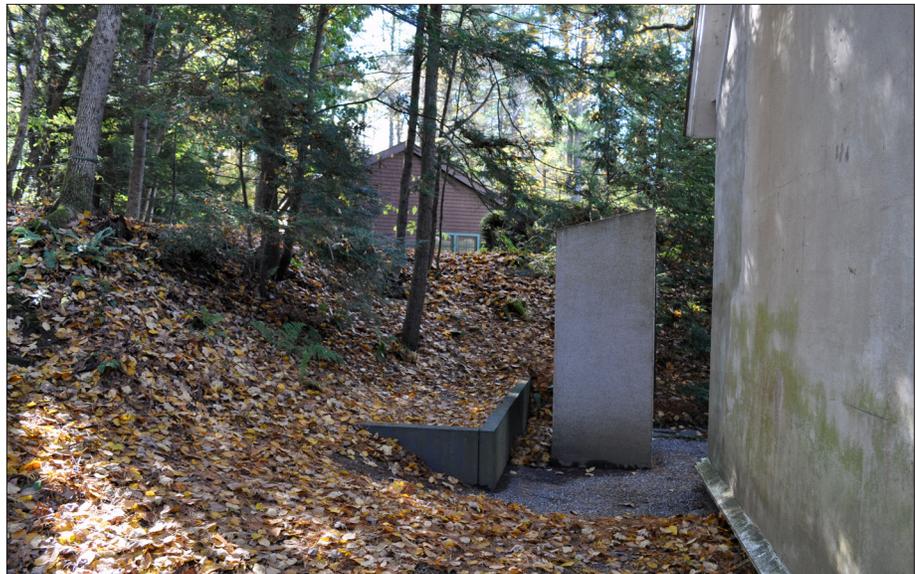
**Figure 150.** View from the visitor center exit showing the existing screening hedge (right), which makes wayfinding to the core of the site (beyond the white birch trees at right) confusing. View looking west, 2012 (OCLP).

**Recommendation:** To better serve its present use as the primary visitor center, the immediate landscape setting of the visitor center should be redesigned to provide better greeting, gathering, and orientation functions (Figures 150 and 151).

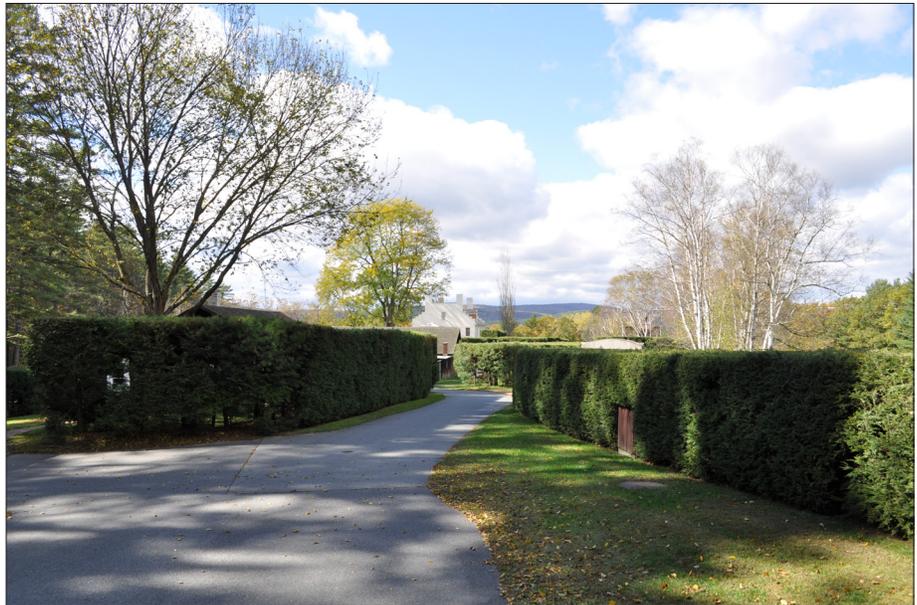
**Figure 151.** Photo simulation of proposed treatment visitor center entrance area, including realignment of the screening hedge, installation of new white birches, and construction of a visitor center entry plaza. Proposed view looking west, 2013 (OCLP).

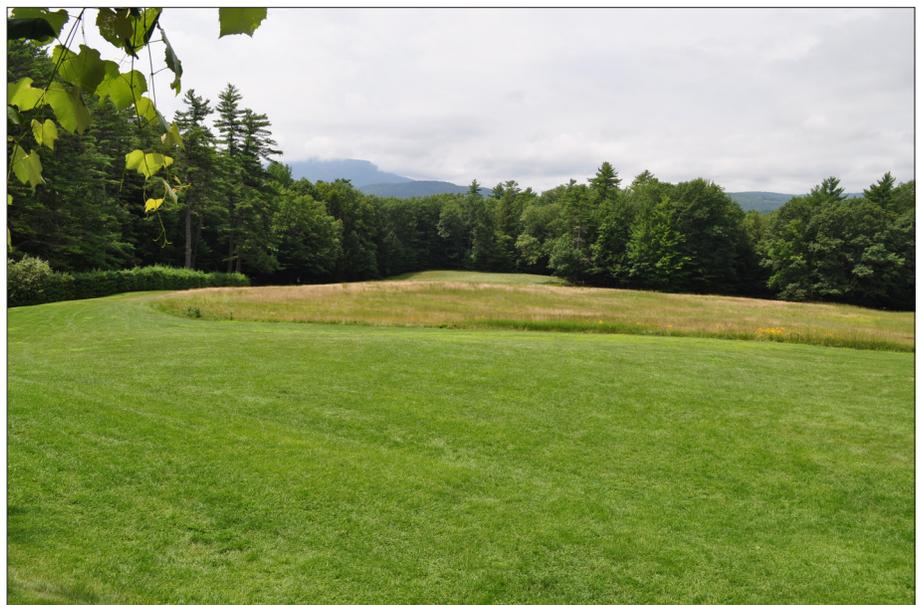
Figure 152. West meadow and hedge showing the special event parking area. View looking west, 2013 (OCLP).

**West Meadow (Current Location):** The lower edge of the meadow is mowed for overflow parking and used for concert events. The area that is currently maintained for overflow parking and can accommodate approximately 200 cars. If necessary, the meadow could accommodate up to 500 cars (Figure 152). The park currently uses this area for overflow parking and can transport visitors that require assistance in a golf cart. Access to bathrooms is provided by a temporary ADA-compliant portable toilet unit that is placed in the west meadow for special events which draw a large number of visitors, such as the “Masque of the Golden Bowl.”

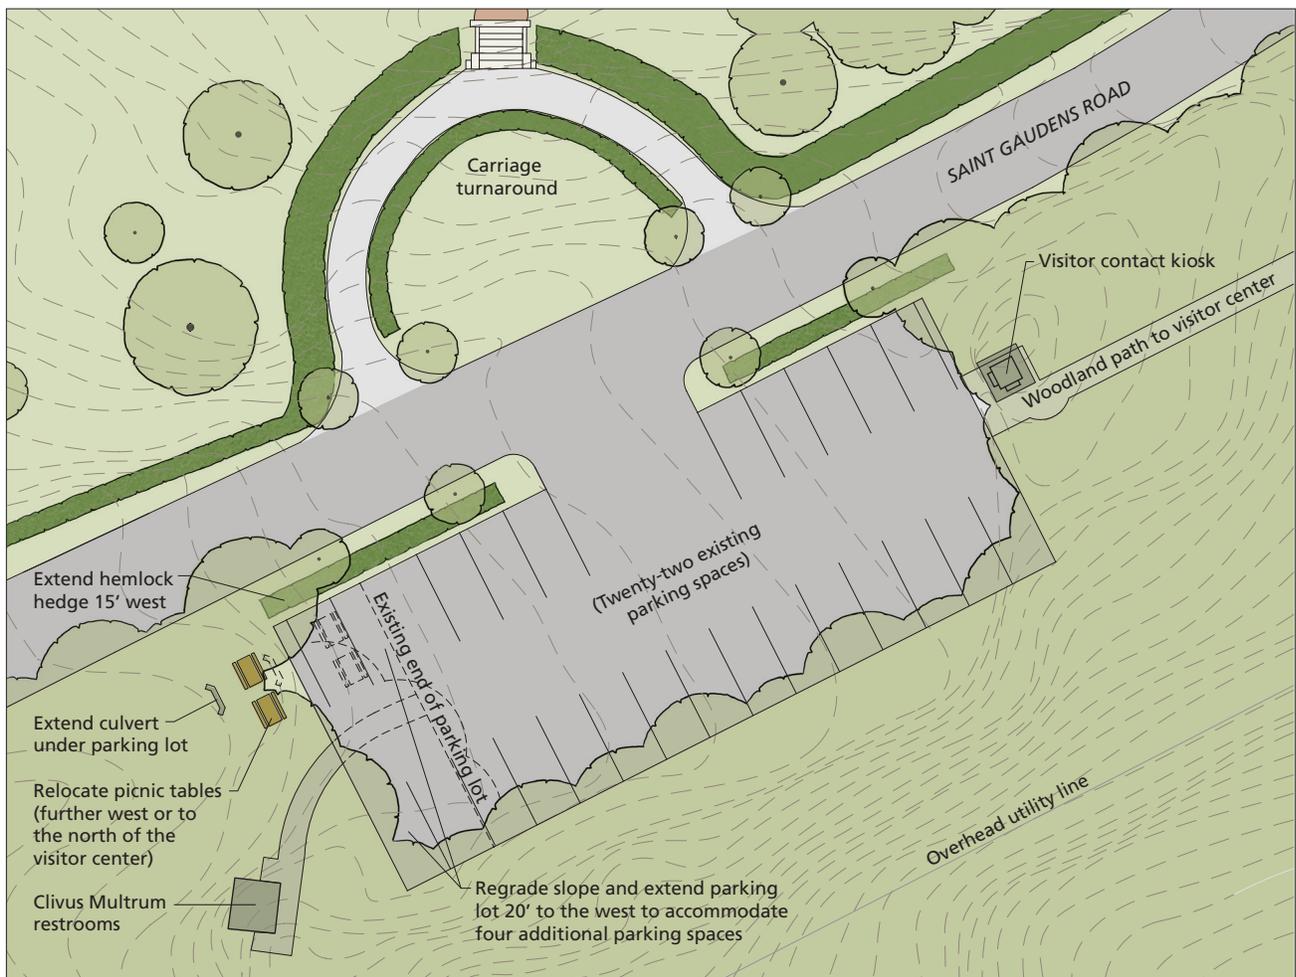
Figure 153. Diagram showing proposed expansion of the visitor parking lot to the west to accommodate four additional parking spaces, 2013 (OCLP).

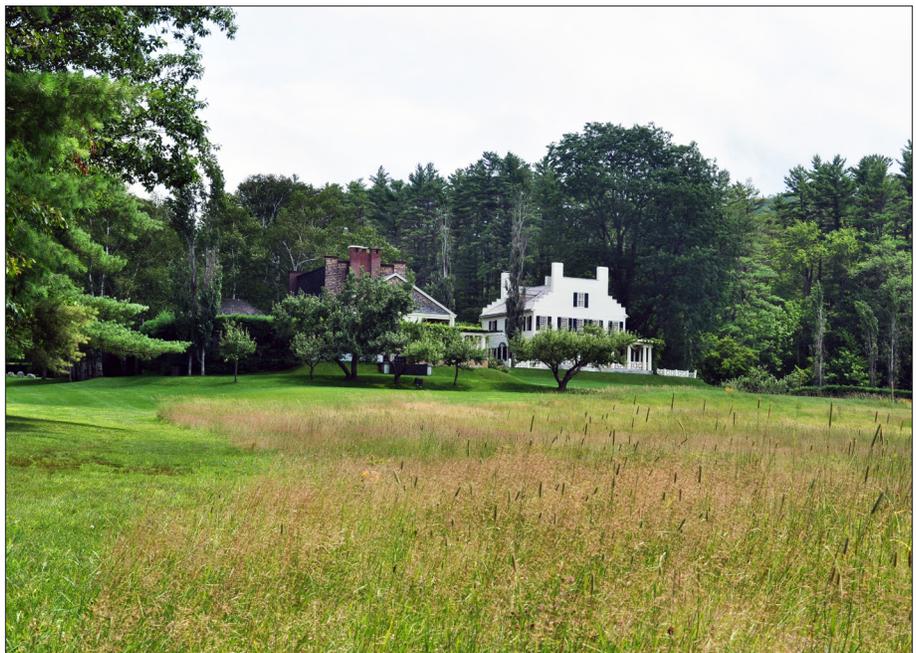
Figure 154. Apple trees to the west of the Little Studio from the west meadow. View looking east, 2013 (OCLP).

Three groupings of apples are located in the historic core: to the east of the entry walk, to the west of the entry walk, and to the west of the Little Studio (Figure 154). The three groupings are visible in 1885 to 1893 photographs and recorded on the French and Bryant survey completed in December 1903 (see Figures 5, 19, 23, 26, 119).<sup>12</sup> A fourth grouping—an apple, cherry and plum orchard near the Studio of the Caryatids—was removed by the 1920s and is shown in Figure 93.

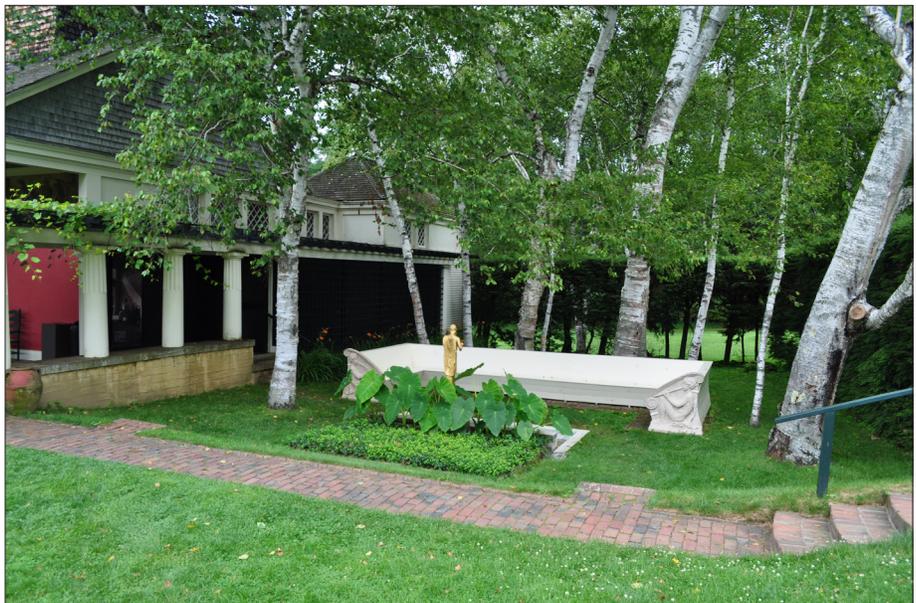
Figure 156. Pan Grove birches. View looking north, 2013 (OCLP).

Augustus Saint-Gaudens planted the original birches in the Pan Grove in the 1890s or earlier (see Figures 17, 20, 28, 32, and 35 to 38). Several trees were damaged in the 1938 hurricane and replaced by the Saint-Gaudens Memorial. Several other birches in the grove have declined since that time and have been replaced, resulting in a stand of mixed aged trees (Figure 156). The few original trees that now remain are over 100 years old and are in decline.

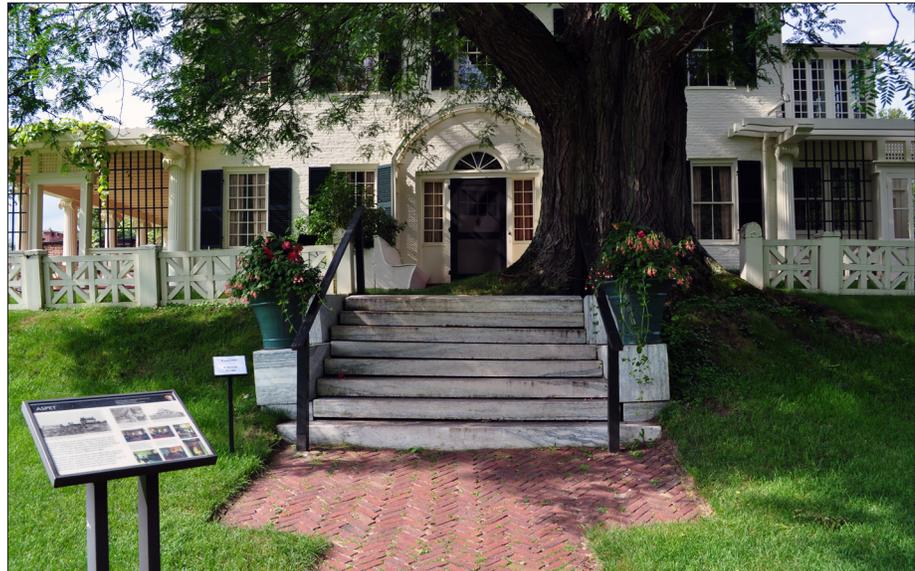
Figure 158. Honeylocust roots have surrounded and shifted the marble cheek wall and top step. View looking northeast, 2013 (OCLP).

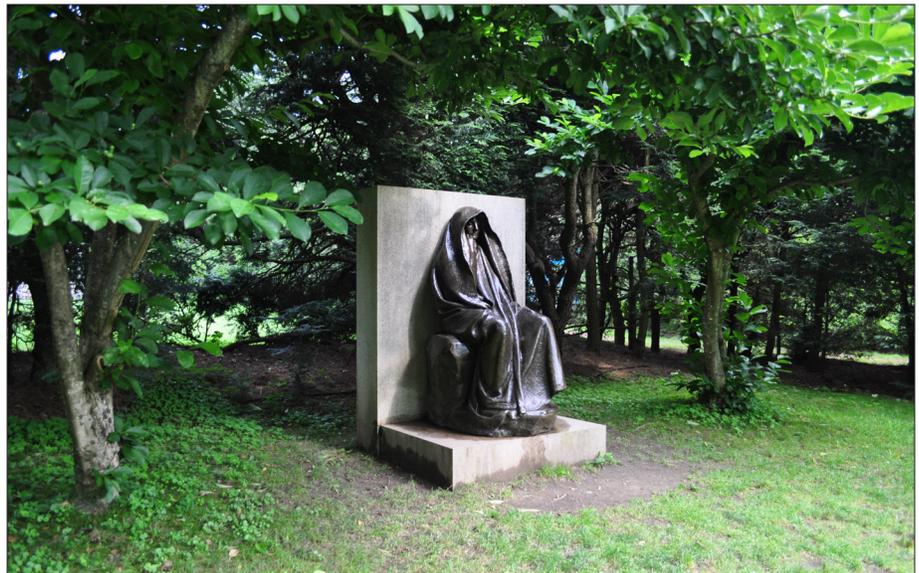
Figure 159. Existing 'Dr. Merrill' magnolias flanking the Adams Memorial in summer. View looking southeast, 2013 (OCLP).

Two "Dr. Merrill" magnolias frame the Adams Memorial (Figures 159 and 160). The young trees were installed circa 1992 as part of an ornamental planting at the request of the park superintendent. Since this time all of the other ornamental plants have been removed, leaving only the pair of magnolias, which have grown quickly and require substantial pruning to contain within the small garden room. Dirr's *Manual of Woody Landscape Plants* describes Dr. Merrill magnolia as a fast-growing cultivar, which matures at a height of twenty-five to thirty feet. Despite the annual pruning by park staff, the vigorous growth and thick leaf canopy create dense shade and as a result the adjacent hemlock and pine hedges are losing all needles.

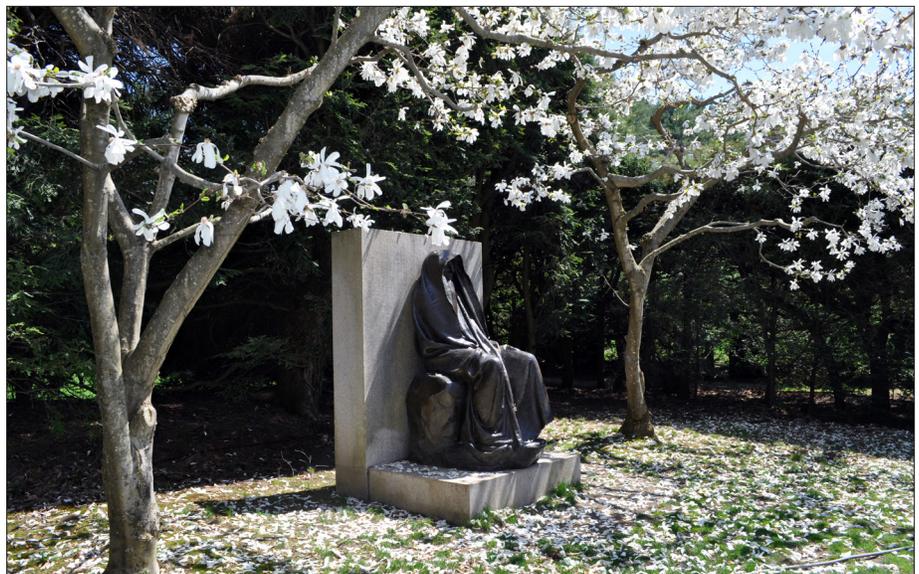
Figure 160. Existing 'Dr. Merrill' magnolias flanking the Adams Memorial in flower in spring. View looking southeast, 2013 (OCLP).

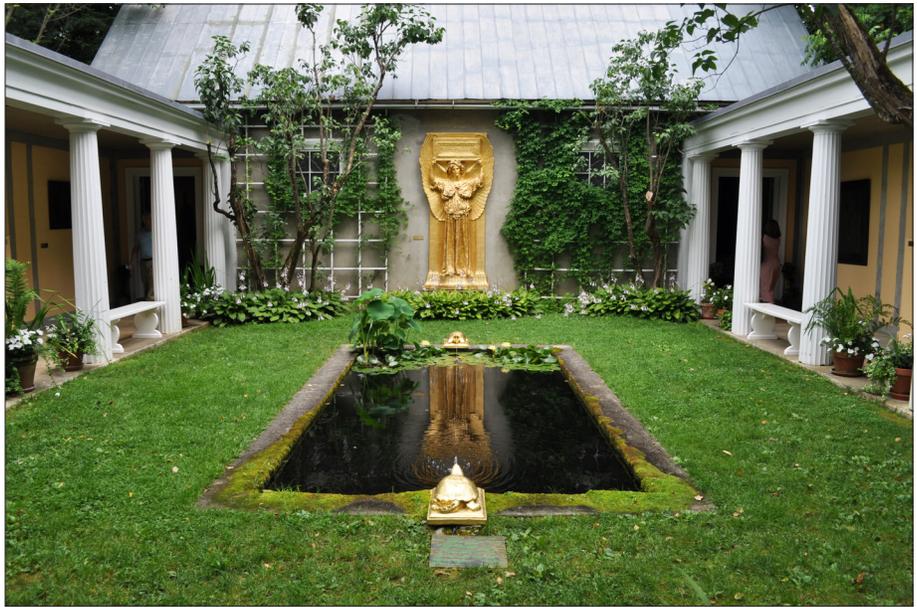
Figure 162. View of the Atrium showing akebia vines on the trellis. View looking north, 2013 (OCLP).

**Recommendation:** The entire building design is based on symmetry on either side of Amor Caritas, therefore akebia should be retained on the trellises on both sides of the sculpture. The clematis vine should be removed (Figure 162).

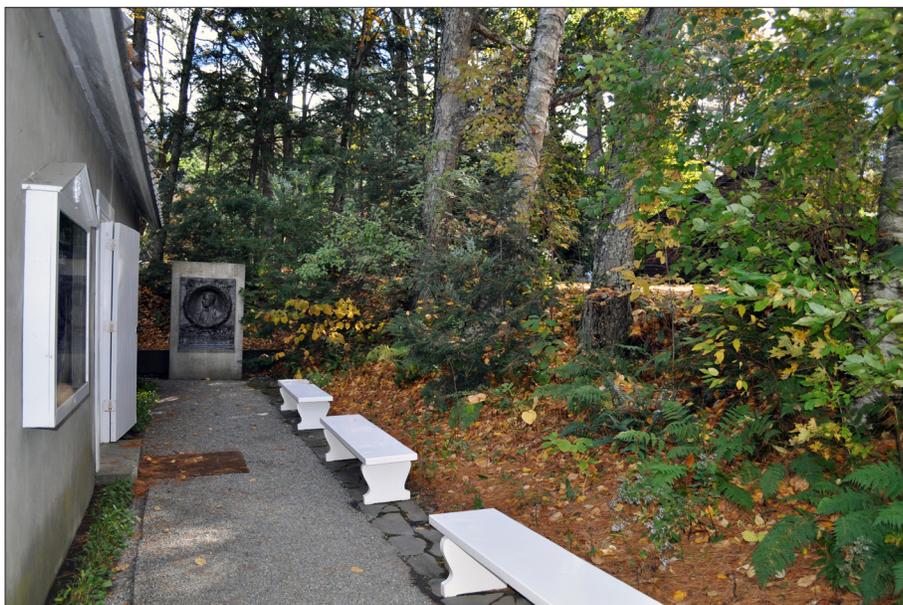
Figure 163. Shrubs to the south of the Picture Gallery. View looking east, 2013 (OCLP).

Recommendation: The non-native species introduced to the woodland bank are non-historic and could potentially spread into the surrounding woods. The non-native species planted on the bank should be replaced with native species. Retain the common witchhazel and remove the Chinese lilac, Koreanspice viburnum, and European cranberrybush viburnum. Appropriate substitutes include arrowwood (*Viburnum dentatum*) and common lilac (*Syringa vulgaris*).

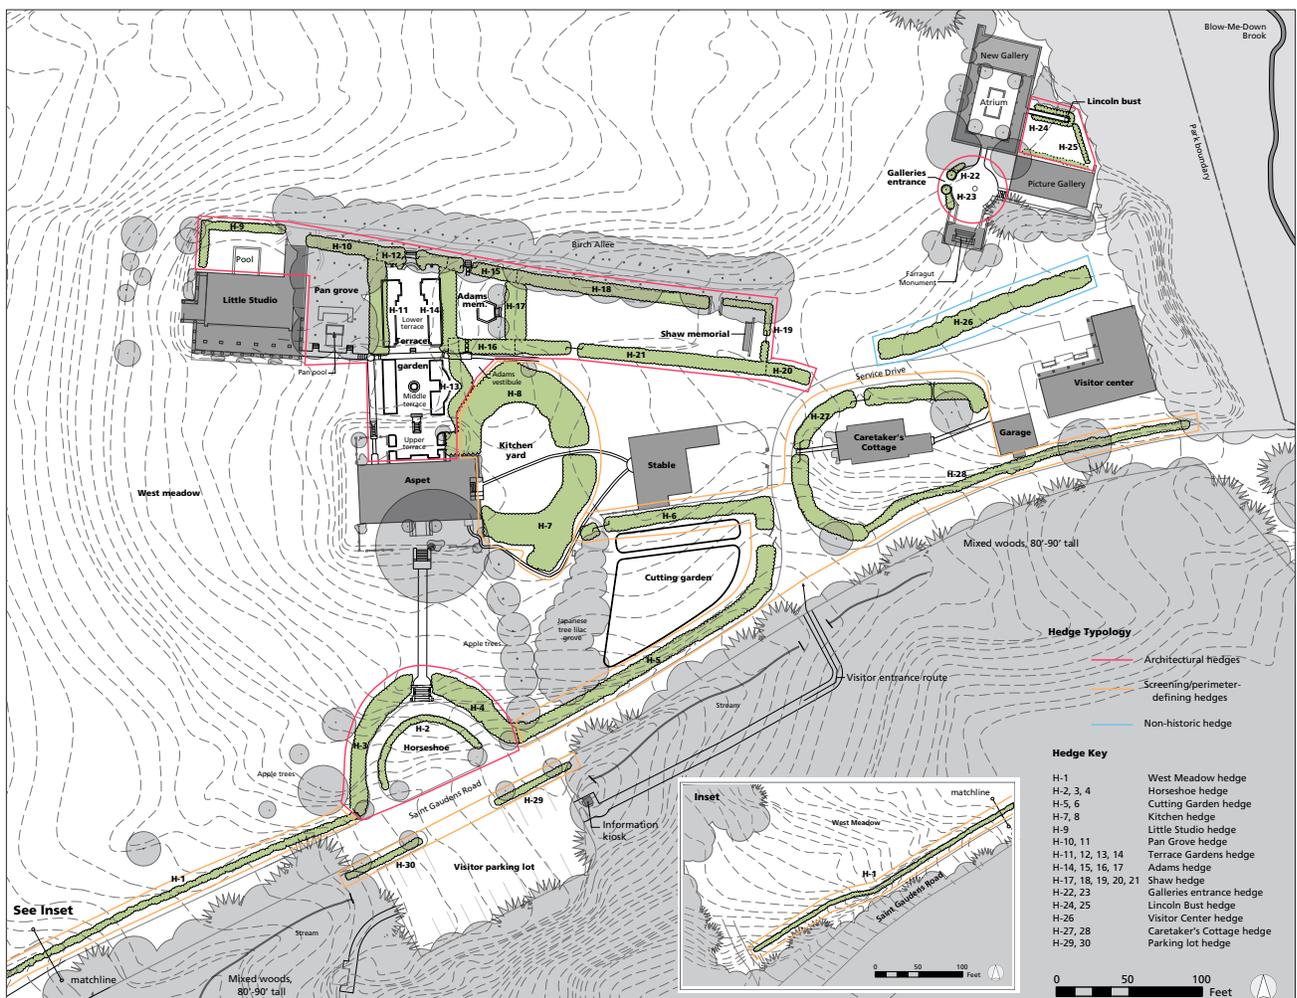
Figure 164. Diagram from the *Hedge Management Plan for Saint-Gaudens National Historic Site* showing the hedge numbering system, 2008 (OCLP).
