# CULTURAL LANDSCAPE REPORT FOR ASPET

SAINT-GAUDENS NATIONAL HISTORIC SITE

VOLUME III: TREATMENT AND RECORD OF TREATMENT

CORNISH, NEW HAMPSHIRE

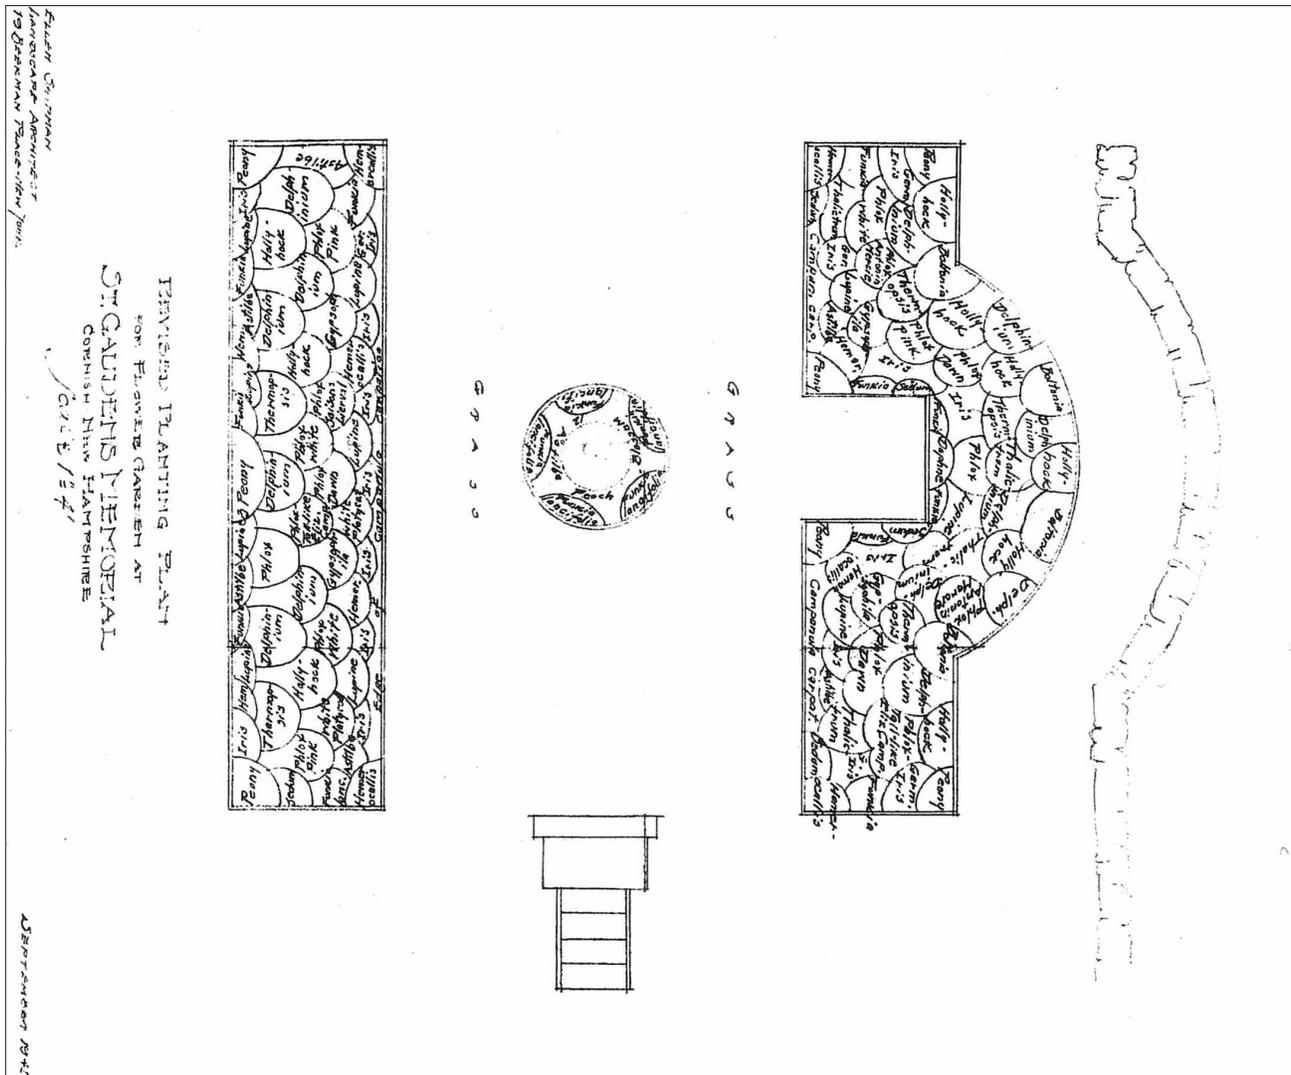
Figure 165. Ellen Shipman’s revised planting plan for the middle terrace of the flower garden, 1941 (Ellen McGowan Biddle Shipman papers, #1259. Division of Rare and Manuscript Collections, Cornell University Library).

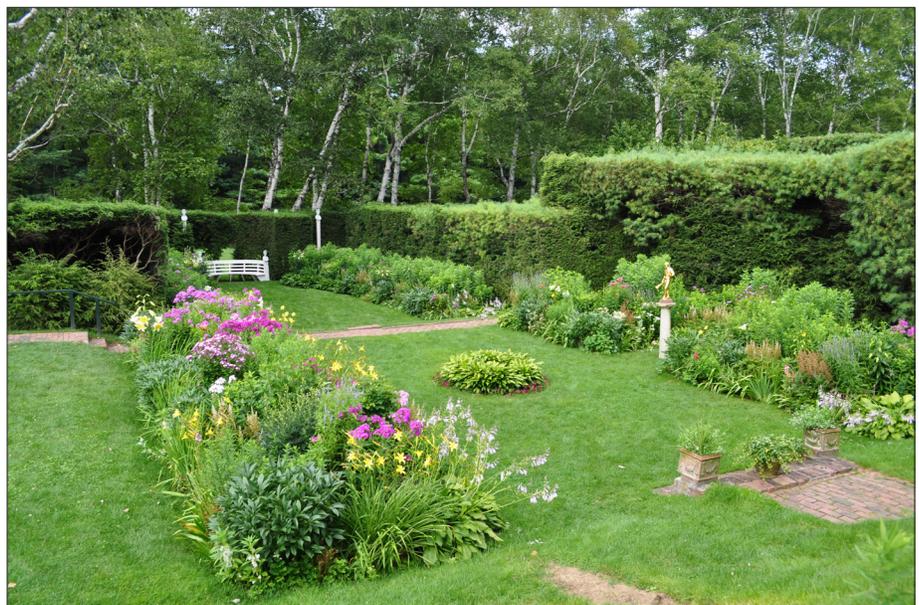
Figure 167. Flower garden from the upper terrace showing the bed layouts depicted on the 1941 Shipman plan for the garden. Note the addition of Zodiac heads to the bench and posts. View looking northeast, 2013 (OCLP).

**Recommendation:** Potted plants can be discretely set into the flower beds to improve the succession of bloom. This practice is continued by the present gardener (see Figure 167). For example, potted hybrid lilies in full bloom are added to the beds as an accent, but would be too crowded if actually grown in the beds. The pots are taken out of the beds after the blooms pass and the plants are later installed directly into the flower beds. Recommendations for separate planters and containers follow in the next section.

The semicircular bench is still featured in a bay at the end of the axis line, but a gap has been created in the hedge behind the bench, allowing a view to the lawn (see Figure 167). This gap is not specified on any of the plans of the 1920s and

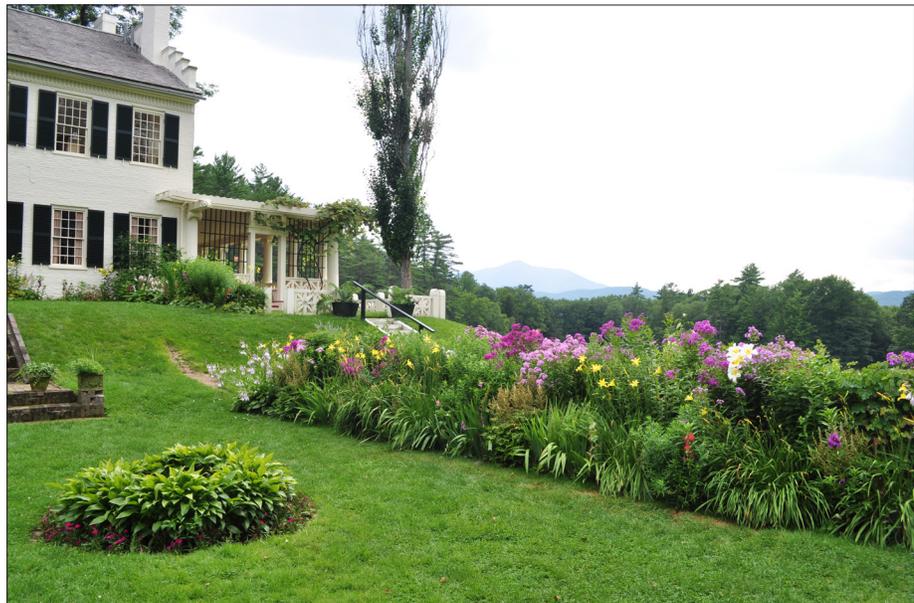
Figure 168. Middle terrace of the flower garden showing two of three beds to be preserved. View looking southwest, 2013 (OCLP).

**Recommendation:** These bricks are still present and should be preserved. All edges should be laid inside the bed lines and bricks should be set upright so as

to project two inches above the grade of the paths. The edging provides a clearly defined edge for each bed and makes it easier to contain the flowers and keep out the turf.

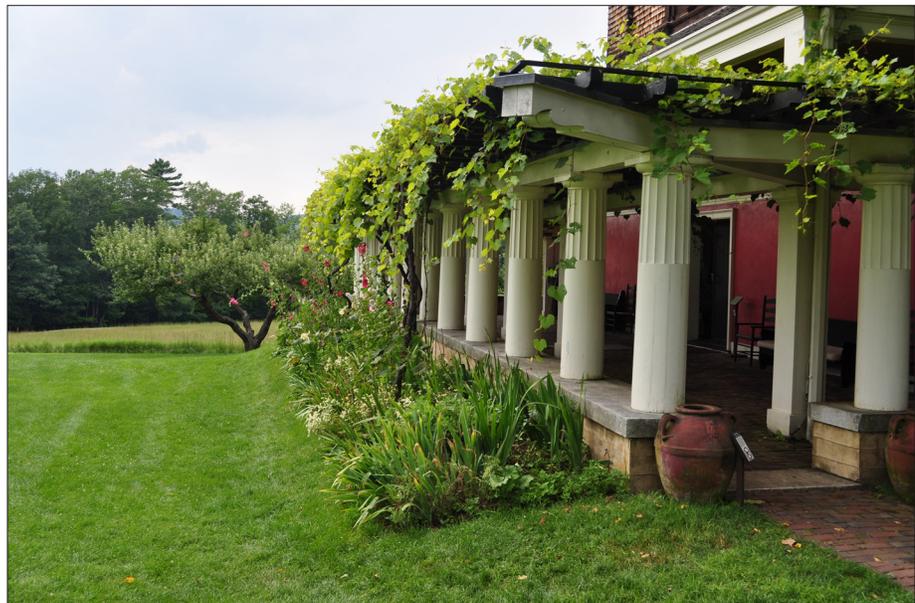
**Figure 169.** Little Studio flower bed in summer. View looking west, 2013 (OCLP).

Augustus Saint-Gaudens added a flower bed to the south side of the Hay Barn/ Studio in circa 1900. An early photograph of Saint-Gaudens shows the bed filled with gladiolus, tiger lily and other flowering plants (see Figure 21). By the end of the historic period, the bed consisted predominantly of hollyhocks as documented in photographs and as recalled by Alan Jansson, Chief of Maintenance from 1953 to 1984.<sup>27</sup> The bed was not redesigned by Ellen Shipman, as was the case of the nearby flower garden. The bed is currently a mix of bulbs, perennials and annuals that bloom throughout the open park season from late May to October (see Figures 30 and 169).

**Recommendation:** The Little Studio bed should be preserved with a collection of bulbs, perennials and annuals that were used in the early 1900s and provide color throughout the late spring, summer and early fall. Within each time frame, one species should provide the dominant blooms across the entire length of the bed:

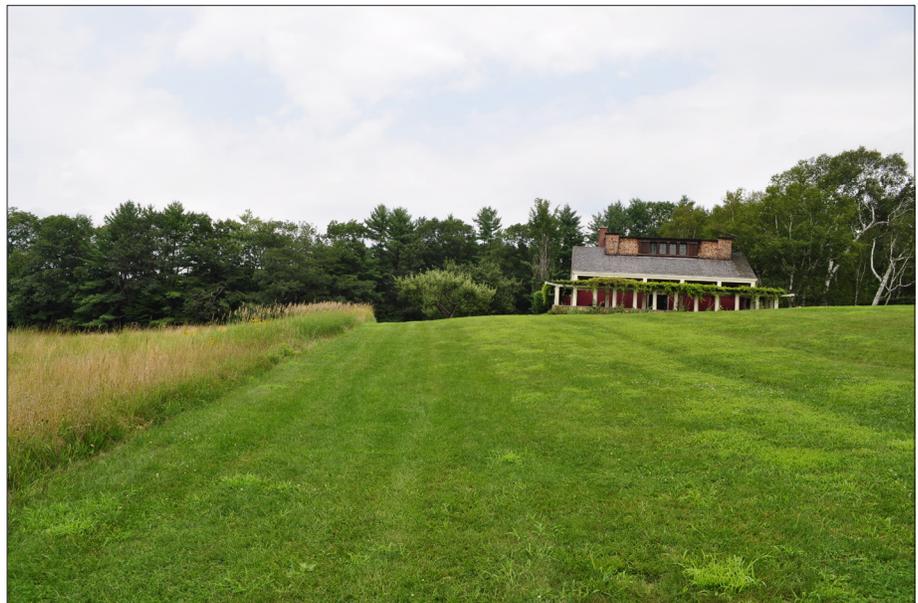
Figure 170. Edge of the west meadow and mown lawn to the west of the Main House. View looking north, 2013 (OCLP).

**Recommendation:** Areas of high visitor use in the historic core and in the overflow parking area in the west meadow should be mowed weekly or as needed to create a comfortable walking surface. The dry areas in the center of the west meadow should be mowed once a year in the fall. Grazing livestock such as sheep could be introduced seasonally to manage a portion of this area, as was the practice early in the historic period (Figure 170).

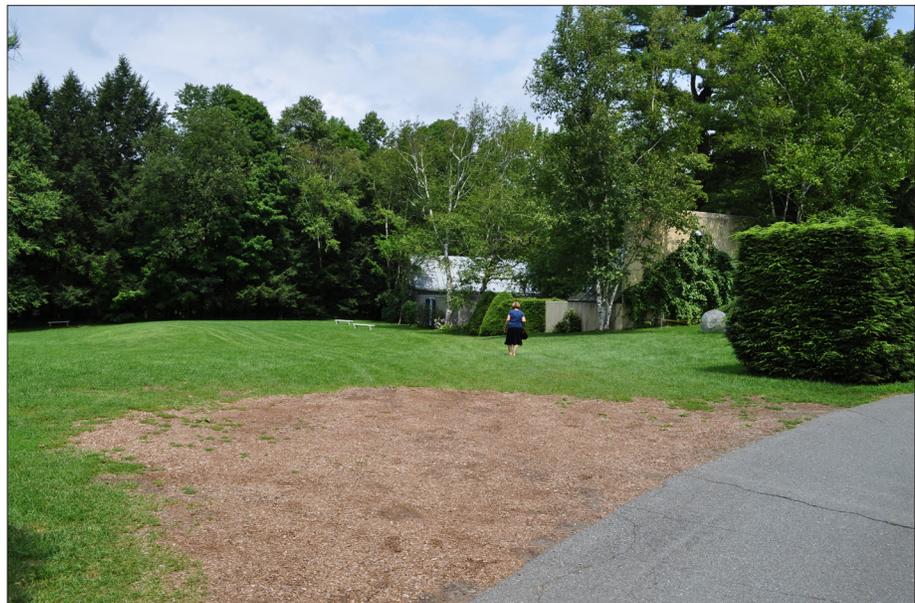
**Figure 171.** Compacted lawn area along the northern side of the Caretaker's Cottage driveway, now surfaced with mulch. View looking north, 2013 (OCLP).

**Recommendations:** Maintain turf with mixed species of fescues, perennial ryegrass, and blue grass varieties to ensure vigor. Install a grid under areas that receive heavy traffic to reduce compaction. Cultivate and overseed compacted areas in the fall upon park closing (which may or may not take depending on the onset of heavy frosts). Cultivate and overseed as early as possible in the spring, so that turf is established by late spring, when the park opens. Along the East Entry Drive, expand the hardened surface to accommodate daily traffic in this area (Figure 171).

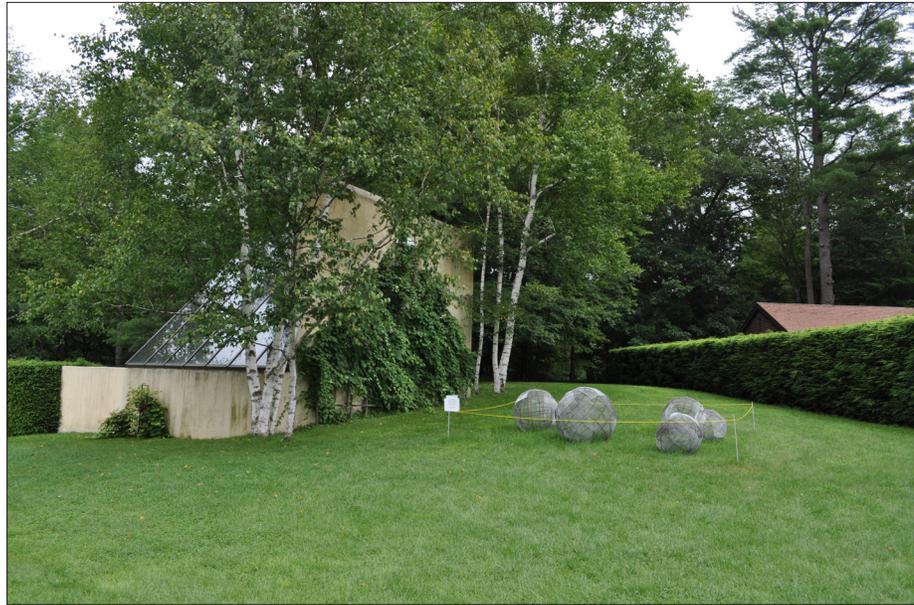
**Figure 172.** Temporary sculpture installation in the lawn to the south of the Farragut enclosure. View looking east, 2013 (OCLP).

- Temporary works of art may appropriately be installed on the lawn to the south of the Farragut enclosure, in proximity to both the New Gallery complex and the visitor center (Figure 172).

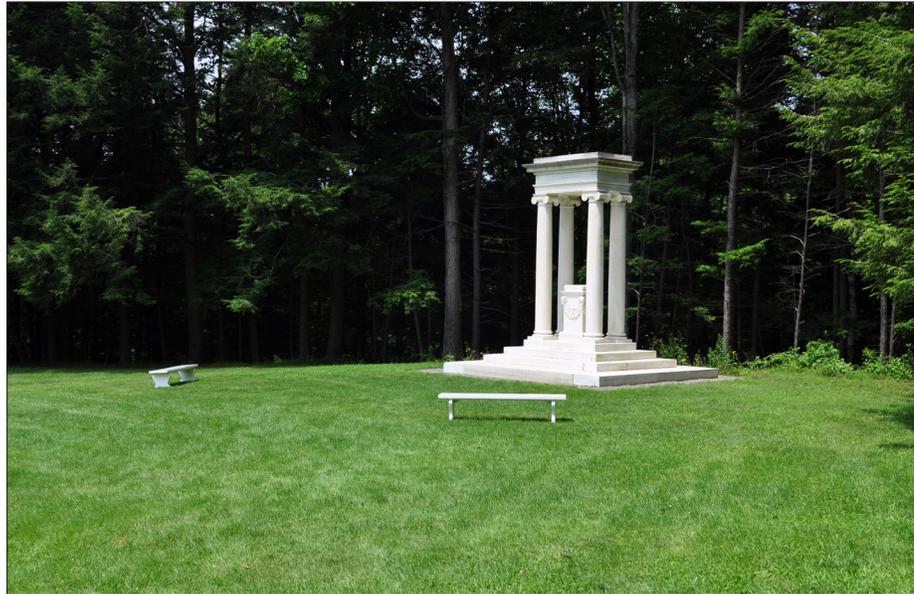
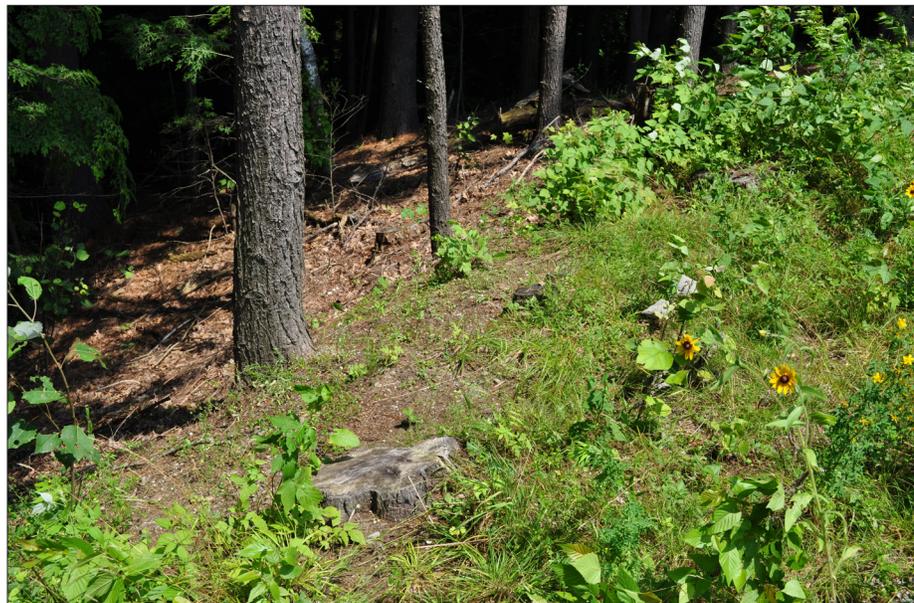
Figure 174. The Temple showing the evergreen backdrop to the north. View looking northwest, 2013 (OCLP).

Figure 175. Stumps from the overgrown hemlock trees removed from the area to the north of the Temple in 2011. View looking east, 2013 (OCLP).

in 1914 as a more permanent structure. The ashes of Saint-Gaudens and family members are interred inside. The landscape surrounding the Temple has changed considerably since the “Masque.” Historic photographs show a thin stand of mature white pines along the slope of the ravine with views to the distant open hillsides. At some point during the late twentieth century, the rim of the ravine was planted with hemlocks, which were sheared into a hedge. The hemlocks were later left to mature. Some of these trees were removed in 2011 (Figures 174 and 175).

**Recommendation:** The woods edge should be managed as detailed under “VT-12. Manage woods edge near the Temple.” Several short benches should be sited in front of the Temple, as illustrated in a 1905 photograph. A park wayside that describes the Temple is appropriately located off to the side of the structure along the edge of the woods, and does not detract from the setting.

A temporary Temple was constructed in 1905 as a backdrop for a performance of “The Masque of the Golden Bowl.” This structure was replaced with a permanent marble Temple in 1914 and now holds the ashes of Saint-Gaudens family members. A hemlock hedge was planted behind the Temple at a later date to supplement a thin stand of white pines that grew behind the Temple at the time of the “Masque.” By 2011, mature hemlocks were overhanging the Temple, resulting in poor air circulation around the Temple. In 2011, Saint-Gaudens National Historic Site staff removed the row of hemlocks closest to the Temple to improve air circulation and reduce moisture build-up on the sculpture (see Figures 174 and 175).

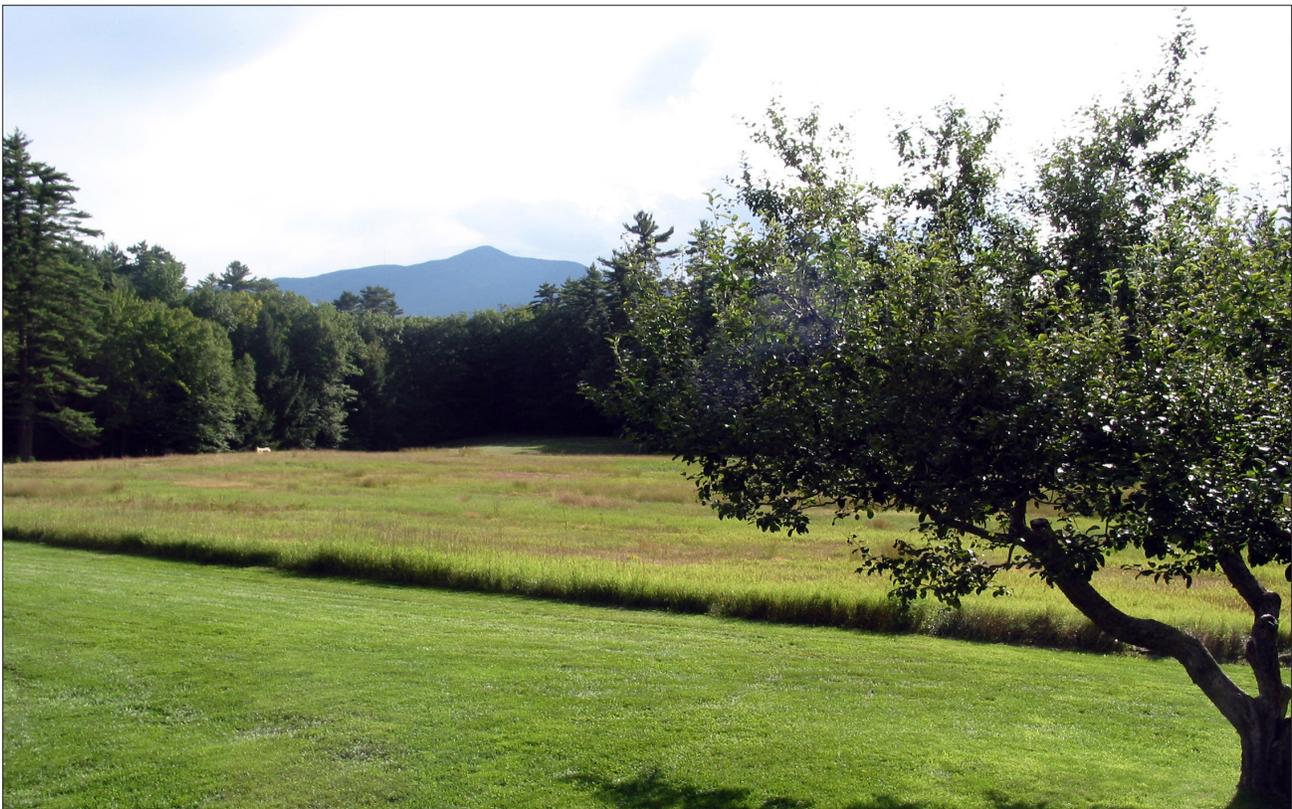
Figure 179. Mount Ascutney from the west meadow. Tall trees on the south side of Saint Gaudens Road and on the west side of the meadow all but block views of Mount Ascutney's ridge. View looking west, 2008 (OCLP).

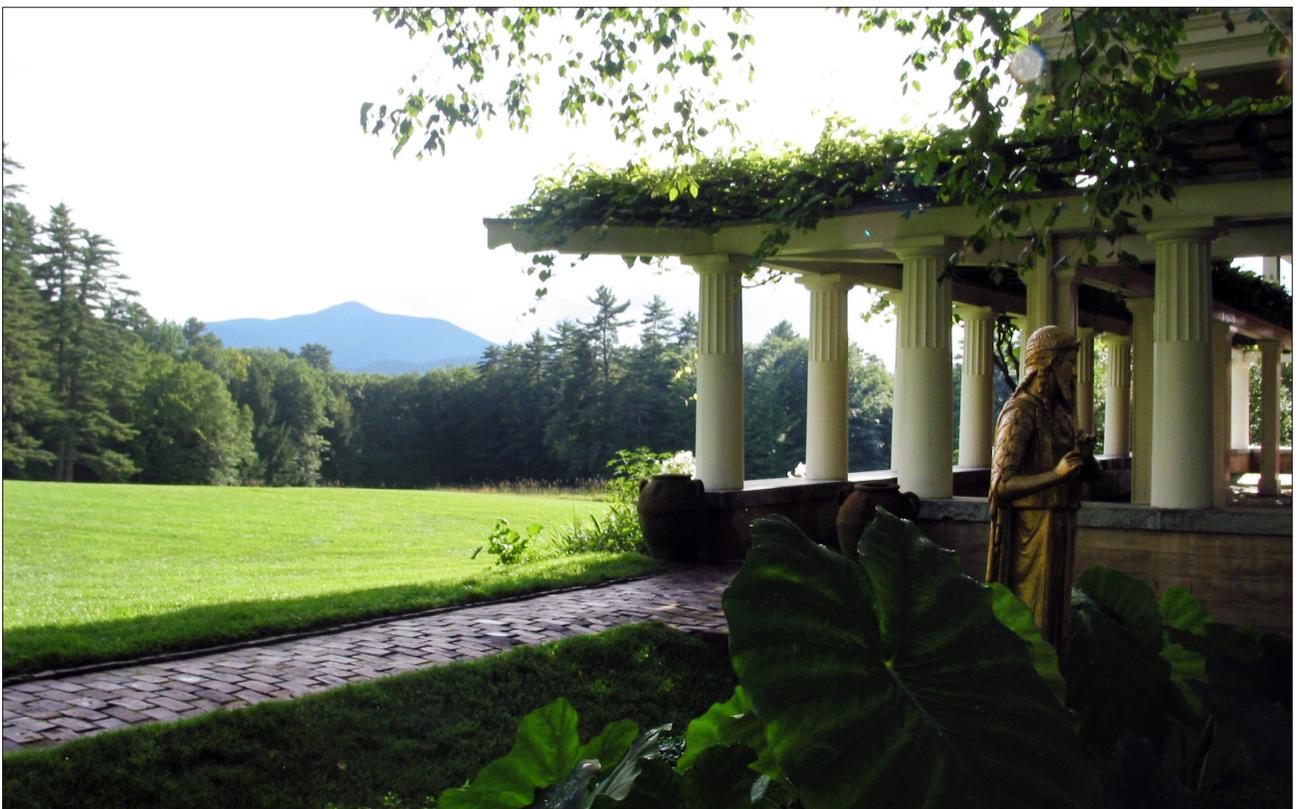
Figure 181. Mount Ascutney from the Pan Grove. Most of Hunt Hill is no longer visible due to mature trees to the west of the west meadow. View looking west, 2008 (OCLP).

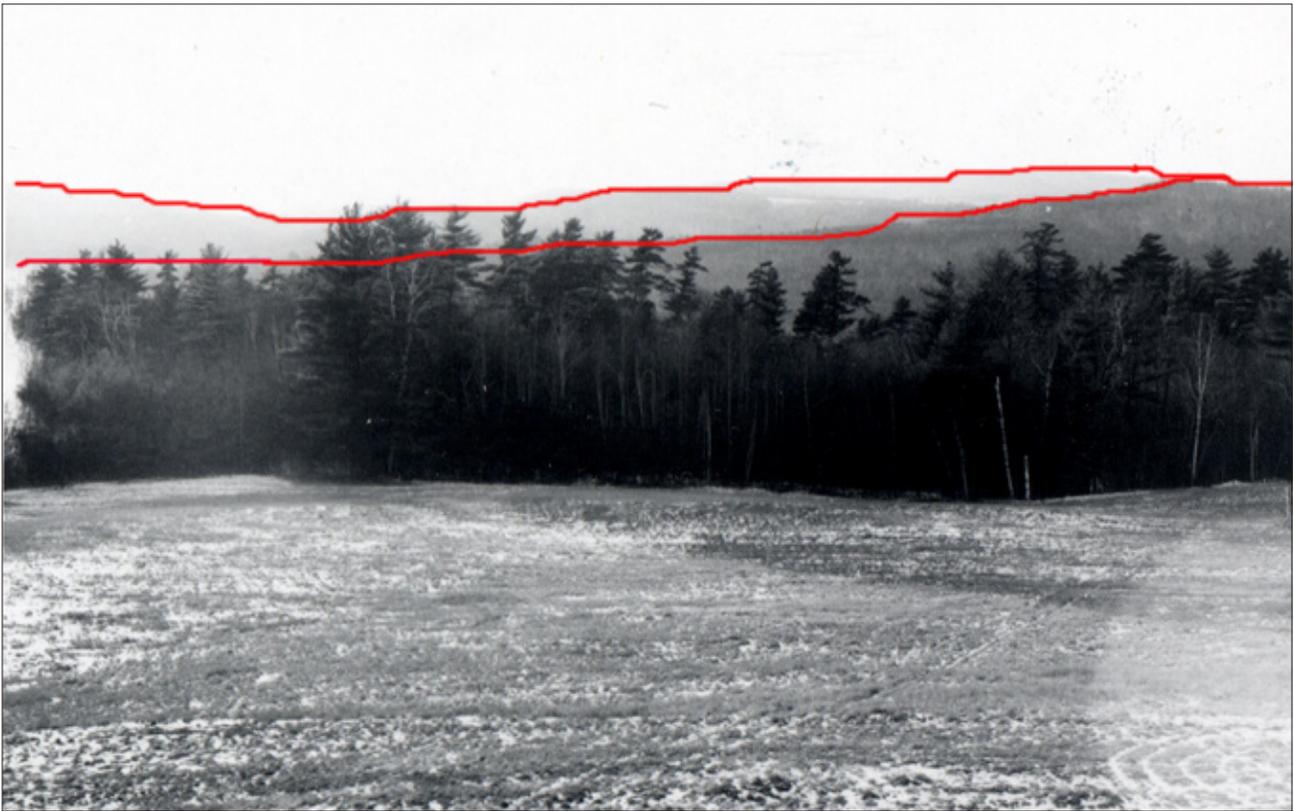
Figure 182. View from the Piazza toward Juniper Hill (outlined in red), above the treeline of the west woods. View looking west, c. 1960 (SAGA 532).

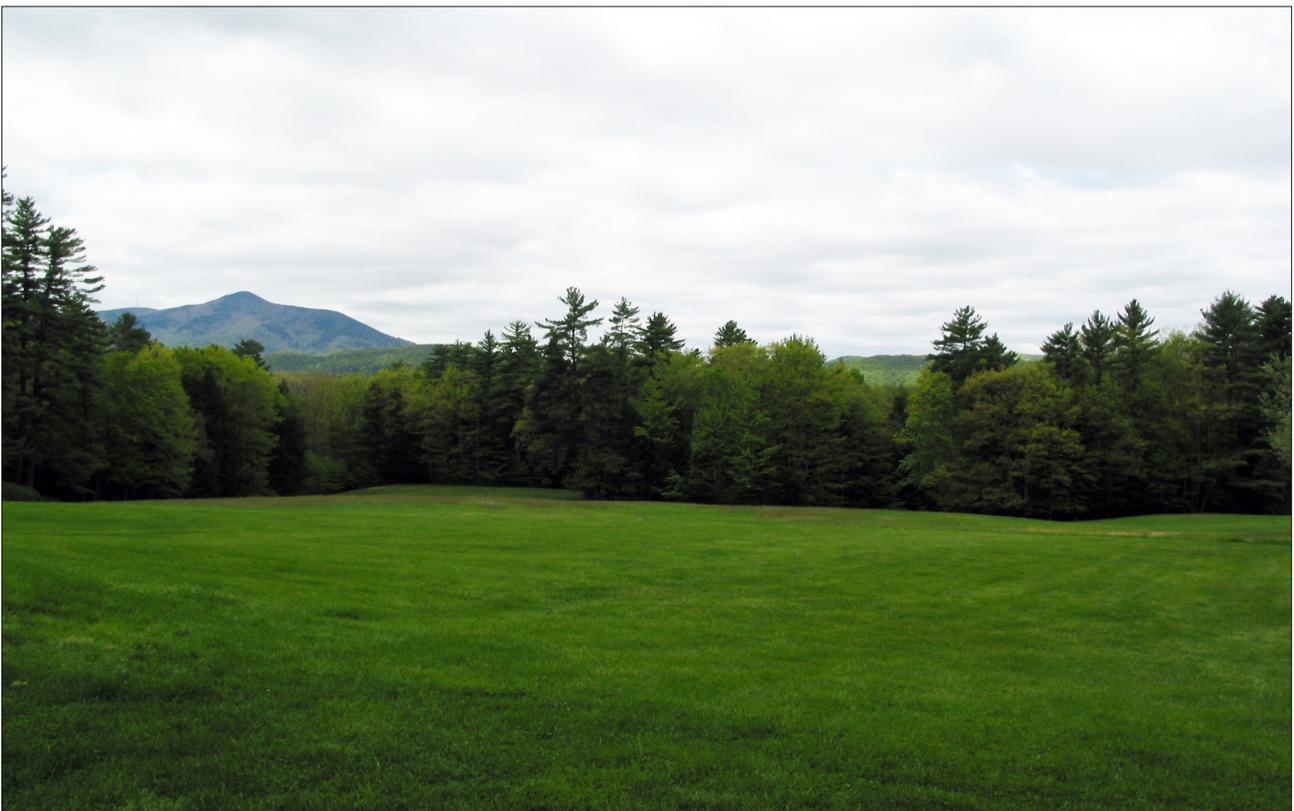
Figure 183. Mount Ascutney and Juniper Hill from the west meadow. Interrupted segments of Juniper Hill area visible through the mature white pines in the west woods. View looking north, 2006 (OCLP).

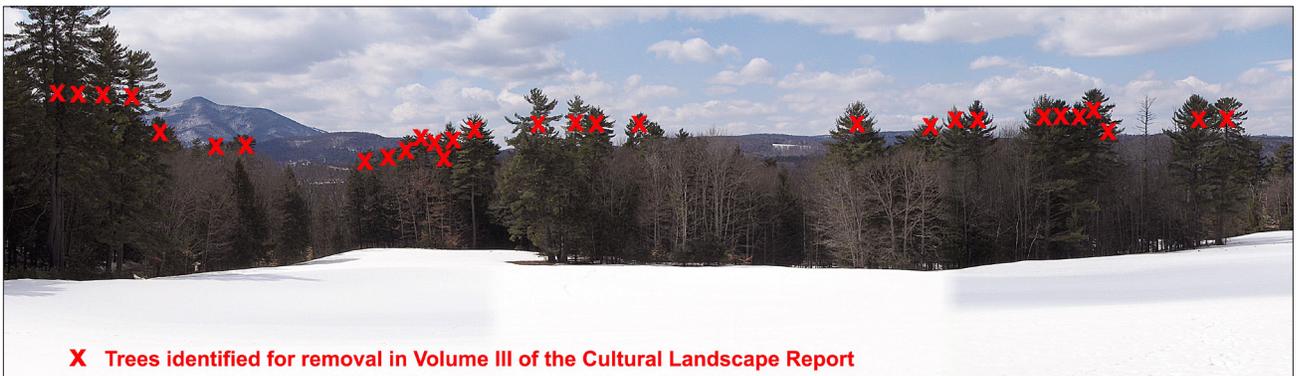
**X Trees identified for removal in Volume III of the Cultural Landscape Report**

Figure 185. View across the west meadow showing trees identified for removal along Saint Gaudens Road (left) and the edge of the west meadow (center and right). Some of these trees were removed in 2009 consistent with this recommendation. See Chapter 4, Record of Treatment for greater detail. View looking west, 2009 (OCLP).

viewshed should be considered. Of the three major components in the distant view, Mount Ascutney, Hunt Hill, and Juniper Hill, providing a clear view of Mount Ascutney is the most important because it is the highest landform in the viewshed. Juniper Hill encompasses a much longer horizontal span and is lower in elevation, making it more challenging to manage. Extensive clearing of the western viewshed may expose views of Interstate 91 in Vermont. There are also concerns about future incompatible development along the ridge that could affect the park's viewshed if exposed. Therefore, it is recommended to concentrate efforts on rehabilitating the viewshed southwest of Aspet, to Mount Ascutney and Hunt Hill, as the first priority, and partial views of Juniper hill as the second priority (Figures 184 and 185).

In the woods to the west of Aspet numerous white pines on the edge of the meadow have grown very tall and block views of the juncture of Hunt Hill and Juniper Hill. It is recommended to remove several mature specimens from this area to open selective views of Juniper Hill. An uninterrupted view of the entire ridgeline is not the desired outcome; a scattered view of Juniper Hill that is revealed and concealed along its length would be more sustainable and could be managed to deal with future development in the viewshed (see Figure 184).

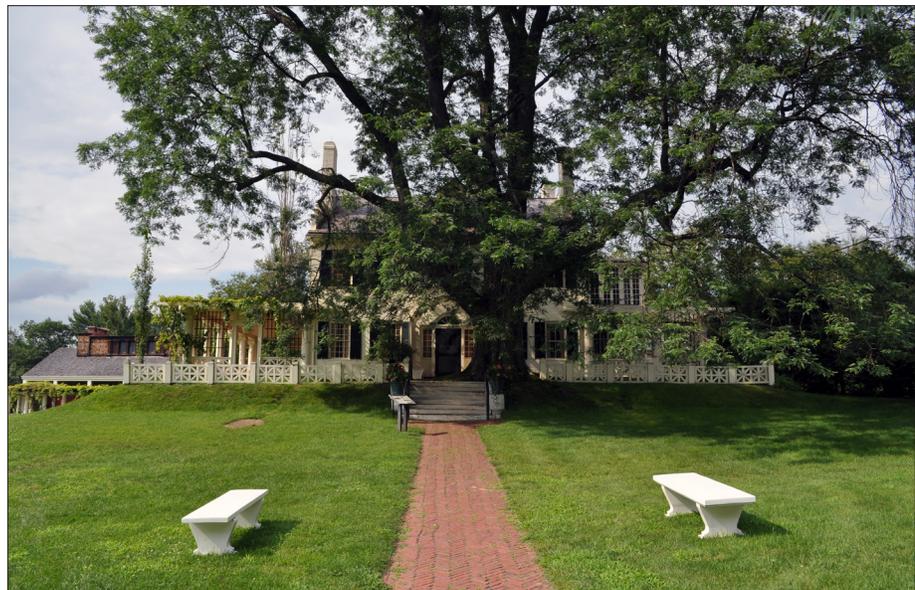
Figure 186. Wooden benches sensitively placed along the brick path from the carriage turnaround to the Main House. View looking north, 2013 (OCLP).

- **Front walk:** The park typically places a white bench above the entrance granite steps from the carriage turnaround, along the right side of the walkway/facing west for views. As this is not a location shown in historic photographs, the bench should be placed close to the outer horseshoe hedge as a resting place at the top of the stairs—and in the shade of the hedge—so as to not be in the primary view of the house entry and honeylocust (Figure 186). Recommended dimensions: 60 x 18 x 18 inches.

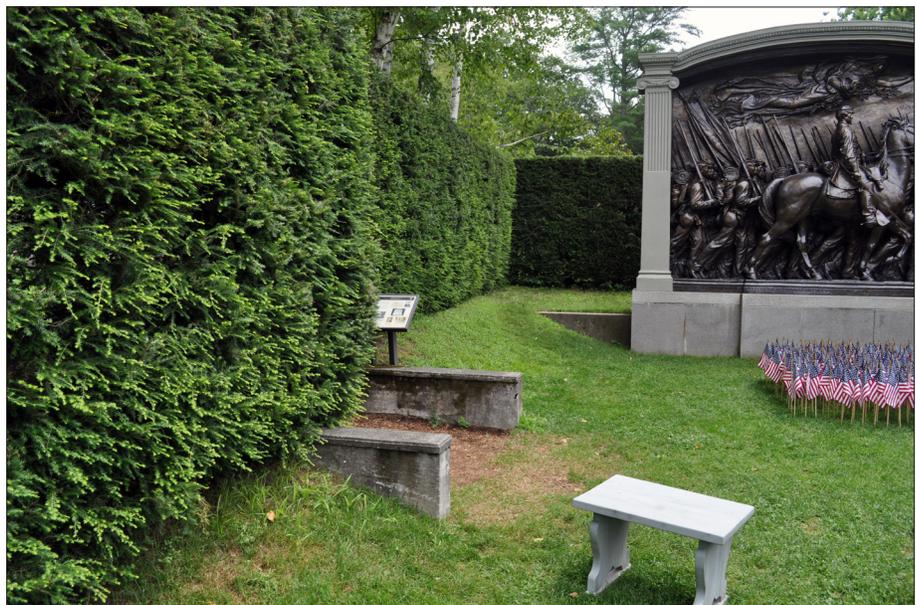
Figure 187. Shaw Memorial space, with twenty-six-inch benches. Note also the sensitive placement of the interpretive panel. View looking east, 2013 (OCLP).

- **Bowling Green/Shaw:** The park currently places three short gray benches in the space. The gray benches harmonize with the memorial and are of an appropriate scale (see Figures 76 and 187). Recommended dimensions: three 26 x 18 x 18-inch benches.

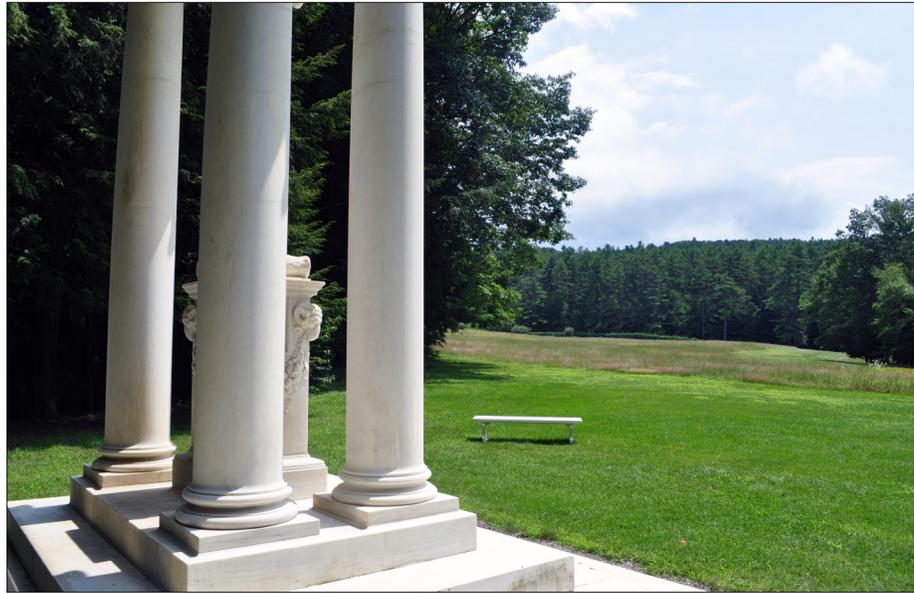
**Figure 188.** Six-foot-long bench placed in the west meadow for viewing the Temple, well out of view from the Main House and Little Studio. View looking southeast, 2013 (OCLP).

- **Walk to Temple:** Visitors typically walk along the old cart path to the Temple. A bench along the way provides a resting point and a bench directly in front of and to the south of the Temple corresponds with historic photographs. Recommended dimensions: 60 x 18 x 18-inch benches (Figure 188).

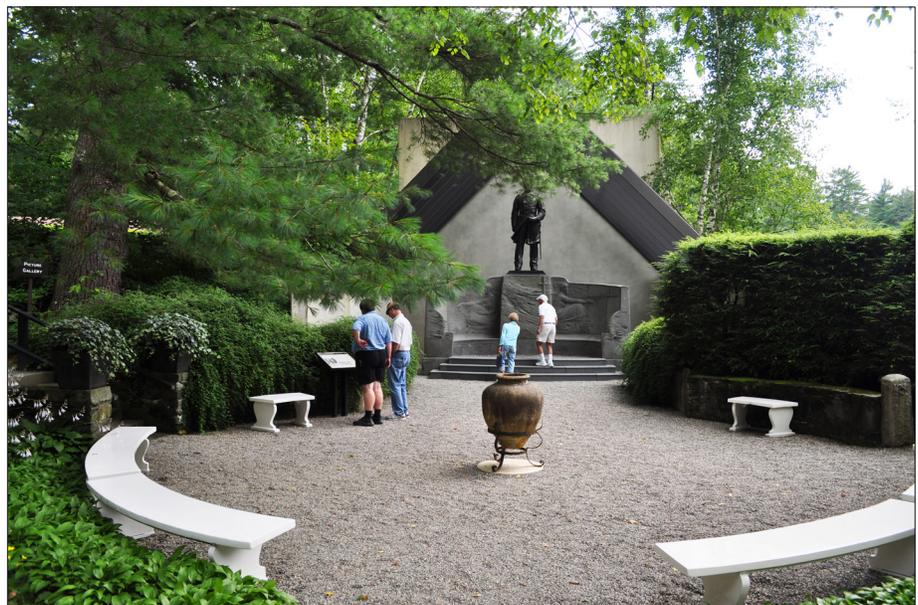
Figure 189. Curved benches in the Farragut forecourt. View looking south, 2013 (OCLP).

In the Farragut forecourt, the curved benches were not specified on the Ames plan, but the benches are similar in character to the straight benches in the Atrium. One curved bench in each quadrant of equal length should be retained and replaced in kind when necessary (see Figures 107, 108, 110, and 189). The short curved benches date to the historic period, 1905, whereas the longer curved benches are newer. The benches are used during special events such as the artist’s opening reception for Picture Gallery exhibits. The benches along the walk to the

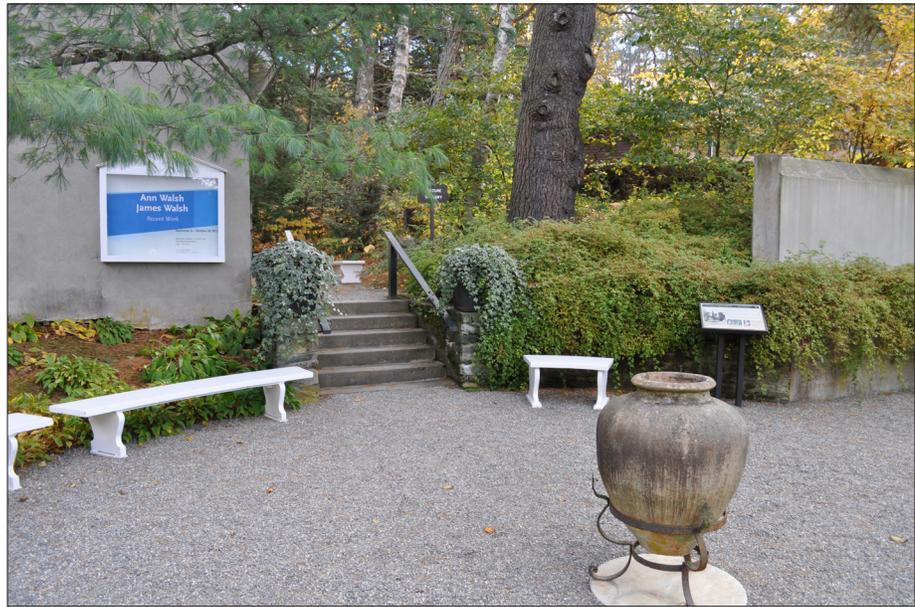
Figure 191. Terra-cotta jar at the center of the Farragut forecourt. View looking east, 2012 (OCLP).

Since about 1948, a terra-cotta jar has been placed at the center of the Farragut forecourt. The jar has several cracks and is in fair condition (see Figures 107 to 111).

**SSF-11. Preserve terra-cotta jar at center of Farragut forecourt and make reproductions**

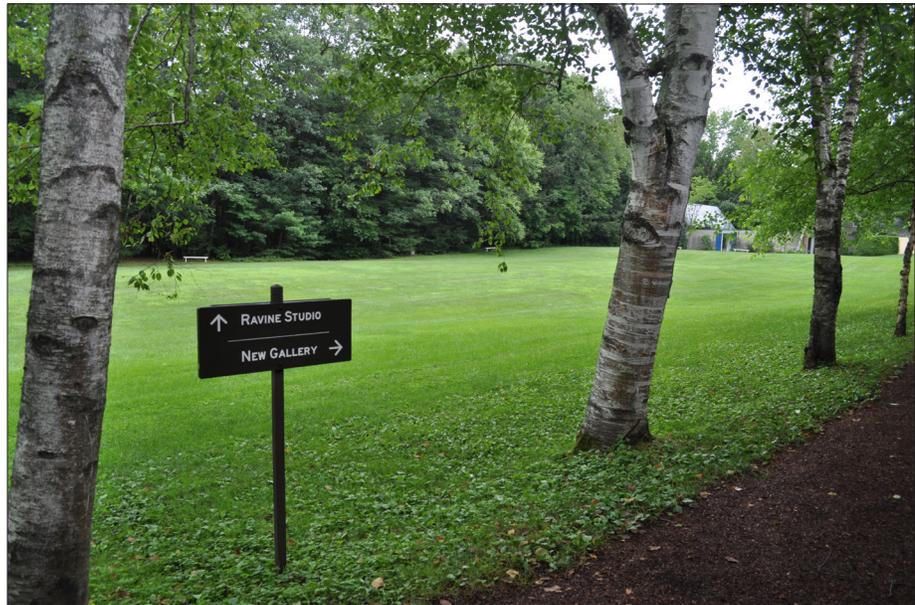
Figure 192. Directional signage sensitively designed and located along the birch allée. View looking northeast, 2013 (OCLP).

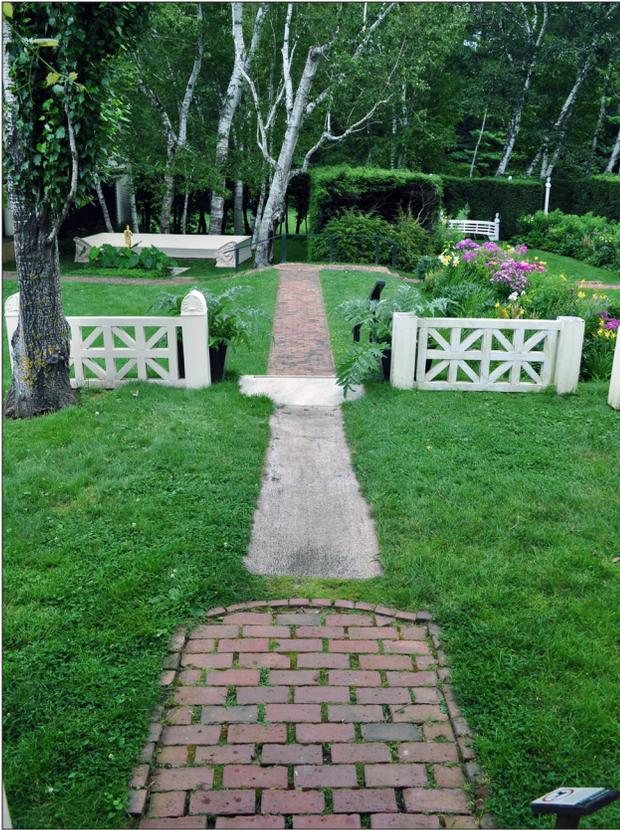
A short section of brick path extended from the north side of the Aspet Piazza to the marble steps on the upper terrace. Between the brick path and the marble steps, a piece of industrial plastic-backed landscape fabric surfaced the path. The material was installed to eliminate muddy conditions on this heavily traveled visitor circulation route. However, the surface was out-of-character with the historic landscape (Figure 195).

Figure 195. Brick path from the Piazza to marble steps across the flower garden upper terrace prior to replacement of the landscape fabric. View looking north, 2013 (OCLP).

In 2013, Saint-Gaudens National Historic Site staff worked with New Hampshire Conservation Corps volunteers to install a new, nine-foot long, three-foot wide brick path extension to replace the landscape fabric. The new paving was designed to replicate the running bond pattern of the existing historic brickwork. Salvaged bricks were used to ensure that the new materials were compatible with historic materials. The historic portion of the path was protected in place during construction (Figure 196).

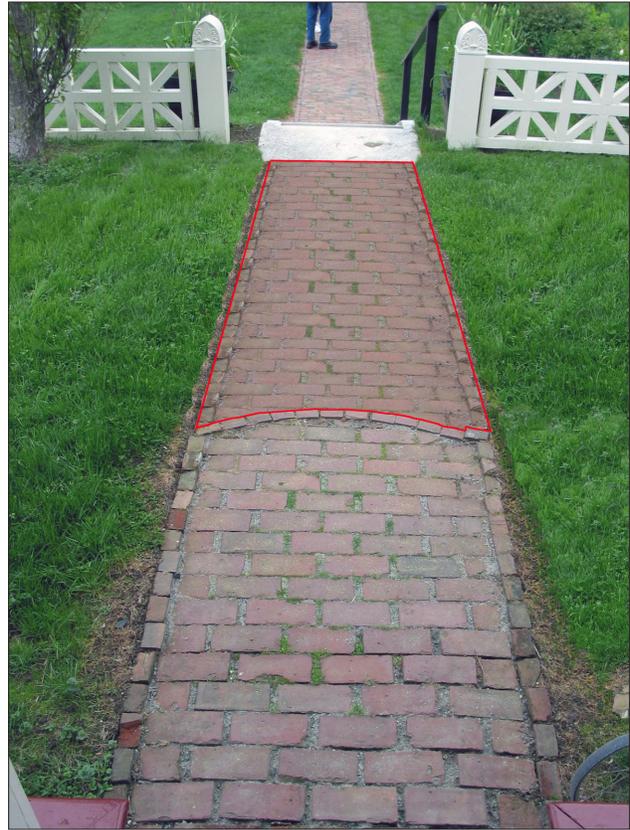
Figure 196. Photo simulation of the brick path extension on the upper terrace, which involved replacing the landscape fabric surface with salvaged brick. View looking north, 2013 (OCLP).

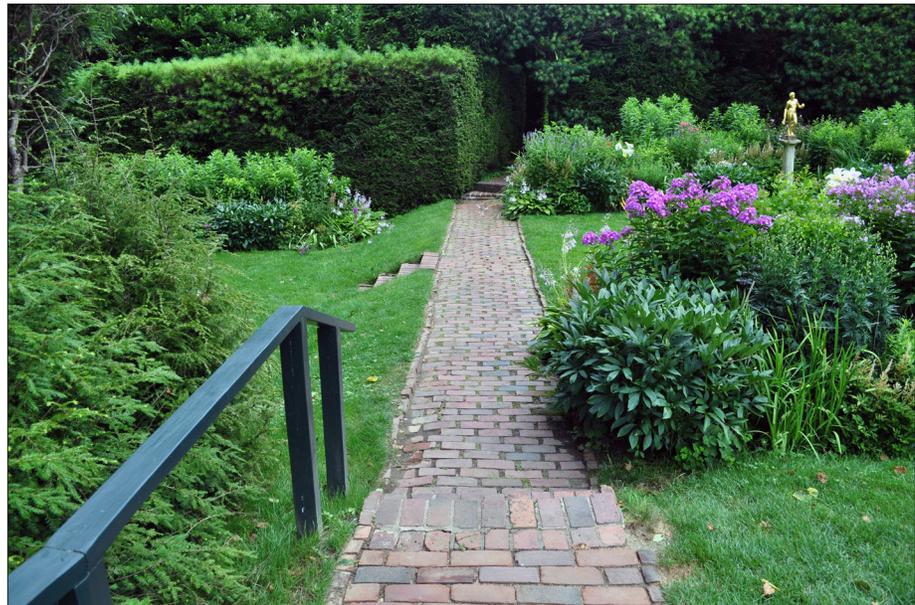
Figure 197. Brick garden path between the middle and lower terraces of the flower garden showing brick repairs. View looking east, 2013 (OCLP).

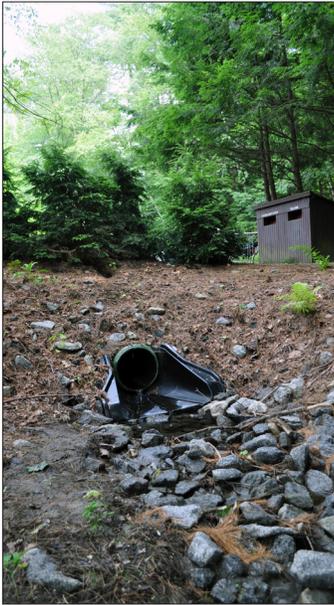
Figure 198. New culvert at the western end of the parking lot. View looking east, 2013 (OCLP).

Saint-Gaudens National Historic Site worked with the Federal Lands Highway Program Park Roads and Parkways Program and the Denver Service Center to procure a design-build contract for parking lot improvements. In 2011, the entire parking area was reconstructed by removing surface bituminous concrete, excavating the fine aggregate base, and replacing the lot with a bank run gravel base and a new bituminous concrete surface. Concurrent with repaving, the failing CMP culvert under the parking lot was replaced with a new fifteen-inch high-density polyethylene (HDPE) pipe culvert (Figure 198). A new four-inch HDPE perforated under drain was also installed along the east, west, and south sides of the parking lot.

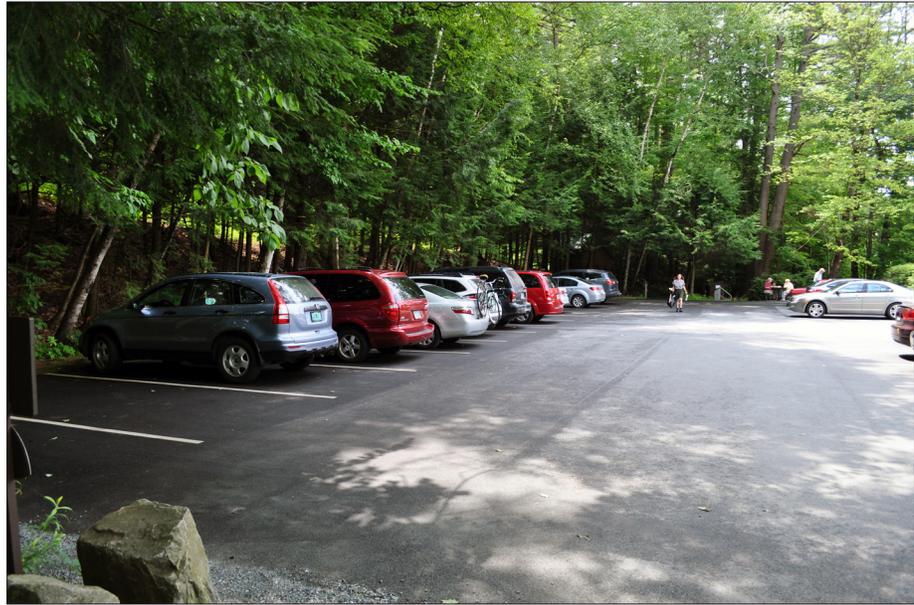
Figure 199. Resurfaced visitor parking lot from the exit from the wooded walk to the visitor center. The visitor information kiosk is immediately to the right of the image frame. View looking southwest, 2013 (OCLP).

Parking capacity was also expanded by four spaces. Partial spaces at both ends of the southern side of the parking lot were formalized by squaring off corners and restriping the southern half of the lot with ten-foot-wide spaces. A small amount of regrading was required to cut into the steep slope at the southeast corner of the

lot. Grass peninsulas on either side of the forty-five-foot-wide entrance were also extended five feet, narrowing the opening to thirty-five feet. After restriping for ten-foot-wide parking spaces, the capacity of the northern side of the lot was also expanded by two spaces for a total parking capacity of twenty-two cars (Figures 199 and 200).

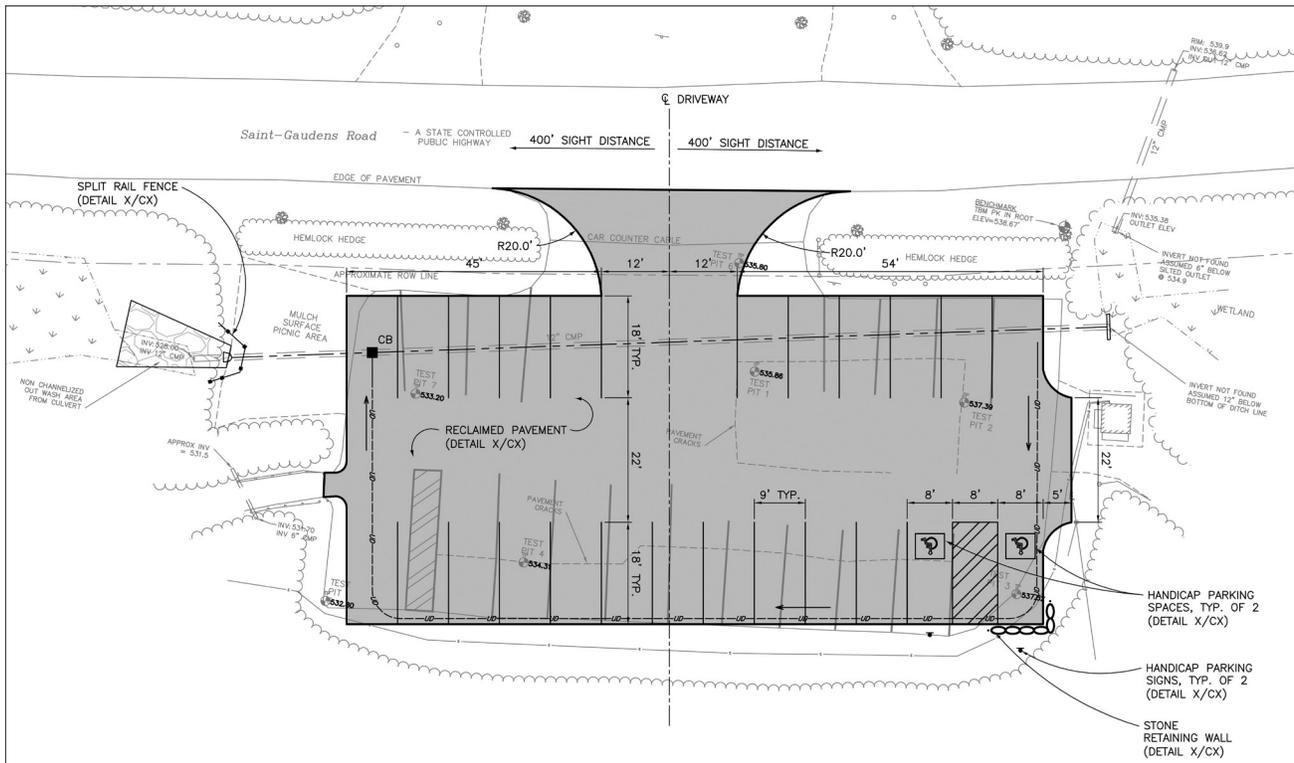
Figure 200. Draft layout plan for the visitor parking area. Minor revisions from this drawing to as-built conditions include striping for twenty-four, ten-foot-wide spaces and relocation of handicap parking to the Caretaker's Cottage driveway area, 2011 (NPS DSC).

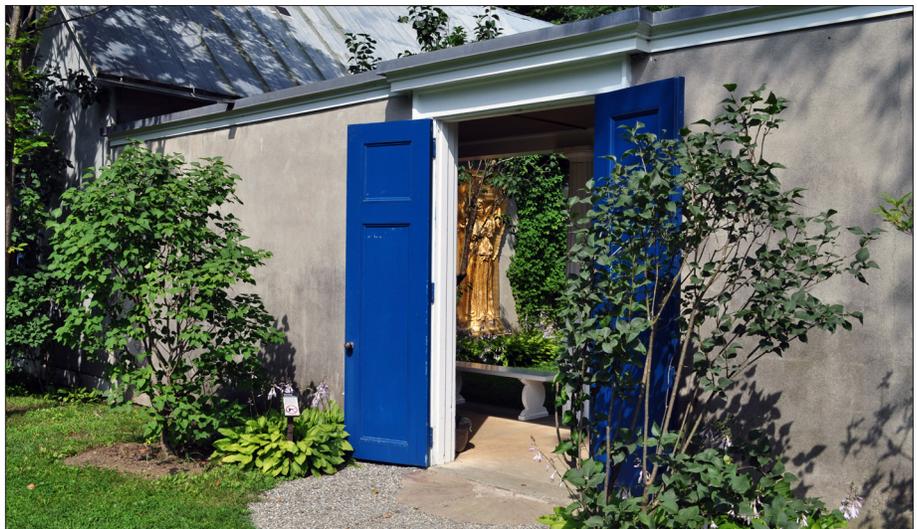
In the 1970s, crabapples were planted on either side of the west doorway to the Atrium. The trees replaced an earlier planting, which appear in historic photographs as either crabapples or burning bushes. By 2011, the crabapples were crowding the west doorway to the Atrium, growing over the roof, and obscuring views of the building.

Figure 201. Purple flowering lilacs flanking the west door to the Atrium. View looking northeast, 2013 (OCLP).

In 2011, Saint-Gaudens National Historic Site staff removed the crabapples. Purple flowering lilacs were planted on either side of the doorway to frame the entrance to the Atrium, consistent with the historic planting location. Lilacs were selected as a compatible substitute species because they resemble the texture and form of the shrubs present during the historic period, are documented growing in the area, and are more manageable (Figures 201 and 202).
