# CULTURAL LANDSCAPE REPORT FOR ASPET

SAINT-GAUDENS NATIONAL HISTORIC SITE

VOLUME III: TREATMENT AND RECORD OF TREATMENT

CORNISH, NEW HAMPSHIRE

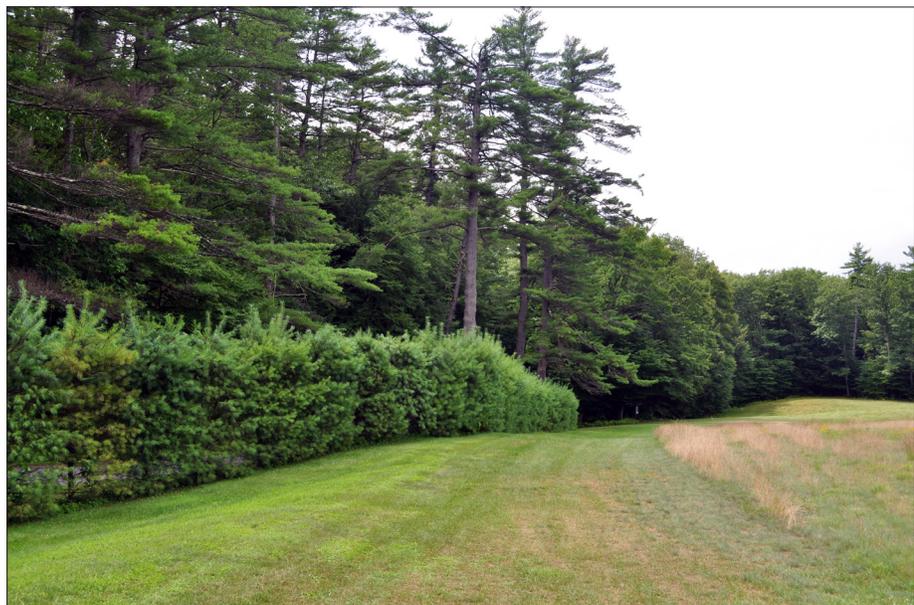
The west meadow hedge was planted in circa 1893–94 as part of a system of perimeter white pine hedges along the north side of Saint Gaudens Road. The hedges were replaced in circa 1972 after they had matured beyond their intended height. The thirty-foot section of the hedge closest to the carriage turnaround was again replaced in 1995. By 2006, growth of weeds in the hedge, including poison ivy, was a problem, and much of the lower canopy on the south side of the hedge had died back. (The three mature white pine trees at the western end of the hedge are likely remnants of the circa 1893–94 hedge.)

**Figure 203. Replacement white pine west meadow hedge. View looking west, 2013 (OCLP).**

In the fall of 2006, following an archeological investigation, the entire west meadow hedge was removed. In the spring of 2007, the hedge was replanted with eighty-five, thirty-two-inch height balled-and-burlapped white pine stock planted

in a single row five feet on center. The trees were raised in central Pennsylvania and purchased through Northern Nurseries in White River Junction, Vermont. The hedge was replaced along the crest of the bank, which largely followed the historic alignment of the planting. Heavy shade cast by mature trees on the south side of Saint Gaudens Road remains the primary challenge in management of this hedge segment (Figure 203).

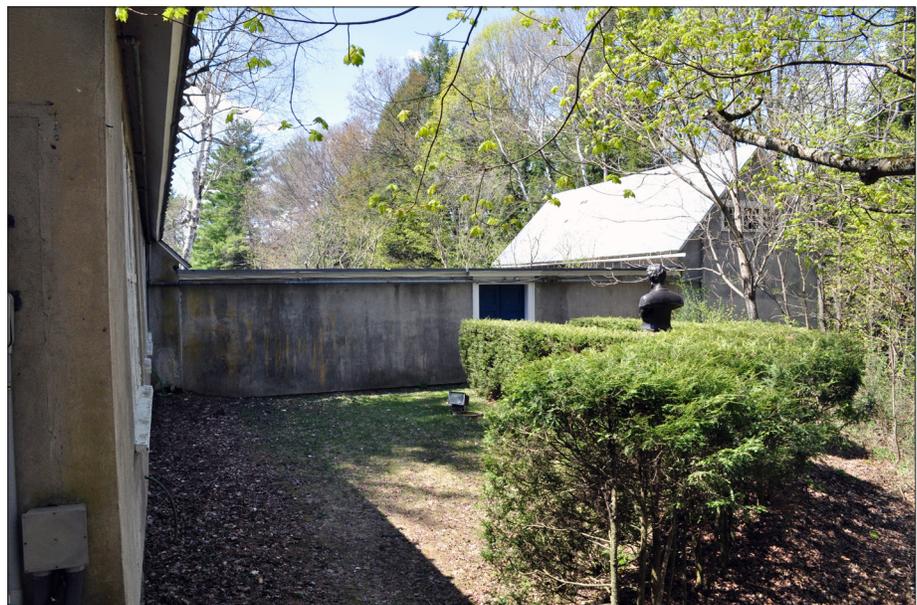
Soon after the New Gallery complex was completed in 1948, hemlock hedges were installed in the vicinity of the Lincoln Bust, an area documented on design plans as the “East Garden.” Hedges framed the walk to the Lincoln Bust and an area to the south, although the purpose of this adjacent room is not known. In 2006, the hedge on the north side of the Picture Gallery was six feet tall, four feet wide, and comprised of trees planted two feet on center. It had a full, but thin canopy, likely due to dense shade.

**Figure 204.** Former location of the hedge to the north of the Picture Gallery (left). Hedges surrounding the Lincoln bust remain. View looking northwest, 2013 (OCLP).

In 2006, Saint-Gaudens National Historic Site staff removed the hedge section along the north side of the Picture Gallery because it was weak and contributing to the deterioration of the Picture Gallery façade. Given that this area may be used to accommodate universal access to the complex in the future and the original purpose of the hedge is unknown, this hedge section has not been replaced (Figure 204).

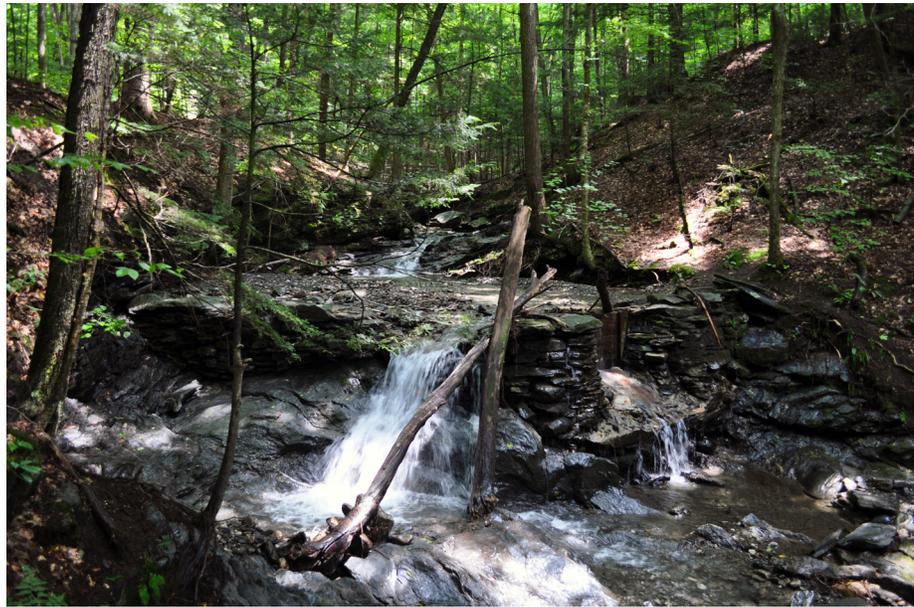
Figure 205. Blow-Me-Up Brook dam looking upstream. The impoundment is filled with sediment and the brook flows through a washout in the dam's coping. View looking northeast, 2013 (OCLP).

The Blow-Me-Up Brook dam was constructed by Augustus Saint-Gaudens in the late 1800s to create a small recreational swimming hole in Blow-Me-Up Brook. The structure is approximately eight feet tall and thirty feet wide, with a three-foot spillway controlled by wooden stop logs. The dam was repaired by the Civilian Conservation Corps in the 1930s and again by a youth conservation crew in the 1980s. In 2000, the Bureau of Reclamation Technical Service Center prepared a condition survey and a Boy Scout troop removed eighteen inches of sediment from the impoundment. By 2008, the dam was again filled to the top with gravel, sediment, and other debris. Stream flow had washed out capstones on the right side of the structure, allowing the flow to pass along the right side of the dam, rather than through the spillway. Erosion was also evident at the toe of the dam.

In 2008, a Student Conservation Association crew from the New Hampshire Conservation Corps worked with park staff to remove accumulated gravel and sediment from the impoundment and repair the fieldstone dam. Following completion of the work, the recreational pool was resorted to working condition. On July 2, 2013, a significant rainfall event caused major flash flooding in Blow-Me-Up Brook, resulting in complete re-sedimentation of the impoundment. The dam was also damaged during the storm, with a portion of the fieldstone structure washed-out. The wooden spillway remains intact and closed.

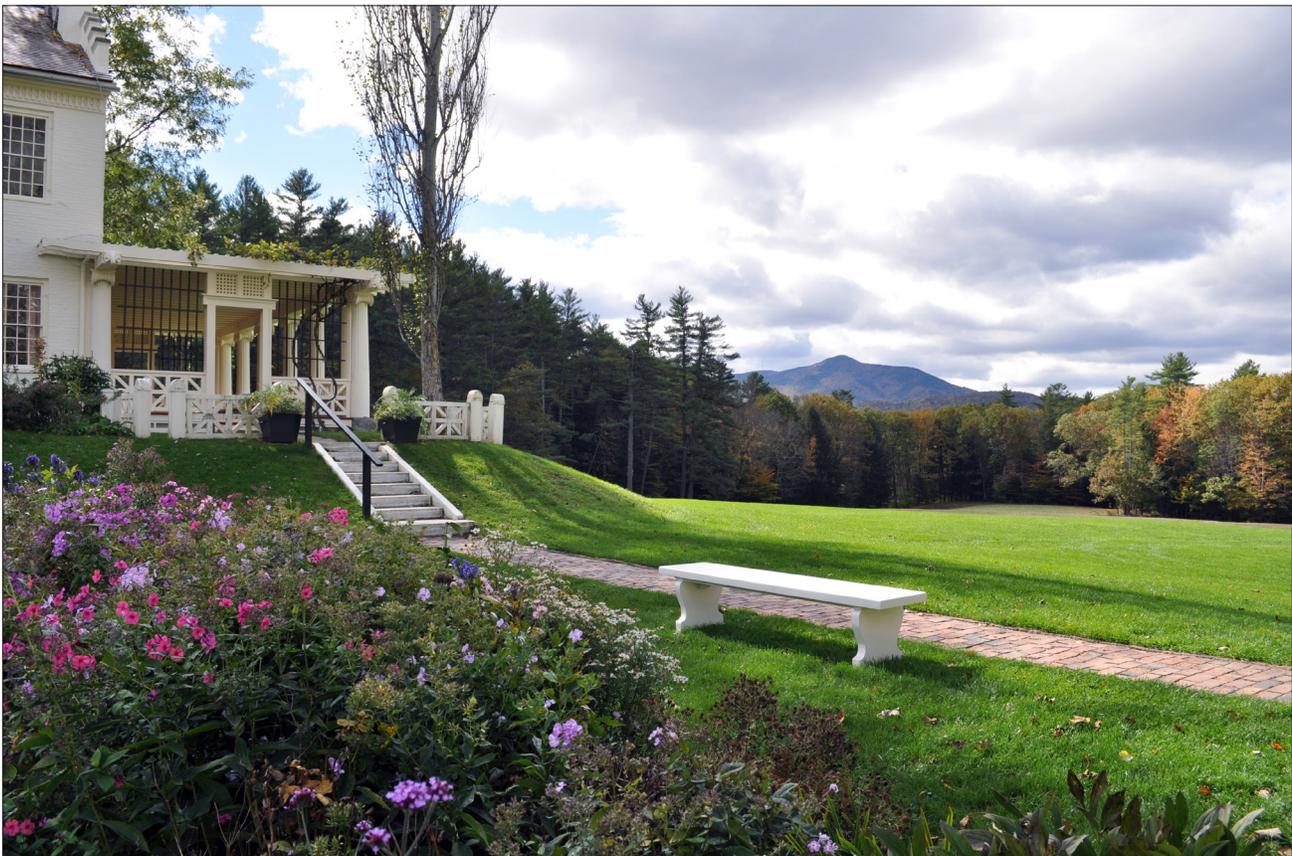
Sweeping westward views from Aspet played a major role in Augustus Saint-Gaudens' design of his home, studio, and gardens. Since the end of the period of significance, trees at the edge of the west meadow had matured, resulting in a thick stand of white pines on the south side of Saint Gaudens Road that diminish views of Mount Ascutney and Juniper Hill.

Figure 208. Reestablished views to Mount Ascutney from the middle terrace of the flower garden. View looking west, 2012 (OCLP).

In 2009, the park completed selective thinning of this forest area, removing twenty of the thirty-one trees identified for removal by this report. Selective thinning entailed removing the tallest trees, leaving smaller trees and undergrowth to preserve the character of the understory and reduce soil erosion. Tree removal was halted due to public concerns about the removal of mature trees along the scenic road. The park plans to monitor the health of remaining trees identified for removal and plan for removal, without replacement, when trees pose any safety hazard (Figure 208).

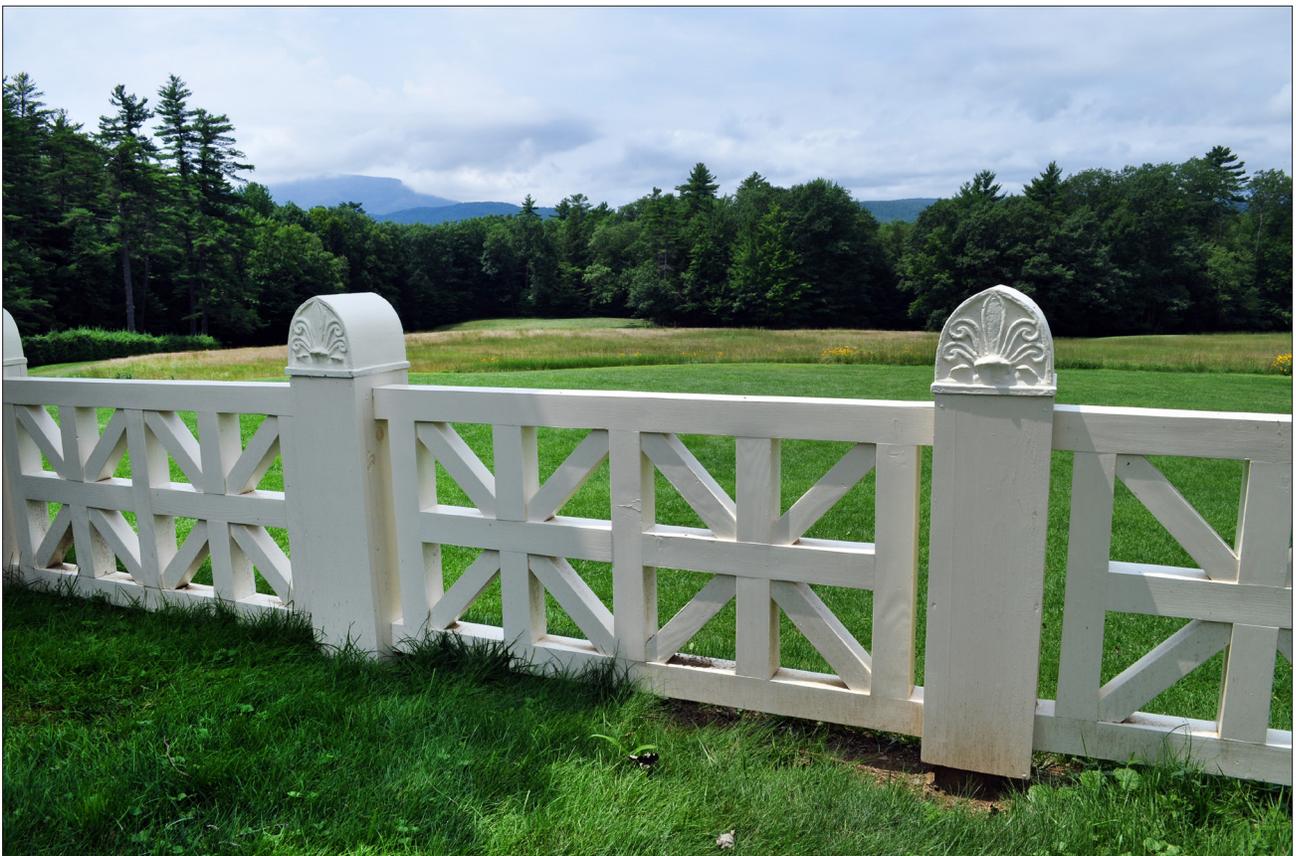
Figure 209. Section of balustrade on the upper terrace following repairs. View looking west, 2013 (OCLP).

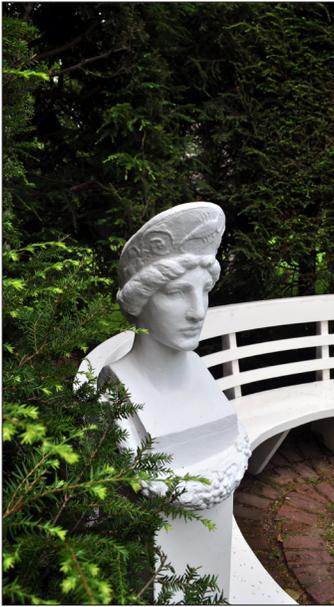
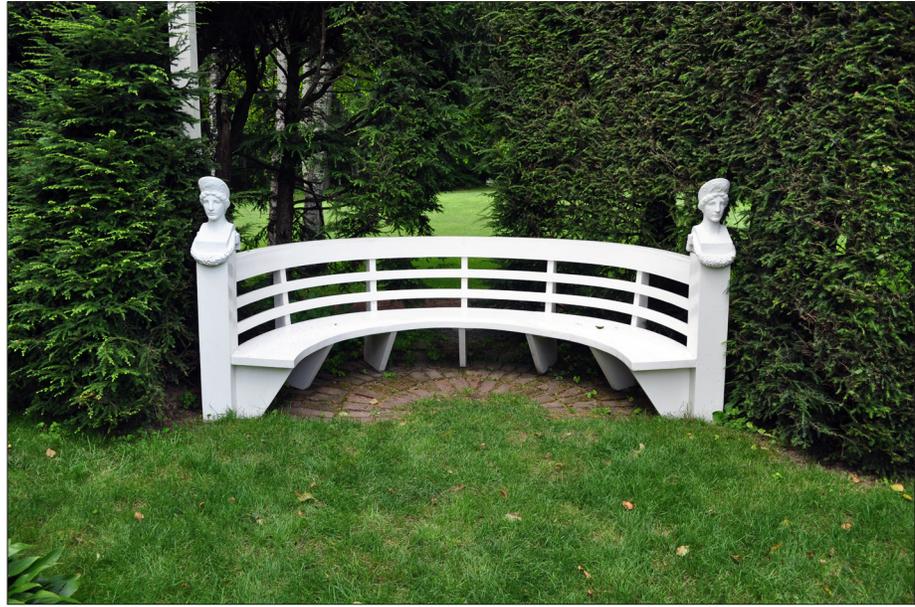
Figure 210. Zodiac head on the semi-circular bench. View looking northeast, 2013 (OCLP).

Figure 211. Semi-circular Zodiac bench at the northern end of the flower garden. A new hemlock has been installed to the west (left) of the bench to replace a section of die-out. View looking north, 2013 (OCLP).

In 2012, Saint-Gaudens National Historic Site carpenter completed minor repairs to the Zodiac bench, including replacing small portions of rotted wood with in-kind materials and repainting (Figure 210 and 211).

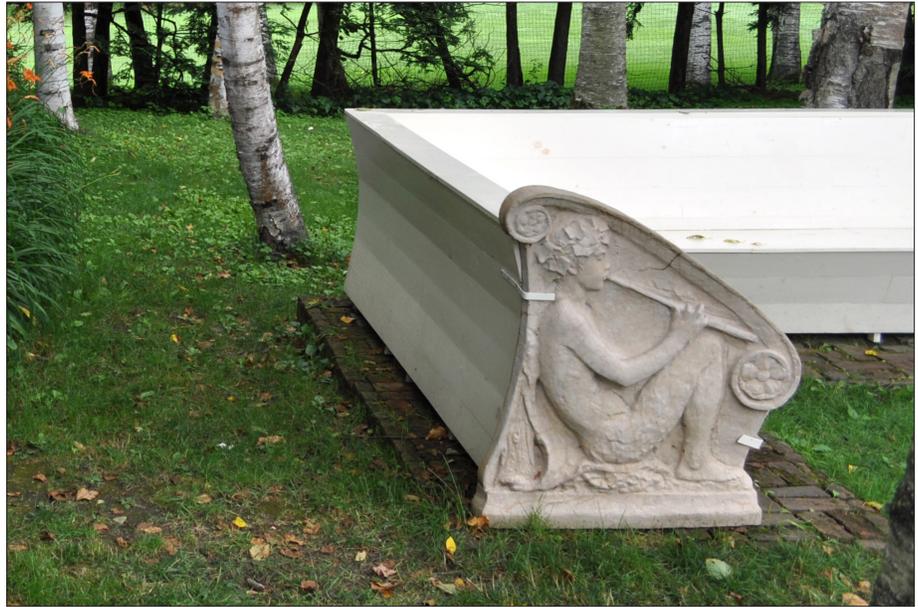
Figure 212. Western decorative relief caps on the Pan Pool bench following bench reconstruction. View looking north, 2013 (OCLP).

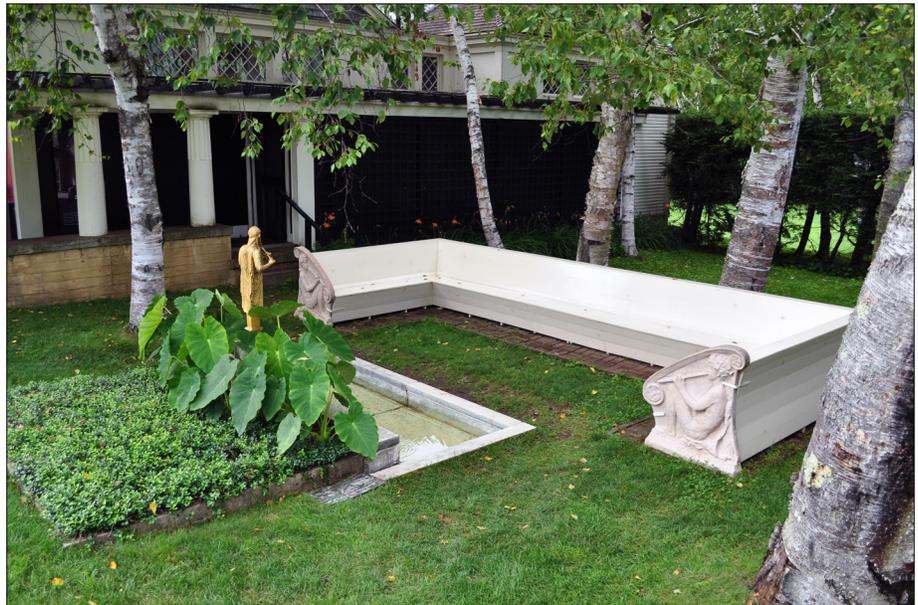
Figure 213. Reconstructed Pan Pool bench from the brick path between the flower garden and Little Studio. View looking northwest, 2013 (OCLP).

In 2012, Saint-Gaudens National Historic Site carpenter reconstructed the Pan Pool bench based on measurements taken from the existing replacement bench. The exterior of the bench was constructed and painted to match the historic bench exactly. Pressure treated lumber was used for interior framing to improve the durability of the reproduction bench (Figures 212 and 213).

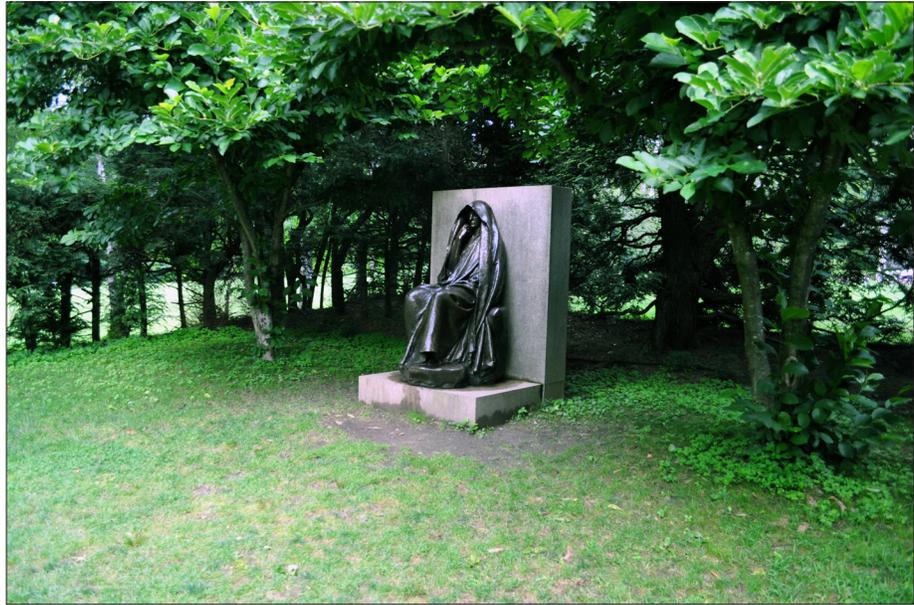
**Figure 214. Adams Memorial from the southern entrance to the space. The granite hexagon paving has been replaced with mown lawn. View looking northeast, 2013 (OCLP).**

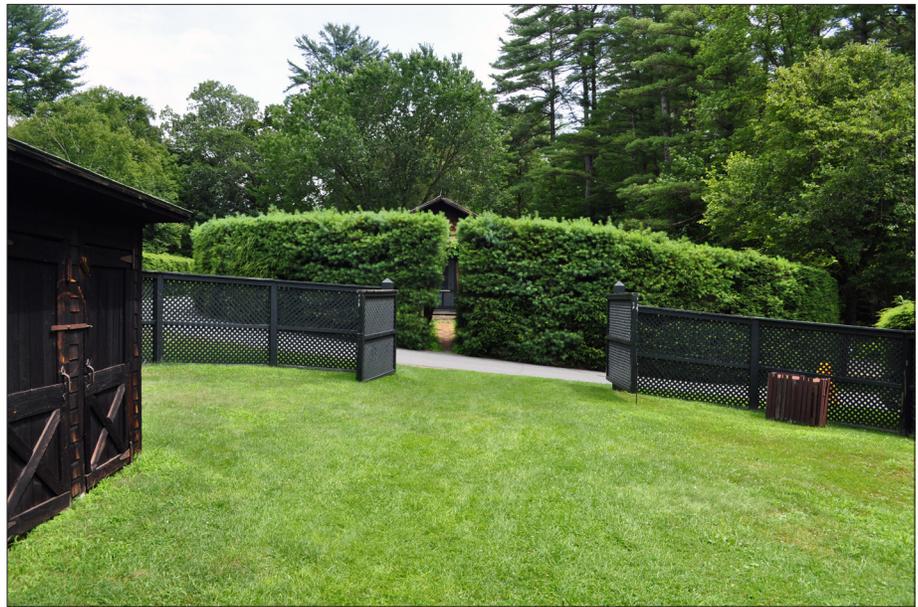
Figure 215. Stables fence and gate from the Stables yard. The Caretaker's Cottage is visible beyond the overgrown hedge beyond. View looking east, 2013 (OCLP).

In 2007, the park hired a temporary maintenance employee to work with the park restoration specialist to repair and repaint 225 linear feet of the Stables fence. The team also completed fine regarding around and below the fence to improve drainage and reduce future risk of rot and deterioration. The area below the fence is surfaced with mown lawn (Figure 215).

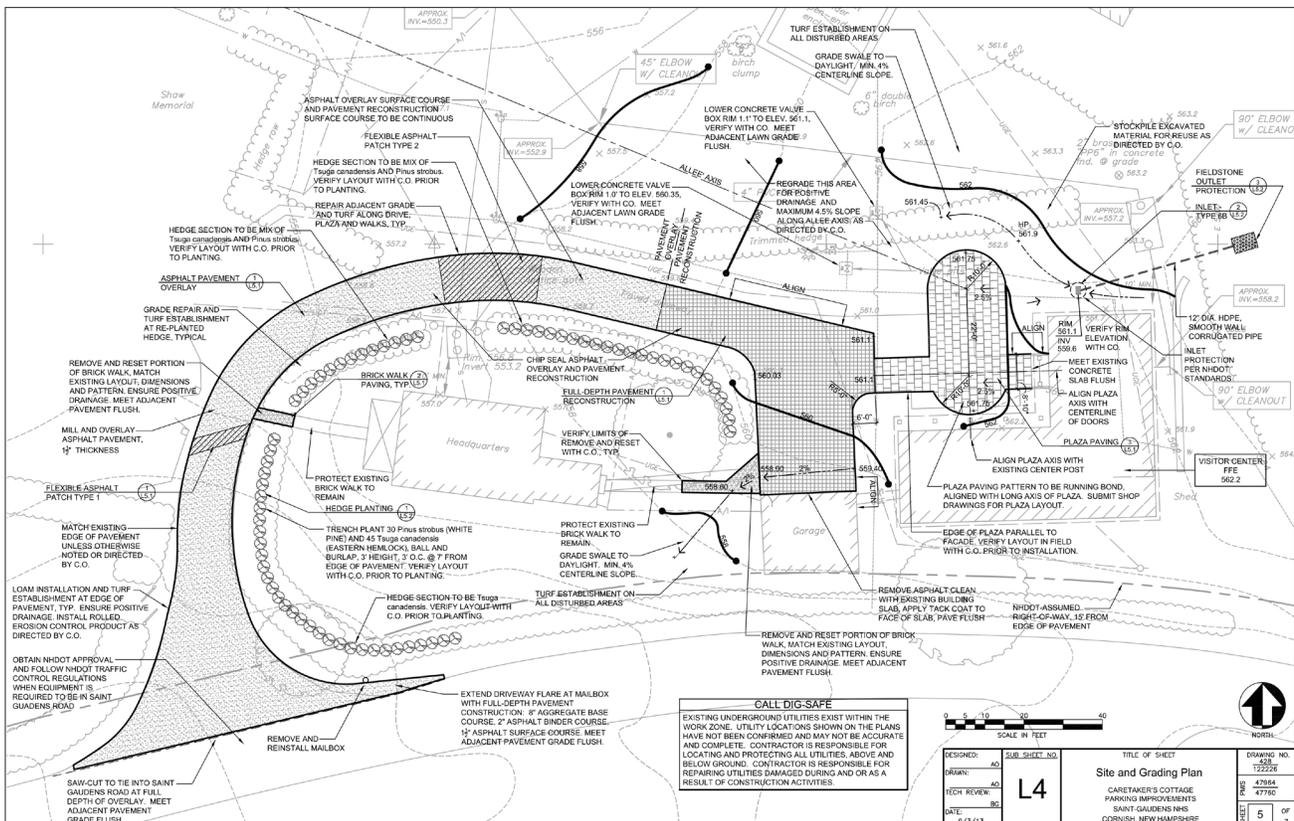
Figure 216. Layout and grading plan for visitor center area site improvements, 2013 (NPS DSC).
