# Wetland, Riparian, Geomorphology, and Floodplain Conditions

Source: K. Noon, M. Martin, J. Wagner, L. Martin, and A. Roberts

## PROJECT SUMMARY

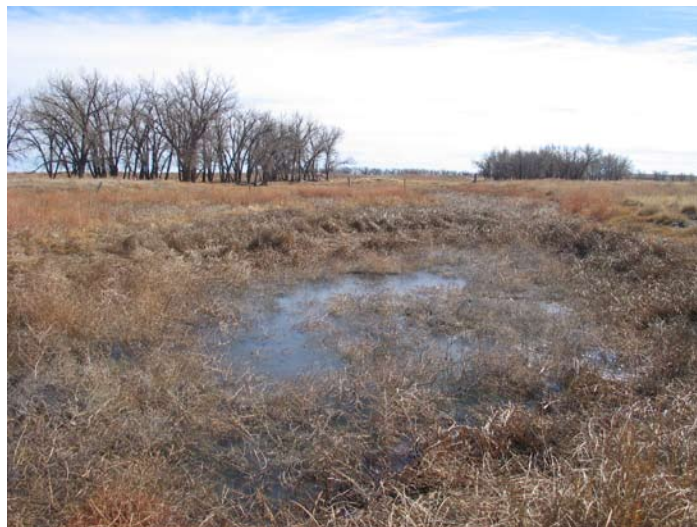
Wetland in Sand Creek Massacre NHS.

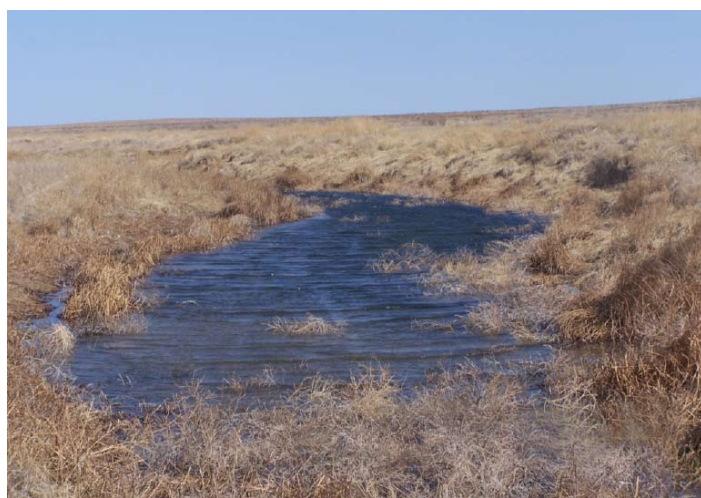
Wetland in Sand Creek Massacre NHS.

the average high water table ranges from one to three feet and supports riparian and wetland plant species such as willows and cottonwoods. Marsh or grassy wetland environment areas increase between the Big Sandy Creek channel floodway and the Kern spring channel, a perennial spring. Cottonwood groves, stream morphology, wetland areas in the immediate floodplain and channel seemed to be stable and properly functioning at the time of the study. It is likely willows and saplings were historically present along the Big Sandy Creek channel in the immediate floodplain area.

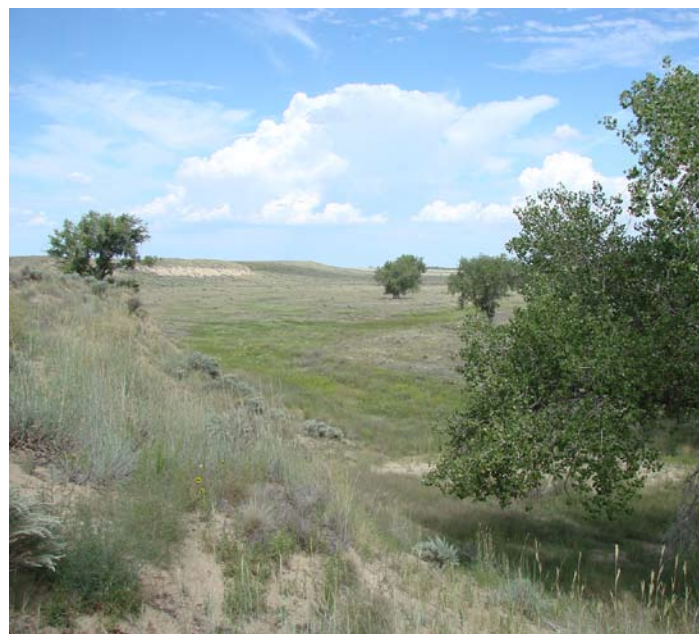
Big Sandy Creek, an intermittent stream, originates northwest of the Sand Creek Massacre site and extends approximately 100 miles southeast to the Arkansas River in southeastern Colorado.

Big Sandy Creek, an intermittent stream, originates northwest of the Sand Creek Massacre site and extends approximately 100 miles southeast to the Arkansas River in southeastern Colorado. The Big Sandy Creek watershed drains more than 3,000 square miles. However, it is unlikely it produces regular extreme flood conditions or floods because of permeable soils and slope of the drainage. The bed and banks of Big Sandy Creek are not well developed which suggests substantial flood events capable of forming channels are rare, though historic data indicates they have occurred. When flooding does occur, effects are exacerbated by undersized culverts and bridges which can reduce flow and introduce road material into riparian wetlands.
