CULTURAL LANDSCAPE REPORT FOR APPOMATTOX COURT HOUSE NATIONAL HISTORICAL PARK

VOLUME II: TREATMENT IMPLEMENTATION PLAN

APPOMATTOX, VIRGINIA

National Park Service, Boston, Massachusetts, 2018

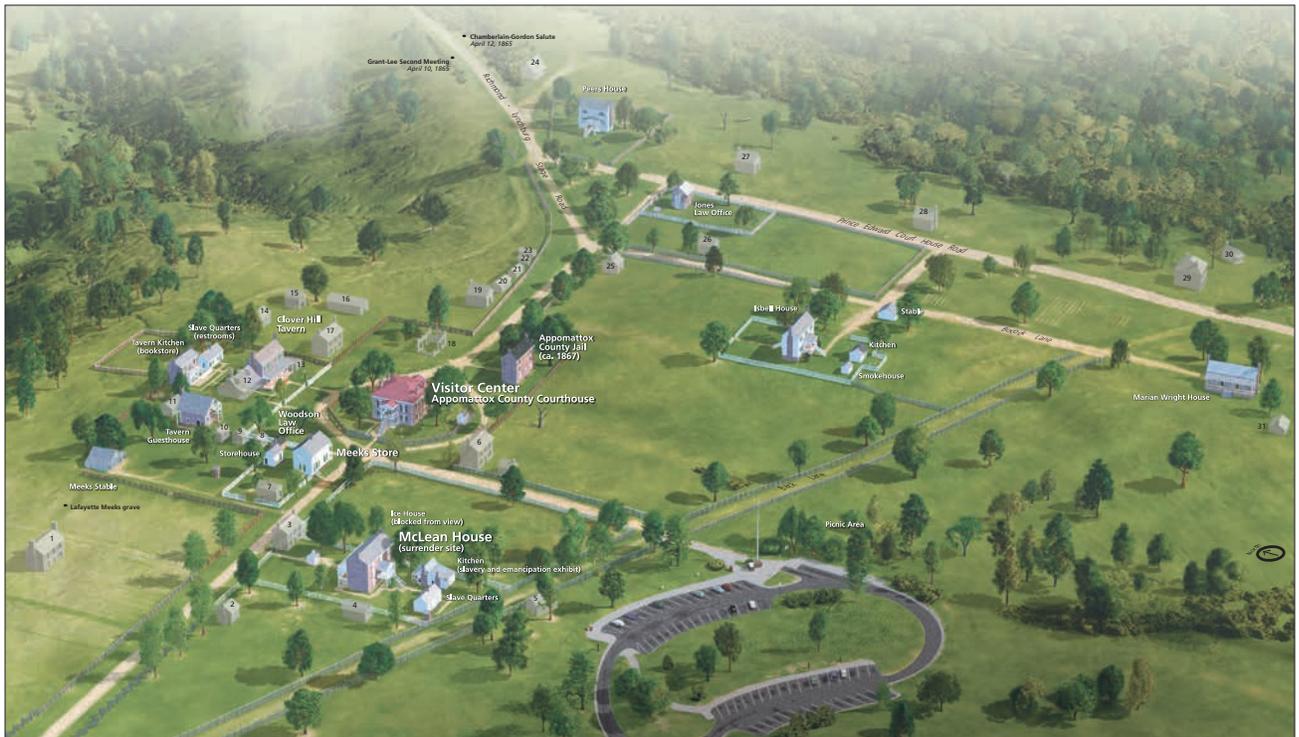
Figure 1.8. Artist's rendering of missing features in the village landscape. (APCO website, accessed 16 January 2018)

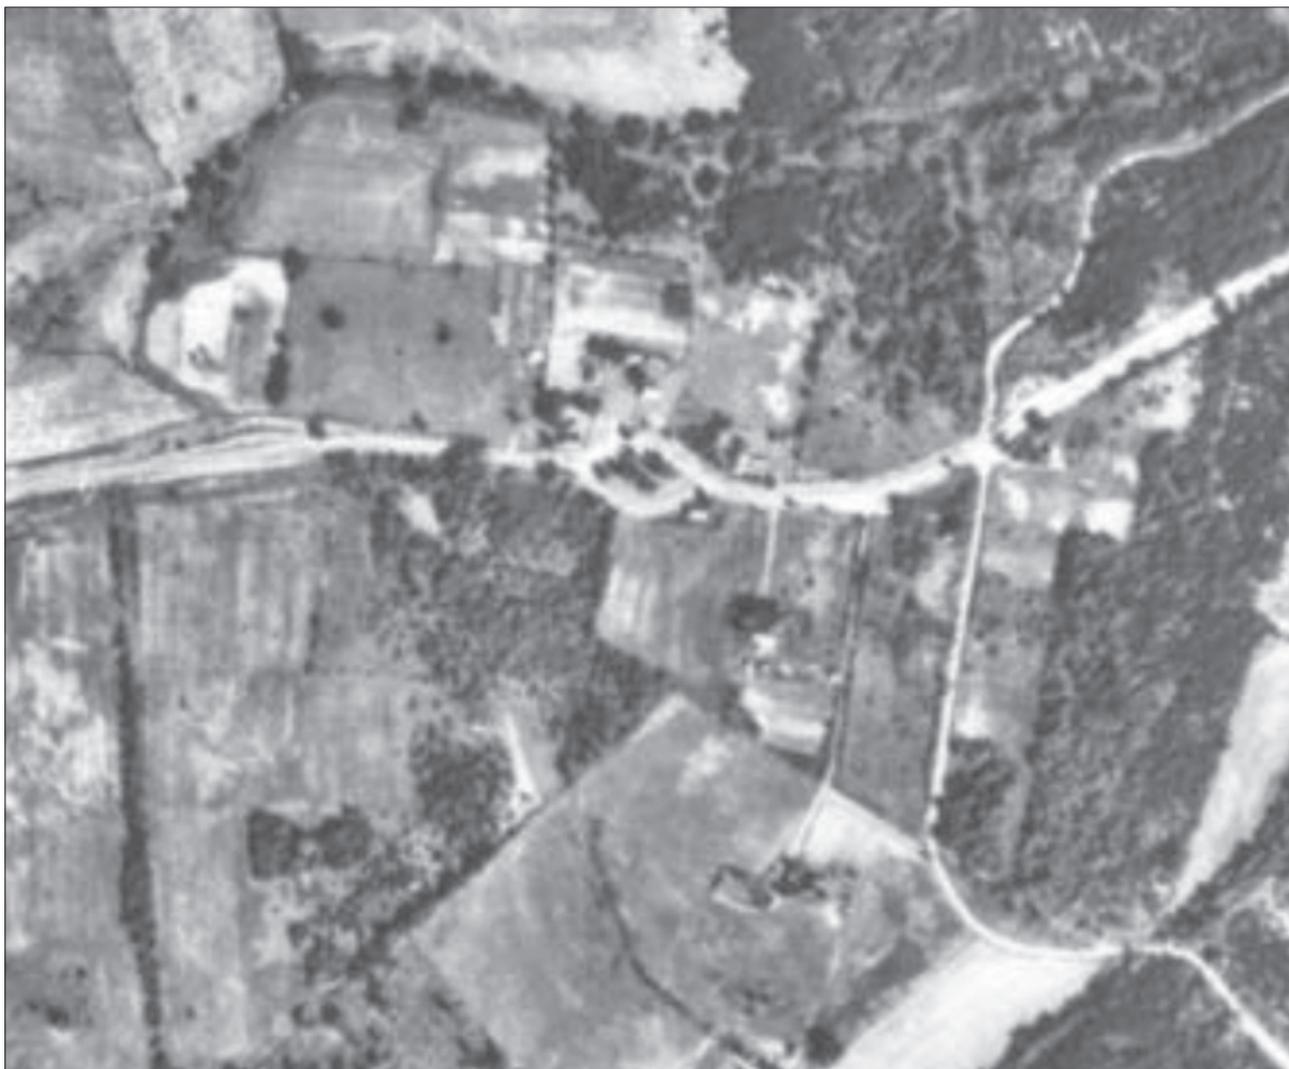
Figure 2.1(c). Detail of aerial from 1937. (CLR, December 2009: Ch.2-p.90)

V-2. Plant Missing Historic Trees and Shrubs (Table 2c.2)	
<i>Location</i>	<i>Recommended Treatment</i>
Village Core	
Courthouse	Plant missing chaste tree (#46) in the lawn on the north side. (Figure 2c.3)
	Plant missing post oak (#52) just south of the white oak (#53).
	Plant missing a red maple (#54) southwest of the courthouse, between the two white oaks (#53,55). (Figure 2c.3)
Clover Hill Tavern and Patteson-Hix Cemetery	Plant missing red maple (#101) in front of the tavern. (Figures 2c.4, 2c.5, 2c.6, 2c.7, 2c.8, 2c.9, see Figure 2.6)
	Plant missing black cherry (#103) along the fence in front of the tavern. (Figure 2c.6) (Remove lilac first, see Project V-1)
	Plant missing red maple (#106) along the fence east of the slave quarters, next to the former well. (Figure 2c.10, see Figures 2.1, 2.3, 2.6)
	Plant missing lilac (#108) at the southeast corner of the slave quarters (Figure 2c.11)
	Plant missing red maple (#112) northwest of the tavern. (Figures 2c.7, 2c.8, 2c.12, see Figures 2.1, 2.2, 2.3, 2.4, 2.5, 2.6, 2.7).

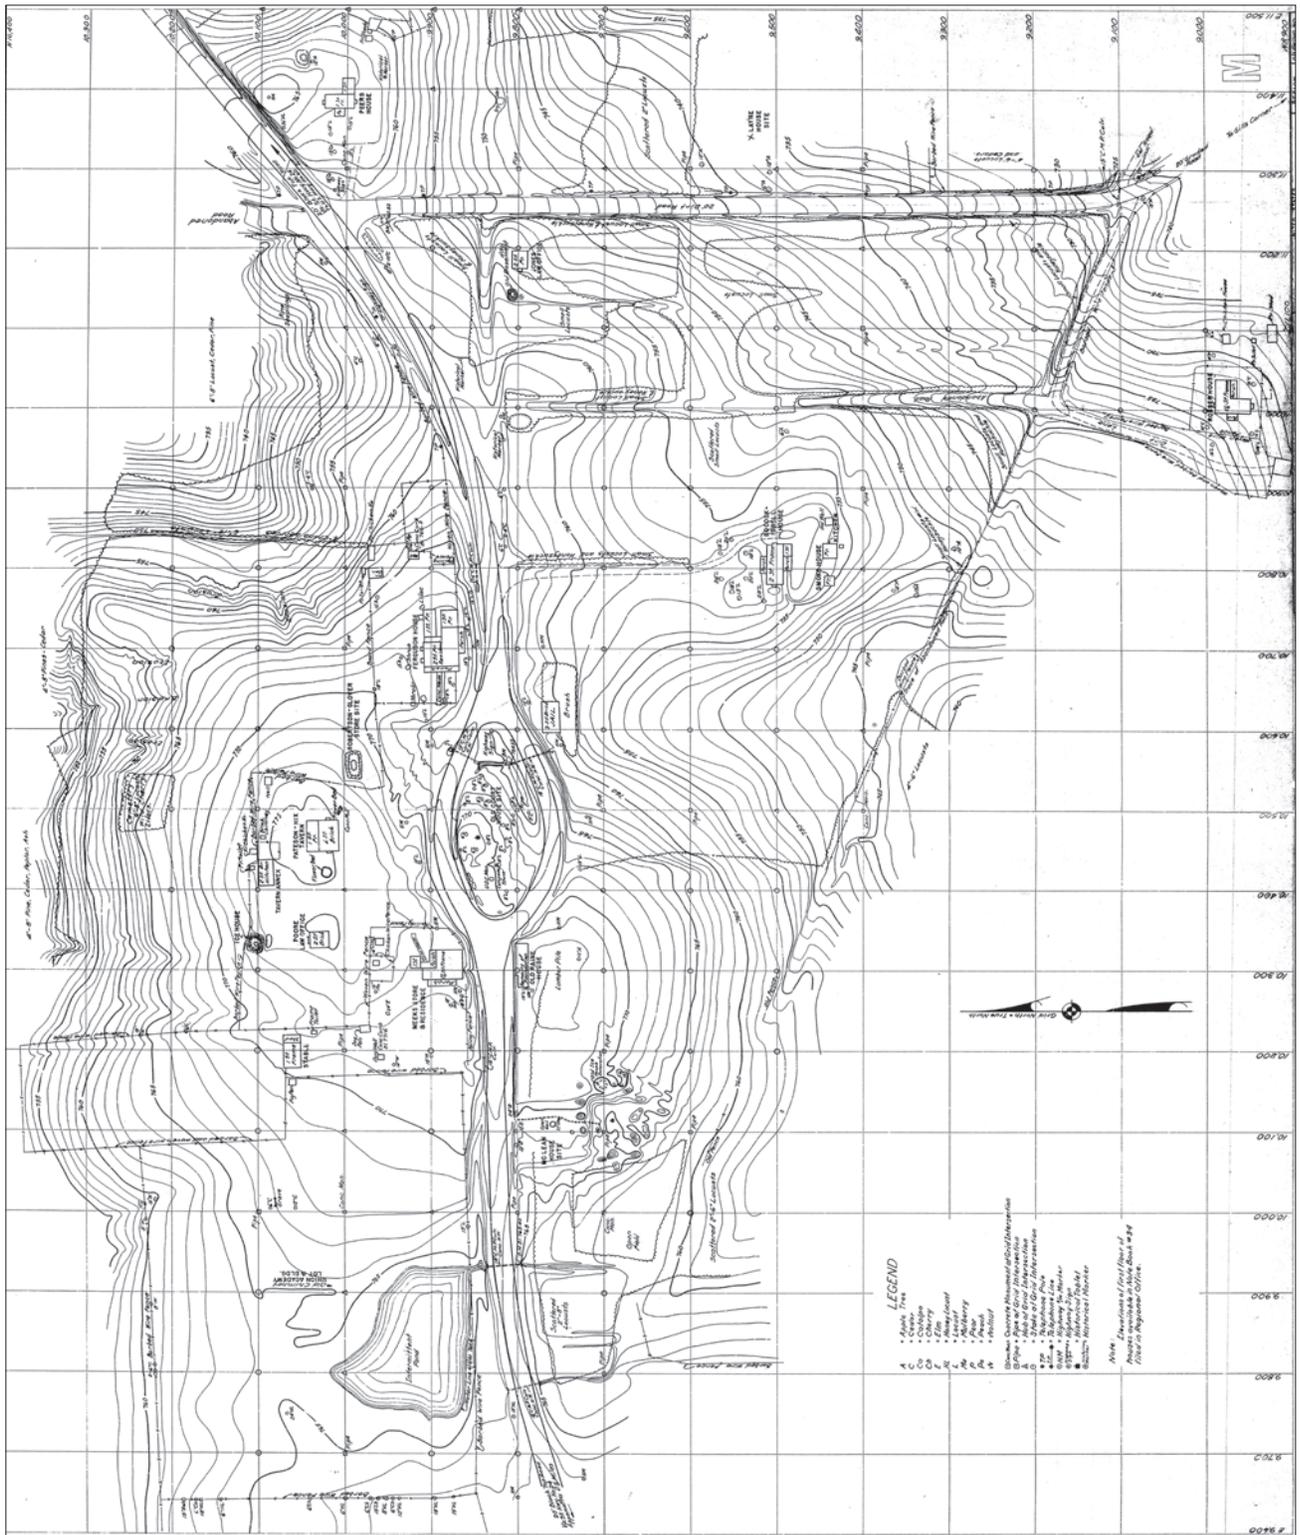
Figure 2.2. Topographic plan of Appomattox Court House NHP from 1940. (Denver Service Center, eTIC, Drawing #APCO 340-5300)

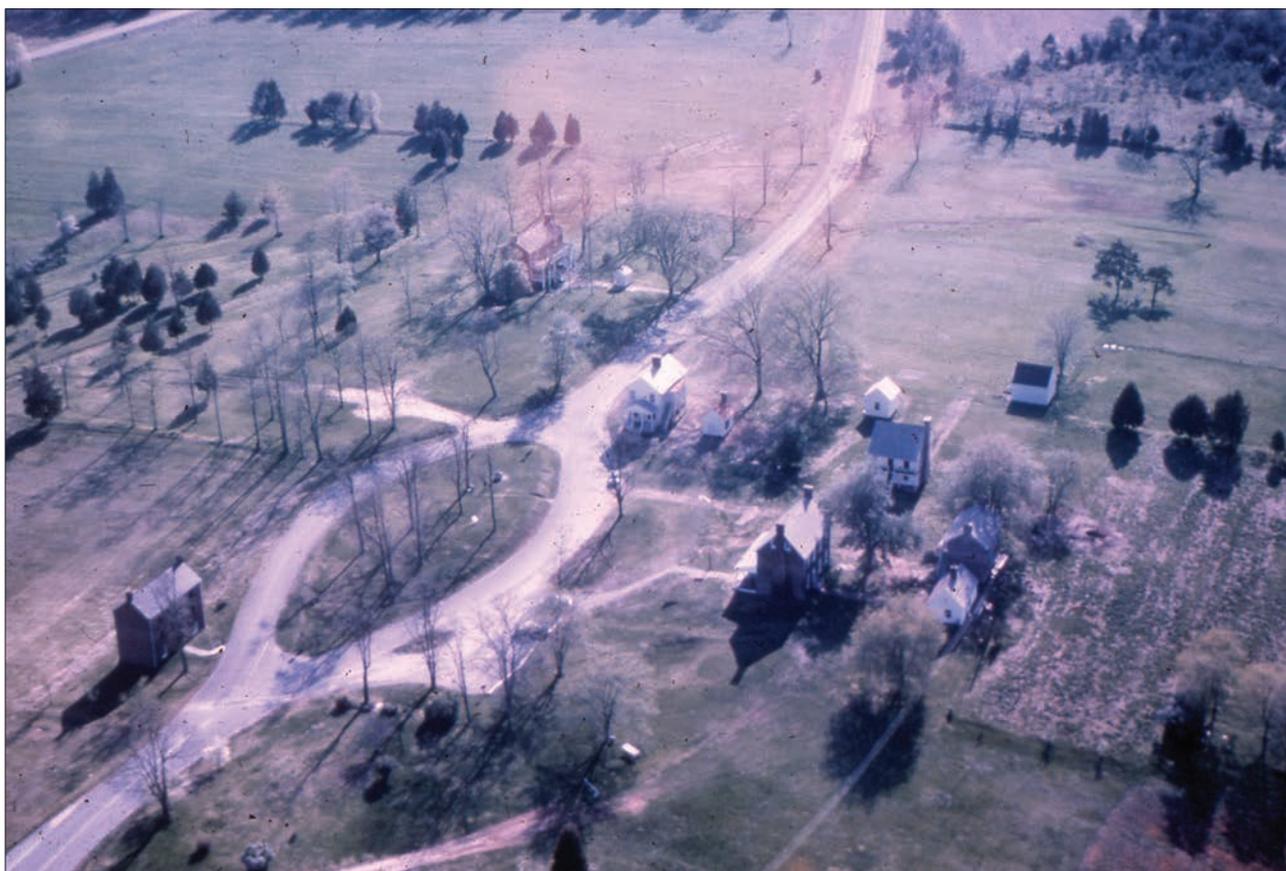
Figure 2.3. Oblique aerial of the village in 1962, view looking southwest. (APCO Archives, no#)

Meeks Store	Plant missing red maple (#128) just east of the Siberian elm (#127). (Figures 2c.24, 2c.25, see Figures 2.1, 2.2, 2.3)
	Plant missing lilac (no#A) southwest of the store, along the fence. (Figure 2c.25)
	Plant missing lilac (no#B) on the east side of the store, on the right side of the porch steps. (Figure 2c.26)
East of Village Core	
Rosser-Ferguson House	Plant three missing black locusts (#231,no#A,no#B) along the north side of the Stage Road. (Figures 2c.27, 2c.28, 2c.29, 2c.30, 2c.31, see Figures 2.2, 2.3, 2.4)
The Triangle	Plant missing white oak (#254) at the west end of the Triangle. (see Figures 2.5, 2.6)
Peers House	Plant missing red maple (#3) and silver maple (#6) in the front yard. (Figures 2c.32, 2c.33, see Figures 3.2, 3.6)
	Plant two missing crabapples (#s 13,14) at the east end of the south yard fence, on the south side of the fence. (see Figure 2.6)
	Plant missing paper mulberry (#15) at the east end of the maples, along the south yard fence. (Figure 2c.34, see Figures 2.2, 2.4, 2.6, 2.7)

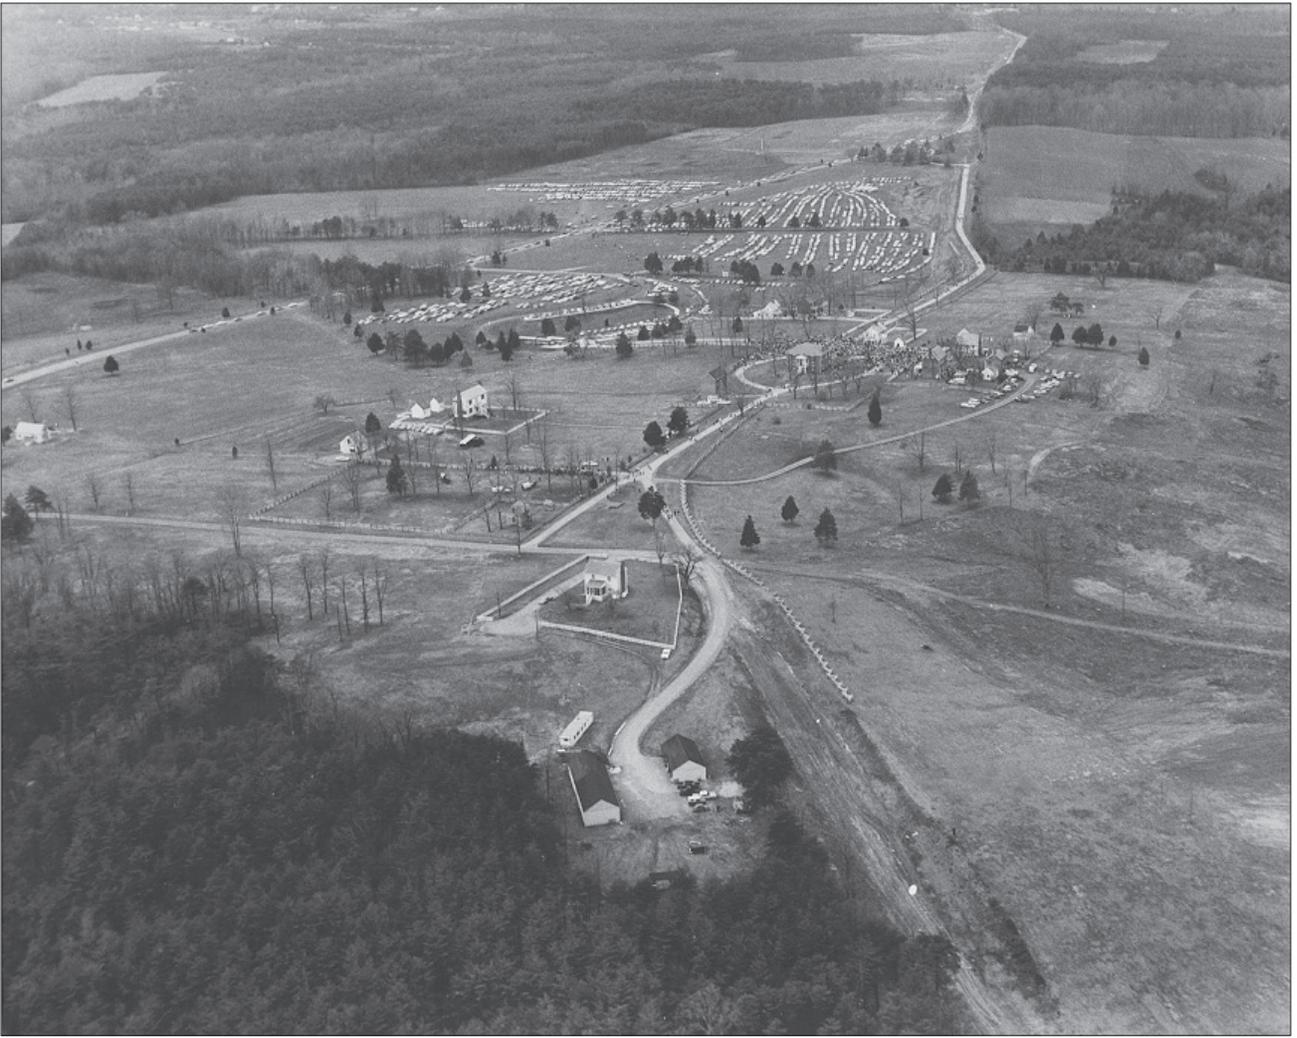
Figure 2.4. Oblique aerial of the village in 1965 during the Civil War Centennial celebration, view looking west-southwest. Photograph by the Virginia State Police. (APCO Archives, #50)

V-2. Plant Missing Historic Trees and Shrubs (Table 2c.2)	
<i>Location</i>	<i>Recommended Treatment</i>
Kelley House and Robinson Cemetery	Plant missing white oak (no#A) near the northeast corner of the building. (Figures 2c.37, 2c.38, see Figures 2.4, 2.6)
	Plant missing white oak (no#B) just east of the building's southeast corner. (Figures 2c.37, 2c.38, see Figures 2.4, 2.6)
	Plant missing honey locust (#264) at the northeast corner of the cemetery. (see Figures 2.4, 2.5, 2.6)
	Plant two missing locusts (#s 244,247) along the west fence line facing Bocock Lane. (Figure 2c.39, see Figures 2.4, 2.5, 2.6)
	Plant missing black locust (no#C) in the far southwest corner of the field. (Figure 2c.39, see Figures 2.4, 2.6)
	Plant missing black locust (#248) along the west fence line facing Bocock Lane, south of the existing Virginia redcedar (#249). (Figures 2c.39, 2c.40)
	Plant missing Virginia redcedar (#273) along the fence facing the Triangle. (see Figures 2.4, 2.6)

Plant two missing black locusts (#s 270,271) in the north part of the field facing the Triangle. (Figure 2c.41, see Figures 2.4, 2.6)
Field between Kelley and Wright Properties	Plant missing black locust (#213) along the east edge of the field, facing Prince Edward Court House Road. (see Figures 2.4 and 2.6)
	Plant missing black locust (no#) along the north edge of the field, facing Isbell Lane. (Figure 2c.42, see Figures 2.4, 2.6)
East Field and Former Union Academy Site	Plant missing black locust (#214) on the east side of Prince Edward Court House Road, northeast of the Kelley House. (Figure 2c.43, see Figures 2.4, 2.6)
Mariah Wright House	Plant missing apple (#195) north of the Mariah Wright House, at the southwest corner of Back Lane and Bocock Lane. (see Figures 2.4, 2.5, 2.6, 2.7)
	Plant missing Virginia redcedar (no#A) in the yard northwest of the house. (Figure 2c.44, see Figure 2.2)

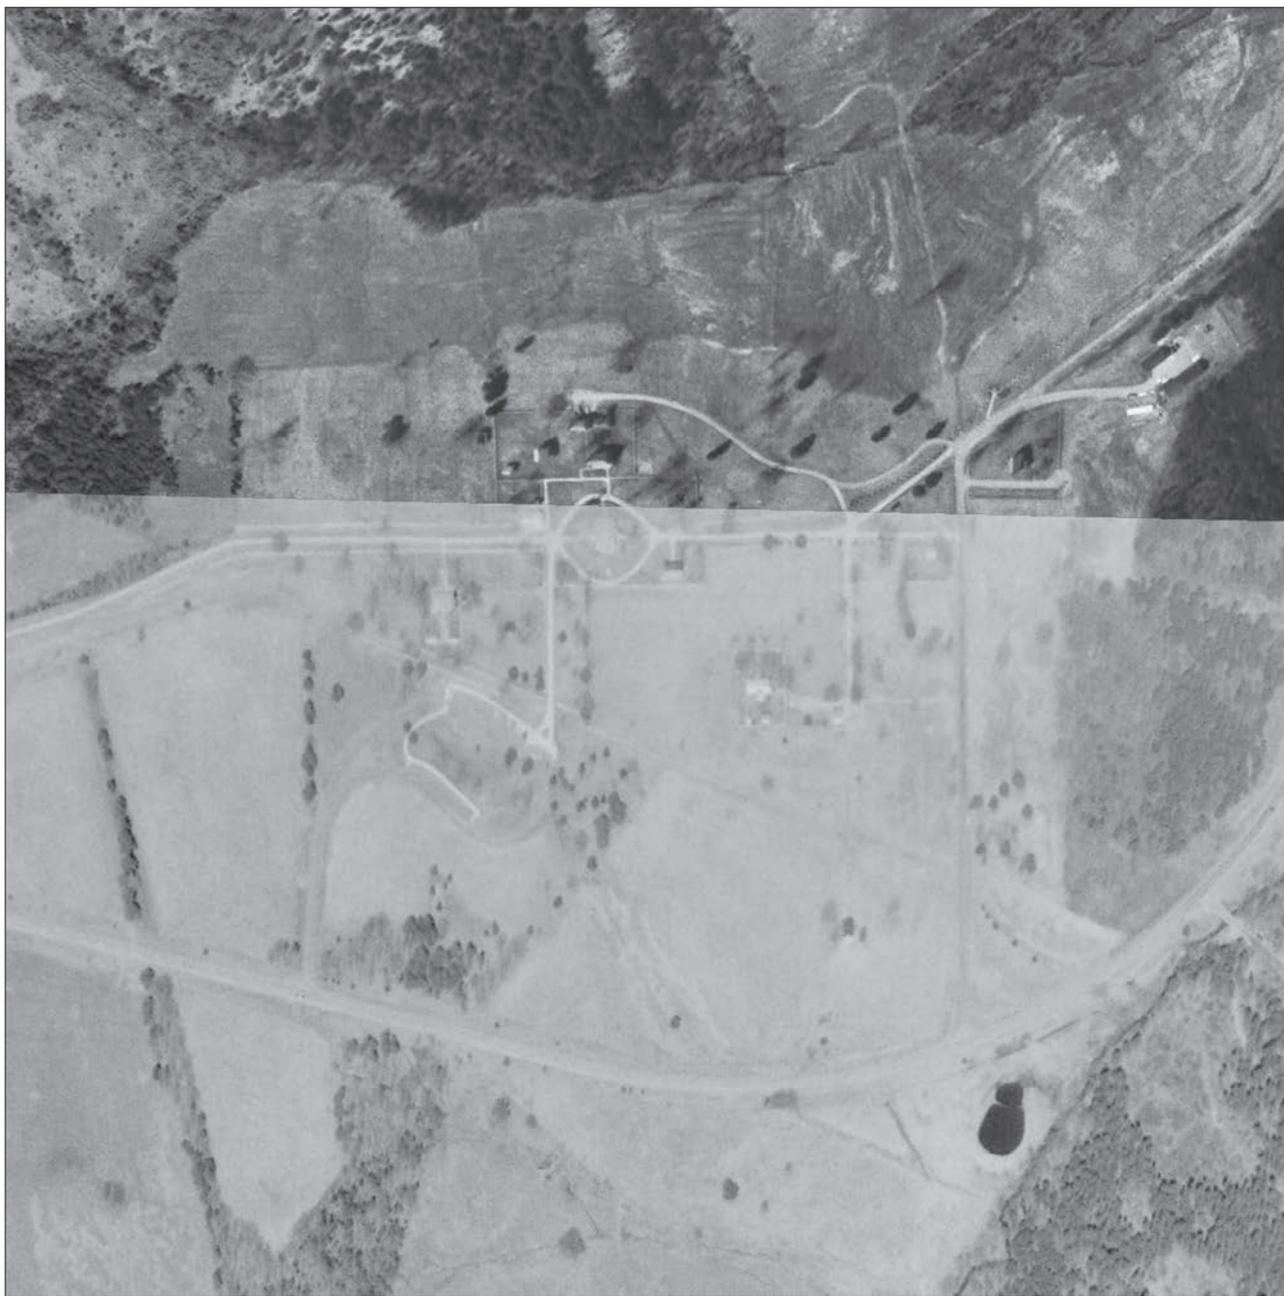
Figure 2.5. Portion of a 1967 aerial of the village. (Historic Aerials by NETR Online, <http://www.historicaerials.com>, accessed 4 April 2015)

Plant two missing black locust (#199,no#B) west-southwest of the house. (Figures 2c.45, 2c.46, see Figures 2.2, 2.5, 2.6)
	Plant missing plum (#201) just south of the house. (Figure 2c.47)

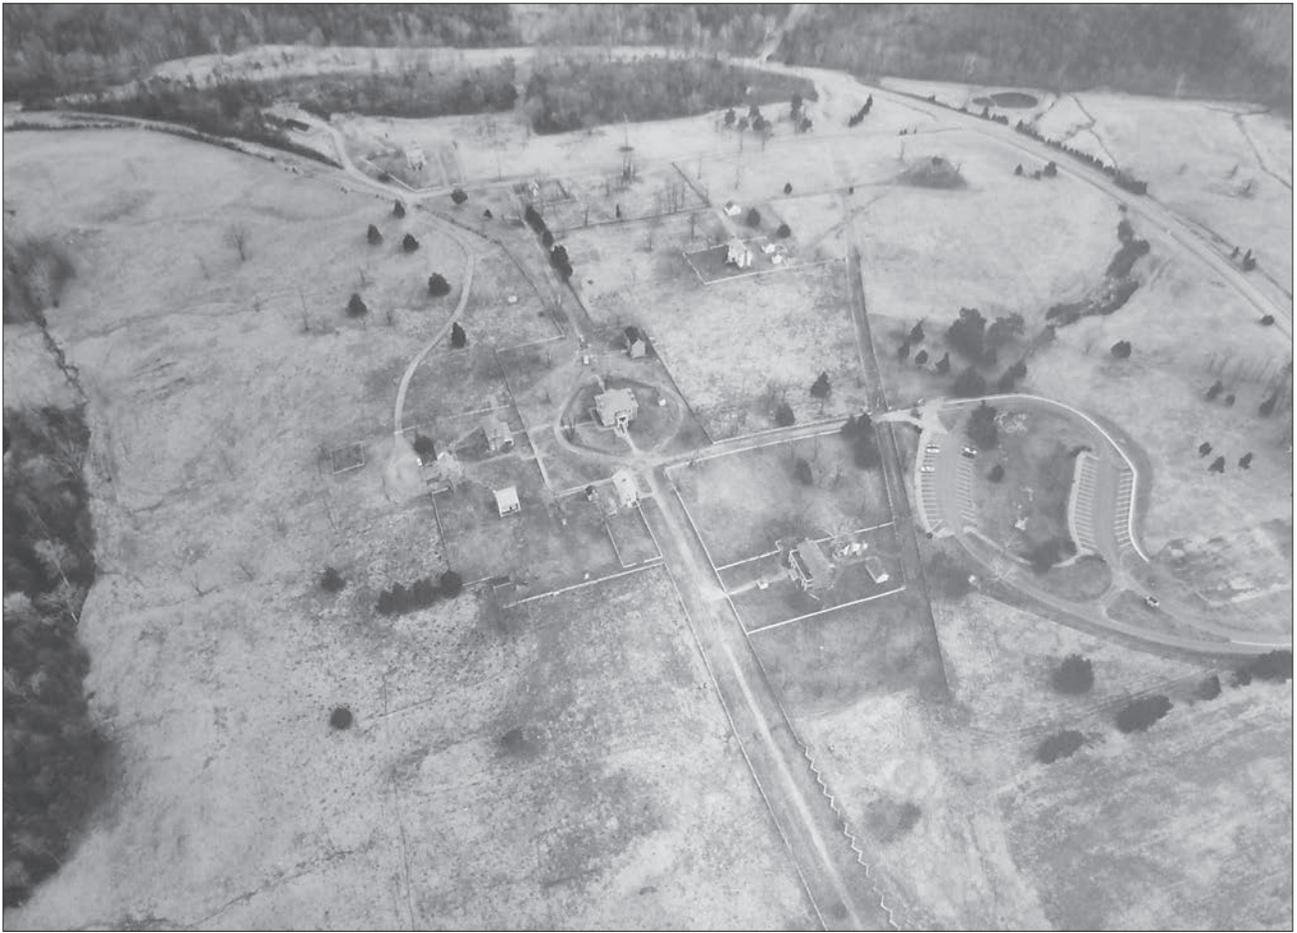
Figure 2.6 (a). Oblique aerial of the village in c.1970 looking east-southeast. (APCO Archives, #11527-792, #11527-793)

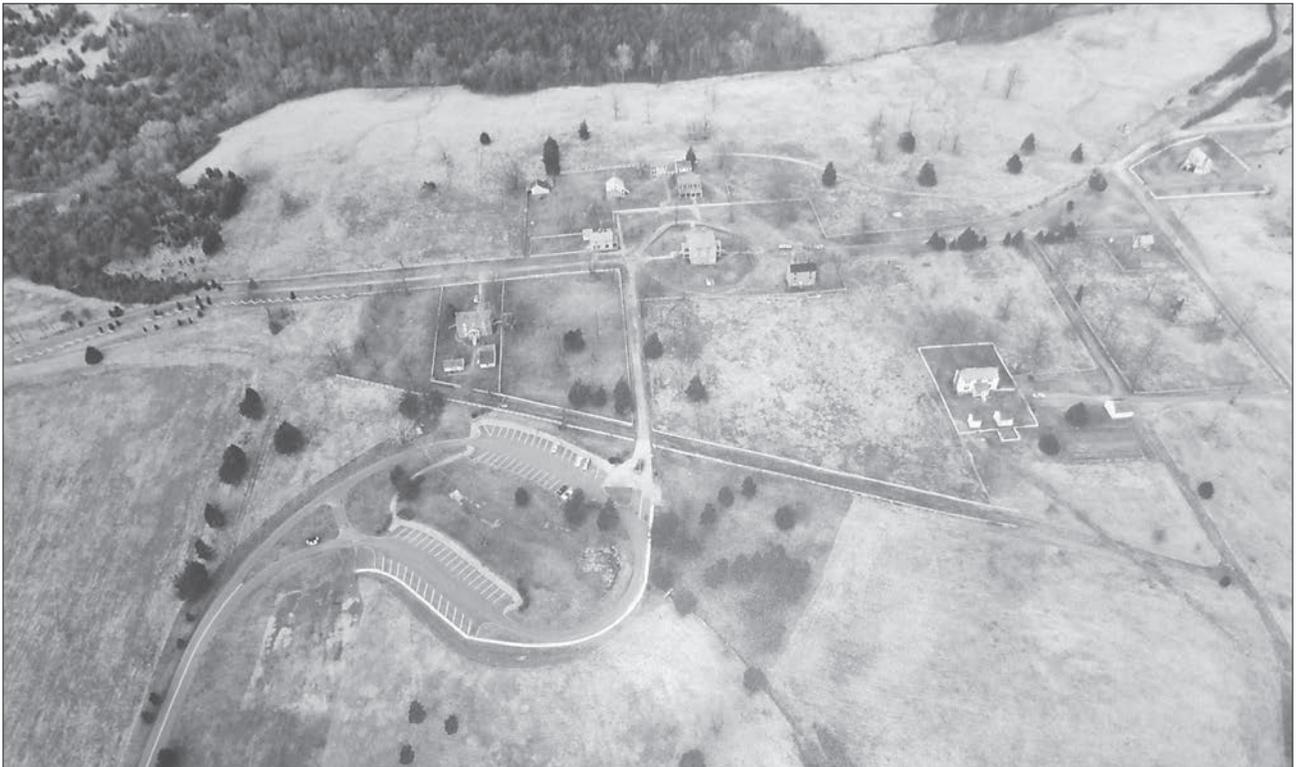
Figure 2.6 (b). Oblique aerial of the village in c.1970 looking north. (APCO Archives, #11527-792, #11527-793)

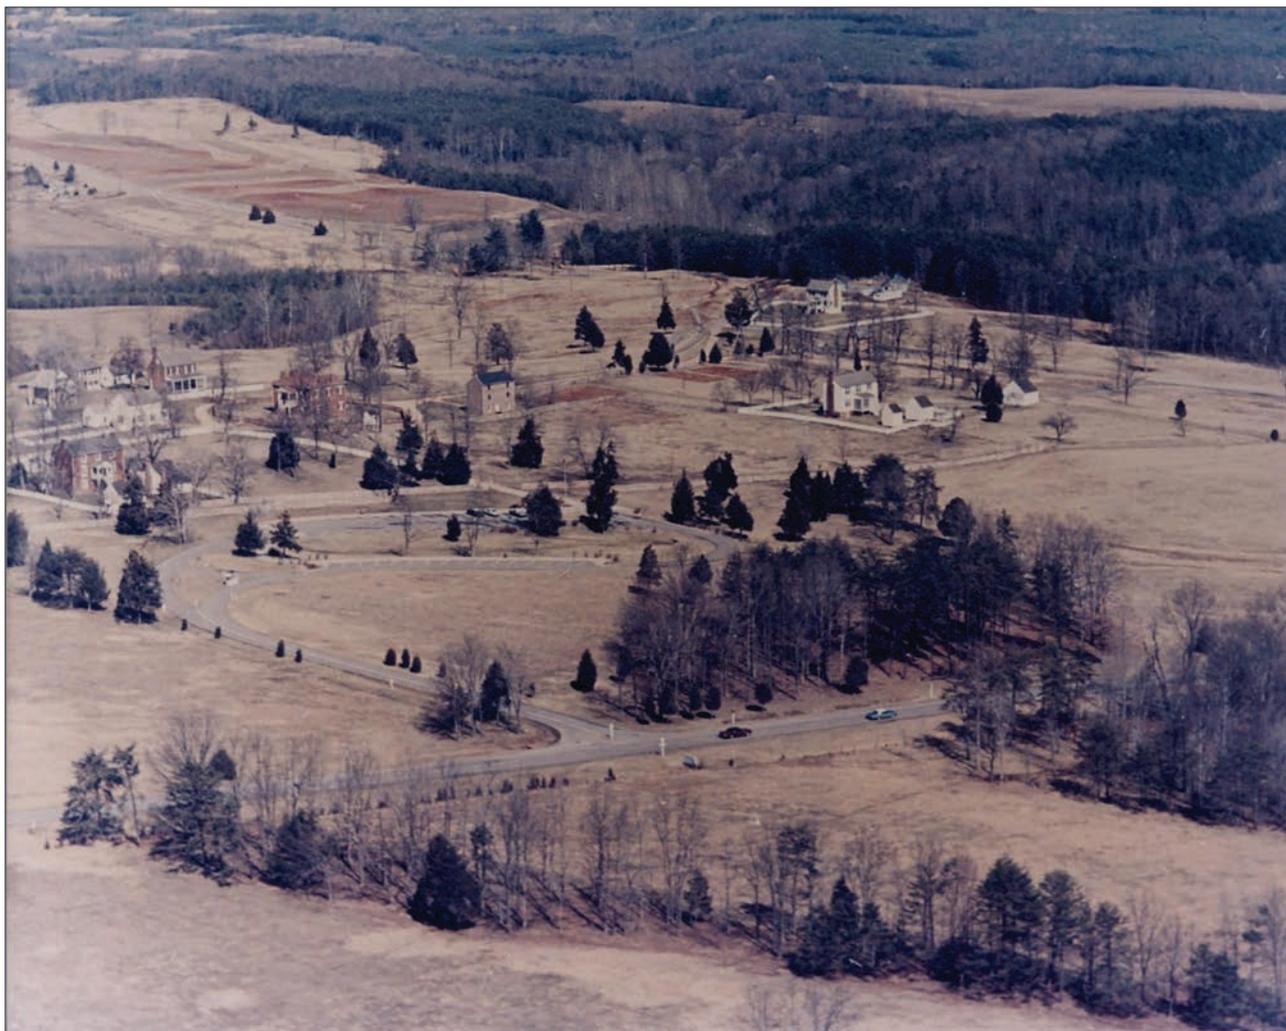
Figure 2.7. Oblique aerial of the village in 1971, view looking northeast. (APCO Archives, #HF-241-A)

Plant missing honey locust (#238) along the Back Lane fence. (Figures 2c.67, 2c.68, see Figures 2.3, 2.6, 2.7)

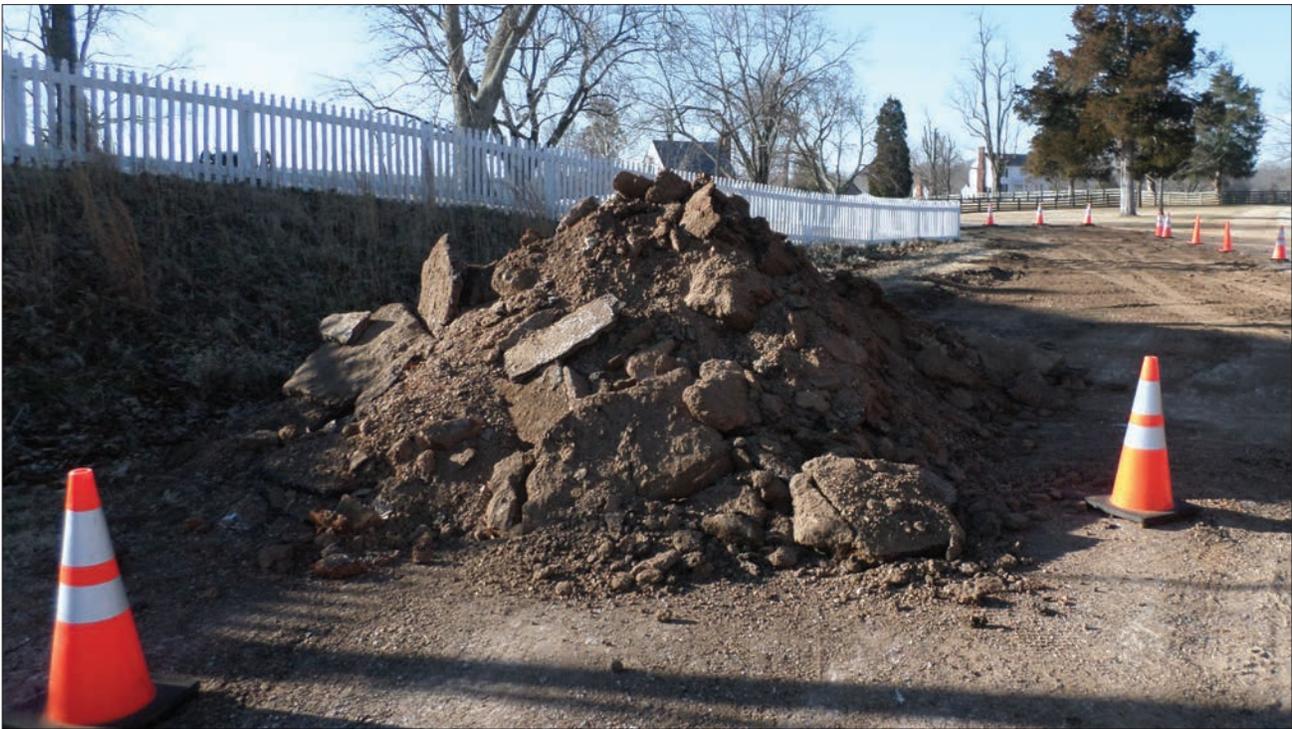
Figure 2a.11. View looking southwest at the recently removed asphalt along the Stage Road. (APCO 2015, SAM_1537)

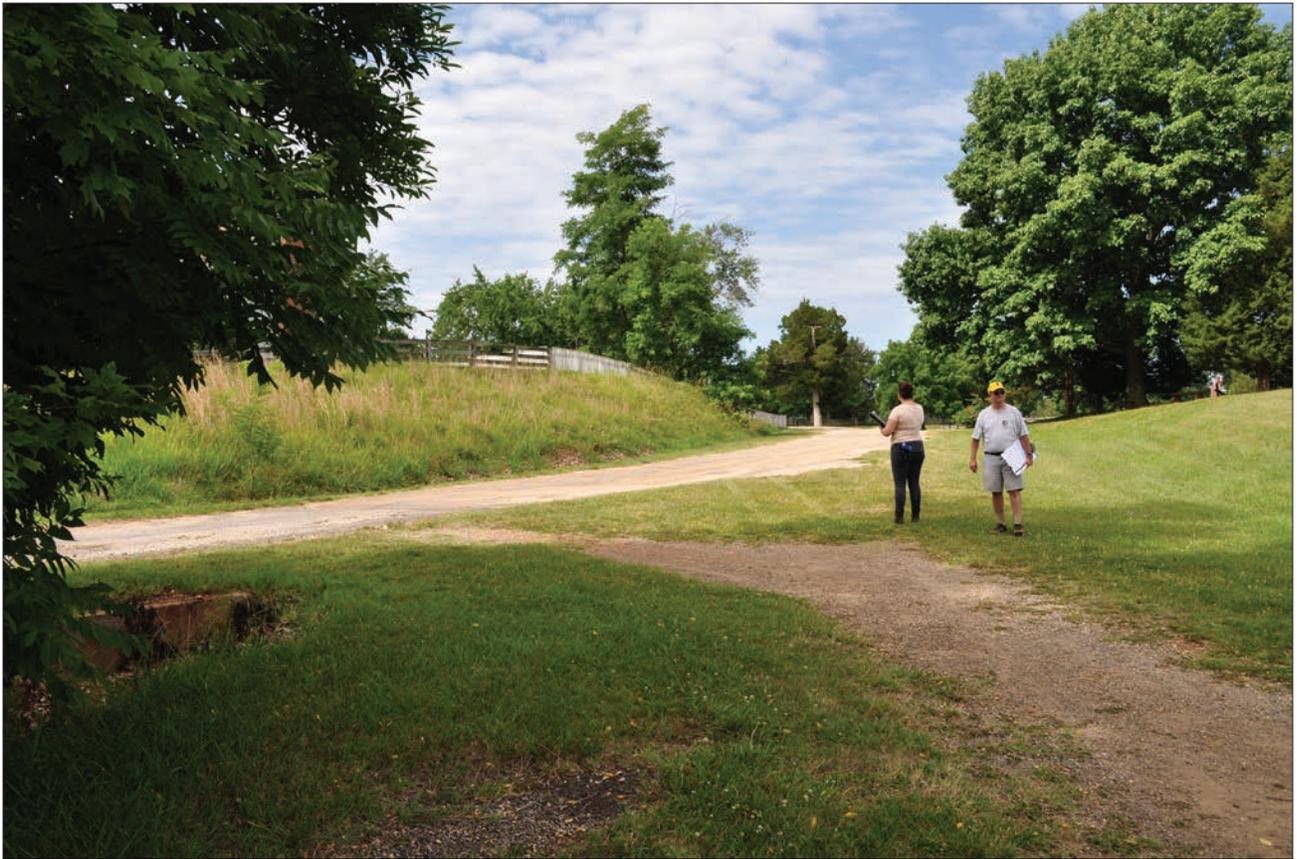
Figure 2a.12. View looking southwest along the Stage Road, from the trace to the paved portion. The Maintenance Access Road (West) and associated culvert are at image left. (OCLP 2014, DSC_1823)

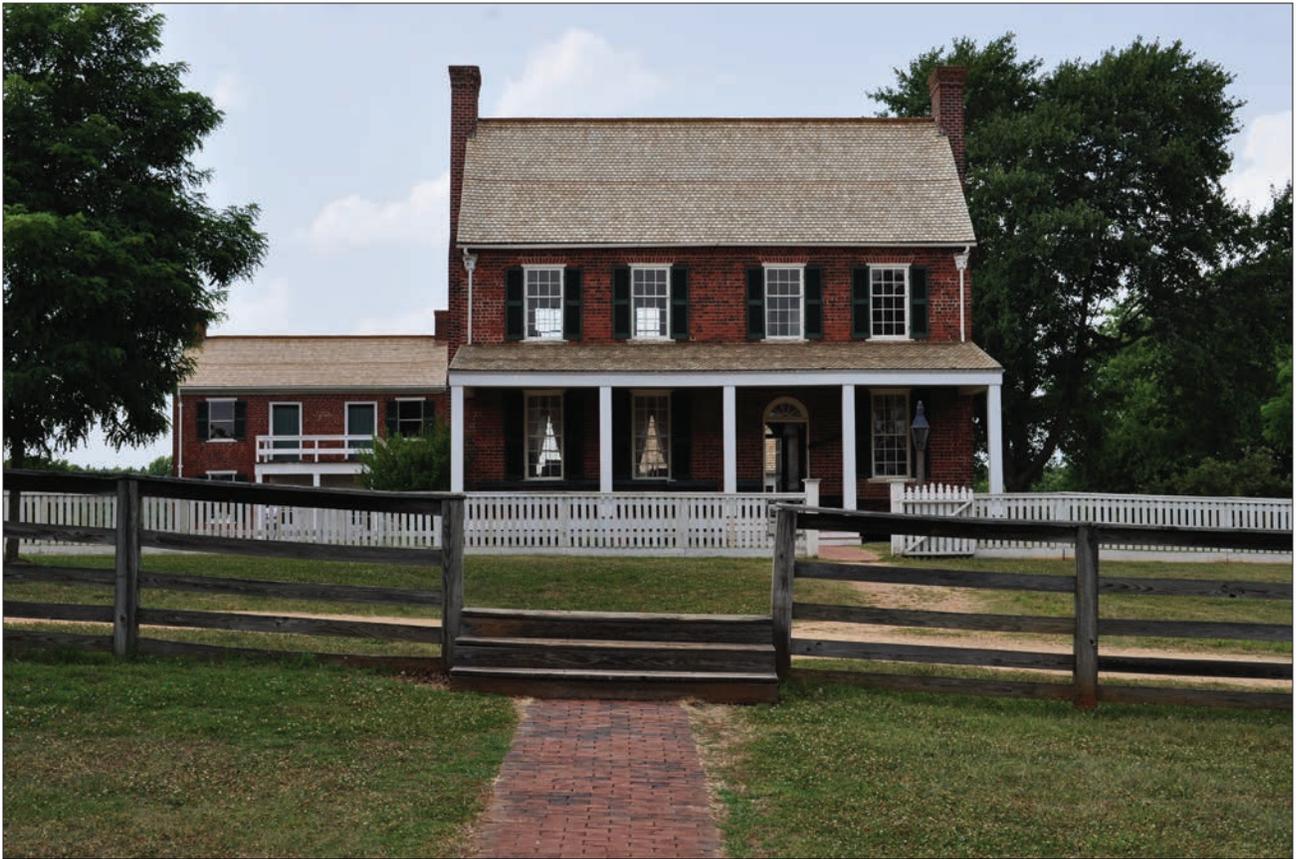
Figure 2a.14. View looking north at brick walks at the Courthouse and Clover Hill Tavern. (OCLP 2014, DSC_2061)

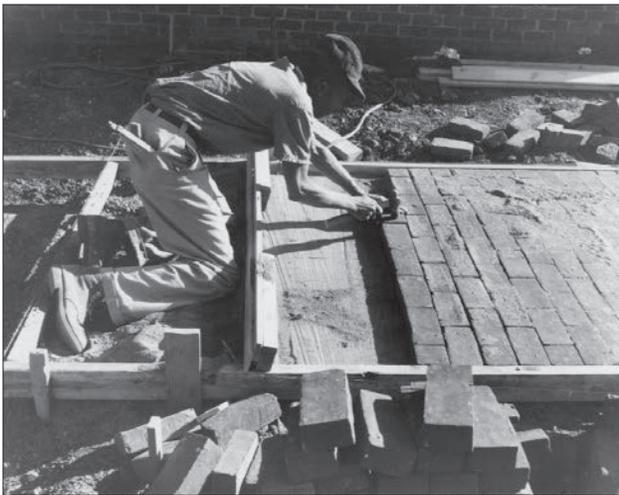
Figure 2a.15. Construction of brick walks, 1964. (APCO Archives, #11486-02 1909)

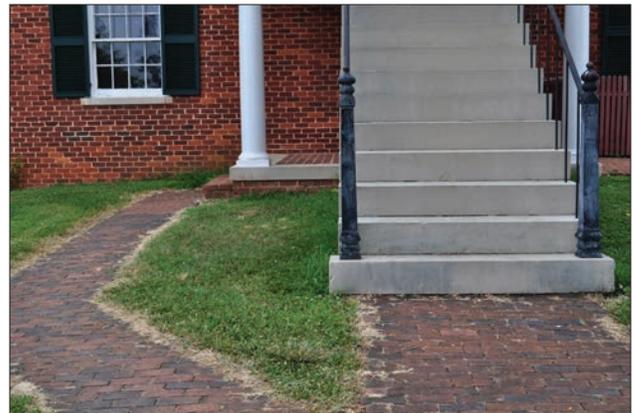
Figure 2a.16. View of a brick walk sections on the east side of the Appomattox Courthouse that are in good condition. (OCLP 2014, DSC_2059).

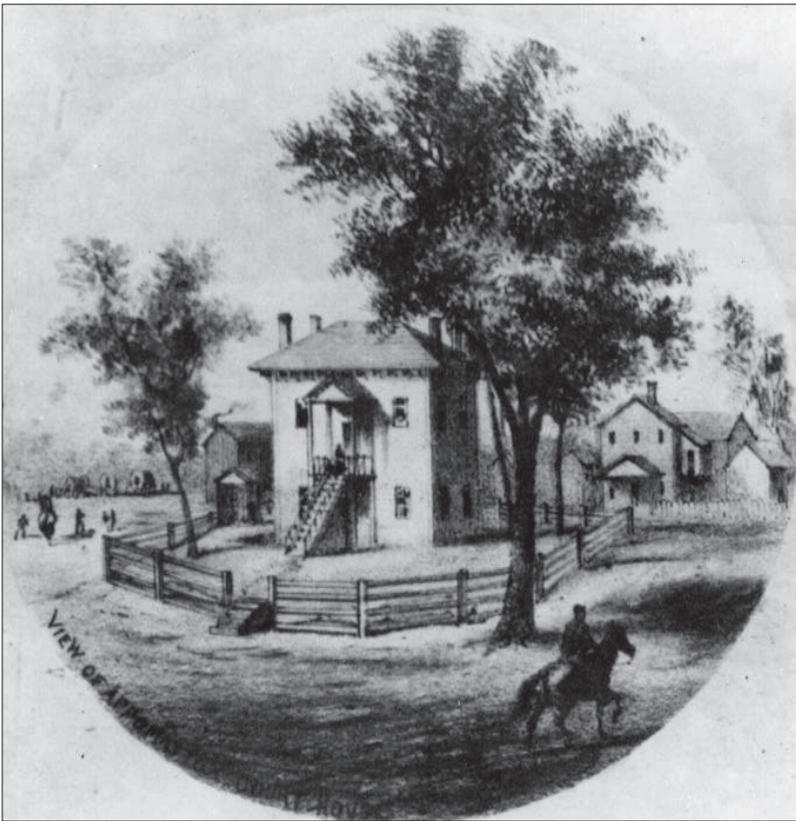
Figure 2a.17. Upper left inset detail in drawing by W. Weber, "Appomattox C.H." showing a path to the Courthouse, c.1865. (APCO Archives, #HF-111-C-01)

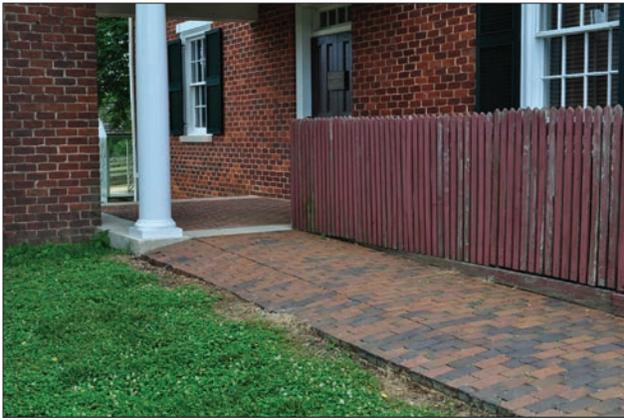
Figure 2a.19. The east part of the brick walk on the east side of the Courthouse should be reset because of the tilt. (OCLP 2014, DSC_2056)

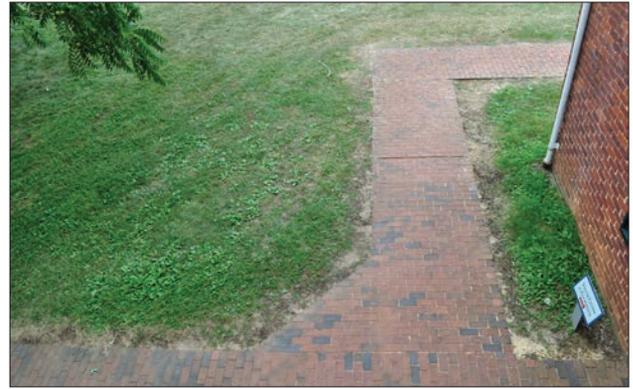
Figure 2a.20. Edges of brick walks on the northwest side of the courthouse should be repaired. (OCLP 2014, DSC_2063)

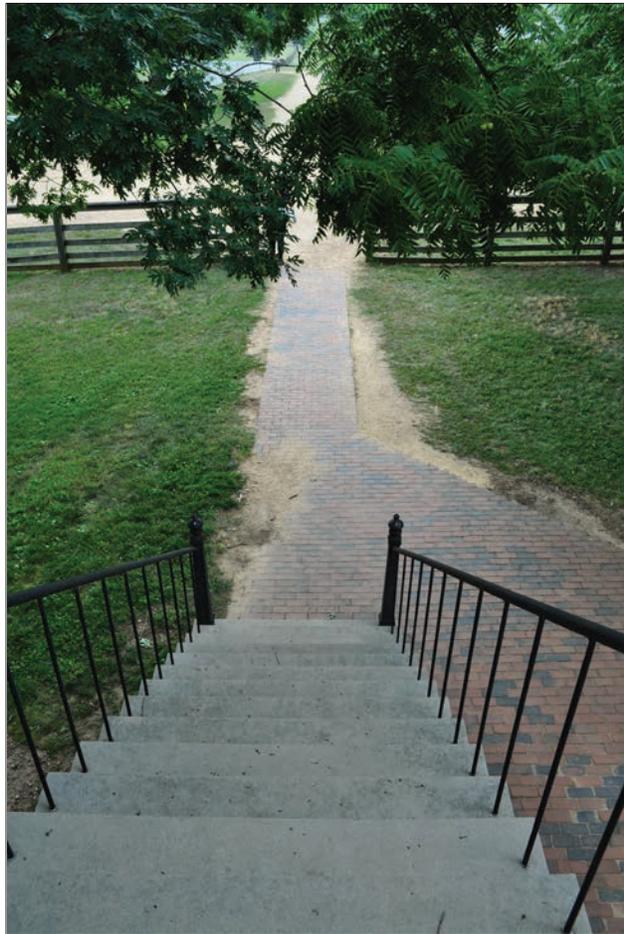
Figure 2a.21. Edges of brick walks on the west side of the courthouse should be repaired. (OCLP 2014, DSC_2064)

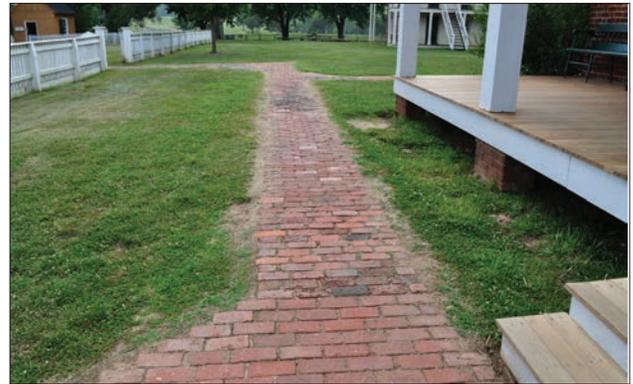
Figure 2a.22. Numerous broken bricks on the south side of the Clover Hill Tavern should be replaced. (OCLP 2014, DSC_2074)

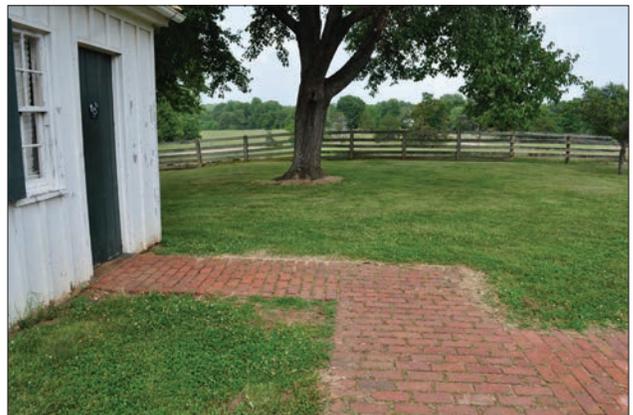
Figure 2a.23. Edges of brick walks at the east door of the Clover Hill Tavern slave quarters should be repaired. (OCLP 2014, DSC_2081)

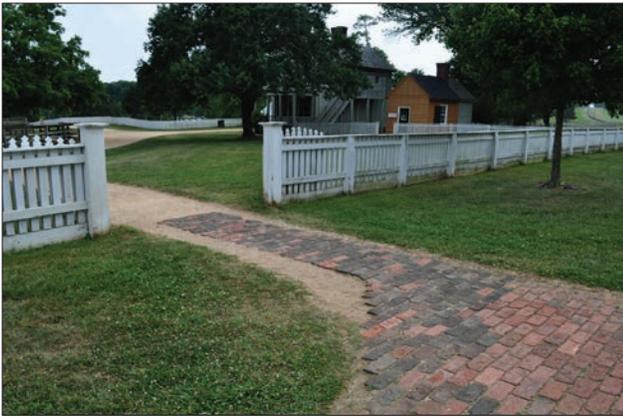
Figure 2a.24. The transition between the brick walk and stone dust path southwest of the Clover Hill Tavern should be repaired. (OCLP 2014: DSC_2076)

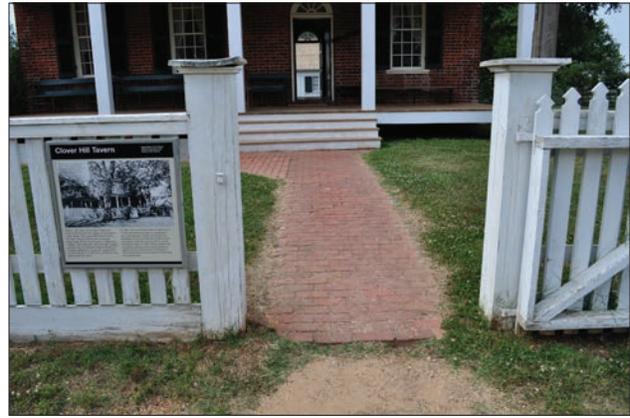
Figure 2a.25. The transition between the brick walk and stone dust path in front of the Clover Hill Tavern should be repaired. (OCLP 2014, DSC_2071)

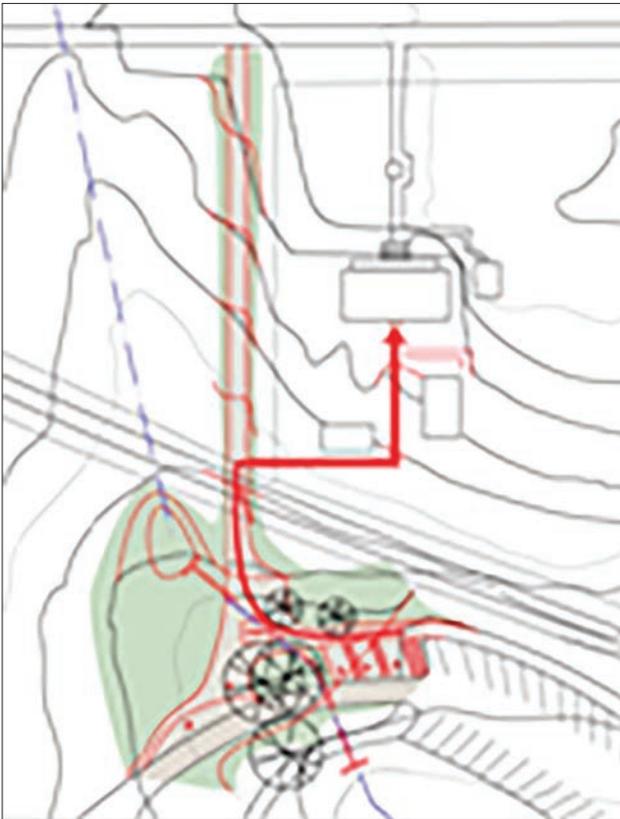
Figure 2a.26. Proposed accessible path (light brown) from the visitor parking lot to the Stage Road and an accessible route directly to the rear of the McLean House (thick red line). (Joanne Hartman Cody, "Self-Evaluation and Transition Plan," 2017: p.6)
