CULTURAL LANDSCAPE REPORT FOR APPOMATTOX COURT HOUSE NATIONAL HISTORICAL PARK

VOLUME II: TREATMENT IMPLEMENTATION PLAN

APPOMATTOX, VIRGINIA

National Park Service, Boston, Massachusetts, 2018

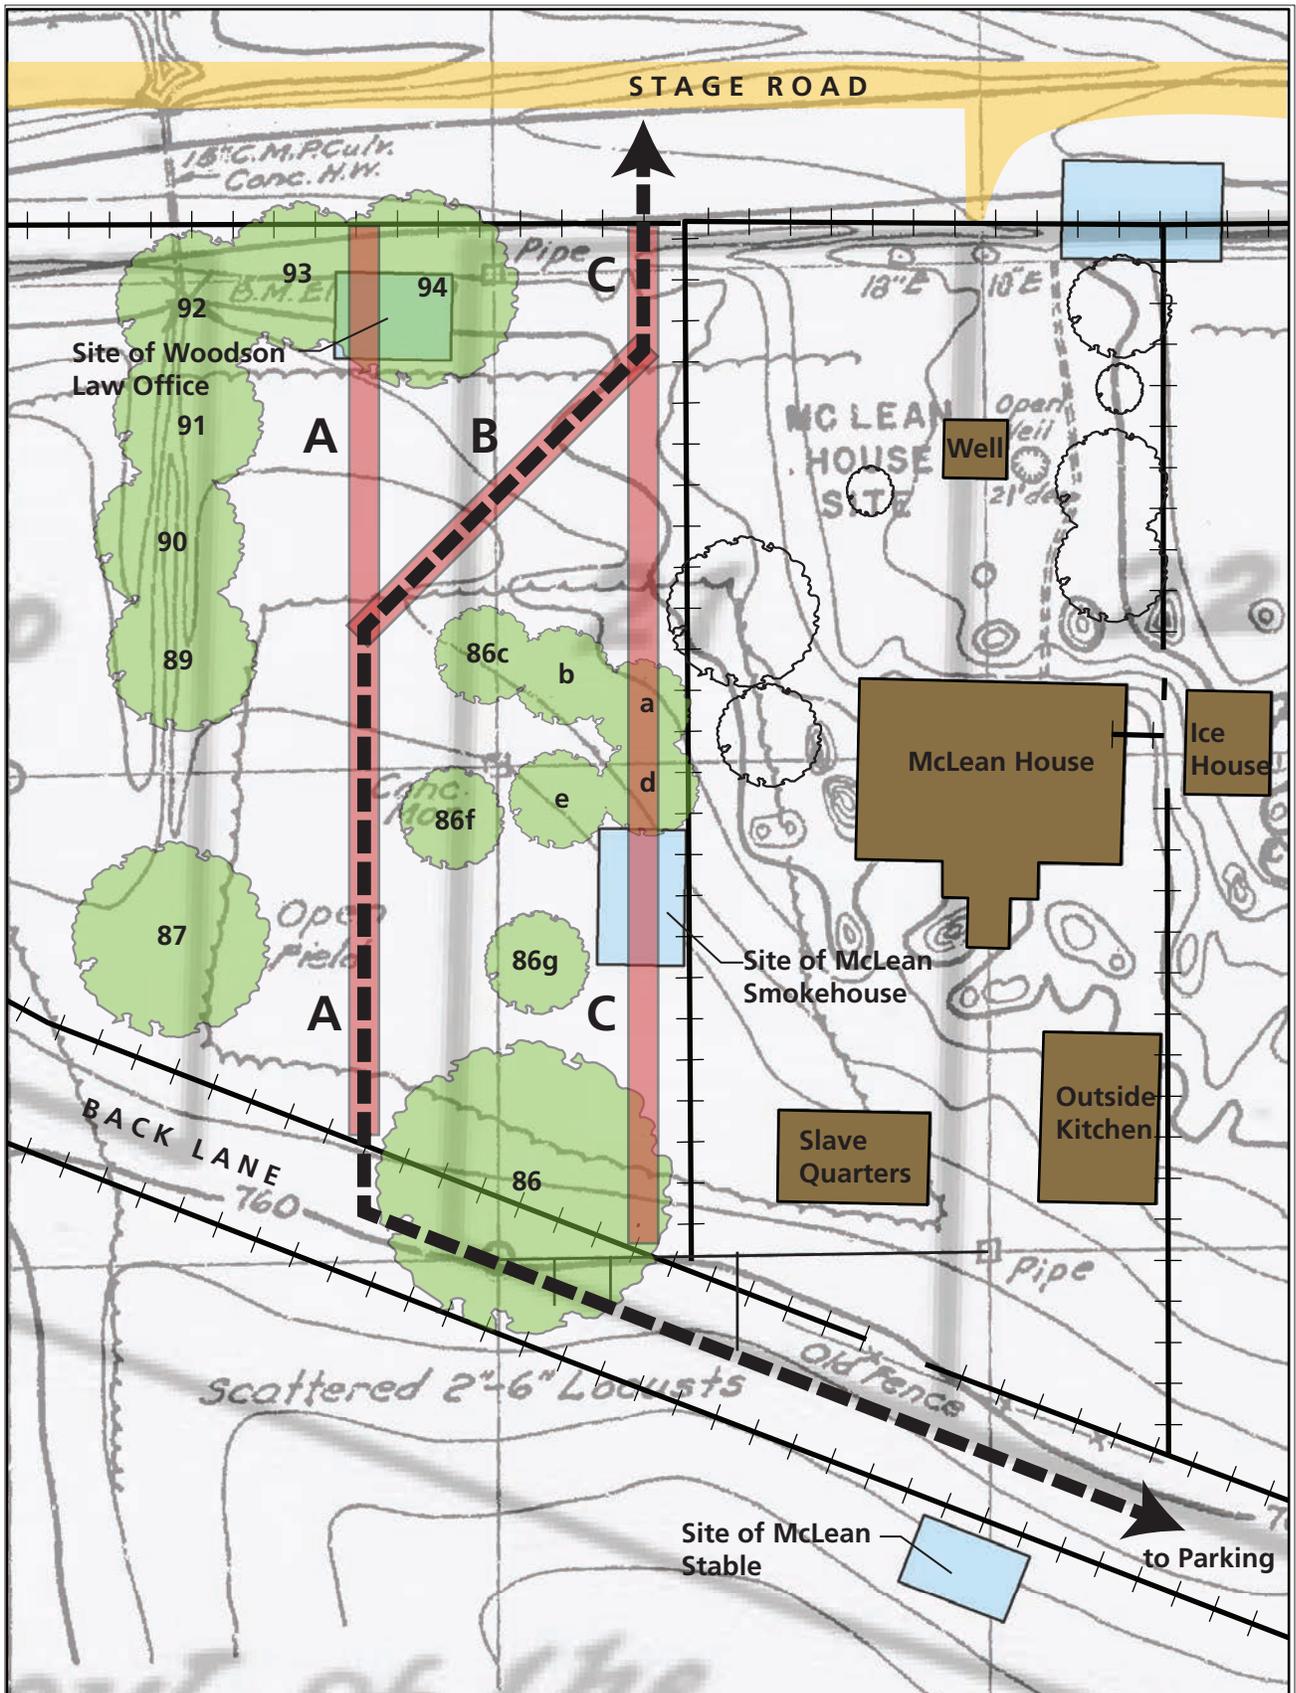
Figure 2a.28. Schematic plan of potential routes (in red) and the preferred route (thick dashed black) for an accessible path in the field west of the McLean House. A topographic map from c.1940 and a map of 1865 lot lines is shown under the following park GIS layers: existing vegetation (green), existing buildings (brown), fence lines (dashed black), and missing buildings (blue). (Annotated by OCLP 2017)

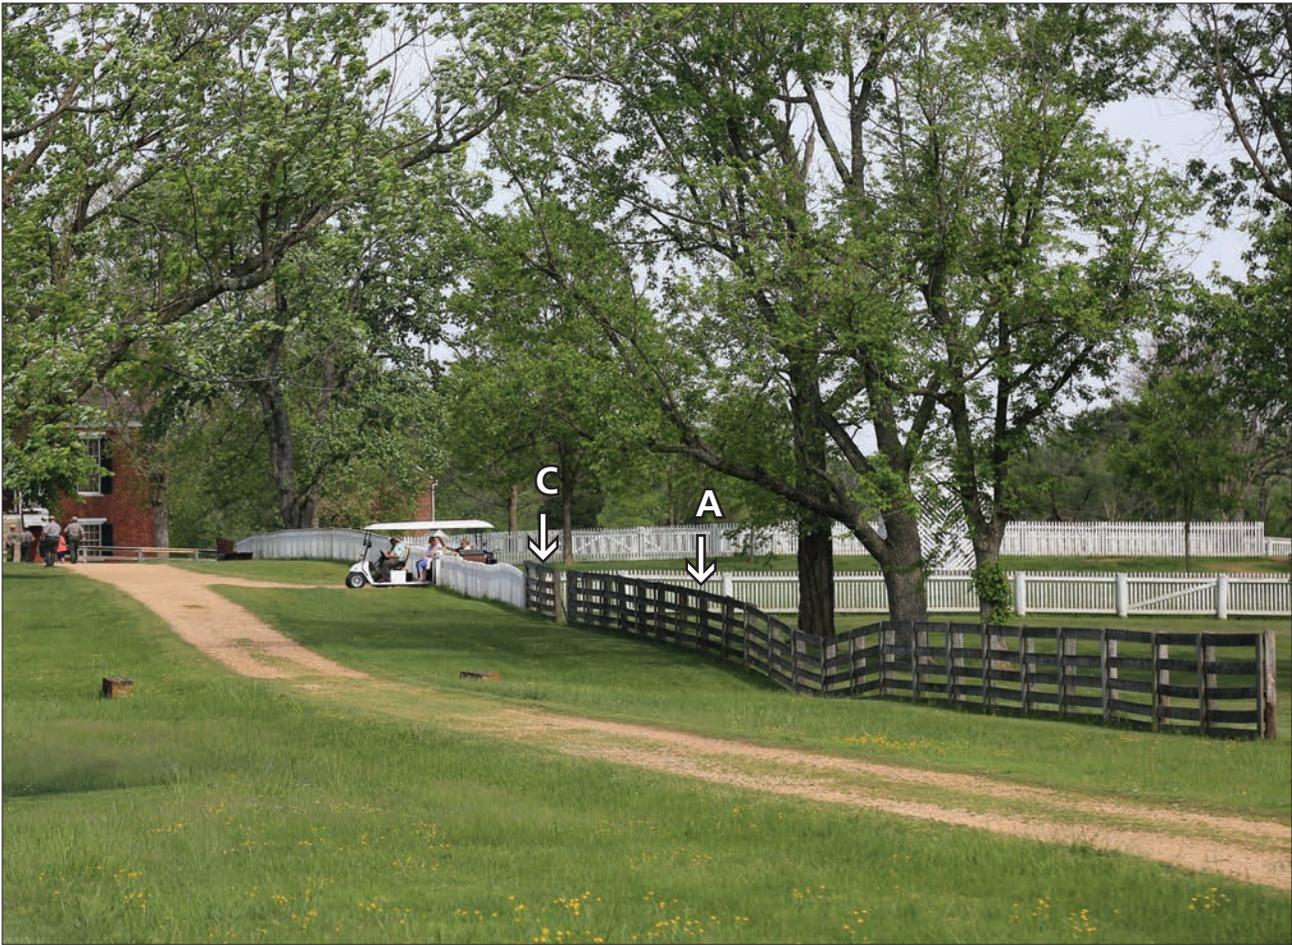
Figure 2a.29. View looking east-southeast at the approximate points where the new path options would intersect the fence along the Stage Road (OCLP 2017, IMG_0799)

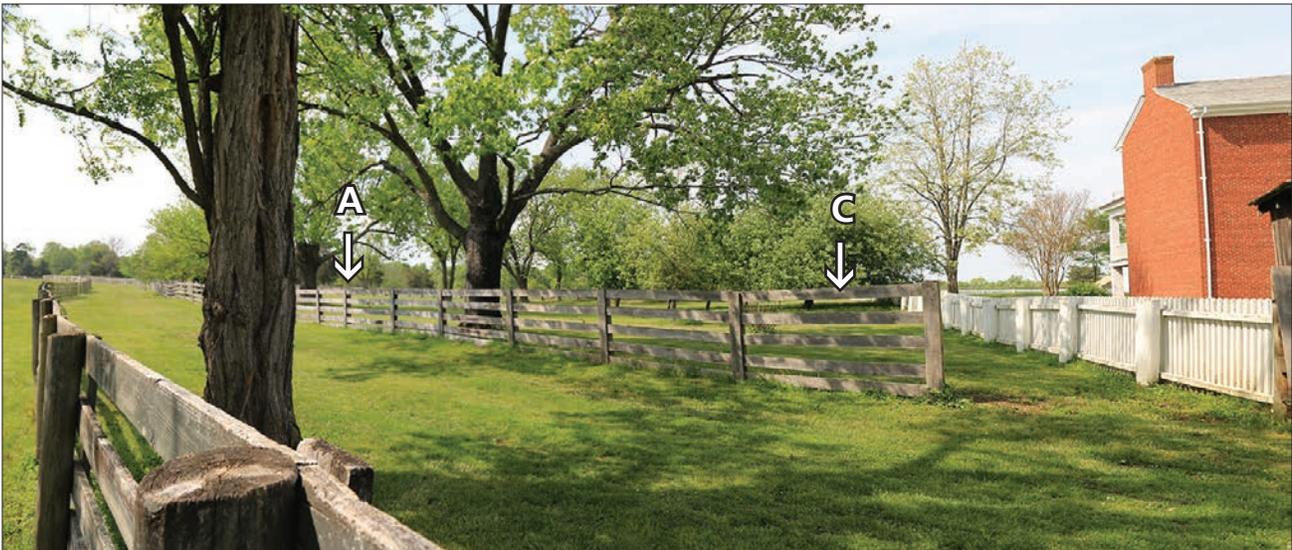
Figure 2a.30. View looking east-southeast at the approximate points where the new path options would intersect the fence along Back Lane. (OCLP 2017, photomerge of IMG_0781 and IMG_0782)

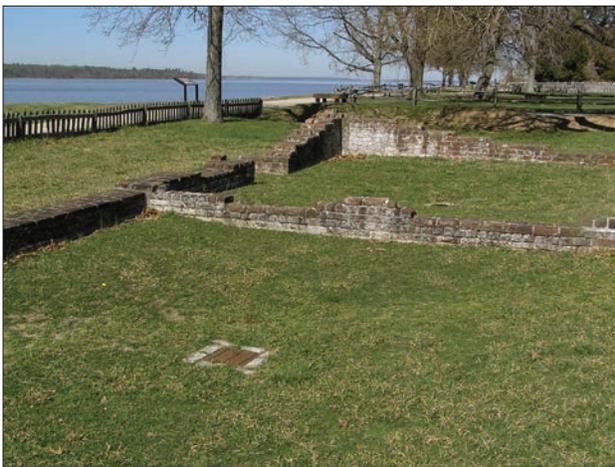
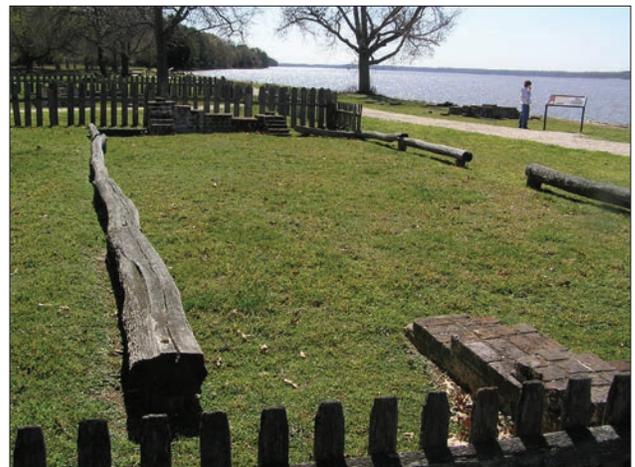
Figure 2b.4. Views of replicated Colonial-era foundations with masonry and logs at Jamestown Island, Colonial National Historical Park. (OCLP 2007, CLI for Jamestown Island Area)

Since the park was established, many of the missing building sites in and beyond the village core have undergone some level archeological field work or archival research. However, the level of investigation and subsequent findings have varied considerably, and in many cases the reports produced for those projects have recommended additional research. The assumption of this project is that the park will evaluate the quality of existing information and decide if additional research will be undertaken to inform the selection of an appropriate method of interpretation for a missing building or structure. Methods of interpretation may include: depiction of buildings and structures in brochures, electronic media, or waysides; physically marking building corners and foundation footprints using masonry, wood posts, or plant material; constructing ghost structure when the overall dimensions, roofline, and massing of a missing building or structure are known; or reconstructing the building entirely if there is sufficient documentation (Figures 2b.3, 2b.4, 2b.5, 2b.6).

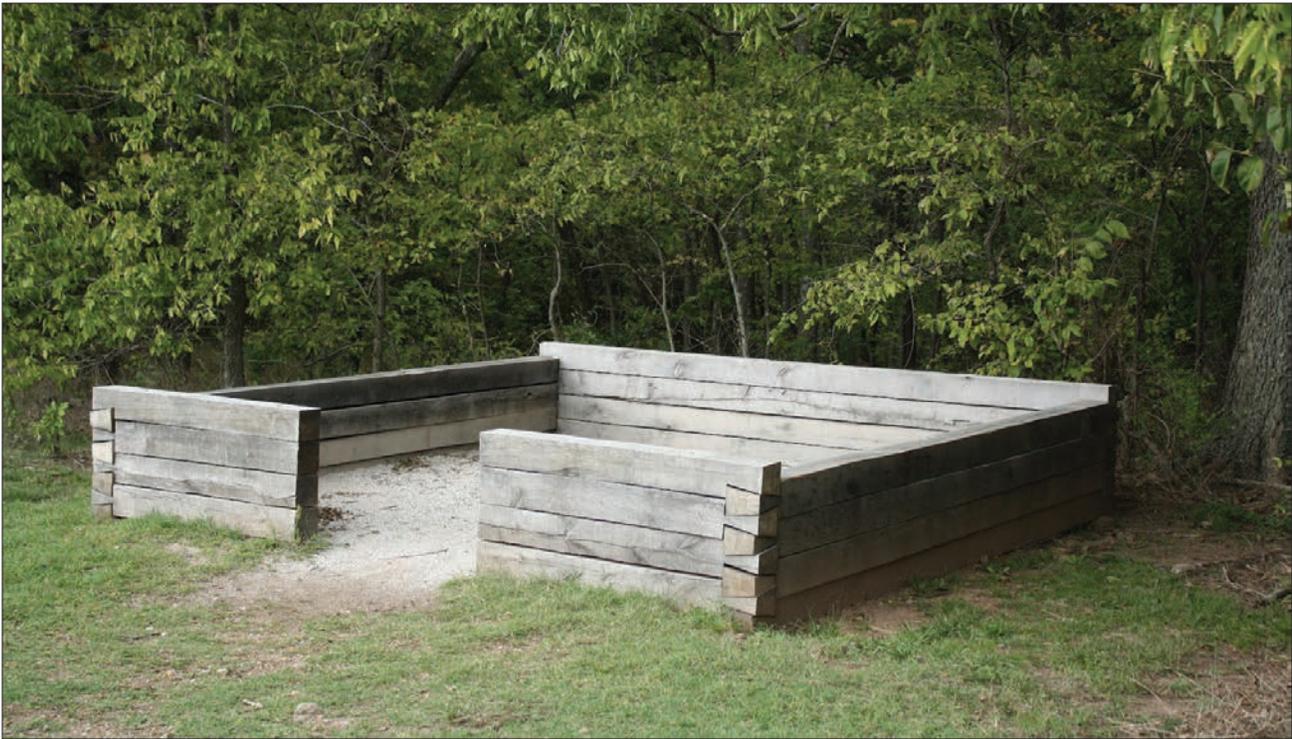
Figure 2b.5. Half timber structure at George Washington Carver National Monument. (OCLP 2014, IMG_5052)

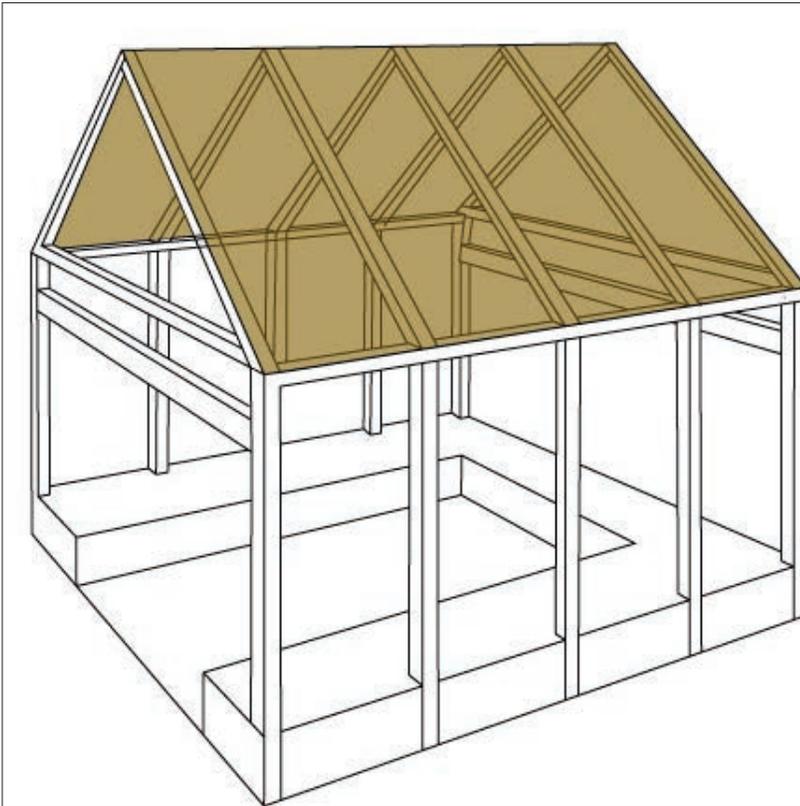
Figure 2b.6. Conceptual drawing of an open "ghost structure" to represent former locations of settlements at Saratoga National Historical Park. The ghost structures will be inspired by 18th-century vernacular architecture and include roofs and seating. (OCLP 2010, SARA-GhostStructure)

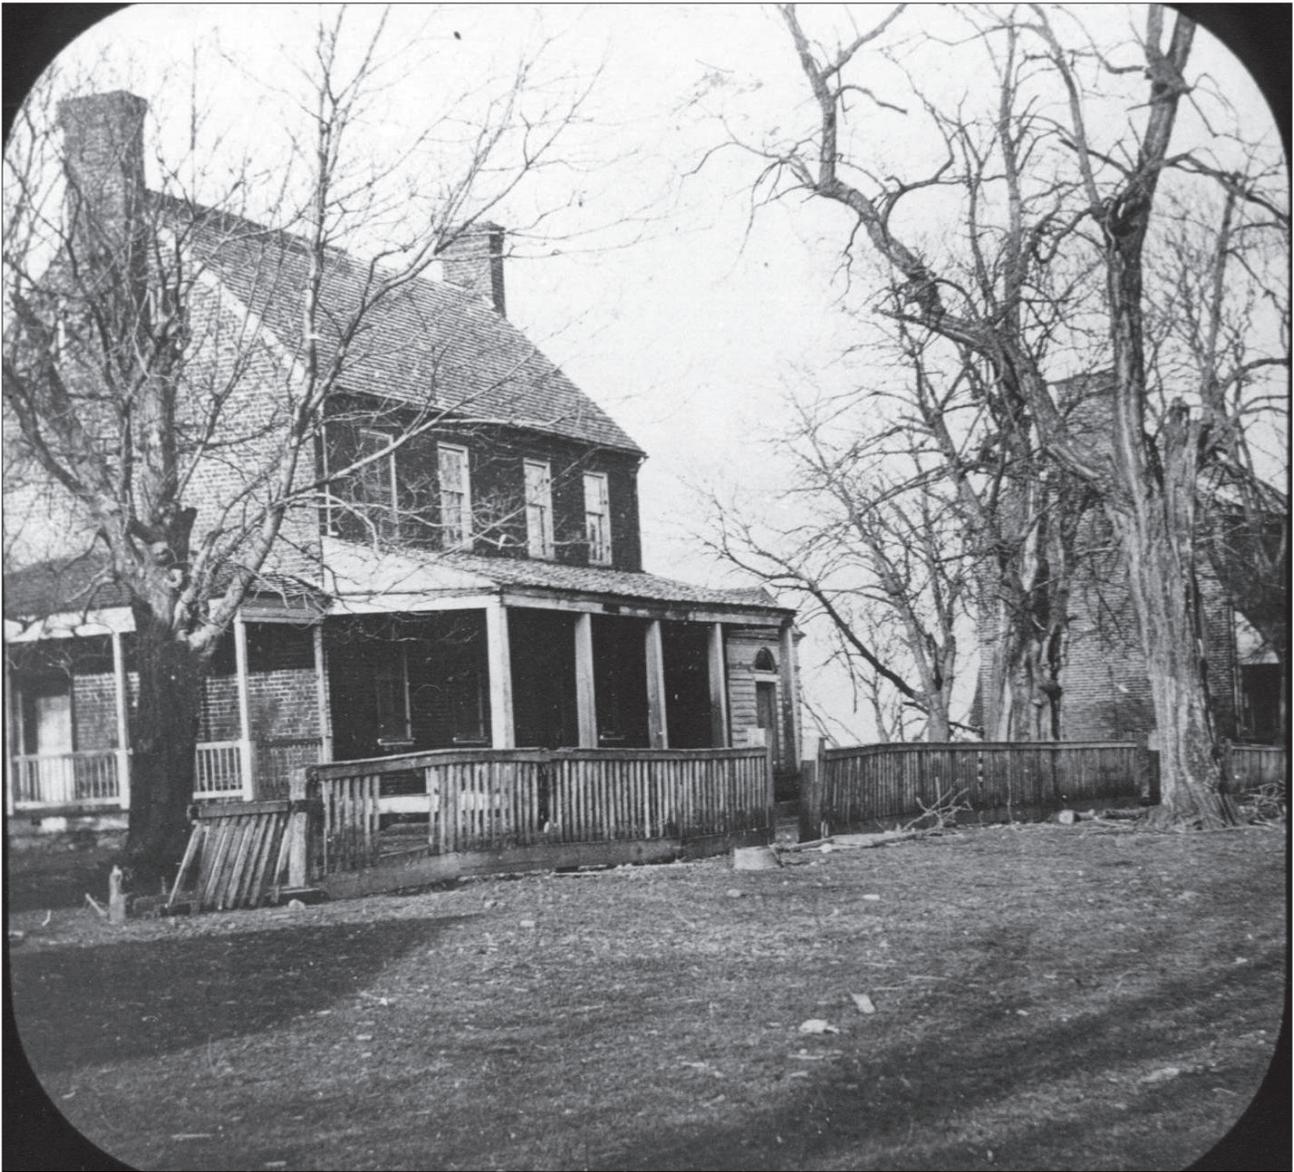
Figure 2b.17. View looking northeast at the Clover Hill Tavern, c.1892. The dining room addition at left has been replaced by a covered porch, and the bar room is at right. The west side of the brick Robertson-Glover Store is visible in the background at image right. (APCO Archives, #HF-074-03)

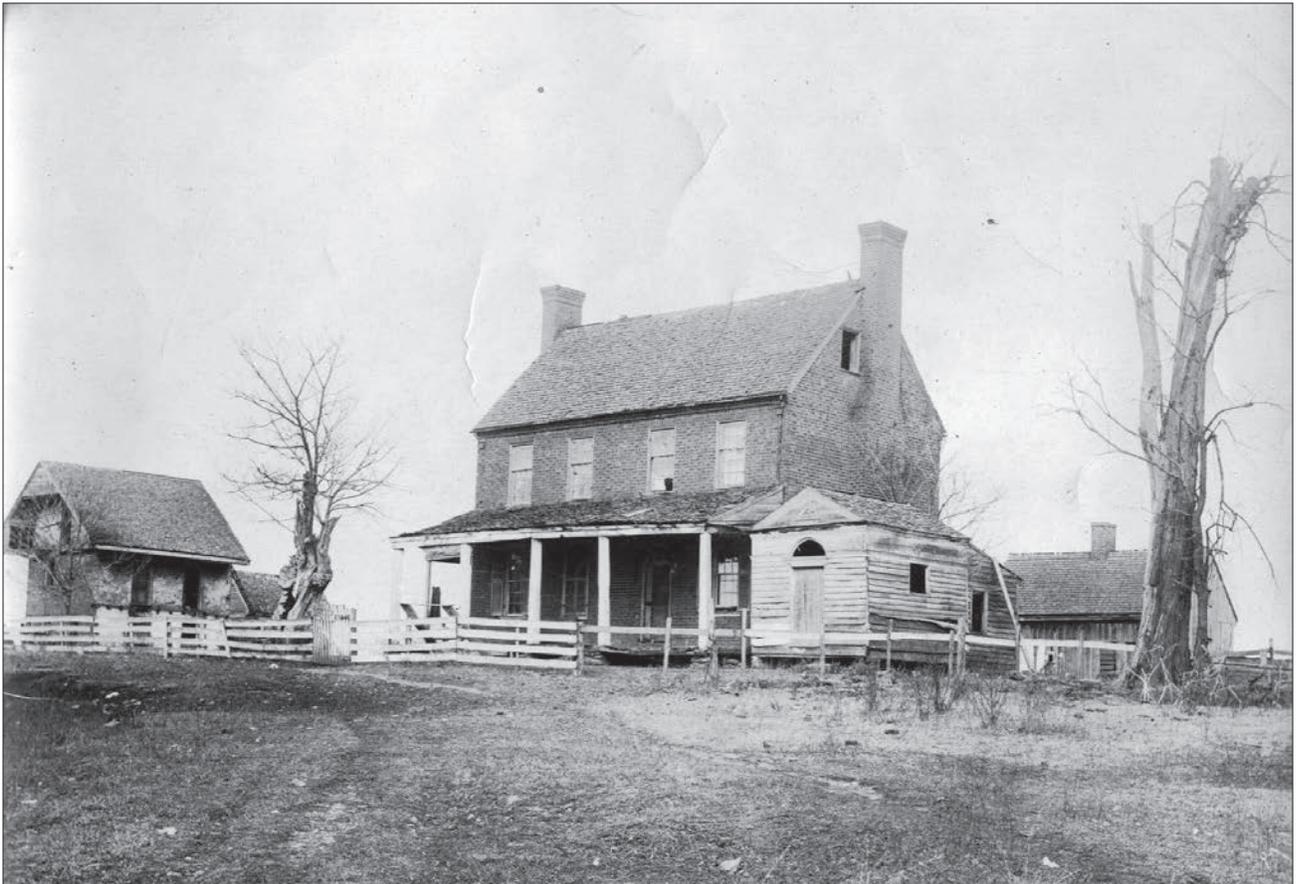
Figure 2b.18. View looking northwest at the Clover Hill Tavern, c.1913. The bar room is visible on the right side of the house but the dining addition has been replaced by a porch. In the background at image left is the Clover Hill guest house, to the right of which may be the roof of the Clover Hill smoke house. (APCO Archives, #HF-054-01)

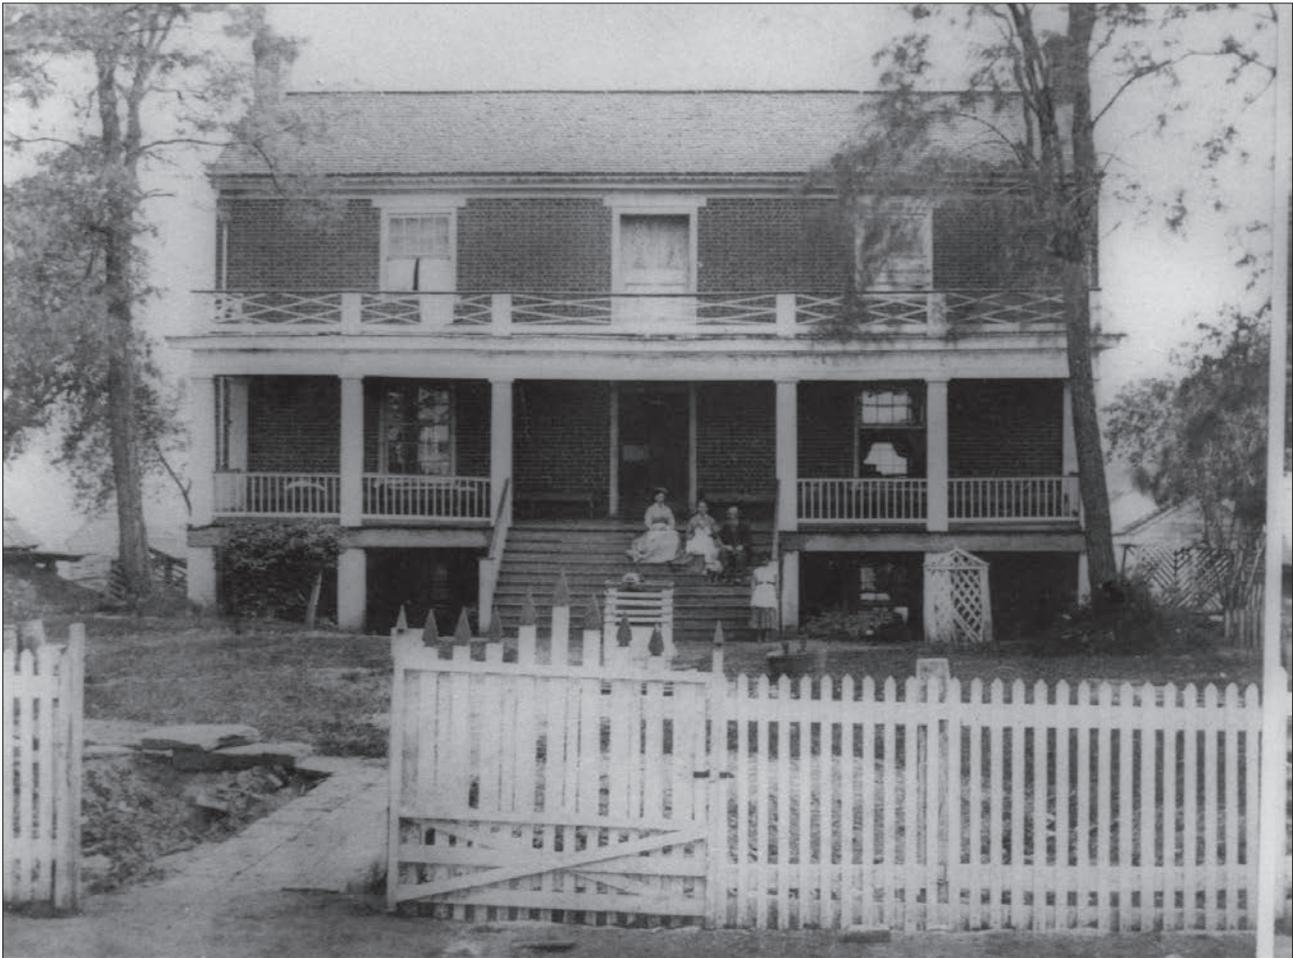
Figure 2b.35. View looking south at the McLean House in c.1865-70. The roofline of the smoke house is in the background at far image right, and part of the foundation of the Old Raine Store is visible in the foreground behind the gate. (APCO Archives, #HF-153-A-01)

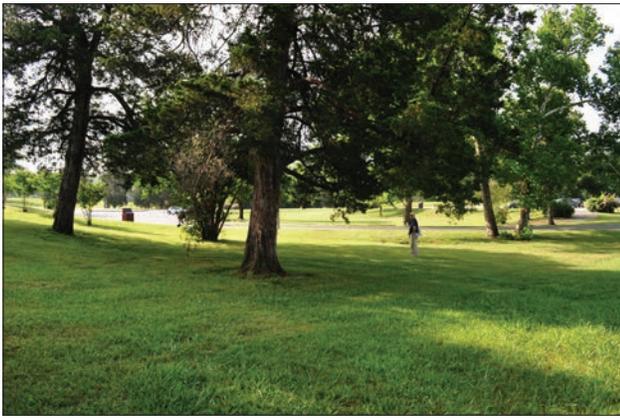
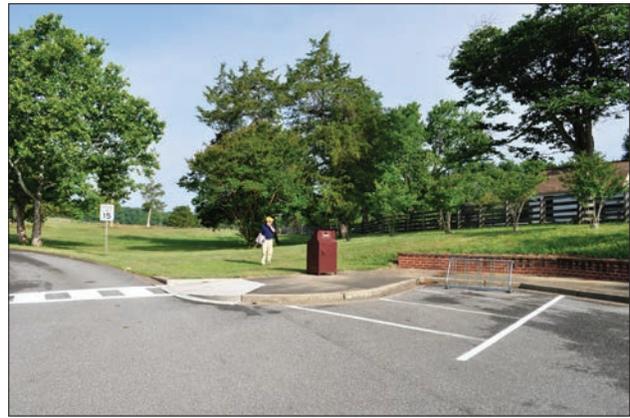
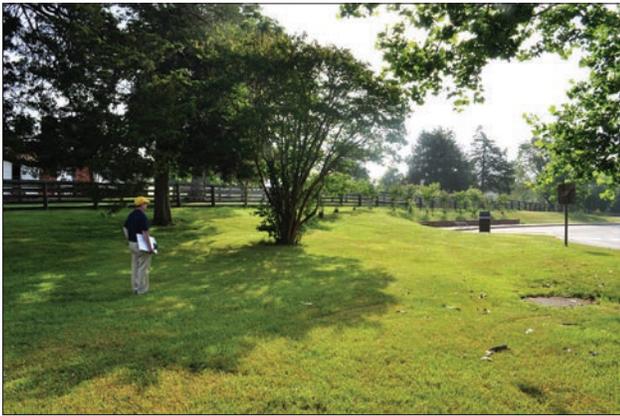
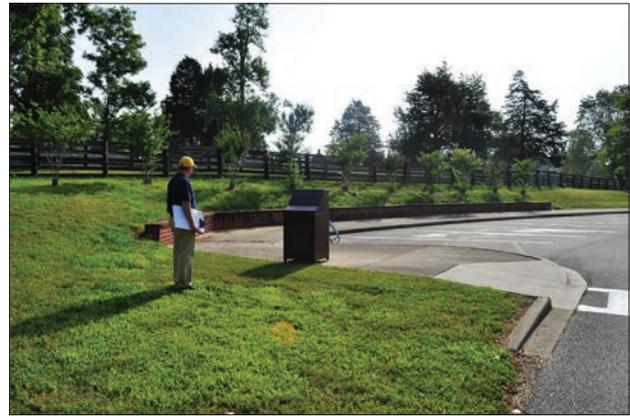
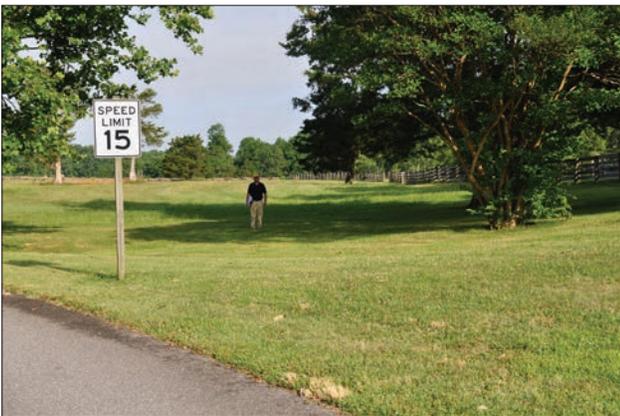
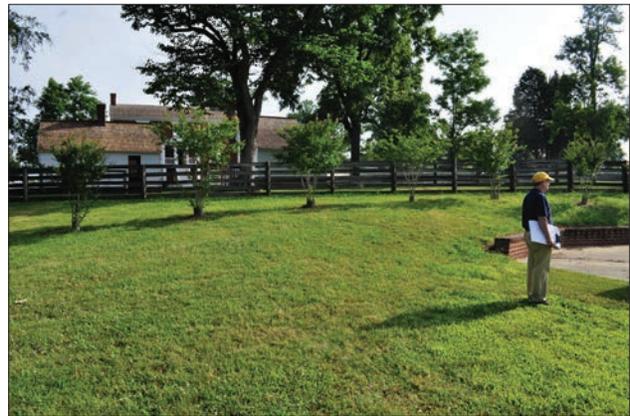
Figure 2b.39. Views of the potential location of a comfort station at the west side of the visitor parking lot. (OCLP 2014, DSC_2134, 2137, 2147)

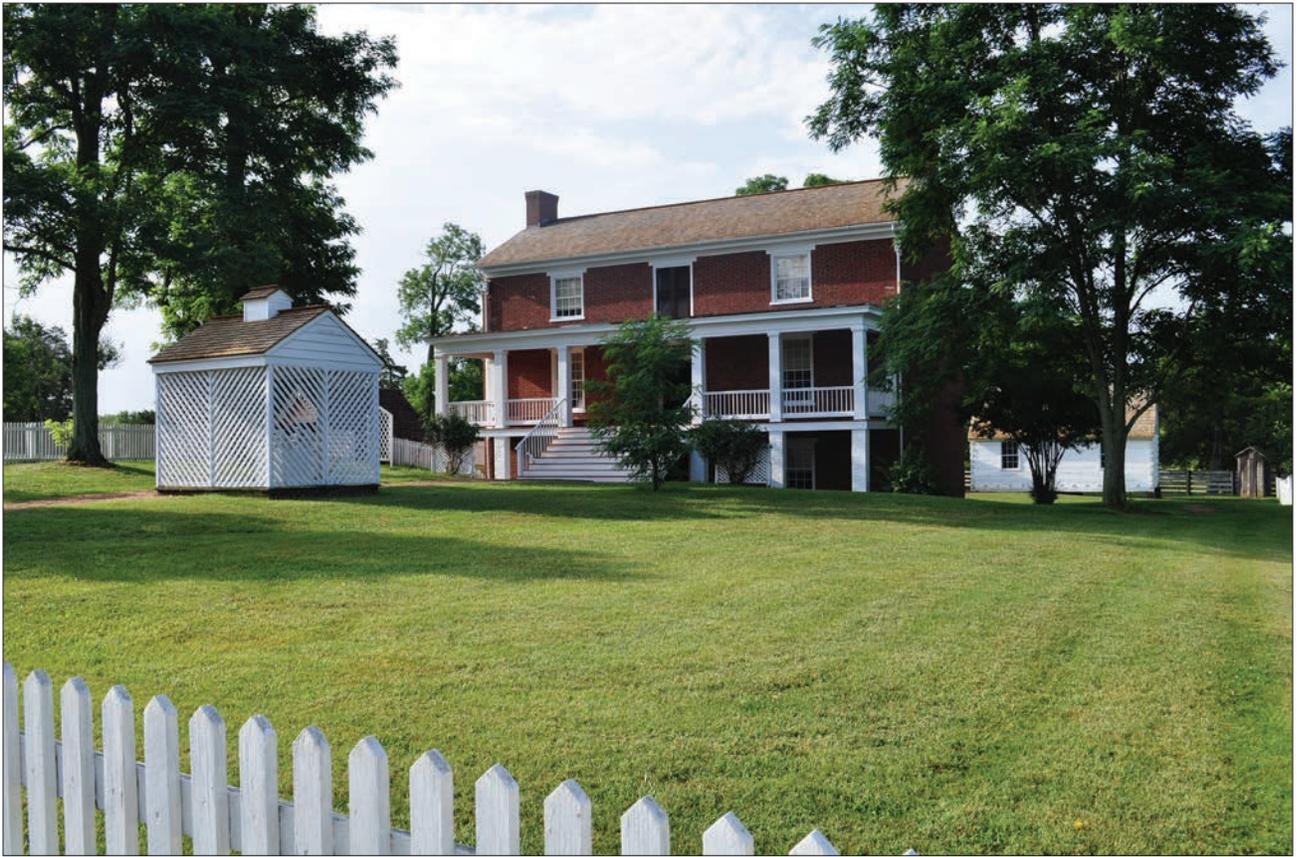
Figure 2c.1. View looking southeast at the McLean House. The historic row of locust trees east of the well has been replanted, but the small locust tree between the well and the house is not historic. There are also several missing trees. (OCLP 2014, DSC_2127)

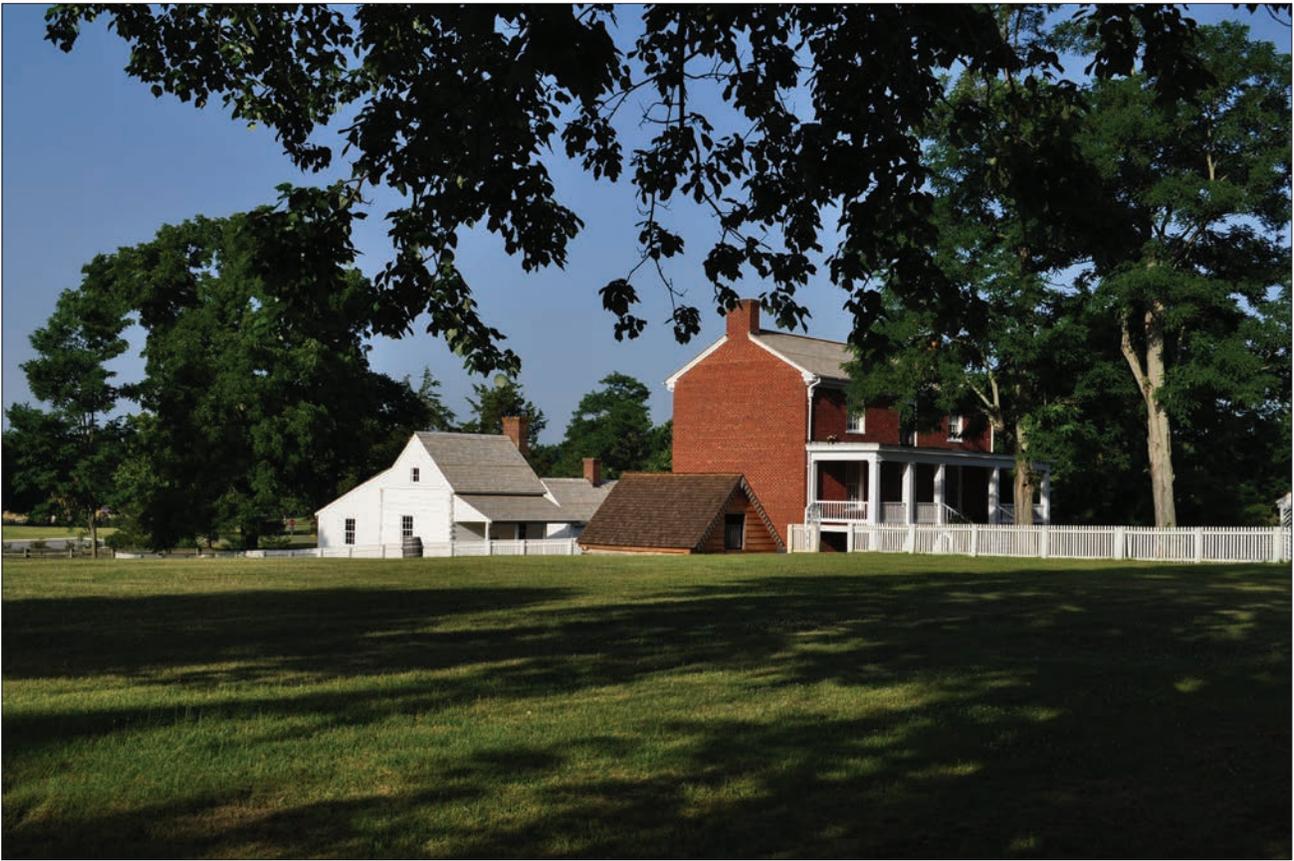
Figure 2c.2. View looking southwest at the McLean House. During the historic period, a large locust and a pear stood next to the ice house, and an apple tree was growing in the field in the foreground. (OCLP 2014, DSC_1884)

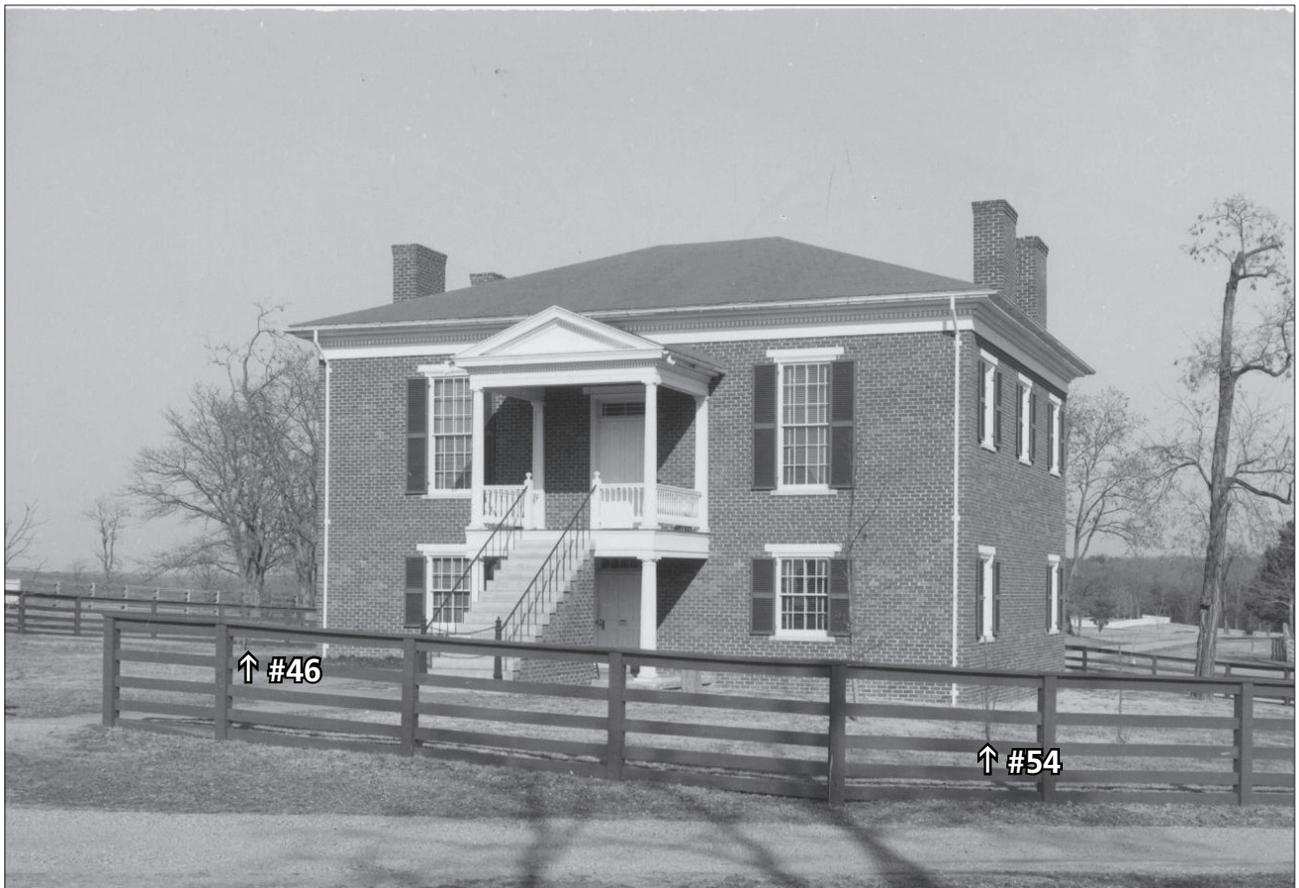
Figure 2c.3. View looking northeast at the Appomattox Courthouse in c.1965, and the missing chaste tree (#46) on the north side of the building and a missing red maple (#54) on the southwest side. (APCO Archives, #11496-10 1886)

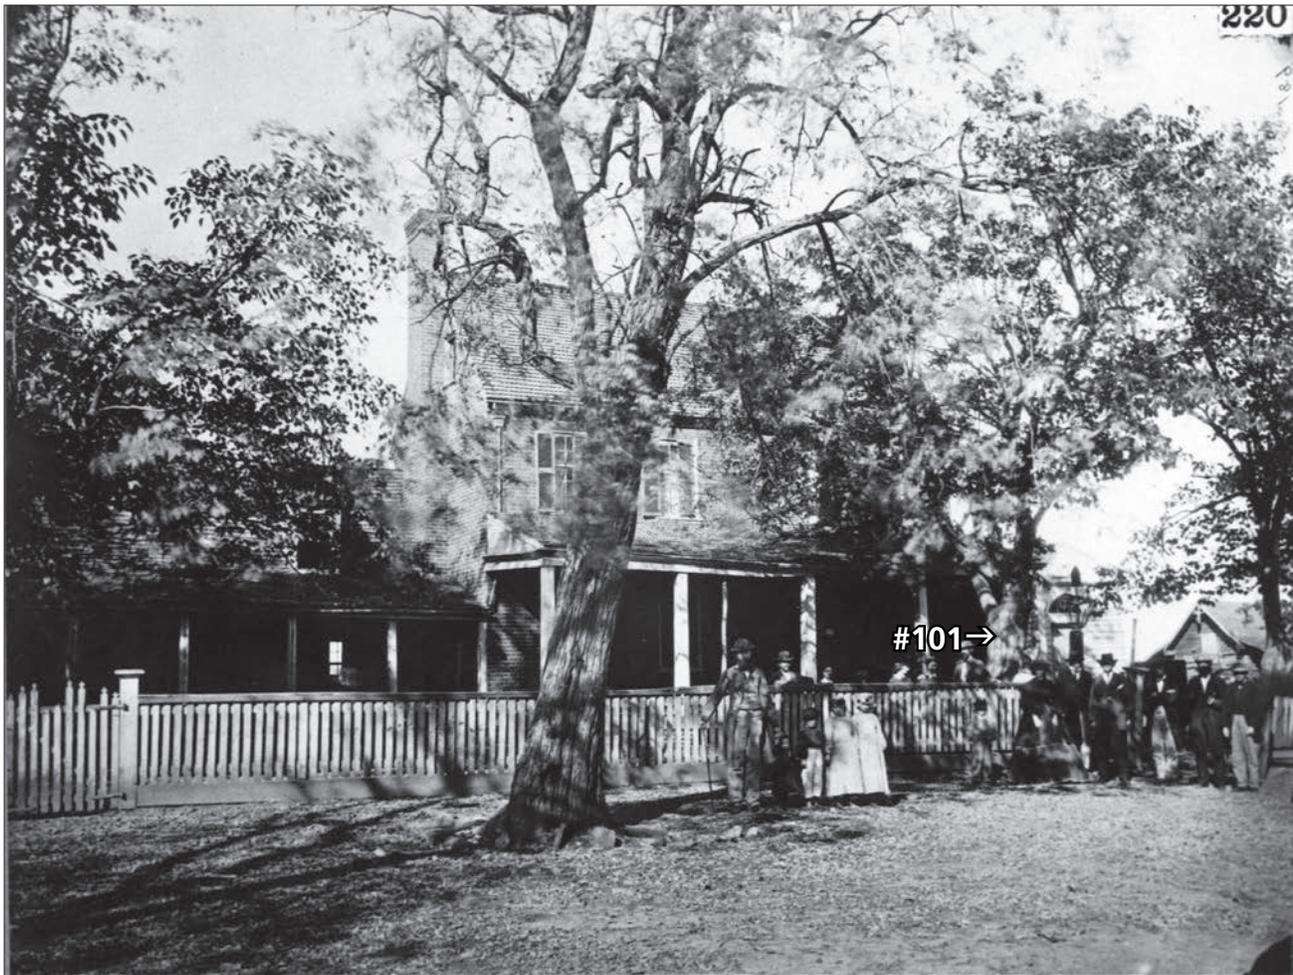
Figure 2c.4. View looking northeast at the Clover Hill Tavern in c.1865, and the missing red maple (#101) near the gate opposite the front door. (APCO Archives, #HF-050-01)

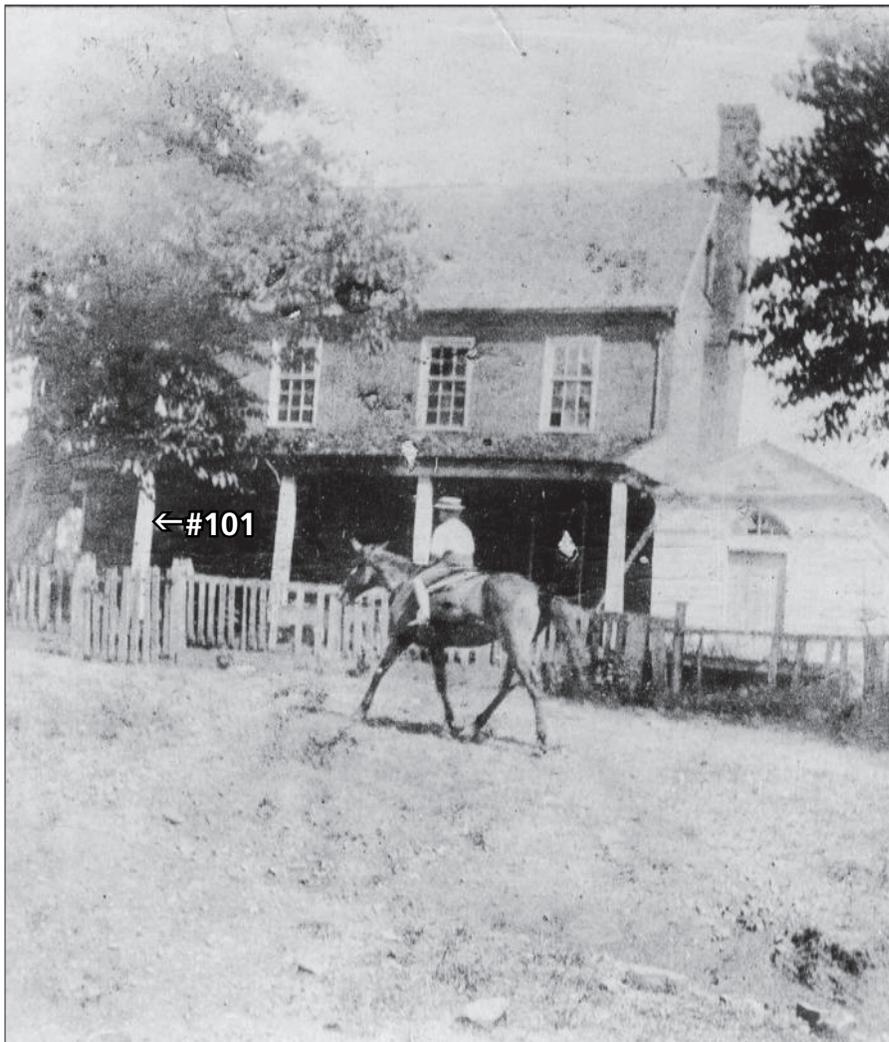
Figure 2c.5. View looking northwest at the Clover Hill Tavern in 1899-1900, and the missing red maple (#101) in the yard left of the front gate. (APCO Archives, #HF-053-02)

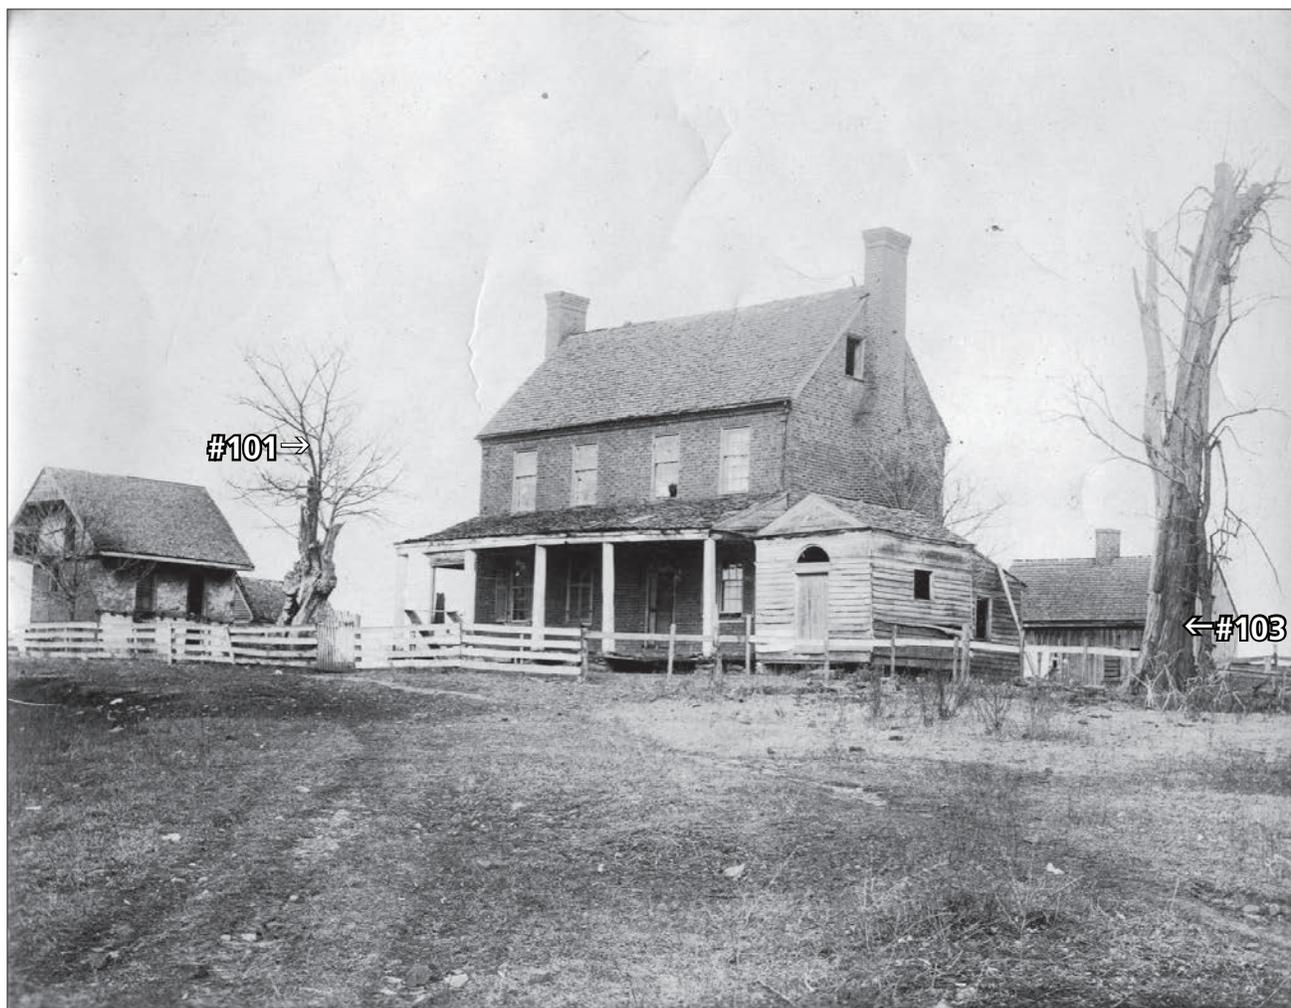
Figure 2c.6. View looking northwest at the Clover Hill Tavern in c.1913, and the missing red maple (#101) in the front yard and black cherry (#103) growing next to a dead black locust along the fence. (APCO Archives, #HF-054-01)

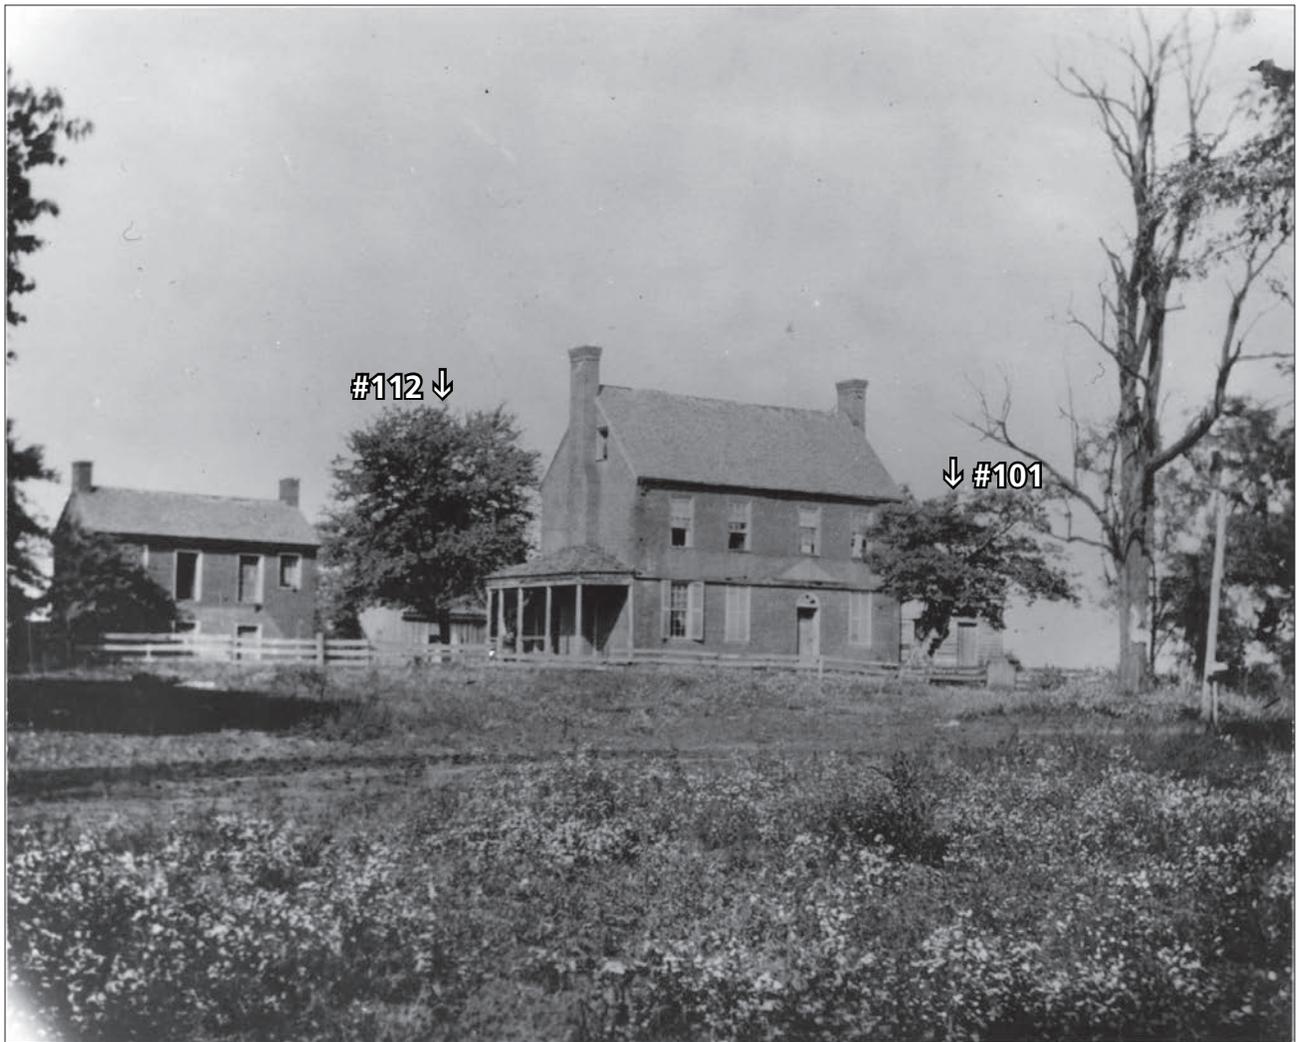
Figure 2c.7. View looking northeast at the Clover Hill Tavern in c.1914, and the missing red maple (#101) in the front yard and red maple (#112) in the back yard. (APCO Archives, #HF-003-01)

V-2. Plant Missing Historic Trees and Shrubs (Table 2c.2)	
<i>Location</i>	<i>Recommended Treatment</i>
Village Core	
Courthouse	Plant missing chaste tree (#46) in the lawn on the north side. (Figure 2c.3)
	Plant missing post oak (#52) just south of the white oak (#53).
	Plant missing a red maple (#54) southwest of the courthouse, between the two white oaks (#53,55). (Figure 2c.3)
Clover Hill Tavern and Patteson-Hix Cemetery	Plant missing red maple (#101) in front of the tavern. (Figures 2c.4, 2c.5, 2c.6, 2c.7, 2c.8, 2c.9, see Figure 2.6)
	Plant missing black cherry (#103) along the fence in front of the tavern. (Figure 2c.6) (Remove lilac first, see Project V-1)
	Plant missing red maple (#106) along the fence east of the slave quarters, next to the former well. (Figure 2c.10, see Figures 2.1, 2.3, 2.6)
	Plant missing lilac (#108) at the southeast corner of the slave quarters (Figure 2c.11)
	Plant missing red maple (#112) northwest of the tavern. (Figures 2c.7, 2c.8, 2c.12, see Figures 2.1, 2.2, 2.3, 2.4, 2.5, 2.6, 2.7).

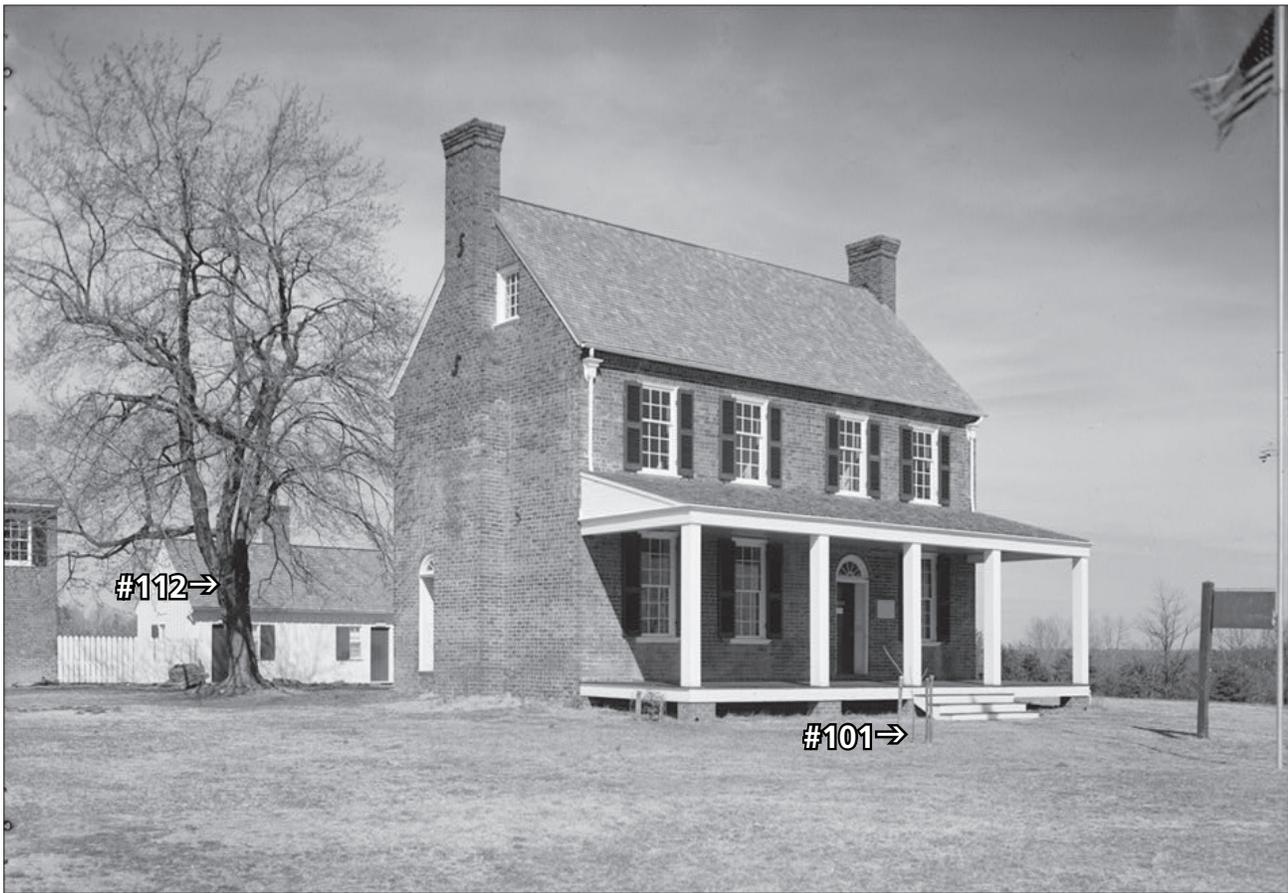
Figure 2c.8. View looking northeast at the Clover Hill Tavern in 1955, and the missing red maples (#s 101,112). (HABS, VA-439-3, #163741)
