CULTURAL LANDSCAPE REPORT FOR APPOMATTOX COURT HOUSE NATIONAL HISTORICAL PARK

VOLUME II: TREATMENT IMPLEMENTATION PLAN

APPOMATTOX, VIRGINIA

National Park Service, Boston, Massachusetts, 2018

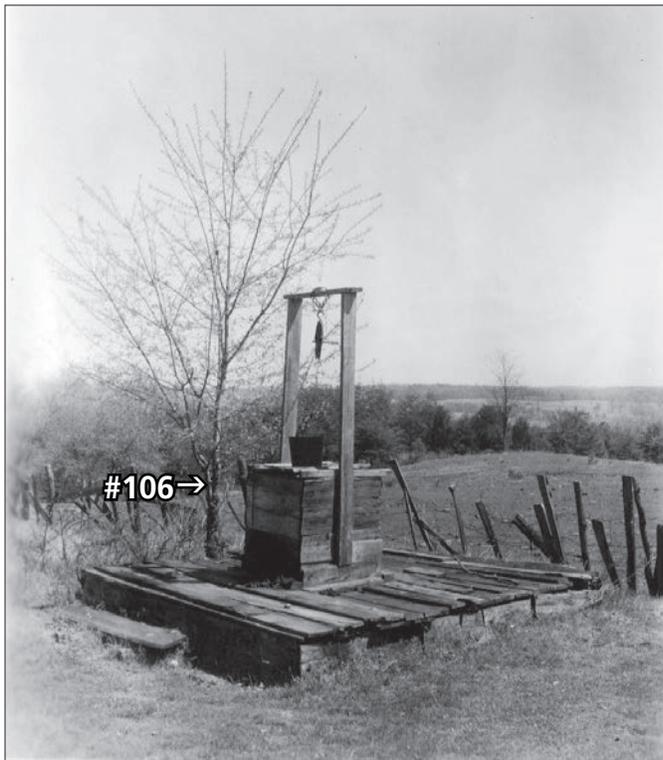
Figure 2c.10. View looking northeast at the well east of the slave quarters in 1937, and the missing red maple (#106) next to it. (APCO Archives, #HF-065-01)

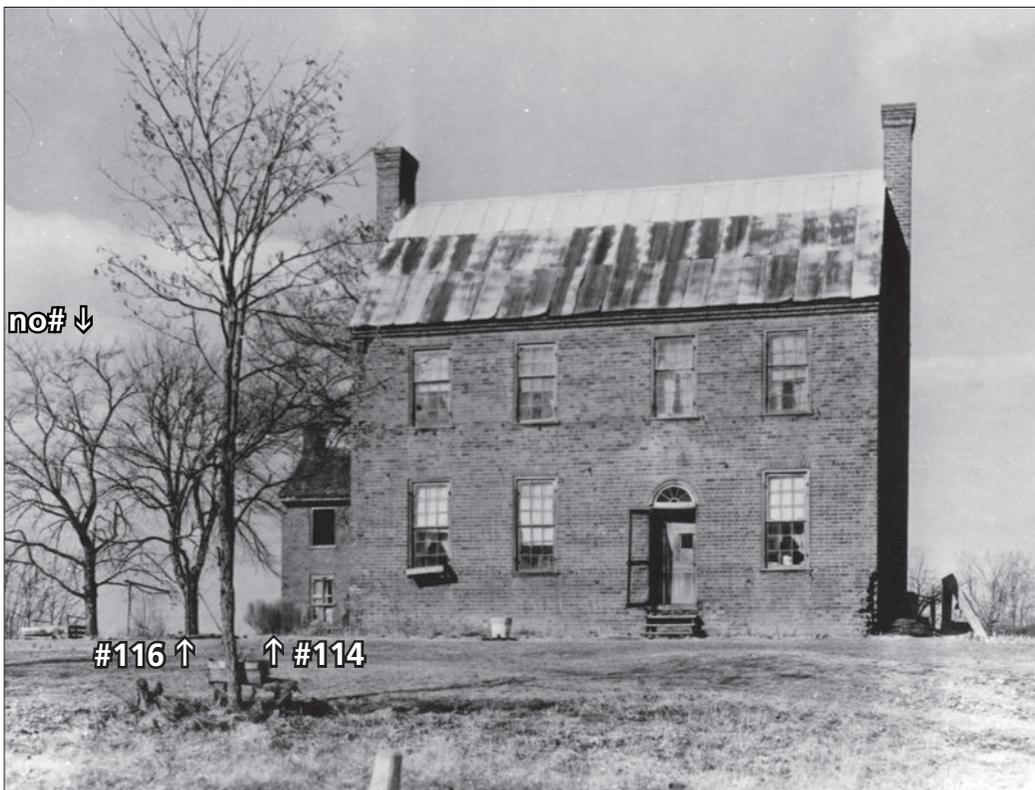
Figure 2c.13. View looking north-northwest at the Clover Hill Tavern complex in 1939, and a missing lilac at the southwest corner of the kitchen/guest house, two missing red maples (#116, no#) to the west of the building. (APCO Archives, #HF-066-01)

Plant missing lilac (#114) at the southwest corner of the kitchen/guest house (Figure 2c.13).
	Plant two missing red maples (#116,no#) west of the kitchen/guest house. (Figures 2c.12, 2c.13, 2c.14, 2c.15, see Figures 2.1, 2.2, 2.3, 2.4, 2.5, 2.6)
Old County Jail Site	Plant missing lilac (#34) northeast of the black locust (#35). (Figures 2c.16, 2c.17, see Figures 2.2, 2.3, 2.4)
	Plant two missing black locusts (#37,no#A) on the northeast side of the roundabout. (Figures 2c.16, 2c.18, see Figures 2.1, 2.3, 2.5, 2.6)
New County Jail	Plant missing black locust (no#) near the northeast corner of the New County Jail. (Figures 2c.19, 2c.20, 2c.21, 2c.22, see Figures 2.1, 2.2, 2.3)
	Plant three missing red maples (#s 28,29,31) along the fence east of the building. (Figures 2c.21, 2c.22, see Figures 2.3, 2.5, 2.6, 2.7)
	Plant missing black locust (#41) at the intersection with Market Lane. (Figure 2c.23, see Figures 2.3, 2.5, 2.6)

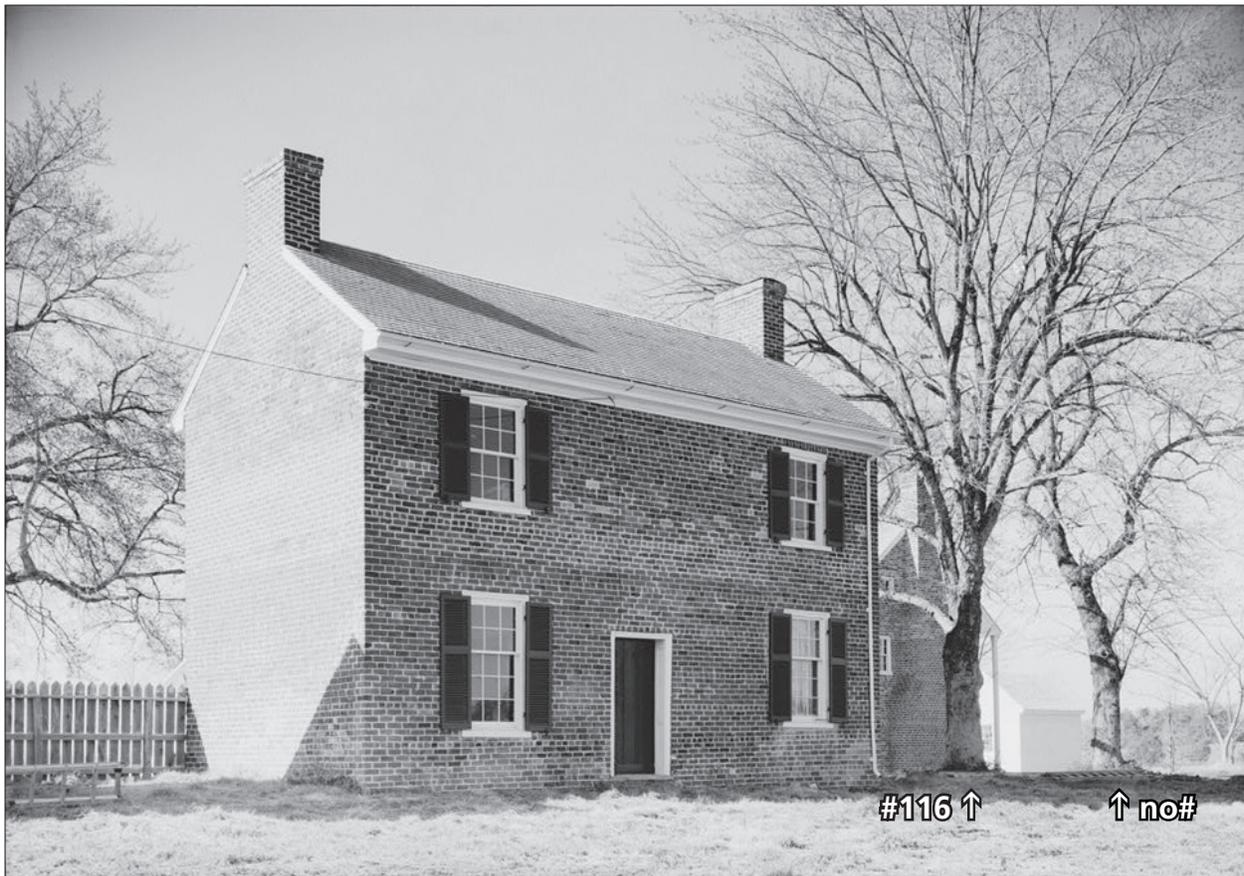
Figure 2c.14. View looking southwest at the Clover Hill kitchen/guest house in 1955, and the two missing red maples (#116, no #) to the west. (HABS, VA-439-A-2, #163793)

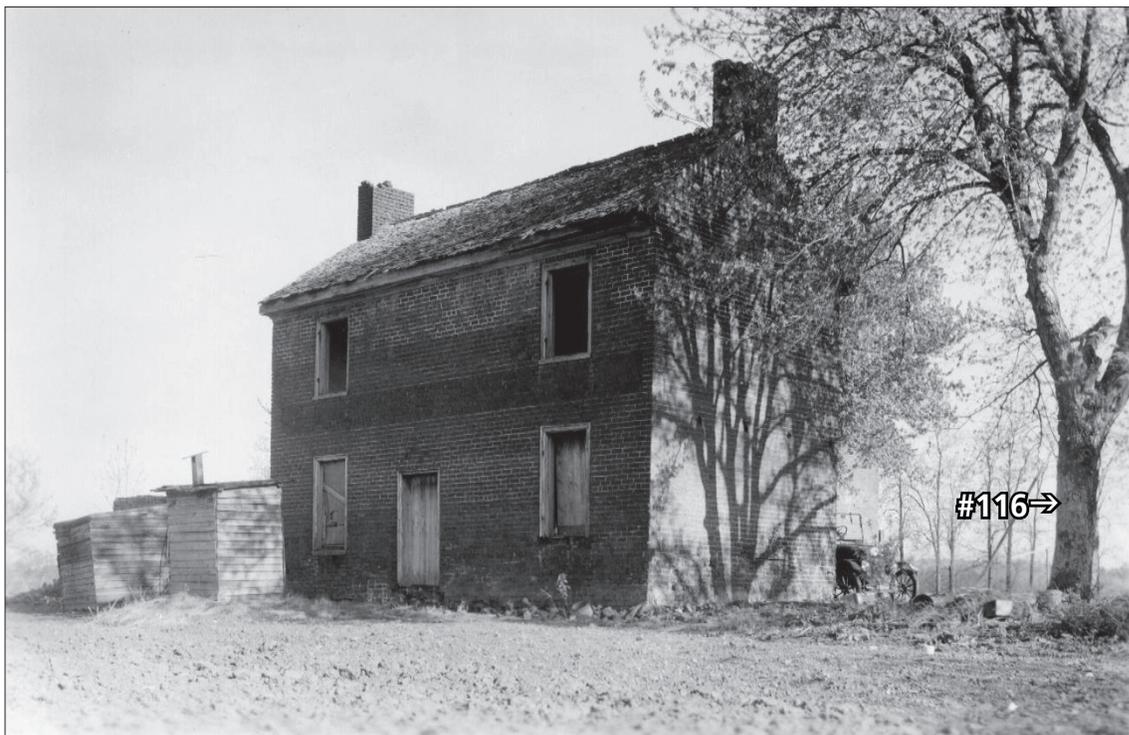
Figure 2c.15. View looking southeast at the Clover Hill kitchen/guest house in 1939, and one of the missing red maples (#116) west of the building. (APCO Archives, #HF-062-01)

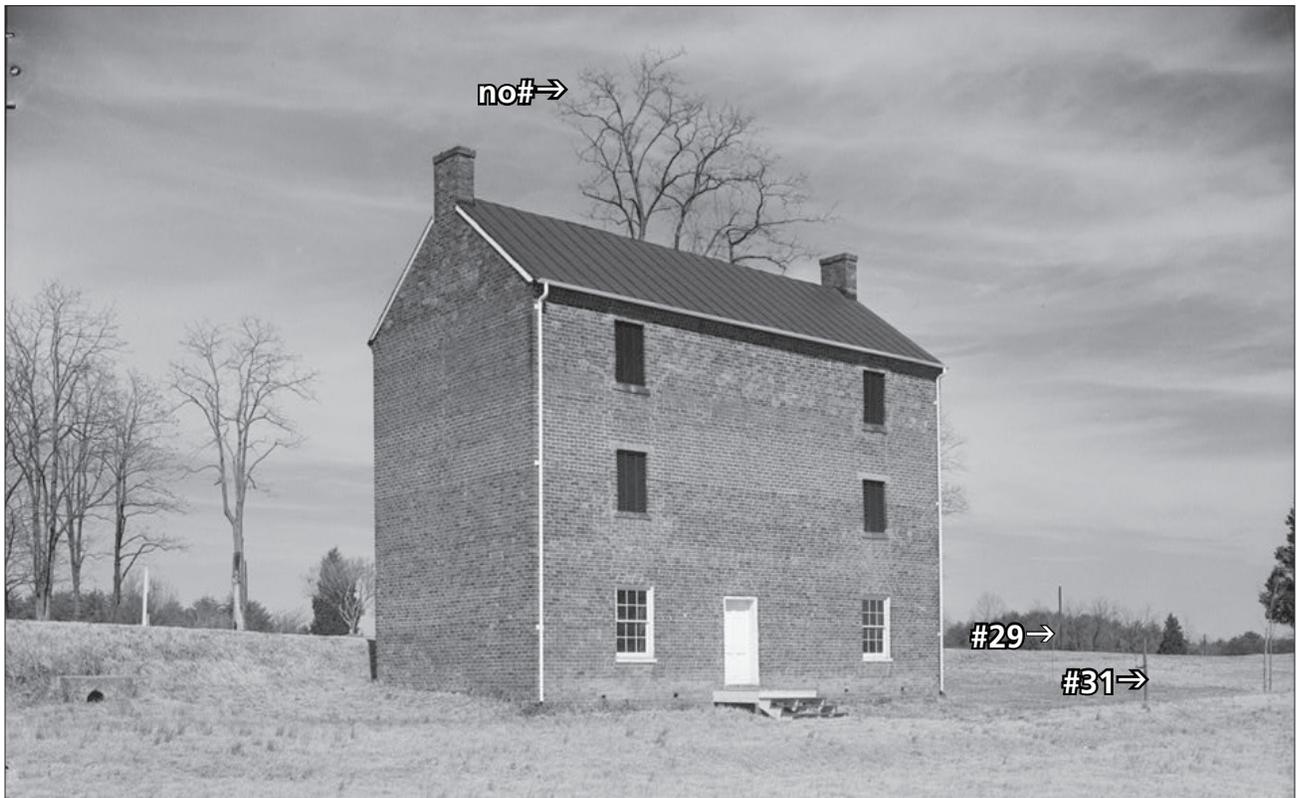
Figure 2c.21. View looking northeast at the New County Jail in 1955, and locations of two of the three missing red maples (#s 29,31). The top of the missing black locust (no#) is visible above the roofline. (HABS, VA-436-2, #163792)

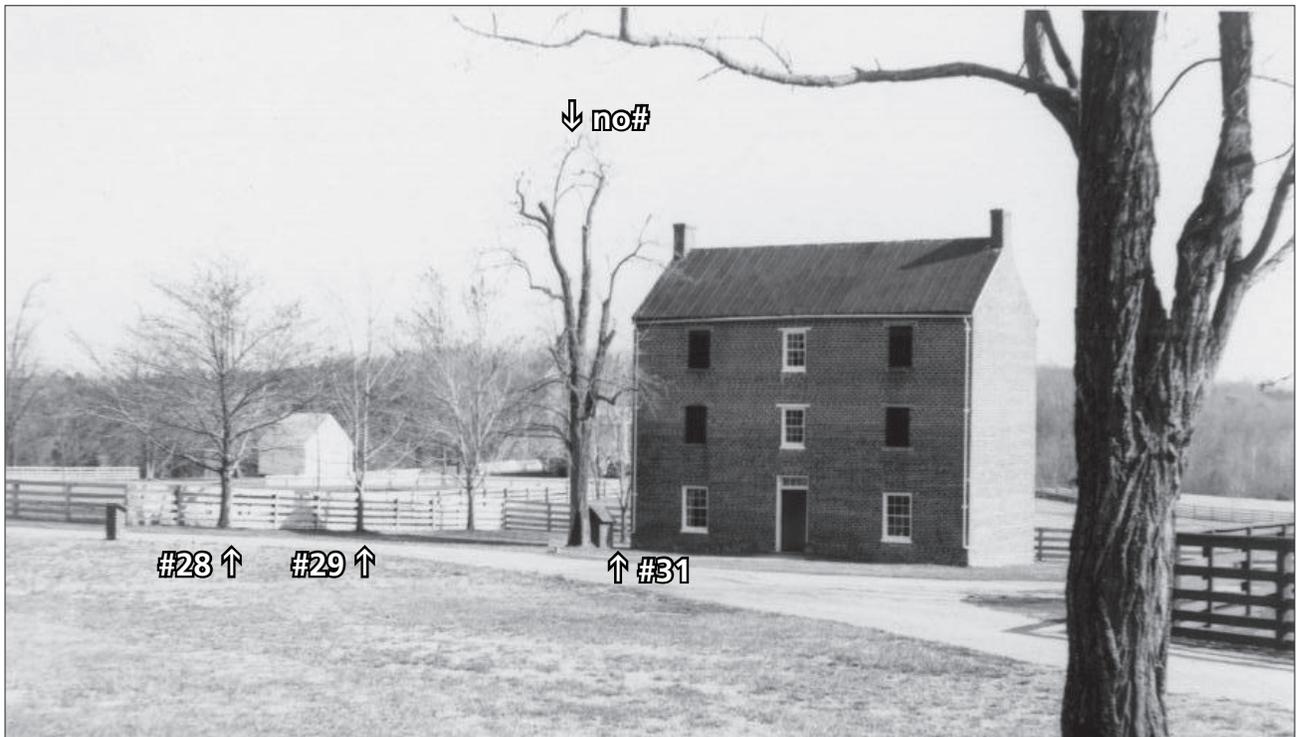
Figure 2c.22. View looking southeast at the New County Jail in 1970, and the three missing red maples (#s 28,29,31) and black locust (no#). (APCO Archives, #11449-04 1914)

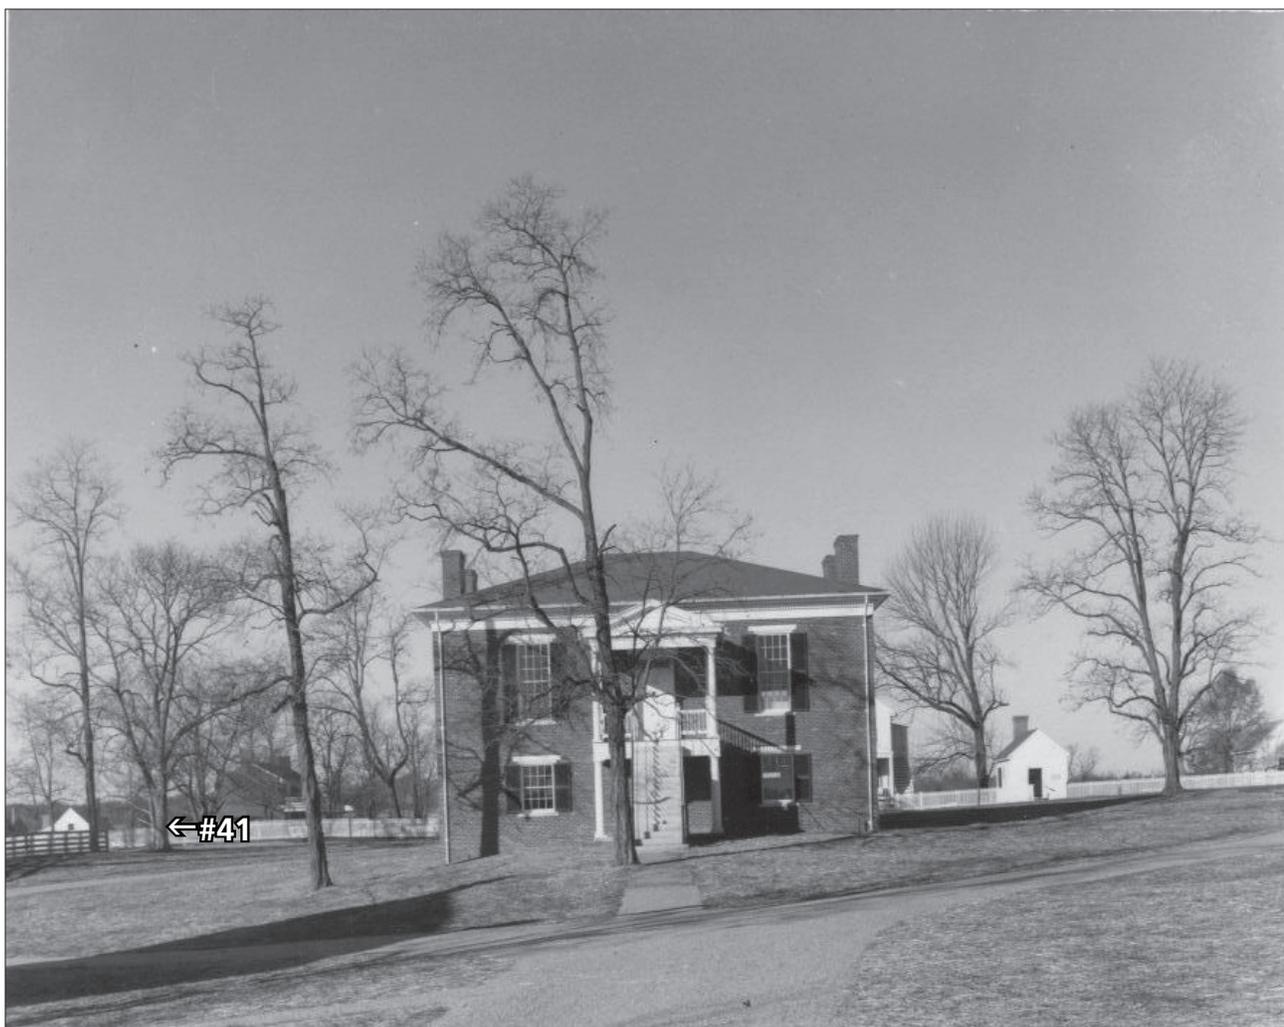
Figure 2c.23. View looking west at the Appomattox Courthouse in 1965, and the missing black locust (#41) at the intersection with Market Lane. (APCO Archives, #11496-08 1886)

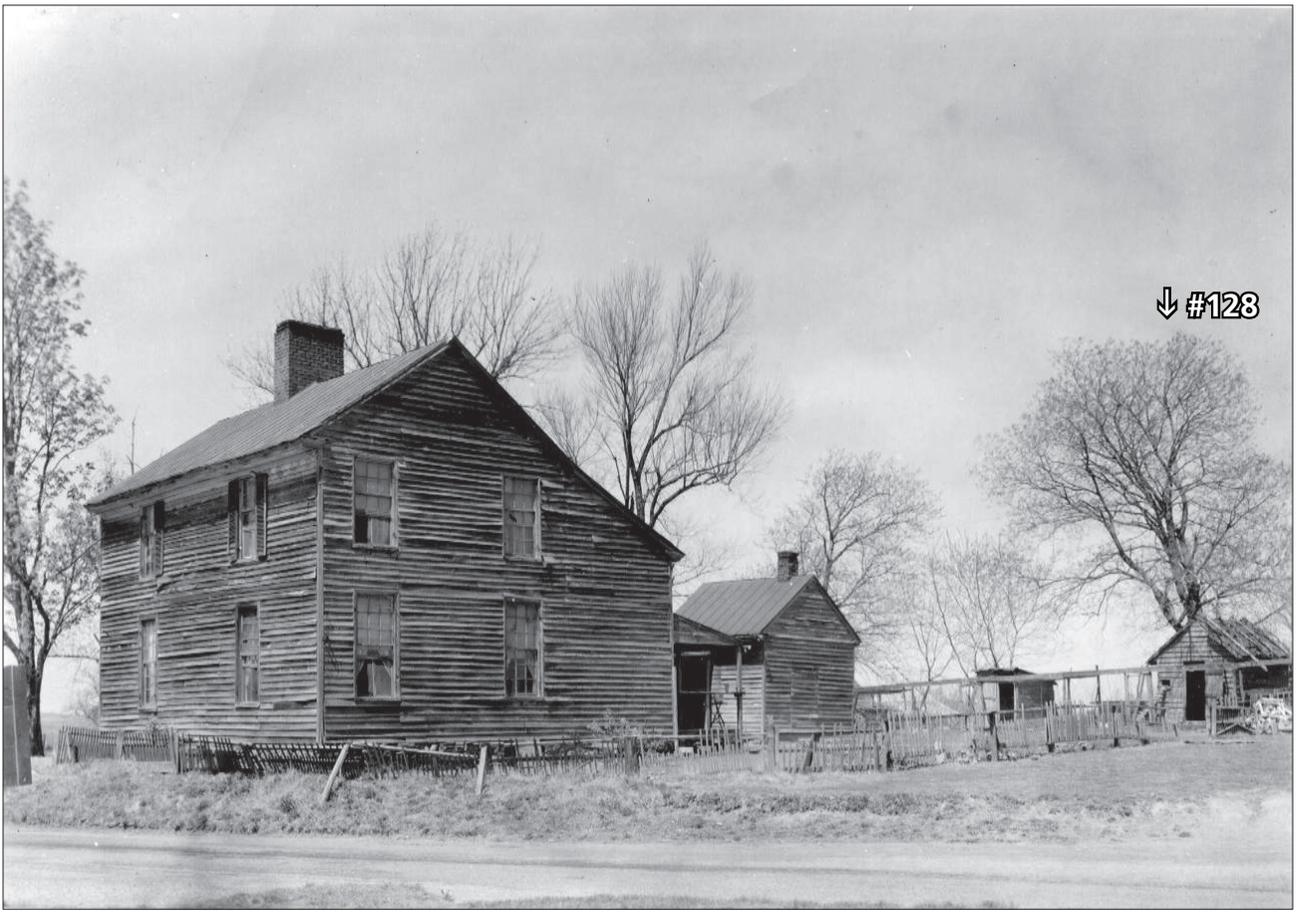
Figure 2c.24. View looking northwest at the Meeks Store and outbuildings in 1939, and the missing mulberry (#128) along a fence directly north of a shed. The tree was later replaced by a red maple that has since been removed. (APCO Archives, #HF-191-01)

Meeks Store	Plant missing red maple (#128) just east of the Siberian elm (#127). (Figures 2c.24, 2c.25, see Figures 2.1, 2.2, 2.3)
	Plant missing lilac (no#A) southwest of the store, along the fence. (Figure 2c.25)
	Plant missing lilac (no#B) on the east side of the store, on the right side of the porch steps. (Figure 2c.26)
East of Village Core	
Rosser-Ferguson House	Plant three missing black locusts (#231,no#A,no#B) along the north side of the Stage Road. (Figures 2c.27, 2c.28, 2c.29, 2c.30, 2c.31, see Figures 2.2, 2.3, 2.4)
The Triangle	Plant missing white oak (#254) at the west end of the Triangle. (see Figures 2.5, 2.6)
Peers House	Plant missing red maple (#3) and silver maple (#6) in the front yard. (Figures 2c.32, 2c.33, see Figures 3.2, 3.6)
	Plant two missing crabapples (#s 13,14) at the east end of the south yard fence, on the south side of the fence. (see Figure 2.6)
	Plant missing paper mulberry (#15) at the east end of the maples, along the south yard fence. (Figure 2c.34, see Figures 2.2, 2.4, 2.6, 2.7)

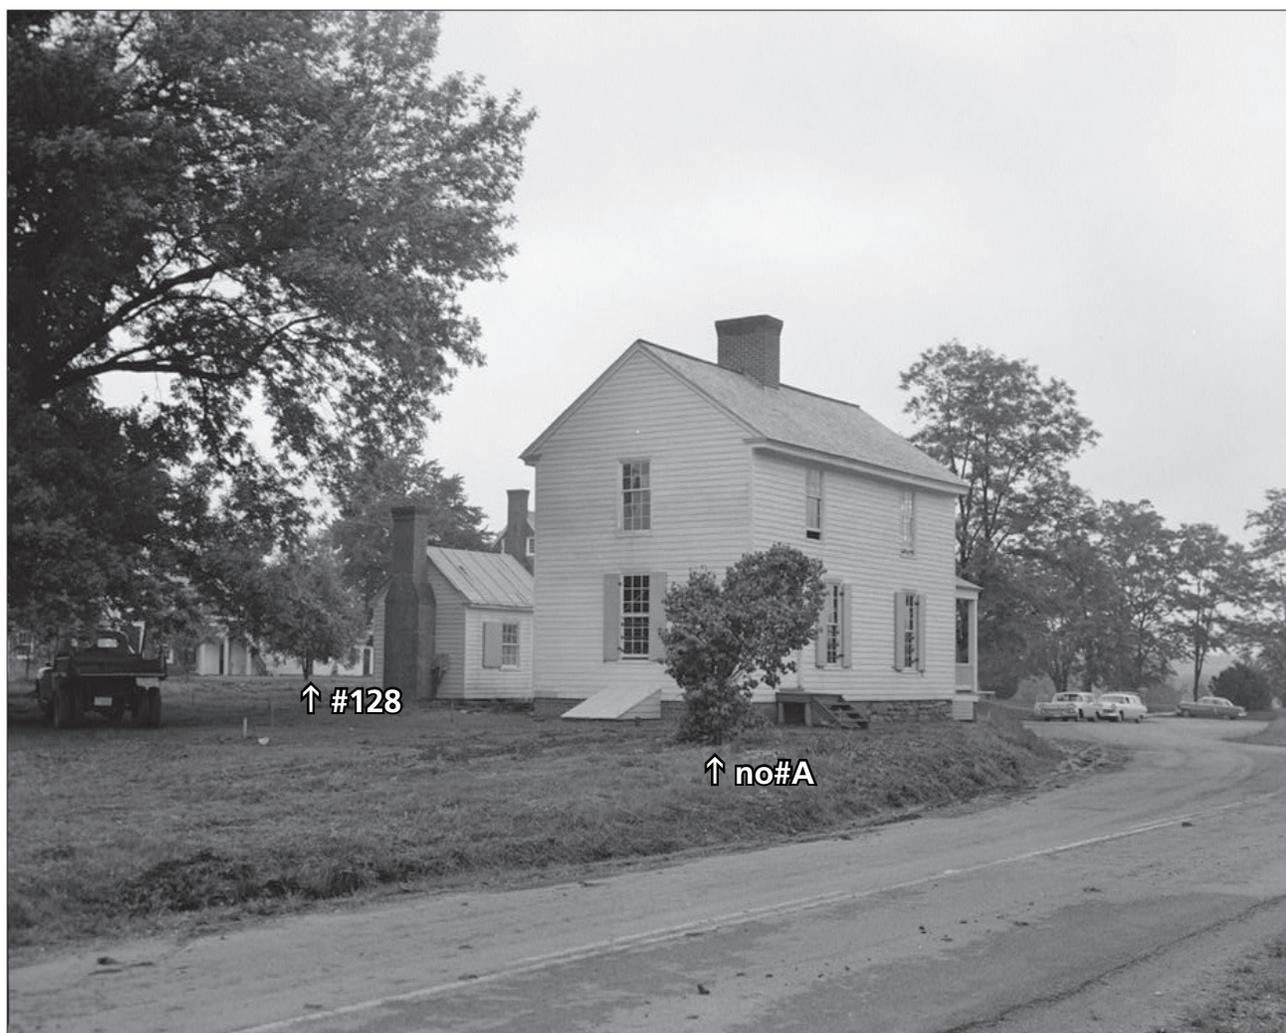
Figure 2c.25. View looking northeast at the Meeks Store in 1959, and the missing red maple (#128) northeast of the Woodson Law Office, and the missing lilac (no#A) at the southwest corner of the store. (HABS, VA-432-5, #163777)

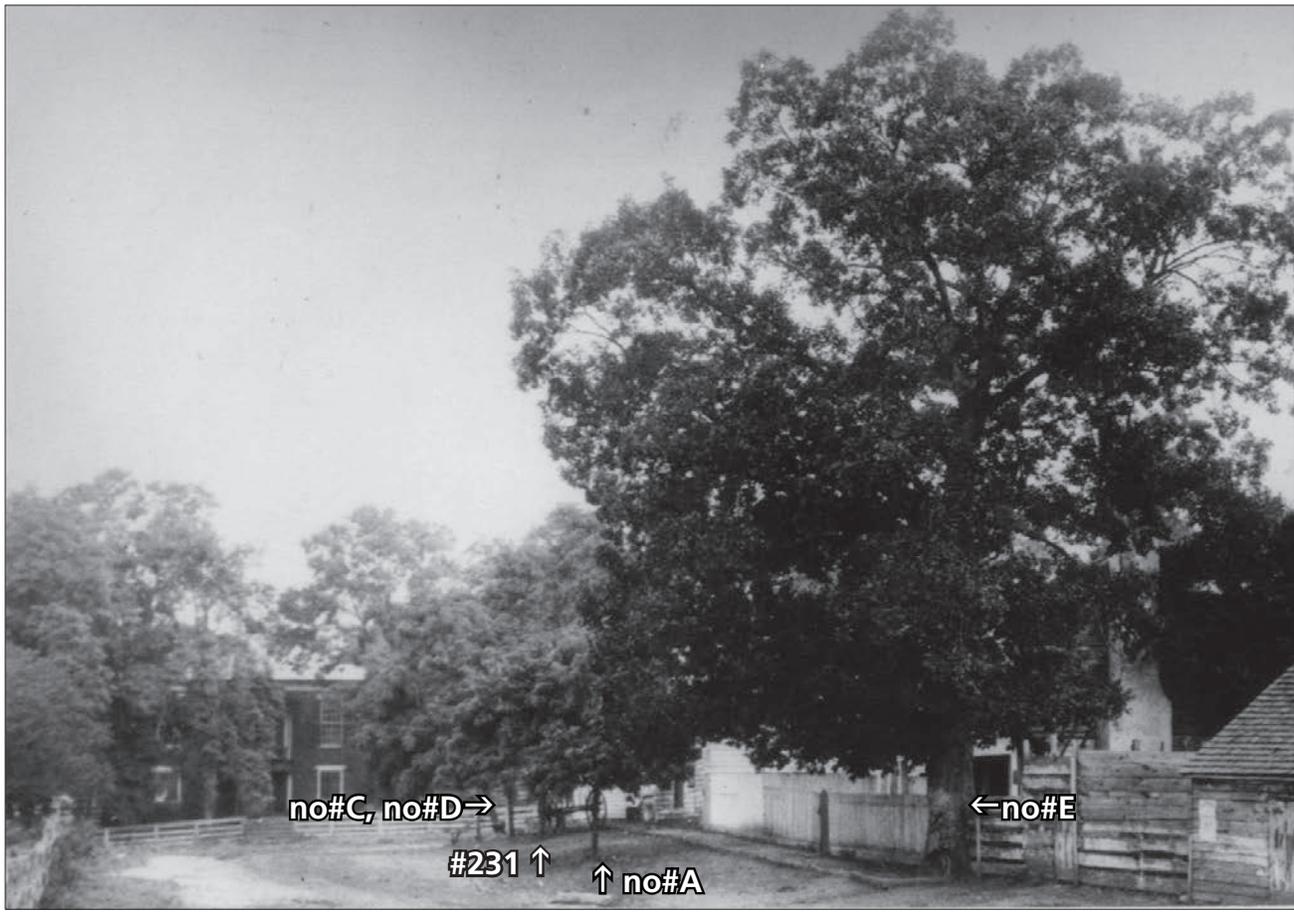
Figure 2c.27. View looking west at the Appomattox Courthouse and Rosser-Ferguson complex in the 1880s, and the four missing black locusts (#231,no#A,no#C,no#D) in the shadow of a massive oak (no#E). (APCO Archives, #HF-047-01)

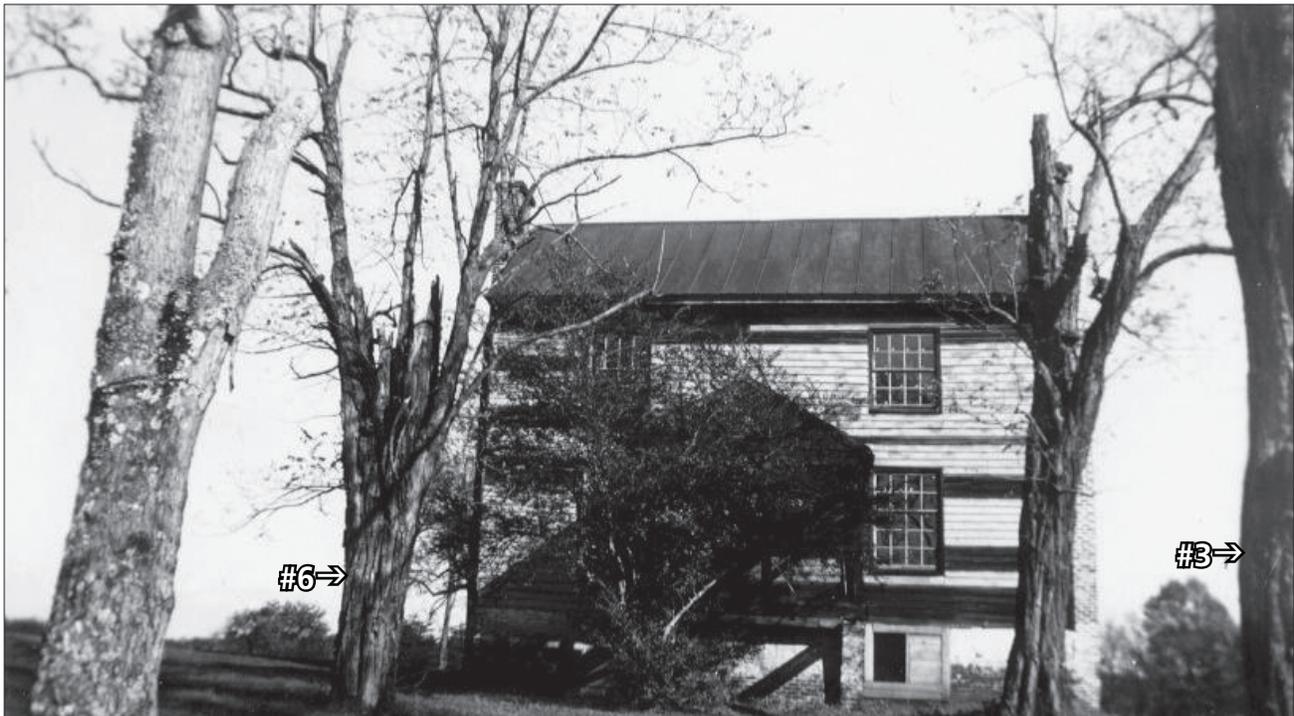
Figure 2c.33. View looking east at the Peers House in 1950, and the red maple (#3) and silver maple (#6). (APCO Archives, #11468-22 1663)

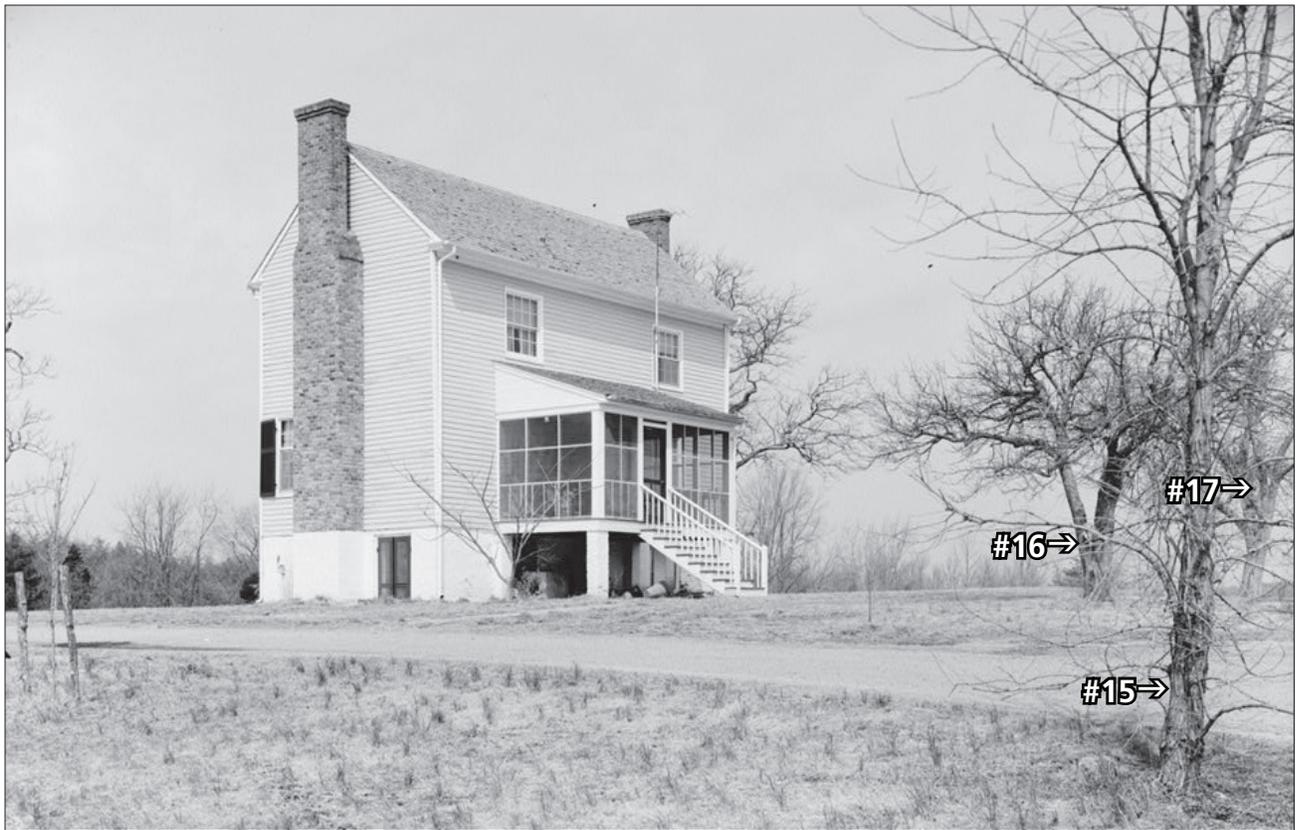
Figure 2c.34. View looking northwest at the Peers House in 1960, and the missing paper mulberry (#15) in the foreground and two missing pears (#s 16,17) in the background. (HABS, VA-1316-2, #163738)

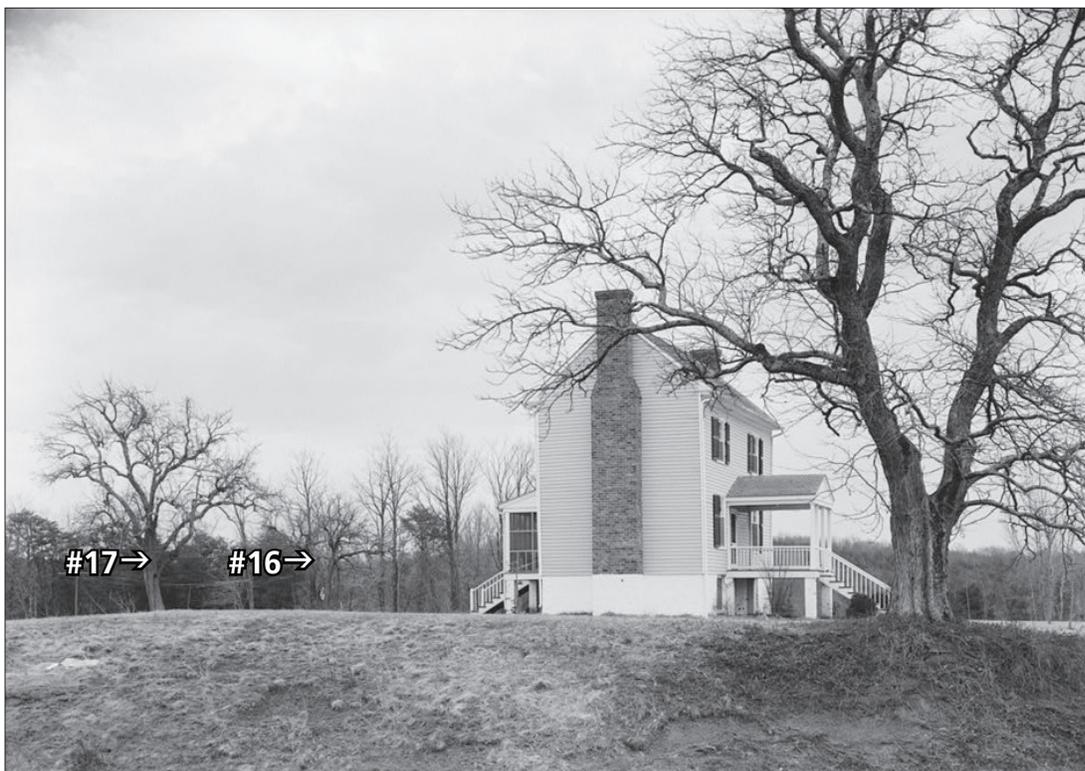
Figure 2c.35. View looking southeast at the Peers House in 1959. A honey locust (#1) dominates the foreground at image right, and two pears (#s 16,17) can be seen in the back yard. (HABS, VA-1316-1, #163737)

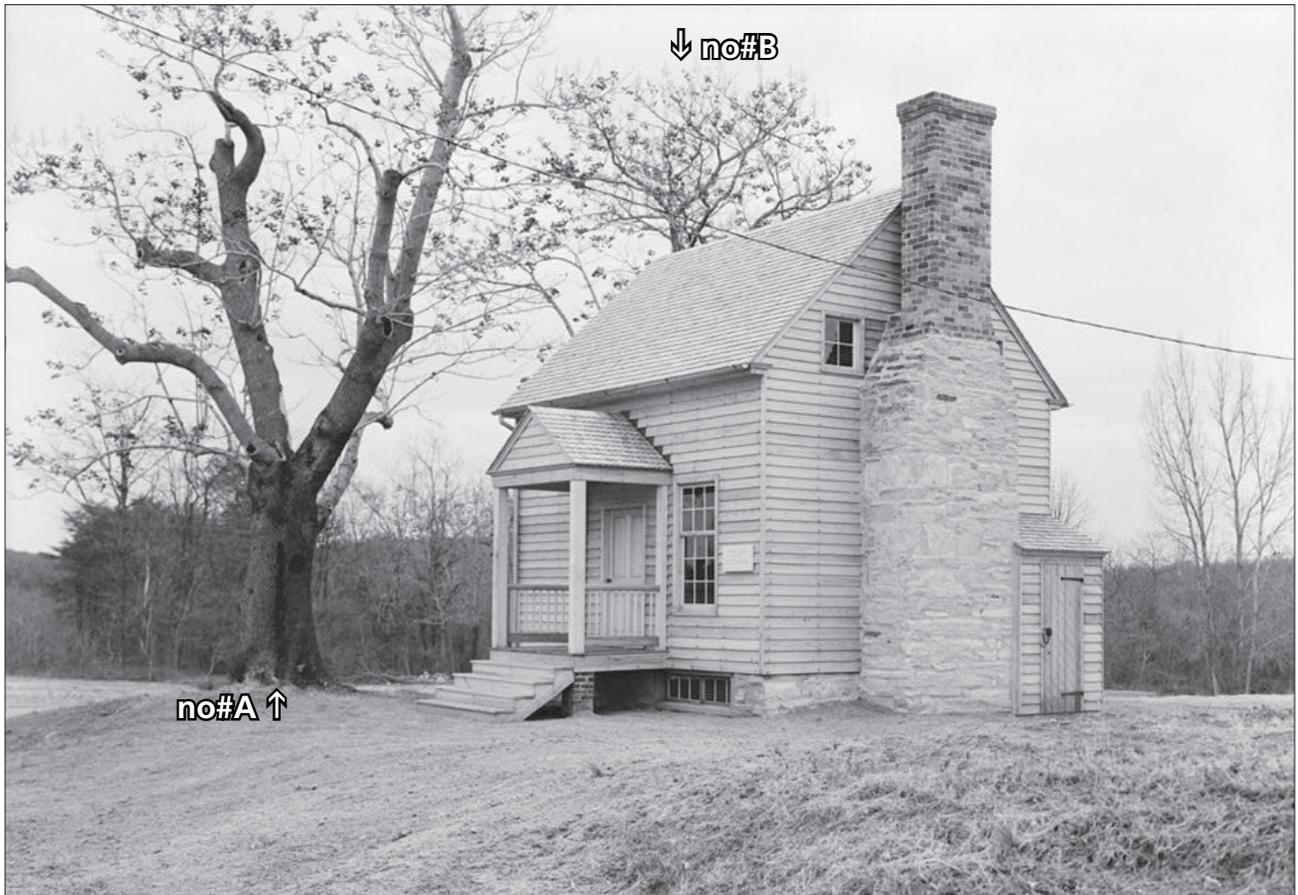
Figure 2c.37. View looking southeast at the Kelley House in 1959, and the missing white oak (no#A) just northeast of the building. The crown of another white oak (no#B) is also visible. (HABS, VA-1315-1, #163752)

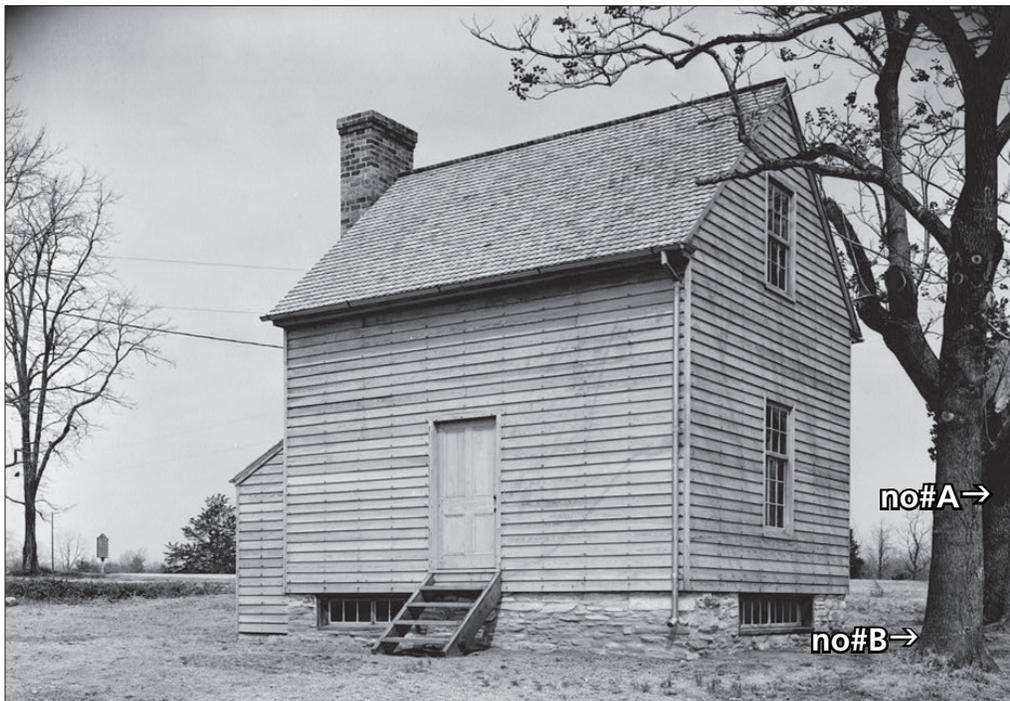
Figure 2c.38. View looking northwest at the Kelley House in 1959, and the missing white oak (no#B) east of the building's southeast corner. A portion of another white oak (no#A) is visible behind it. (HABS, VA-1315-3, #163754)

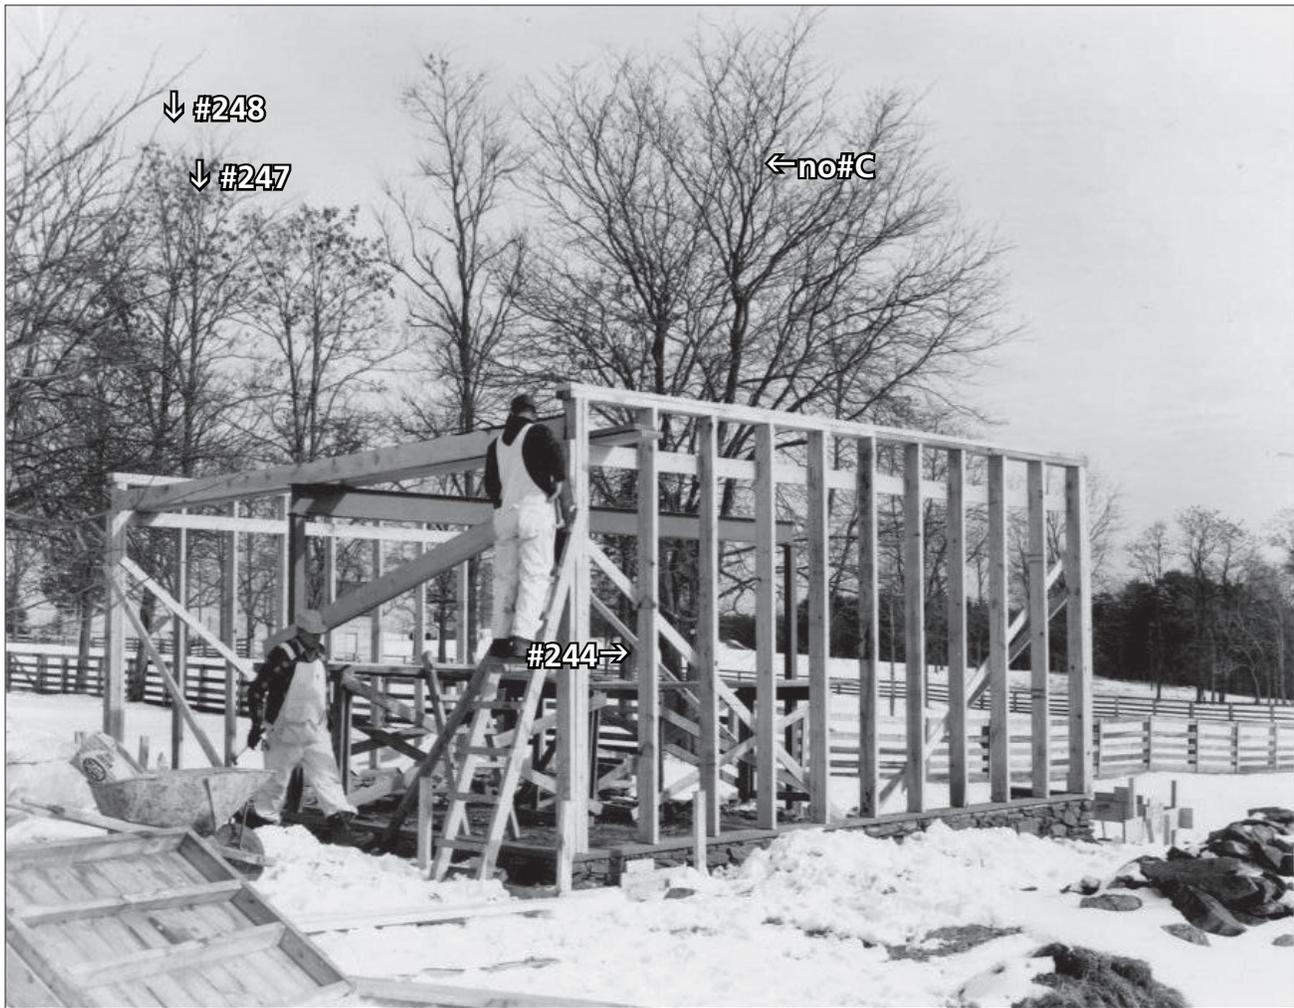
Figure 2c.39. View looking northeast at the reconstruction of the Isbell stable in 1964, and the missing black locusts (#s 244,247,248,no#C) along the fence in the background. (APCO Archives, #11500-01 1893)

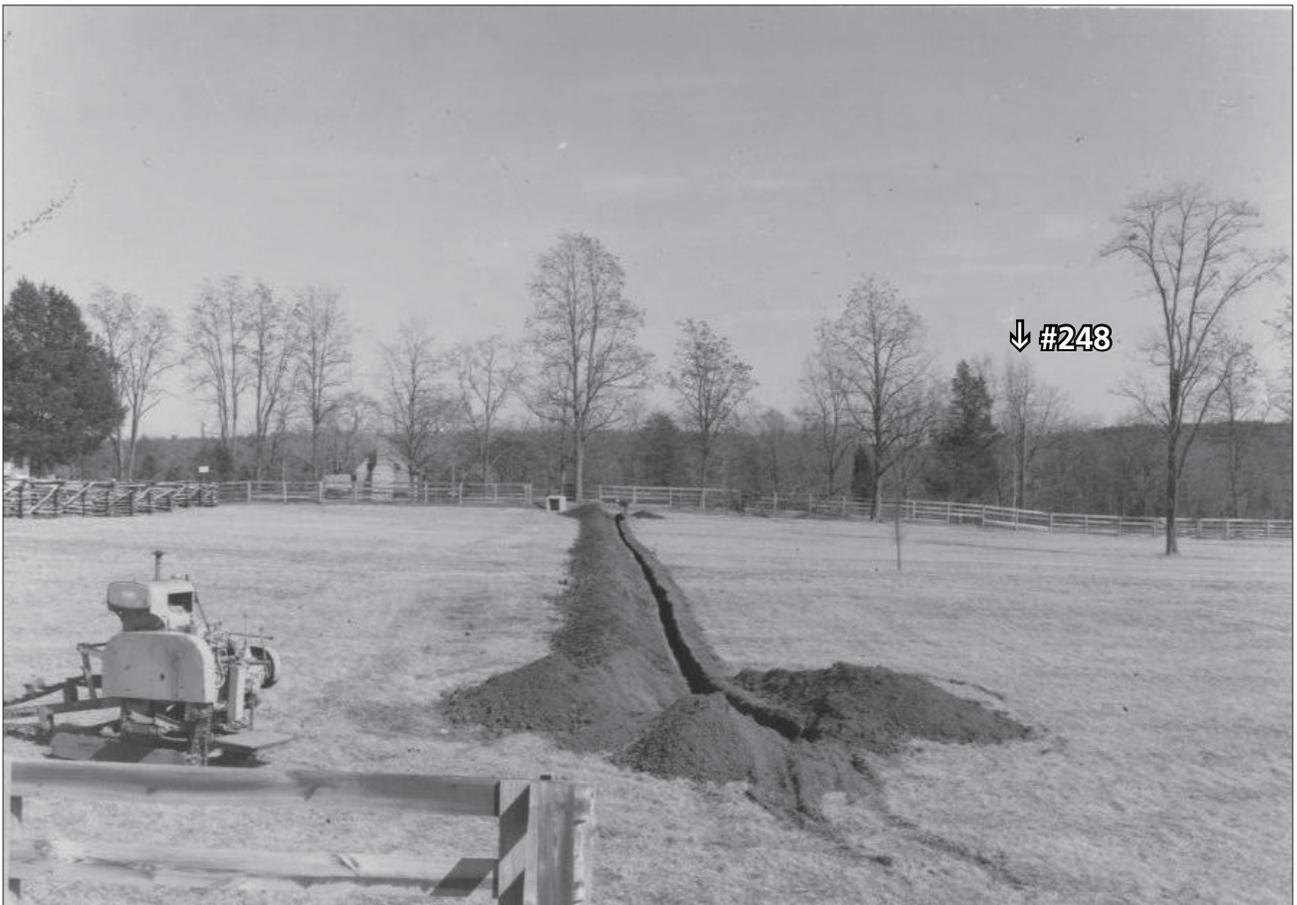
Figure 2c.40. View looking east toward Bocock Lane in 1964, and the missing black locust (#248) along the east side of Bocock Lane. (APCO Archives, #11497-04 1917)

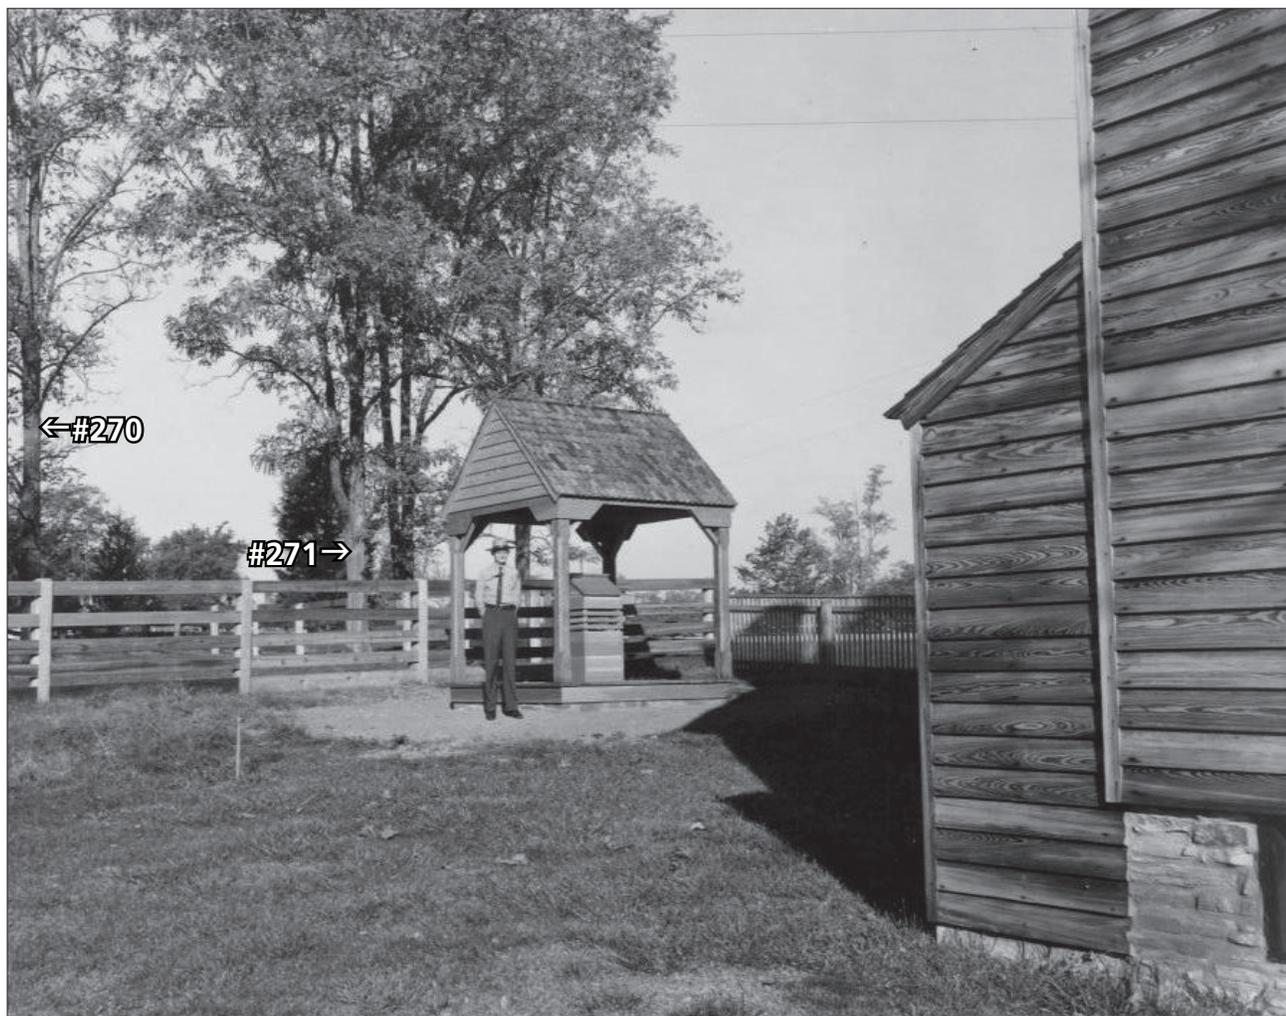
Figure 2c.41. View looking northwest at the well at the Kelley House in c.1963, and the missing black locusts (#s 270,271) in the field west of the house. (APCO Archives, #11503-02 1897)

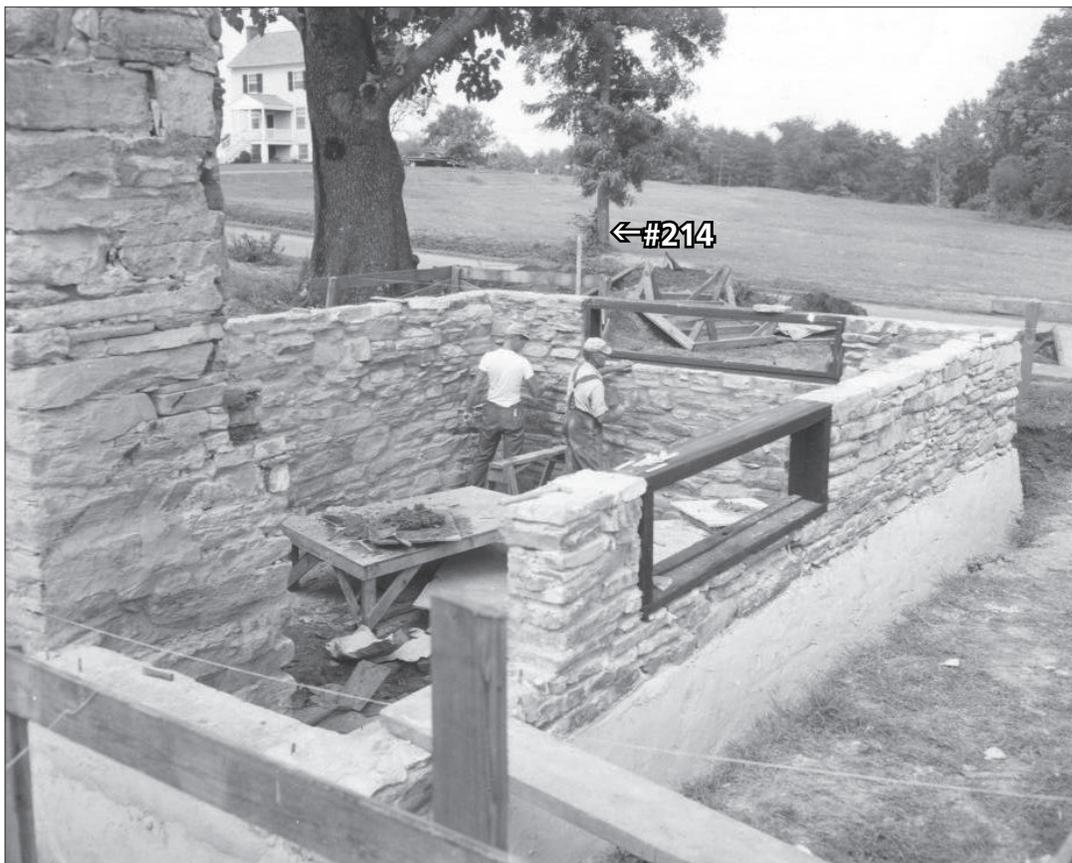
Figure 2c.43. View looking northeast at the reconstruction of the Kelley House in 1959, and the missing black locust (#214) on the east side of Prince Edward Court House Road. (APCO Archives, #11503-05 1897)

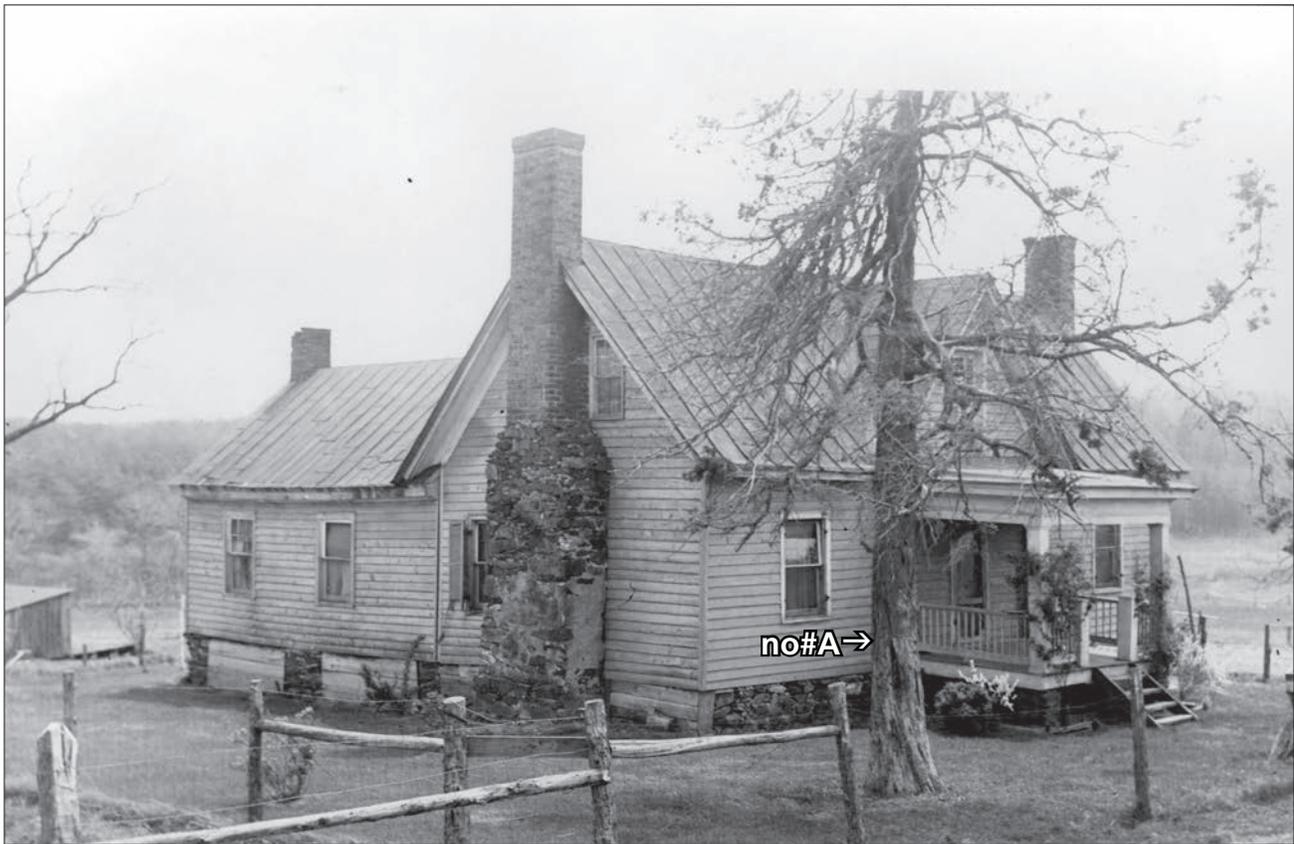
Figure 2c.44. View looking southeast at the Mariah Wright House in 1936, and the missing Virginia redcedar (no#A) within the fenced yard. (APCO Archives, #11918-032)
