CULTURAL LANDSCAPE REPORT FOR APPOMATTOX COURT HOUSE NATIONAL HISTORICAL PARK

VOLUME II: TREATMENT IMPLEMENTATION PLAN

APPOMATTOX, VIRGINIA

National Park Service, Boston, Massachusetts, 2018

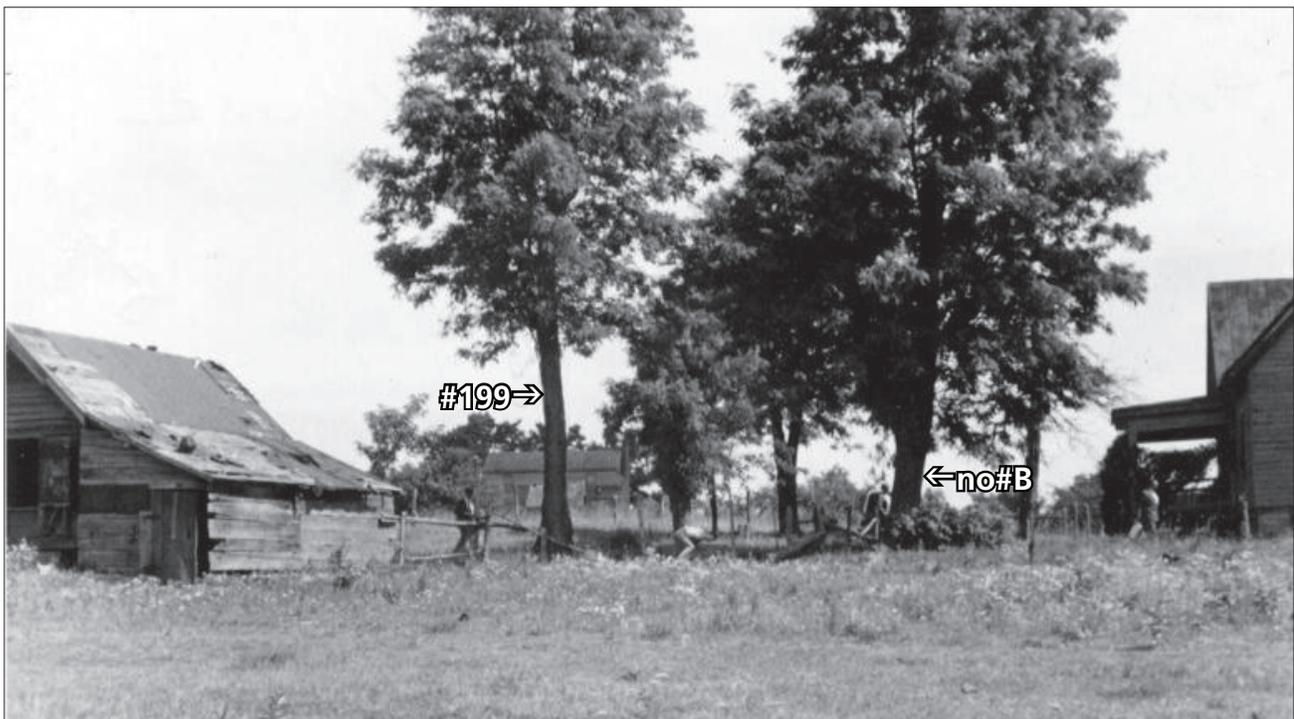
Figure 2c.45. View looking south-southwest at the Mariah Wright House (image right) and stable (image left) in 1940, and the missing black locusts (#199,no#B). (APCO Archives, #11452-04_1246)

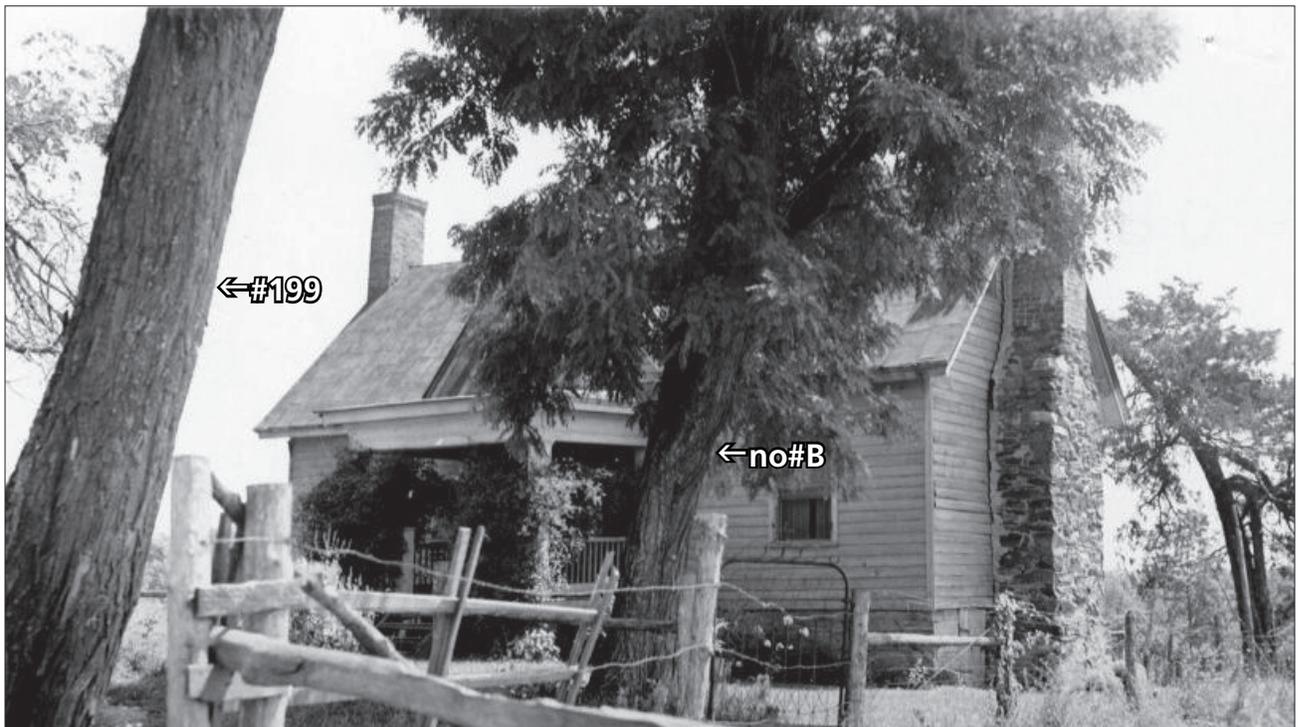
Figure 2c.46. View looking northeast at the Mariah Wright House in 1936, and the missing black locusts (no#B,#199) west-southwest of the house. (APCO Archives, #11918-032)

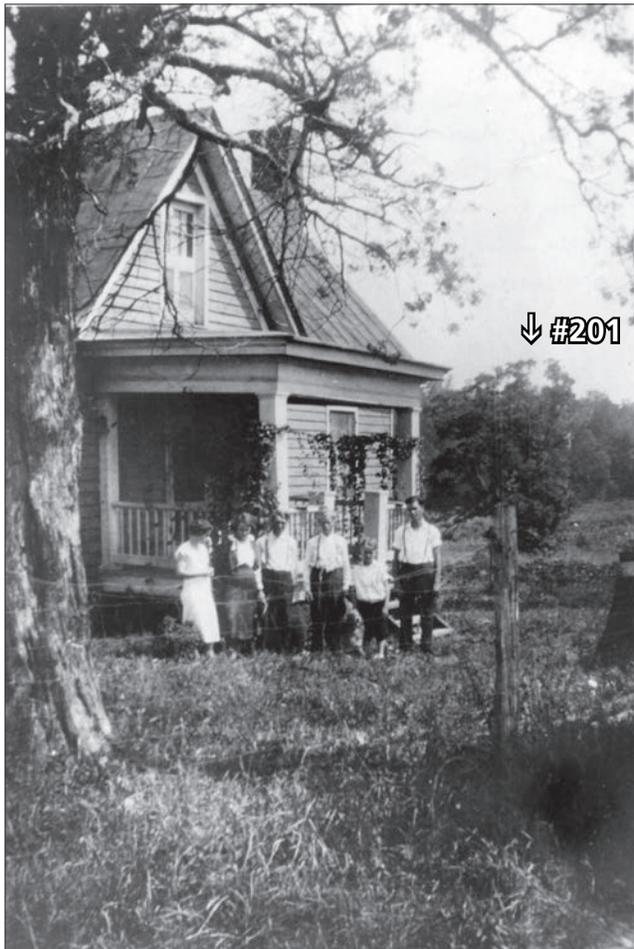
Figure 2c.47. View looking southeast at the Mariah Wright House in 1922, and the location of the missing plum (#201) on the south side of the house. (APCO Archives, #HF-222-01)

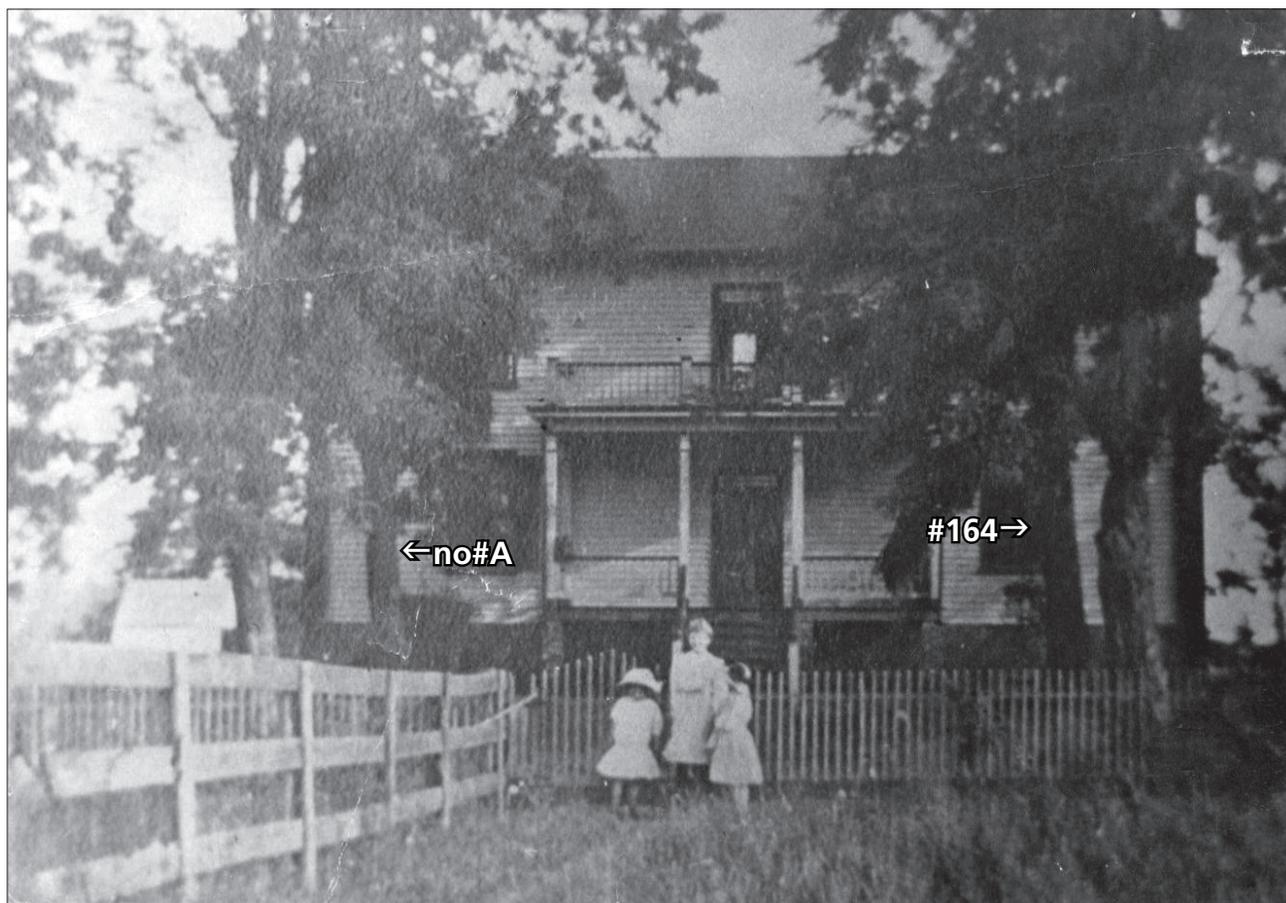
Figure 2c.48. View looking south at the Isbell House in c.1901, and the two missing black locusts (no#A,#164) in the front yard. (APCO Archives, #HF-200-01)

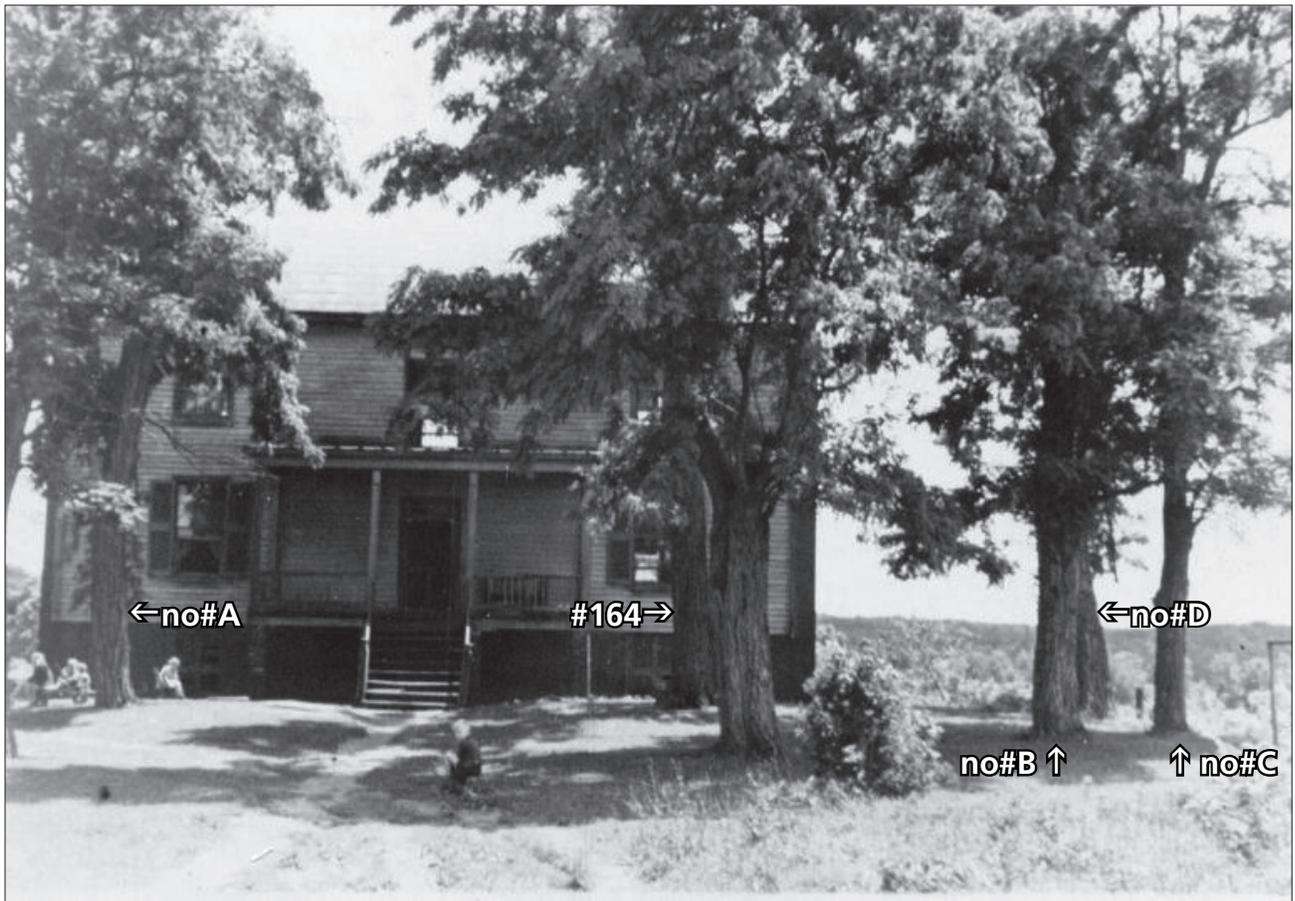
Figure 2c.49. View looking south at the Isbell House in 1940, and the two missing black locust (no#A,#164) flanking the front earthen path, the black locust (no#B) to the west, and the two black locusts (no#C,no#D) along the west fence line. (APCO Park Archives, #11409-01 1071)

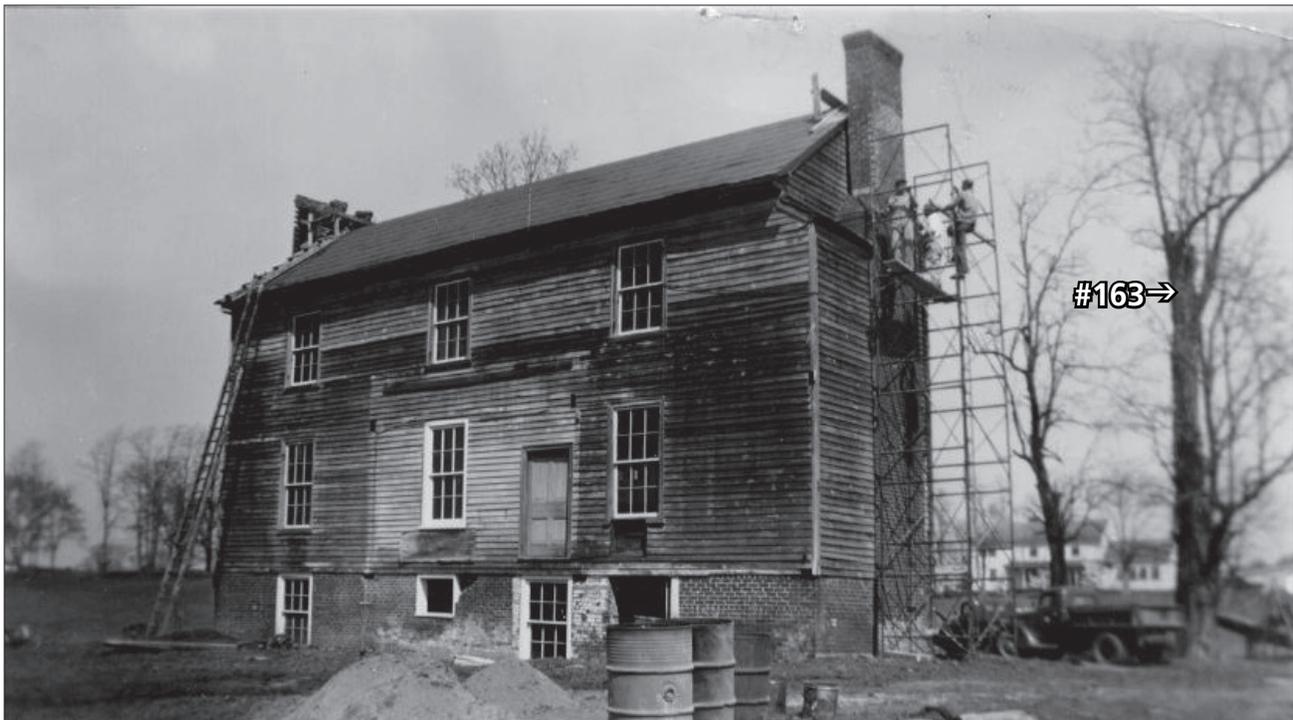
Figure 2c.50. View looking northwest at the Isbell House in 1948, and the missing black locust (#163) northeast of the house. (APCO Archives, #11416-01 1114)

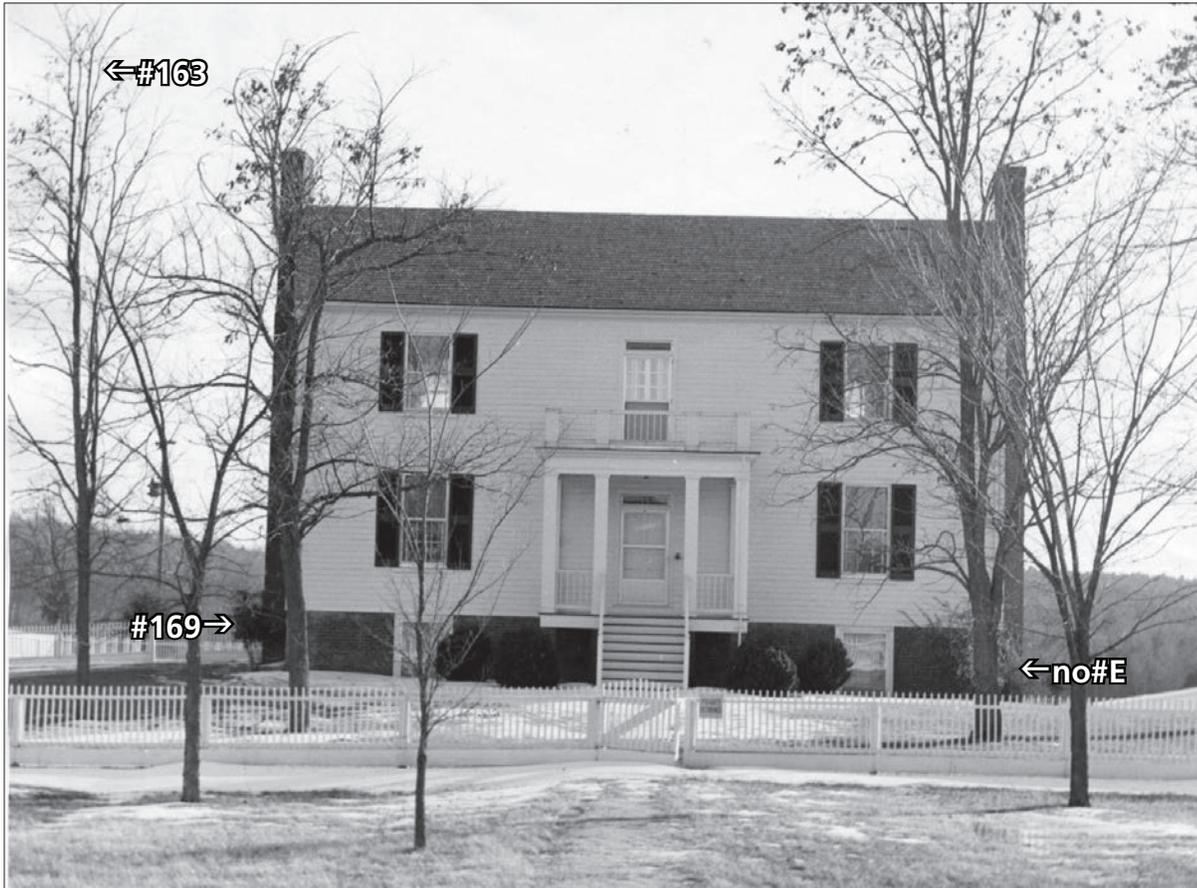
Figure 2c.51. View looking south at the Isbell House in c.1960, and the missing black locust tree (#163) in the front yard and the lilacs (#169,no#) at the northeast and northwest corners of the house. (APCO Park Archives, #11501-01 1894)

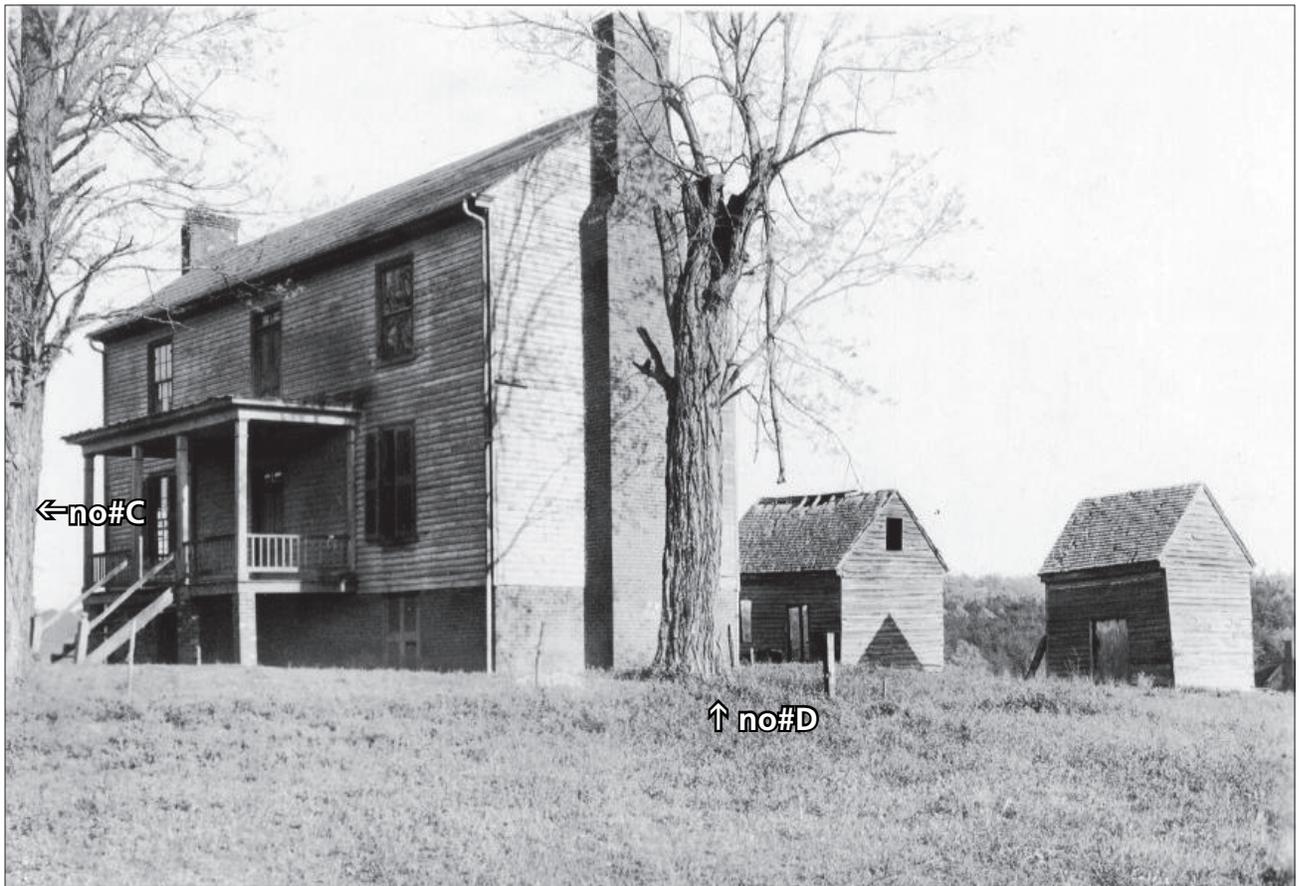
Figure 2c.52. View looking southeast at the Isbell House in 1941, and the missing black locusts (no#C,no#D) along the west yard fence. (APCO Archives, #11411-07 1080)

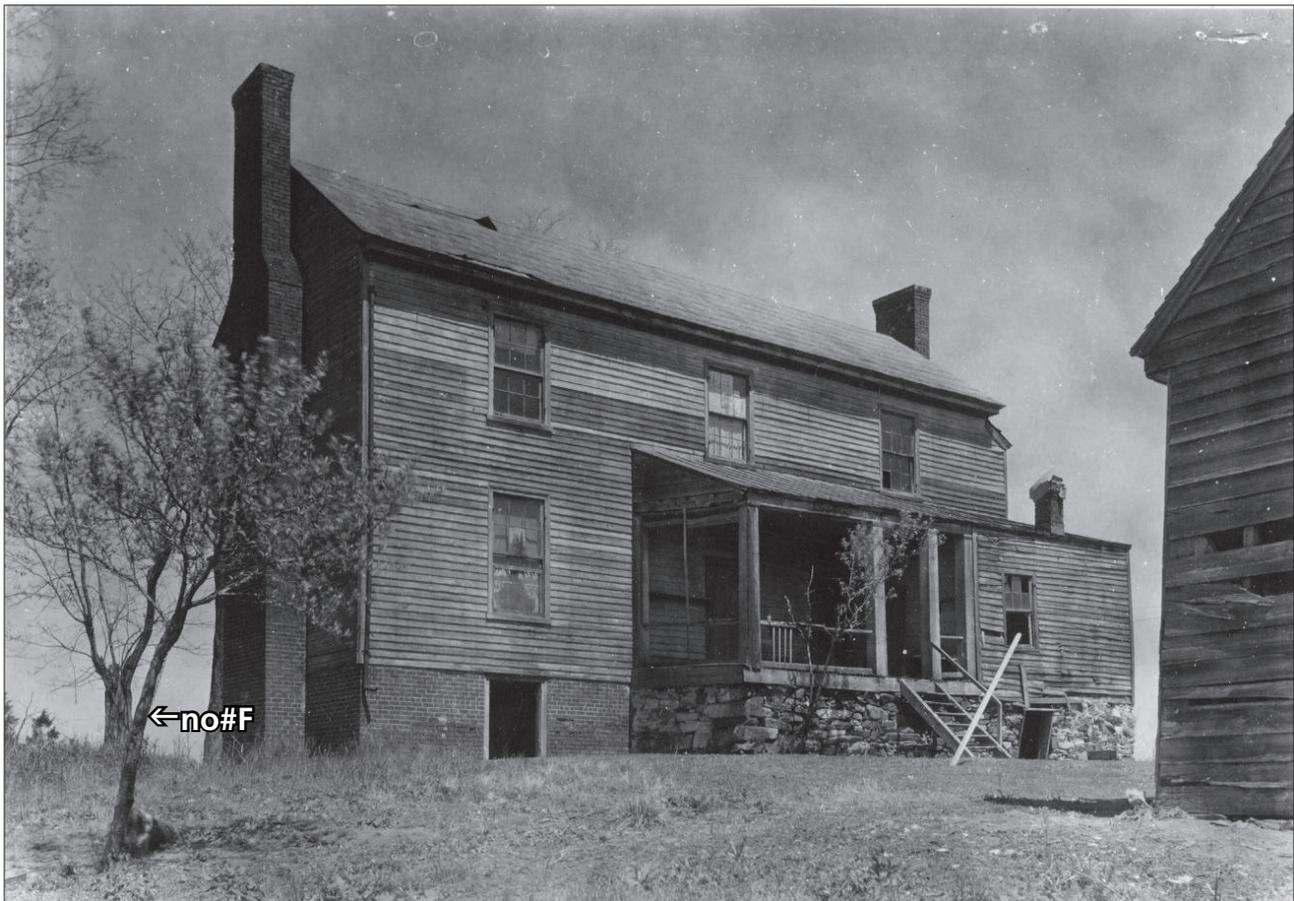
Figure 2c.53. View looking northeast at the Isbell House in 1941, and the missing apple (no#F) southwest of the house. (APCO Archives, #11411-02 1075)

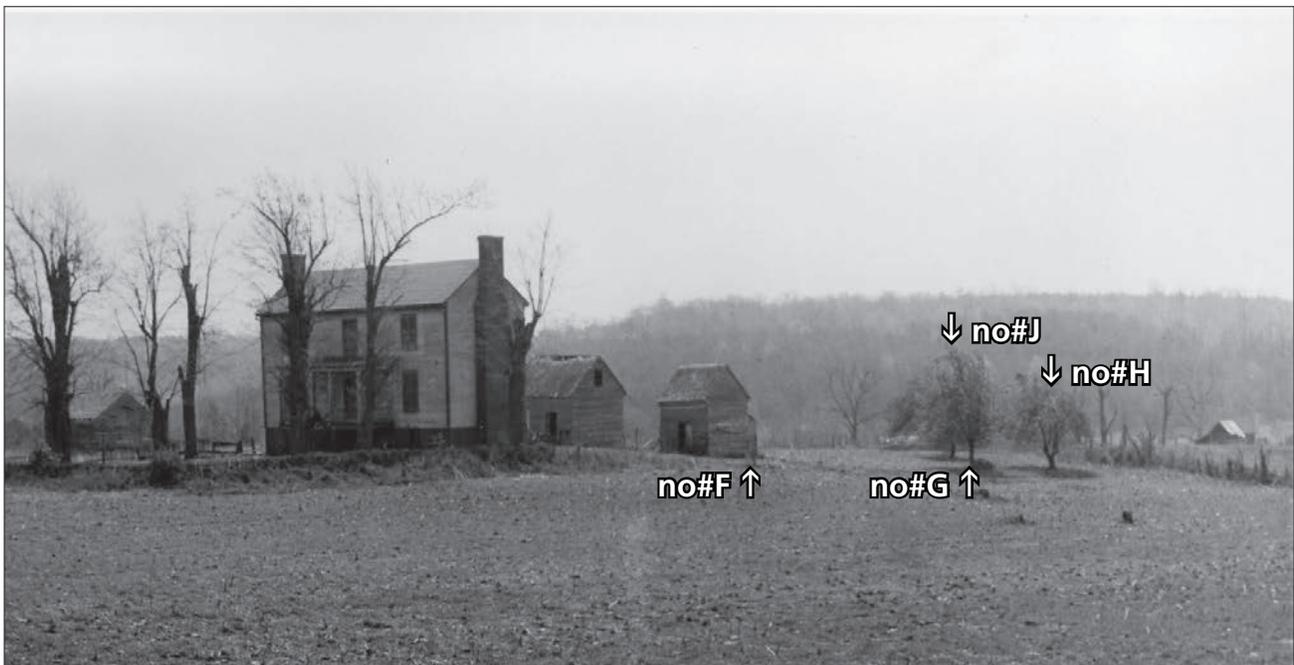
Figure 2c.54. View looking southeast at the Isbell House and outbuildings in 1936, and the missing apples (no#F,no#H,no#J) and pear (no#G). (APCO Archives, #11989)

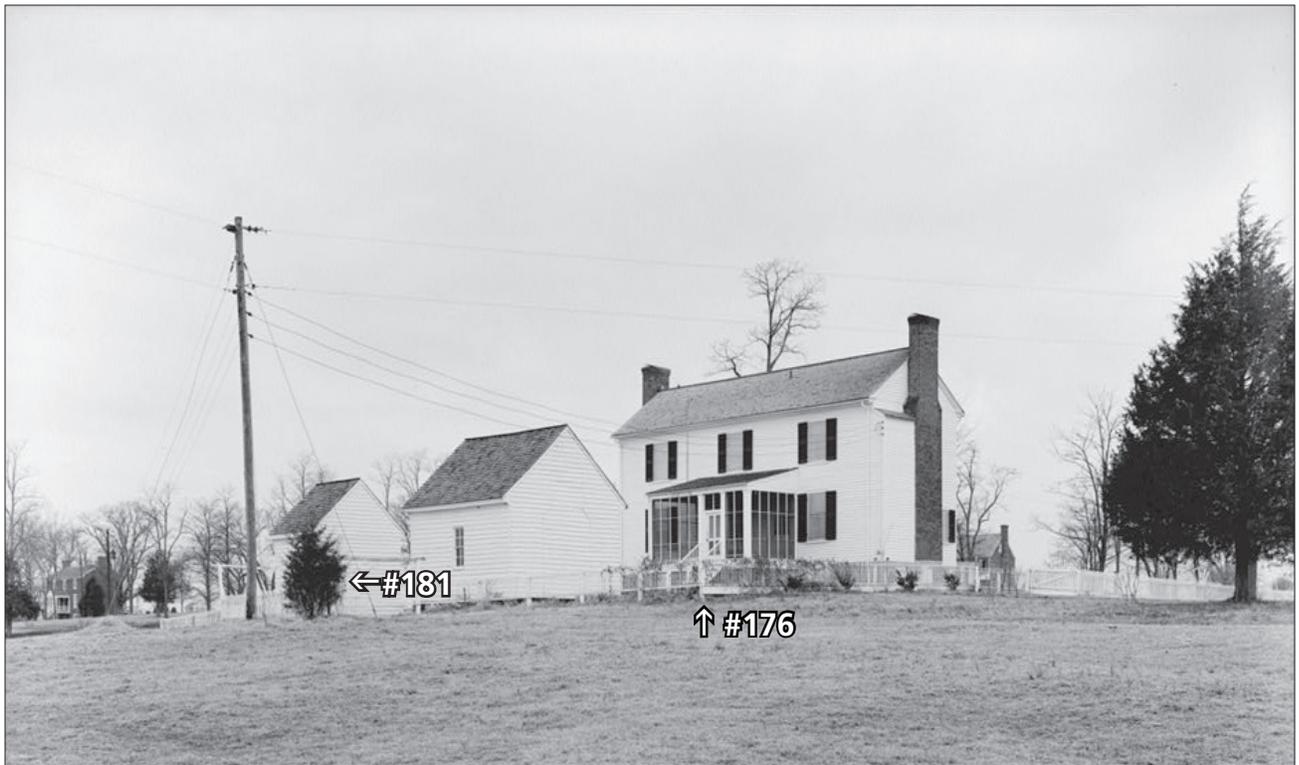
Figure 2c.55. View looking northwest at the Isbell House, outside kitchen, and smoke house in 1964, and the missing rose (#176) at the southeast corner of the fence and Virginia redcedar (#181) just south of southeast corner of the fence. (HABS, VA-1314-1, #163736)

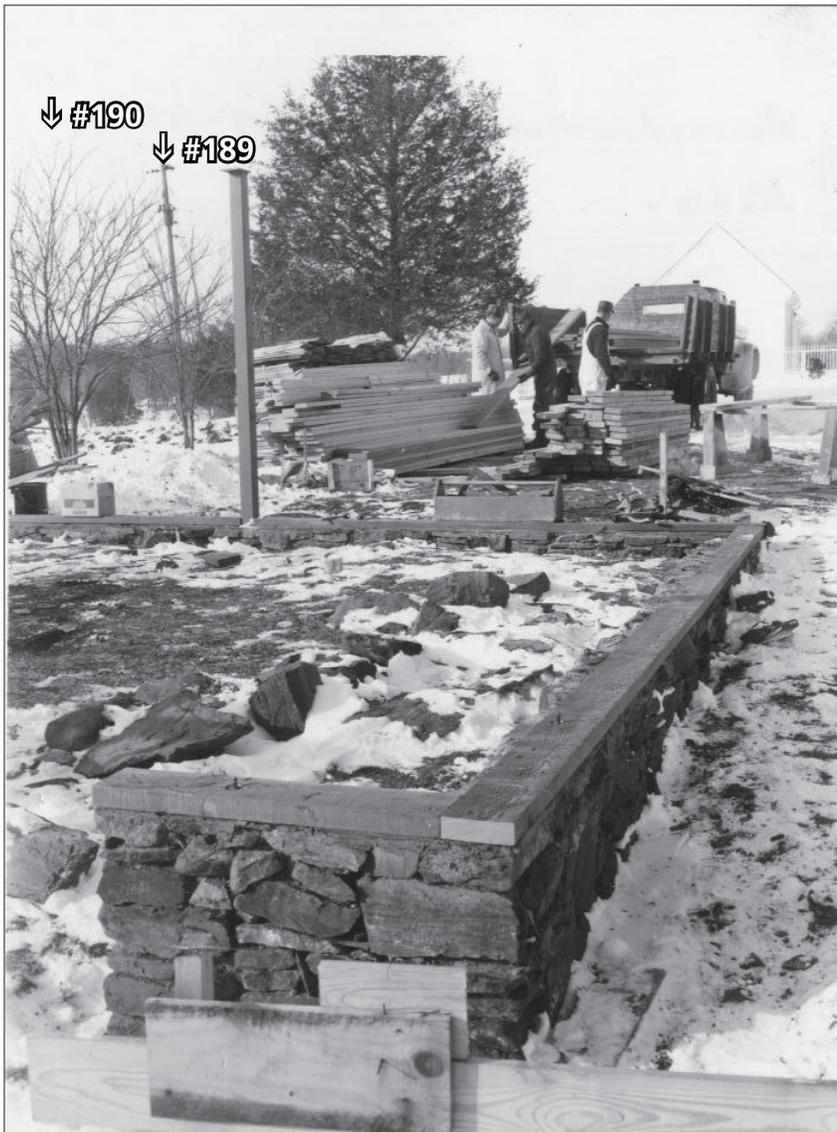
Figure 2c.56. View looking west-southwest at the Isbell stable foundation in 1964, and the missing redbuds (#s 189,190) between the Virginia redcedar and the stable. (APCO Archives, #11500-05 1893)

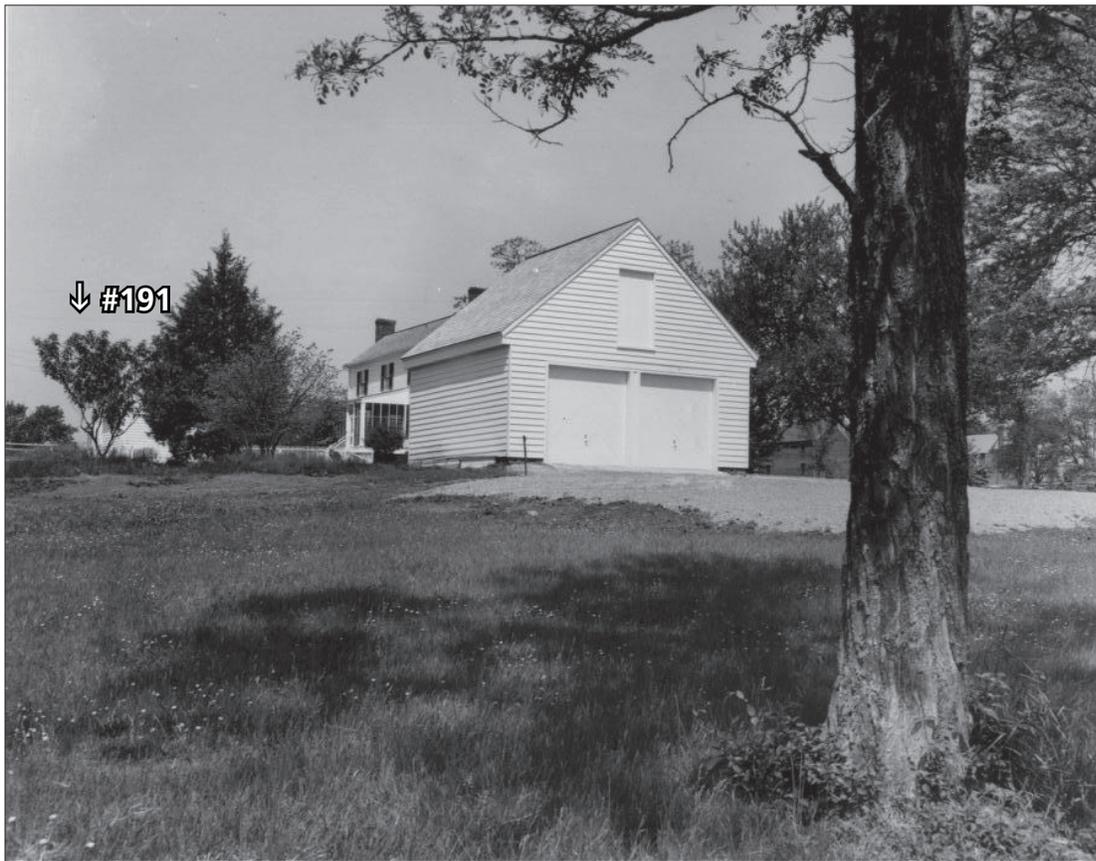
Figure 2c.57. View looking northwest at the Isbell stable in 1964, and the missing paper mulberry (#191) just south of the stable. (APCO Archives, #11500-05 1893)

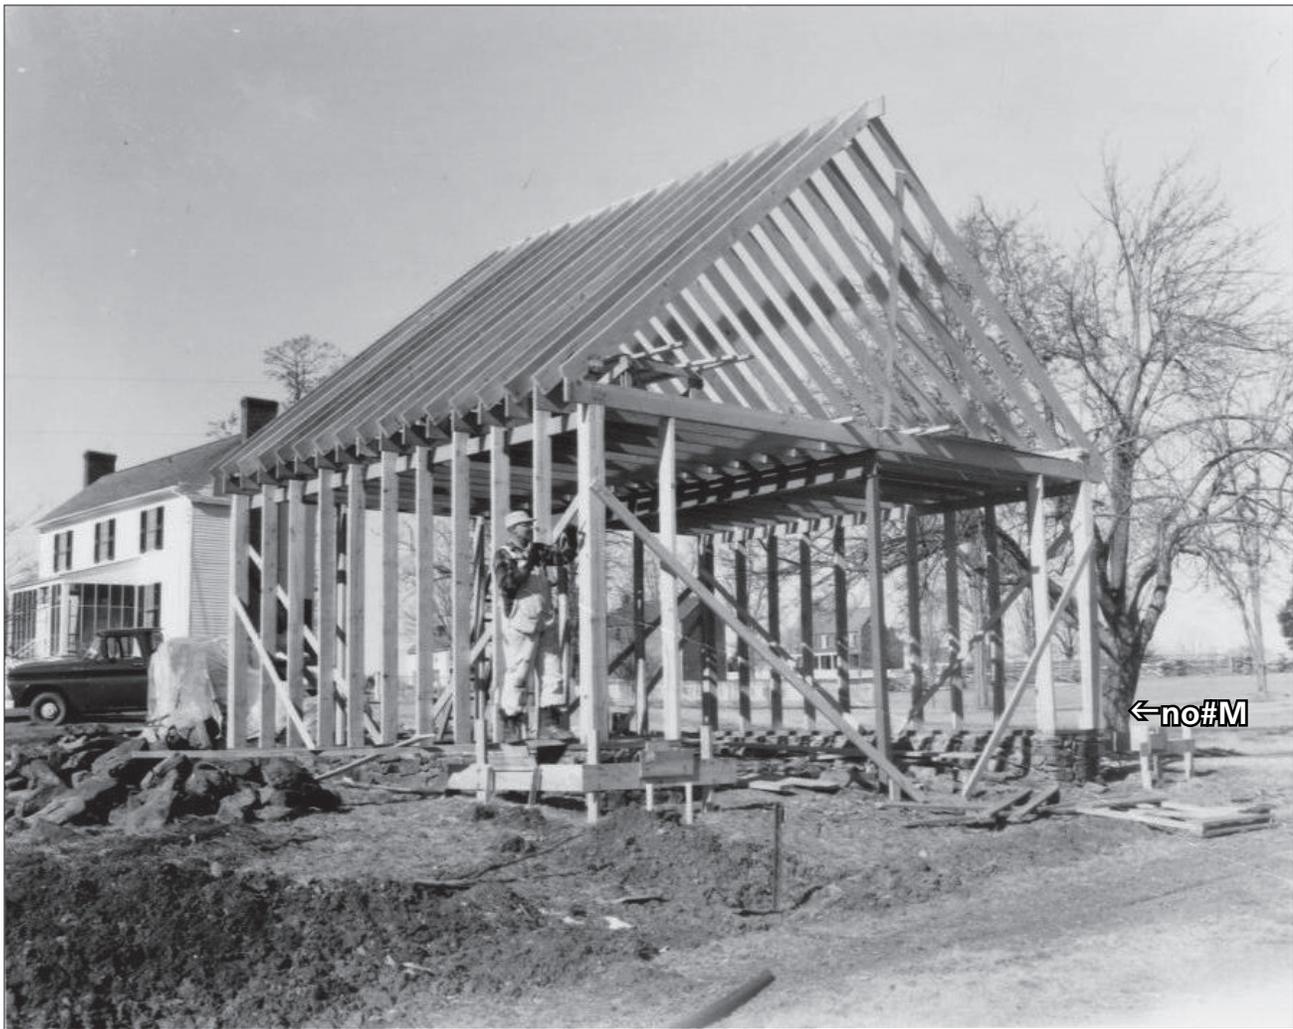
Figure 2c.58. View looking northeast at the reconstruction of the Isbell stable in 1964, and the missing apple (no#M) on the north side of the driveway. (APCO Archives, #11500-01 1893)

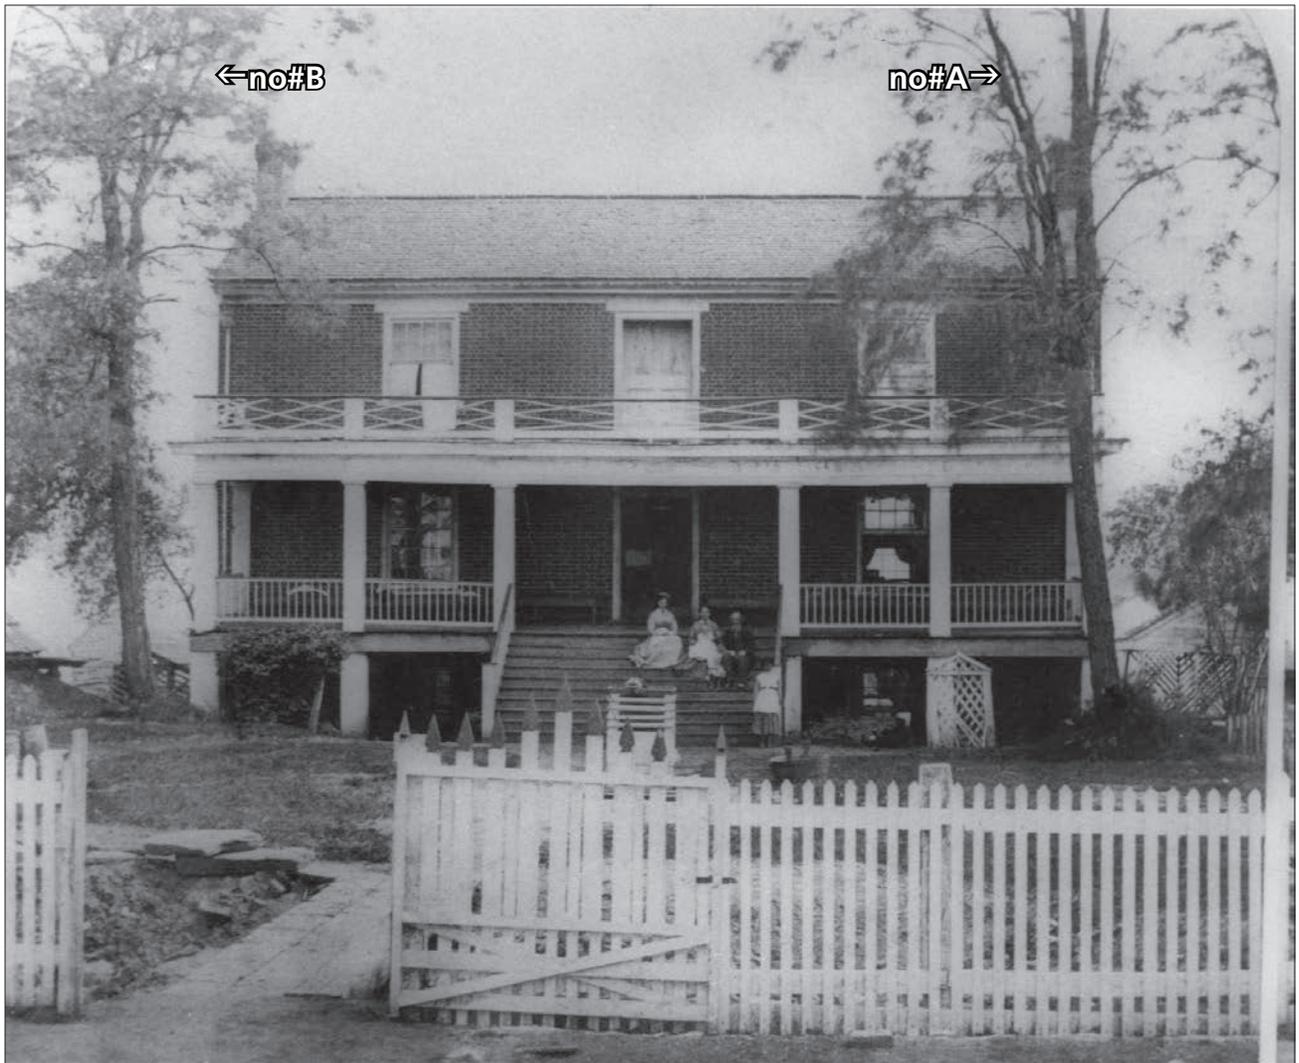
Figure 2c.59. View looking south at the McLean House in c.1865-70, and the missing black locusts (no#A,no#B) at the corners of the front porch. (APCO Archives, #HF-153-A-01)

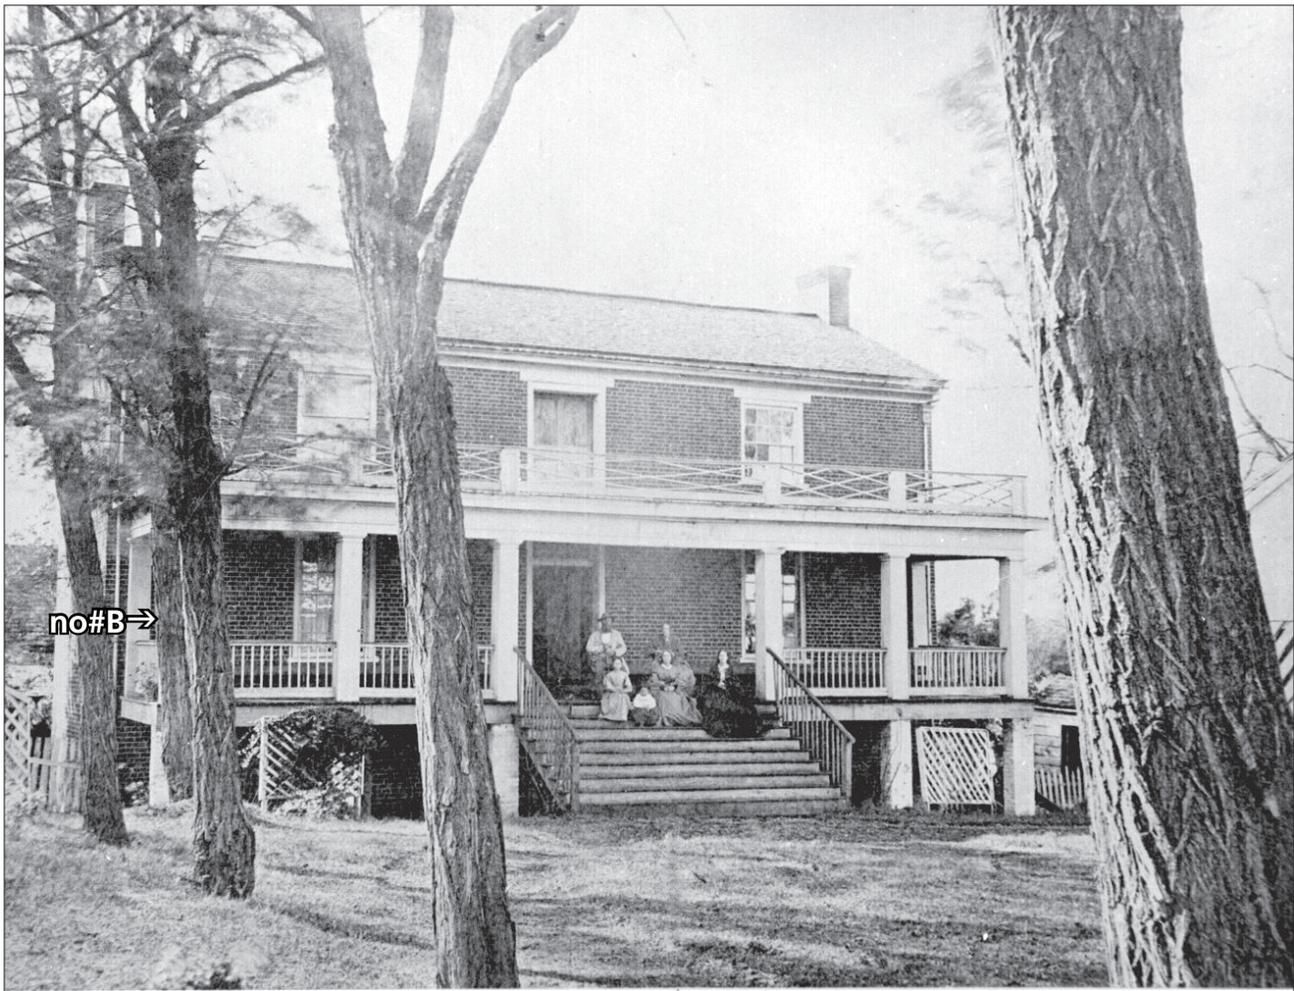
Figure 2c.60. View looking southwest at the four locusts on the east side of the front lawn at the McLean House in c.1865, and one of the missing black locusts (no#B) at the northeast corner of the front porch. (APCO Archives, #HF-152.75)

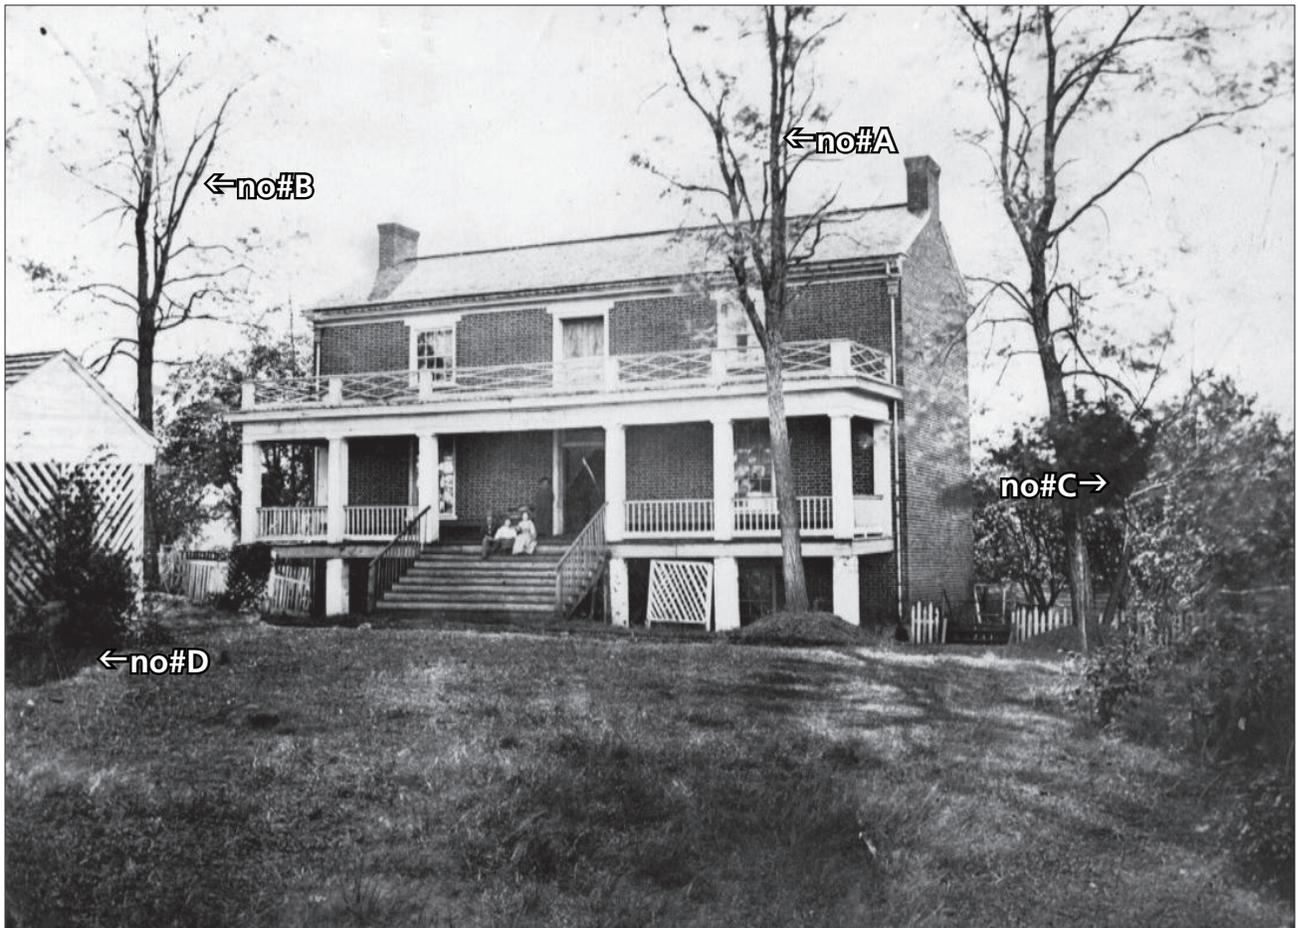
Figure 2c.61. View looking southeast at the McLean House and the well house on left, c.1865, and the two missing black locusts (no#A,no#B) flanking the corners of the front porch, a missing Virginia redcedar (no#C) along the west edge of the yard, and a missing rose (no#D) on the west side of the well structure. (APCO Archives, #HF-150-01)

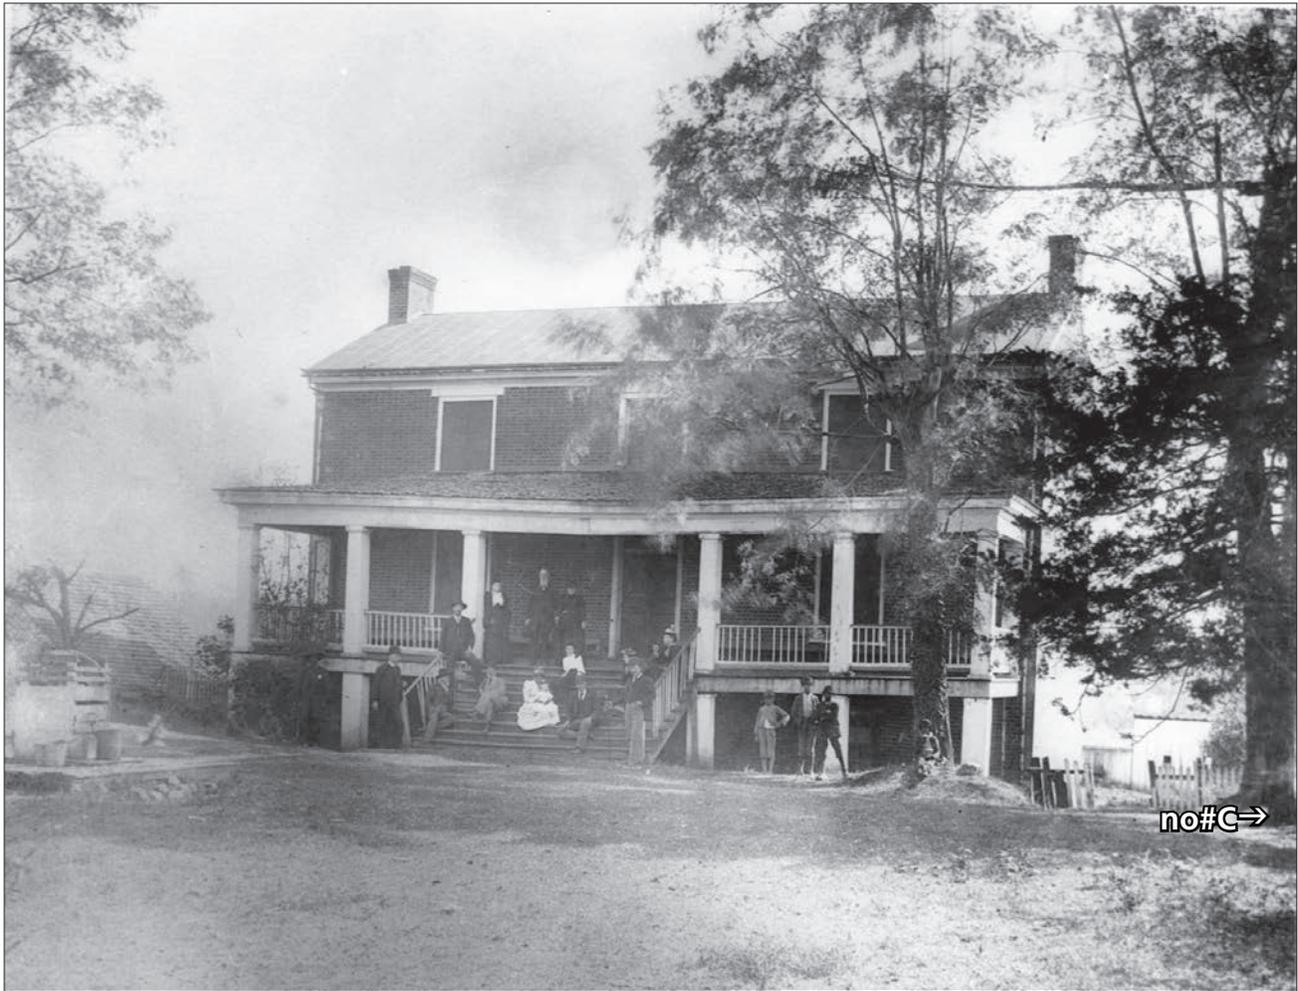
Figure 2c.62. View looking south at the McLean House c.1892, and the missing Virginia redcedar (no#C) on the west edge of the front lawn. (APCO Archives, #HF-157-01)

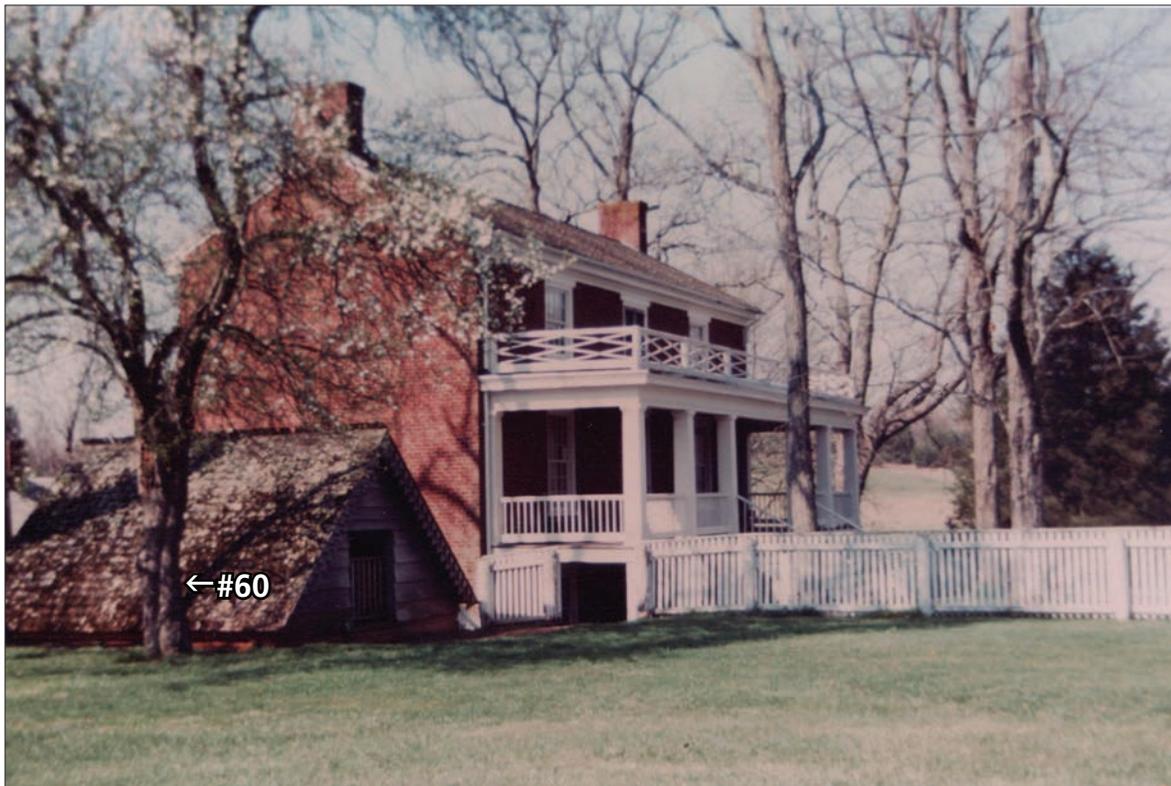
Figure 2c.63. View looking west-southwest at the McLean House in 2000, and the missing pear tree (#60) next to the ice house. (APCO Archives, #HF-167-A-01)

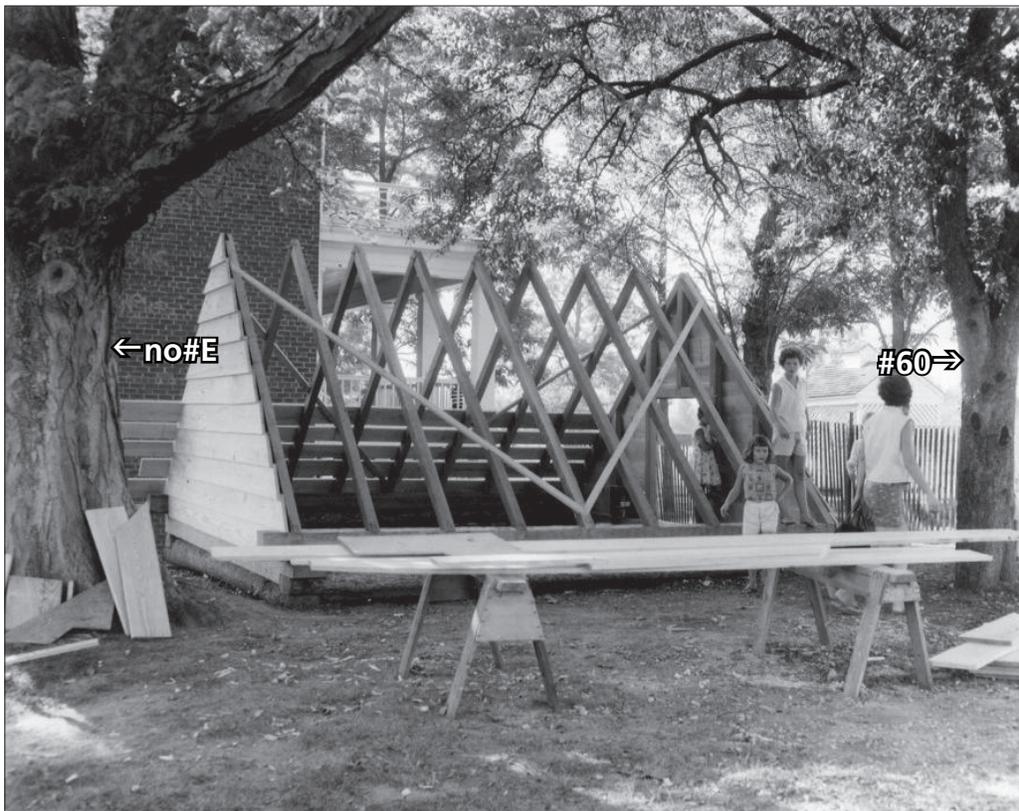
Figure 2c.64. View looking west-northwest at the reconstruction of the ice house in c.1964, and the missing honey locust (no#E) and pear (#60). (APCO Archives, #11513-04 1903)

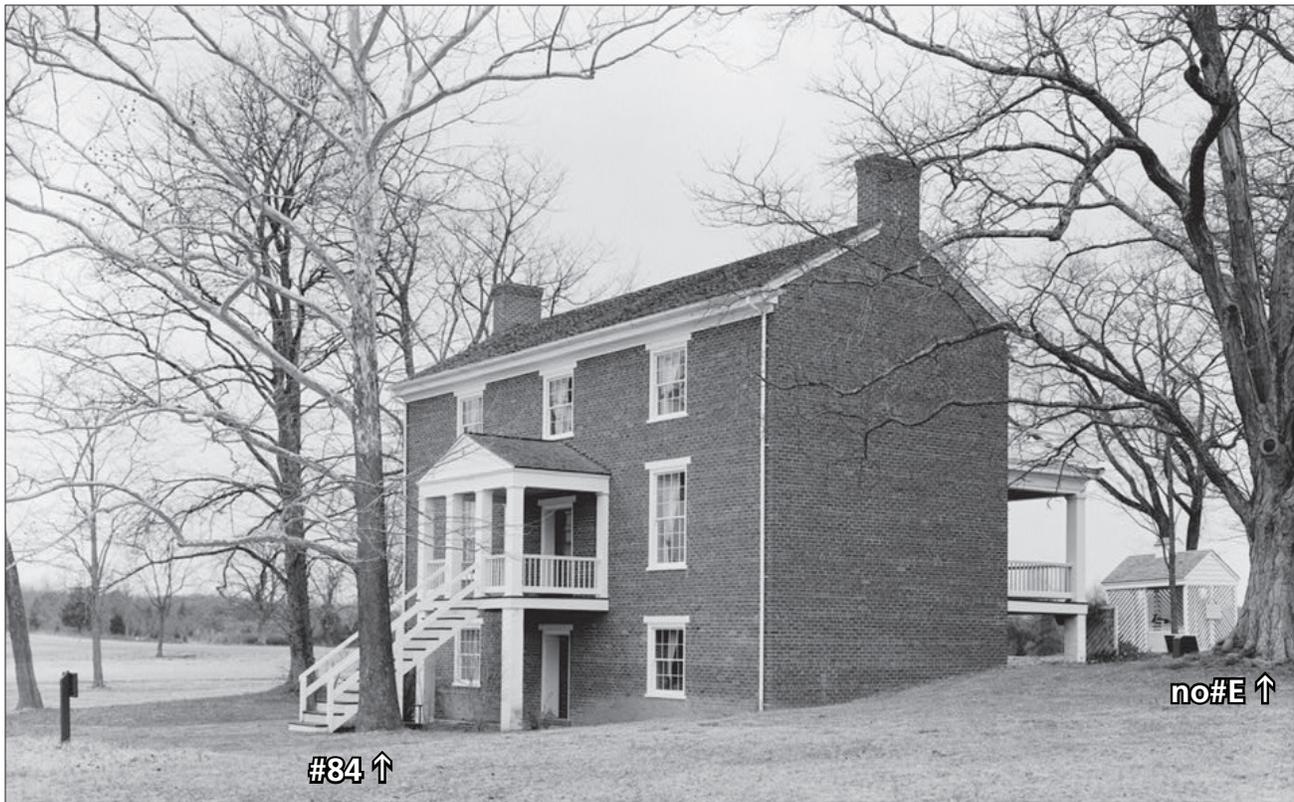
Figure 2c.65. View looking northwest at the south (rear) and east sides of the McLean House in 1964, and the missing sycamore (#84) at the back steps and the honey locust (no#E) next to the former ice house. (HABS, VA-240-3, #163748)
