CULTURAL LANDSCAPE REPORT FOR APPOMATTOX COURT HOUSE NATIONAL HISTORICAL PARK

VOLUME II: TREATMENT IMPLEMENTATION PLAN

APPOMATTOX, VIRGINIA

National Park Service, Boston, Massachusetts, 2018

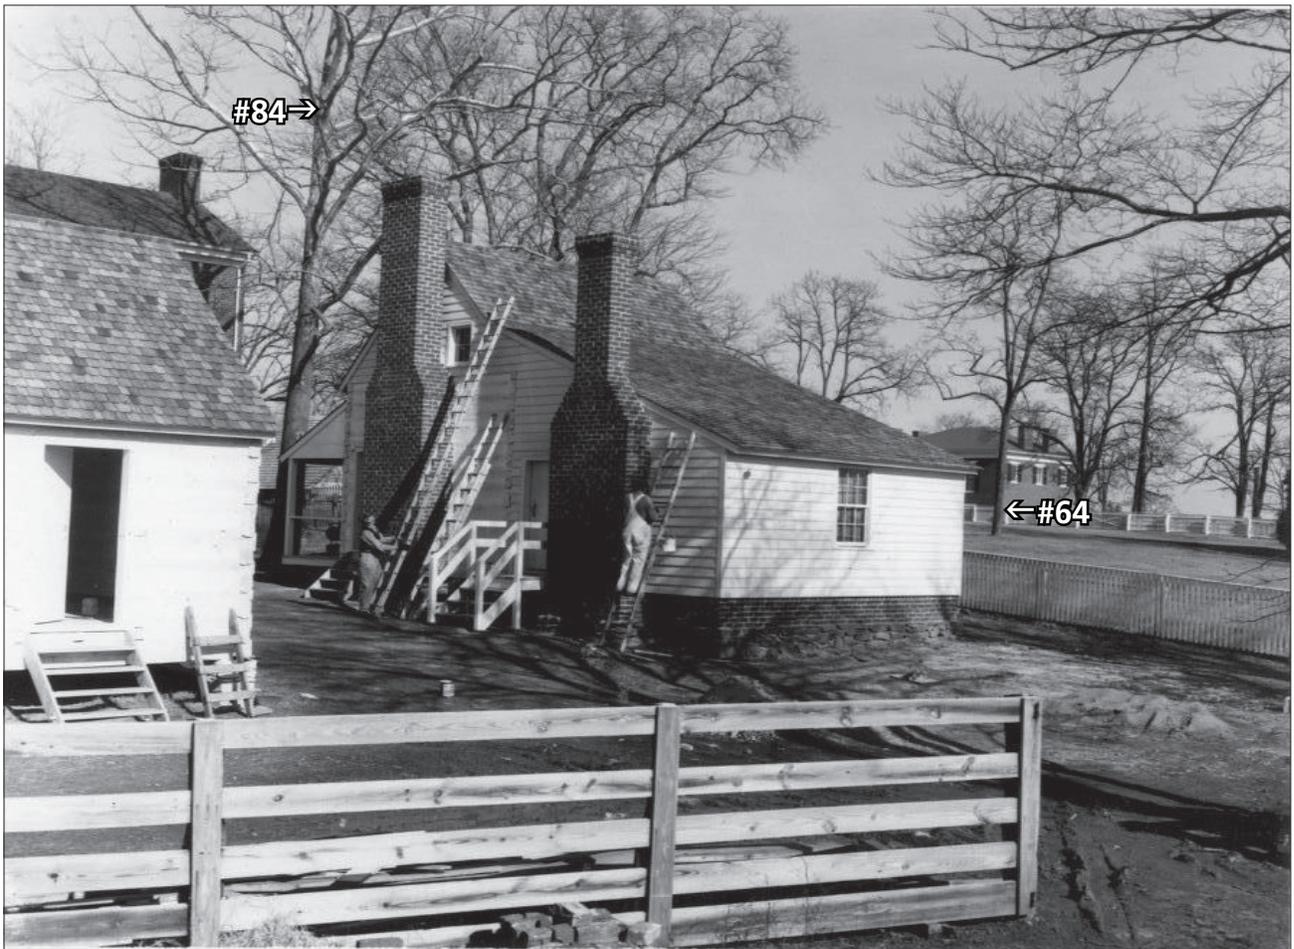
Figure 2c.66. View looking northeast at the slave quarters and outside kitchen in 1964, the missing sycamore (#84) between the McLean House and kitchen, and the missing honey locust (#64) in the field east of the house. (APCO Archives, #11519-01 1908)

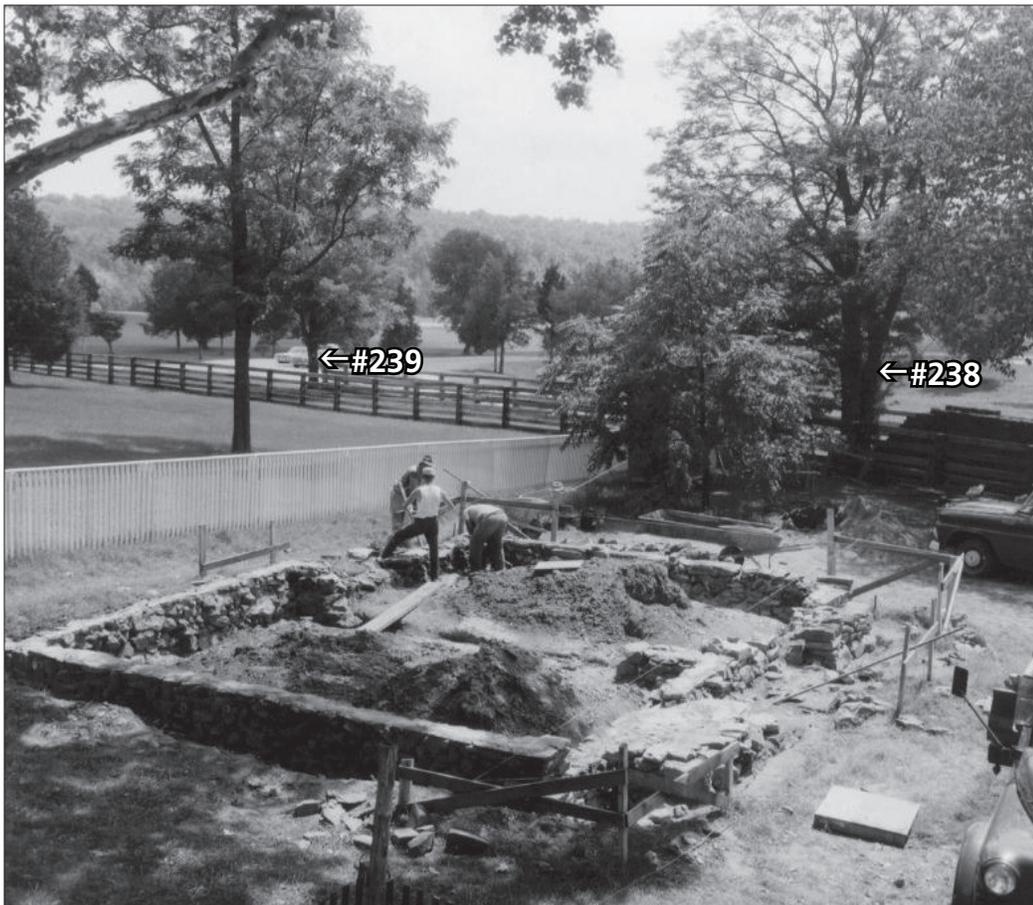
Figure 2c.68. View looking southeast at the reconstruction of the McLean Kitchen in 1963, and the missing honey locust (#238) and black locust (#239) along the Back Lane fence. (APCO Archives, #11519-05 1908)

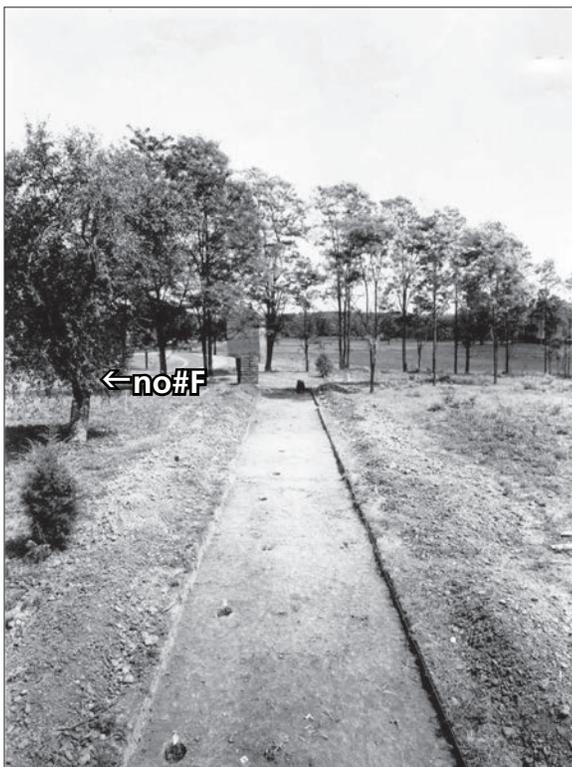
Figure 2c.69. View looking east at archaeological work in the field east of the McLean House in 1941, and the missing apple tree (no#F). (APCO Archives, #11461-22 1370)

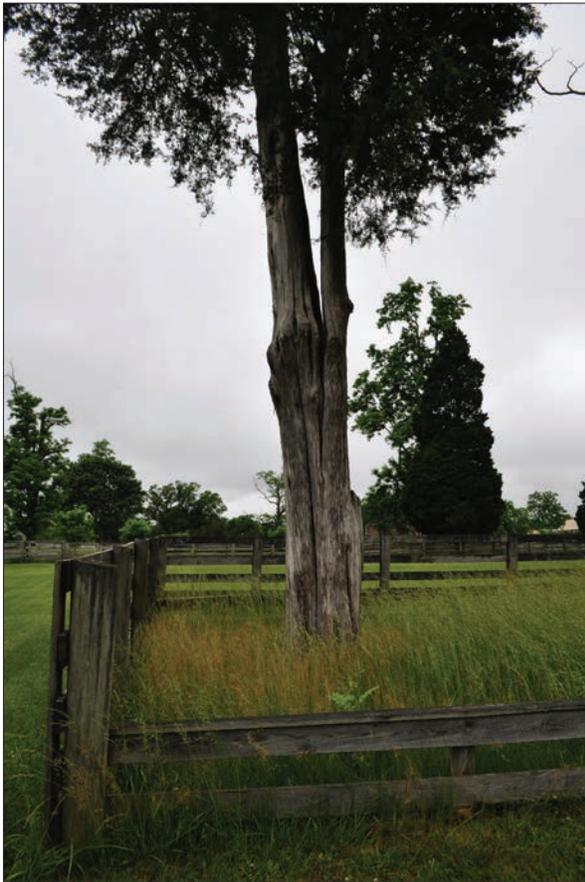
Figure 2c.70. View looking south at the Robinson Cemetery. The historic Virginia redcedar (#265) is splitting and should be stabilized. (OCLP 2014, DSC_0751)

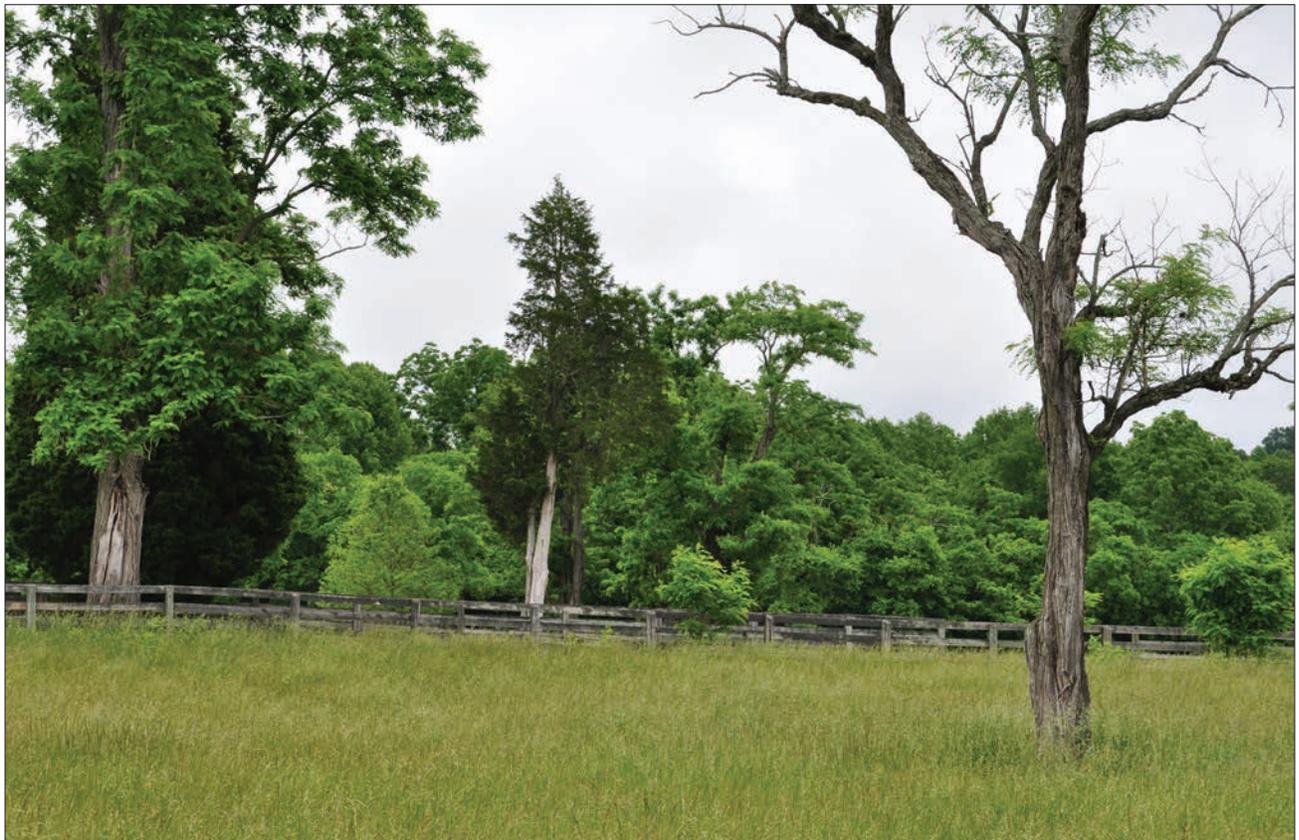
Figure 2c.71. View looking east from the field northeast of the Isbell House. The historic black locust (#141) on the right is in poor condition and should be replaced-in-kind. (OCLP 2014, DSC_0779)

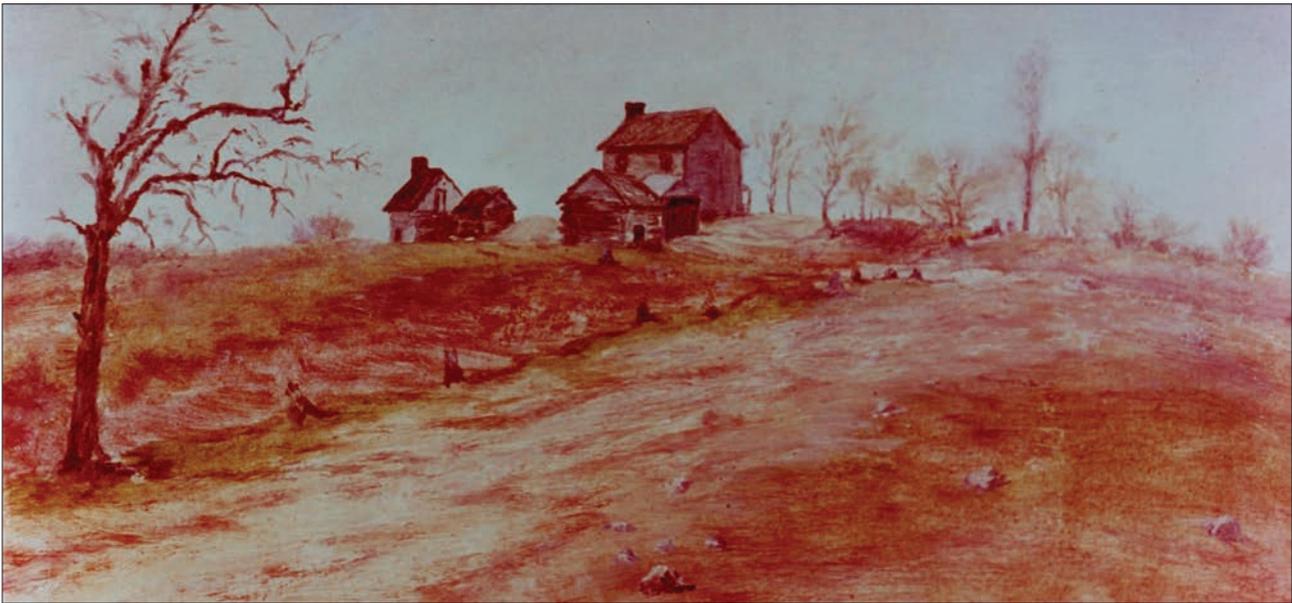
Figure 2c.72. Frankenstein's sketch of the Peers House, c.1866, suggests orchard trees in the yard northwest of the house. (APCO Archives, #HF-106-01)

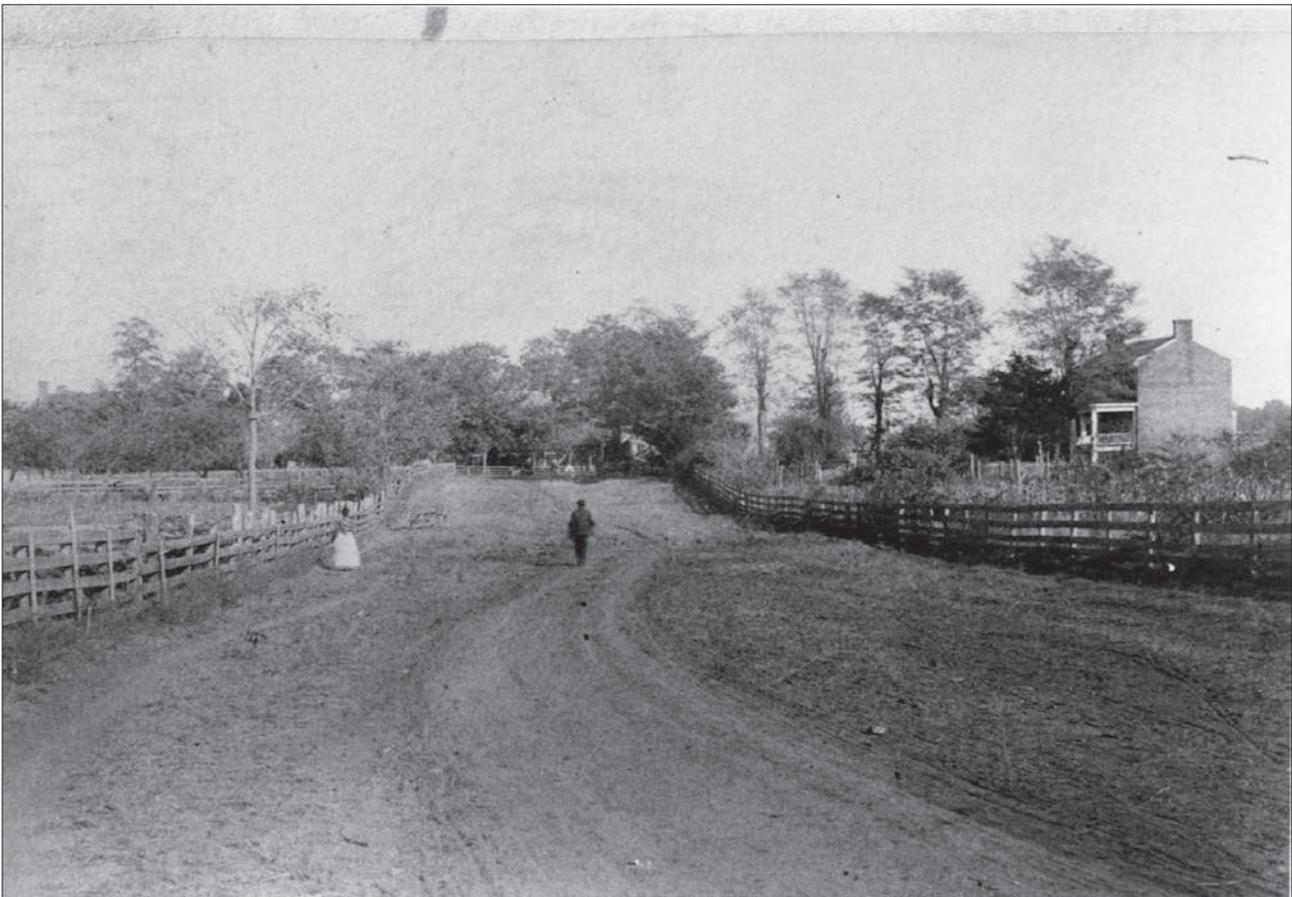
Figure 2c.73. View looking east along the Stage Road, c.1890, and what may be orchard trees in the field west of the McLean House. (APCO Archives, #HF-234-A-01)

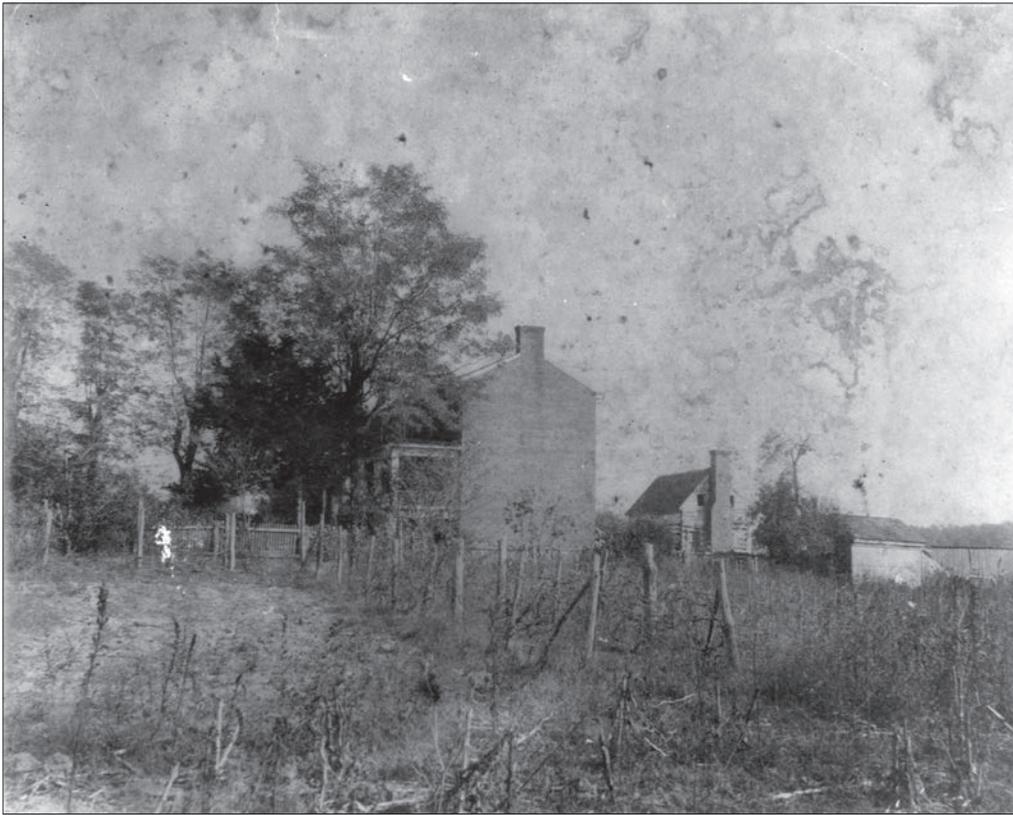
Figure 2c.74. View looking east at vegetation in the field west of the McLean House, c.1893. (APCO Archives, #HF-161-01)

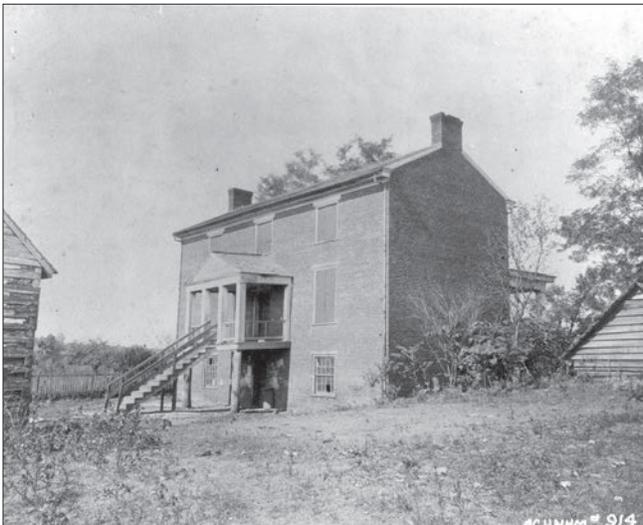
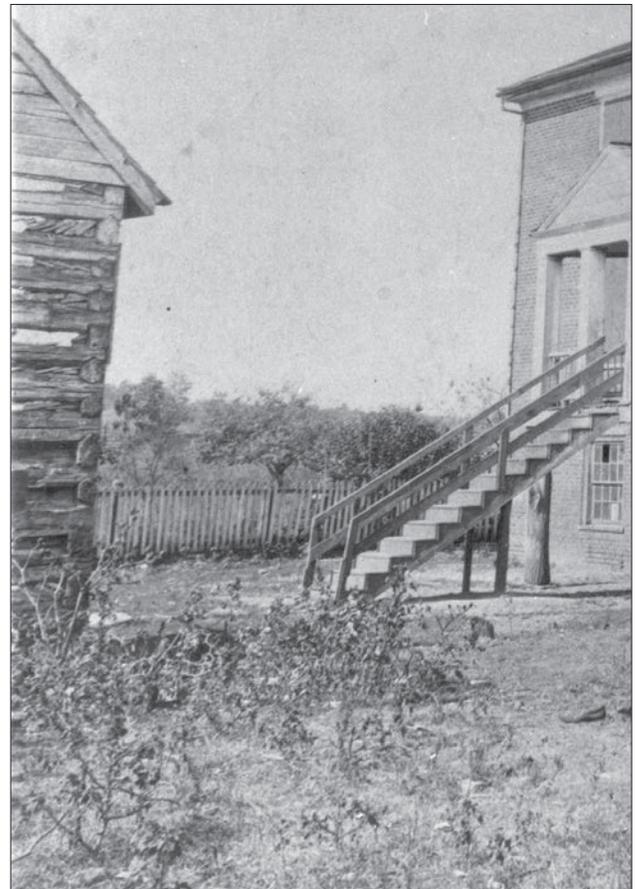
Figure 2c.75. View from c.1892 looking northwest at the McLean House. The enlargement at the right shows orchard trees in the field west of the house. (APCO Archives, #HF-159)

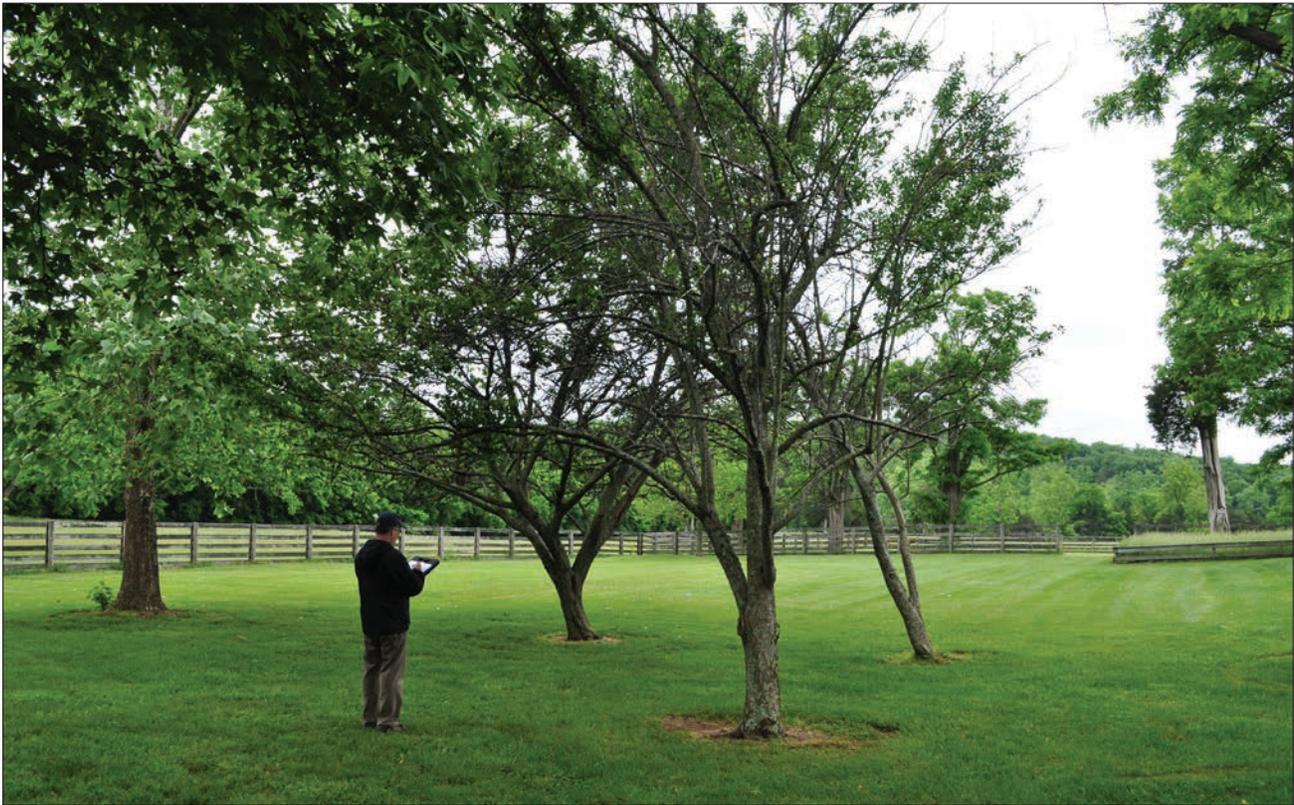
Figure 2c.76. View looking southeast at the small plum orchard in the yard just southwest of the Kelley House. The three plums (#s 262a-c) are not historic and should be removed. (OCLP 2014, DSC_0735)

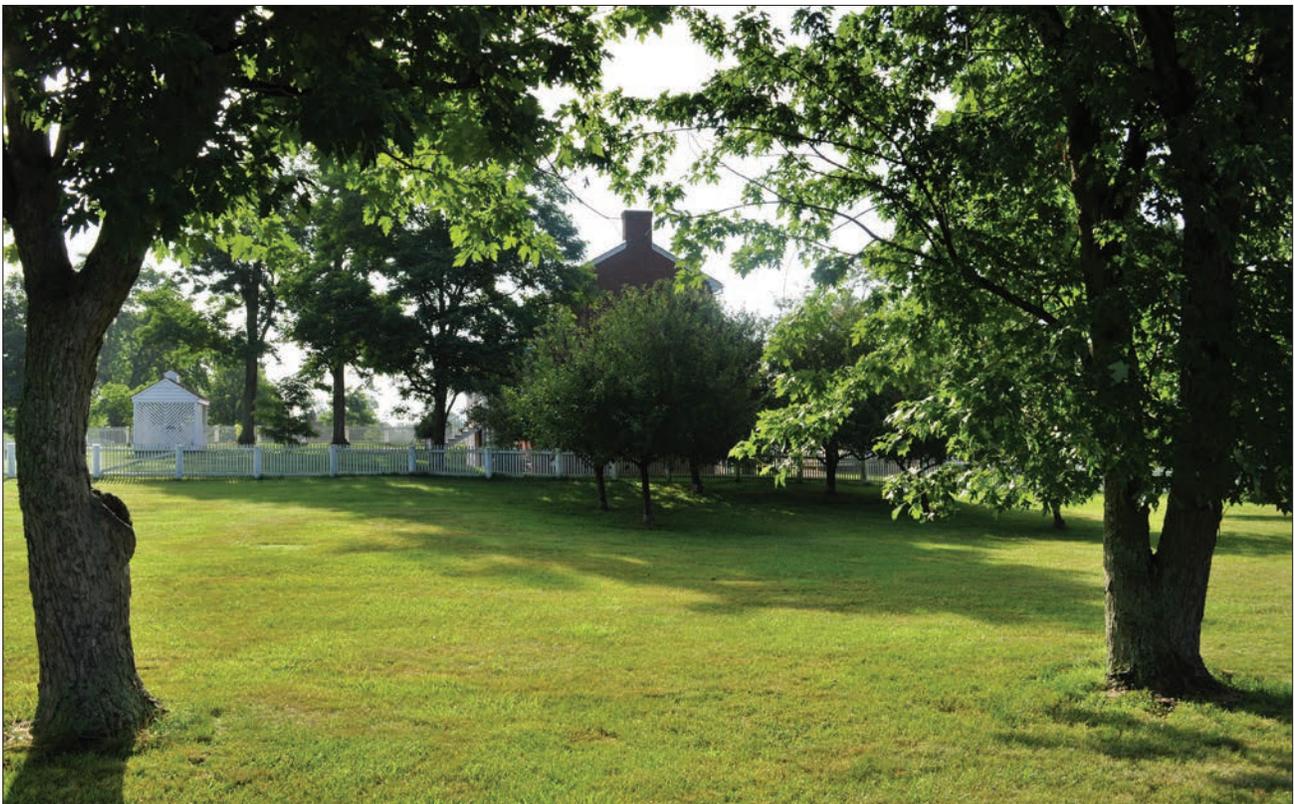
Figure 2c.77. View looking east at the apple orchard in the field west of the McLean House, next to the fence. The apples (#s 86a-f) are based on interpretation of historic photographs from the 1890s. (OCLP 2014, DSC_2131)

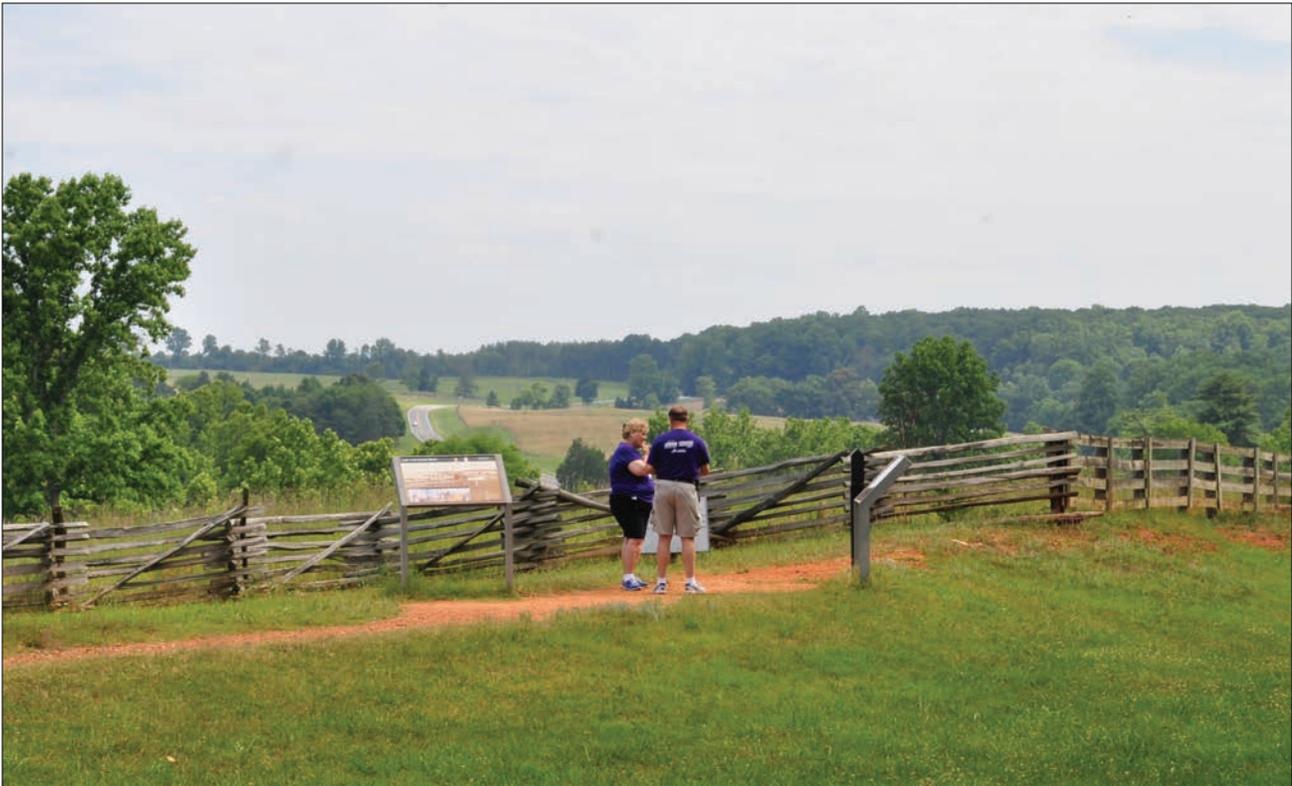
Figure 2d.1. View looking northeast at the wayside at the Grant & Lee Meeting Site. From this location, visitors should see the Richmond-Lynchburg Stage Road and Lee's apple tree site. (OCLP 2014, DSC_1821)

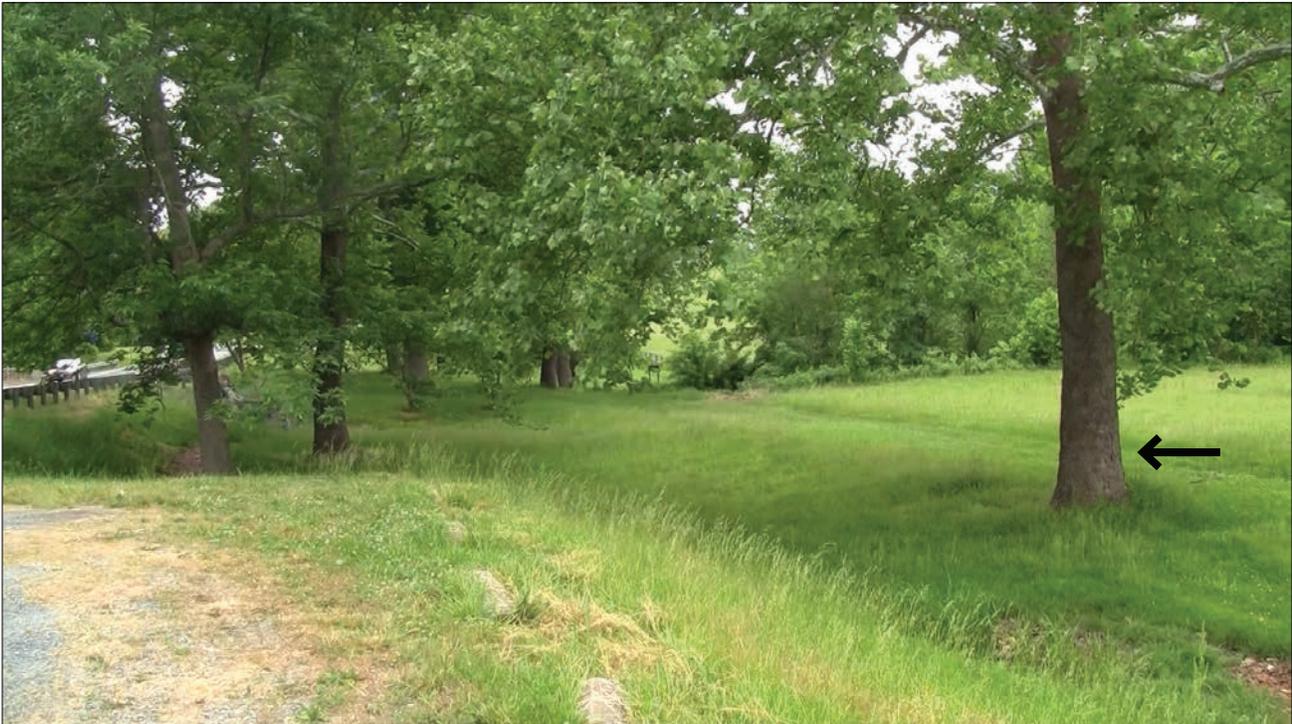
Figure 2d.2. Still frame of a video looking south from the picnic area next to the Memorial Bridge. The sycamore at image right (indicated with a black arrow) should be removed to improve the view from the Grant & Lee Meeting Site. (OCLP 2014, AVCHD Video, #00664)

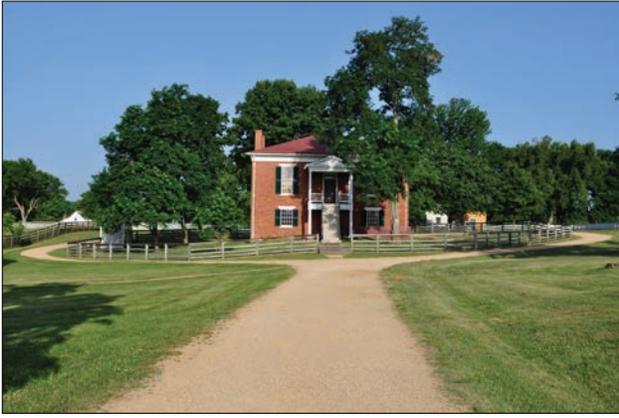
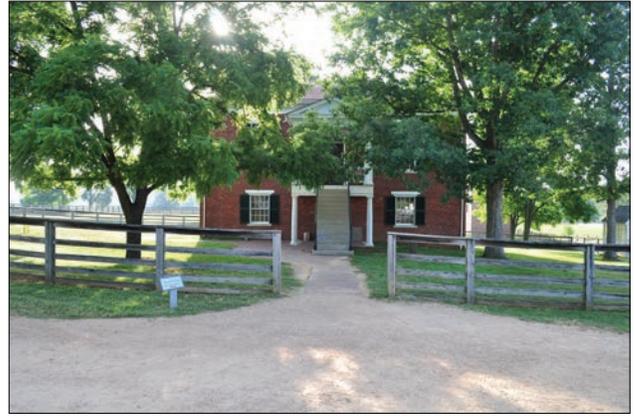
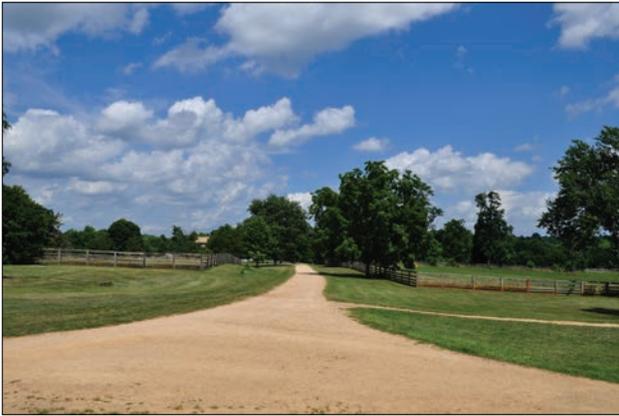
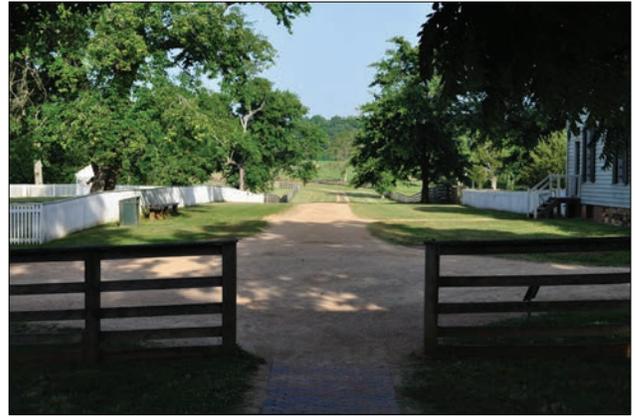
Figure 2d.3. Views to/from the east side of the courthouse. The lower image is taken from the second floor of the courthouse. (OCLP 2014, DSC_1881,1835,1876)

Figure 2d.4. Views to/from the west side of the courthouse. The lower image is taken from the second floor of the courthouse. (OCLP 2014, DSC_1867,1869,1870)

Views looking west at the east façade of the courthouse are in good condition, but the views looking east at the west façade of the courthouse are in fair condition (Figures 2d.3, 2d.4). The black walnut (#43) and the white oak (#55) on the west side of the building have matured to the point where their canopies now meet above the central brick walk. In many cases such growth would be a desirable effect, but the intertwined canopy blocks the important view to the courthouse from the Stage Road. The canopy of another tree farther west on the Stage Road, a red maple (#234), also blocks part of the view of the courthouse. This project aims to address the blocked view from Stage Road looking east to the courthouse.

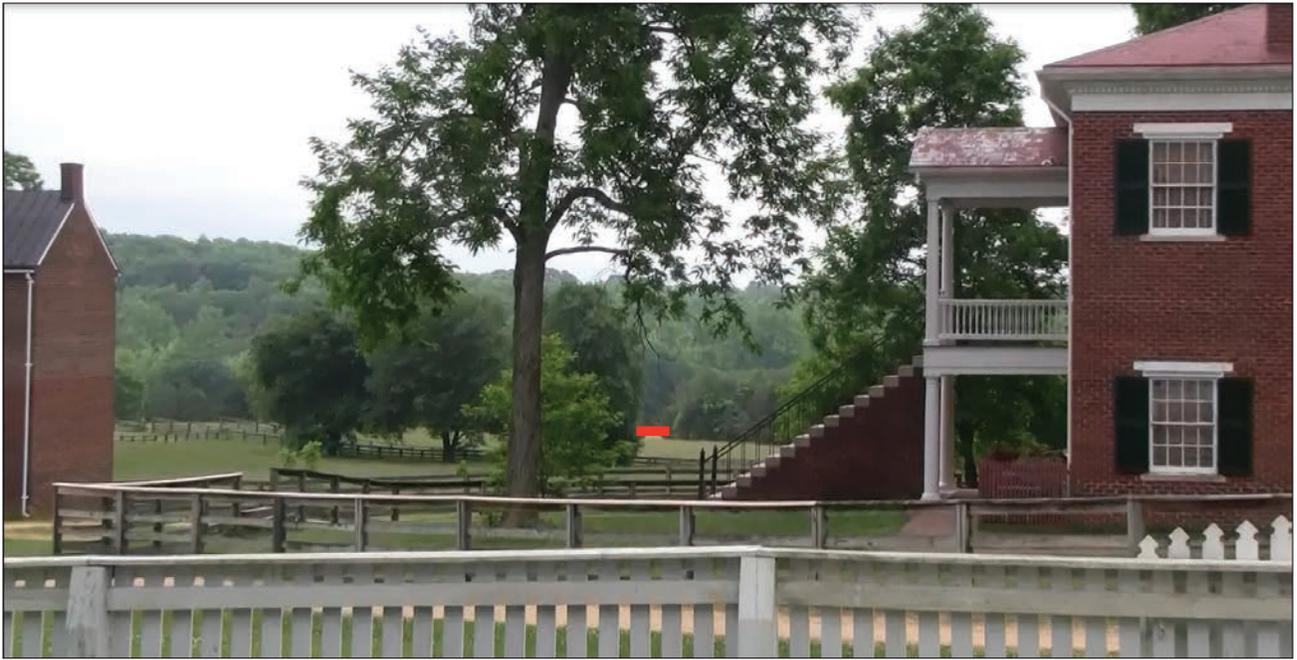
Figure 2d.9. Still frame of a video looking southeast from the Clover Hill Tavern. The proposed screen of vegetation is indicated by a red line, which coincides with the profile of the highway. (OCLP 2014, AVCHD Video, #00686)

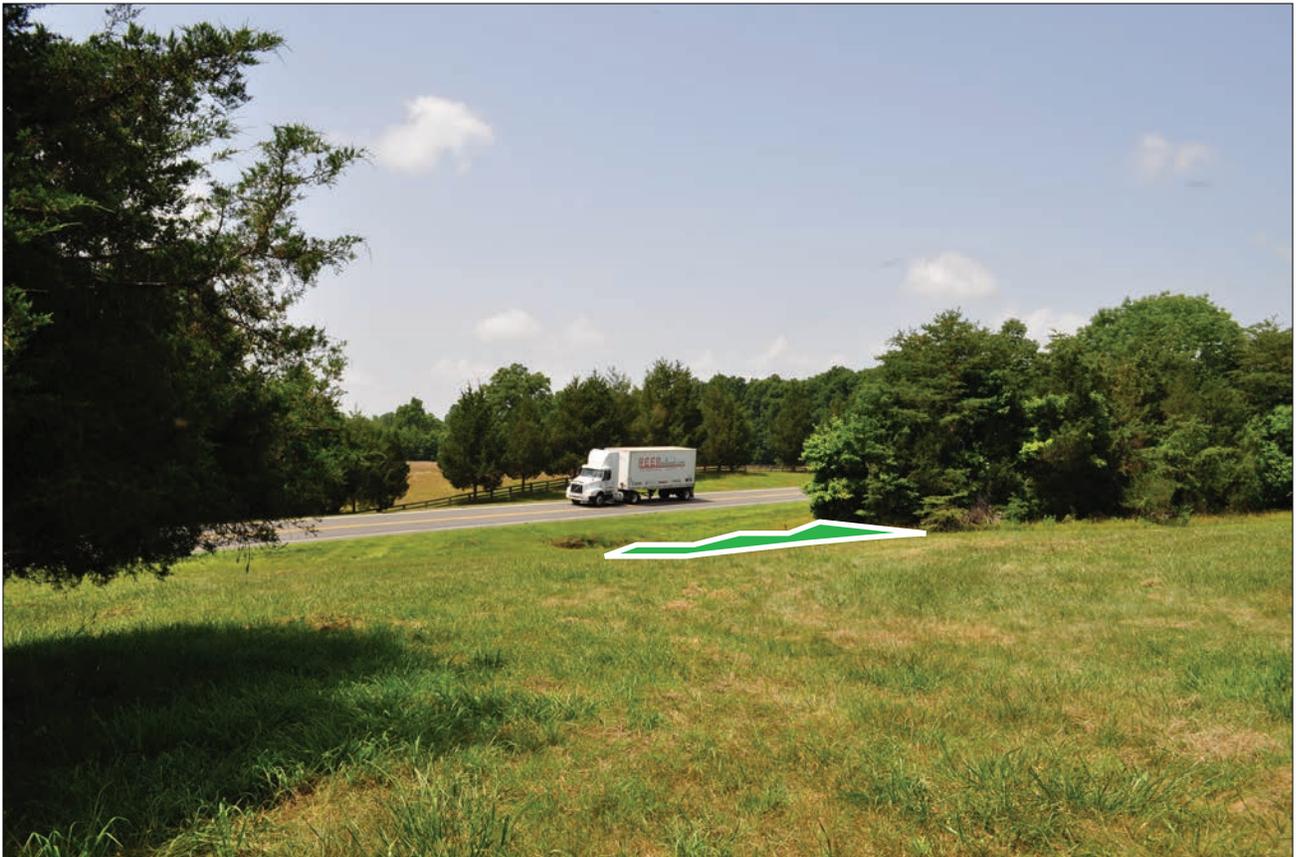
Figure 2d.10. View looking southwest at State Route 24. The mass of trees on the right should be extended eastward (indicated in green) to block the view of the road from the Clover Hill Tavern. (OCLP 2014, DSC_2020)

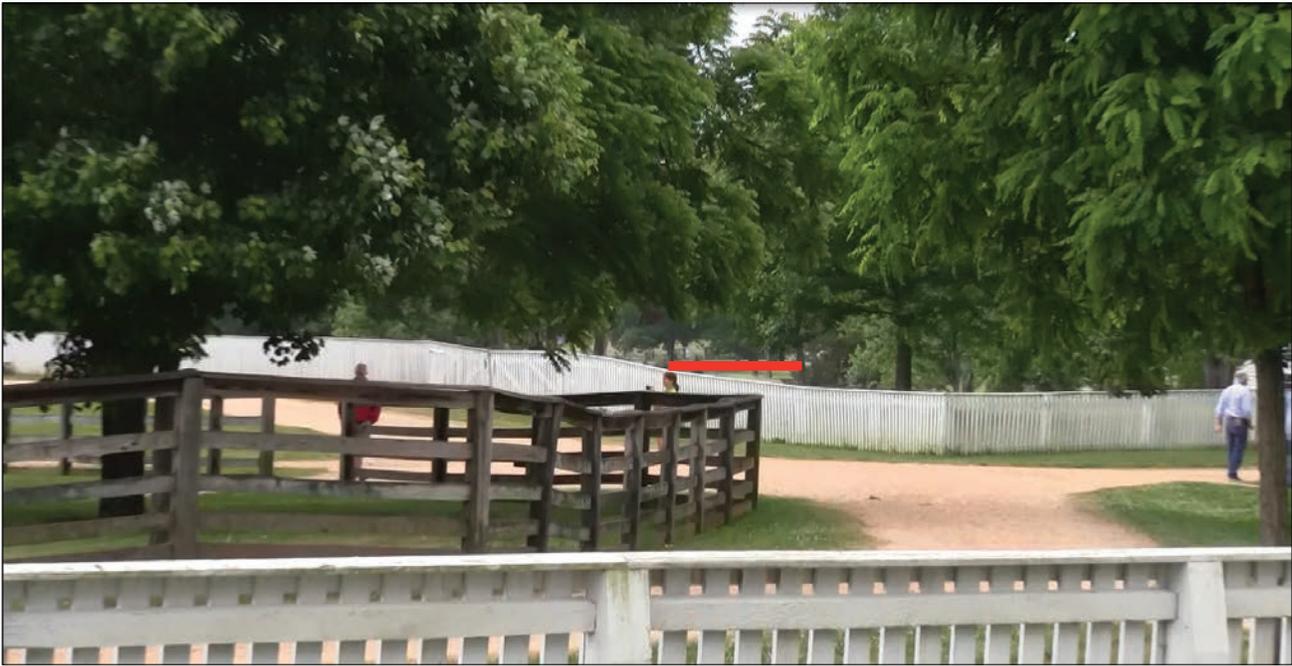
Figure 2d.11. Still frame of a video looking southwest from the Clover Hill Tavern. The proposed screen of vegetation is indicated by a red line, which coincides with the profile of the highway. (OCLP 2014, AVCHD Video, #00686)

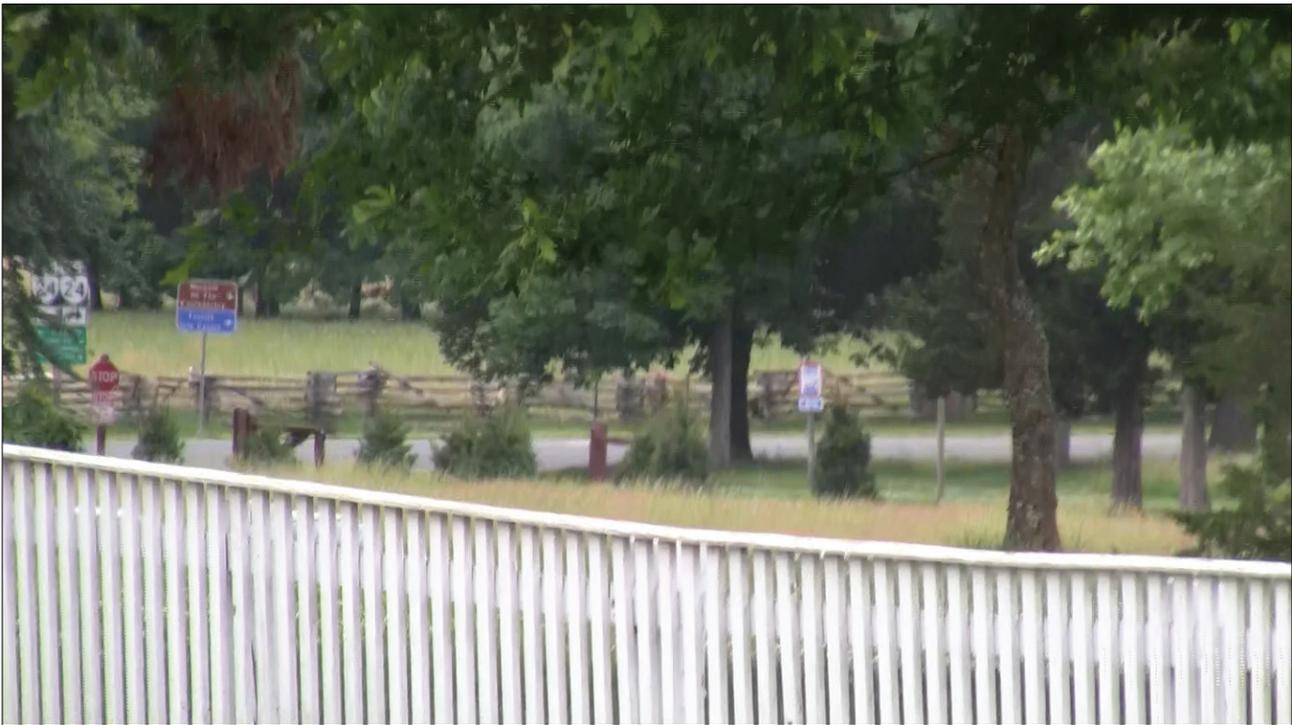
Figure 2d.12. Still frame of a video looking southwest at State Route 24. The existing screen of young evergreen trees on the east side of the visitor entrance drive (foreground) should be enhanced with additional plantings, while a second screen of evergreen plantings should be installed on the west side of the drive. (OCLP 2014, AVCHD Video, #00679)

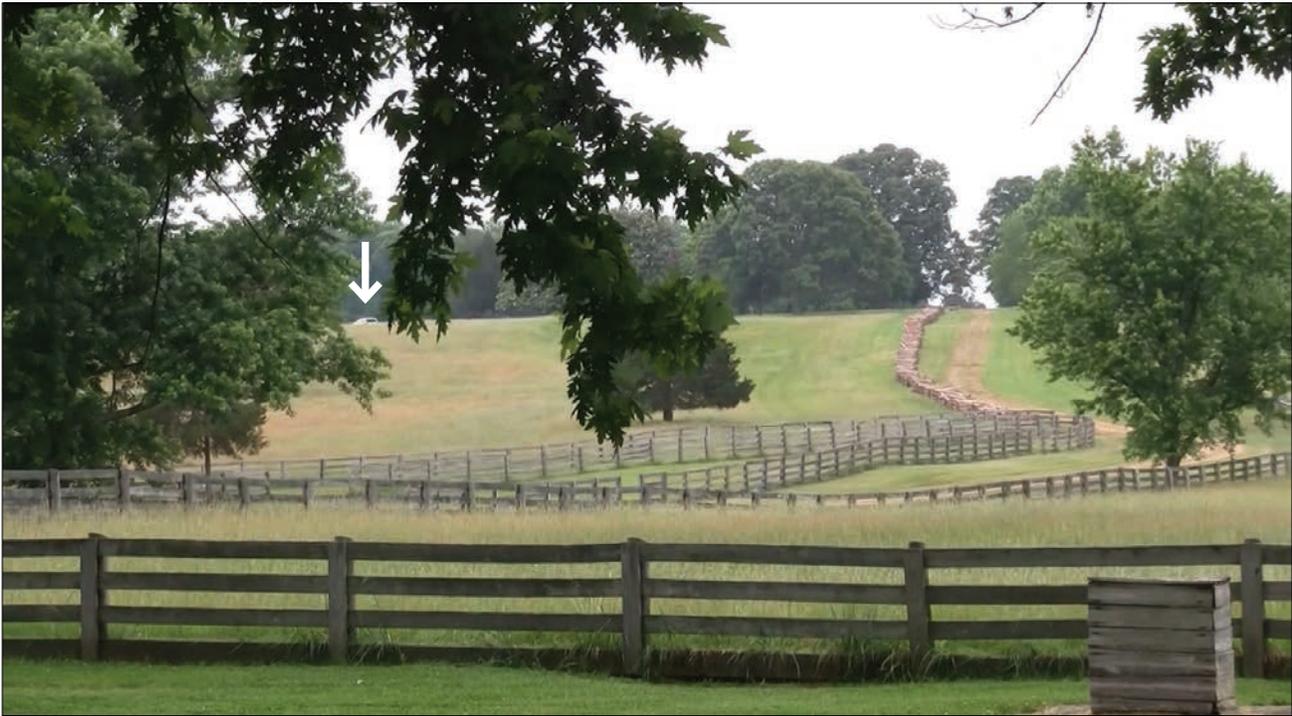
Figure 2d.15. Still frame of a video looking west-southwest to where the Stage Road crests the hill, which was key terrain during the April 9, 1865 battle. At image left, a passing vehicle on State Route 24 is visible (shown with a white arrow). (OCLP 2014, AVCHD Video, #00681)

The park should plant a screen of vegetation along State Route 24 to block the view of moving traffic from the benches at the Meeks complex (Figures 2d.15, 2d.16). Beginning near the southeast corner of the Confederate Cemetery and extending southeast, a 300-foot long hedgerow of inkberry holly, American holly, and Virginia redcedar is recommended along the high point between the park's

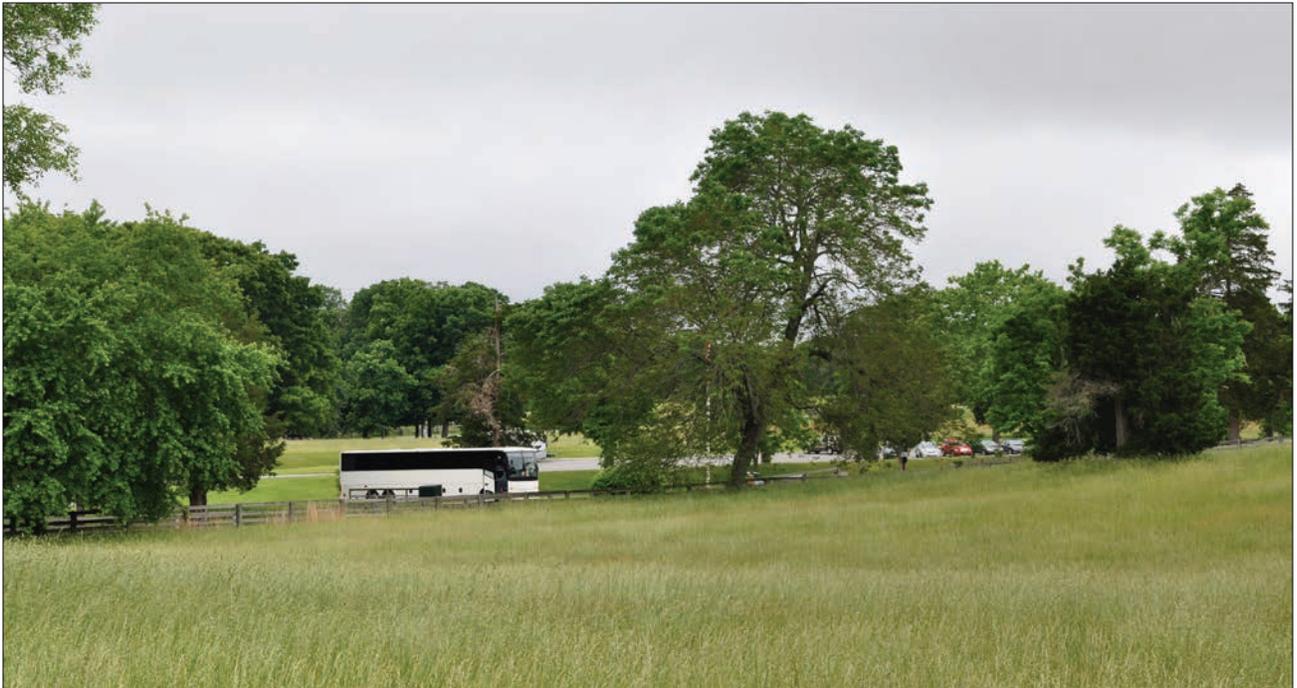
Figure 2d.19. View looking southwest from the Isbell House to a bus in the north bay and cars in the south bay. The spaces for automobiles in the north bay are not visible. (OCLP 2014, combination of DSC_0786 and 0787)

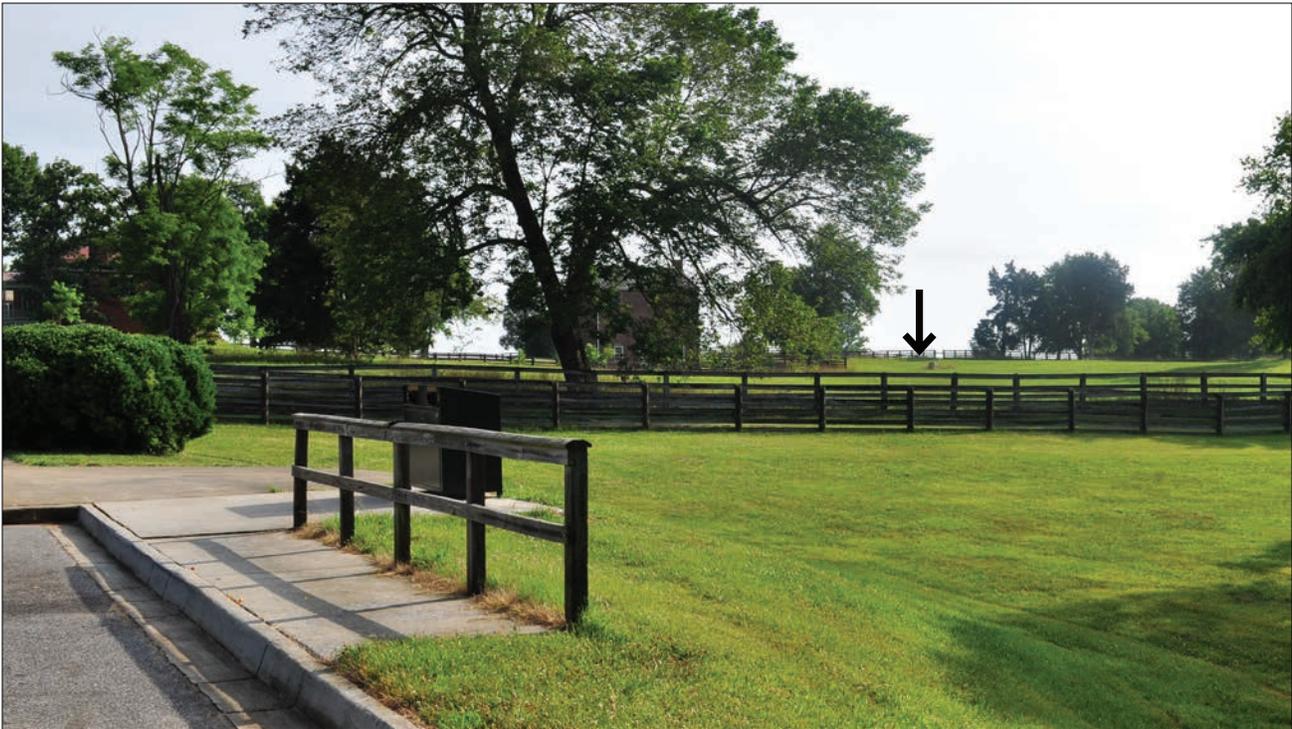
Figure 2d.23. Buses that park in the designated space in the foreground can be seen from sections of the Richmond-Lynchburg Stage Road (noted with a black arrow). New plantings should be installed in the area between the parking space and Back Lane fence. (OCLP 2014, DSC_2189)

To screen the view of the parking lot from the Stage Road, new trees should be planted at several locations along Back Lane and just southeast of the intersection of Back Lane and Market Lane (Figure 2d.23). Although the new plants are not historic, installing some of them along the existing fence lines will be compatible with the historic scene, as trees often grew at such locations. A mix of Virginia red cedar, Virginia pine, oak, tulip poplar, and black locust trees are recommended because as they mature their height will achieve the desired effect. In particular, the lower branches of the cedars and pines should not be cut.

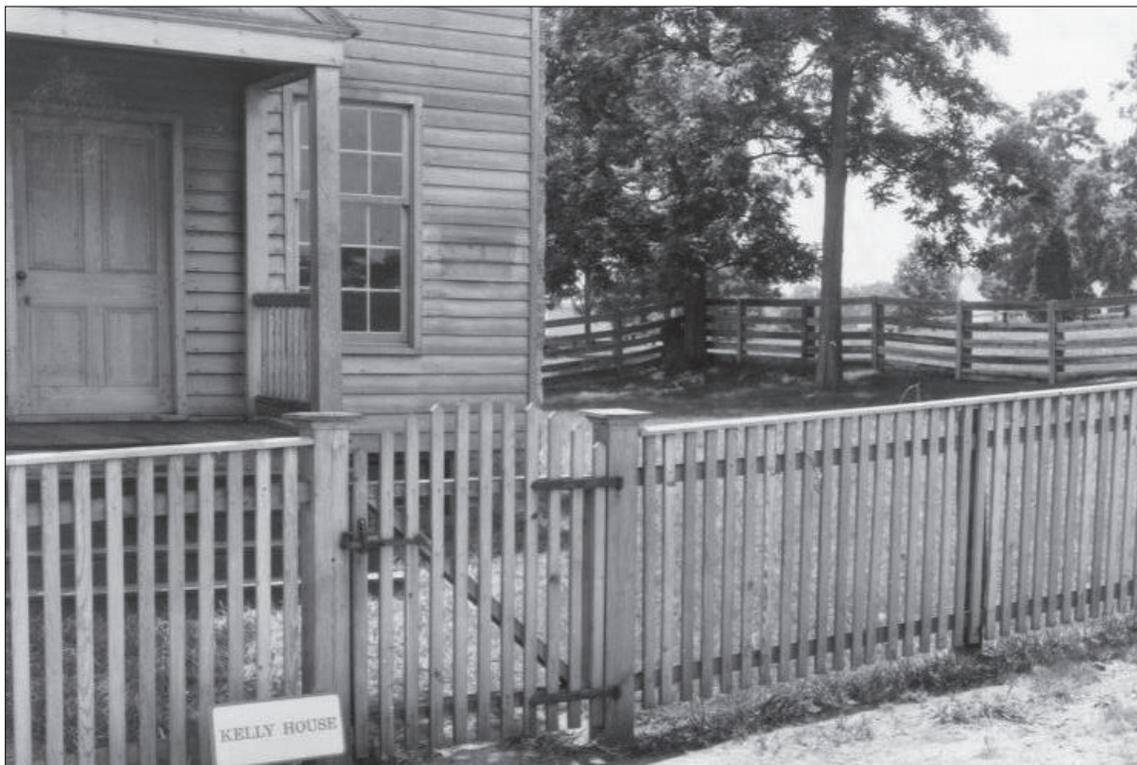
Figure 2e.4. View of the Kelley House in 1963-65 looking southwest. Post and board fencing marked the west and south sides of the house yard at this time. (APCO Archives, #11498-02 1889)

The fences that define the yard at the Kelley House should be restored to their historic 1960s conditions by rebuilding the south post and rail fence and replacing the west picket fence with a post and rail fence (Drawing 23). In the nineteenth century, the style of fence accommodated land uses and reflected the landowners' wealth and
