CULTURAL LANDSCAPE REPORT FOR APPOMATTOX COURT HOUSE NATIONAL HISTORICAL PARK

VOLUME II: TREATMENT IMPLEMENTATION PLAN

APPOMATTOX, VIRGINIA

National Park Service, Boston, Massachusetts, 2018

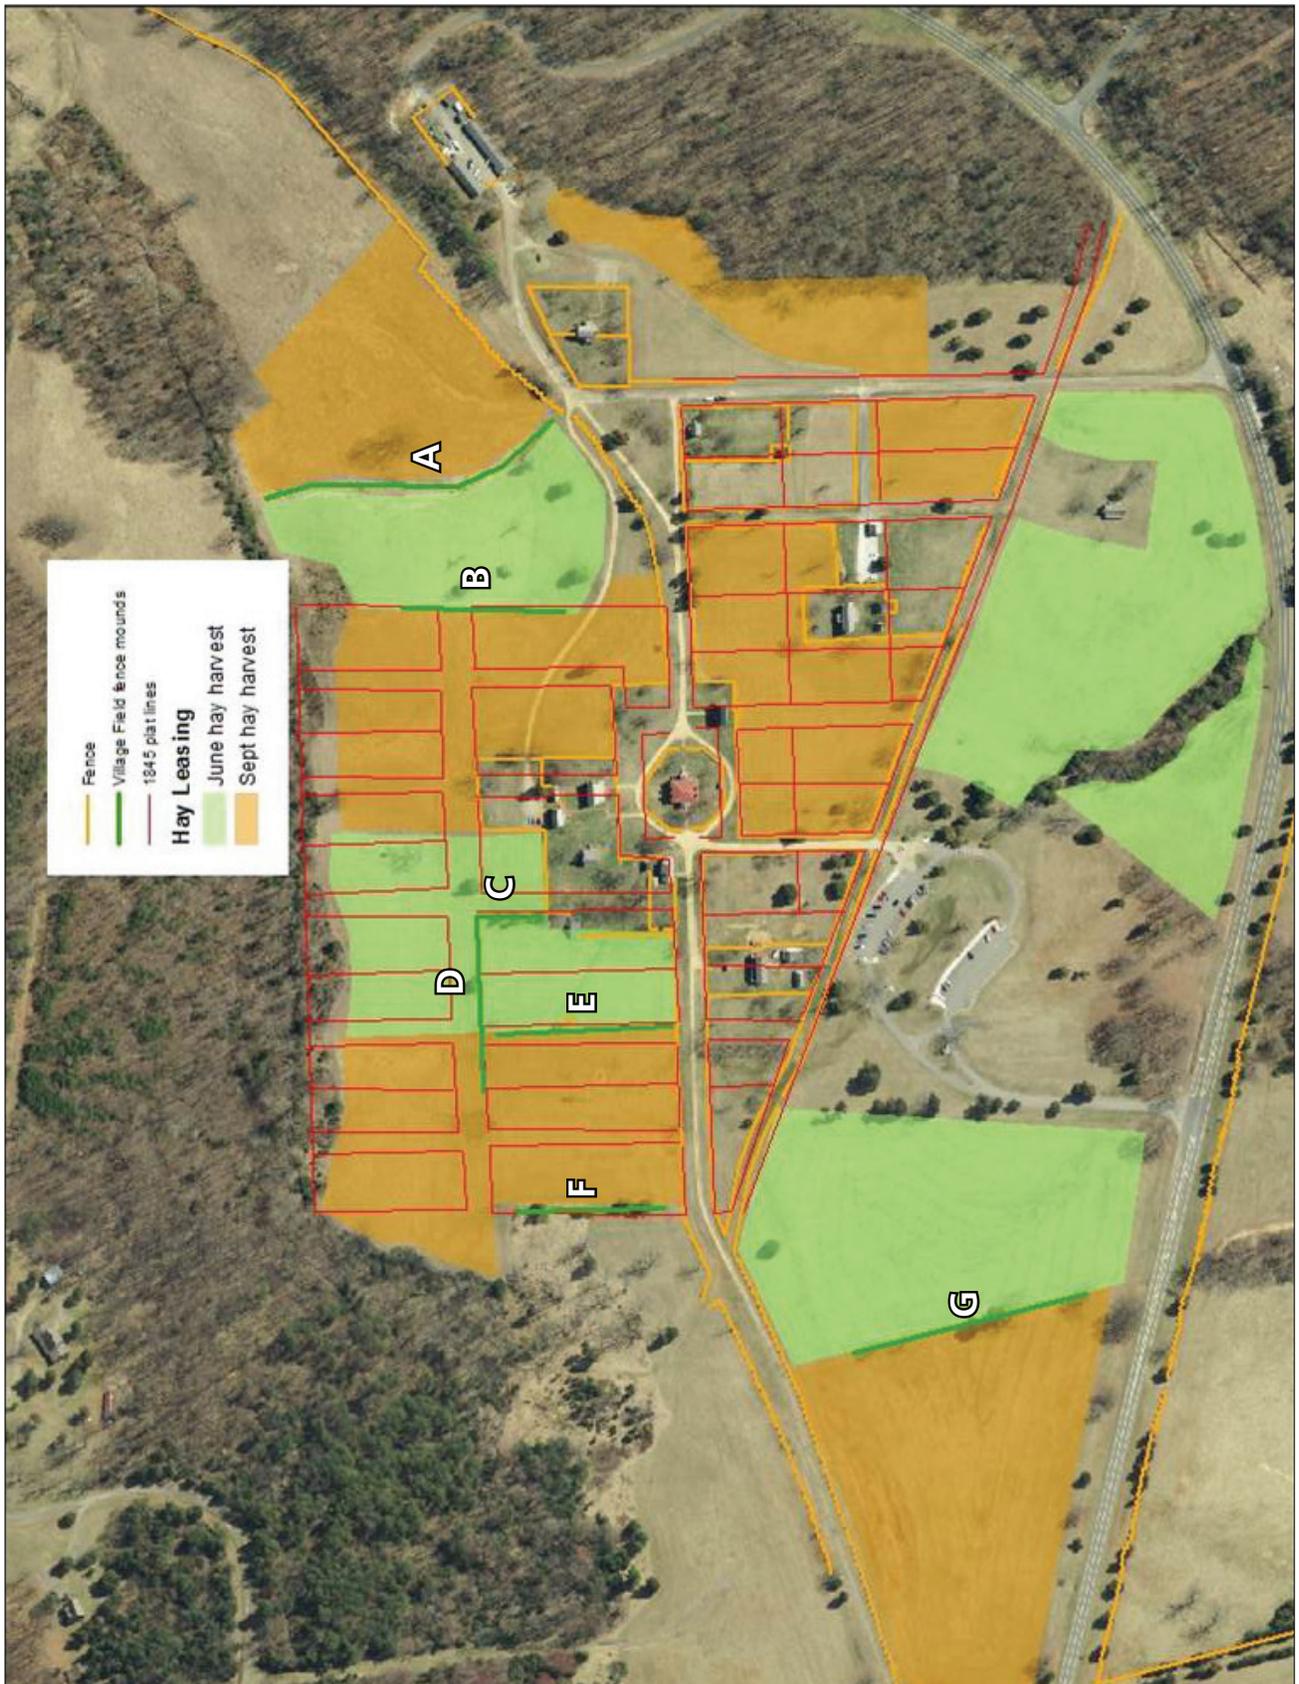
Figure 2e.6. Plan showing field configurations and harvesting schedule in the village. The red lines represent the 1932 lot lines. (Map by Brian Eick, APCO, October 2017)

The park should consider reestablishing missing fence lines based on the plan developed in 2017 by Brian Eick, which shows locations of missing fence lines derived from analysis of the 1932 plat map (itself based on older records), property ownership lines, and visible mounds at field edges (Figure 2e.6). As recommended by Mr. Eick, the park should conduct additional research and archeological investigation at these locations. Post location and spacing can be potentially be verified with the use of ground penetrating radar, peeling back sod to inspect for soil staining, or analysis with a soil resistivity meter. However, most fence lines also contained trees, the remnants of which will read as anomalies similar to fence posts. Hence, historic photos, property deeds, and post war property damage claims may prove to be the most informative sources of information.

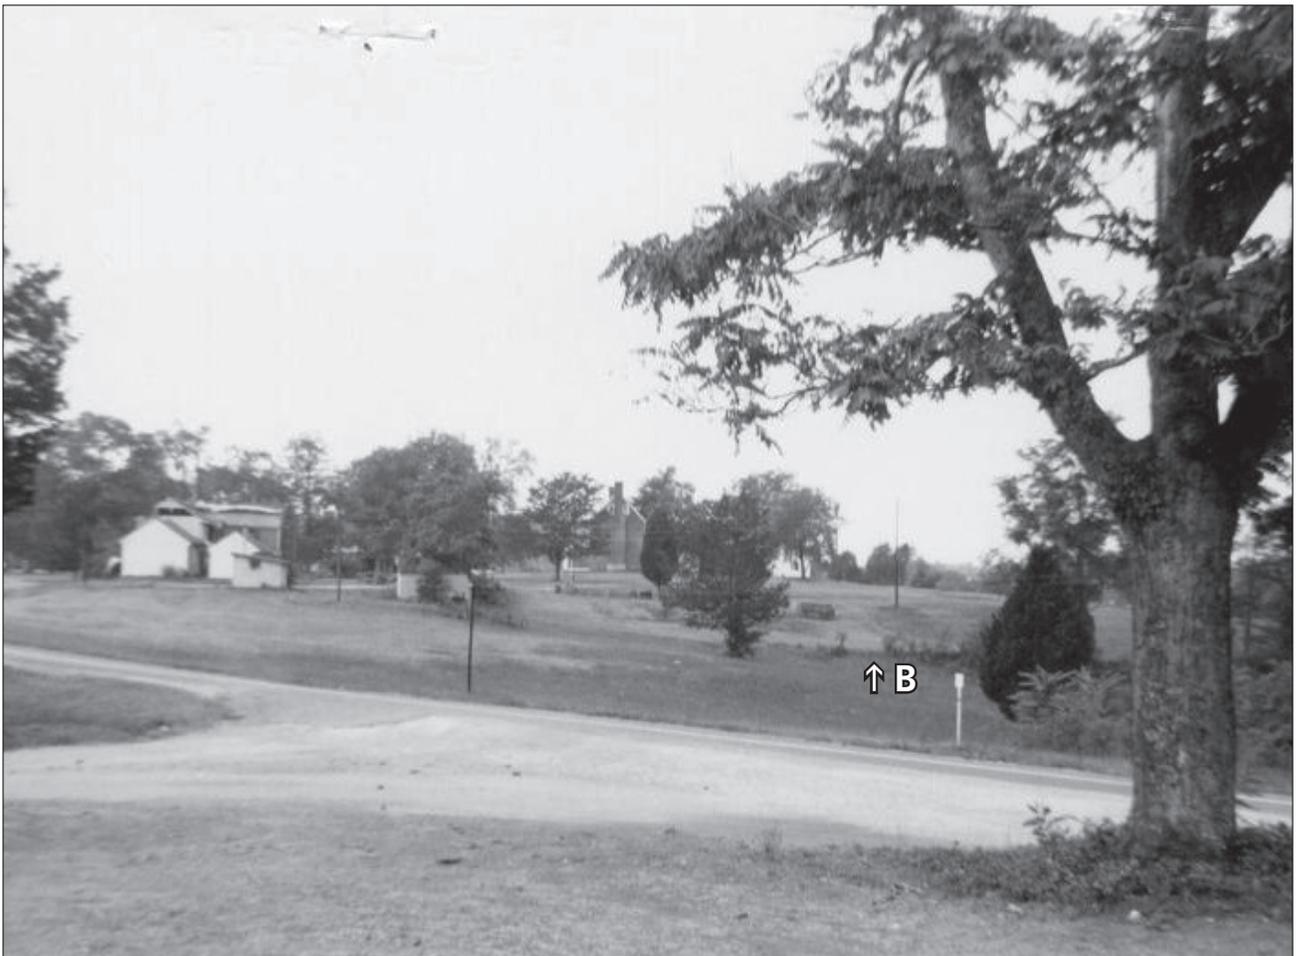
Figure 2e.9. View looking west from the intersection of the Stage Road and Court House Road, 1941. Small trees are visible along fence line B, although the fence itself appears to be gone. (APCO Archives, #11406-13_1048)

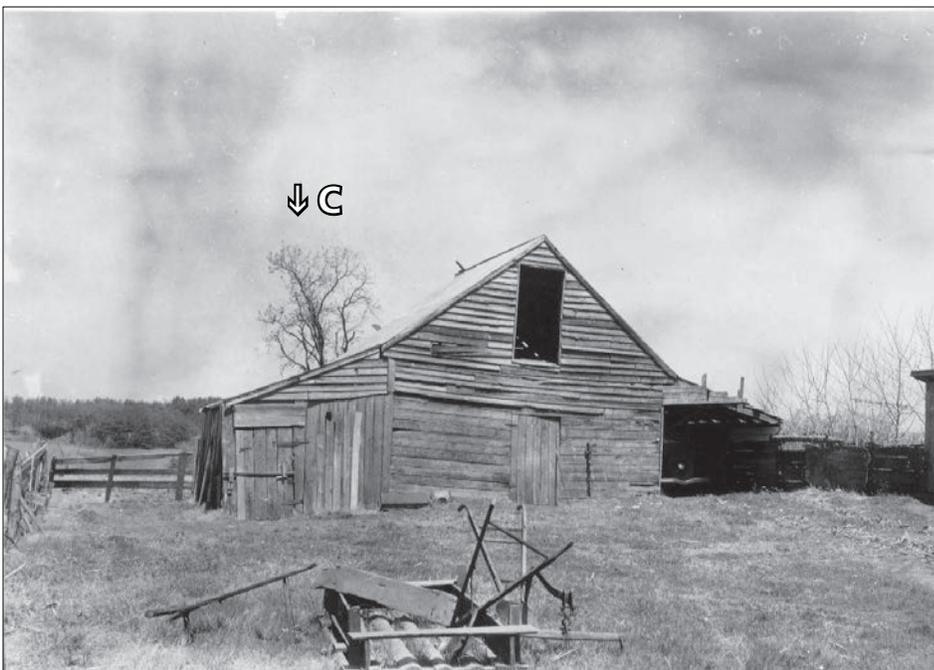
Figure 2e.10. View looking north from just south of the Meeks Stable, 1939. The position of the tall trees north of the stable are consistent with the location of fence line C. (APCO Archives, #HF-195-01)

SSF-2. Reestablish Historic Fence Lines in Fields Adjacent to the Village (Table 2e.1)	
<i>Fence Location</i>	<i>Description</i>
A	North of village, east of Williams Lane. Curving fence line oriented north-south. --Location visible in 1937 oblique aerial and 1937 aerial. (Figure 2e.7, see also Figures 2.1b-c)
B	North of village, east of Williams Lane. Straight fence line oriented north-south. --Tree line visible in 1937 oblique aerial, 1937 aerial and 1940 topographic map. (Figures 2e.8, 2e.9, see also Figures 2.1b-c, 2.2)
C	North of village, north of Meeks Stable. Straight fence line oriented north-south from northeast of stable. --Wire fencing visible in 1937 oblique aerial and 1937 aerial. Tree line visible in 1937 oblique aerial, 1940 topographic map, 1962 oblique aerial, 1965 oblique aerial, 1967 aerial, and 1970 oblique aeriels. (Figures 2e.10, 2e.11, see also Figures 2.1a-c, 2.2, 2.3, 2.4, 2.5, 2.6a-b)

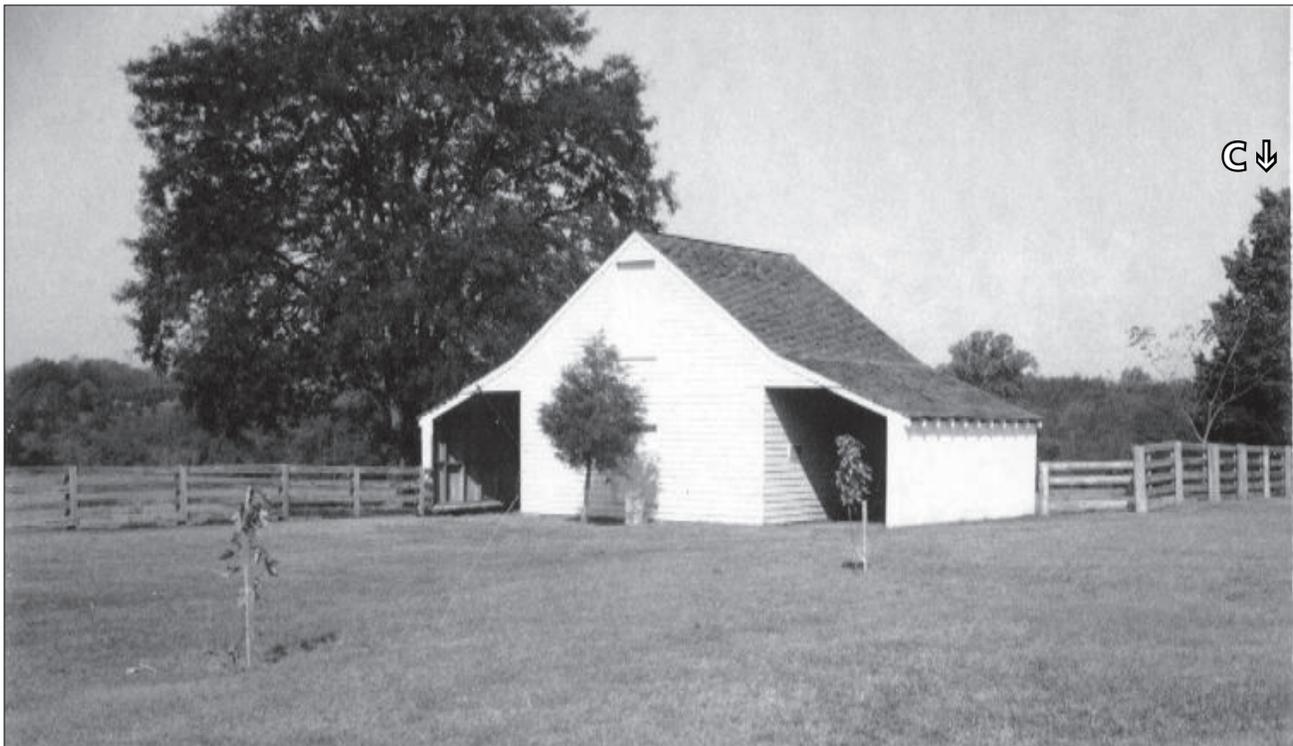
Figure 2e.11. View looking northwest at the Meeks Stable, 1967-70. The Virginia redcedars at far image right are located along fence line C. (APCO Archives, #HF-196-02)

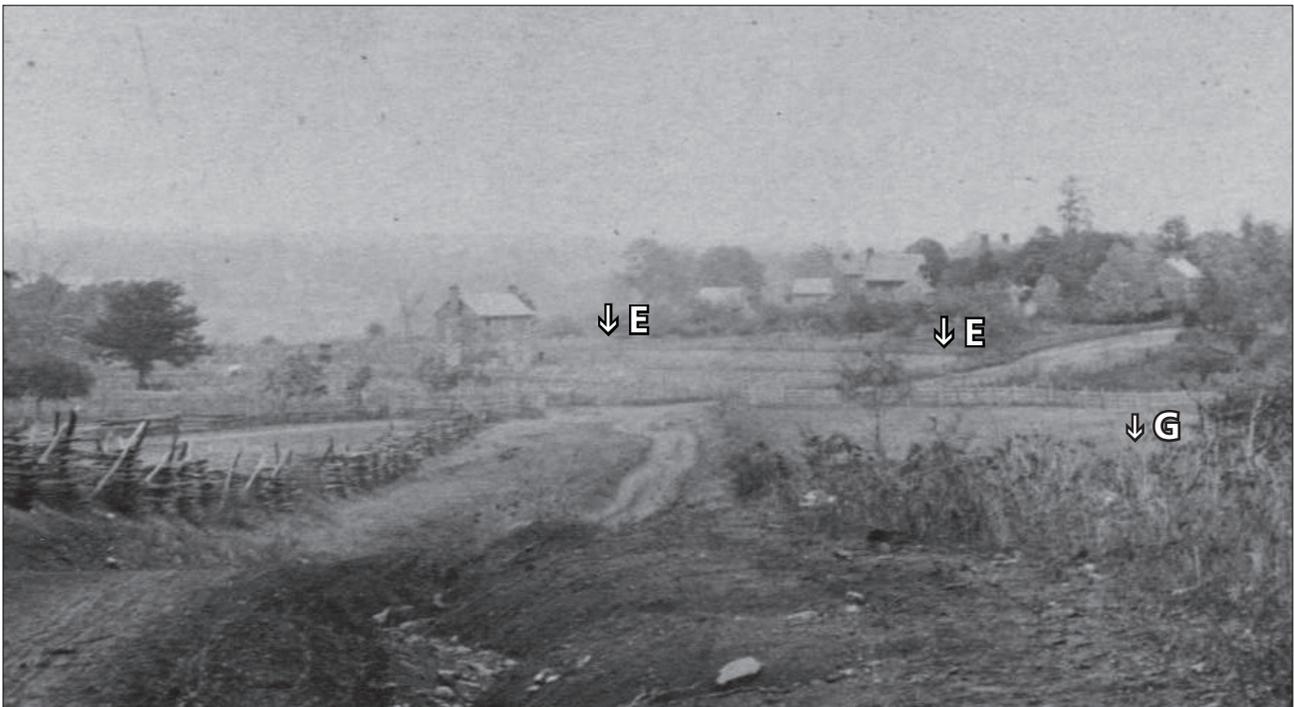
Figure 2e.14. Cropped and enlarged view looking northeast toward the village from the Stage Road, c.1892. Fence line E, a post and rail fence, is barely visible. Fence line G is visible at image right. (APCO Archives, #HF-236-01)

D	Northwest of village, northwest of Meeks Stable. Straight fence line oriented east-west from northwest of stable. --Wire fencing visible in 1940 topographic map. Tree line visible in 1937 oblique aeriels and 1937 aerial. (Figures 2e.12, 2e.13, see also Figures 2.1a-c, 2.2)
E	West of village, west of Lafayette Meeks grave. Straight fence line oriented north-south. --Fence visible in photograph. (Figure 2e.14)
F	West of village, west of former Union Academy Dwelling. Straight fence line oriented north-south. --Wire fencing visible in 1940 topographic map. Tree line visible in 1937 oblique aeriels, 1937 aerial, 1962 oblique aerial, 1965 oblique aerial, 1967 aerial, and 1970 oblique aeriels. (Figure 2e.13, see also Figures 2.1a-c, 2.2, 2.3, 2.4, 2.5, 2.6a-b)
G	Southwest of village, west of Stage Road and Back Lane intersection. Straight fence line oriented northwest-southeast. --Tree line visible in 1937 oblique aeriels, 1937 aerial, 1962 oblique aerial, 1965 oblique aerial, and 1967 aerial. (Figure 2e.14, 2e.15), see also Figures 2.1a-c, 2.3, 2.4, 2.5)

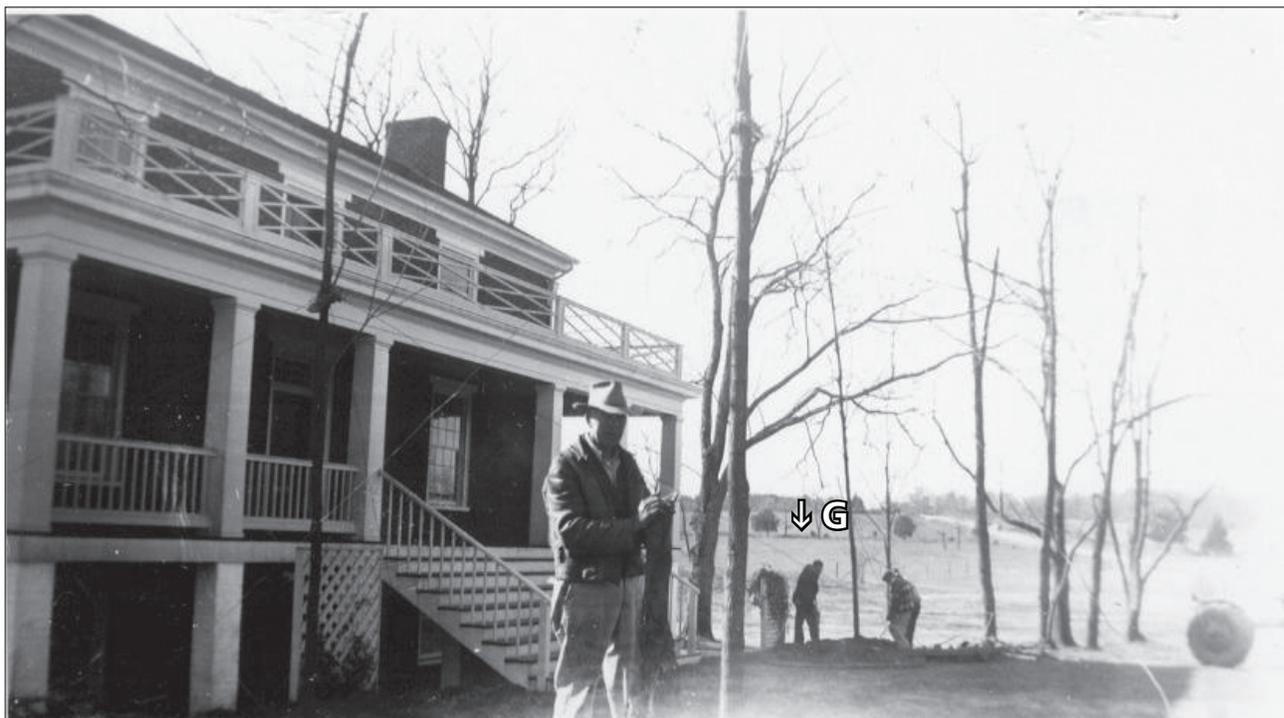
Figure 2e.15. View looking west from the front yard at the McLean House, 1949. In the distance is fence line G. (APCO Archives, #11460-03_1481)

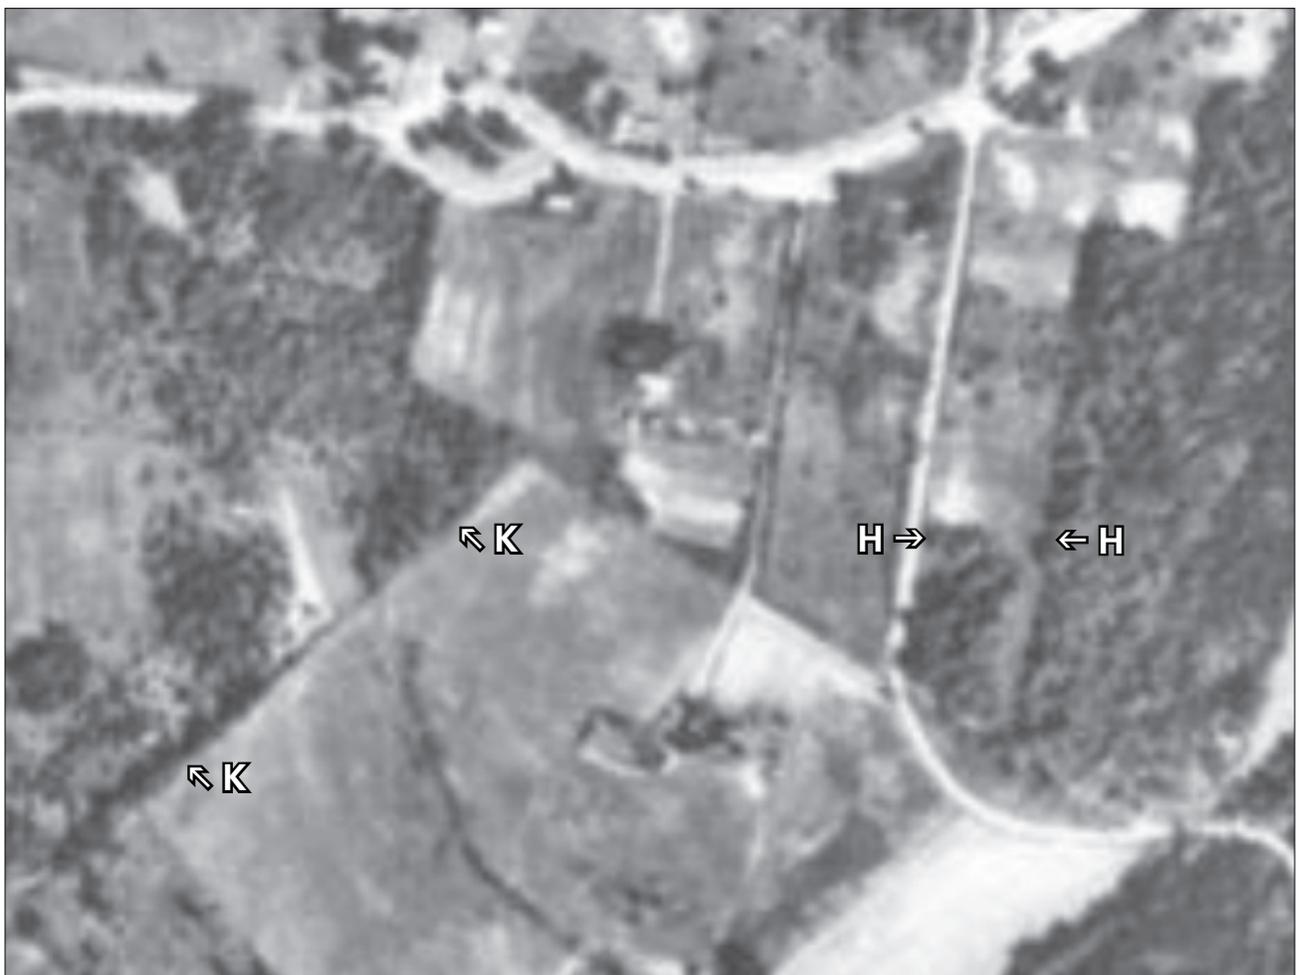
Figure 2e.17. Portion of aerial from 1937, showing possible fence lines (H,K). (CLR, December 2009: Ch.2-p.90)

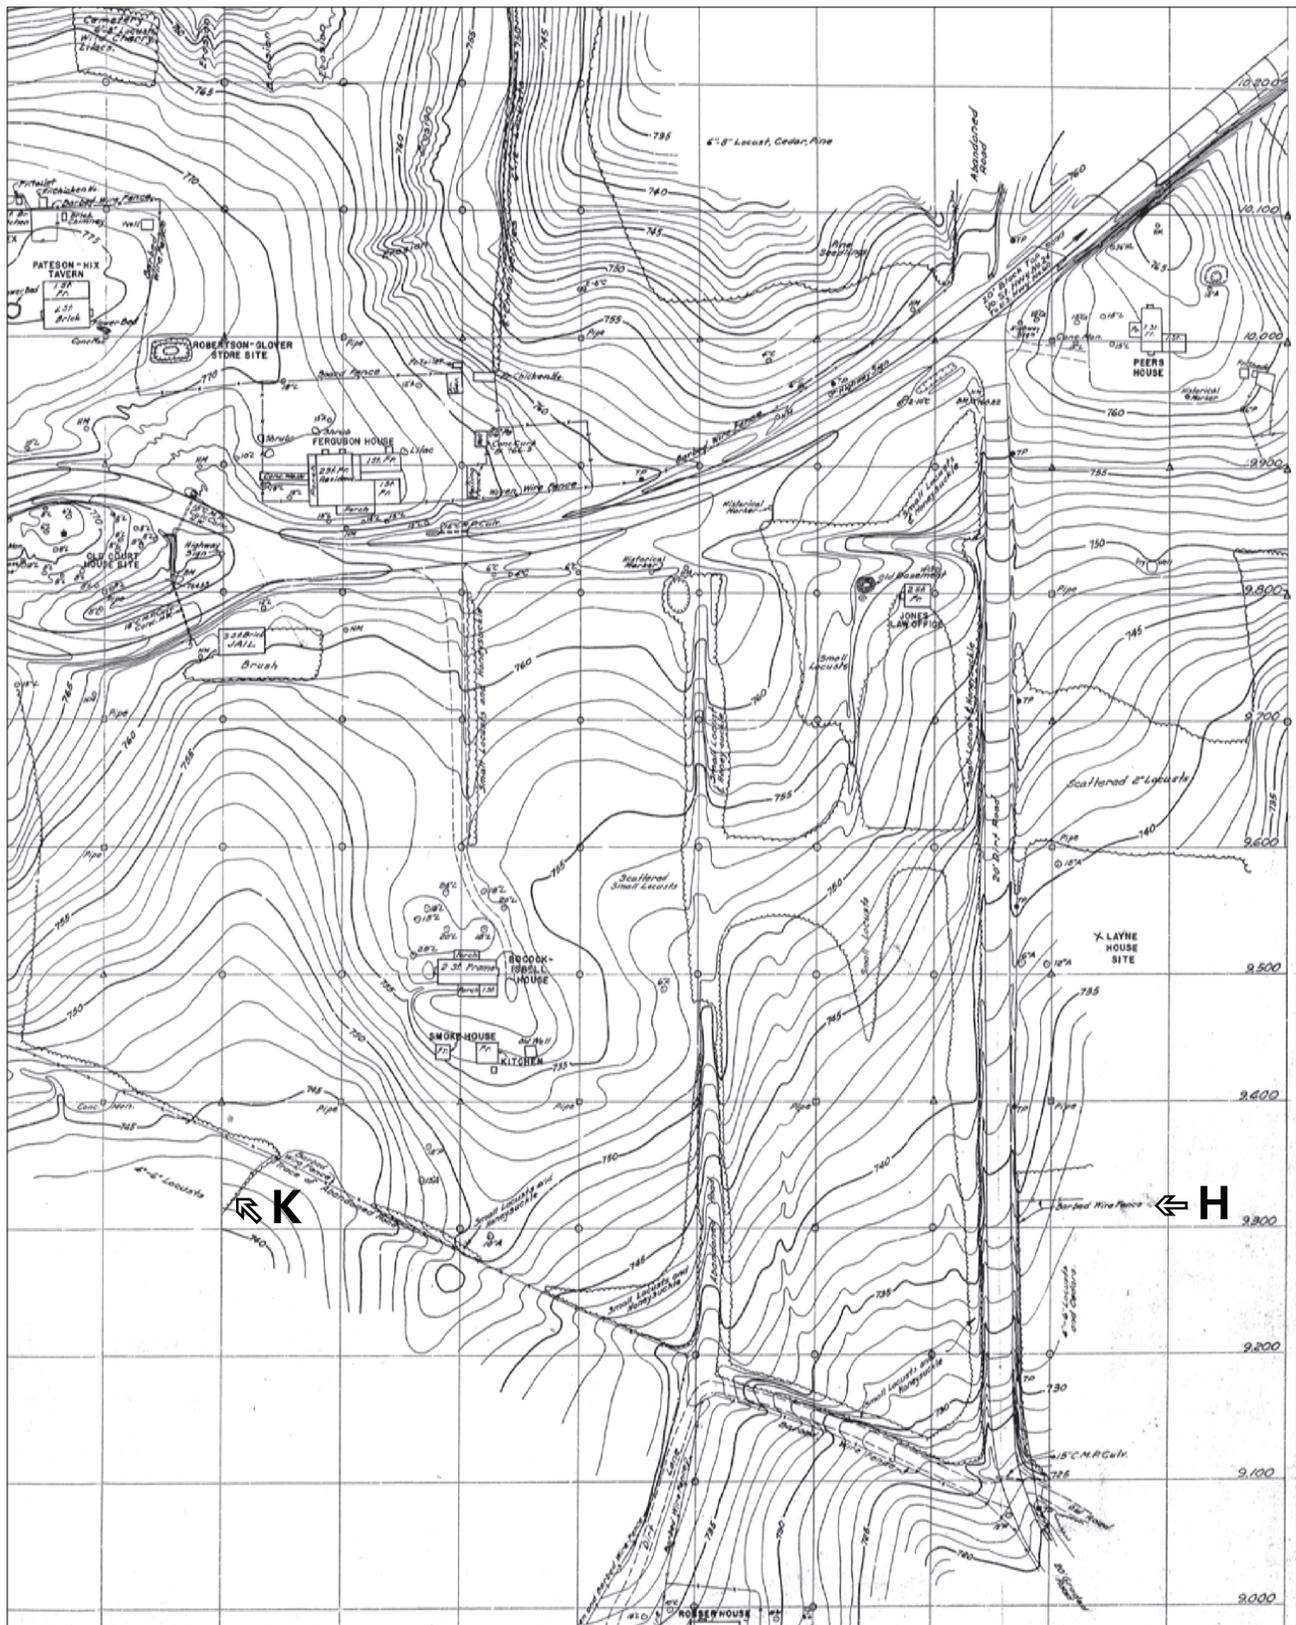
Figure 2e.18. Portion of topographic plan of Appomattox Court House NHP from 1940 showing locations of possible fence lines (H,K). (Denver Service Center, eTIC, Drawing #APCO 340-5300)

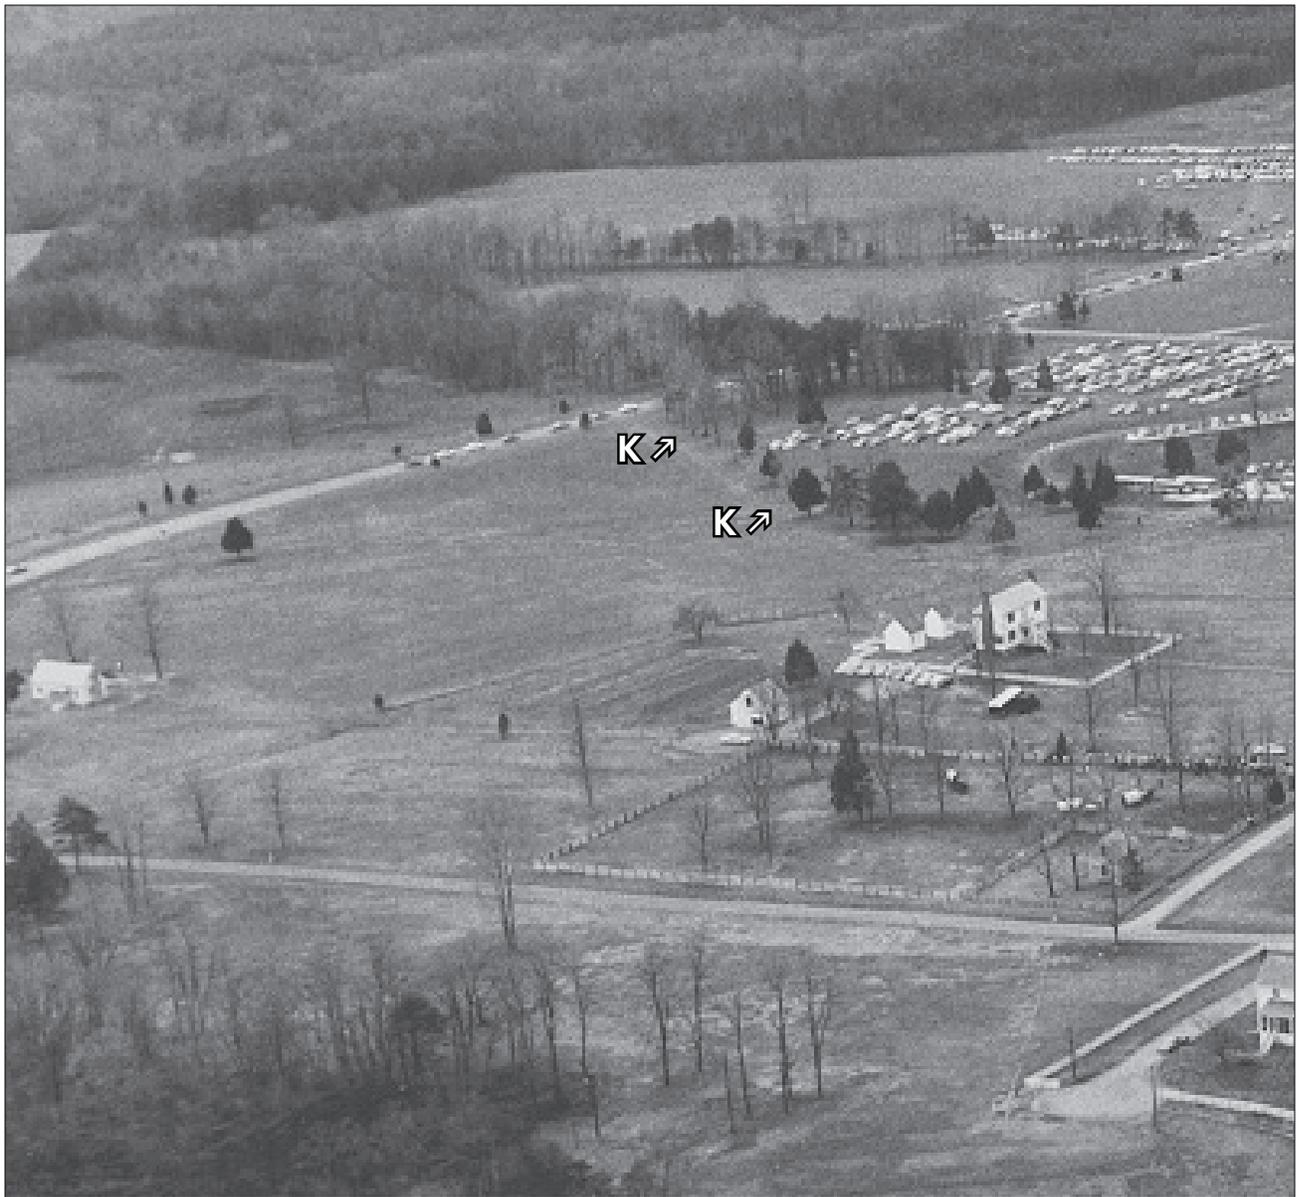
Figure 2e.19. Portion of oblique aerial of the village in 1965 during the Civil War Centennial celebration, view looking west-southwest, showing possible fence line (K). (Photograph by the Virginia State Police, APCO Archives, #50)

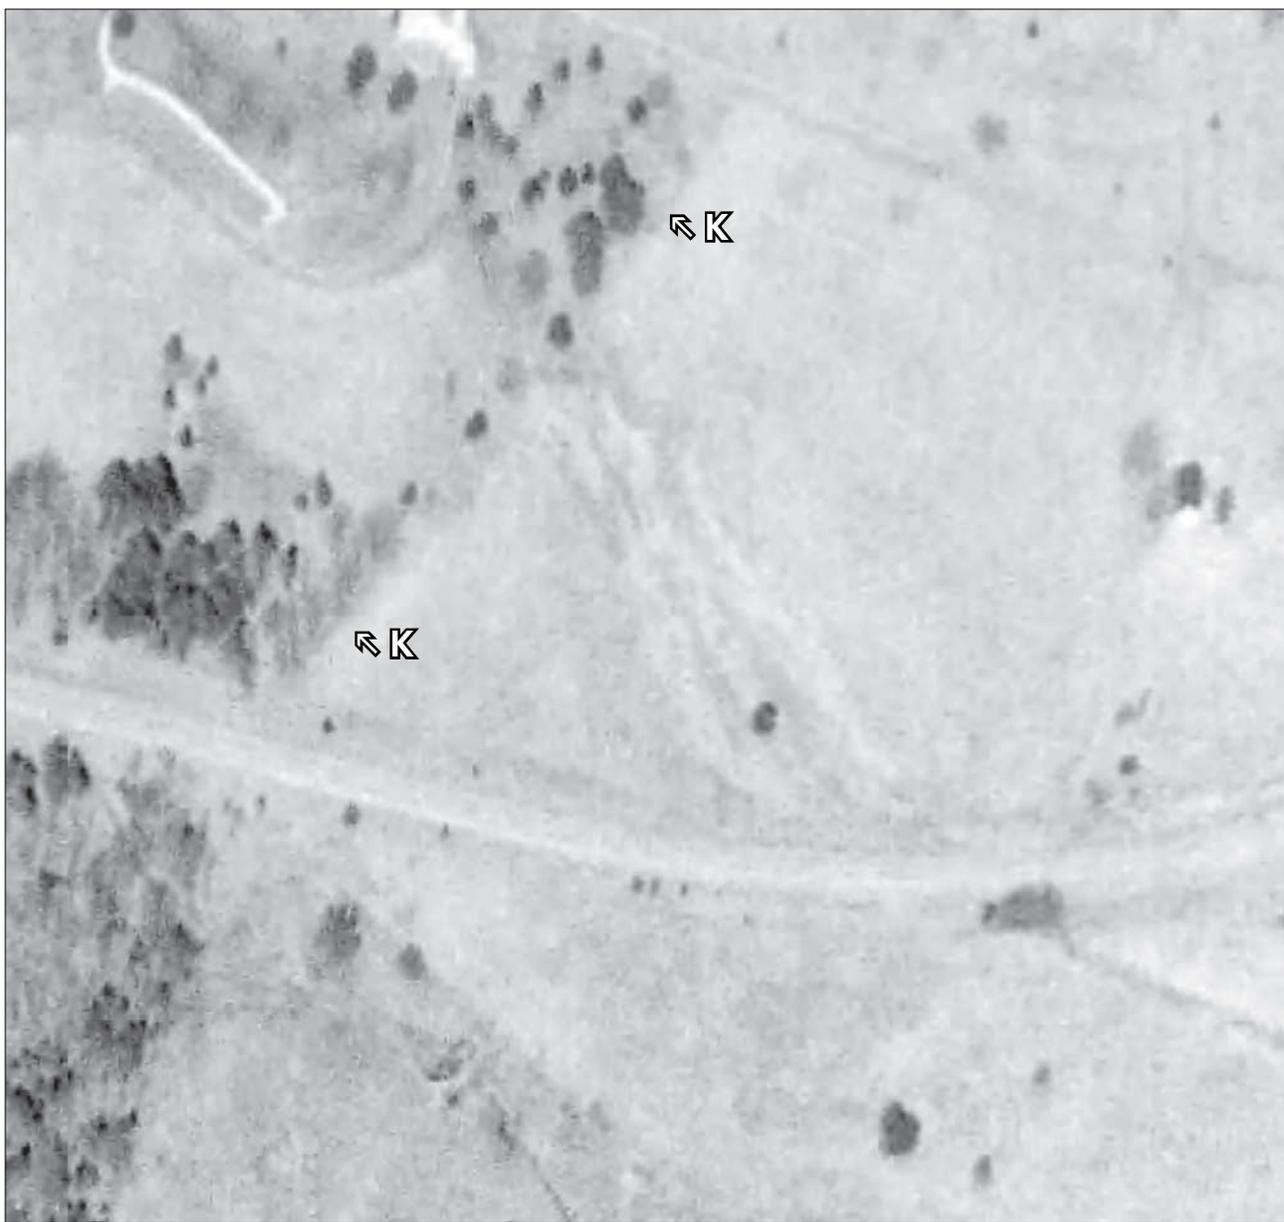
Figure 2e.20. Portion of a 1967 aerial of the village, showing possible fence line (K). (Historic Aerials by NETR Online, <http://www.historicaerials.com>, accessed 4 April 2015)

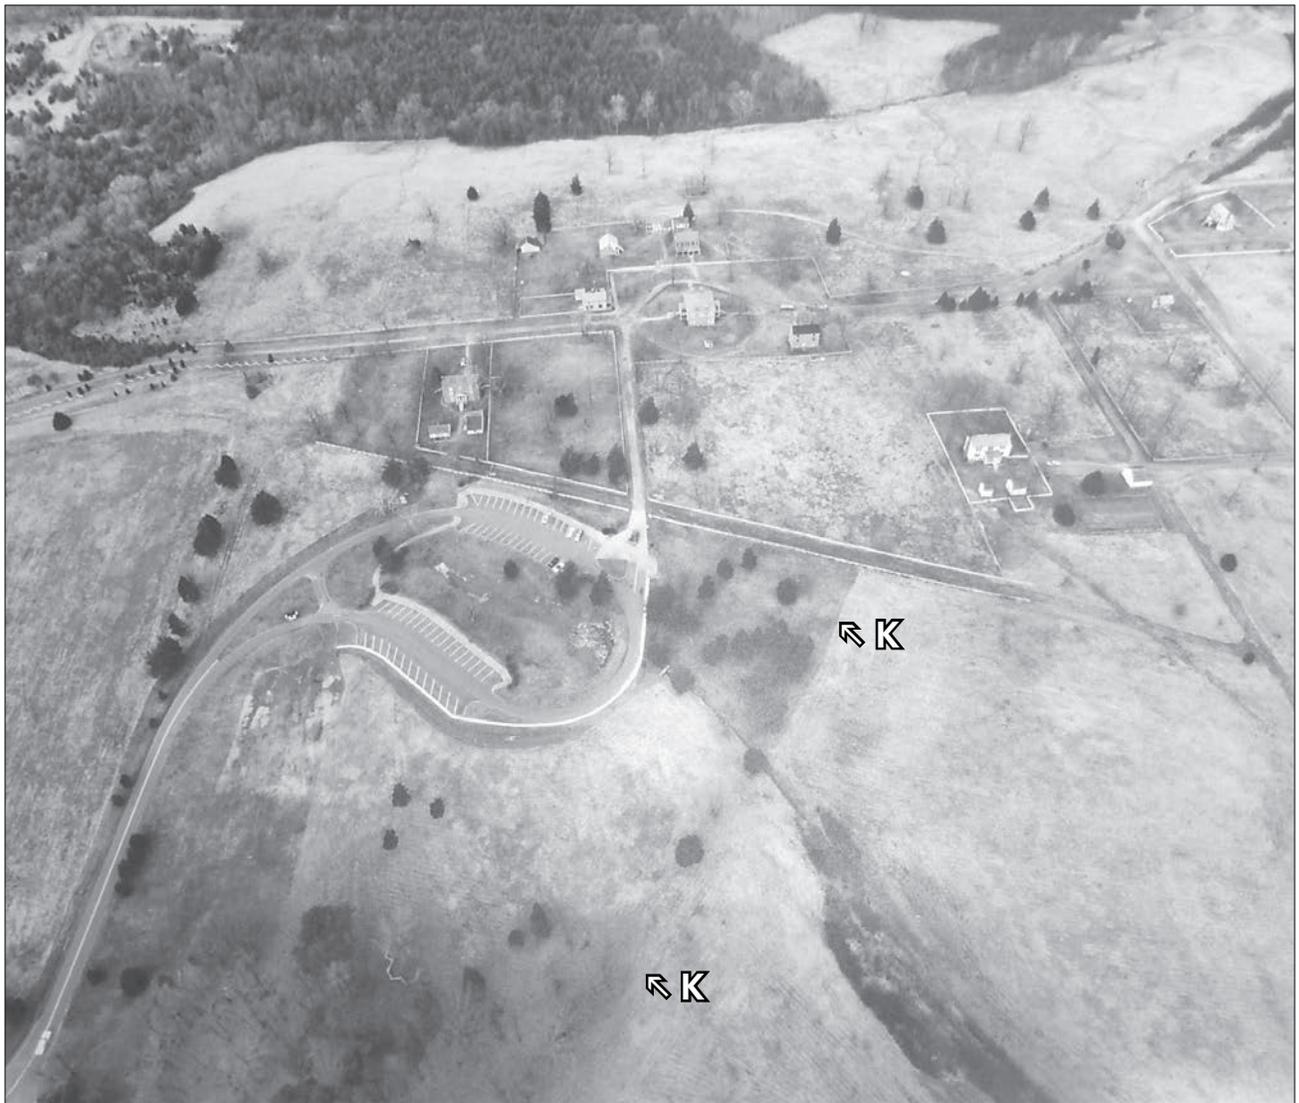
Figure 2e.21. Portion of oblique aerial of the village in c.1970 looking north, showing possible fence line (K). (APCO Archives, #11527-793)

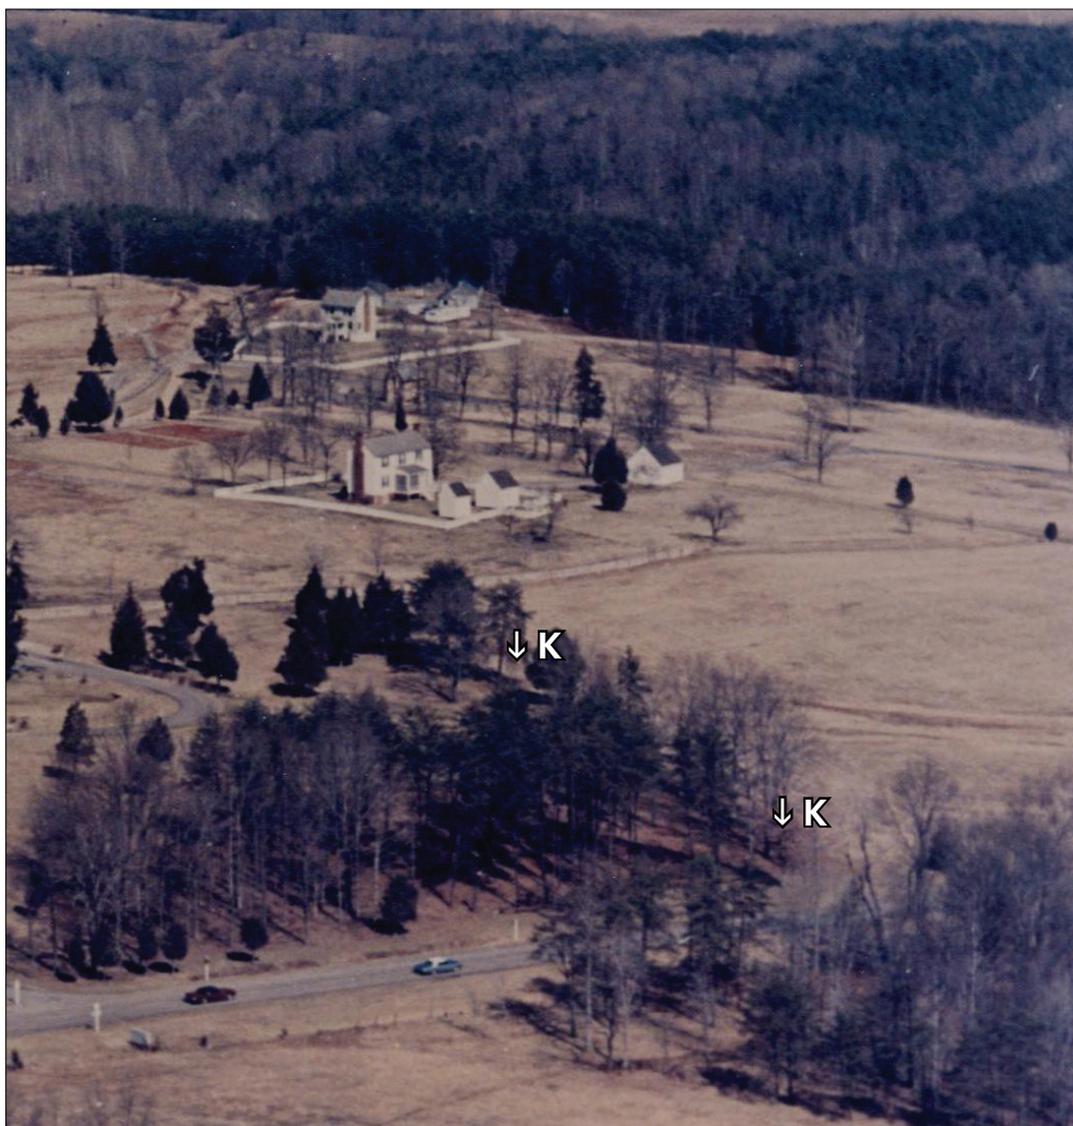
Figure 2e.22. Portion of oblique aerial of the village in 1971, view looking northeast, showing possible fence line (K). (APCO Archives, #HF-241-A)

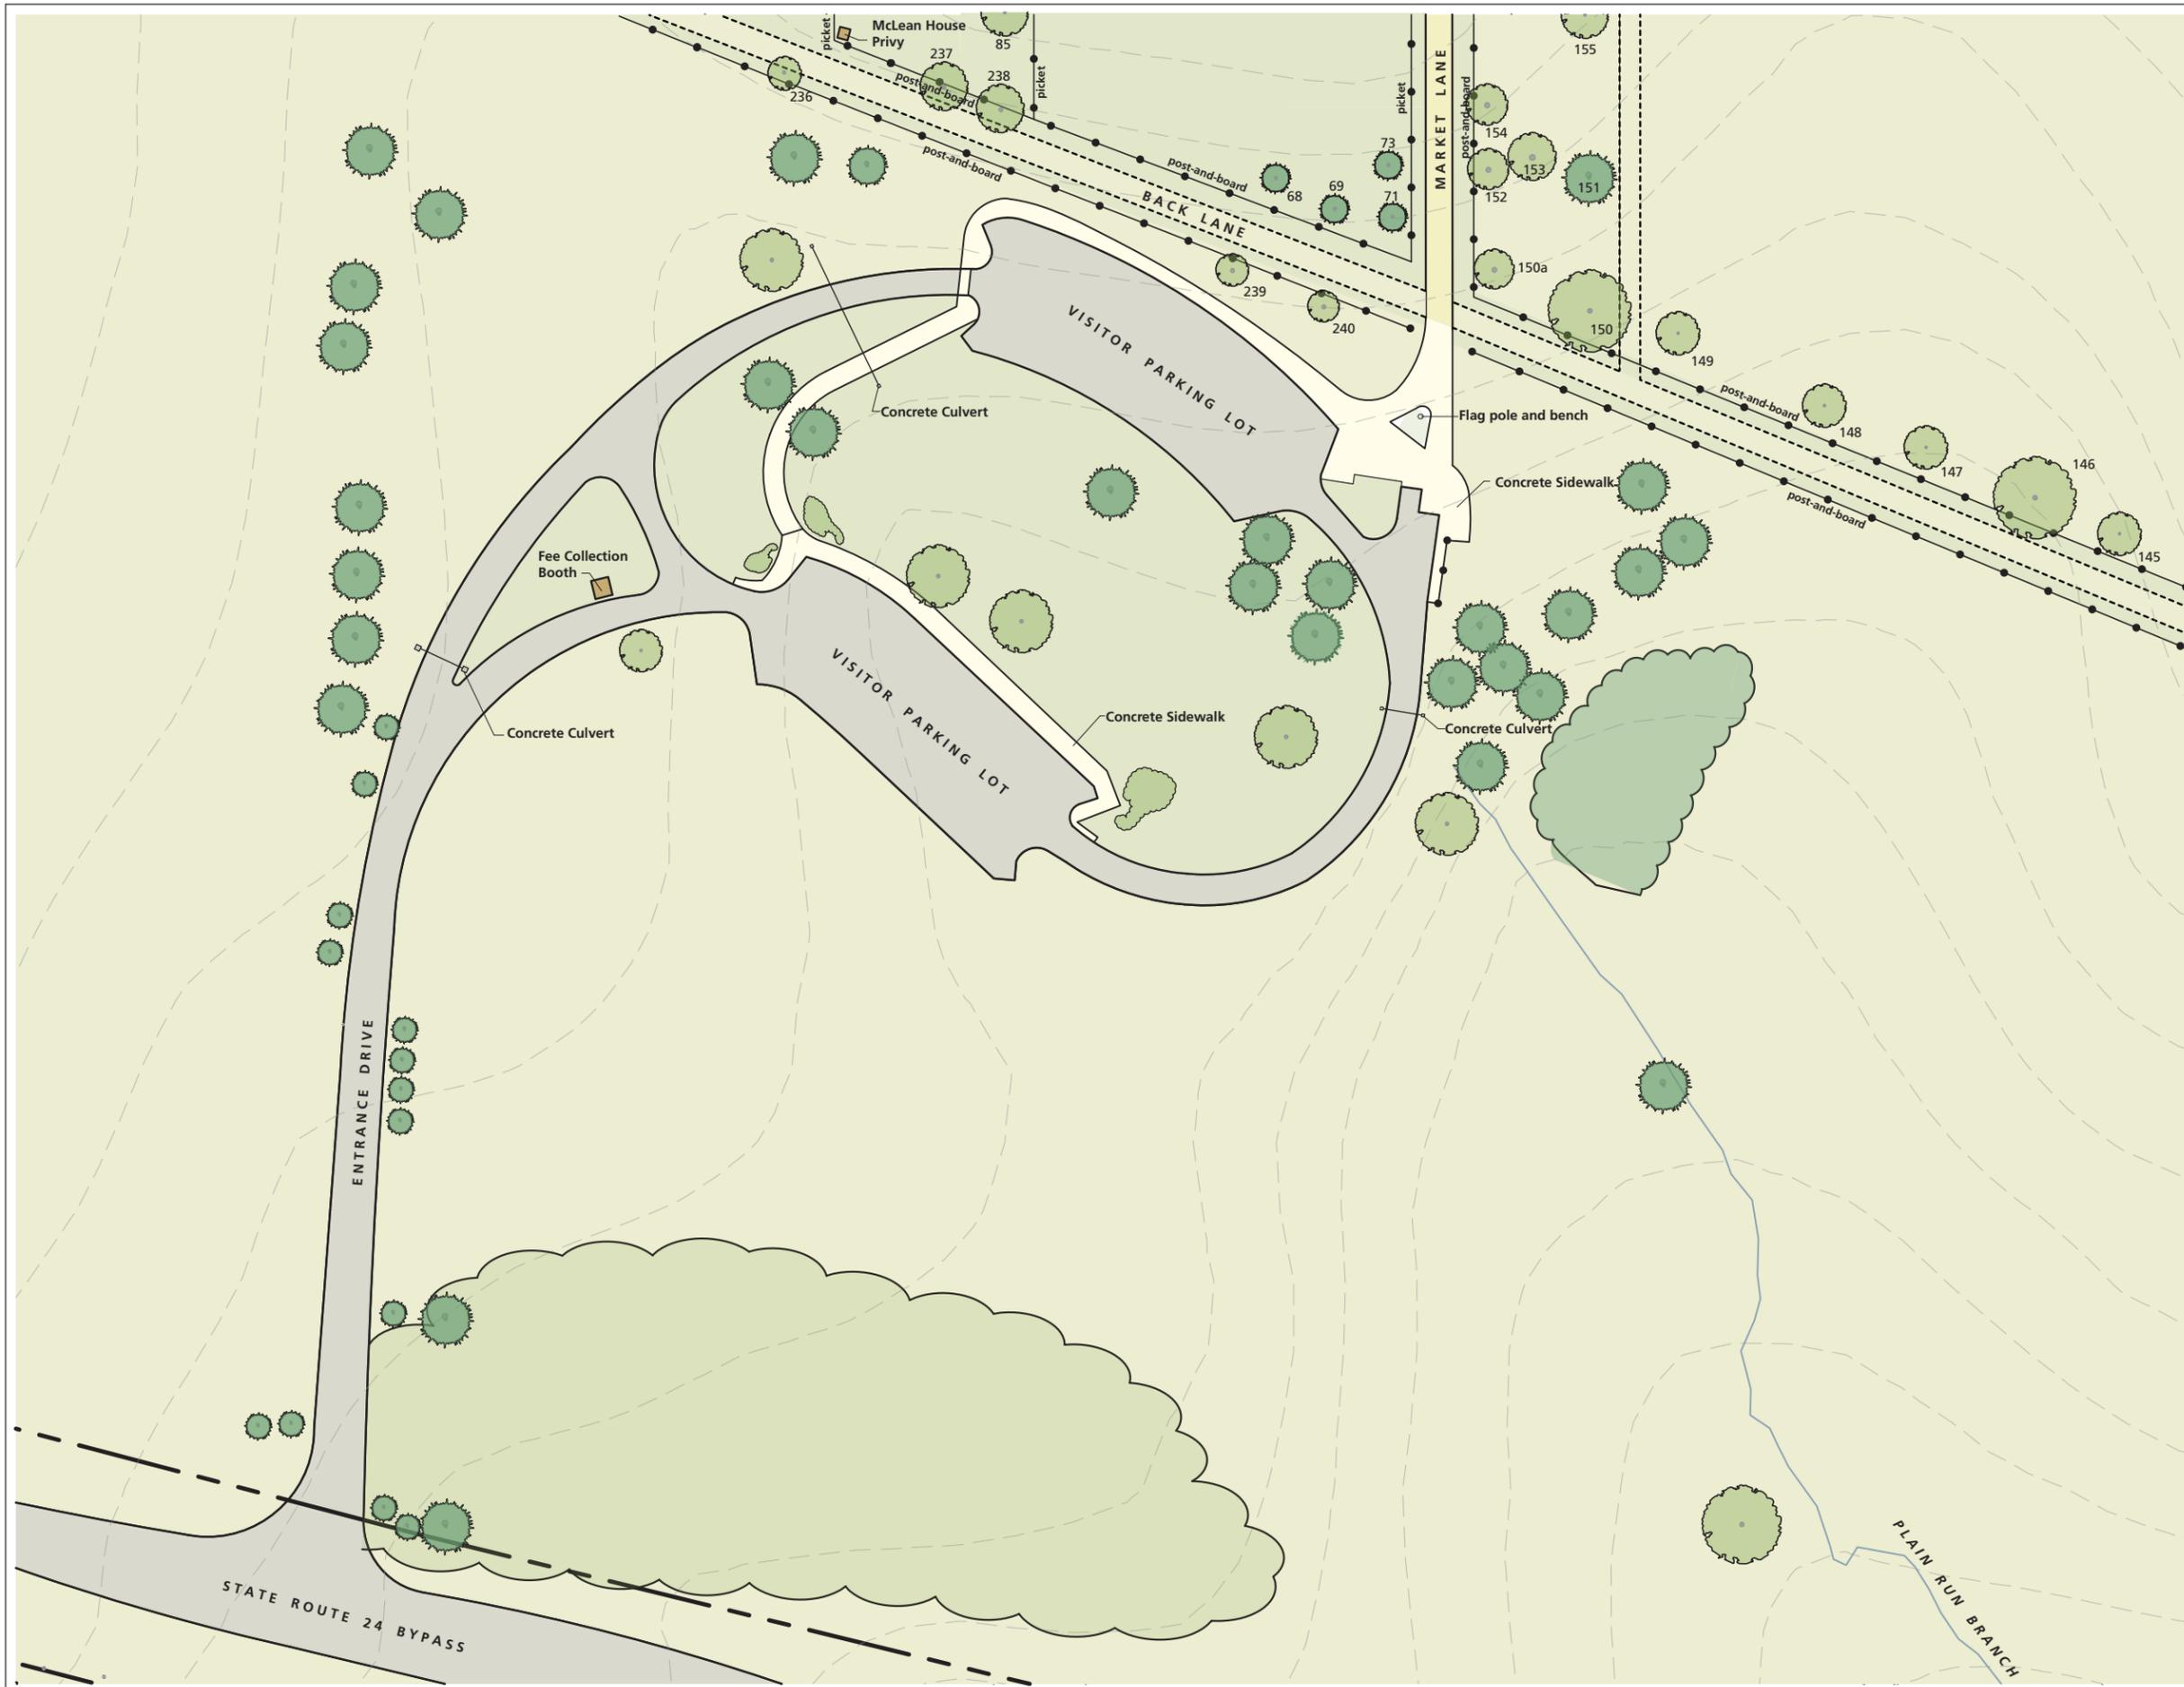
Drawing #21

Village Enlargement (NW) 2018 Existing Conditions

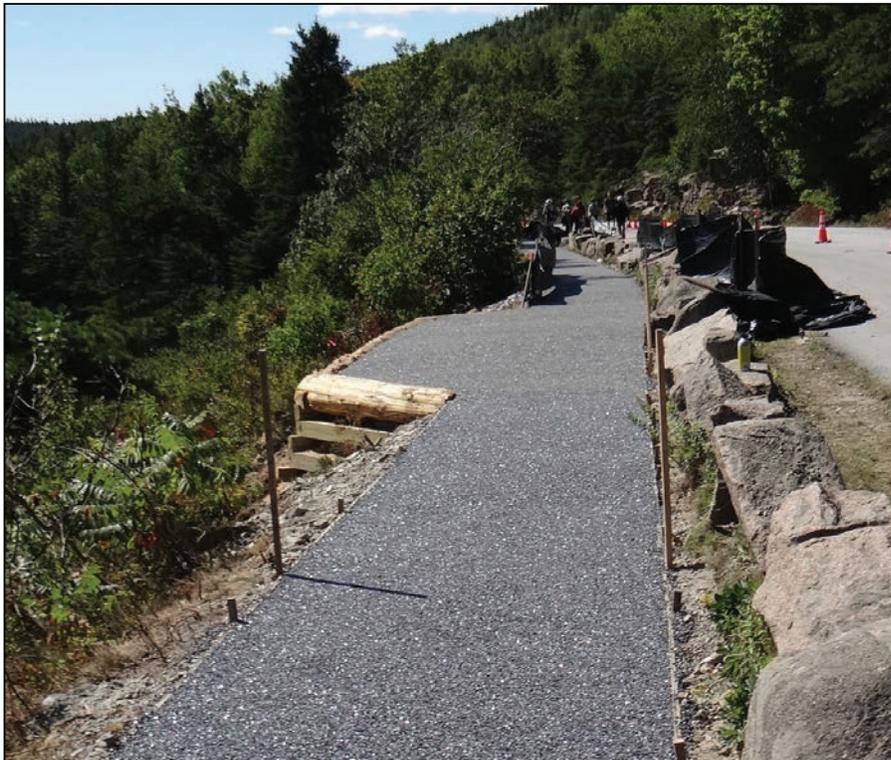
Filterpave on ACAD's Ocean Path.

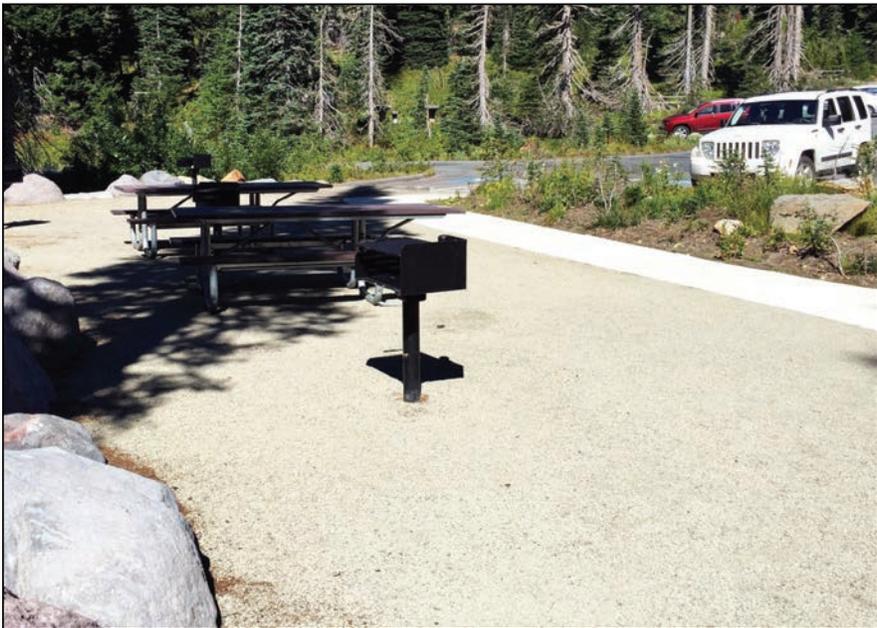
GreenPave at MORA’s Paradise Picnic Area.

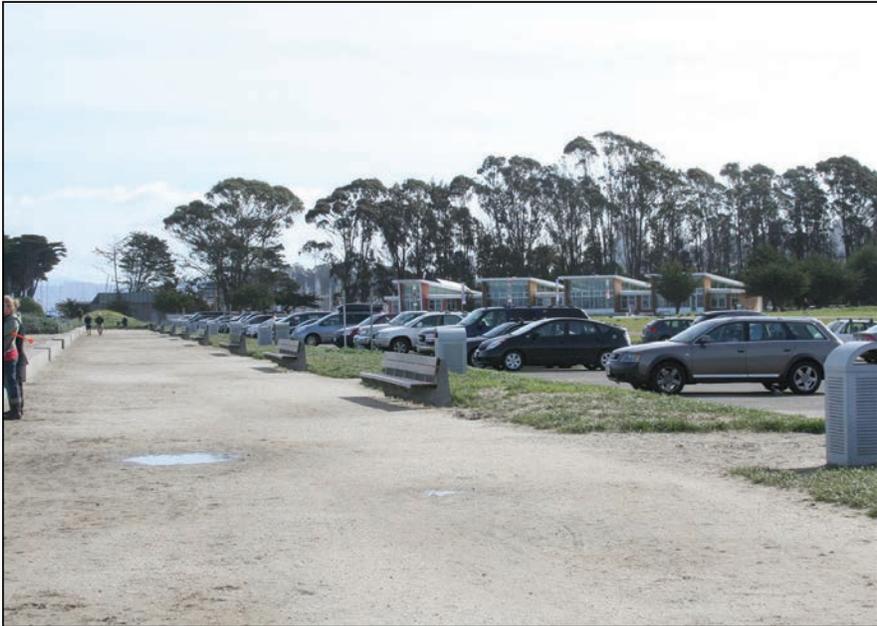
Road Oyl path at Crissy Field, GOGA.

[National Trails and Training Partnership’s *Evaluation of ‘Road Oyl’ for Trail Stabilization*](#)

See also the FHWA report, *Soil Stabilizers on Universally Accessible Trails* in the [Resources](#) section for an evaluation of Road Oyl.
