CULTURAL LANDSCAPE REPORT FOR APPOMATTOX COURT HOUSE NATIONAL HISTORICAL PARK

VOLUME II: TREATMENT IMPLEMENTATION PLAN

APPOMATTOX, VIRGINIA

National Park Service, Boston, Massachusetts, 2018

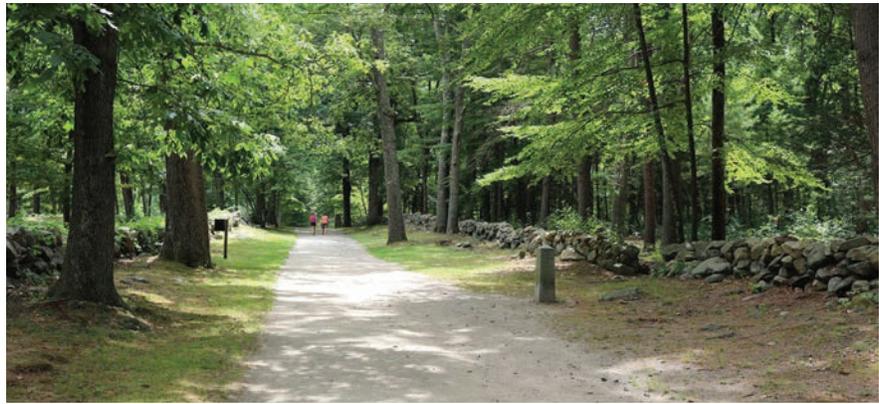
A section of the 5.5-mile Battle Road Trail at MIMA. The earthen trail is hardened with *Stabilizer*.

installation process. Overall the treatment has been very successful and enduring (now almost 20 years old). Flat sections have held up particularly well. Drainage is fundamental to the success of the hardened trail. Where the surface is slightly crowned and water sheets off of the surface, the trail is in good condition. In sections where water has concentrated and built up speed (sloped sections that have lost crown and shoulder), the water has scoured and washed away the stabilized surface. It is difficult to patch and repair the stabilized surface. Some subsequent patches are soft, because the mix contained too much sand and not enough clay. At an underpass, where the trail descends and ascends at about a five percent slope, the surface is notably soft. Here, mountain bikes chew up the surface as riders ascend the hill. As a result, this sloped section will be resurfaced with crowned asphalt with a matching chipseal surface in the year ahead. The park also used Stabilizer for two parking areas (a similar product designed for vehicle use areas). Again, due to their generally flat topography, the surface has remained hardened, particularly where drainage is carefully maintained.”

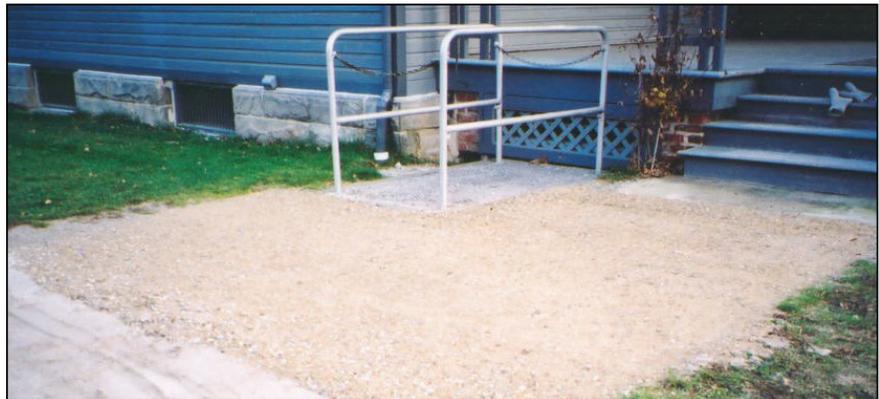
Test plot installation of *Stabilizer* at JAGA.

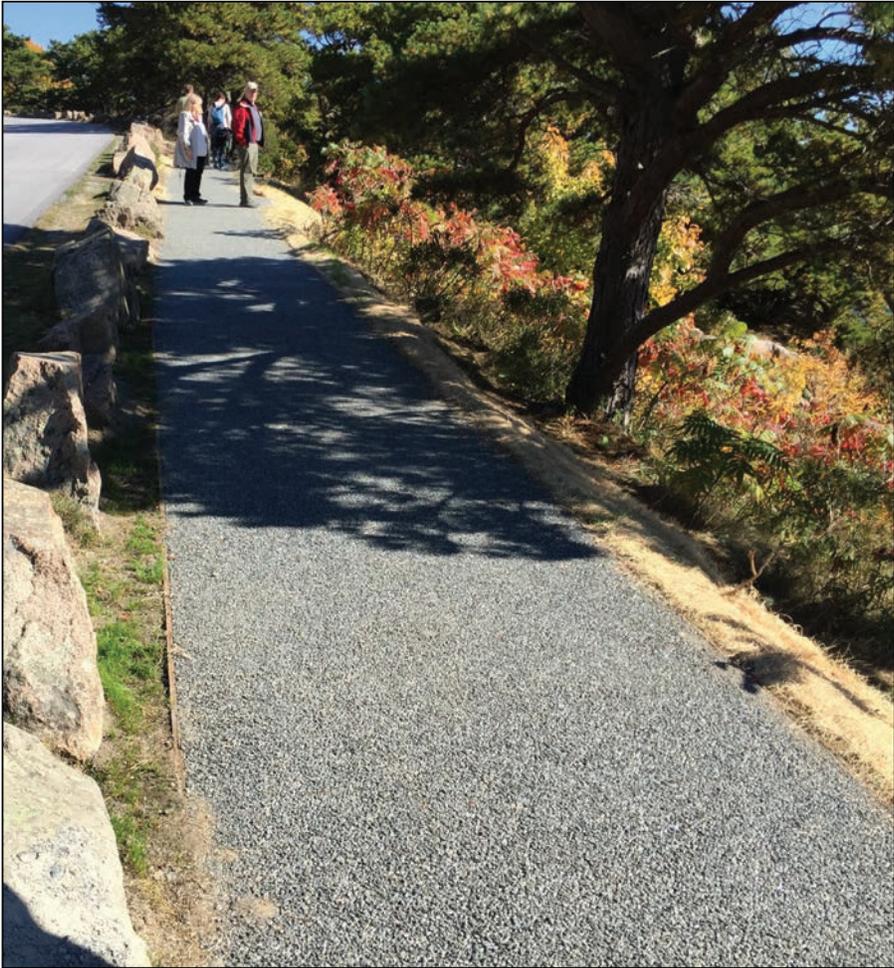
FilterPave on ACAD's Ocean Path.

- It is indeed porous - water rolls right through it.
- After a three weeks, it look great, we’re quite happy. We’ll let you know more in about 10 years!”

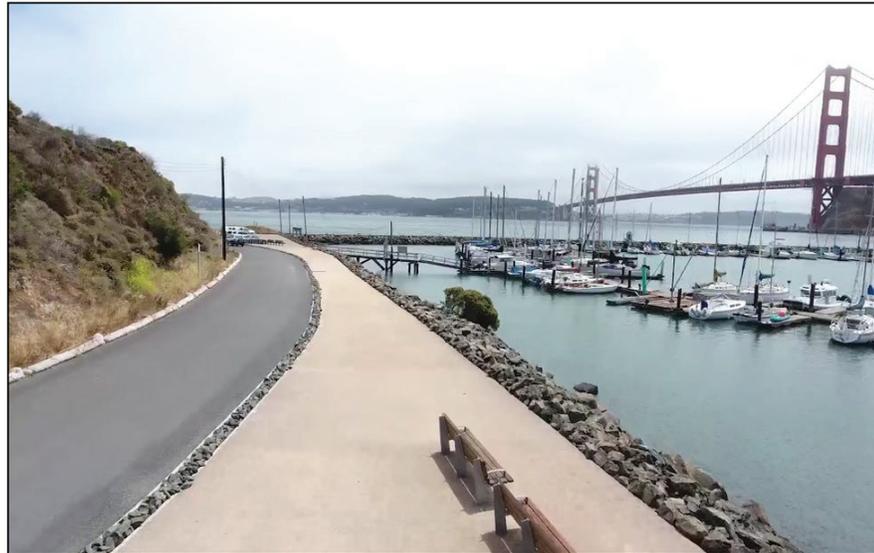
GraniteCrete at Crissy Field, GOGA. Source: granitecrete.com

GOGA: "The installation is very difficult and there are often imperfections in the material from the beginning. It also cracks like concrete. It could work well in small areas."

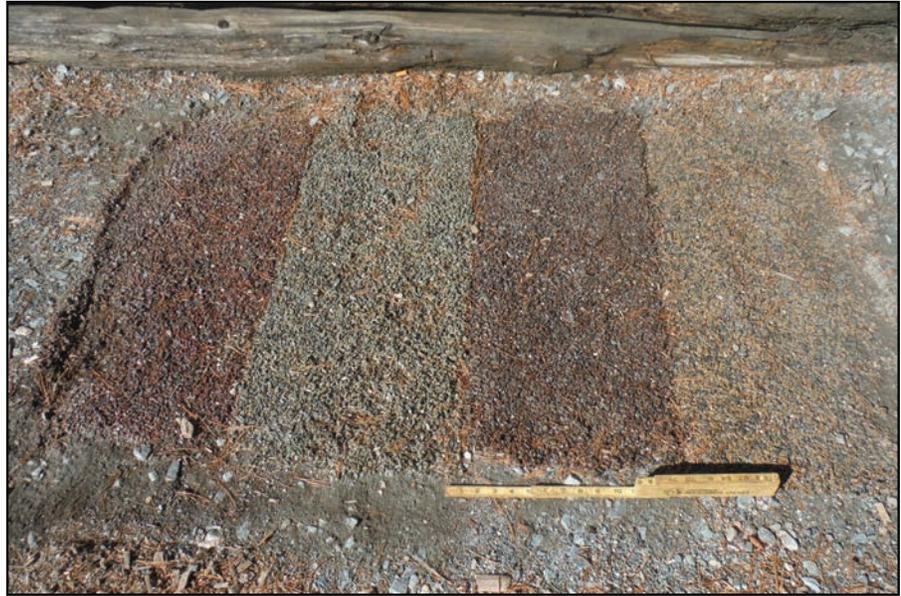
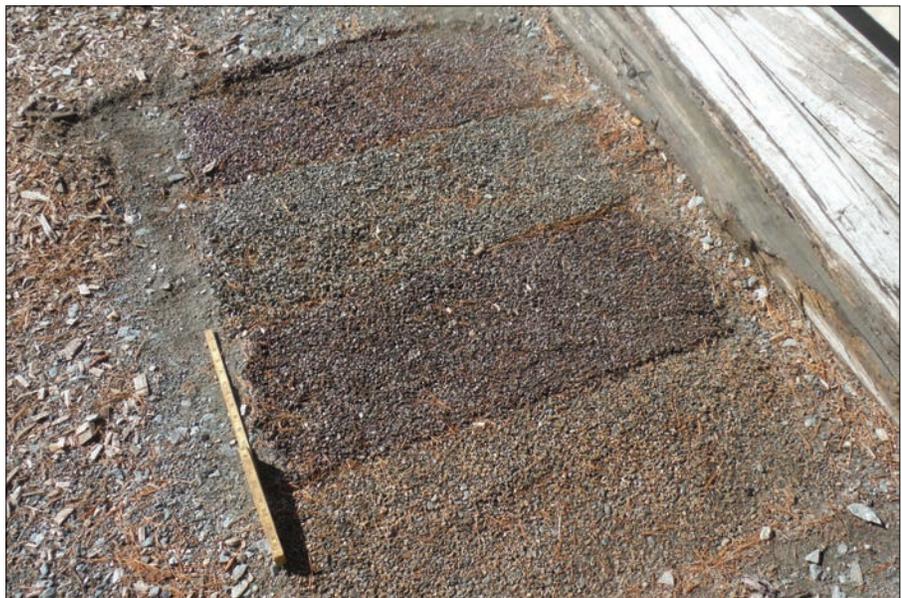
Four *Porous Pavement* test plots at ACAD.

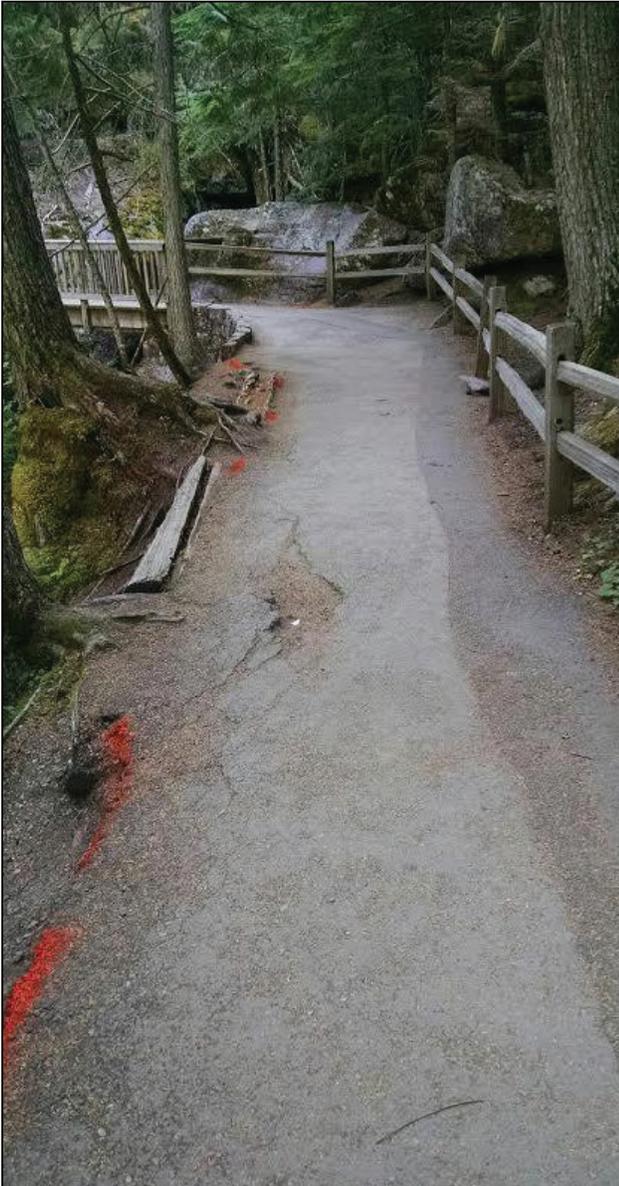
StaLok installation before (left) and after (right) on the Trail of Cedars at GLAC.

YOSE: "Yosemite has experimented with numerous decomposed granite paving materials and the Facilities Management group favors a product called StaLok which seems to hold up well under a wide range of weather conditions."

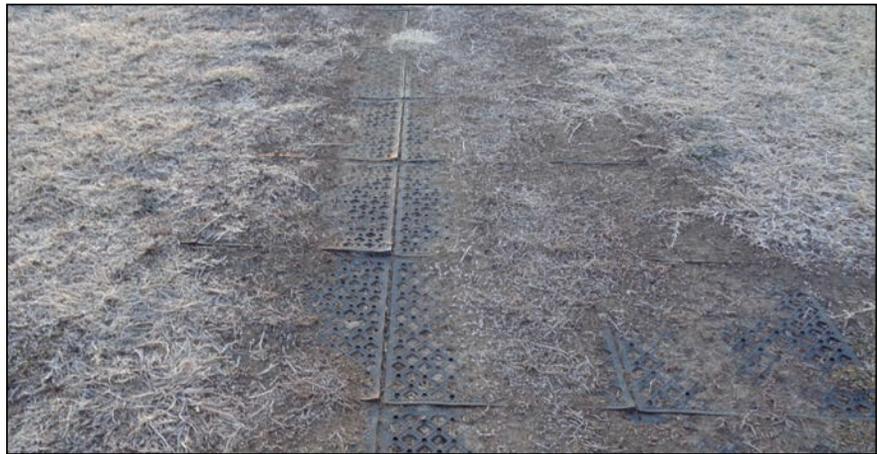
Safety Deck II installed at BRVB.

Concerns about removal: How to dispose of material. What is the best replacement?"

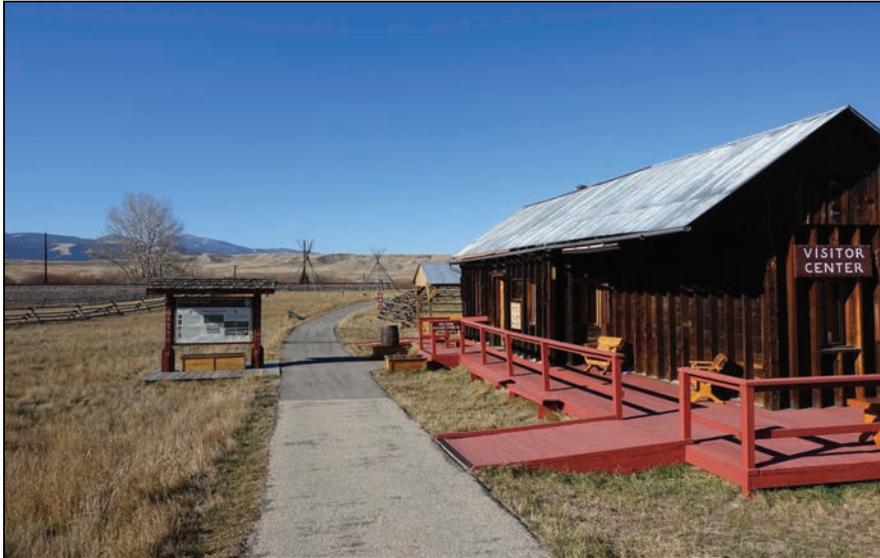
A chip seal treatment meets unsurfaced asphalt at GRKO.

OCLP: “I generally prefer to recommend tried and true materials that can be patched or repaired with in-house labor and equipment. That is what sustainable means to me. I have recommended lots of asphalt-concrete chip seal pathways (WEFA), and have widely distributed ACAD “dense graded -crushed stone” spec for the carriage road surface or “wearing” course. I have also widely recommended installation of FHWA “shoulder mix” 50/50 to 60/40 mix of topsoil and crushed stone. Used this at DAAV in the flying field where even predictable footing was required over a turf surface; and a crisp walkway edge was undesirable.”

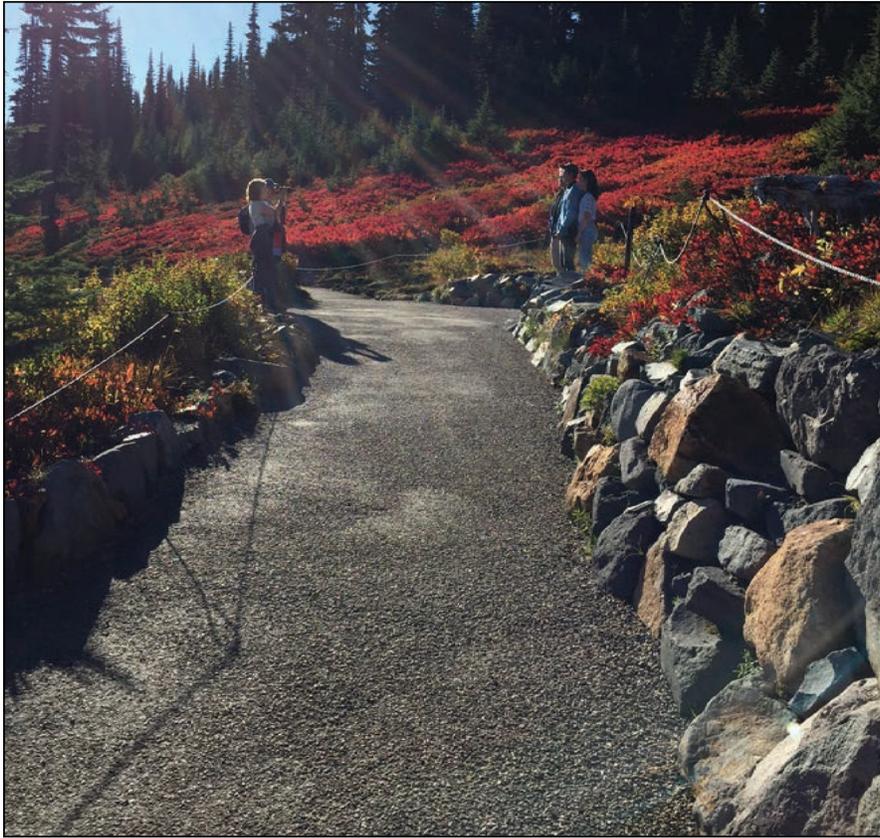
Chip-sealed asphalt near Paradise Visitor Center within MORA NHL.

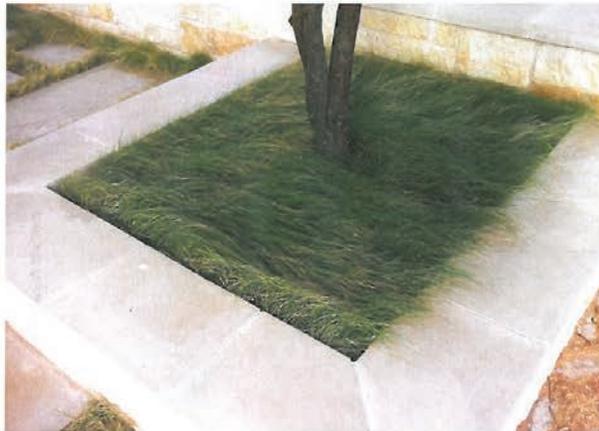
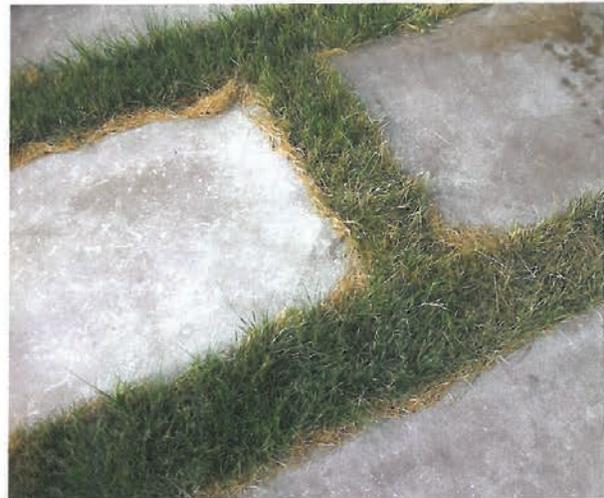
TOP LEFT AND RIGHT
Left unmown, "Habiturf" looks soft and slightly tousled; mowed to a height of three to four inches, it looks more traditional.

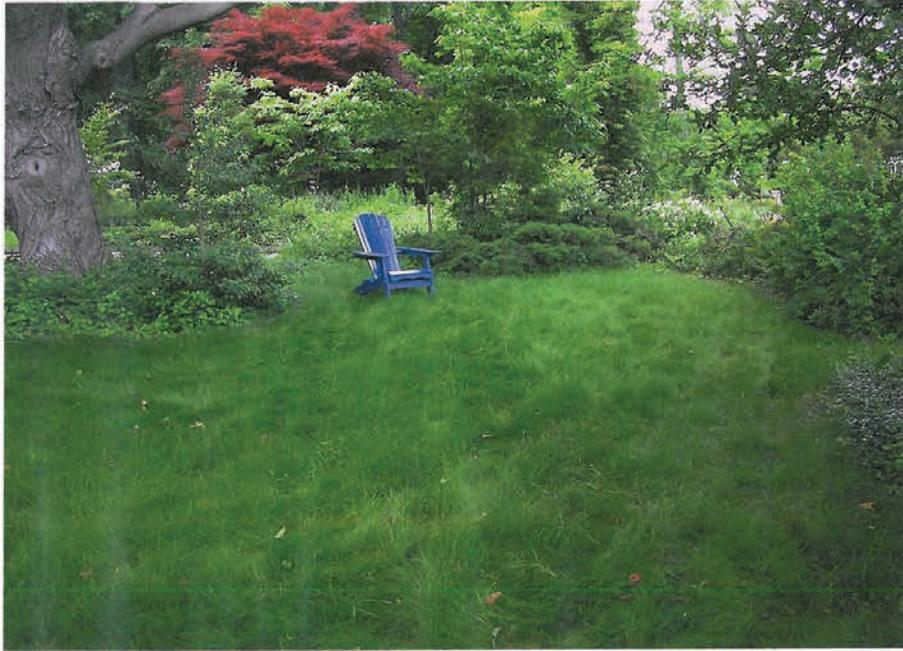
Two mowings annually with no fertilization or irrigation are all the care this Connecticut fine fescue lawn requires.

Yet another overlooked species is sheep fescue (*Festuca ovina*). Traditionally reserved for erosion-control plantings along highways, sheep fescue is a useful and attractive, low-input turf for challenging sites in the Northeast. It's a cool-season bunchgrass that is nearly invulnerable to drought and tolerates poor, acidic soils. Like all the bunchgrasses, this species takes time to knit together into a uniform turf, but once established it requires almost no irrigation and no fertilization, especially when combined with white clover. It makes a soft-looking, fine-textured
