CULTURAL LANDSCAPE REPORT FOR GETTYSBURG NATIONAL MILITARY PARK

RECORD OF TREATMENT: VOLUME II

RECORD OF TREATMENT, AREAS 11–15

Olmsted Center for Landscape Preservation
National Park Service, Boston, Massachusetts, 2018

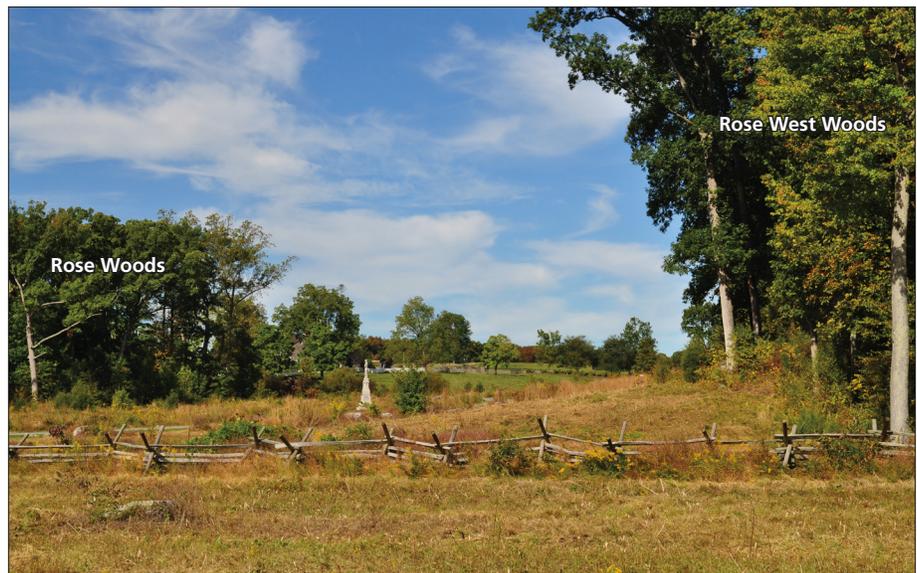
Figure 14. Rose Lane Gap woods removal. View northwest from Rose Wheatfield, 2013 (OCLP).

In 1999, successional woody vegetation filled Rose Lane Gap and contractors removed the non-historic woods in 2004. The park utilized an indefinite delivery/indefinite quantity (IDIQ) agreement, delivery order P3-031, and contracted with Pennington Tree Experts to clear a 3.33-acre area. After the clearing component was completed, the park's Resource Management division seeded the area predominately with big bluestem (*Andropogon gerardii*) purchased from Ernst Conservation Seeds, Inc. The cleared area is mowed one time a year and presently remains open (Figure 14).

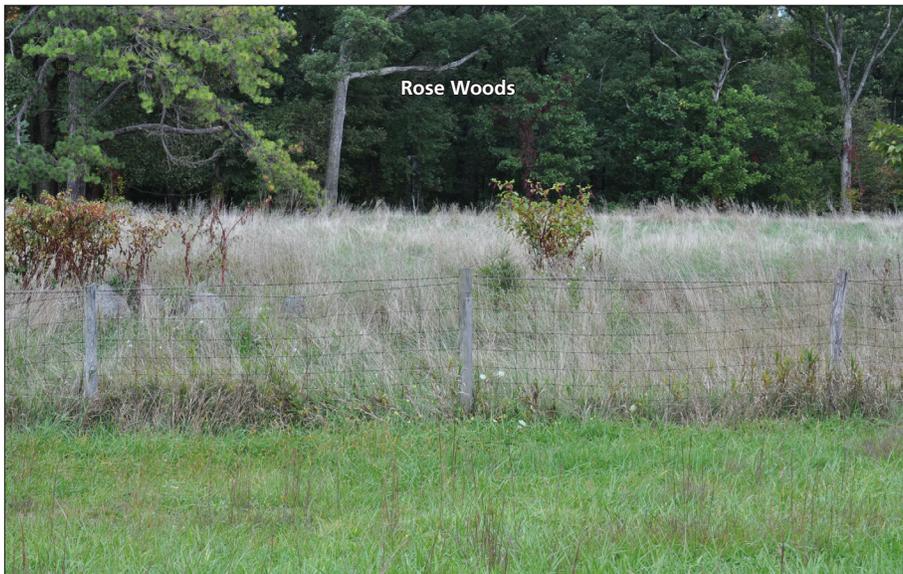
Figure 16. Rose Field 10 woods removal. View east from Rose Field 9/ Rose Old Orchard, 2014 (OCLP).

In 1999, successional woody vegetation filled portions of Rose Field 10 and contractors removed the non-historic woods in 2006. The park utilized an indefinite delivery/indefinite quantity (IDIQ) agreement, delivery order T4-068, and contracted with Pennington Tree Experts to clear a 0.86-acre area. Existing grasses present in Rose Field 10 before the contracted work began were allowed to self-seed. The cleared area is maintained as a pasture and through grazing, presently remains open (Figure 16).

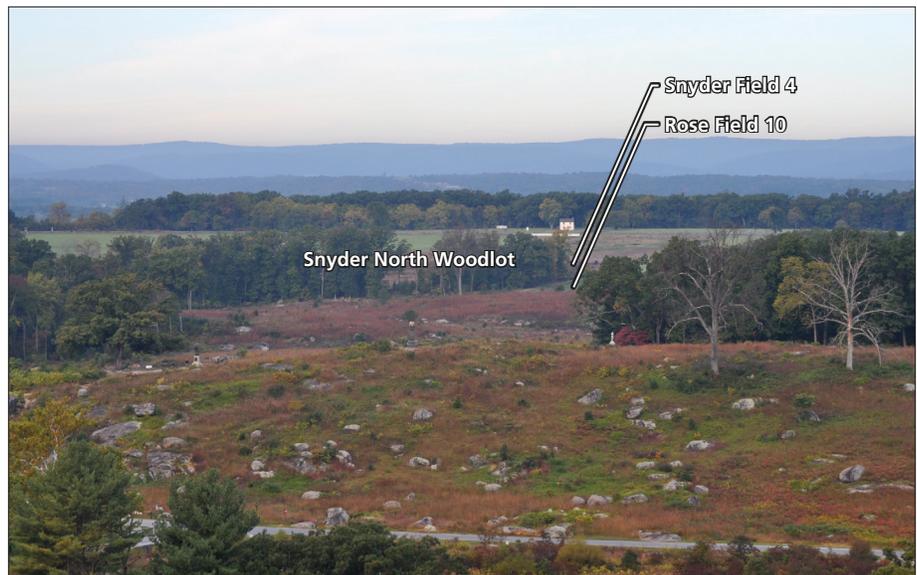
Figure 18 (right). Rose and Snyder Fields woods removal. View west from Little Round Top, 2014 (OCLP).

In 1999, successional woody vegetation filled portions of the Rose and Snyder fields and contractors removed the non-historic woods in 2006. The park utilized an indefinite delivery/indefinite quantity (IDIQ) agreement, delivery order T5-050, and contracted with Pennington Tree Experts to clear a 3.84-acre area. The area contained Indian grass (*Sorghastrum nutans*) and other warm season grass species before the contracted work began and was allowed to self-seed after the clearing was completed. The cleared area is mowed one time a year and presently remains open (Figure 18).

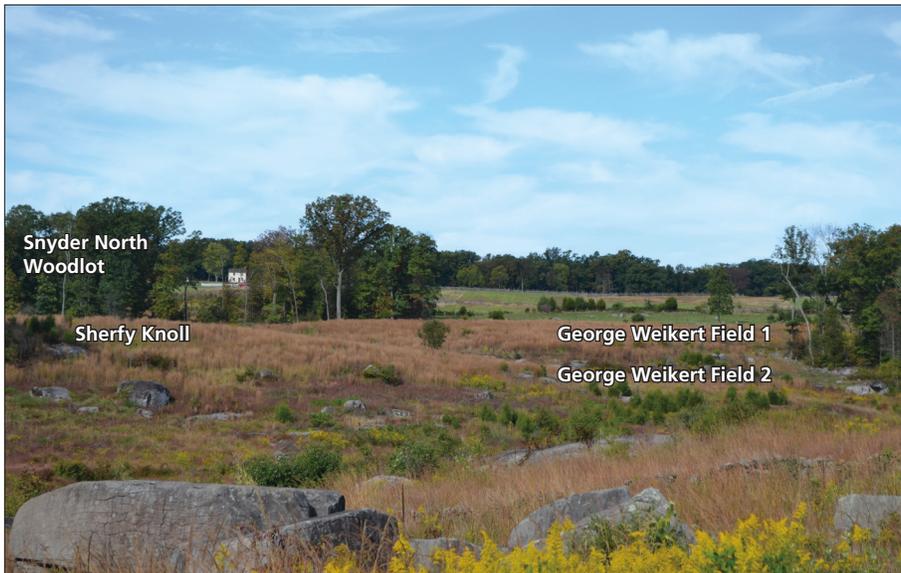
Figure 20. Sherfy Knoll and George Weikert Fields woods removal. View west from George Weikert Field 3, 2013 (OCLP).

In 1999, successional woody vegetation filled Sherfy Knoll and George Weikert and Snyder Fields. Contractors removed the non-historic woods in 2006 with the park utilizing an indefinite delivery/indefinite quantity (IDIQ) agreement, delivery order T4-068, and contracting with Pennington Tree Experts to clear an 18.19-acre area. After the contracted work was completed, the park’s Resource Management division seeded the area with little bluestem (*Schizachyrium scoparium*), big bluestem (*Andropogon gerardii*), Indian grass (*Sorghastrum nutans*), and Eastern gammagrass (*Tripsacum dactyloides*) purchased from Ernst Conservation Seeds, Inc. The cleared area is mowed one time a year and presently remains open (Figure 20).

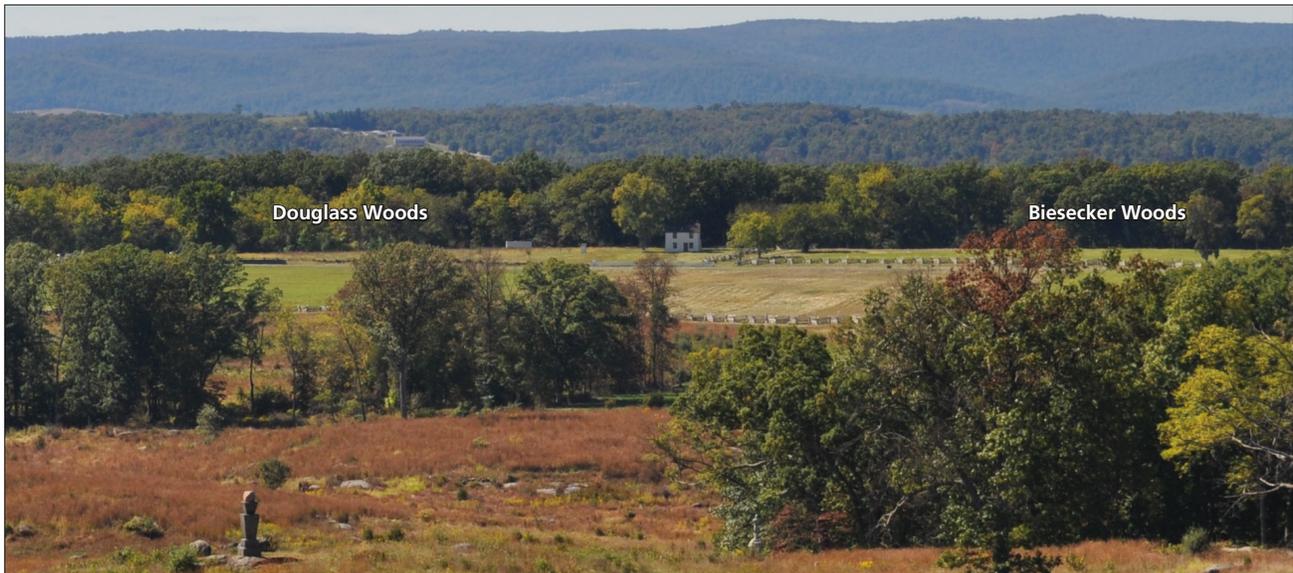
Figure 24 (bottom). Biesecker and Douglass Woods health cuts. View west from Little Round Top, 2013 (OCLP).

In order to maintain and sustainably perpetuate the character of a woodlot involved in battle action, the park contracted for health cuts in Biesecker and Douglass Woods. Under delivery order T7-101, contractors performed health cuts in a 23.86-acre area and completed the work in 2008 (Figure 24). Specifications for health cuts are included in Appendix A.

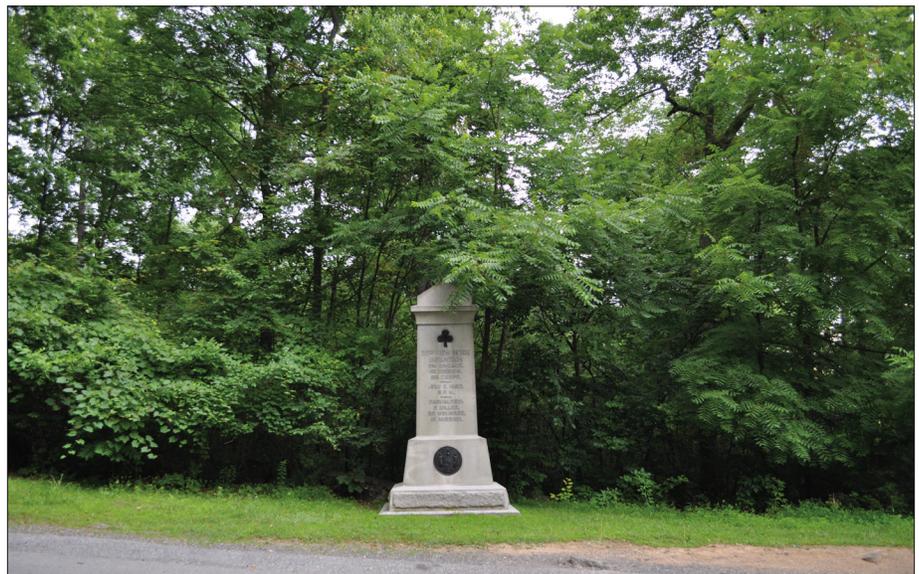
Figure 26. Rose Woods health cuts. View northeast from the 66th New York Monument, 2016 (OCLP).

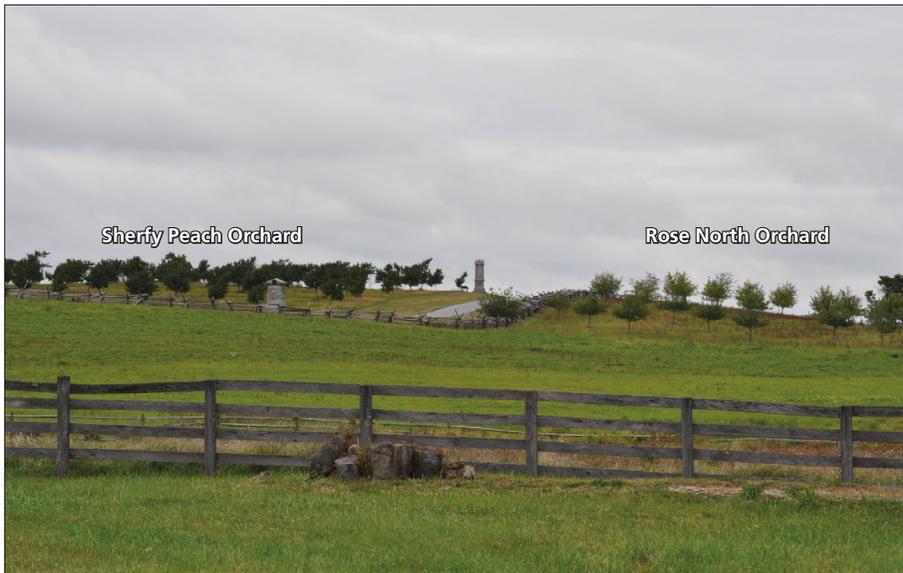
Figure 28. Rose North Orchard replanting. View north from Rose Farm, 2014 (OCLP).

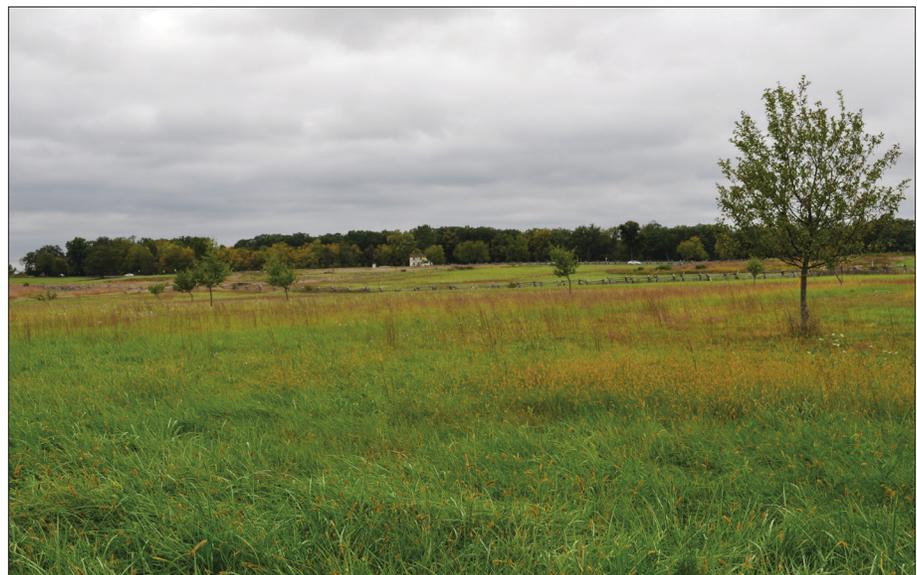
Figure 34. Rose Old Orchard replanting. View southwest, 2014 (OCLP).

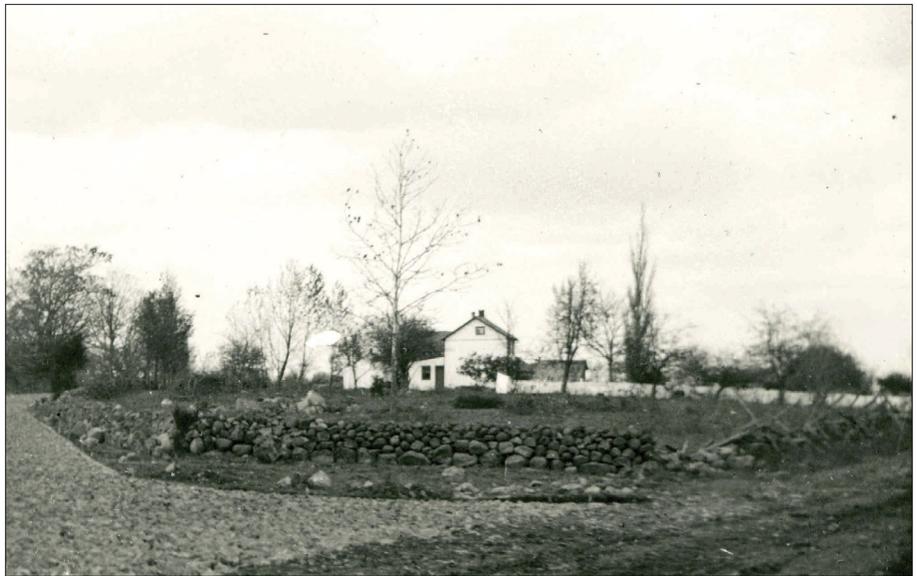
Figure 38. Snyder Orchard replanting. View northeast from Confederate Avenue, 2014 (OCLP).

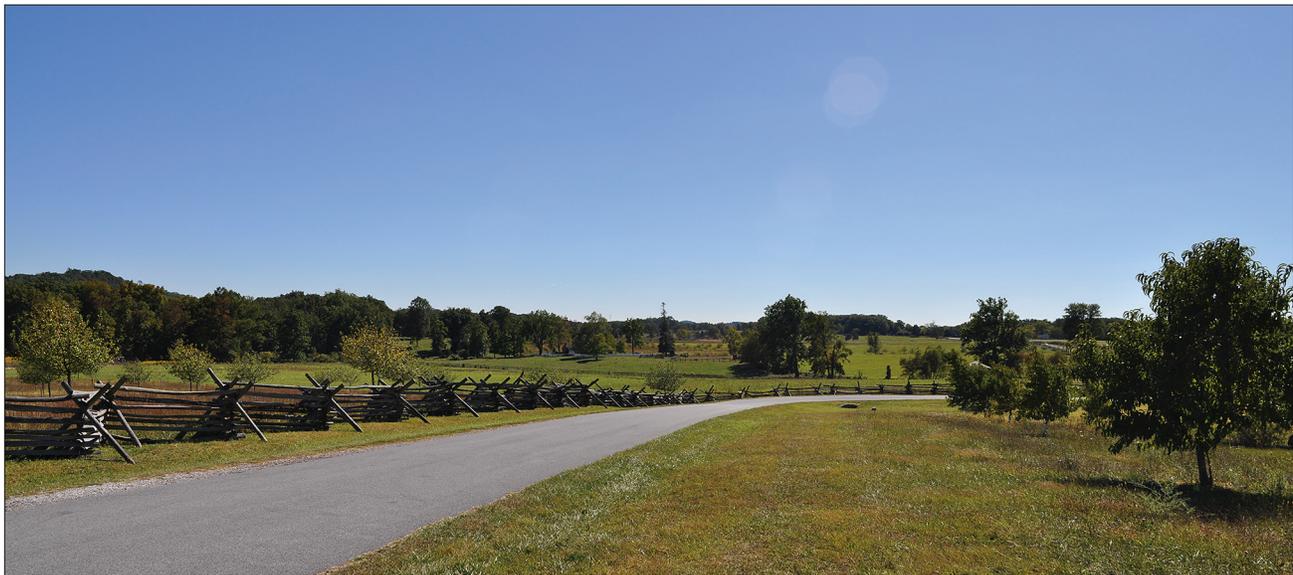
Figure 41. Rose Field 5 north and east boundary worm fence. Detail of view southeast from Trostle Field 1, circa 1889 (GETT 41136, Tipton Collection, T2455b).

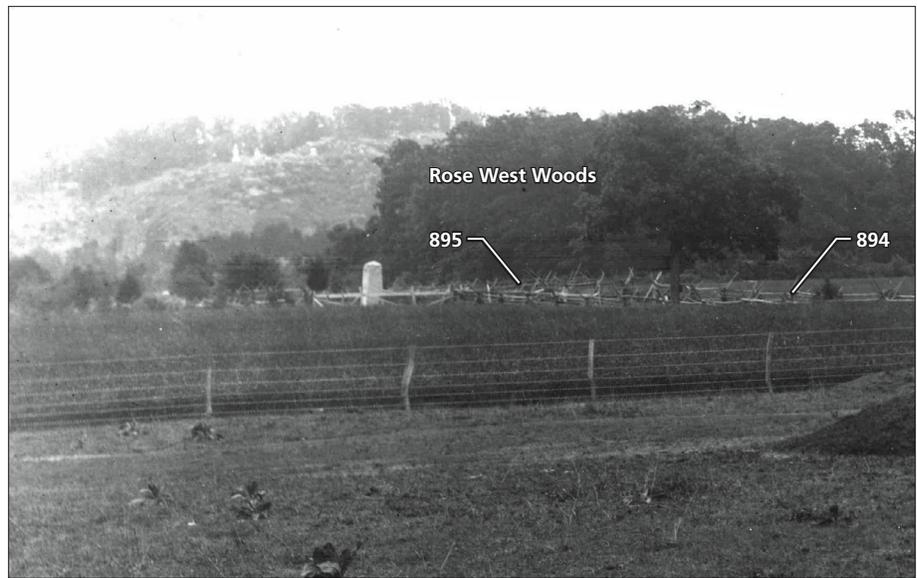
Figure 42. Rose Field 5 north and east boundary worm fence installation [GIS IDs 894, 895]. View southeast from Wheatfield Road, 2013 (OCLP).

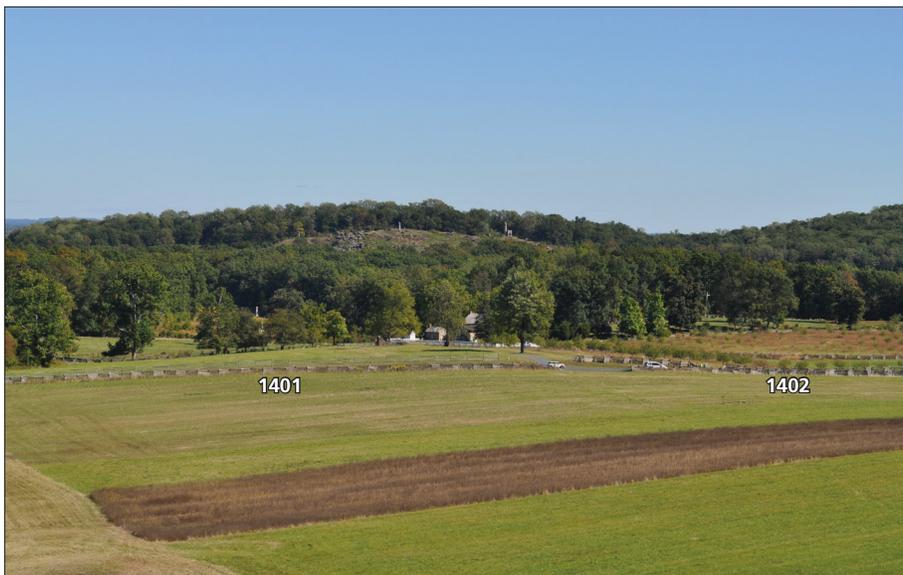
Figure 48. Rose Fields 1–3 east boundary and Snyder Field 1 east boundary worm fence installation [GIS IDs 1401, 1402, 1403]. View southeast from Confederate Avenue Observation Tower, 2013 (OCLP).

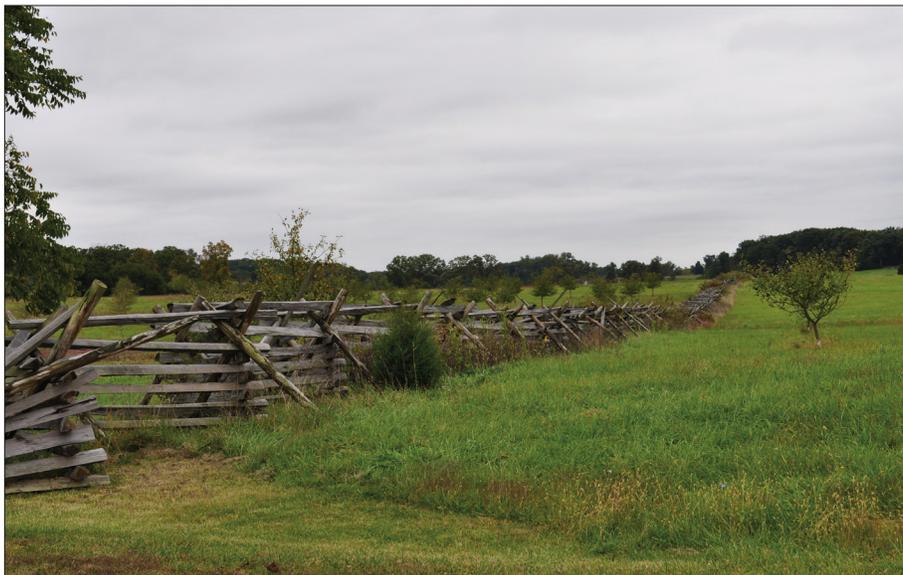
Figure 52. Snyder Fields 3 and 7, Rose Field 9, and Rose Orchards west boundary worm fence installation [GIS ID 1406]. Woody vegetation along the fence should be removed to prolong the materials' life. View southeast from Rose Farm Lane, 2014 (OCLP).

TABLE 3: RECORD OF TREATMENT SUMMARY, AREA 11		
Task	Date Completed	Notes
Rose Field 8 West Boundary Worm Fence Installation [GIS IDs 1404, 1405]	2010	
Snyder Fields 3 and 7, Rose Field 9, and Rose Orchards West Boundary Worm Fence Installation [GIS ID 1406]	2010	
Rose Yard and Garden Picket Fence and Gate Installation [GIS IDs 355, 356, 359, 1115, 1116, 1117]	2012	
Rose Yard and Garden Modern Picket Fence Installation [GIS IDs 360, 1198]	2012	
Rose Yard and Garden Modern Wire Fence Installation [GIS ID 1114]	2012	Consider removing if no longer needed for animal control or resource protection
Thickets		
Sherfy Thicket, Snyder East Thicket, and Snyder Thicket Replanting [GIS ID 29E, 29W]	2006, 2008	Monitor and consider removing trees that exceed ten to fifteen feet high as warranted to maintain historic viewsheds.
Streams		
Snyder Branch of Plum Run Non-Historic Riparian Buffer Establishment [GIS IDs 28A]	2009	Monitor and consider removing trees that exceed ten to fifteen feet high as warranted to maintain historic character.

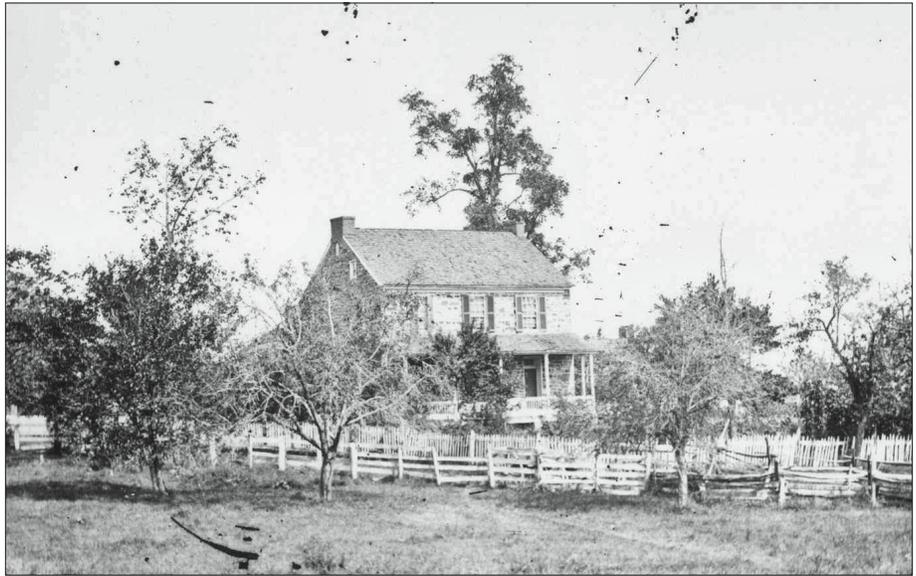
Figure 54. Rose Yard and Garden picket fence and gate installation [GIS IDs 355, 356, 359, 1115, 1116, 1117]. View northwest, 2014 (OCLP).

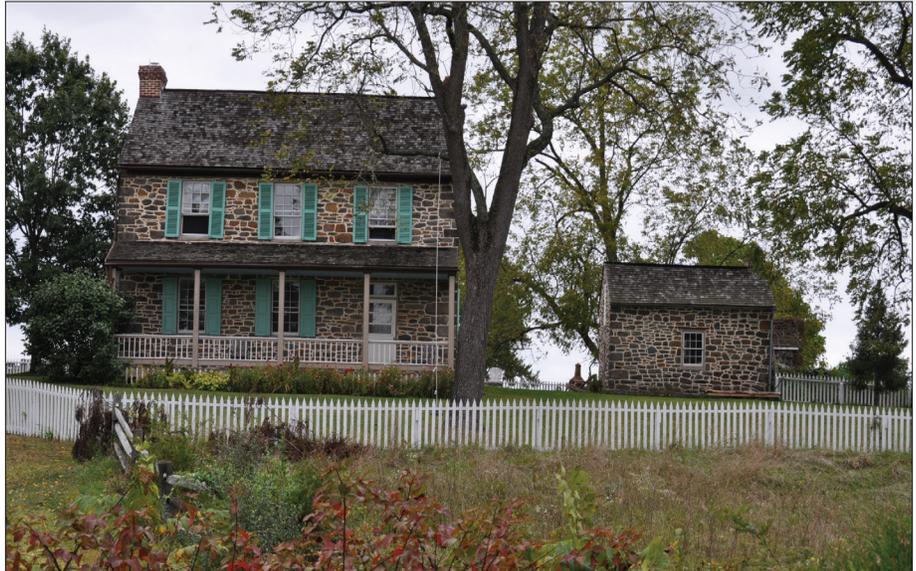
Figure 55. Rose Yard and Garden modern picket fence installation [GIS IDs 360, 1198]. View south from Wheatfield Road, 2013 (OCLP).

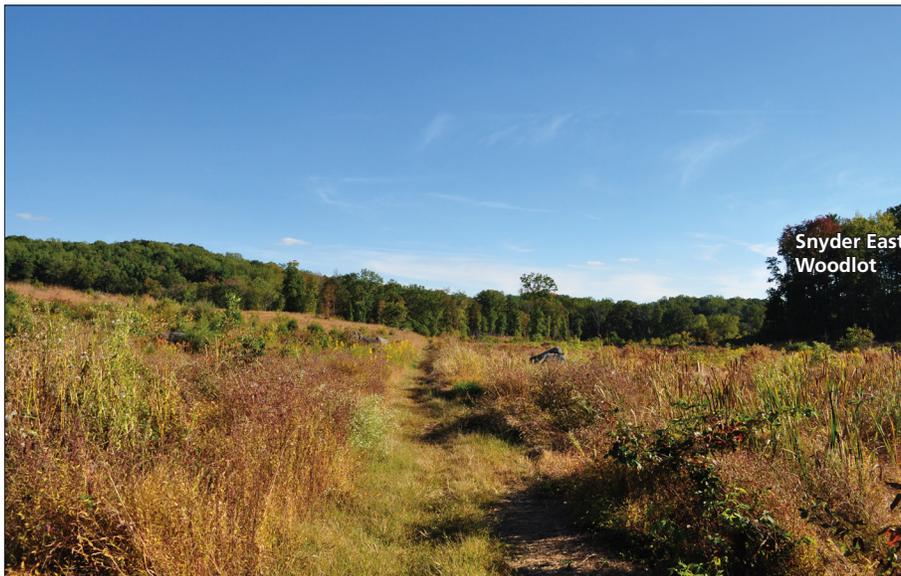
Figure 57. Sherfy Thicket replanting. View southeast, 2013 (OCLP).

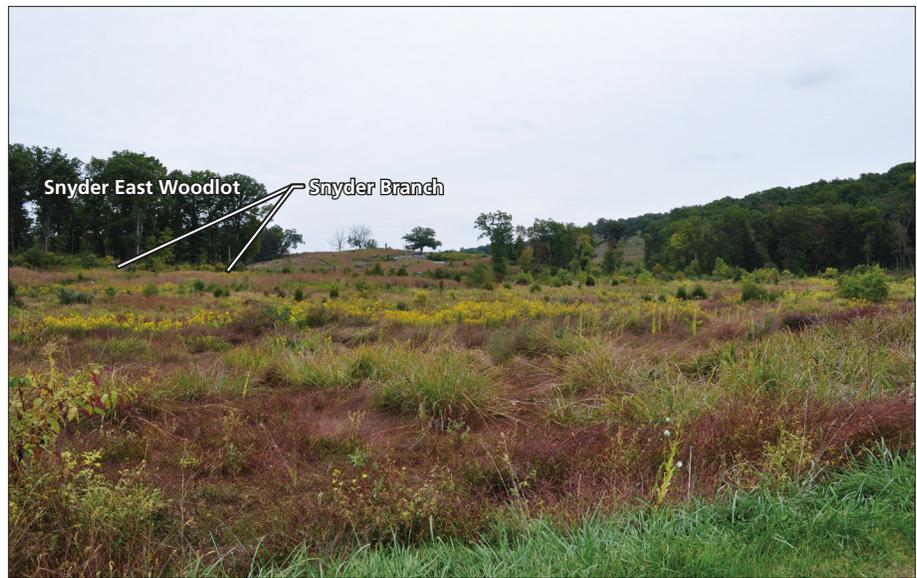
Figure 58. Snyder Branch of Plum Run non-historic riparian buffer establishment. View northeast from Snyder Farm Lane, 2014 (OCLP).

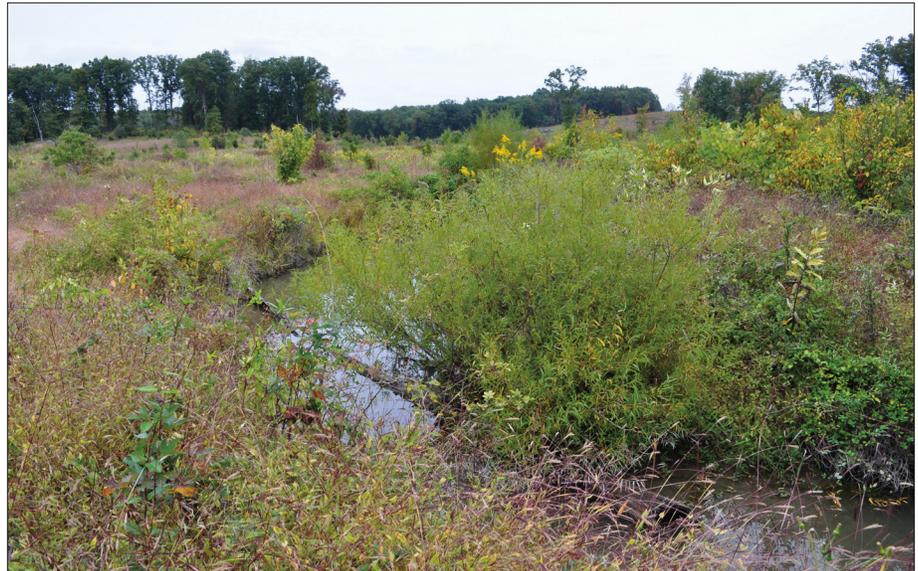
Figure 59. Rose and Plum Runs non-historic riparian buffer establishment. View northeast of Plum Run from Snyder Thicket, 2014 (OCLP).

Rose and Plum Runs Non-Historic Riparian Buffer Establishment [GIS IDs 27, 29]		Regenerating naturally Monitor and consider removing trees that exceed ten to fifteen feet high as warranted to maintain historic character.

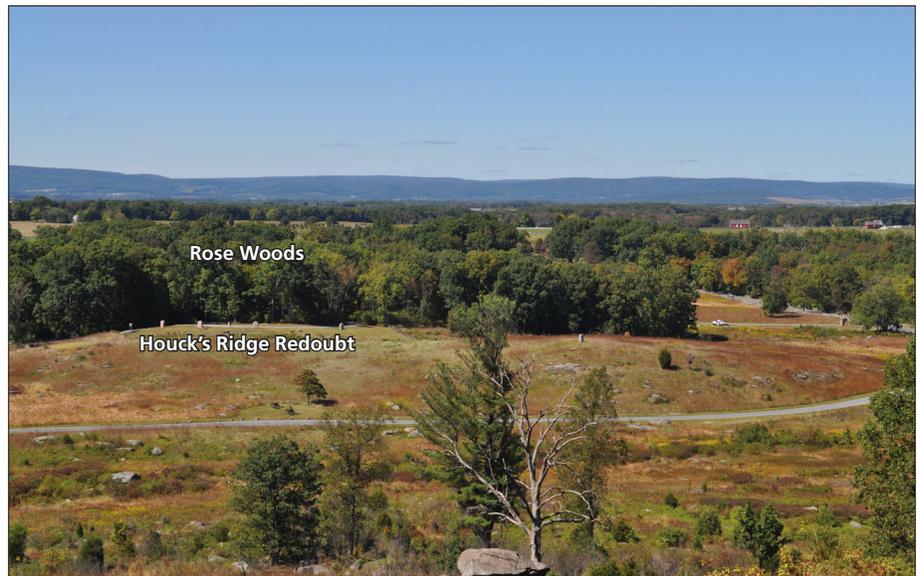
Figure 62. Houck's Ridge Redoubt woods removal. View northwest from Little Round Top, 2013 (OCLP).

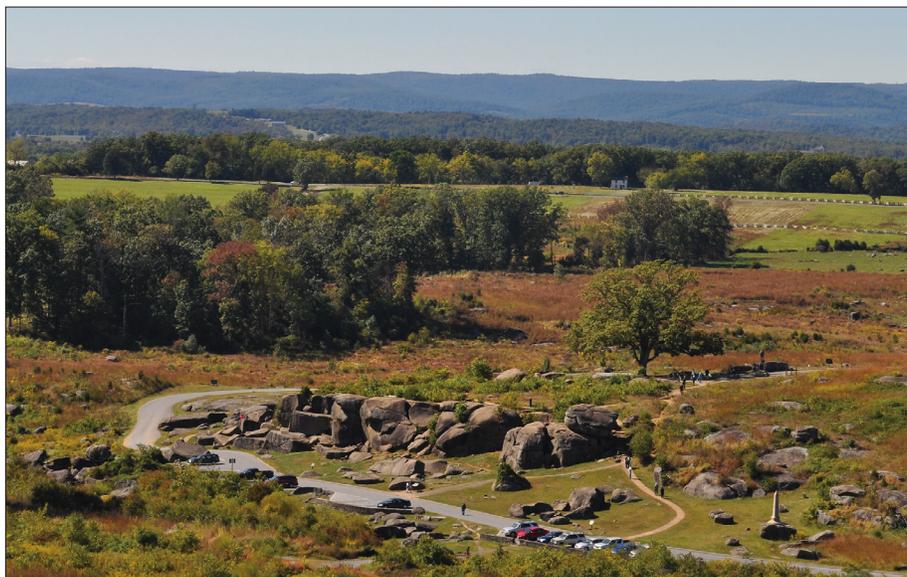
Figure 64. Devil's Den woods removal. View southwest from Little Round Top, 2013 (OCLP).

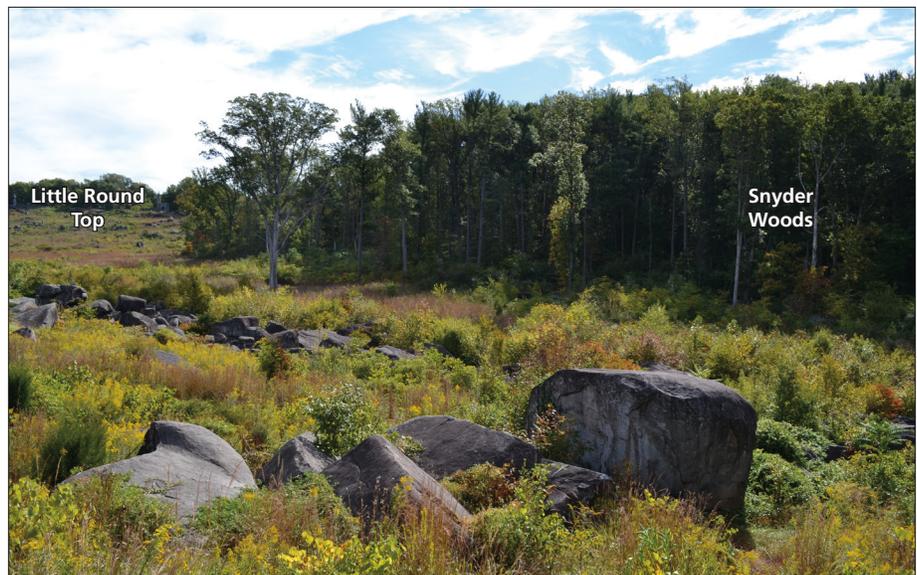
Figure 66. Plum Run Gorge woods removal. View northeast, 2013 (OCLP).

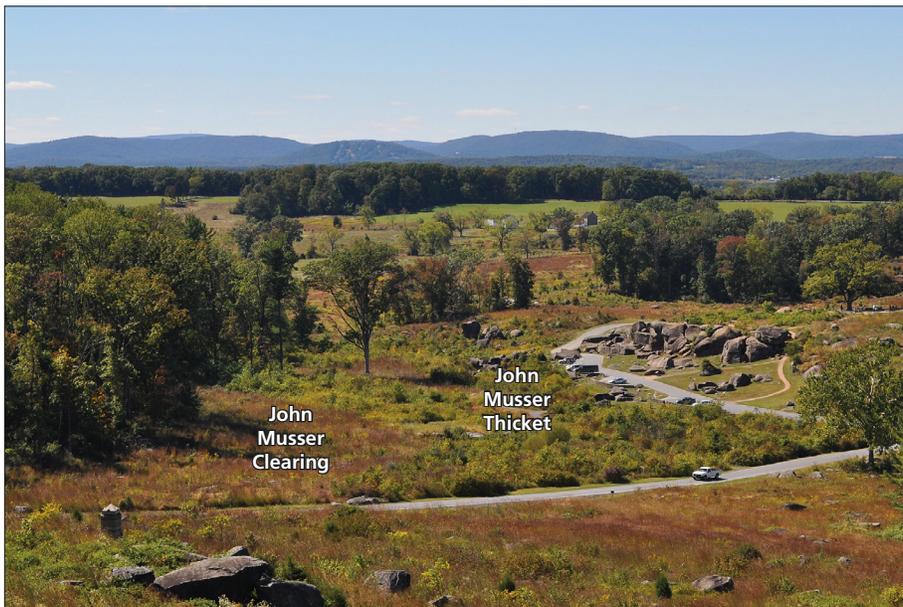
Figure 68. John Musser Clearing and Thicket woods removal. View southwest, 2013 (OCLP).

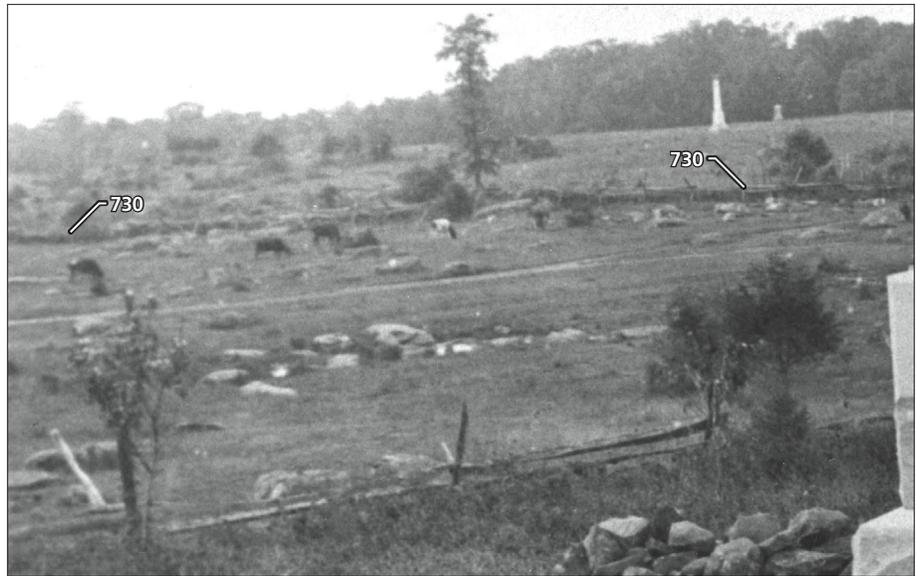
Figure 70. Houck Field west boundary stone and rider fence installation [GIS ID 730]. Woody vegetation along the fence should be removed to prolong the materials' life. View southeast from Wheatfield Road, 2014 (OCLP).

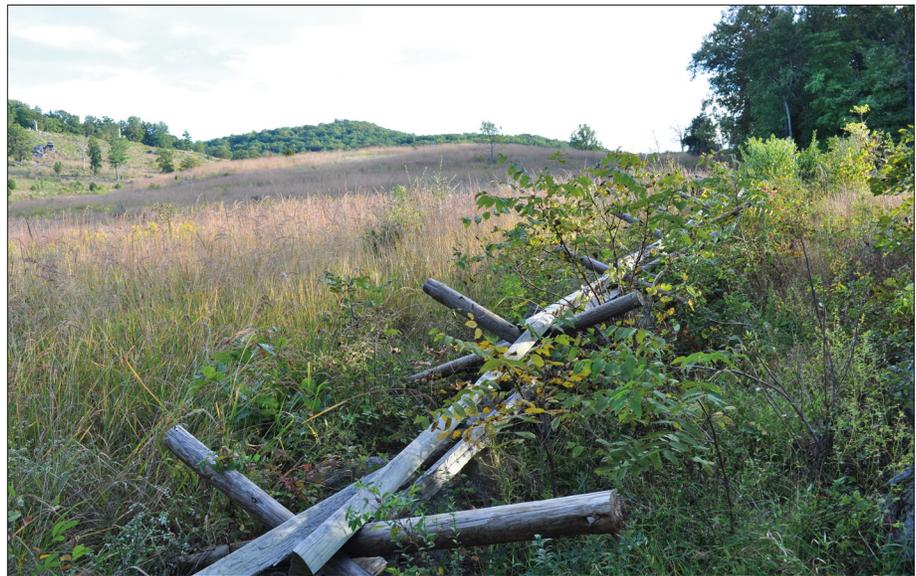
Figure 71. Plum Run non-historic riparian buffer establishment. View southeast from Devil's Den, 2013 (OCLP).

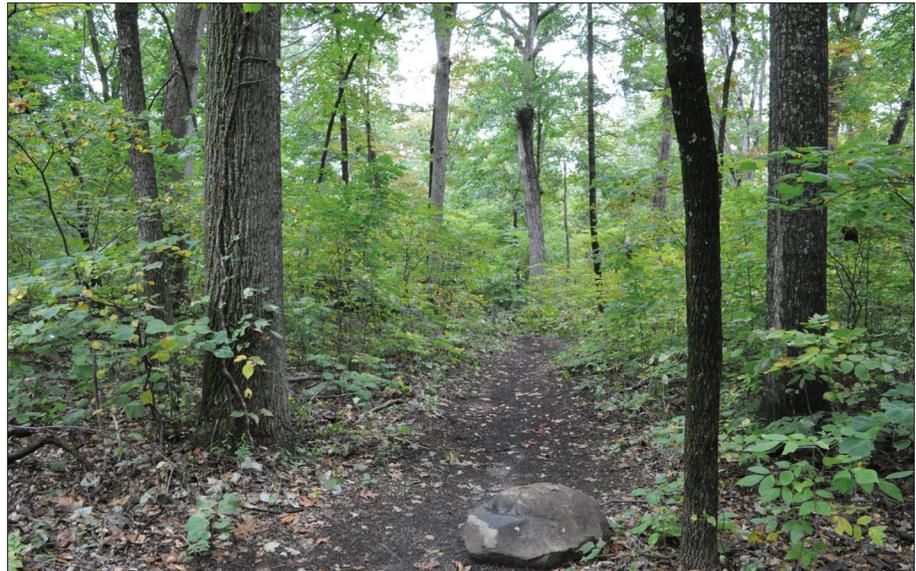
Figure 74. Weikert Woods health cuts. The trail leads east to the 20th Maine Company B Marker. View east, 2014 (OCLP).

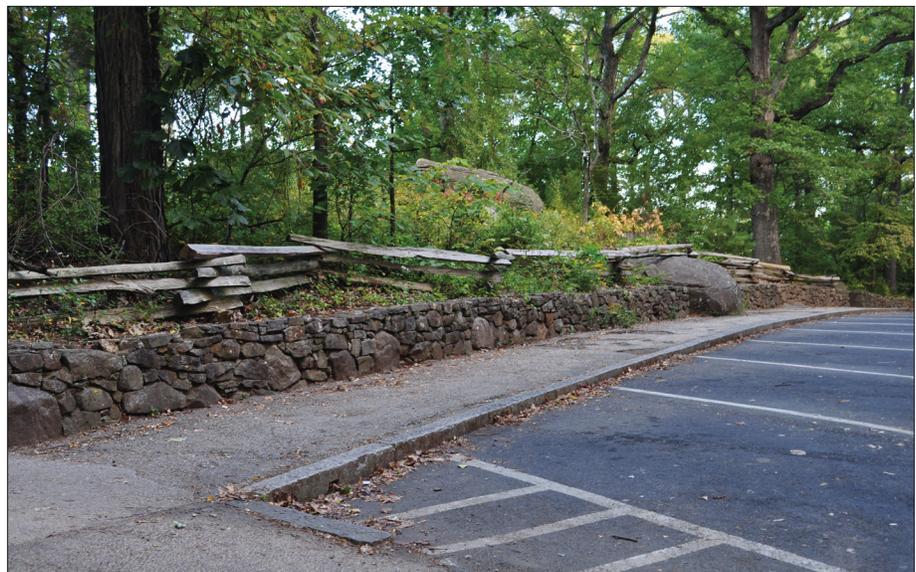
Figure 75. Little Round Top modern worm fencing installation [GIS ID 1464]. View northwest from visitor parking area, 2014 (OCLP).

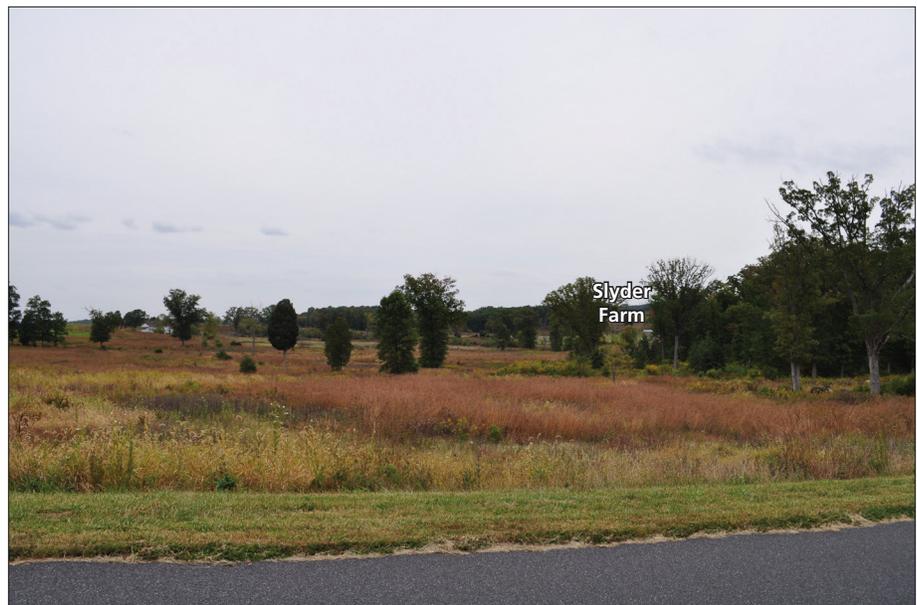
Figure 78. Bushman/Hammer and Slyder fields woods removal. View northeast, 2014 (OCLP).

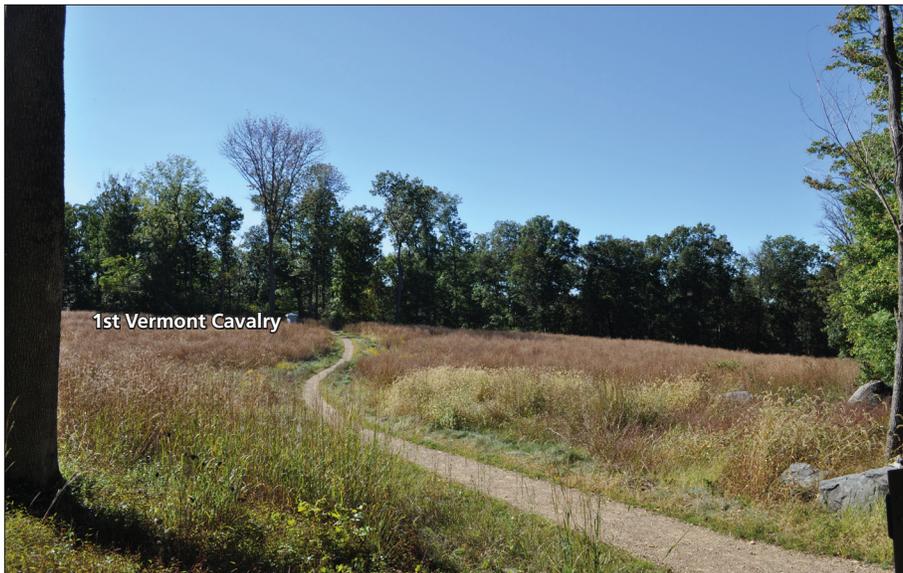
Figure 80. Slider Field 5/Slider Knoll woods removal. View northwest, 2013 (OCLP).

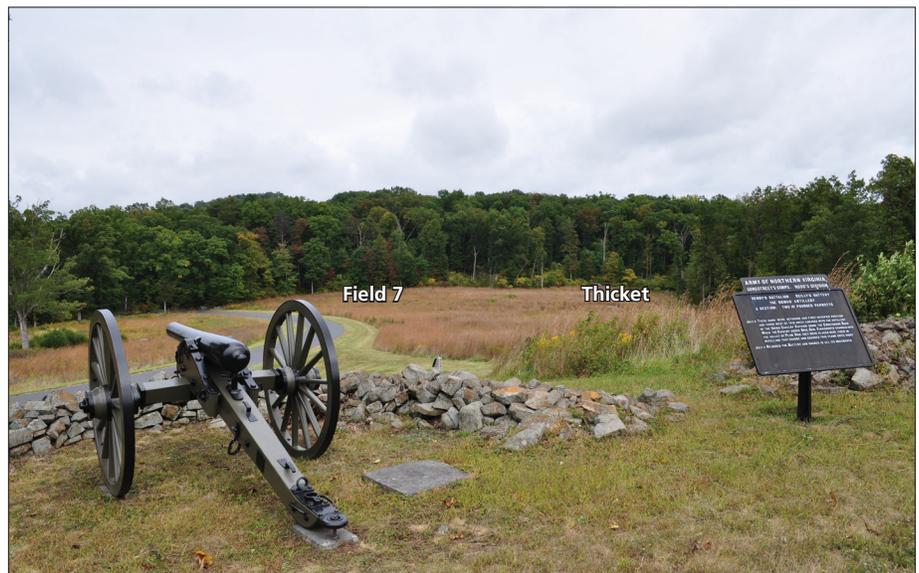
Figure 82. Bushman/Hammer Field 7 and Thicket woods removal. View east, 2014 (OCLP).

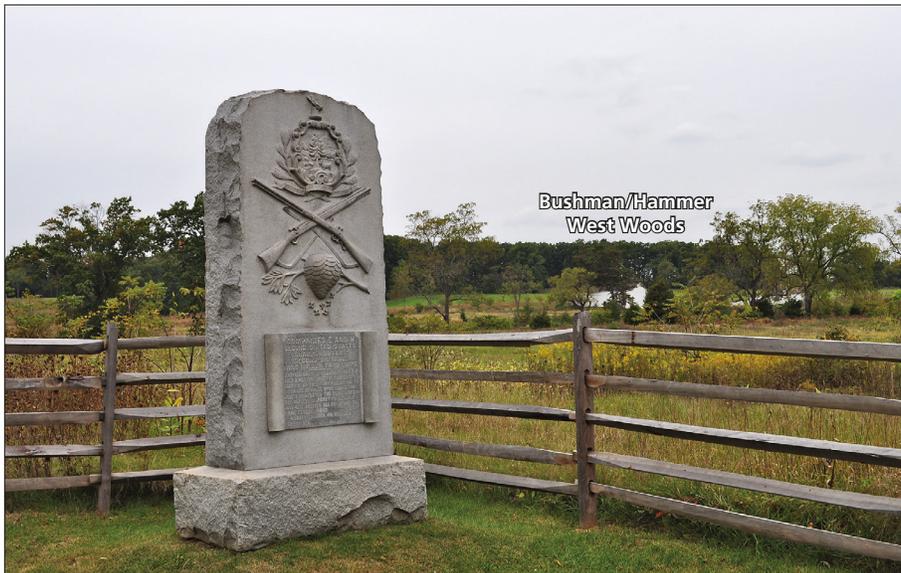
Figure 84. Bushman/Hammer West Woods health cuts. View southwest from Slyder Farm Lane, 2014 (OCLP).

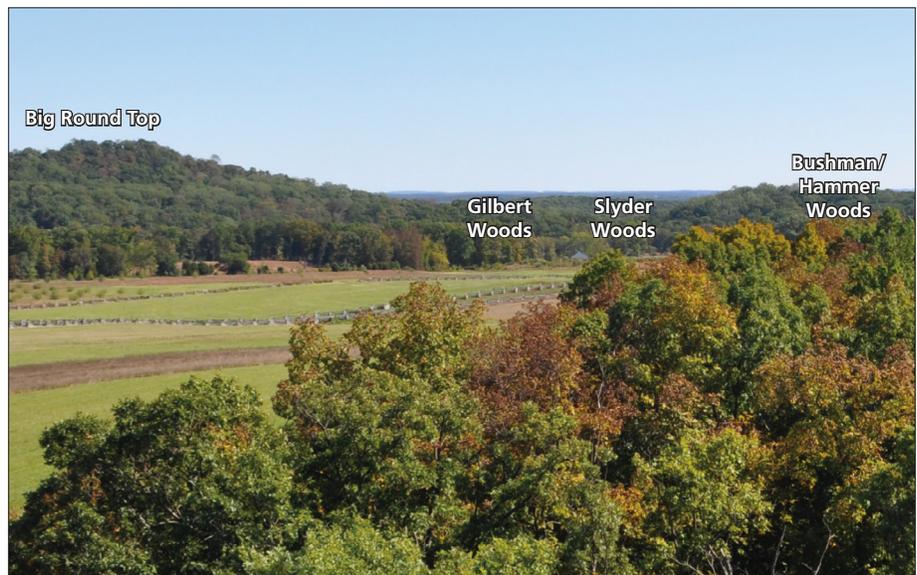
Figure 86. Bushman/Hammer, Slyder, and Gilbert woods health cuts. View southeast, 2013 (OCLP).

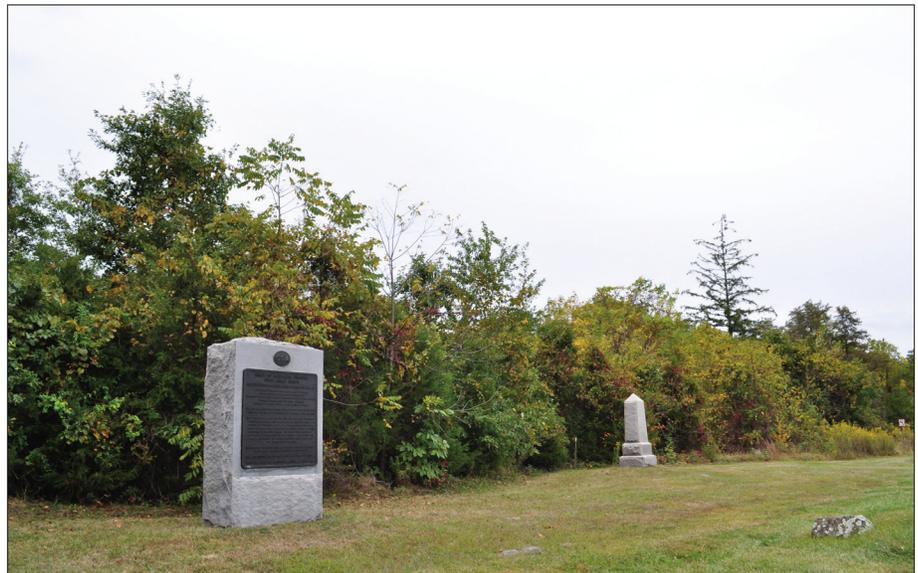
Figure 90. Douglass Woods replanting. View northwest from South Confederate Avenue, 2014 (OCLP).

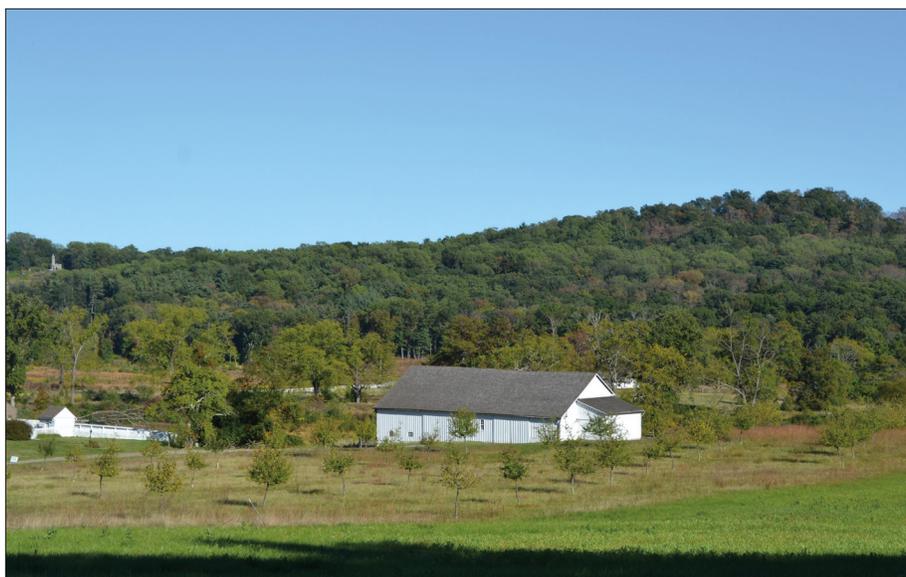
In 2005, the park completed replanting of the Bushman Orchard. The replanted orchard consists of 57 apple trees arranged in seven rows. The northern three rows consist of 26 'Liberty' apples and the next row consists of 2 'Liberty' and 7 'Williams Pride' apples. The final rows consist of 22 'Williams Pride' apples. All 57 trees were planted on EMLA 111 standard rootstock in a quincunx pattern at 40-foot on center spacing. In 2014, the park completed a condition assessment for the Bushman Orchard and recorded 30 trees in good condition, 6 trees in fair condition, 11 trees in poor condition, and 10 trees missing (Figure 92).

Figure 92. Bushman/Hammer Orchard replanting. View east from South Confederate Avenue, 2013 (OCLP).

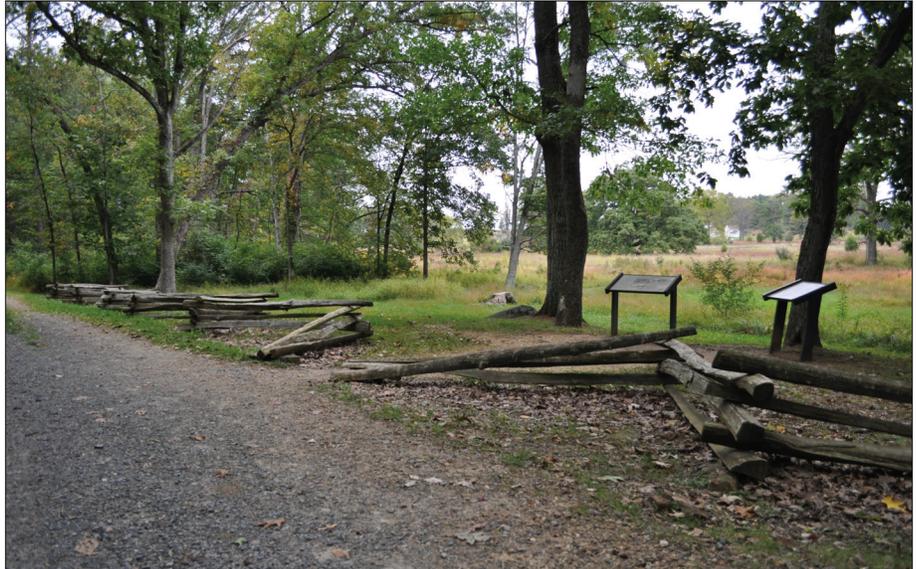
Figure 95. Wells Monument roadside modern worm fence installation [GIS IDs 1462, 1463]. View southeast from South Confederate Avenue, 2014 (OCLP).

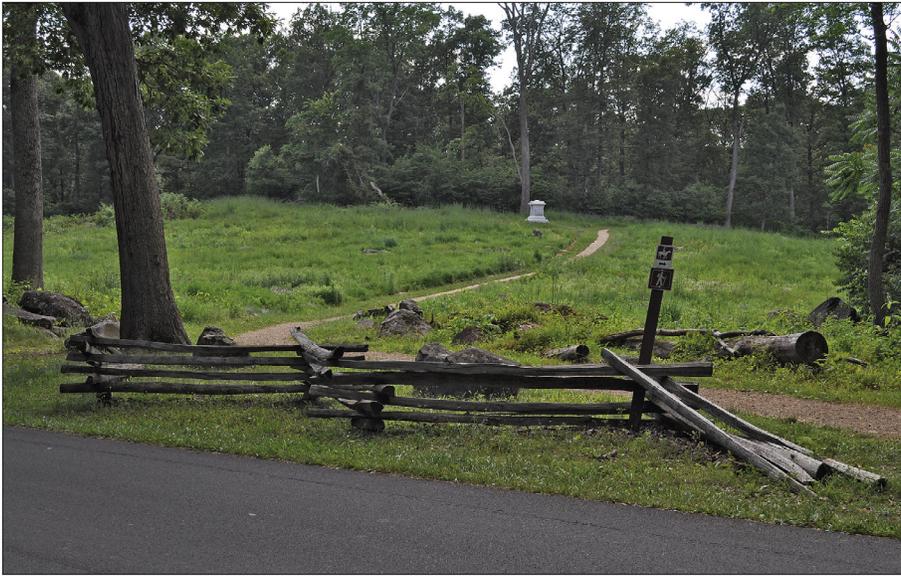
Figure 96. Snyder Field 5/
Slyder Knoll modern worm fence
installation [GIS ID 1383]. View west
from South Confederate Avenue,
2016 (OCLP).

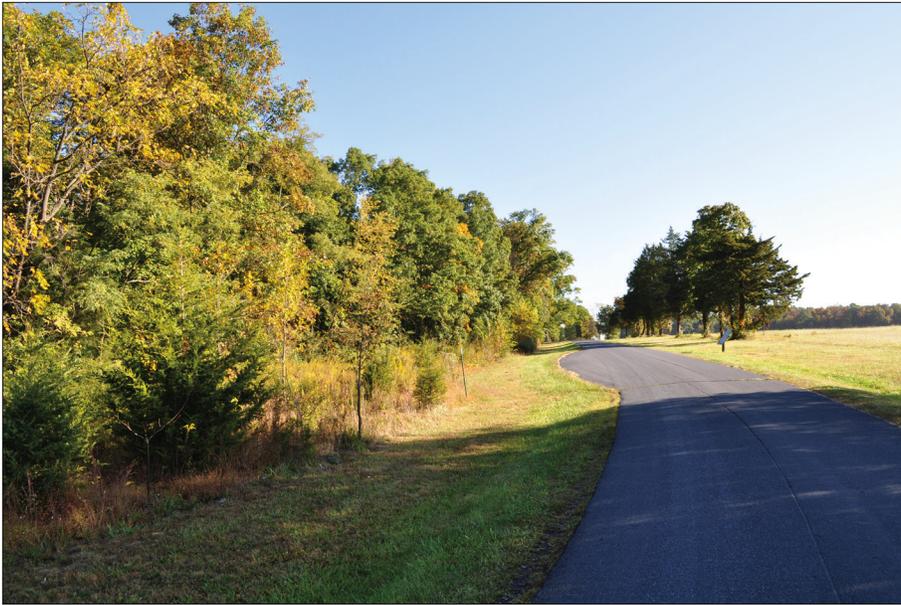
In order to rehabilitate the full extent of a woodlot involved in battle action, the park planted 0.33 acres in 2005. Deciduous material was planted at a rate of 680 bare-root seedlings per acre resulting in approximately 224 seedlings planted (Figure 102). Based on the field review conducted in September 2014, eastern red cedar seedlings (*Juniperus virginiana*) are beginning to colonize the planted area. To promote the health and vigor of the deciduous material in the replanted woodlot, the park should remove the eastern red cedars by cutting them as flush to ground level as possible. When cut below the lowest branches, eastern red cedars do not resprout and it is not necessary to treat the cut stumps with an herbicide.⁵

Figure 102 (left). Rummel Woods replanting. Note the eastern red cedars colonizing the replanted area. View northwest from Confederate Cavalry Avenue, 2014 (OCLP).

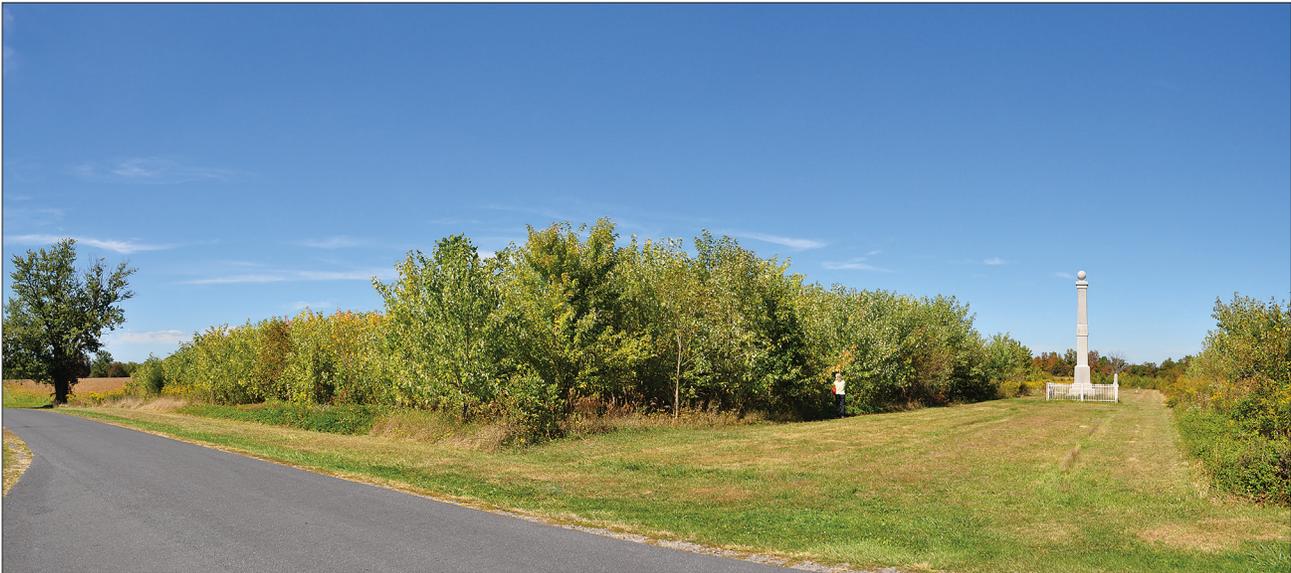
Based on the field reviews conducted in September 2013 and September 2014, the replanted western section contains a dense stand of red maples (*Acer rubrum*) and other deciduous material. In the eastern section, as Gregg Avenue turns around the Lott Farm complex, woody material is noticeably sparser and goldenrod (*Solidago* sp.) dominates a relatively open area (Figure 104). The park should consider additional replanting in the eastern section to achieve consistent woodlot character present at the time of the battle.

Figure 103 (middle). Lott Woods replanting, western portion from Gregg's Division monument. Note the density of young deciduous trees west of the monument. View northwest from Gregg Avenue, 2013 (OCLP).
