CULTURAL LANDSCAPE REPORT FOR GETTYSBURG NATIONAL MILITARY PARK

RECORD OF TREATMENT: VOLUME II

RECORD OF TREATMENT, AREAS 11–15

Olmsted Center for Landscape Preservation
National Park Service, Boston, Massachusetts, 2018

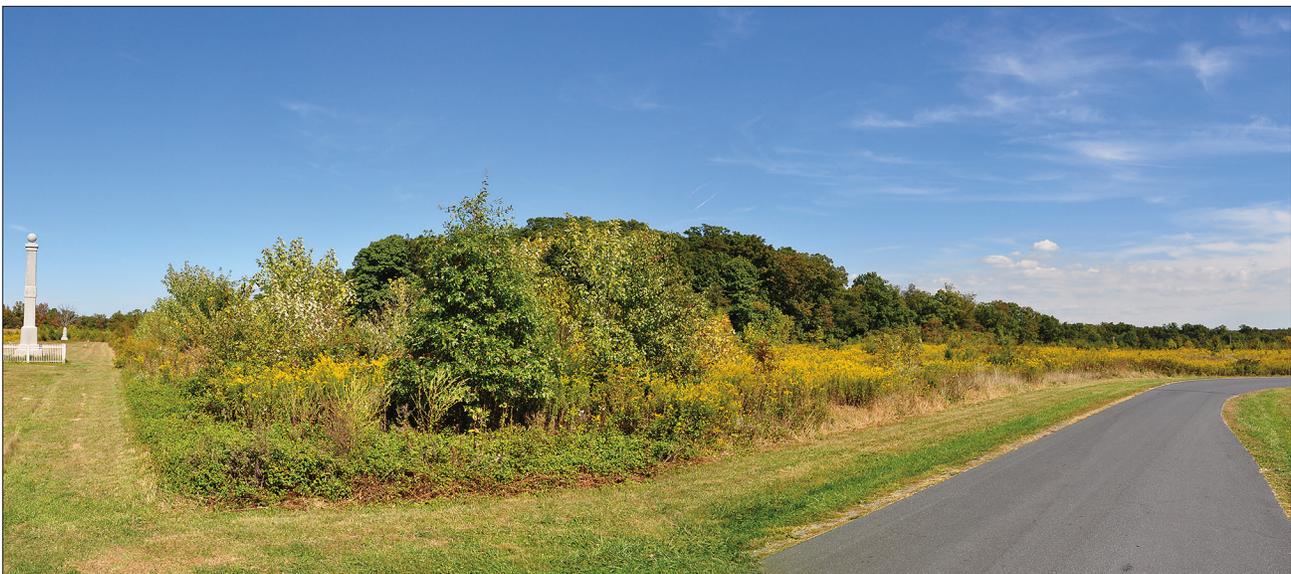
Based on the field reviews conducted in September 2013 and September 2014, the replanted western section contains a dense stand of red maples (*Acer rubrum*) and other deciduous material. In the eastern section, as Gregg Avenue turns around the Lott Farm complex, woody material is noticeably sparser and goldenrod (*Solidago* sp.) dominates a relatively open area (Figure 104). The park should consider additional replanting in the eastern section to achieve consistent woodlot character present at the time of the battle.

Figure 104 (bottom). Lott Woods replanting, eastern portion from Gregg's Division monument. Note sparse planting east of the monument and abundance of goldenrod. View northwest from Gregg Avenue, 2013 (OCLP).

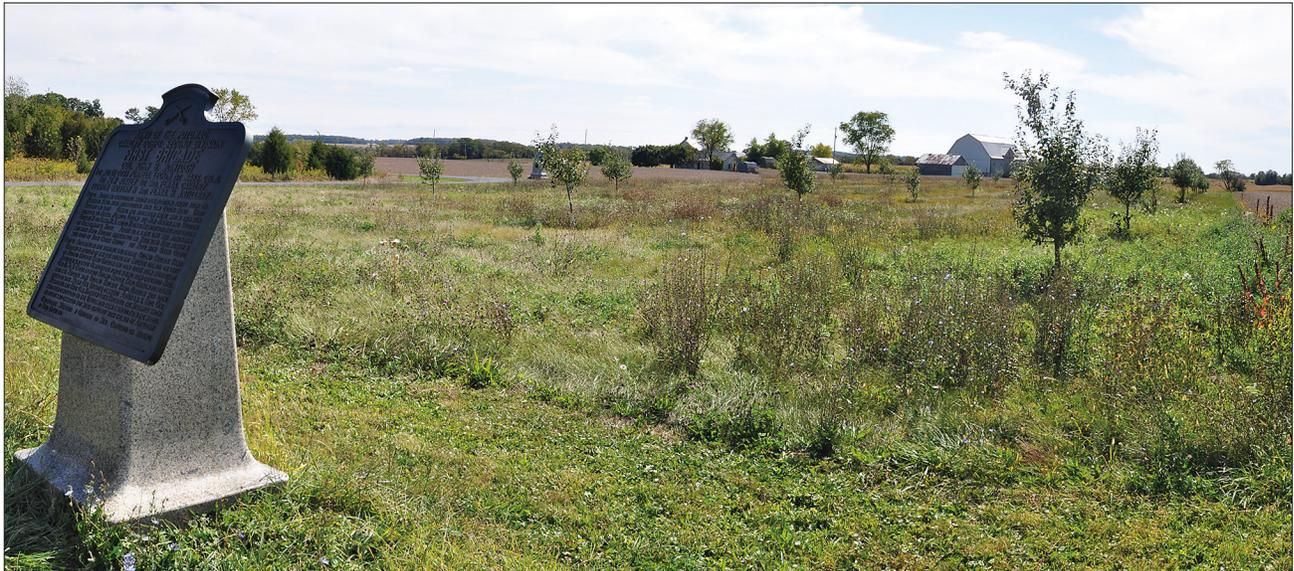
In 2008, the park completed replanting of the Lott Orchard. The replanted orchard consists of 48 apple trees arranged in 26 rows. The northern 12 rows consist of 24 'Liberty' apples and the remaining rows consist of 24 'Enterprise' apples. All 48 trees were planted on EMLA 111 standard rootstock in a quincunx pattern at 40-foot on center spacing. In 2014, the park completed a condition assessment for the Lott Orchard and recorded 41 trees in good condition and 7 trees missing (Figure 106).

Figure 106 (middle). Lott Orchard
replanting. View southeast from
Gregg Avenue, 2013 (OCLP).

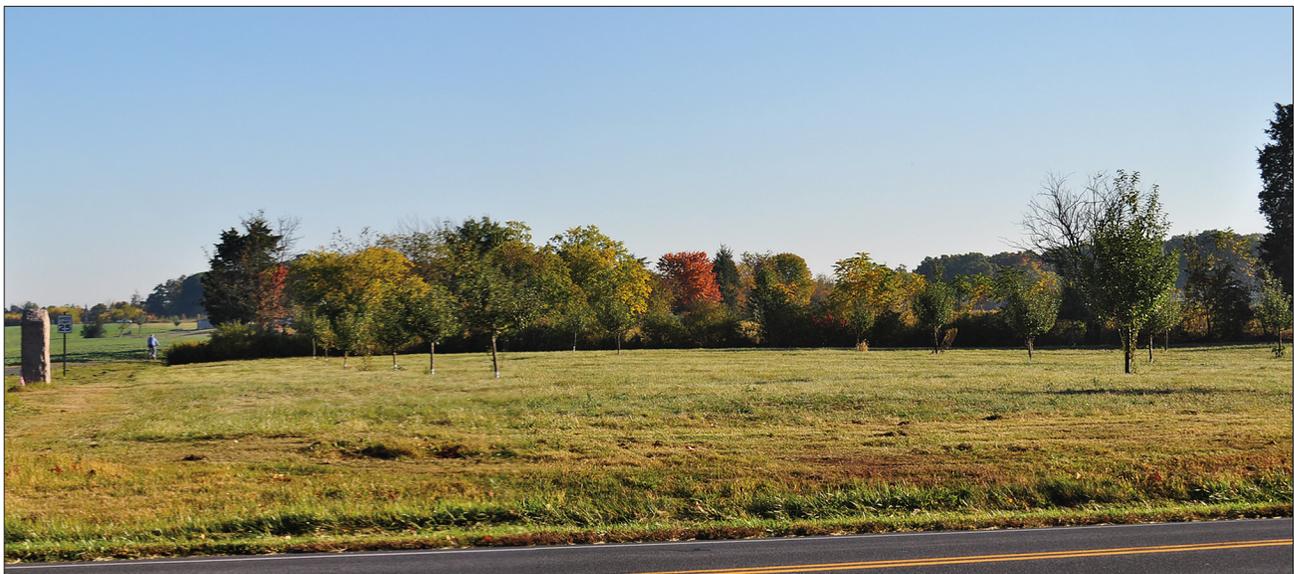
In 2008, the park completed replanting of the Joseph Spangler Orchard. The replanted orchard consists of 60 apple trees arranged in nine columns. The western three columns consist of 24 ‘Liberty’ apples and the next column consists of 6 ‘Liberty’ and 2 ‘Enterprise’ apples. The remaining five columns consist of 28 ‘Enterprise’ apples. All 60 trees were planted on EMLA 111 standard rootstock in a quincunx pattern at 40-foot on center spacing. In 2014, the park completed a condition assessment for the Joseph Spangler Orchard and recorded 40 trees in good condition and 20 trees missing (Figure 107). Since over 20 percent of the trees are missing, the Joseph Spangler Orchard should be considered for a replanting program to maintain the orchard’s historic limits. The limits of an orchard and height of its trees affected cover, obstacle, and avenue of approach during the battle.

Figure 107 (bottom). Joseph Spangler
Orchard replanting. View northeast
from Hanover Road, 2014 (OCLP).

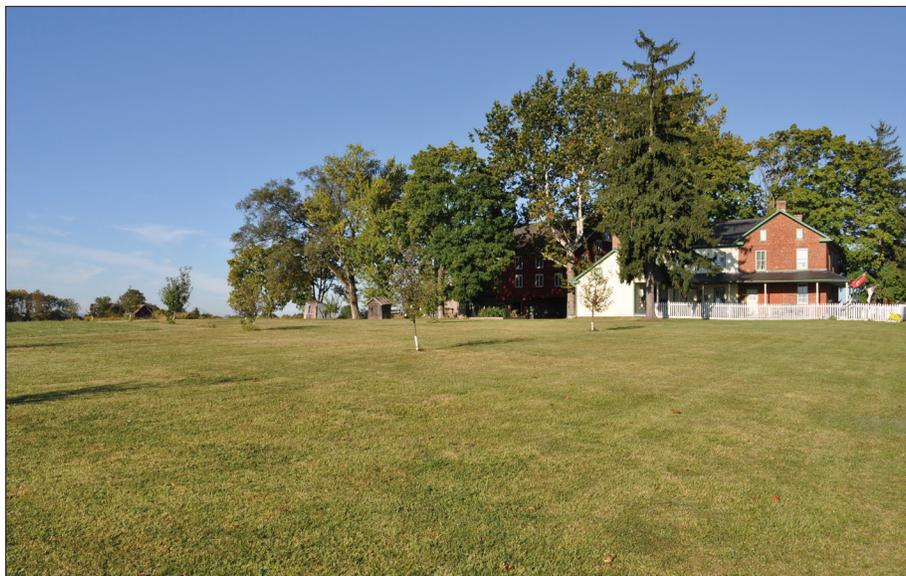
In 2009, the park completed replanting of the Joseph Spangler Fruit Garden. The replanted orchard consists of 18 apple trees arranged in three columns. The western column consists of 5 ‘Liberty’ apples and the next column consists of 4 ‘Liberty’ and 2 ‘Goldrush’ apples. The final column consists of 7 ‘Goldrush’ apples. All 18 trees were planted on EMLA 111 standard rootstock in a quincunx pattern at 40-foot on center spacing. In 2014, the park completed a condition assessment for the Joseph Spangler Fruit Garden and recorded 14 trees in good condition and 4 trees missing (Figure 108). Since over 20 percent of the trees are missing, the Joseph Spangler Fruit Garden should be considered for a replanting program to maintain the orchard’s historic limits. The limits of an orchard and height of its trees affected cover, obstacle, and avenue of approach during the battle.

Figure 108. Joseph Spangler Fruit Garden replanting. View west, 2014 (OCLP).

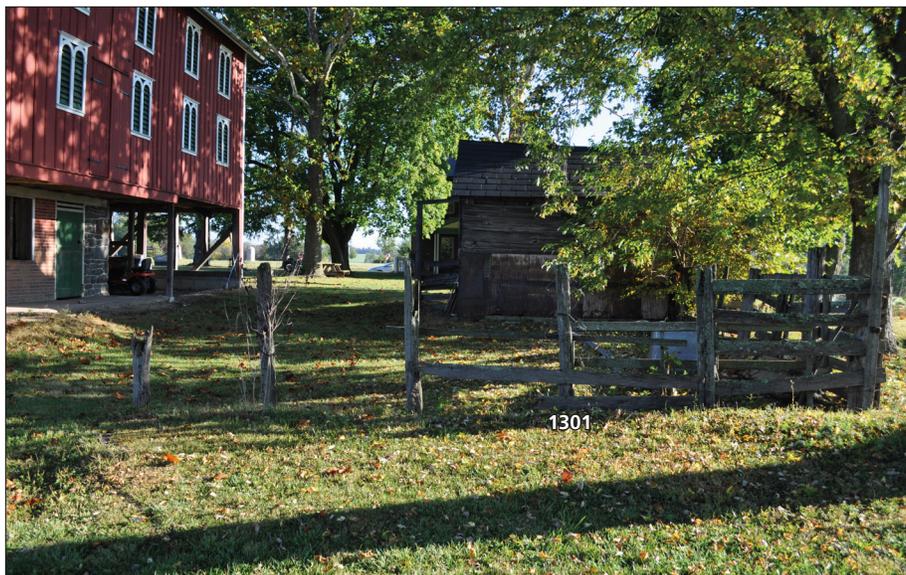
Figure 109. Joseph Spangler Barn modern post and rail fence installation [GIS IDs 1296, 1301, 1302, 1303]. View northeast, 2014 (OCLP).

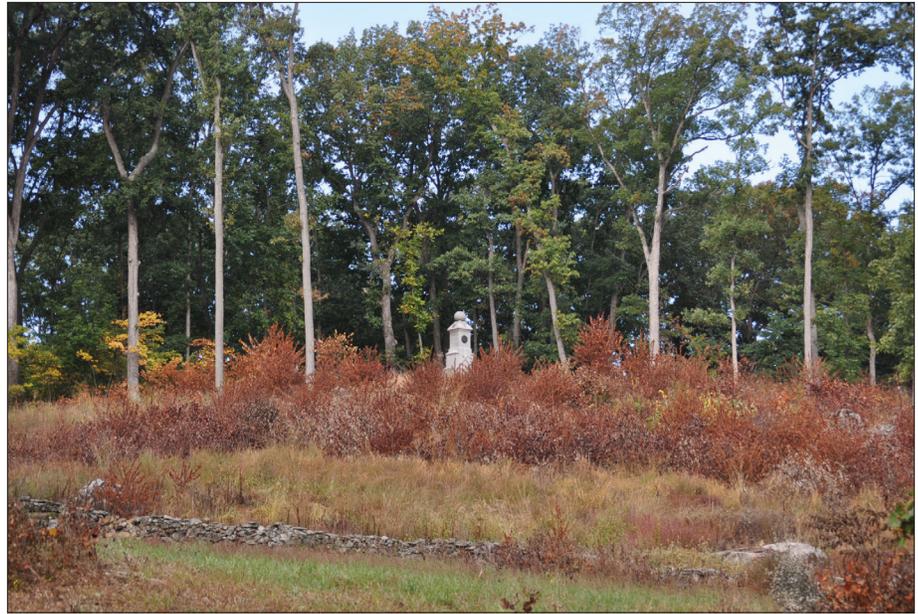
Figure 110 (right). Powers Hill Field 1. The brown leaves indicate where a woody herbicide has been applied as part of a two-year monitoring program following non-historic woody vegetation removal. View west, 2014 (OCLP).

As a component of this 15-year effort, the park's Natural Resource Management division monitored and treated the cleared areas with herbicides for two years to control emerging woody vegetation. After the two-year period, park Facilities and Maintenance added the rehabilitated fields in their regular mowing cycles (Figure 110). There are presently no fields in the two-year monitoring program and the park has no plans to continue removing non-historic woody vegetation.

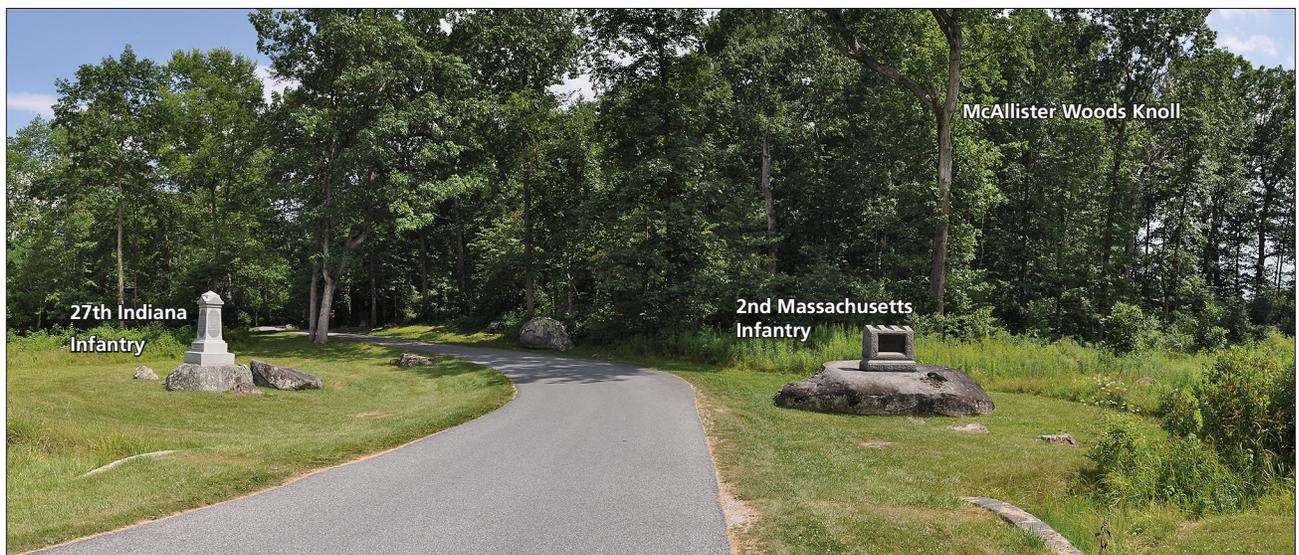
Figure 112 (bottom). McAllister Woods Knoll health cuts. The park opted for sustainable forest management versus reestablishing open woodlot character. View southeast from Colgrove Avenue, 2016 (OCLP).

The challenge the park faced in rehabilitating the battle-era character of a woodlot from a late-twentieth-century woods was to balance sustainable forest management versus the open character seen in historic imagery. The park opted for sustainable forest management in order to maintain the woodlot areas as wooded. If too many trees were removed and a strong storm event hit the park, a rehabilitated woodlot representing battle era character could lose all its trees and require a large and costly replanting project. With a mixture of trees and less open character, the historic woodlots have been treated to remain wooded without undertaking major future projects and intensive routine maintenance (Figures 111 and 112).

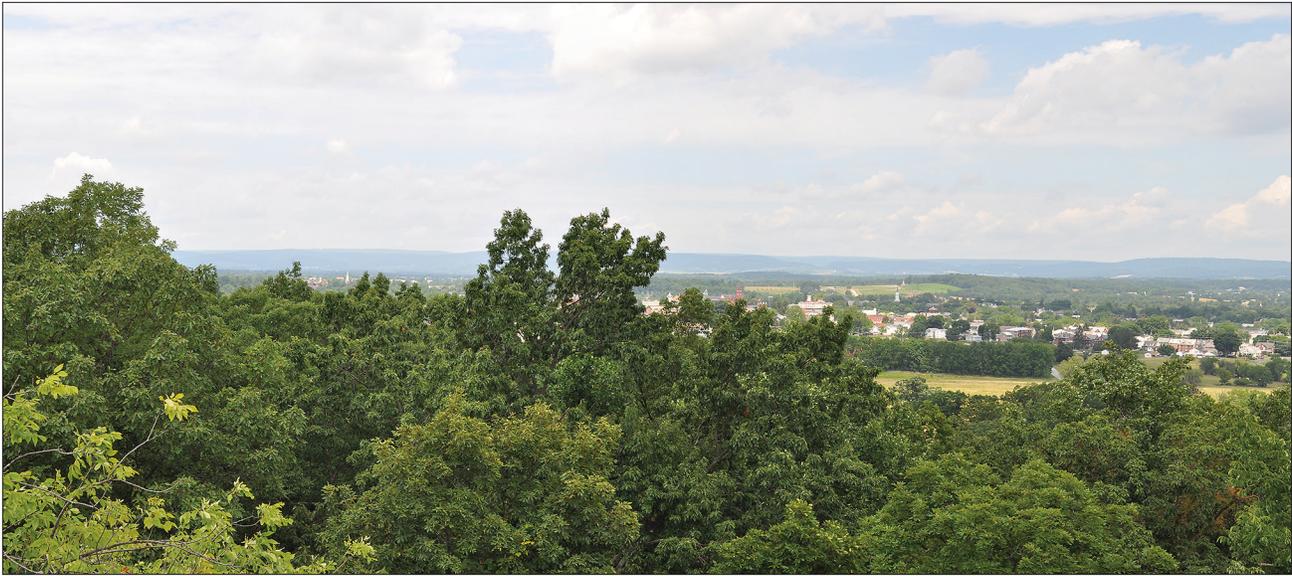
Figure 113 (top). Culp's Hill Observation Tower views. In addition to health cuts for sustainable forest management, specific and limited clearing may be needed to achieve visitor experience and interpretive goals. View northwest, 2016 (OCLP).

Historically, farmers would have harvested timber at a frequency where the trees would unlikely reach the heights observed presently at the park. In addition health cuts for sustainable forest management, specific and limited clearing may be needed to achieve visitor experience and interpretive goals. A primary example is Culp's Hill and the views from the commemorative-era observation tower (Figure 113).

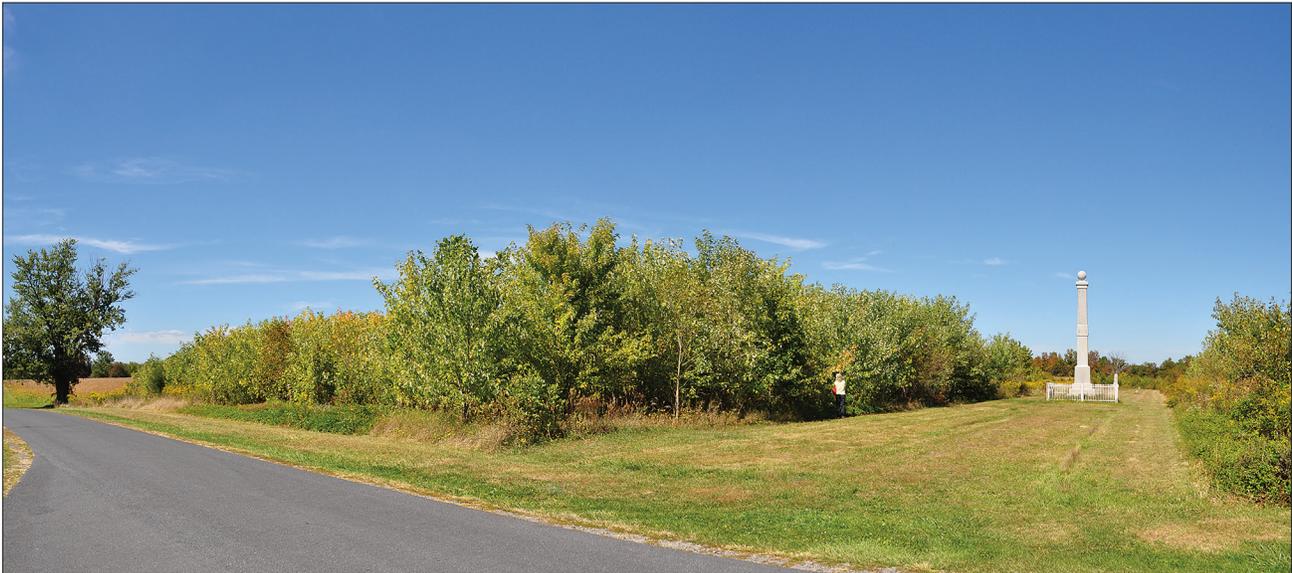
Figure 114 (middle). Lott Woods, western portion from Gregg's Division monument. Successfully replanted in 2004, Lott Woods now requires thinning. View northwest from Gregg Avenue, 2013 (OCLP).

In the East Cavalry Field area, on-going maintenance for the replanted Lott Woods now requires thinning, especially east of Gregg's Division Monument (Figure 114). In the Culp's Hill area, Abraham Spangler's Grove and Woods Above Spangler's Spring are specific areas needing infill planting.

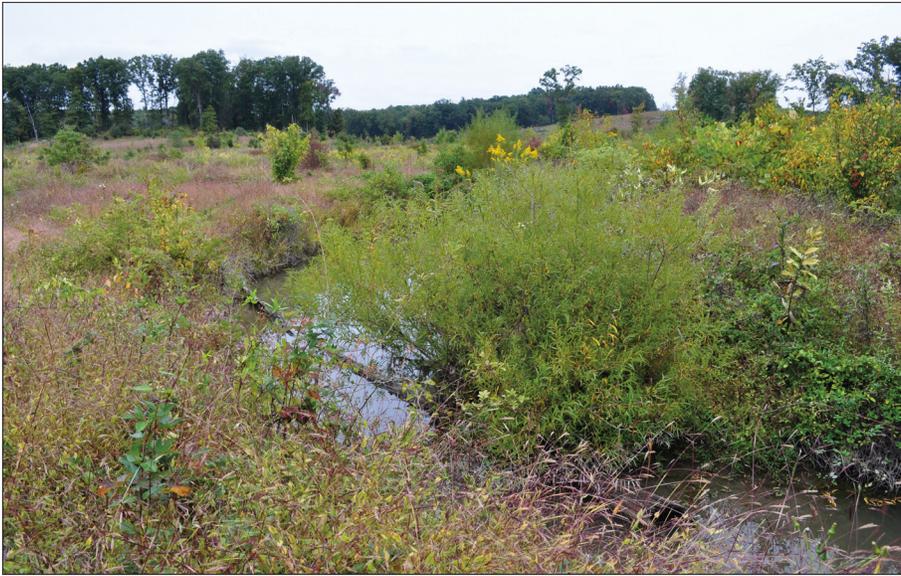
Figure 117. Plum Run non-historic riparian buffer. Based on the park's *Treatment Philosophy* guidance for thickets, all riparian buffer habitat plantings should be monitored and trees removed that exceed ten to fifteen feet high as warranted to maintain historic character. View northeast from Snyder Thicket, 2014 (OCLP).

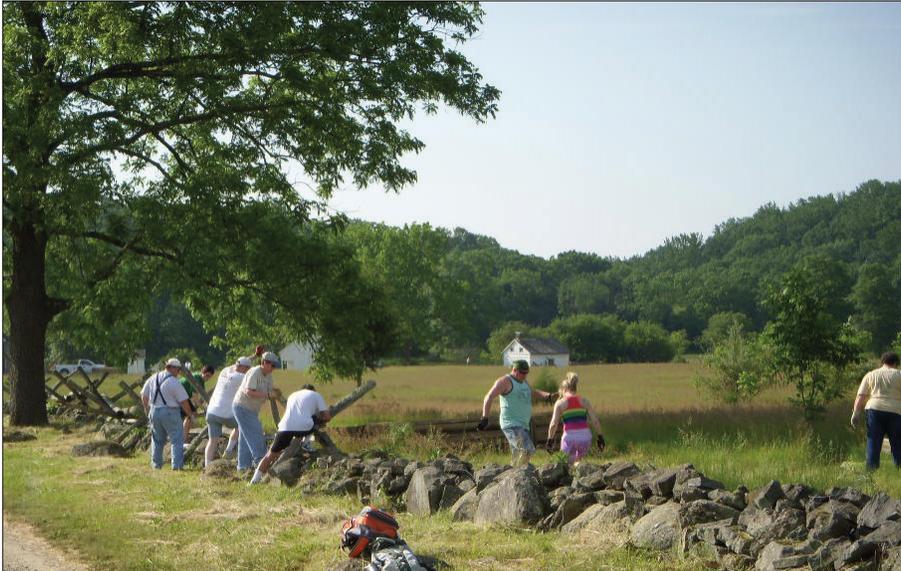
Figure 118. Slyder Field 1 north boundary stone and rider fence. Rebuilding historic fencing continues at the park and is a popular volunteer group activity. A prudent future strategy would prioritize repairing or replacing fence lines rebuilt between 1999 and 2014. View southeast, 2013 (GETT, Randy Hill Files).

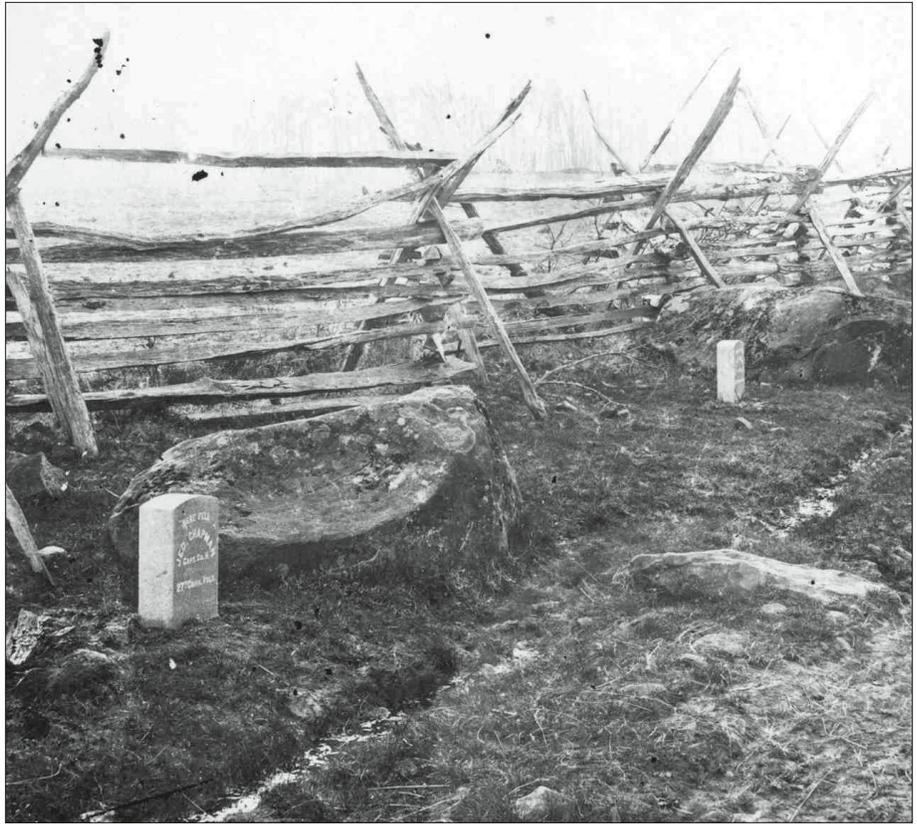
Figure 119. Virginia worm fence alongside Merwin and Chapman markers at Stony Hill Ridge along Wheatfield Road, circa 1880. Note the sector (pie-shaped) rails and their equal spacing. Cross braces are irregular in width and partially decayed at ends (GETT 41136, Tipton Collection, T1872).

When rebuilding Virginia worm fences, height and rail spacing are key elements. Those fences built too low are easily crossed over, and those built with large gaps between the stack of rails and the rider can be climbed through. The angled rail should close the gap, making it impossible to crawl through.⁹

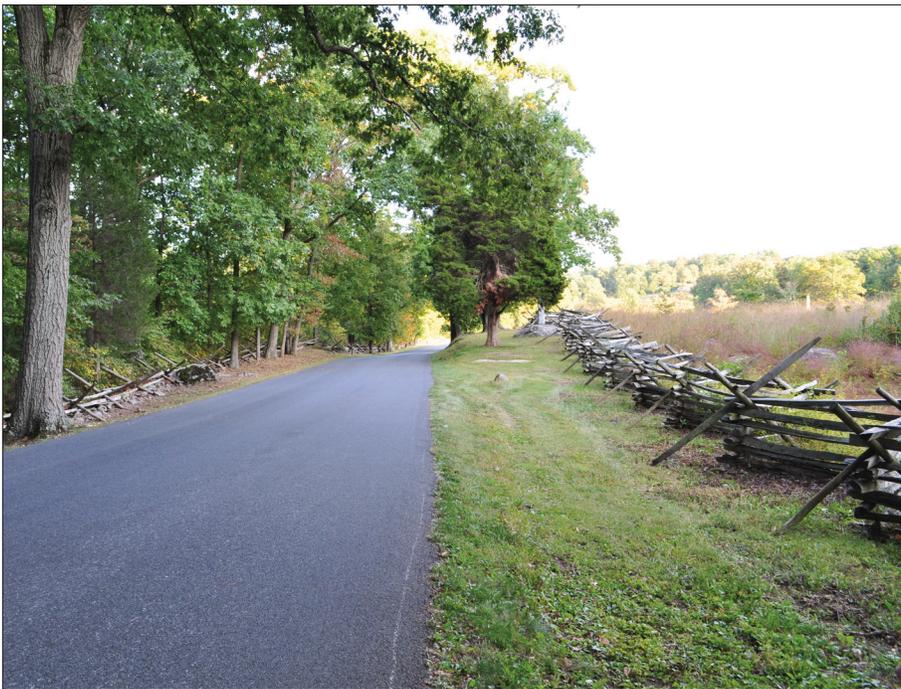
Figure 122. Virginia worm fence along Wheatfield Road. The base of the cross braces can be placed at a slightly steeper angle, closer to the rails, which will facilitate maintenance. The existing riders should be replaced with heavier rails. The fenceline has been moved south into the field and behind the monument (partially concealed by cedar) to accommodate the wider tour road. View looking east, September 2014. (OCLP 5592).

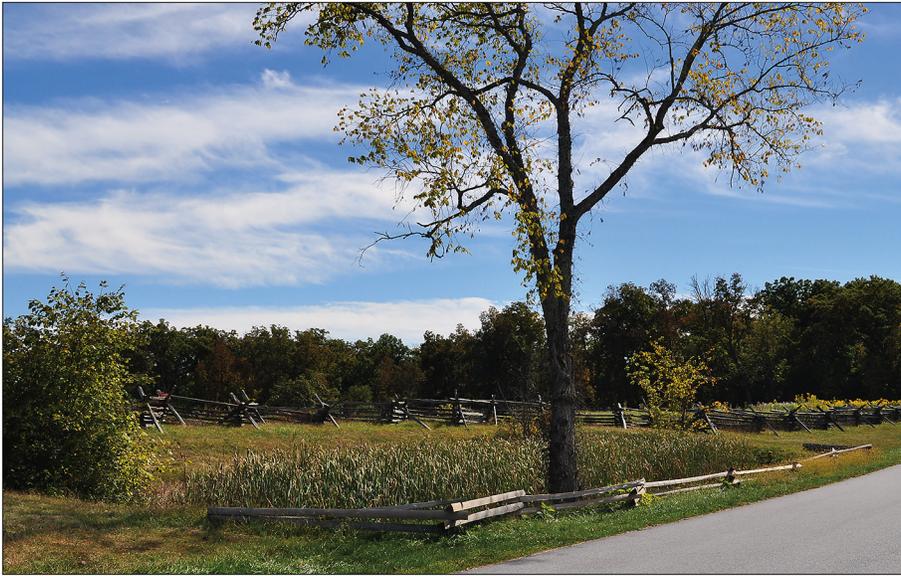
Figure 123. Low Virginia worm-style fence along Stone-Meredith Avenue prevents vehicles from driving into a shallow pond. View southeast, September 2013 (OCLP FD100).

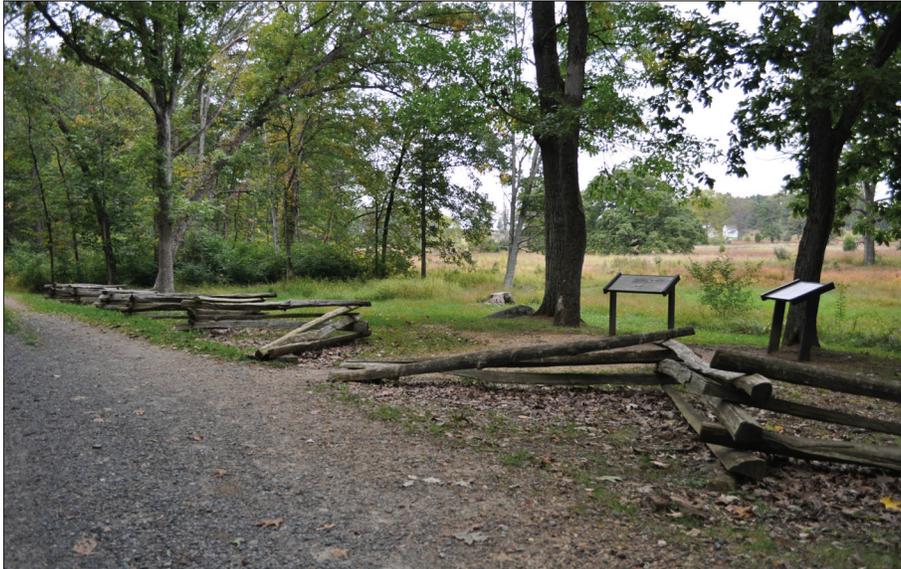
Figure 124. Low Virginia worm-style fence at the south boundary of Snyder Field 4. View northwest from South Confederate Avenue, September 2014 (OCLP 5912).

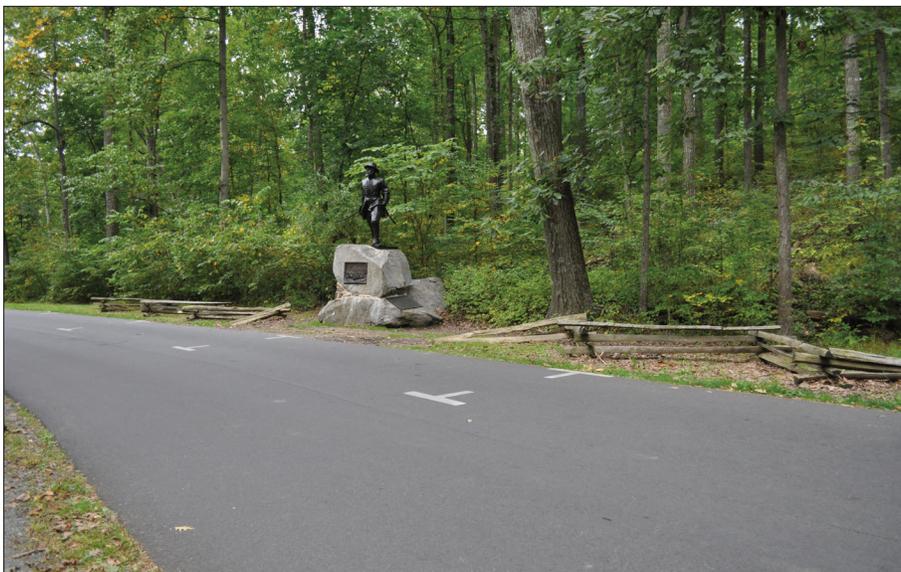
Figure 125. Low Virginia worm-style fence near the Wells Monument. View southeast from South Confederate Avenue, September 2014 (OCLP 5090).

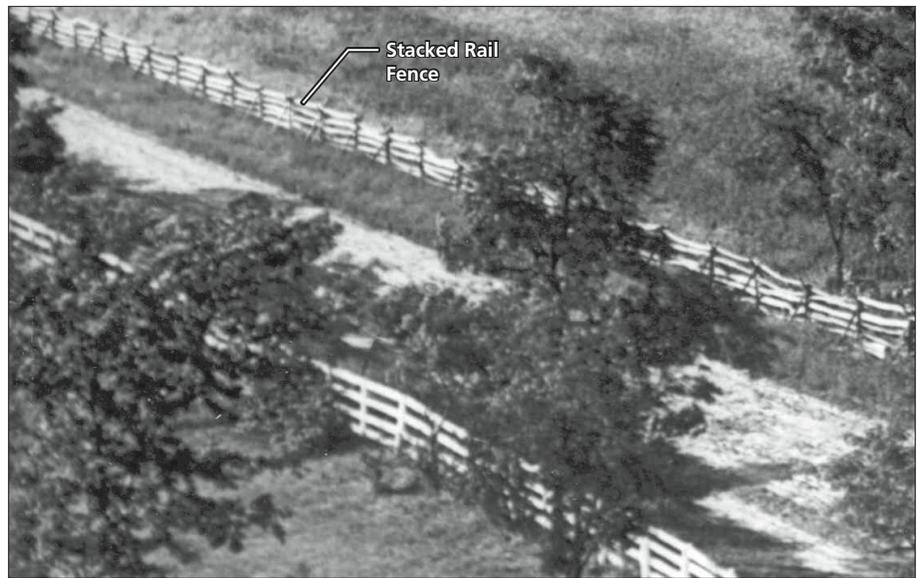
Figure 126. Detail of stacked rail fence located along Mummasburg Road at the Forney farm, circa 1896 (GETT 41135, Historic Photograph Collection, T27009b).

Due to its posts, this fence was more difficult to dismantle during the battle than Virginia worm fence and became an obstacle, as soldiers had to cross over while under fire. The stack of rails on the lower portion of the fence provided cover for troops.

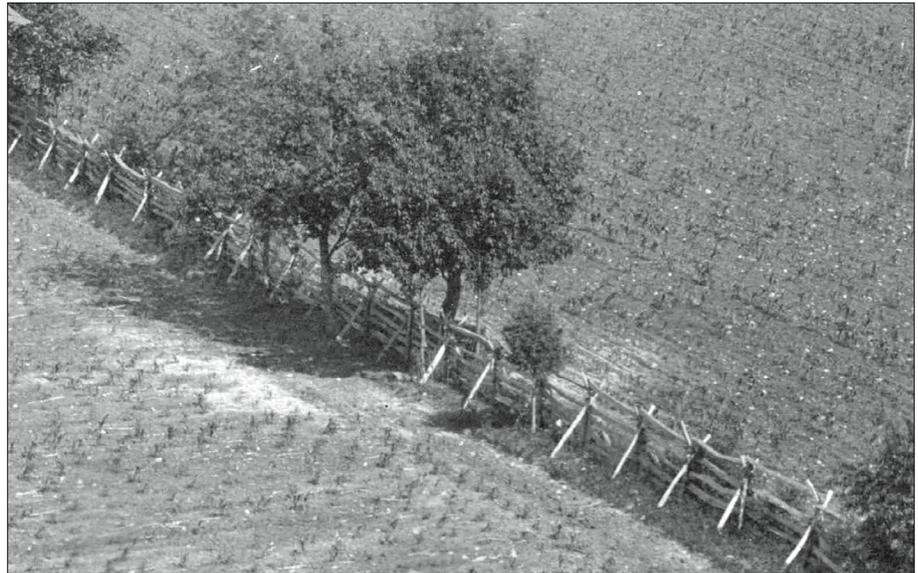
Figure 127. Detail of stacked rail fence located at the Warfield farm, circa 1900 (GETT 41135, Historic Photograph Collection, OS2B-2185b).

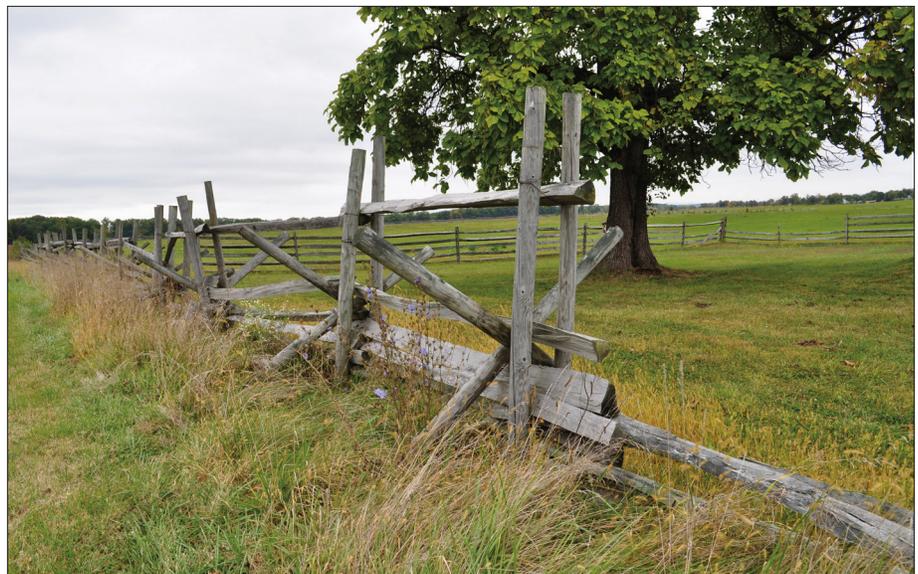
Figure 128. Stacked rail fence located along the Rodgers Field and Codori Field 4 boundary, September 2014. Note that the stack of rails is too low to restrict livestock movement and the top rail is not seen in historic imagery (OCLP 6078).

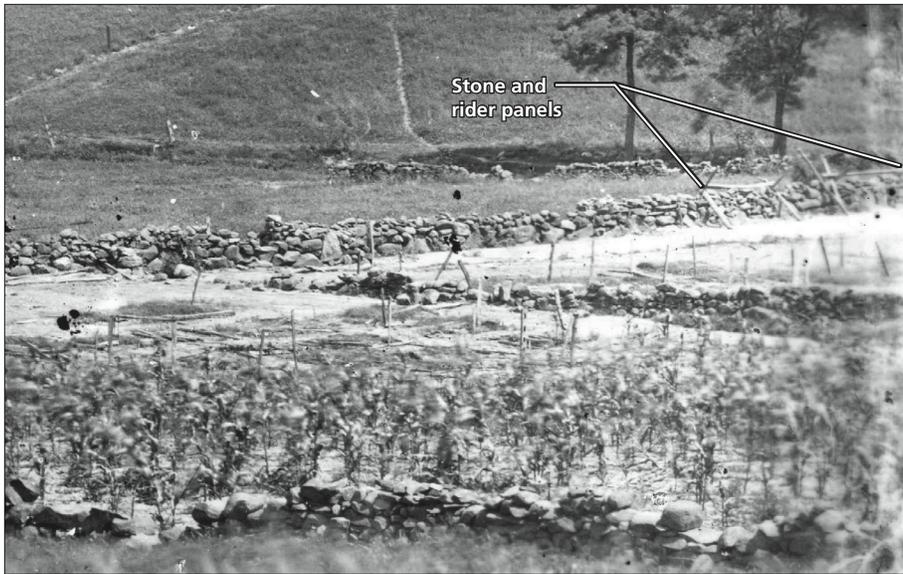
Figure 132. Stone and rider fence panels along east side of Brickyard Lane. Detail of view southeast from East Cemetery Hill, 1863 (GETT 41135, Historic Photograph Collection, 2B-2038b).

wooden portion of the fence for military purposes. The rails were sometimes stacked atop the wall to provide a tighter and higher barricade or were removed altogether and carried to a new location for incorporation in construction of defense works. Both armies also removed rails for firewood during their occupation of the Gettysburg area.

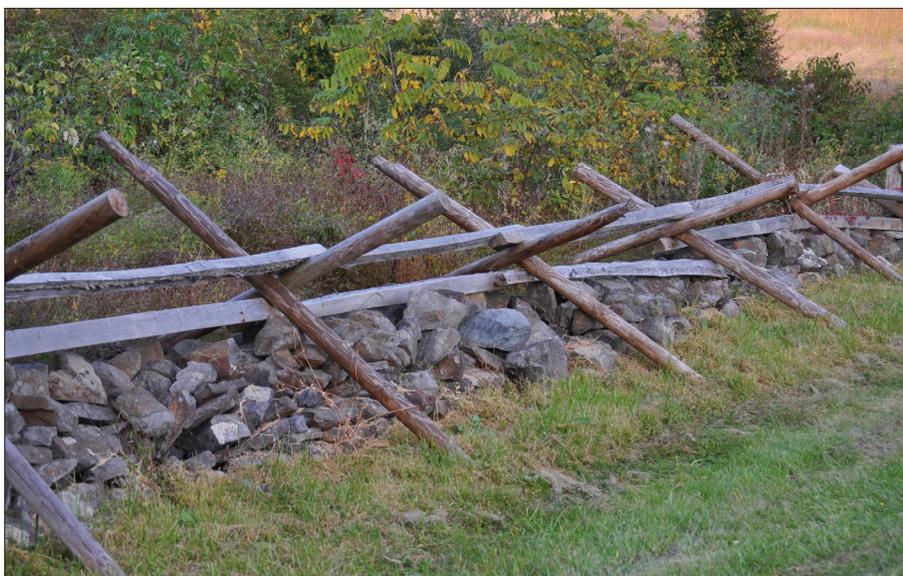
Figure 134. Stone and rider fence along south boundary of Sherfy Meadow. View northeast from Wheatfield Road, September 2014. Note when the wooden component is rebuilt, milled posts will no longer be used (OCLP 0027).

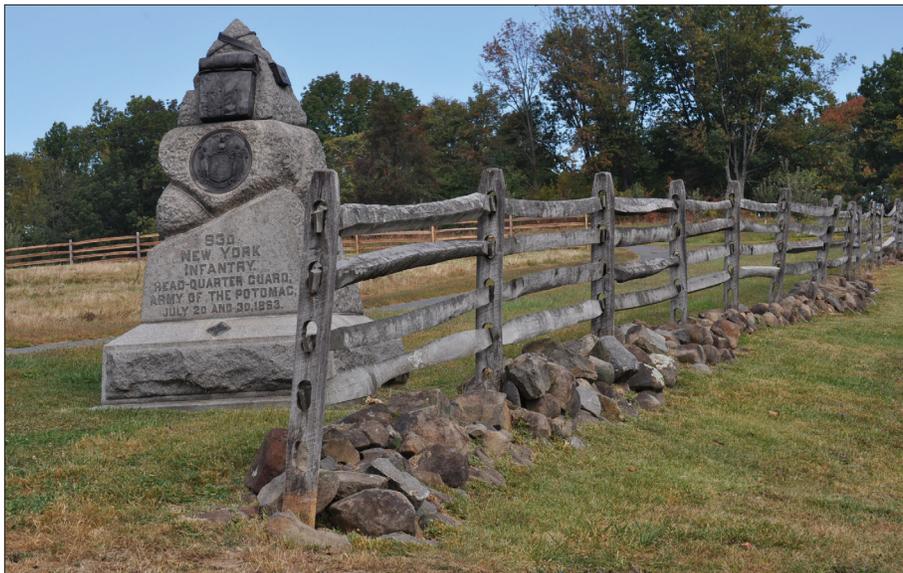
Figure 138. Stone and rail fence along east boundary of Frey Field 3. After this photograph was taken, the park scattered the stacked stones to depict gathered rubble stones randomly set to replace a missing lower rail. View northwest, September 2014 (OCLP 0069).

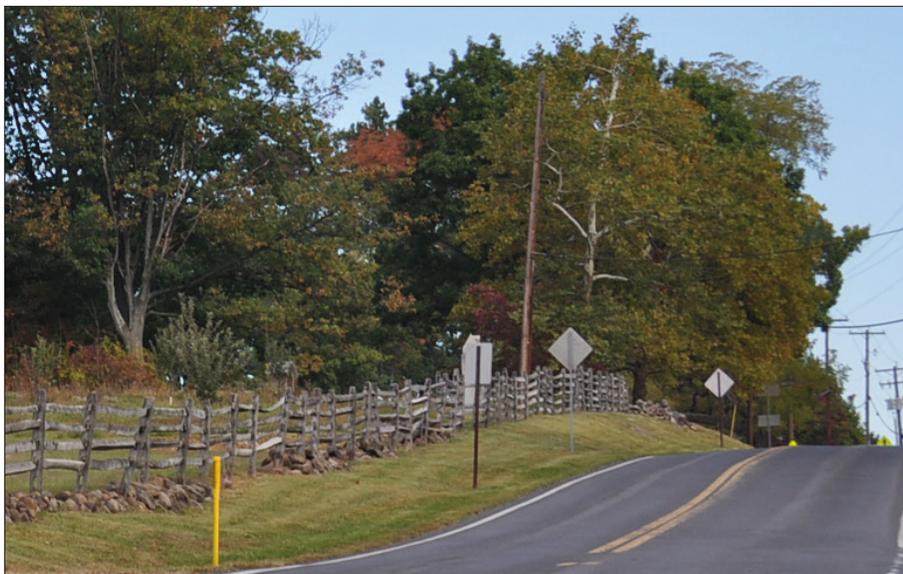
Figure 139. Stone and rail fence along east boundary of Frey Field 3. View northwest, September 2014 (OCLP 0058).

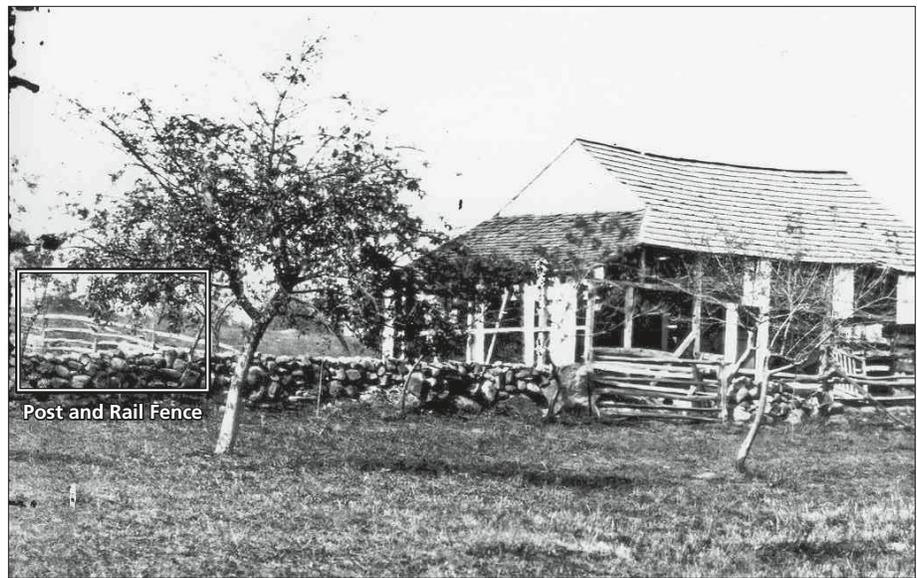
Figure 140. Post and rail fence along north boundary of Leister Field 3. Detail of view northwest, 1863 (GETT 41136, Tipton Collection, T2403).

This five-foot high wooden fence was more difficult to tear down than the Virginia worm fence, and hence was an obstacle that soldiers had to climb over while under fire. These massive and sturdy fences were so formidable to the armies that whenever possible, officers detailed men with axes and saws to cut them down prior to an advance.¹²

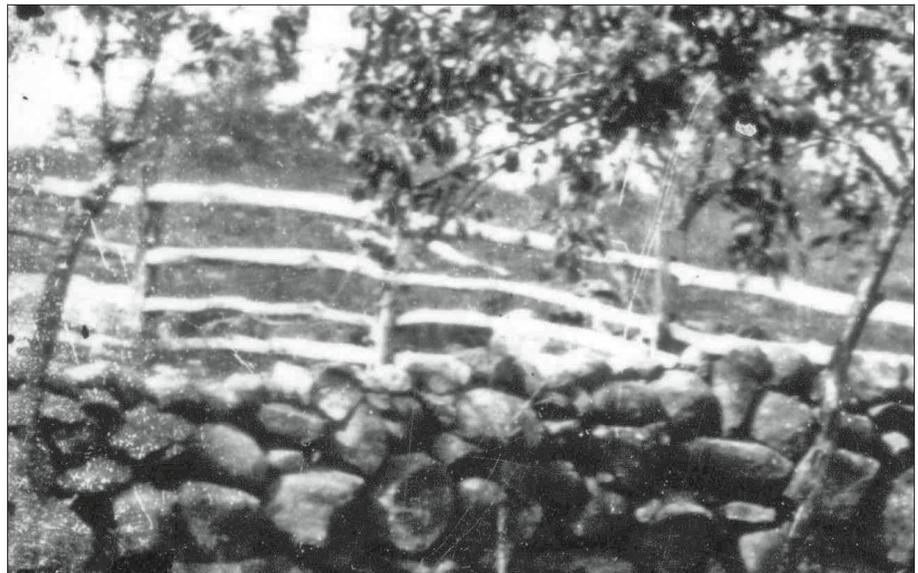
Figure 141. Post and rail fence along north boundary of Leister Field 3. Noted the graduated spacing of the rails. Detail of view northwest, 1863 (GETT 41136, Tipton Collection, T2403).

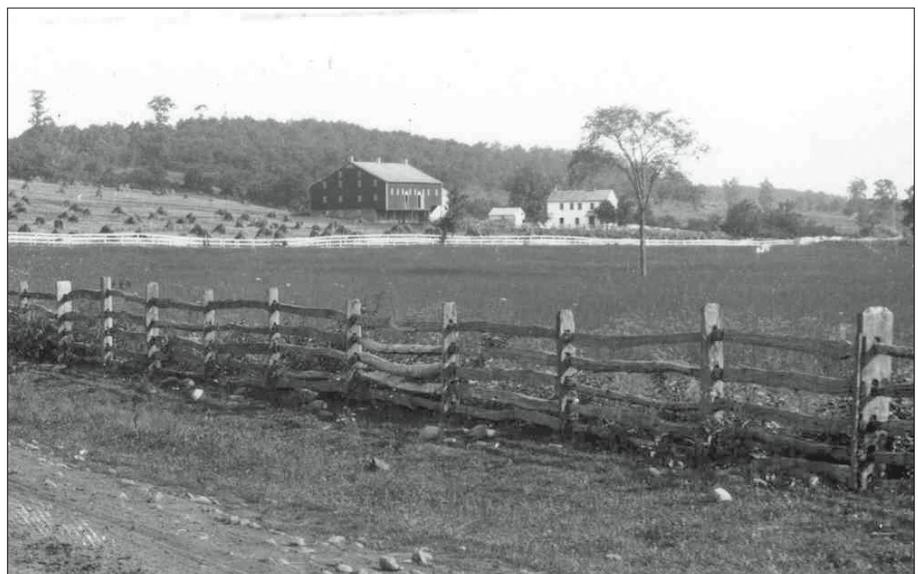
Figure 142. Post and rail fence along south boundary of McClean Field 8. Detail of view northwest from Mummasburg Road, 1870s (GETT 41136, Tipton Collection, T1801a).

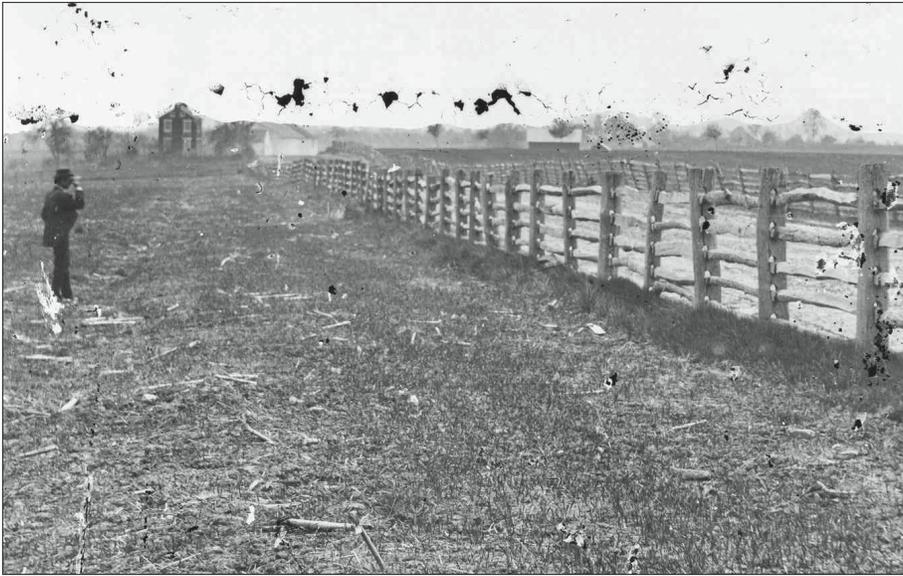
Figure 143. Post and rail fence along west boundary of Small Field 2. Detail of view southwest, circa 1875 (GETT 41135, Historic Photograph Collection, 2B-2049a).

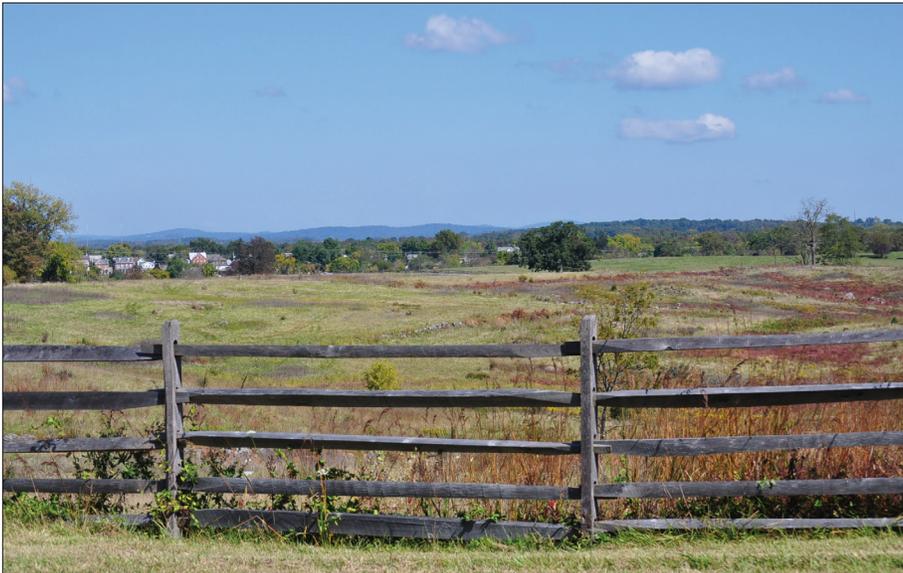
Figure 144. Post and rail fence along south boundary of McKnight Field 3. View northwest, September 2014 (OCLP 0208).

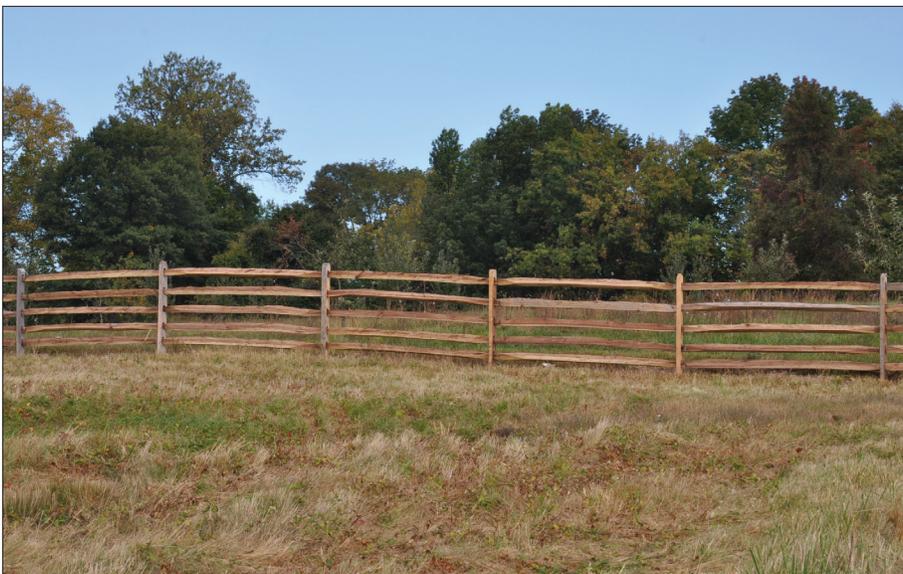
Figure 145. Post and rail fence along north boundary of Frey Field 3. View north, September 2014 (OCLP 0071).

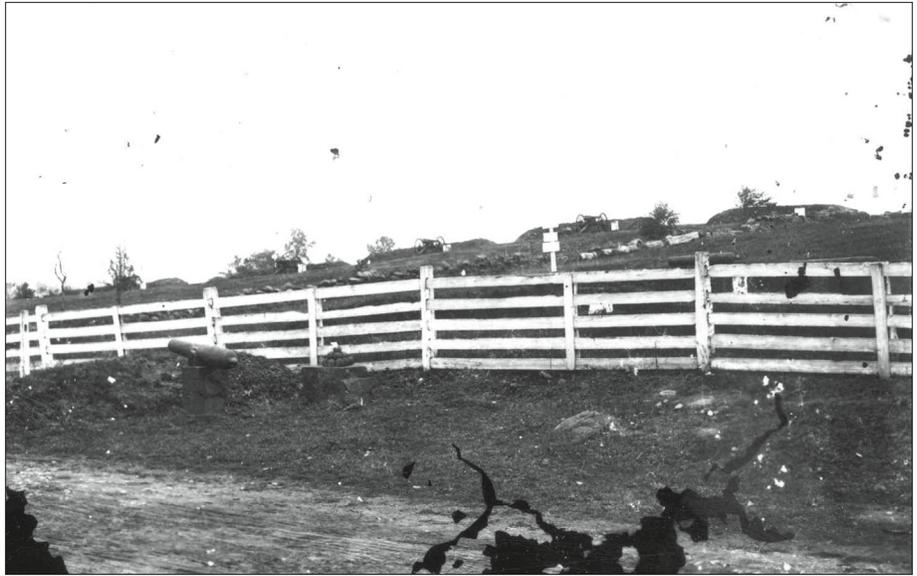
Figure 146. Post and plank fence along Baltimore Pike at East Cemetery Hill, circa 1885 (GETT 41136, Tipton Collection, T1833).

This five foot high wooden fence was more difficult to tear down than the Virginia worm fence and post and rail due to the mortised and nailed boards. The fence was considered an obstacle during the battle, as soldiers had to climb over the fence while under fire. The fence also provided some cover.

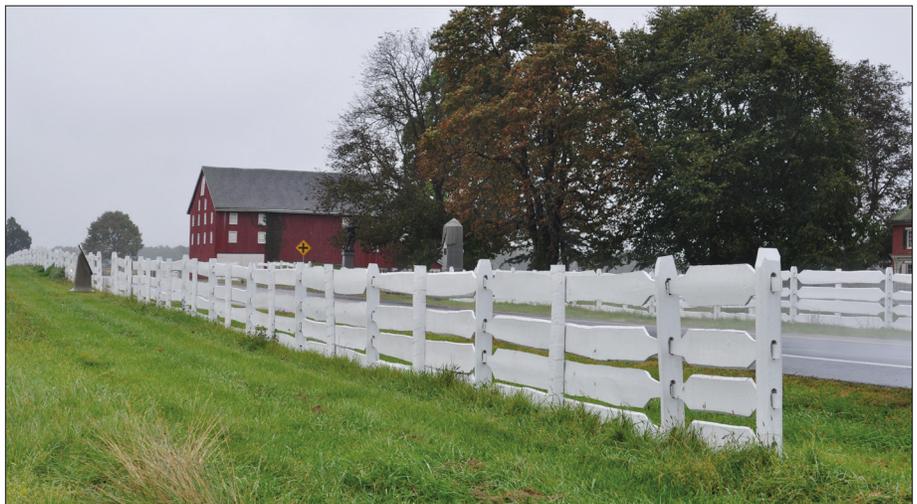
Figure 148. Post and plank fence along both sides of the road at Sherfy farm, September 2014. Note the intermediate posts are on the inside/owner's side of the fence (OCLP 5924).

The post and plank or slab fence is uncommon and only found at the Sherfy Fields 1, 2, and 5 boundaries along Emmitsburg Road. Typically, one panel is 10 feet in length by 5 feet in height with a width of between 9 and 10 inches from the front of the line post to the back of the intermediate post. The long planks are supported mid-length by intermediate posts. Spacing between boards ranges from 2 to 4 inches. All plank or slab fences presently in the park are painted white.

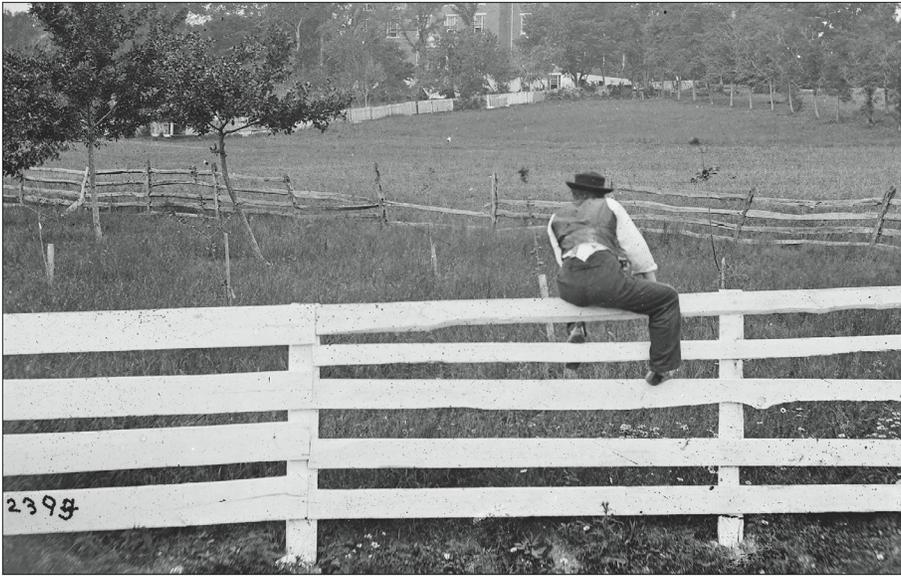
Figure 149. Detail of sawn board nailed fence west of the Lutheran Seminary viewed from the Foulk Farm, 1863. Note the variable size of nailed boards (Library of Congress, Digital ID cwpb 01650).

The sawn board fence is common and is found throughout the park. Typically one panel is 7 to 8 feet in length and 7 inches wide by 5 feet in height. Typically the upper and lower boards align from panel to panel, but the intermediate boards may not align. Spacing between boards ranges from 2 to 6 inches. Many sawn board fences are painted white.

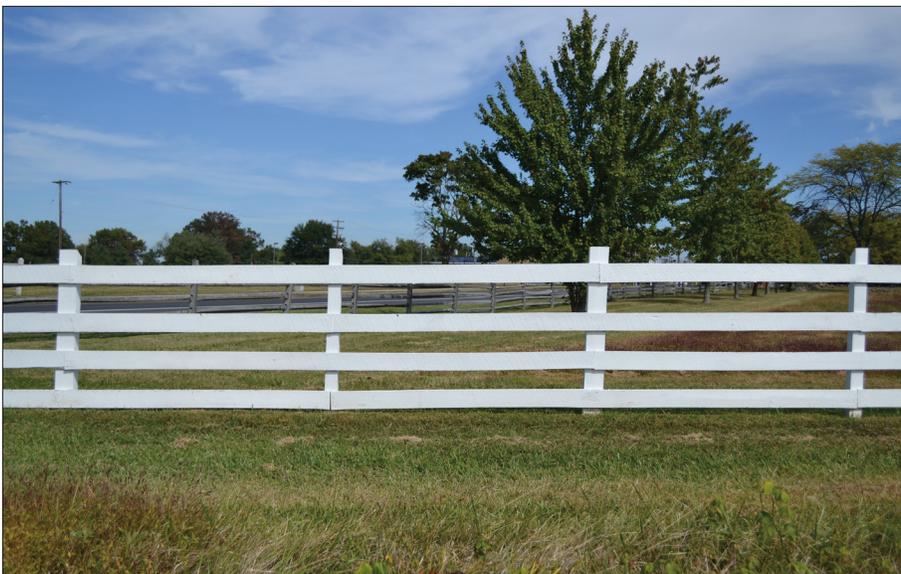
Figure 151. Sawn board nailed fence painted white along Brian Field 1, September 2013 (OCLP PC066).
