CULTURAL LANDSCAPE REPORT FOR GETTYSBURG NATIONAL MILITARY PARK

RECORD OF TREATMENT: VOLUME II

RECORD OF TREATMENT, AREAS 11–15

Olmsted Center for Landscape Preservation
National Park Service, Boston, Massachusetts, 2018

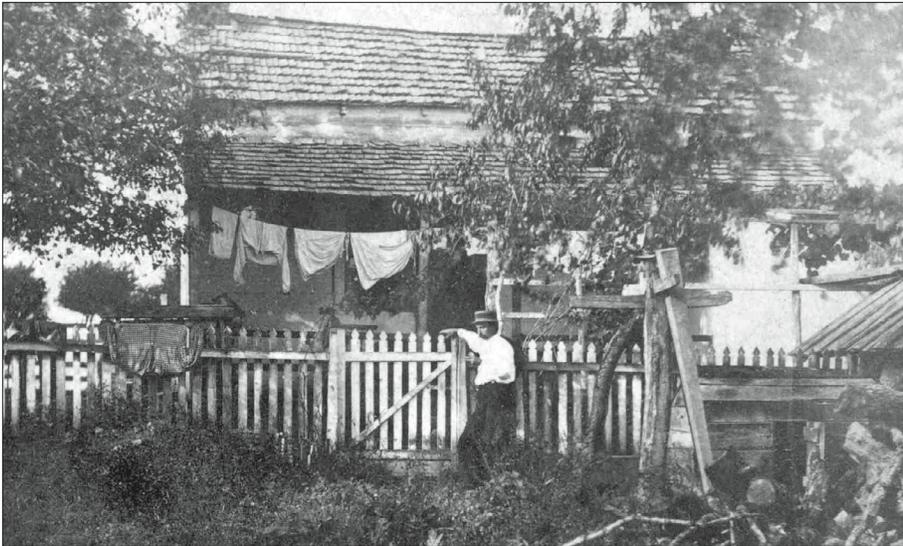
Figure 152. Picket fence at Leister House, 1860s. Note the ornamentation of pickets (Sue Boardman Collection, SV606a).

The picket fence is common and is found throughout the park. The fence is generally 3 to 4 feet high and one panel extends 6 feet in length. The fence bed is generally 6 inches wide. Each fence typically had a unique type of picket and the park has simplified some to facilitate rebuilding and repairs. All picket fences within the park are painted white.

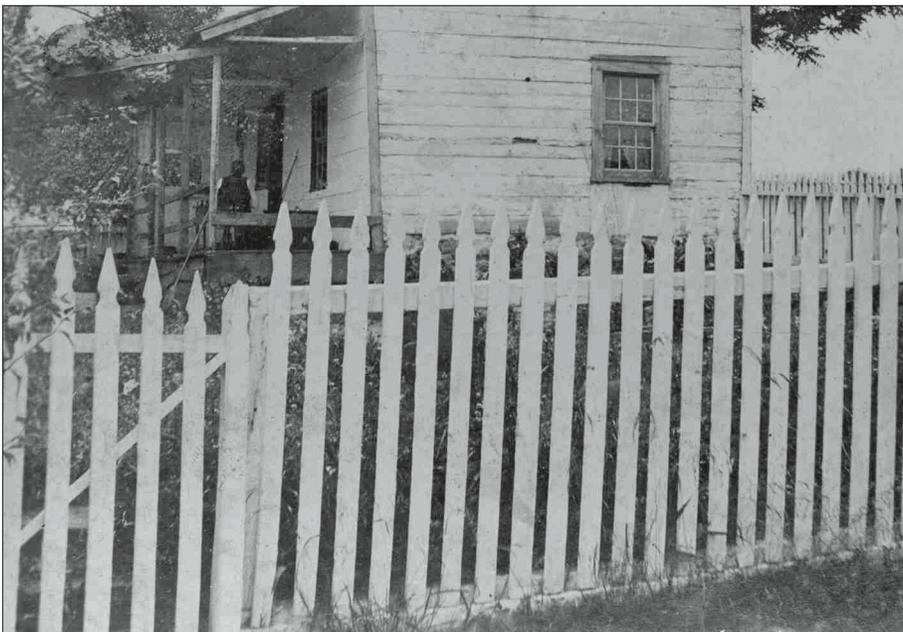
Figure 154. Picket fence at Leister House, circa 1890. Note the increased ornamentation and wider spacing of replaced pickets (Sue Boardman Collection, SV445a).

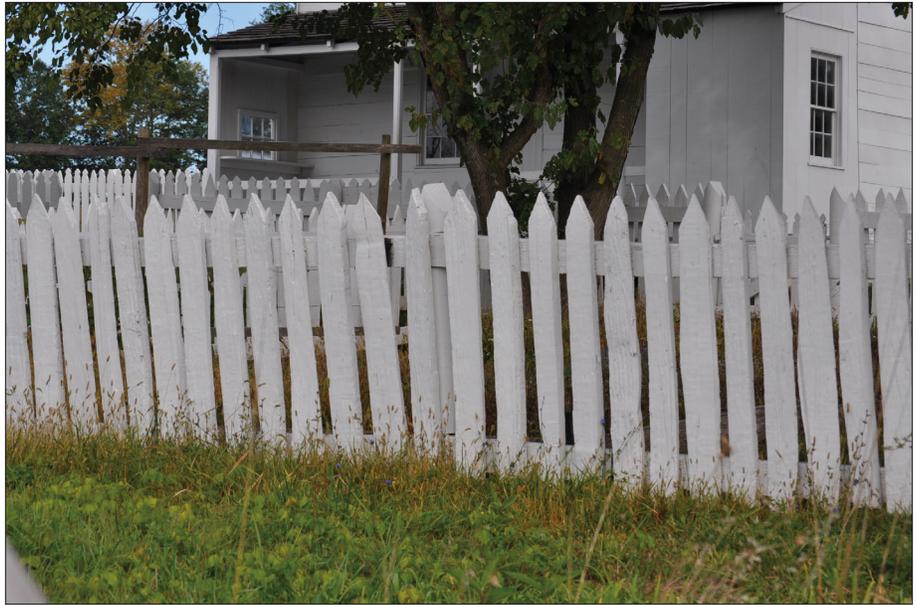
Figure 155. Picket fence sections at Leister House, September 2014. Note variation in picket styles, which is evident in historic photographs on previous page (OCLP 0063).

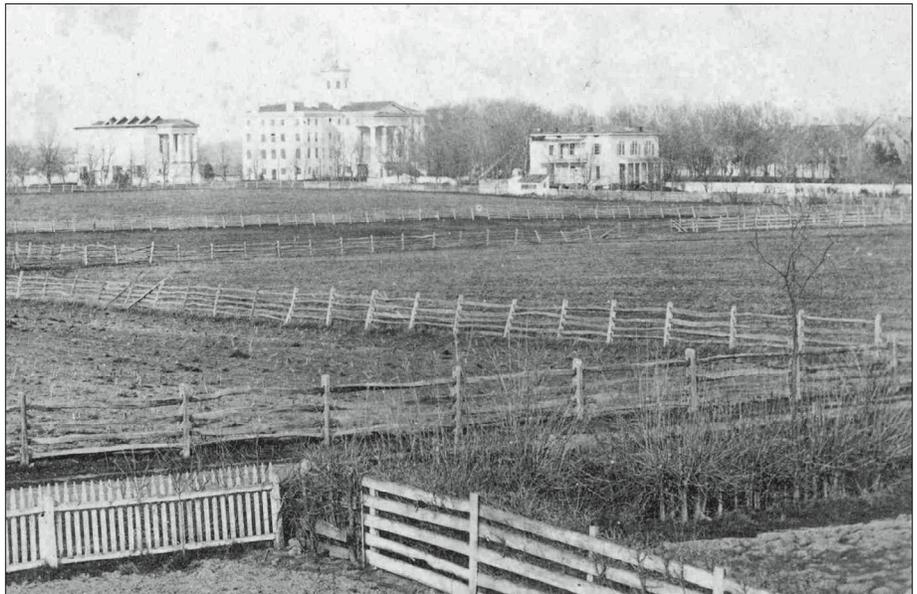
Figure 156. Picket fence in foreground of McPherson lot near Sheads with Lutheran Seminary and college in the distance, 1880s (Sue Boardman Collection, SV79a).

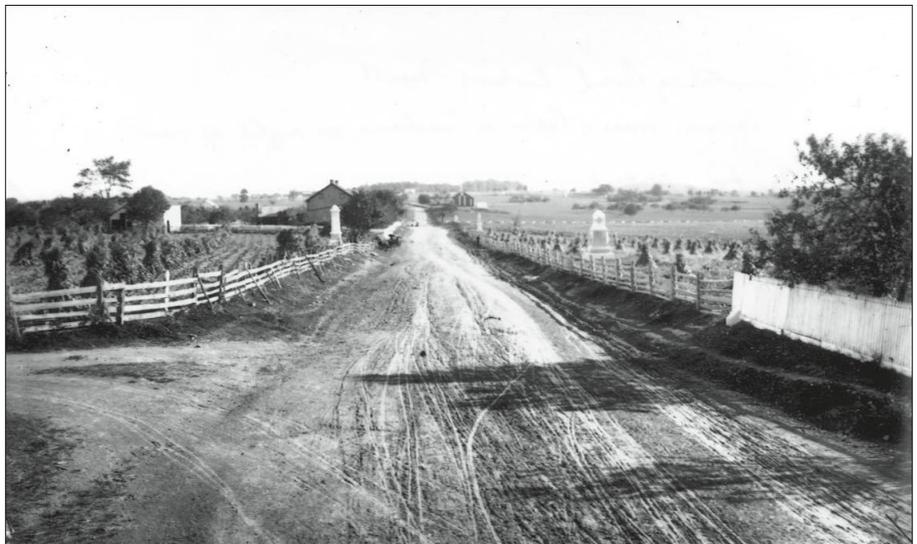
Figure 157. Picket fence, image right, along road abutting post and rail fence (GETT 41135, Historic Photograph Collection, 21P-1266).
