Water Quality Monitoring for Knife River Indian Villages National Historic Site

2019 Data Report

Natural Resource Data Series NPS/KNRI/NRDS—2022/1382

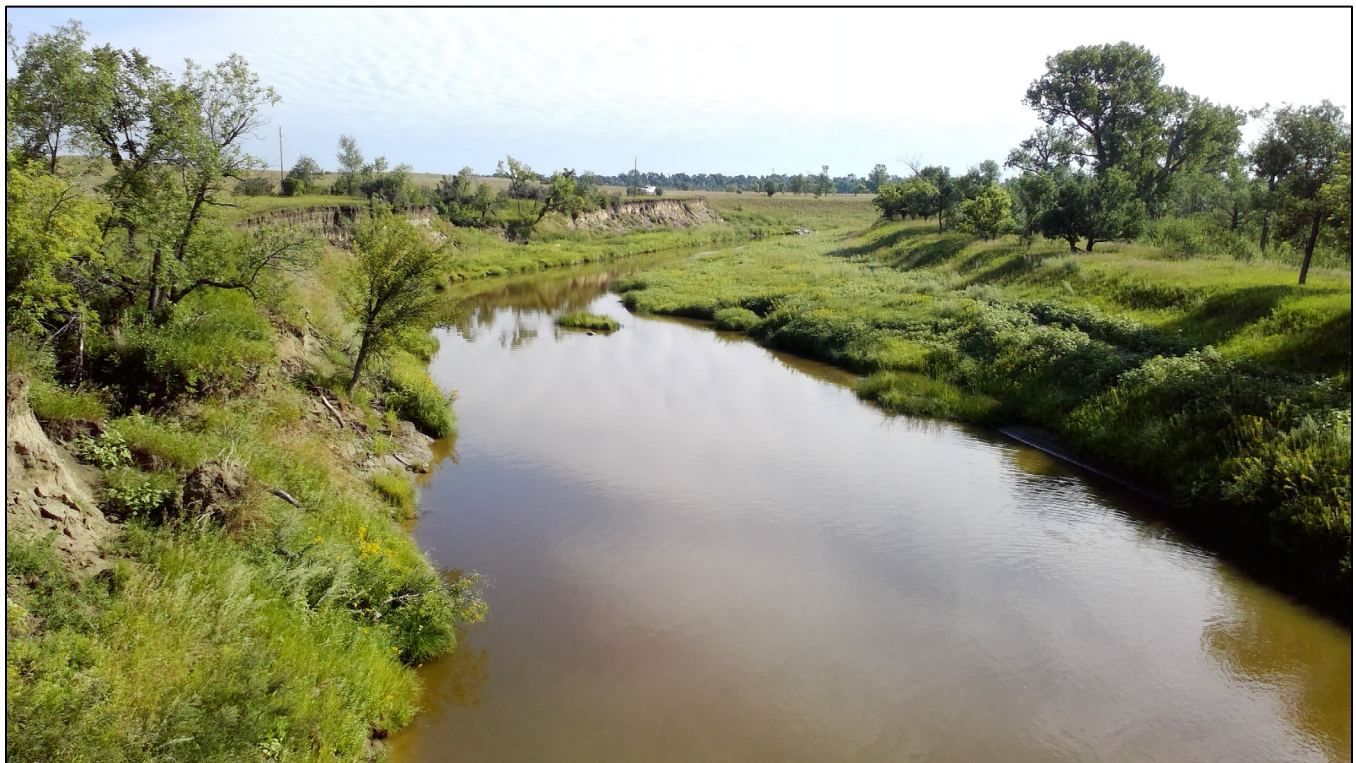
Upstream from USGS Gaging Station 06340590 on the Knife River in July 2019 at Knife River Indian Villages National Historic Site, North Dakota.

Photograph by USGS, station 06340590.

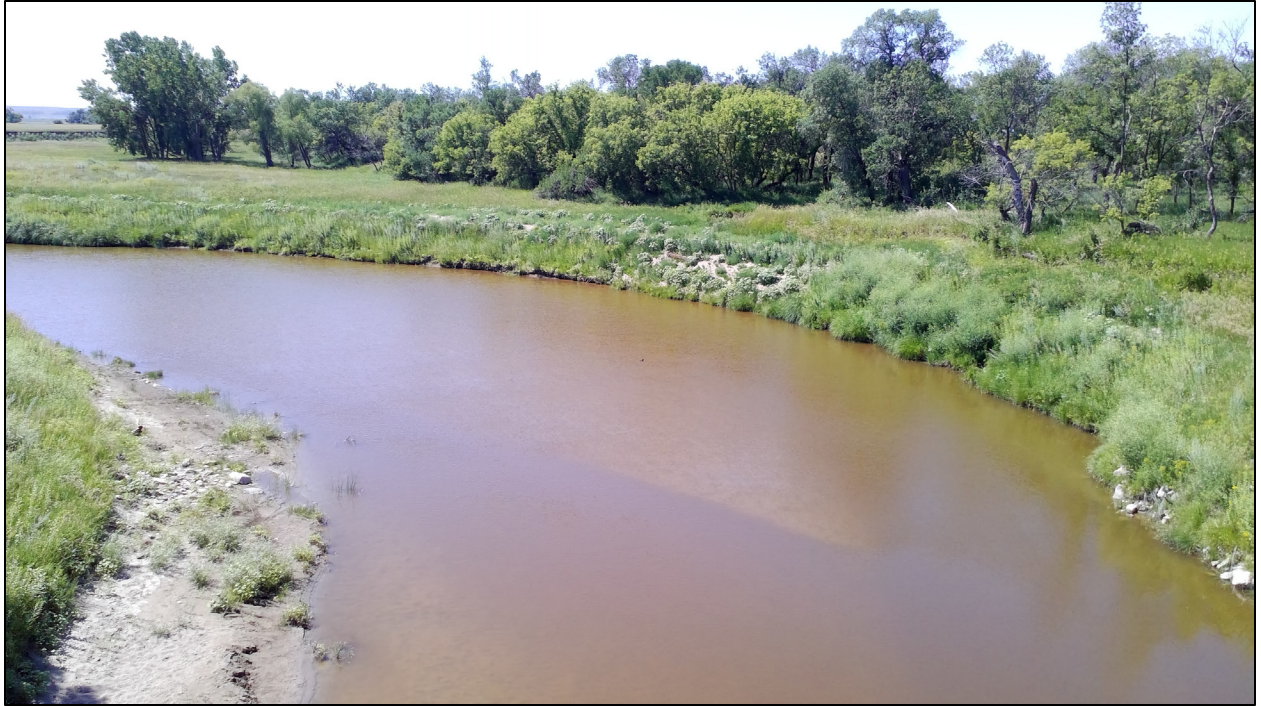
Downstream from USGS Gaging Station 06340590 on the Knife River in August 2019 at Knife River Indian Villages National Historic Site, North Dakota.

Photograph by USGS, station 06340590.

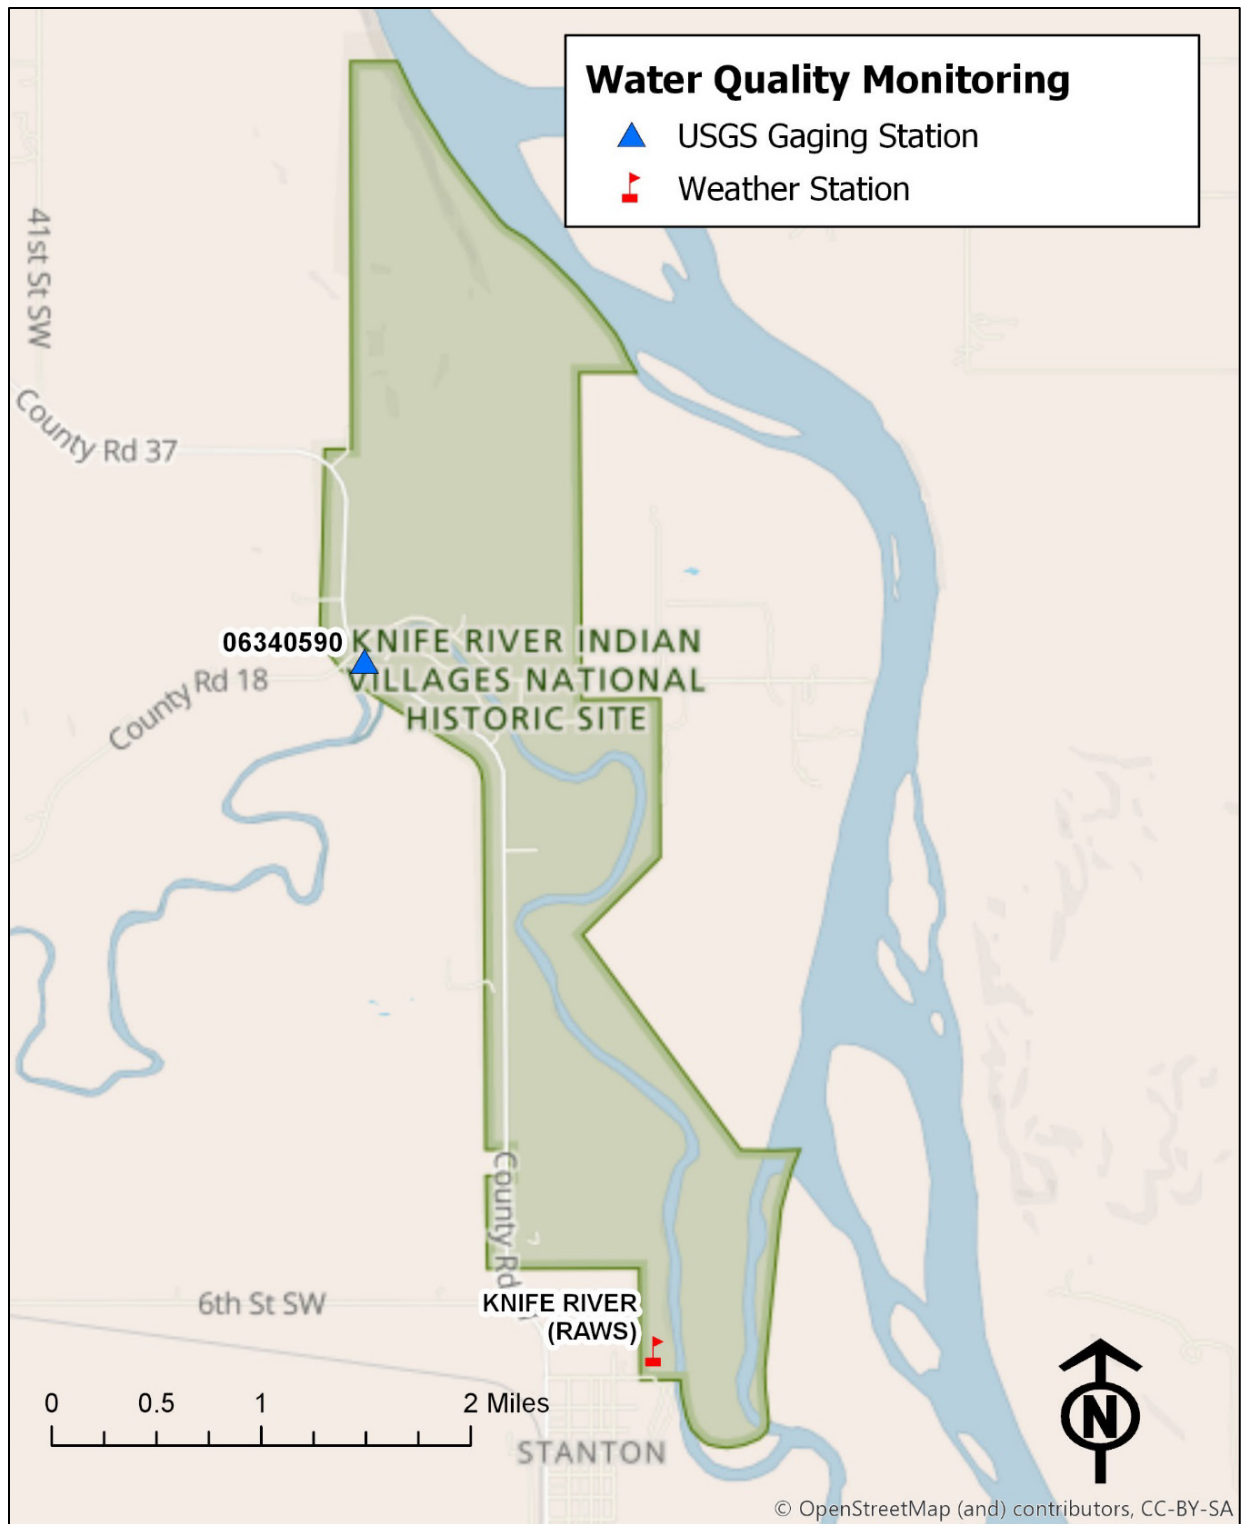
Figure 2. Map of Knife River Indian Villages National Historic Site and water quality monitoring location (blue triangle) and nearby weather station (red flag). Climate data in this report is taken from the Knife River RAWS weather station.

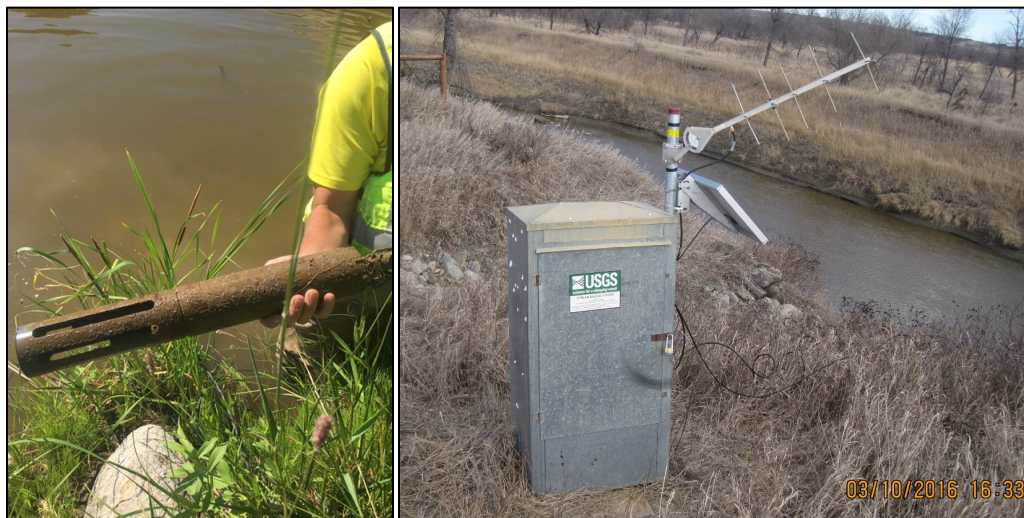
Figure 3. A sonde device is used to measure water quality on the Knife River in 2019 at Knife River Indian Villages National Historic Site (left panel). This sonde is coated in sediment. The United States Geological Survey Knife River gaging station (06340590) is set up for real-time data transmission via satellite (right panel). Photographs courtesy of NPS.

In 2019, NGPN continued to partner with the USGS North Dakota Water Science Center to have USGS staff collect water quality and streamflow data at KNRI. The USGS deployed a continuous, multi-parameter sonde along the left bank downstream of the bridge along the Knife River on April 18, 2019 (Figure 3) and visited the gaging station every 3–4 weeks for equipment maintenance (Table 2). This instrument recorded dissolved oxygen, pH, specific conductivity, and water temperature every 15 minutes, while the gage simultaneously measured stream stage (or gage height) and discharge, a measure of streamflow.
