# Reclamation of Abandoned Mines At New River Gorge, Gauley River, and Bluestone

By Carol A. Pollio

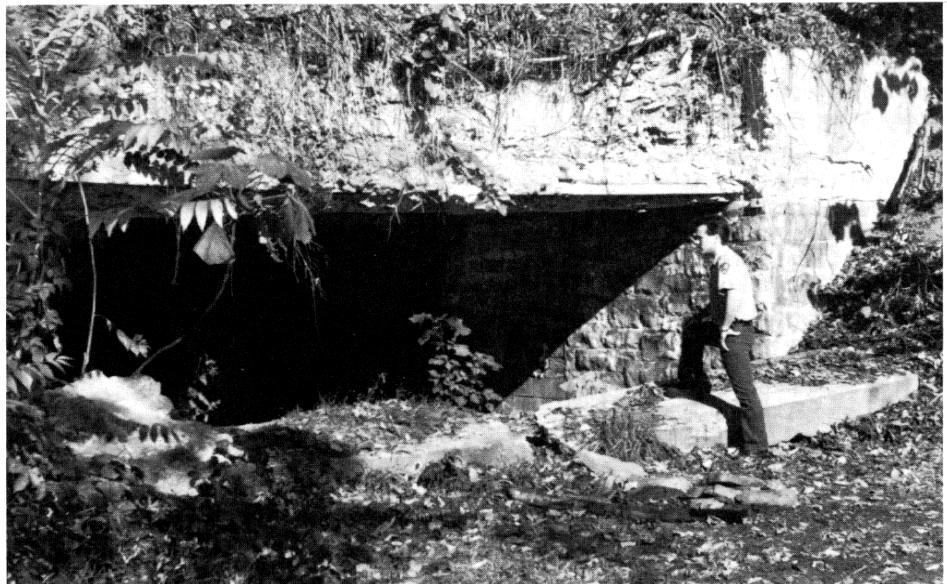
Resource Management Ranger Robert Sullivan looks into the main portal at the Ames Mine, scheduled to be reclaimed this year. Photo by Robert Sullivan.

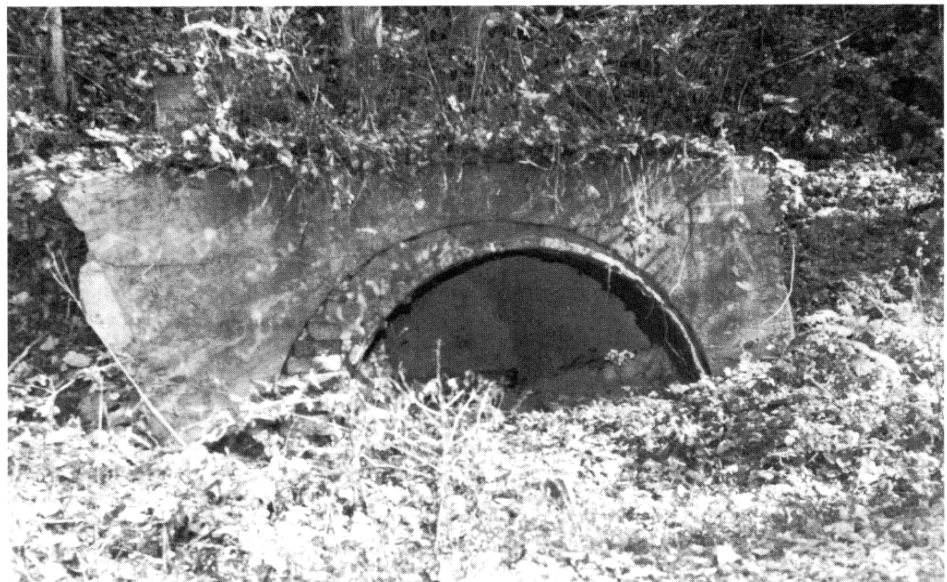
Open portal at Ames Mine. Photo by Robert Sullivan.

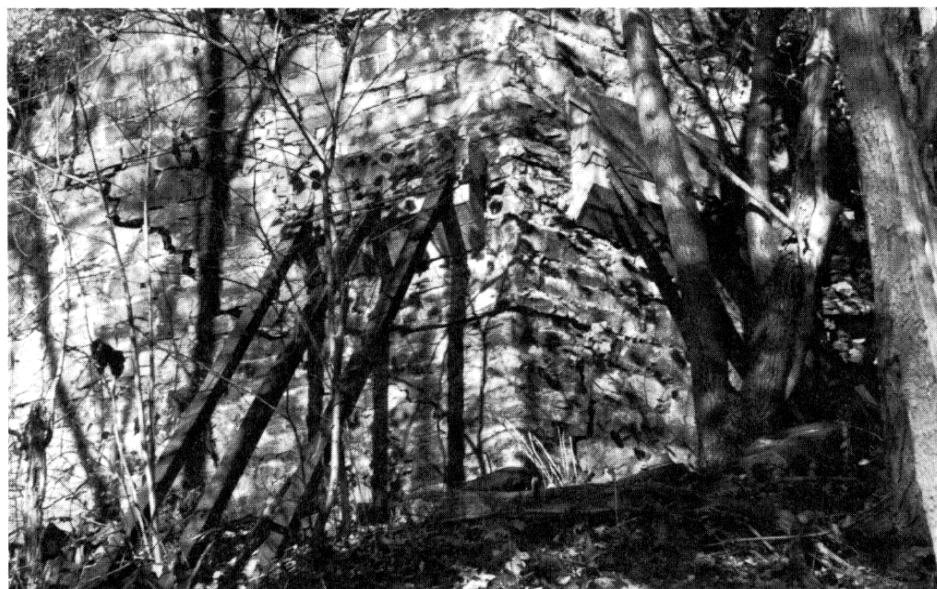
**Deteriorating stone wall** from the Ames Mine site. Photo by Robert Sullivan.
