assessment of alternatives  
for development concept plan

HUBBELL TRADING POST

NATIONAL HISTORIC SITE / ARIZONA

ASSESSMENT OF ALTERNATIVES  
for the  
DEVELOPMENT CONCEPT PLAN

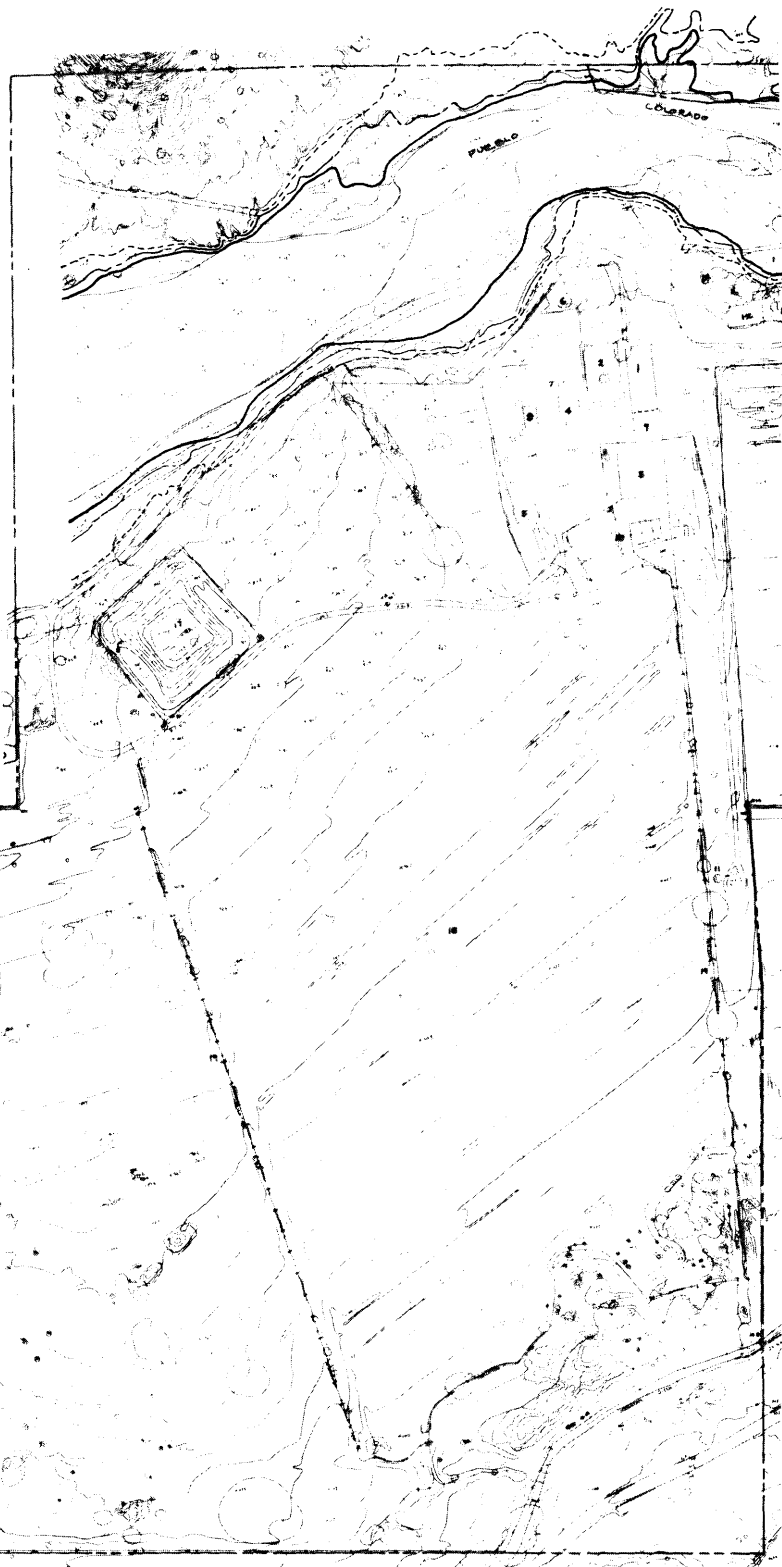
## FLOODPLAINS

While the Pueblo Colorado Wash is dry much of the year, periodic intense rainfall causes flooding on the main stem and tributary washes. The Pueblo Colorado has a drainage basin above Hubbell Trading Post of  $670 \text{ km}^2$  (270 square miles) of which one-third is impounded by a dam at Ganado Lake. The 100 year and 500 year floodplains, as reported by the Los Angeles District of the Corps of Engineers, are shown on the Floodplains map. Much of the site is located on a terrace above these flood levels.

- 100 YEAR FLOODPLAIN  
- - - 500 YEAR FLOODPLAIN WITHOUT GANADO DAM FAILURE  
· · · 500 YEAR FLOODPLAIN WITH GANADO DAM FAILURE

SOURCE: FLOODPLAIN DATA PROVIDED BY THE  
U.S. ARMY, CORPS OF ENGINEERS, LA DISTRICT

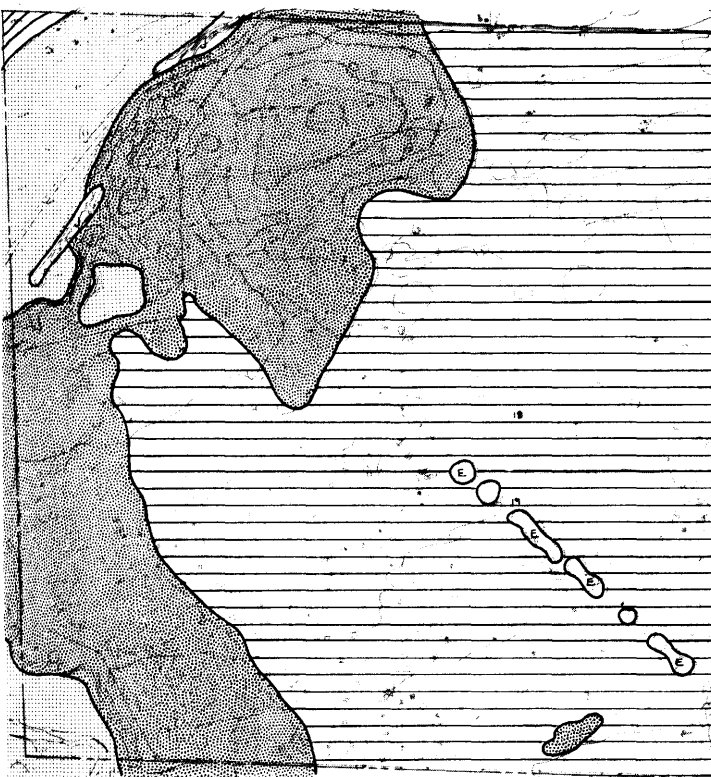
# VEGETATION

As shown on the Vegetation map, The natural vegetation, largely removed for agricultural purposes, consists of scattered juniper and desert scrub. Rabbitbrush, fourwing saltbush and snakeweed are common. Due to their uncultivated status and grazing over the past 20 years, the irrigated fields now support weedy, exotic species such as field bindweed and russian thistle. Cottonwoods line the washes and the bottomlands of the Pueblo Colorado have been invaded by the exotics, including russian olive and tamarisk. Prior to National Park Service acquisition of Hubbell Trading Post, exotics such as elms were planted in the trading post area, especially on the school tract.

SOURCE: VEGETATION MAP BY PHILLIPS, 1978
