Submerged Cultural Resources Study:  
USS Arizona and Pearl Harbor National Historic  
Landmark

USS ARIZONA MEMORIAL  
and  
PEARL HARBOR NATIONAL HISTORIC LANDMARK

DANIEL J. LENIHAN, EDITOR  
SUBMERGED CULTURAL RESOURCES UNIT  
NATIONAL PARK SERVICE

**Professional Papers No. 23  
1989**

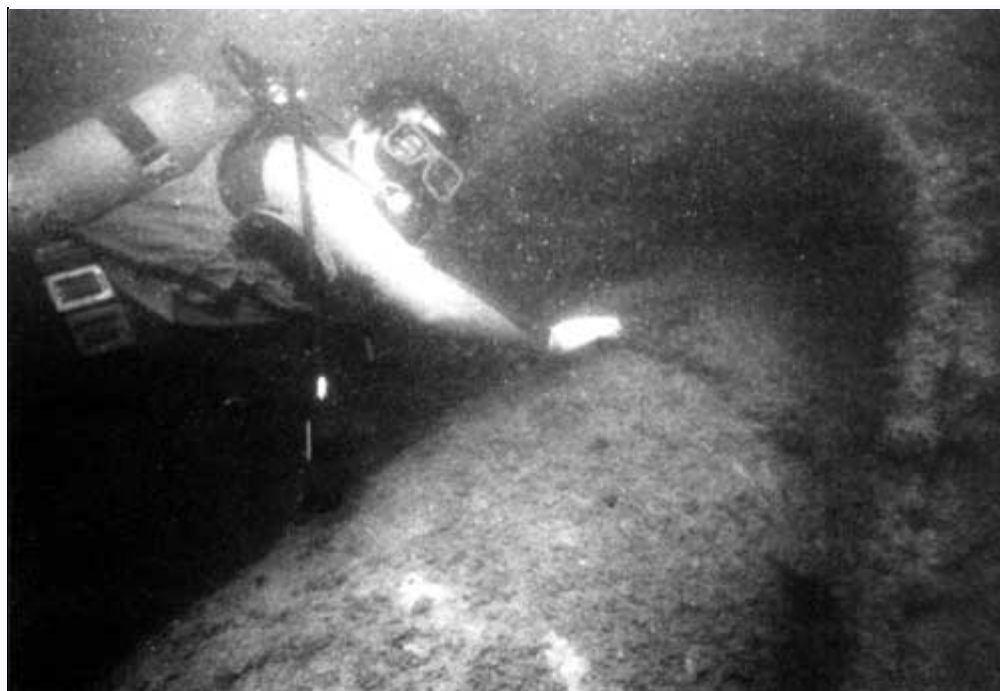
Figure 1.1. Gary Cummins, Superintendent of ARIZONA National Memorial inspects embrasures of No. 1 turret. It was not known that the 14-inch guns were still in place on the ship until the underwater survey.  
(NPS photo by Larry Murphy)

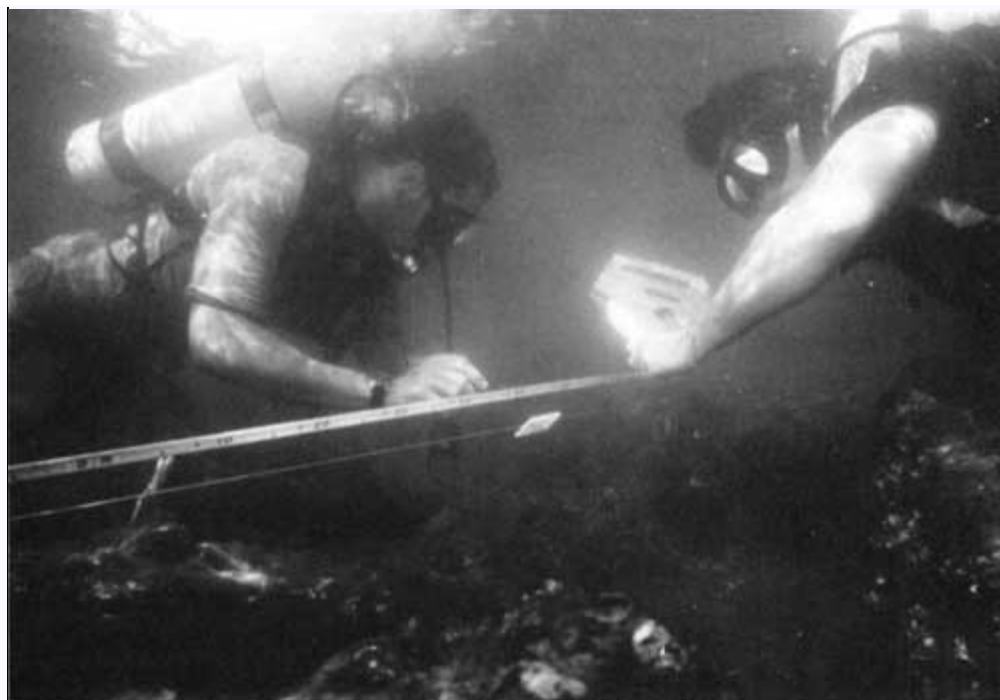
Figure 3.1. U.S. Navy divers add marked clips every 10 feet to survey line on USS ARIZONA after it was installed by NPS underwater archeologists.  
(NPS photo by Larry Murphy)

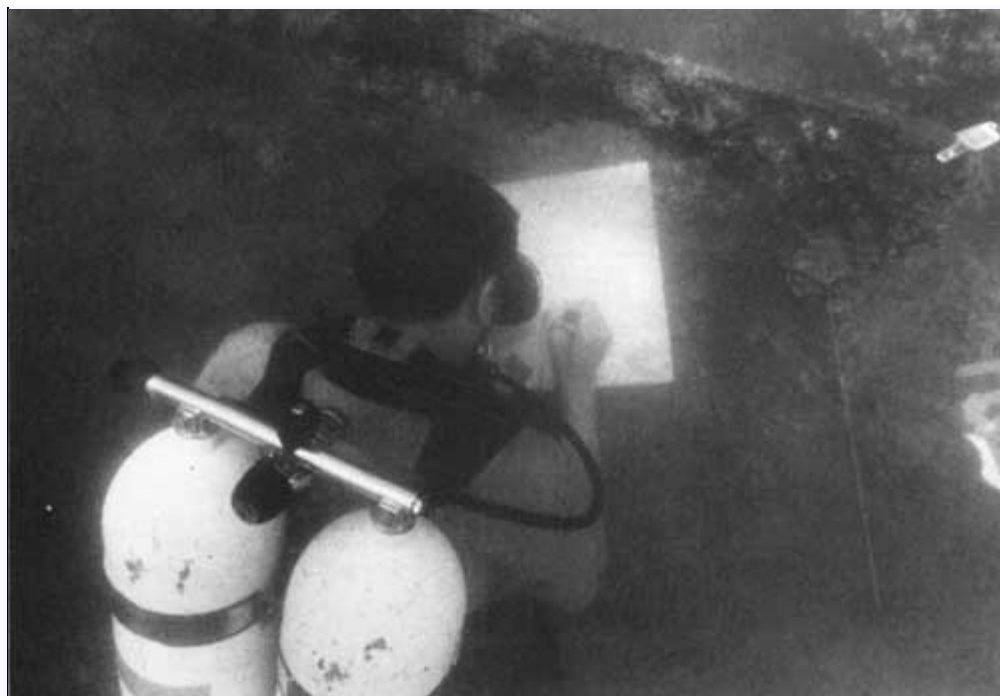
Figure 3.2. Numbered clothespins in upper right hand corner marks a survey point. Diver is sketching feature for inclusion in site map.  
(NPS photo by Larry Murphy)

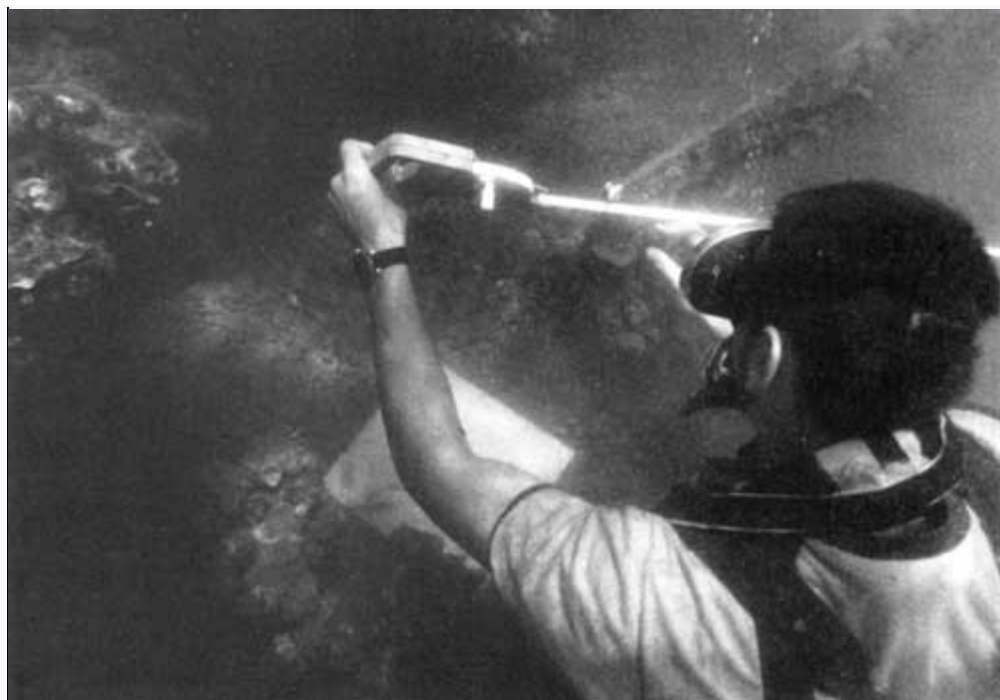
Figure 3.3. After being drawn, each feature is measured back to two points on the baseline. This allows accurate mapping through a simple geometric procedure called trilateration.  
(NPS photo by Larry Murphy)

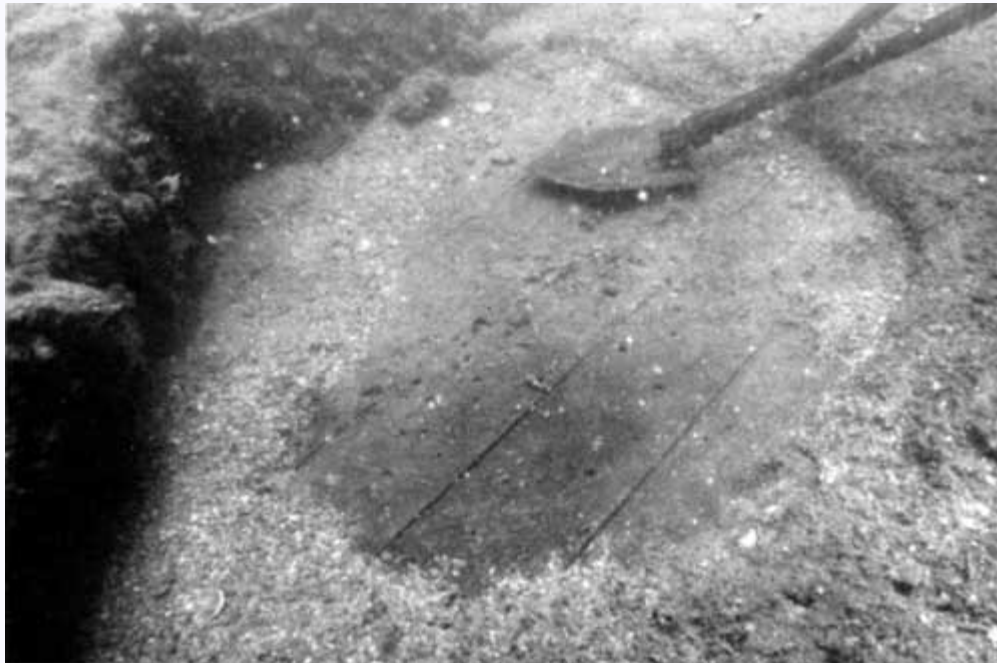
Figure 4.7A. Area is cleared on deck for installation of horizontal surface monitoring stations.  
(NPS photo by Larry Murphy)

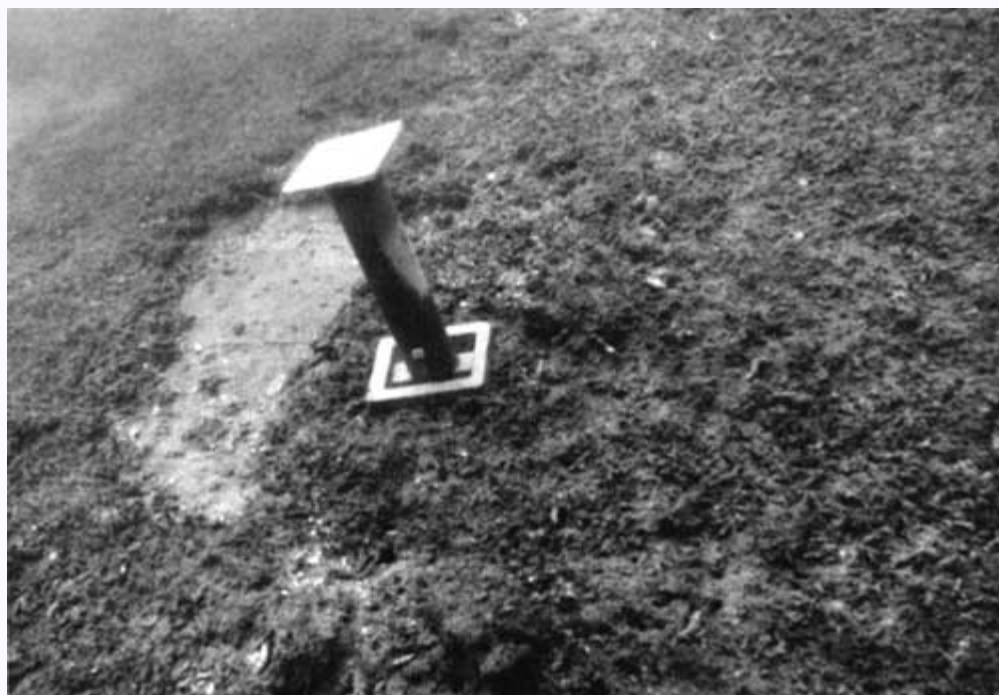
Figure 4.7B. Horizontal surface monitoring station marker in place.  
(NPS photo by Larry Murphy)

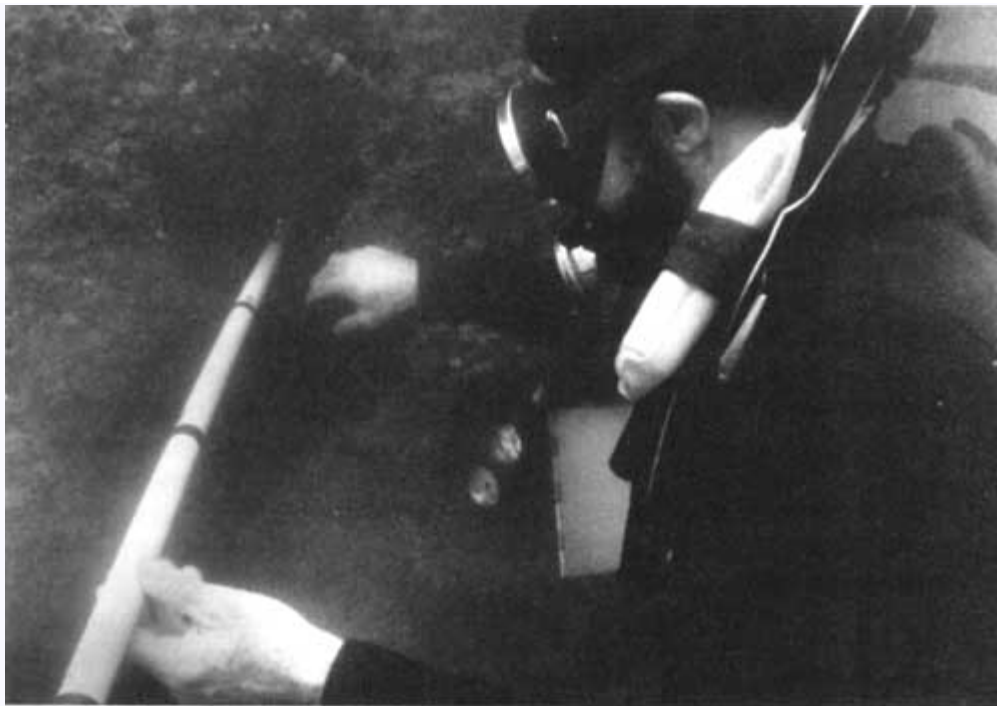
Figure 4.10. Water is drawn from interior spaces of the USS ARIZONA to surface through a PVC pipe and vinyl tube. Pipe is marked to establish exact distance of penetration.  
(NPS photo by Larry Murphy)

As expected, oxygen levels measured 15 to 16 feet inside interior spaces were substantially lower than ambient values (Table 4.6). At distances of 8 to 9 feet inside openings, oxygen levels were only moderately lower than ambient, indicating that water volumes within about 10 feet of hull openings are relatively well flushed. Oxygen concentrations were at or less than 1 mg/l at 15-foot distance from opening in 3 out of 6 stations, thus it would be reasonable to assume that most other enclosed volumes in the hull that are distant from openings would also exhibit sub-1 mg/l oxygen concentrations.

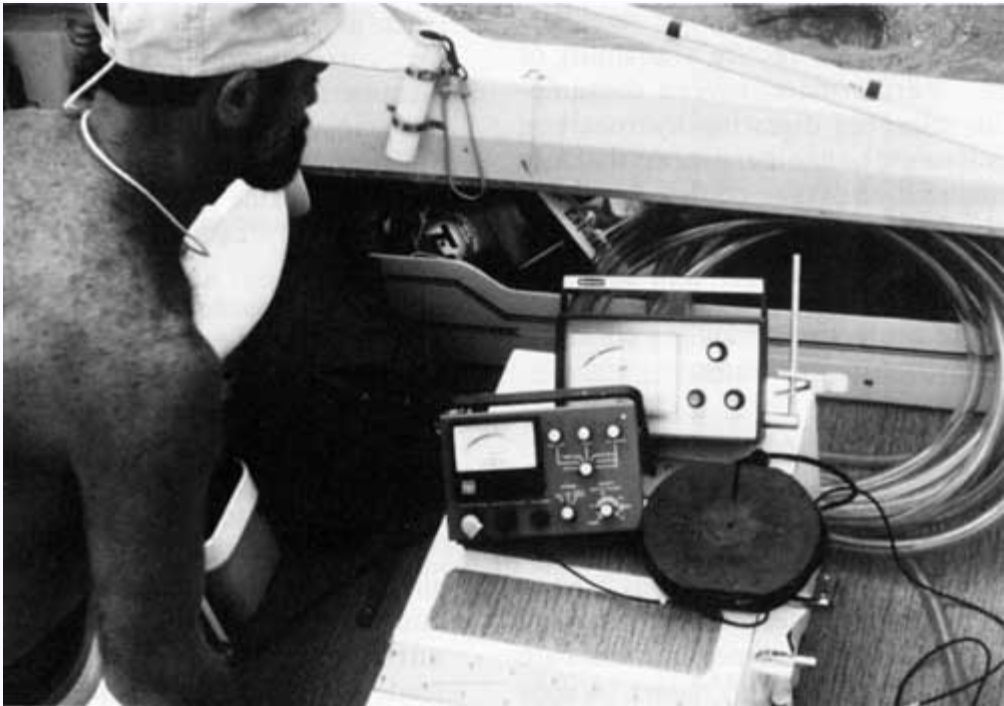
Figure 4.11. On the surface, water drawn from inside the wreck was analyzed for oxygen, temperature and pH levels.  
(NPS photo by Larry Murphy)

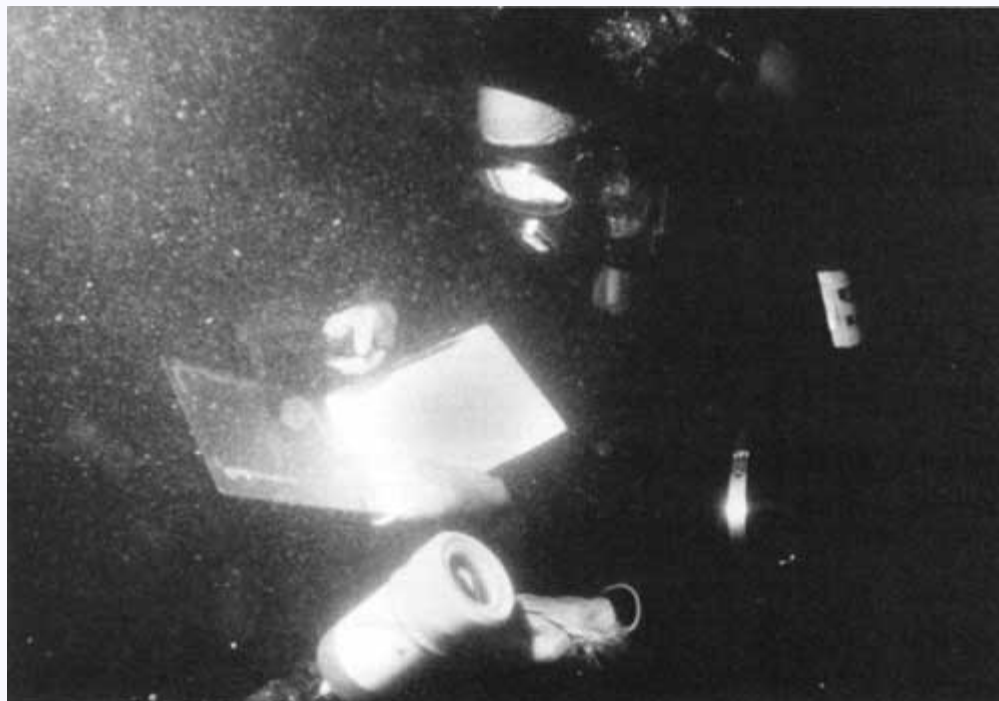
Figure 4.13. Scott Henderson and another diver record bathycorrometer readings.  
(NPS photo by Larry Murphy)

Control/drift check measurements were usually made on a gunnel site on the USS ARIZONA that was located about midship on port side. Drift was generally in the range of 0.002 volt over the course of a 1 to 2 hour dive.
