SUMMARY OF EROSION-CONTROL REHABILITATION WORK

UNIT 81-5

Y-2 ROAD I.F.B. CONTRACT

March, 1982

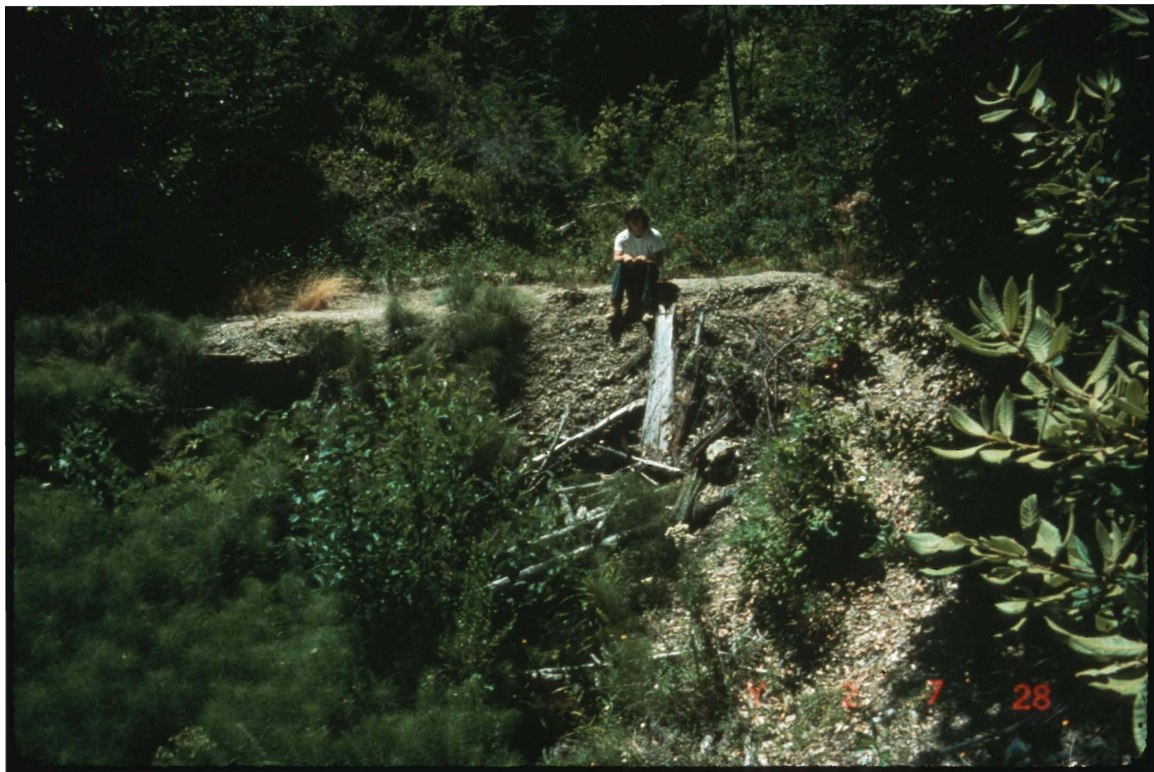
Unit: 81-5 1-A 7/28/81 PP#3B OS @ Sta 38-00

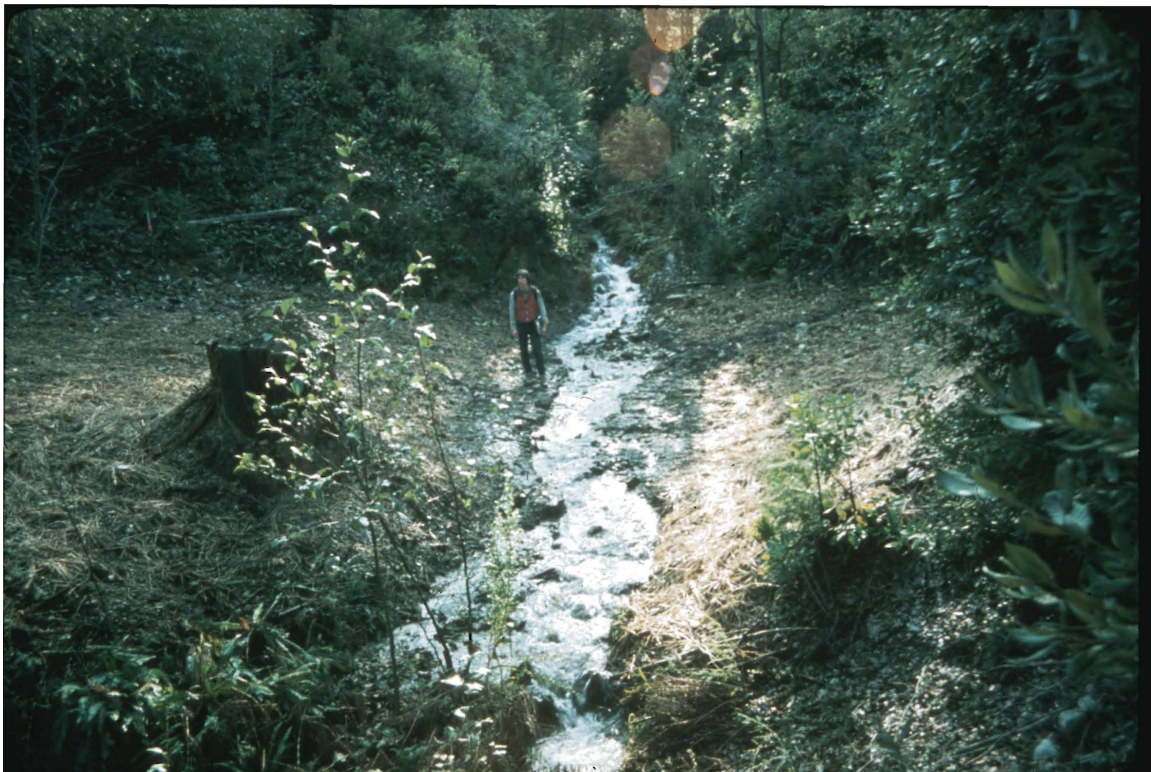
Unit: 81-5 1-B 11/15/81 PP#3B E.W.

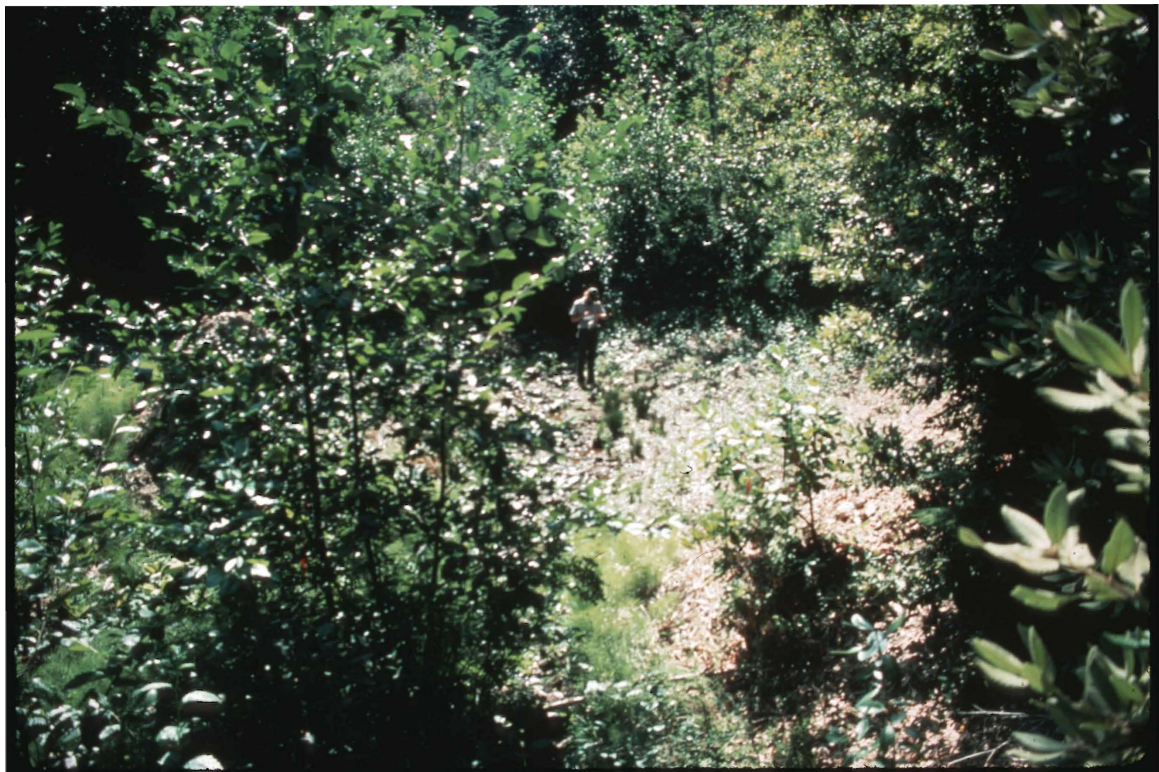
Unit: 81-5 1-C 9/15/82 PP#3B E.W.

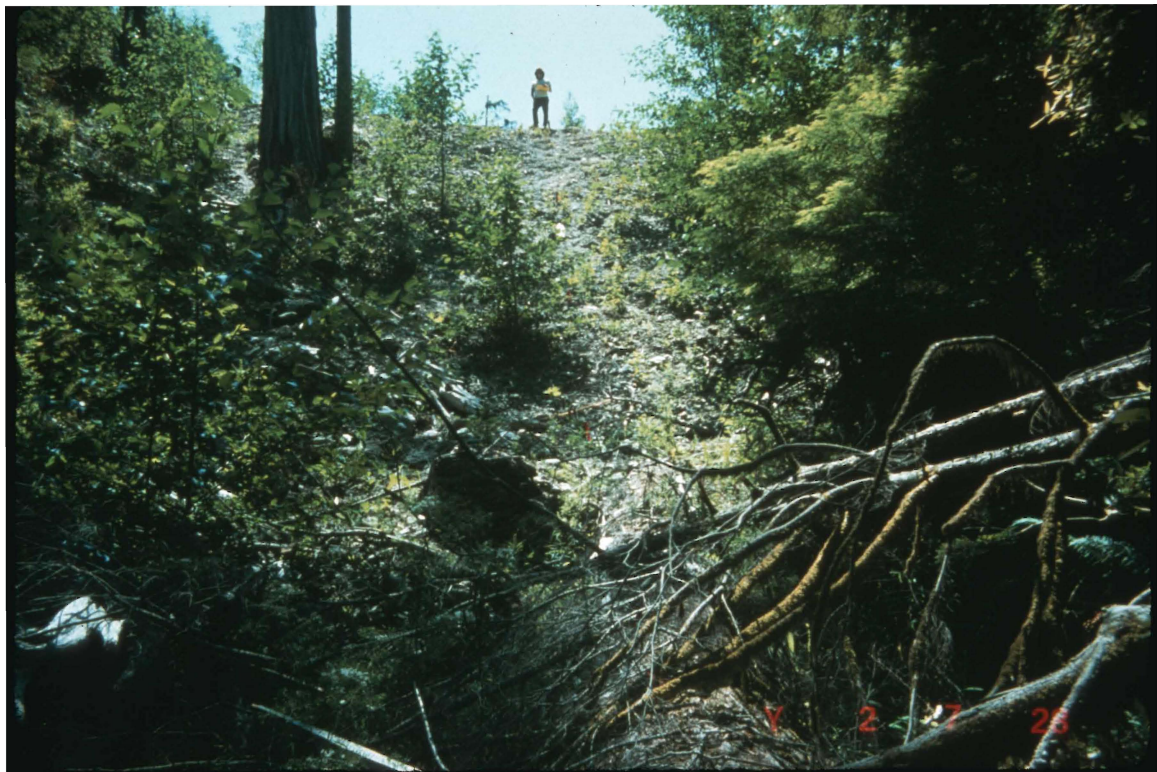
Unit: 81-5 2-A 7/28/81 PP#8 E.W.

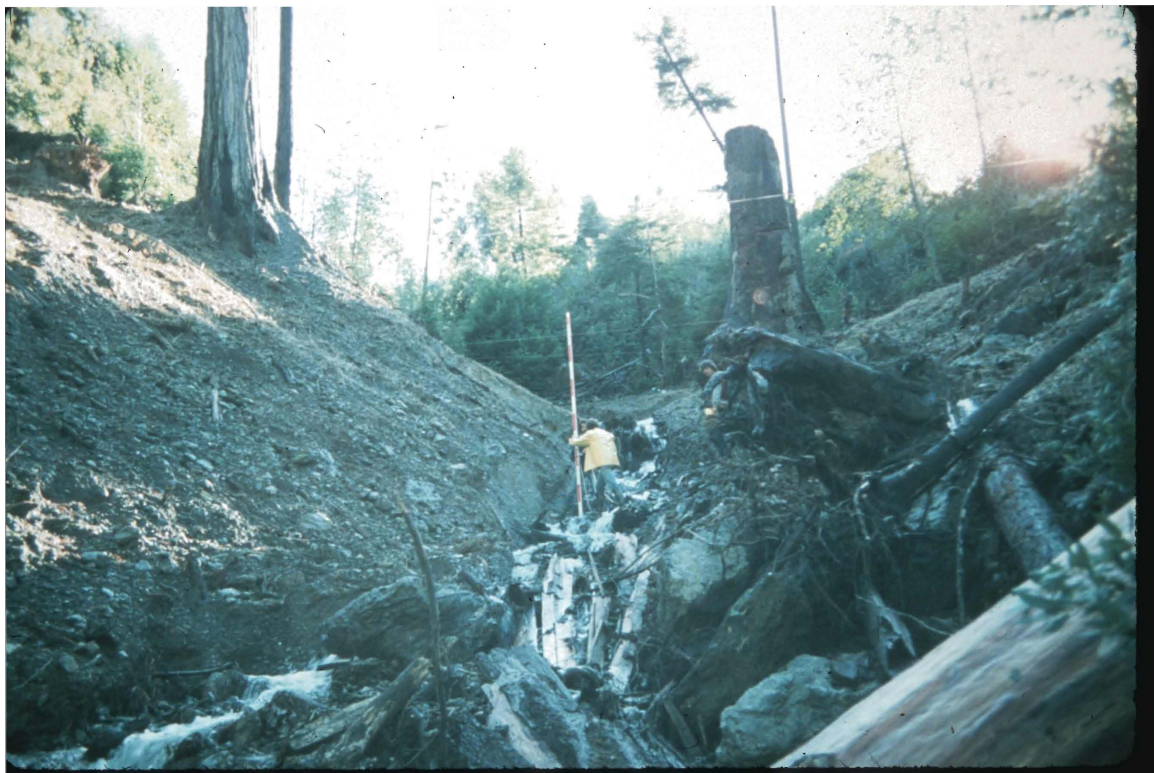
Unit: 81-5 2-B 11/15/81 PP8 E.W.

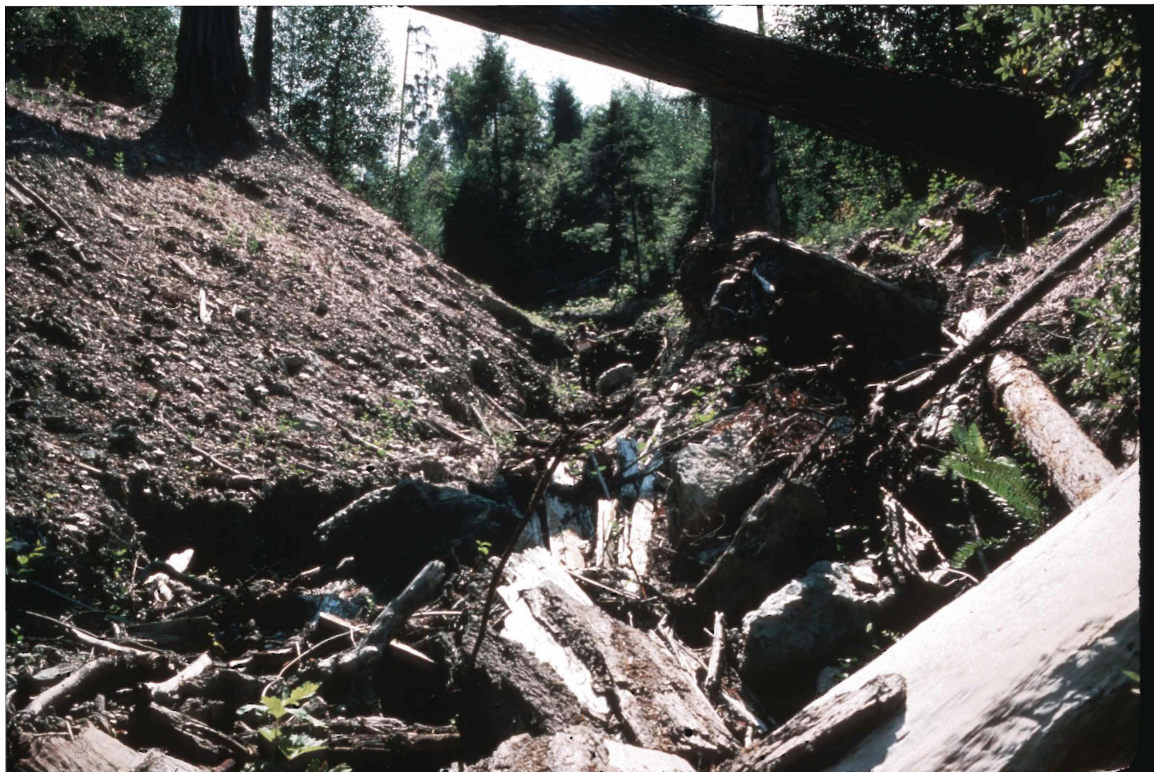
Unit: 81-5 2-C 9/15/82 PP8 Xing 48-50

The crossing excavation at sta. 48+50 has experienced a loss of between 300 and 700 cubic yards, (depending on the original configuration of the excavation) most of which appears to have occurred in the 1997 storm event. Most of the material seems to have been transported offsite. Channel sideslopes are freshly exposed and oversteepened, and incision within the channel appears to be active and headcutting upstream. Up to 300 cubic yards of fill material remains within the boundaries of the crossing, and hundreds of cubic yards remain above the crossing, all at great risk of mobilizing in future events.

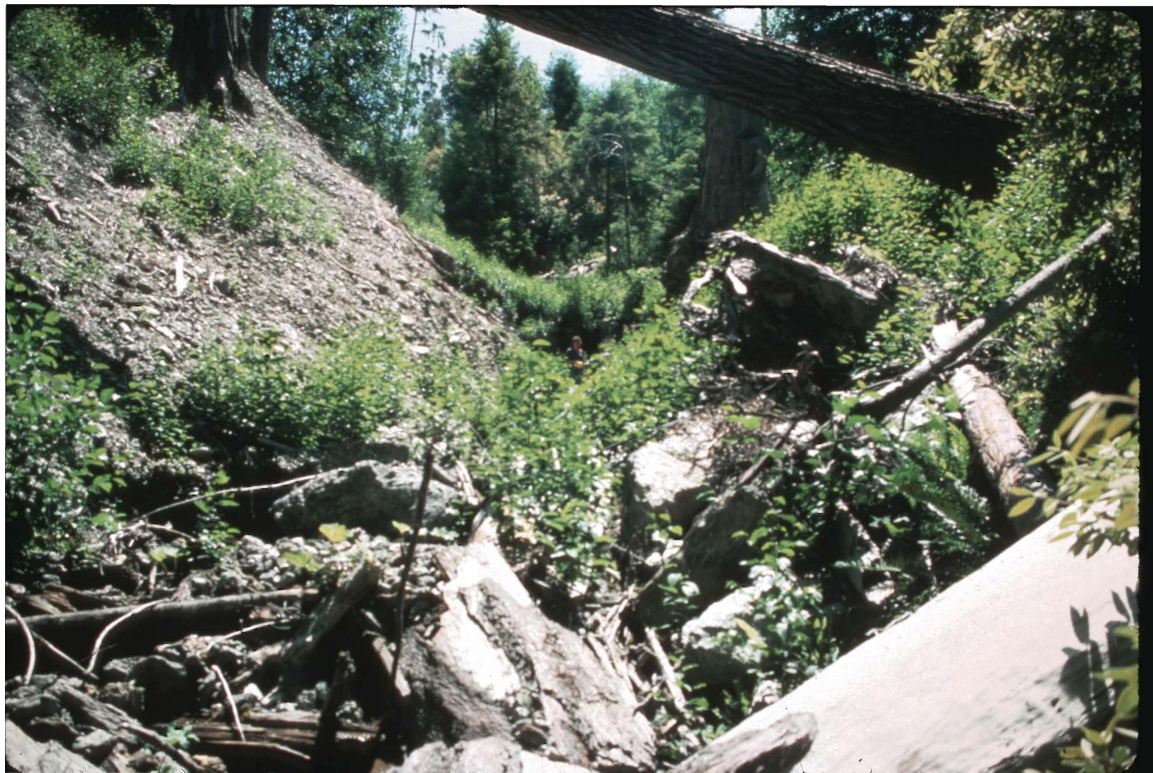
Unit: 81-5 2-D 7/21/83 PP8 L.T.
