SUMMARY OF EROSION CONTROL WORK  
UNIT 83-5  
W-LINE/K & K SLOPE

Redwood National Park  
Orick, California

November 1983

# UNIT 83-5: W-LINE/K&K SLOPE

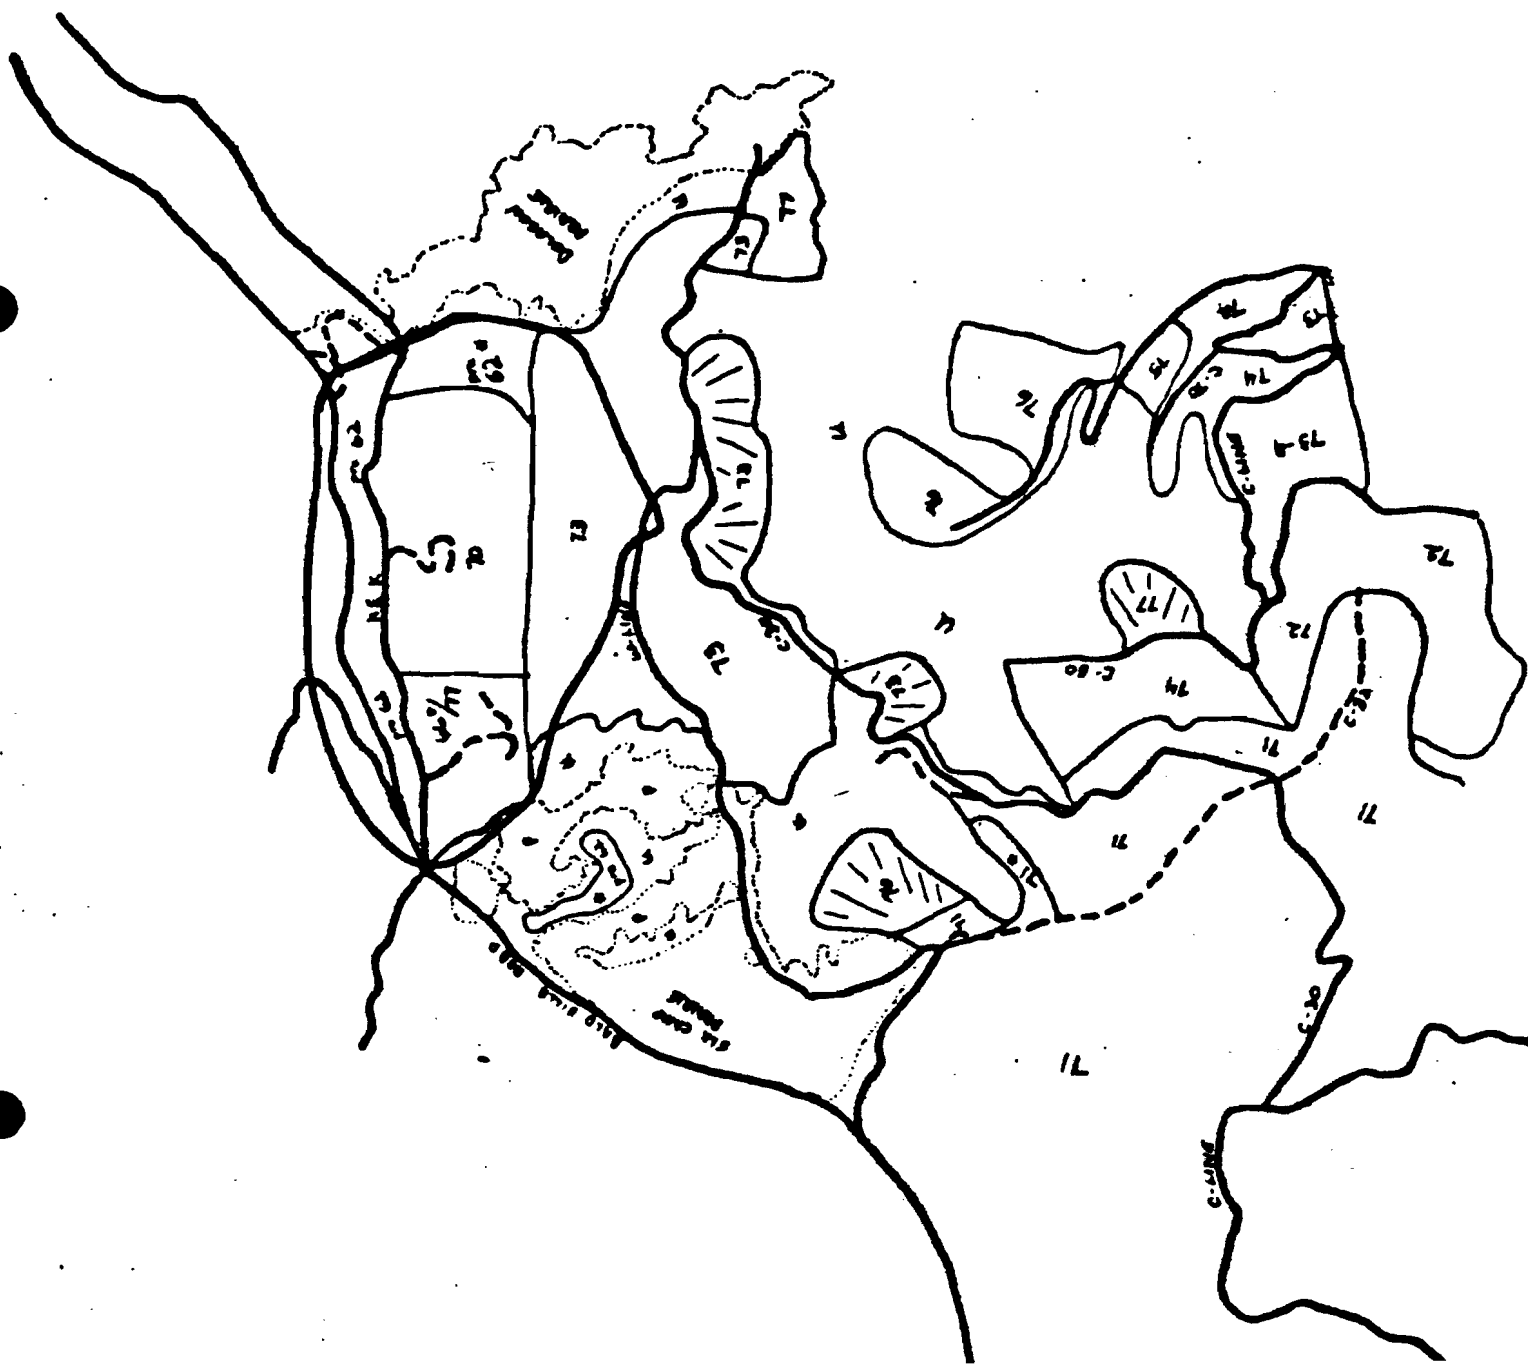
| | <u>Page</u> |
|---|---|
| Map B - Logging History . . . . . | 16 |

- Mapping Boundary
- ..... Private Boundary
- Cut Block Boundary
- 71 Year of Cut
- U Uncut
- Select Cut
- /// Cable Yarded (all others truster yarded)

Air Photo years used to determine logging history: 62, 66, 68, 70 (partial), 71, 72 (partial), 73, 74, 76, 77, 78.

Construction of the Klamath-Korbel (K & K) Road in the late 1950's initiated commercial logging in the Emerald Creek basin, and on much of the east side of Redwood Creek (Map B). During the 1960's, three small areas in the unit were cut, each less than 40 acres. These tractor-yarded cutblocks are high on the slope, where drainages are small and few crossings were constructed. Little erosion potential exists in these areas.

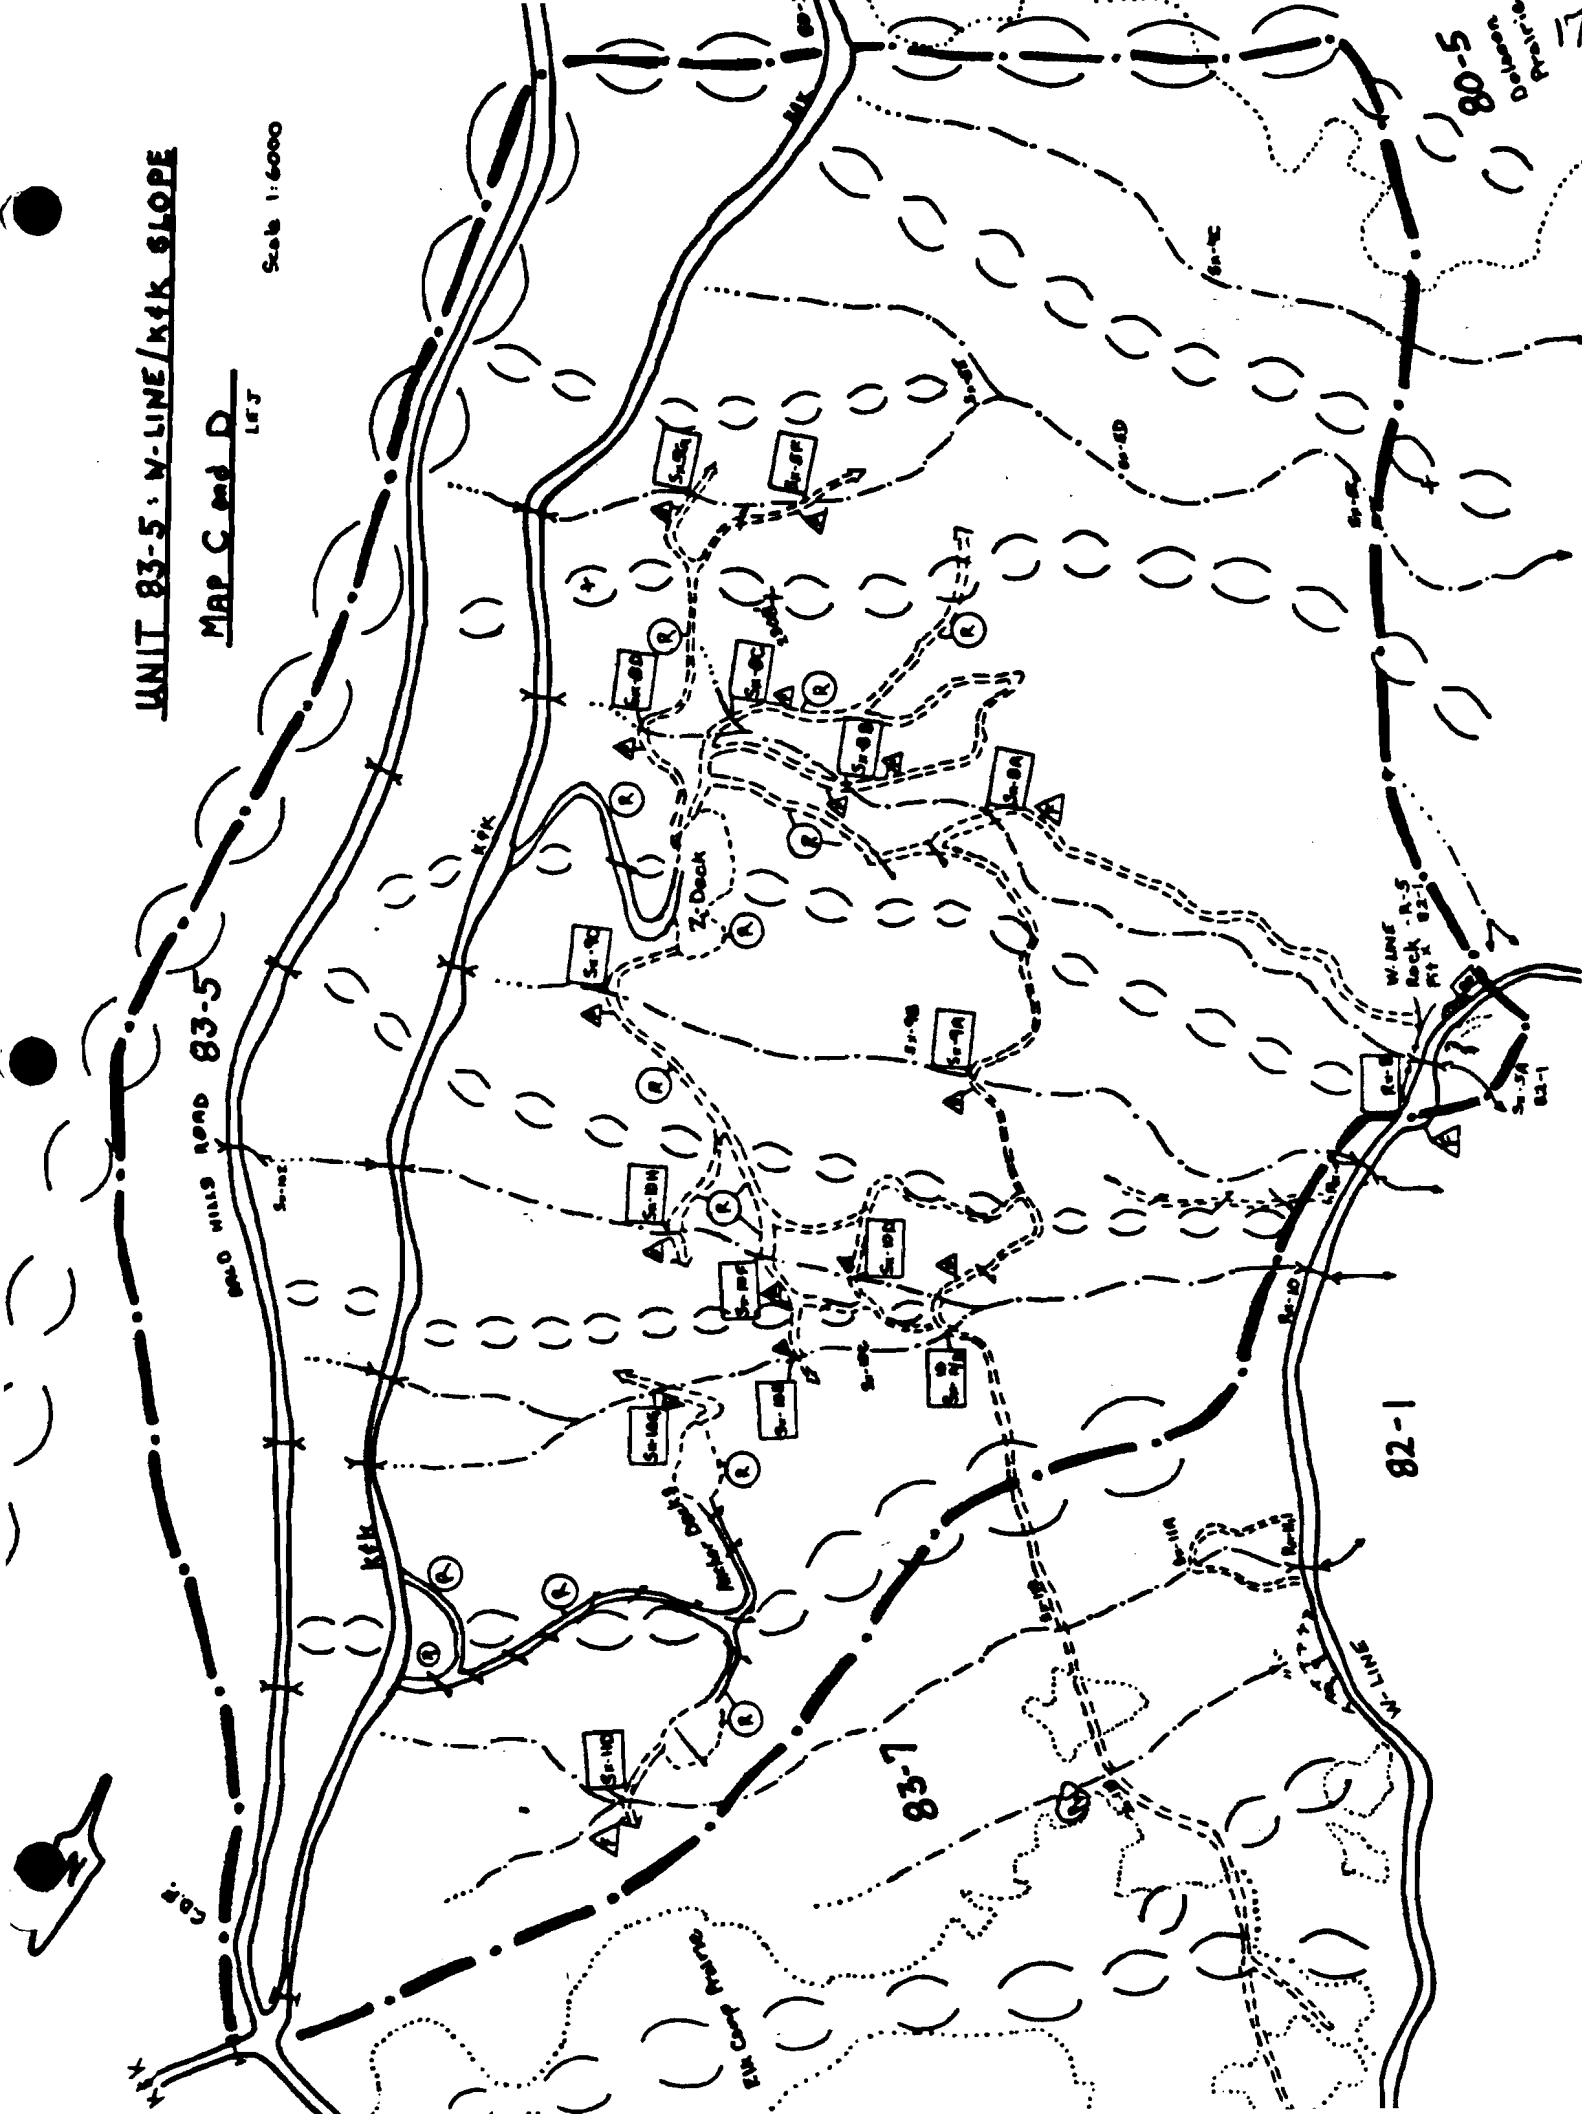
Map C and D 165

- ..... Ephemeral Stream Channel
- - - - - Intermittent Stream Channel
- Perennial Stream Channel
- Active Gully
- ..... Prairie Boundary
- ○ Ridge
- ===== Main Haul Road
- - - - - Skid Trails
- X Culvert
- ——— • Unit Boundary
- + ○ Knobs
- Sx-# Skid Trail Crossing and Number
- Rx-# Haul Road Crossing and Number
- 83-1 Site numbers; rehabed in 1983; 83-5 only.
- // Waterbars
- Ⓡ Ripped Road Reach or Deck
- ~~~~~ Mass Movements: Fill Failure
- △ Fill Outslope
- Photo Point numbers

Table 1 shows the overall cost summary of erosion-control work on the W-Line/K & K Unit. The grand total of the project was \$26,968.40. Of this, 8 percent was spent on the evaluation and documentation phases and 92 percent on the actual implementation of erosion-control work (88 percent on the heavy equipment and 4 percent on labor-intensive work). Table 5 summarizes the erosion-control work completed. Map D shows all worksite locations.

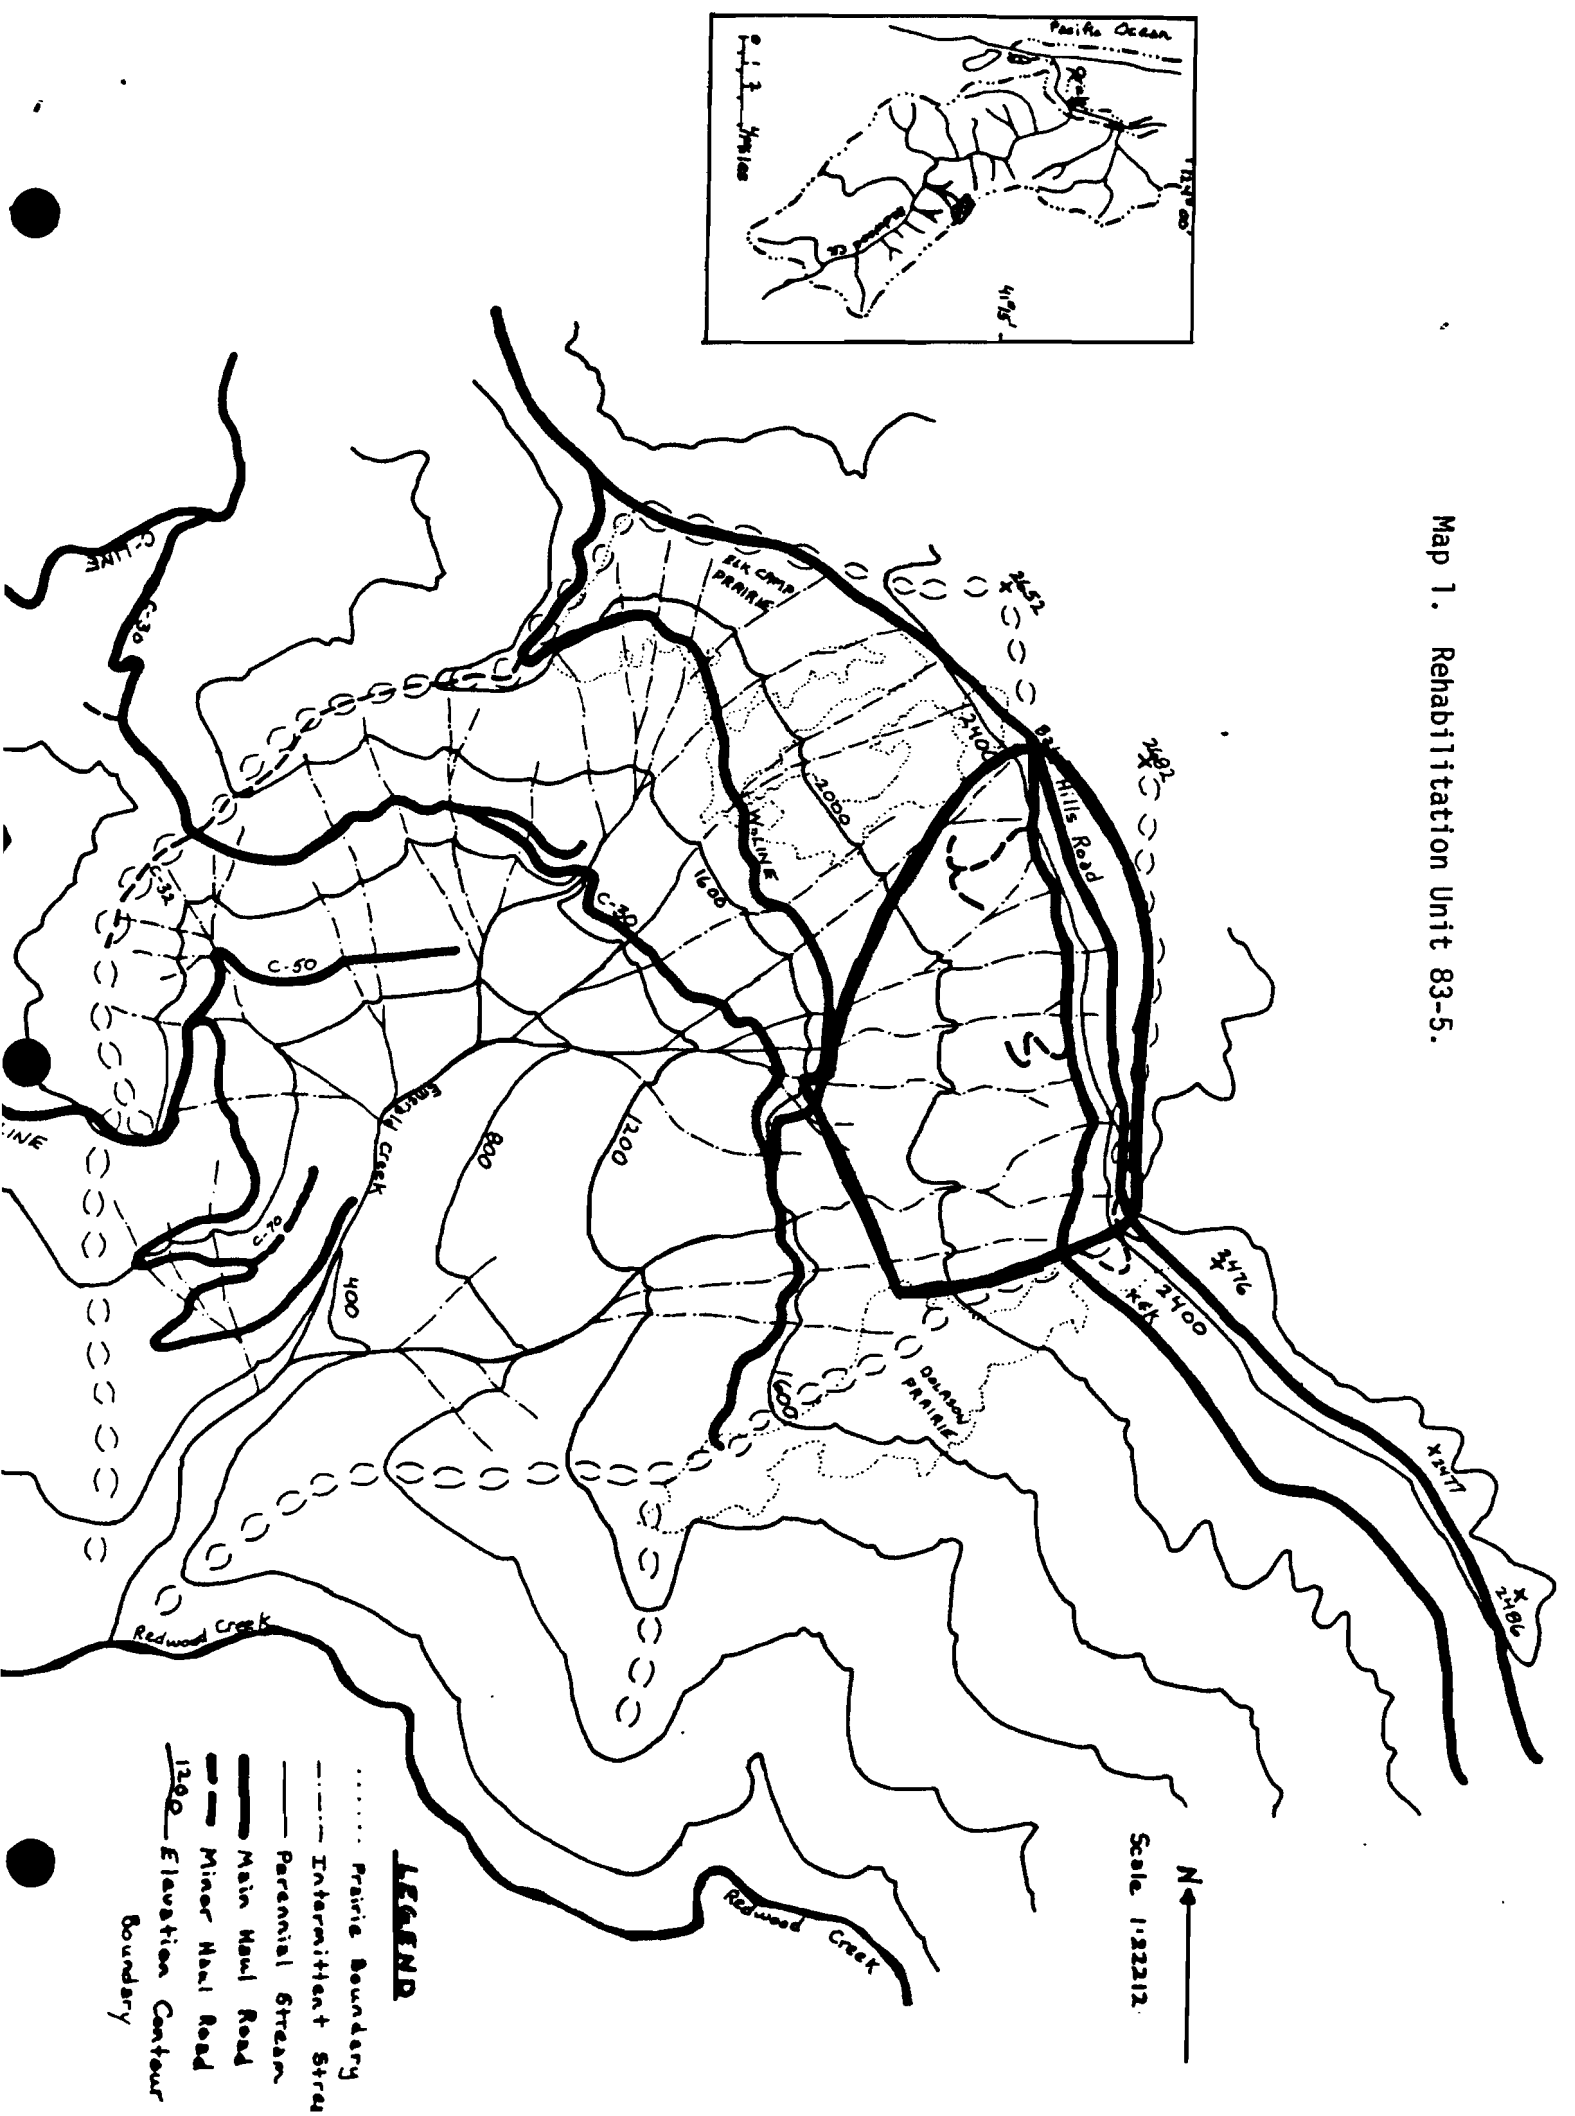
Map 1. Rehabilitation Unit 83-5.

Rehabilitation Unit 83-5, 13 miles east of Orick, is located on the east side of Redwood Creek basin between the K and K Road and the W-Line (Unit 82-1) (see map 1). Flanked by Elk Camp Prairie to the northwest and Dolason Prairie to the south, Unit 83-5 covers 296 acres of logged terrain. The unit has a southwest aspect with an elevation range of 1600 to 2682 feet and a slope of 25 to 50 percent. Weather conditions range from cool, foggy summers to cool rainy winters with a mean annual precipitation of 70 to 100 inches and a mean annual temperature of 53° F.
