**Summary Report**

**1840/1850 Roads and Slope  
Watershed Rehabilitation Unit**

**84-4**

**January, 1985**

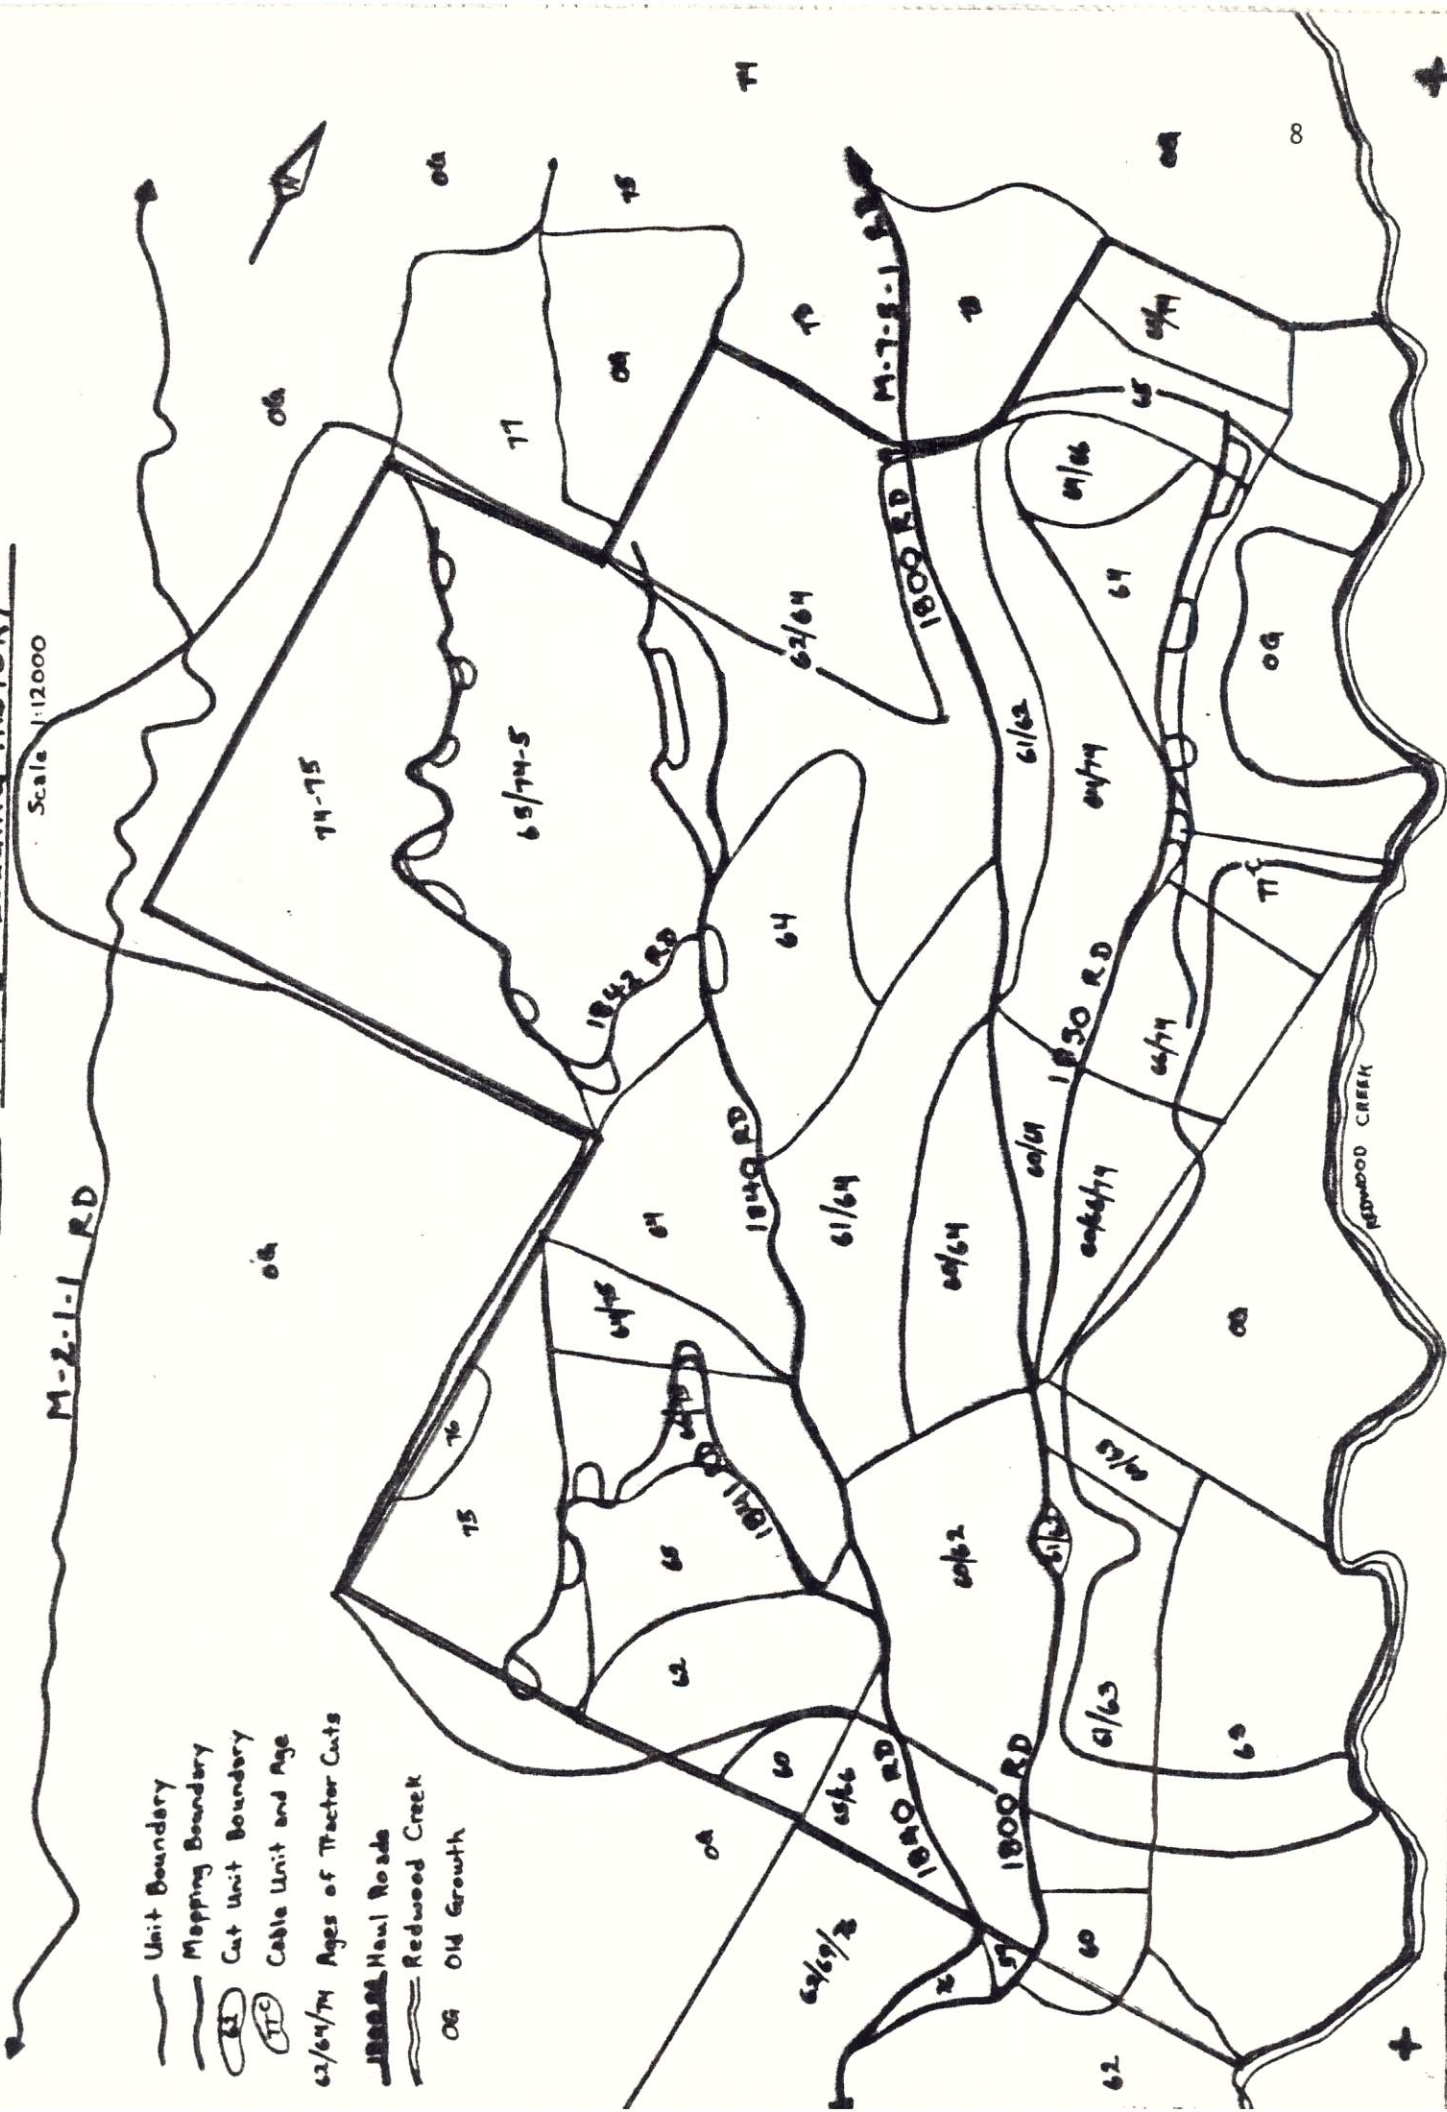
## 1-1AP C: Loading History

constructed. Between 1974 and 1977, 37 percent (325 acres) of the unit was relogged (206 acres) or newly logged (119 acres), and the remaining 1.1 mile of haul road was completed. During this period all harvest areas were clearcut; most yarding was done by tractors, only 12 acres were cable yarded. Only 12 percent (102 acres) of the unit remains as old growth redwood, and these two patches are located between the 1850 Road and Redwood Creek (Map C).

Rehabilitation Unit 84-4 contains 890 acres. Approximately 665 acres were mapped requiring 75 person days to complete (Map C shows the mapping boundary). Prescriptions, planning, and documentation required an additional 88 person days to complete. The heavy equipment work was completed between August 2 and September 20, 1984. Worksites on the 1840 road were treated starting at the north end of the road and proceeding towards the 1800 road. Slope work along the 1840 road was done in conjunction with adjacent haul road crossings. The equipment was then moved to the end of the 1850 road where slope work and haul road excavations were done simultaneously proceeding back towards the 1800 road. The last work completed was the slope work above and below the 1800 road. All worksites are located on Map D.

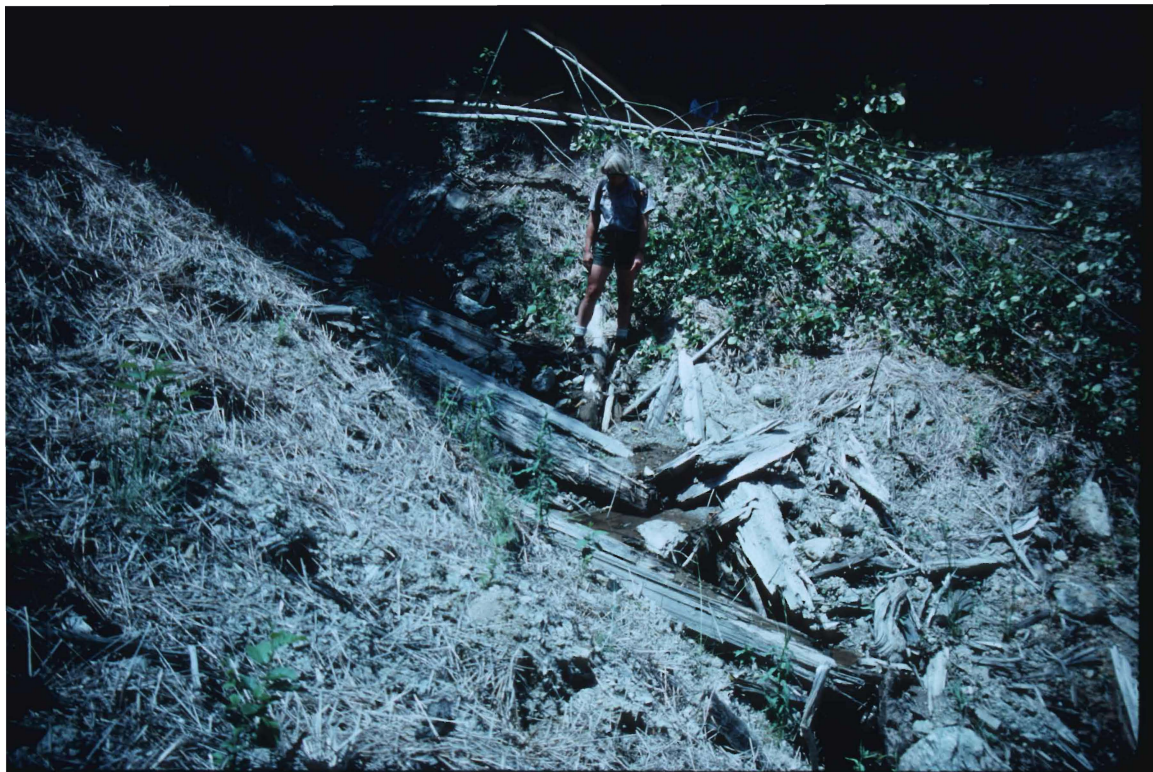
Unit: 84-4 6/27/85 Herringbone logs in channel.
