SUMMARY REPORT

EROSION CONTROL REHABILITATION OF  
THE M-6-1 ROAD, BRIDGE CREEK  
UNIT 86-4

GREGORY J. BUNDROS

JANUARY, 1989

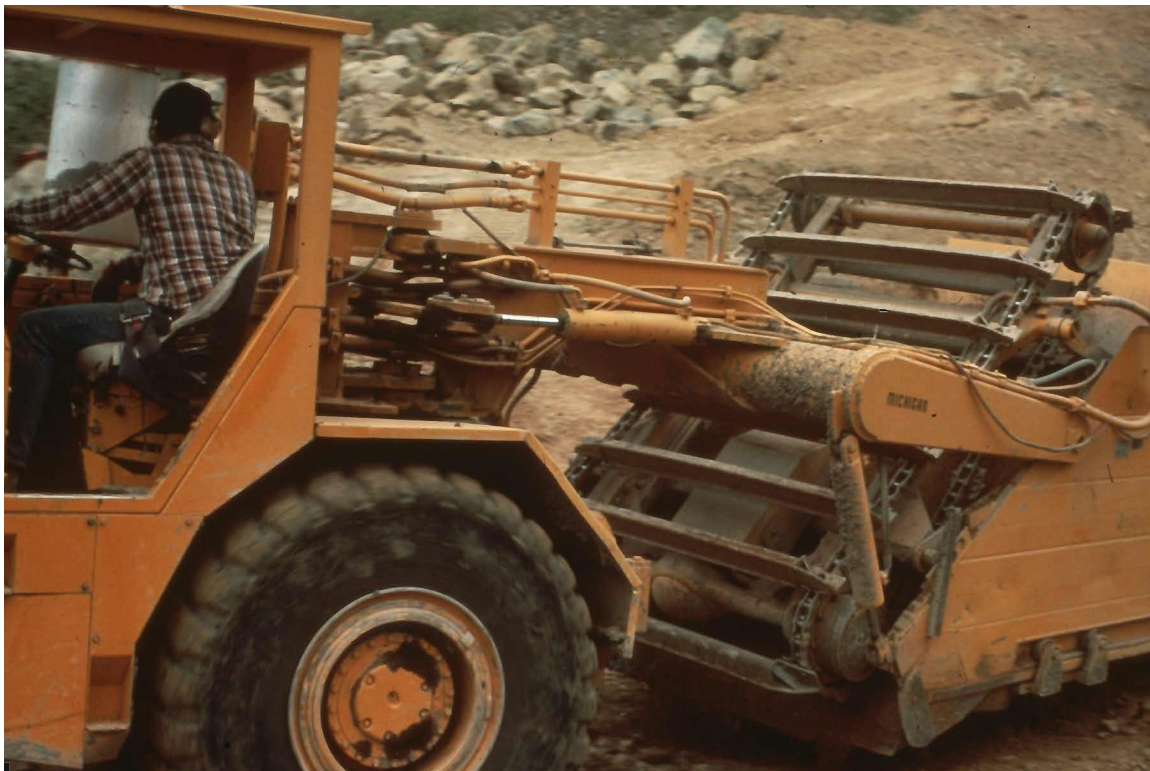
Unit: 86-4 Date: 8-26-86, M-6-1 Michigan 110-110B Elevating Scraper, 50mm, (GB)

<sup>3</sup>Short, easy carry by scraper into rock pit fillsite. Scraper repeatedly broke its loading mechanism due to the high concentration and large size rocks within this material. For the two scraper endhaul worksites, the 1150 dozer supports the scraper 100% of time.

This was also the first time that a scraper had been utilized on a rehabilitation project. It was a novel and appropriate approach to excavating and endhauling the landslide material. Unfortunately, it was the wrong type of scraper. A small to medium size, push-type scrapper would have been more appropriate than the self loading (paddle wheel) type. The self loading type is designed to handle river bed or unconsolidated, fine grained material. This scraper experienced recurring breakdown because of the type of material it was forced to handle.

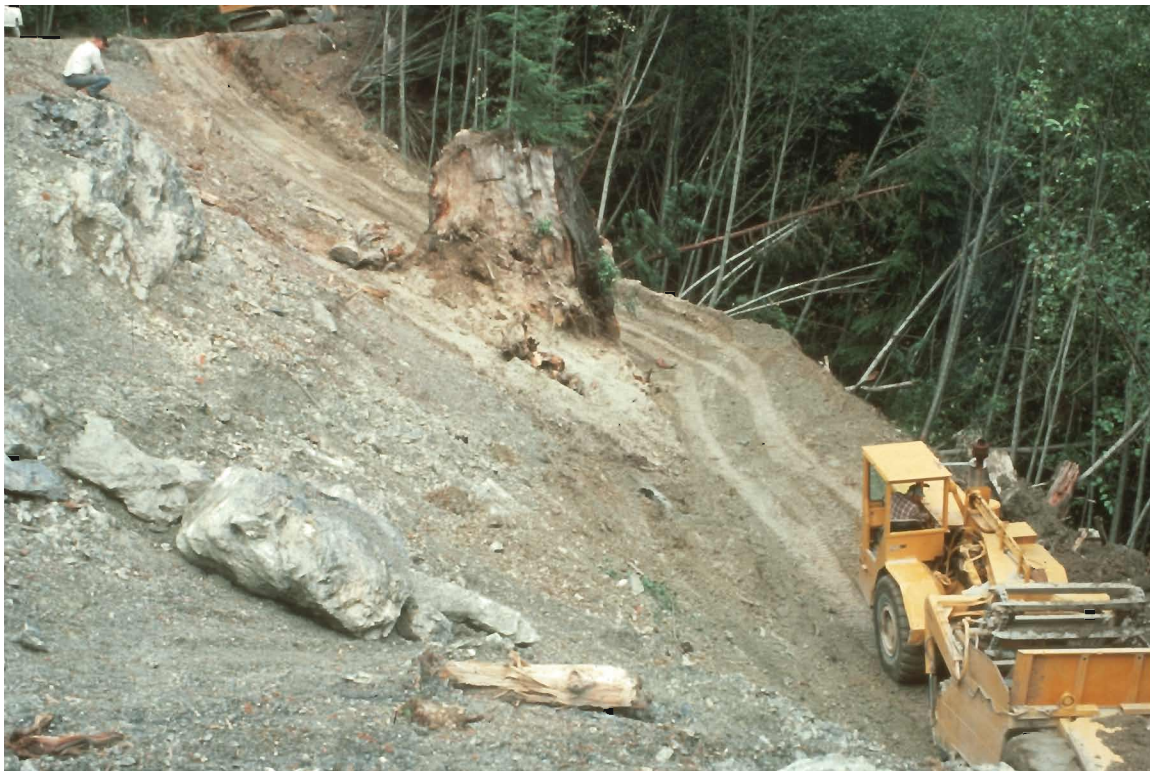
Unit: 86-4 Date: 9-29-86, M-6-1 Michigan 110-110B Slide from upper outcrop, 50mm, (GB)

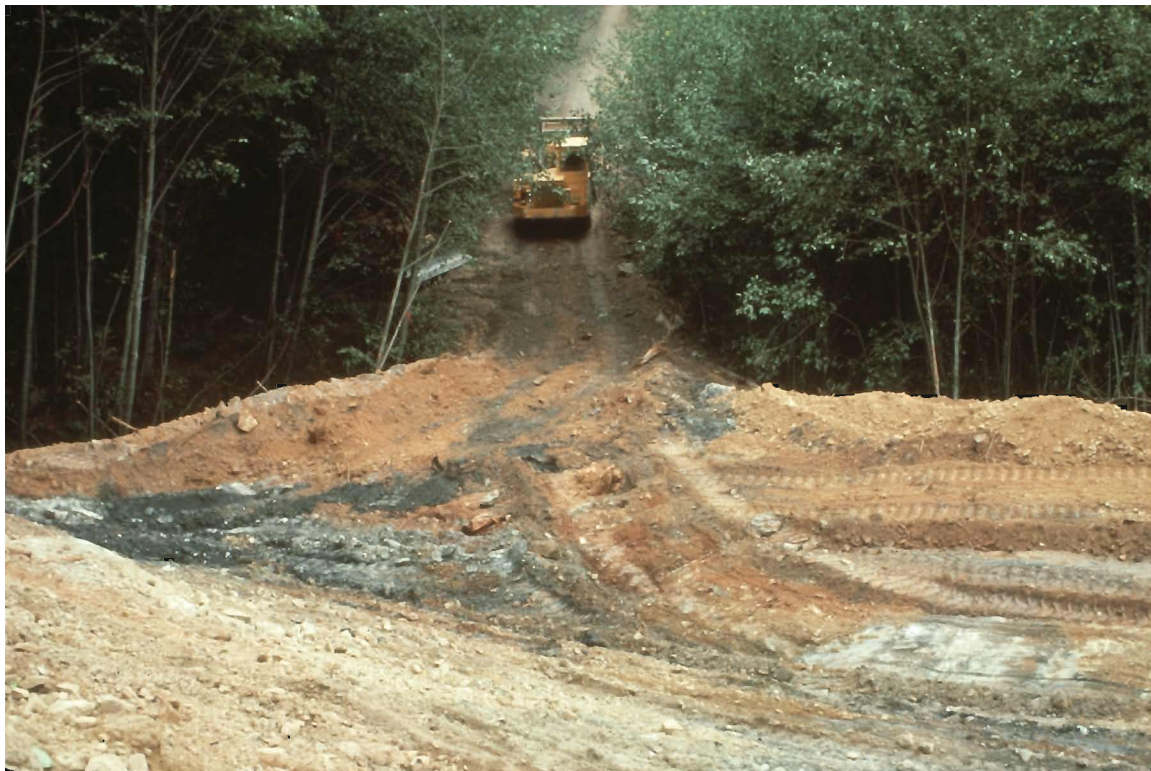
Unit: 86-4 Date: 8-28-86, PP3C M-6-1 onto RX-1 from top 2+71, 50mm, (GB)

<sup>2</sup>Excavator placed rock found in fill into completed stream channel as excavation progressed. Sidebank steepness to this major, flowing stream exceeded 60%.

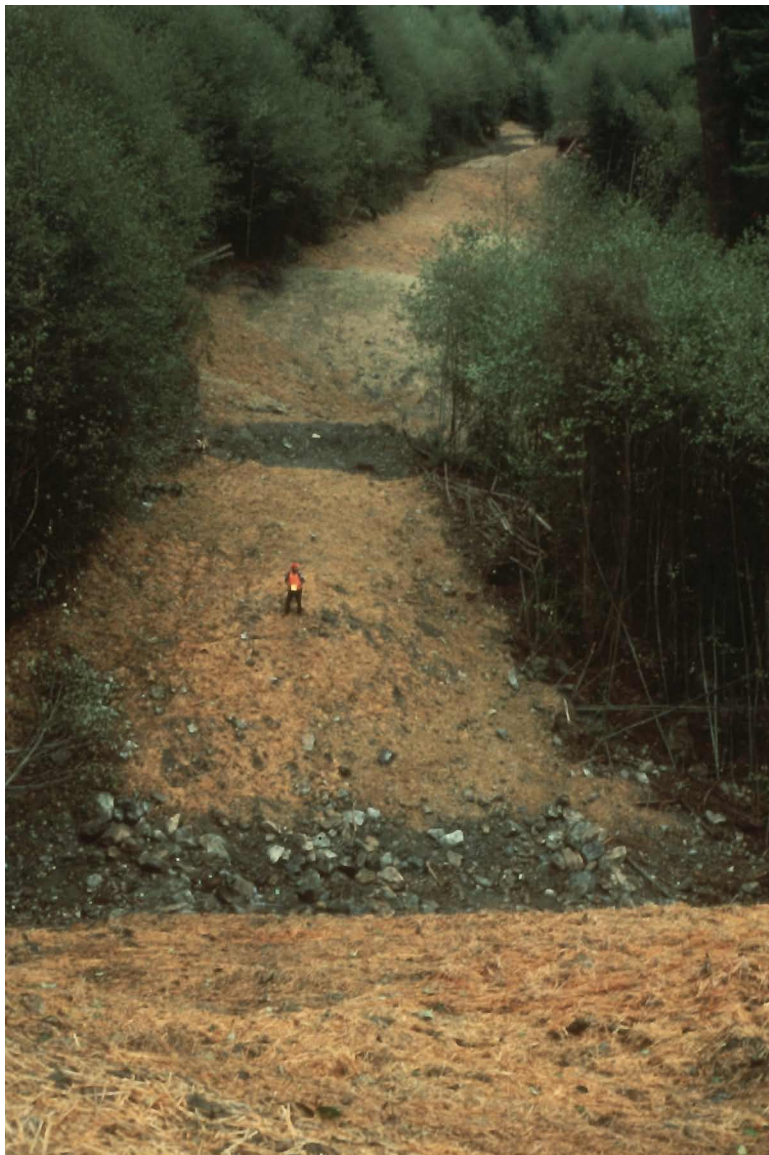
Unit: 86-4 Date: 10-28-1986, PP3D M-6-1 Rx-1 to Rx-2 from CP3 at 2+71, 50mm, (GJB+DLS)

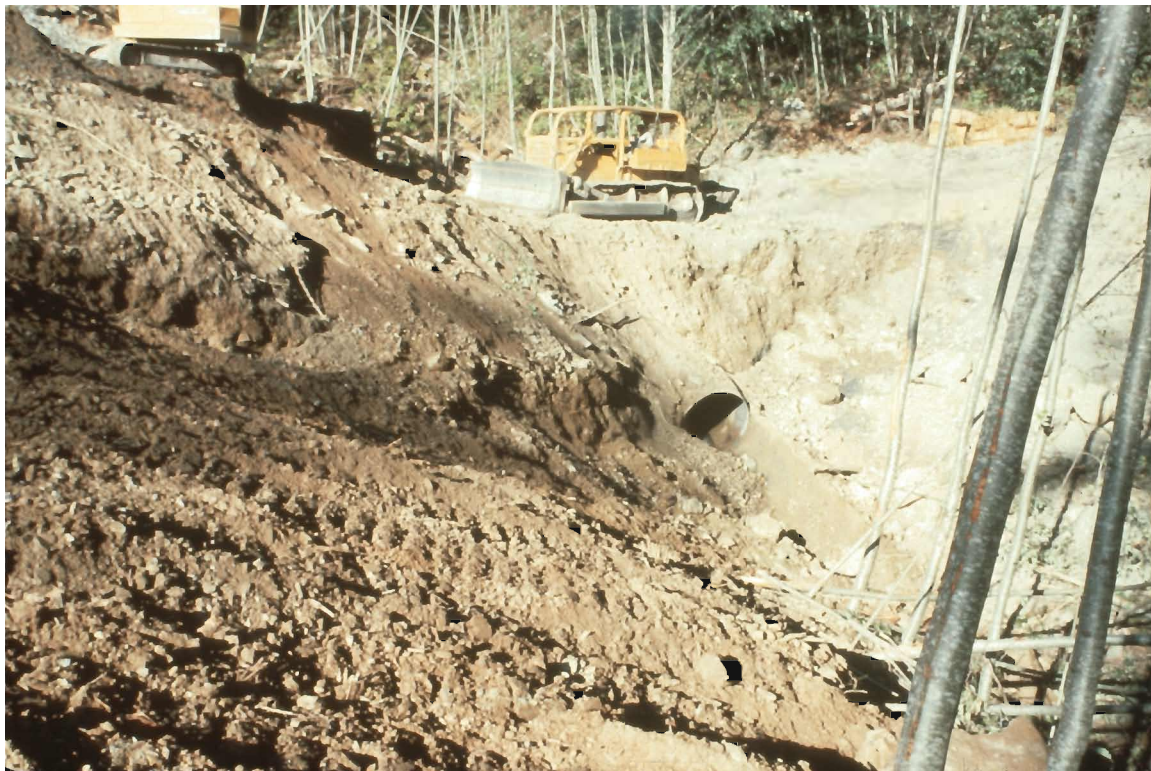
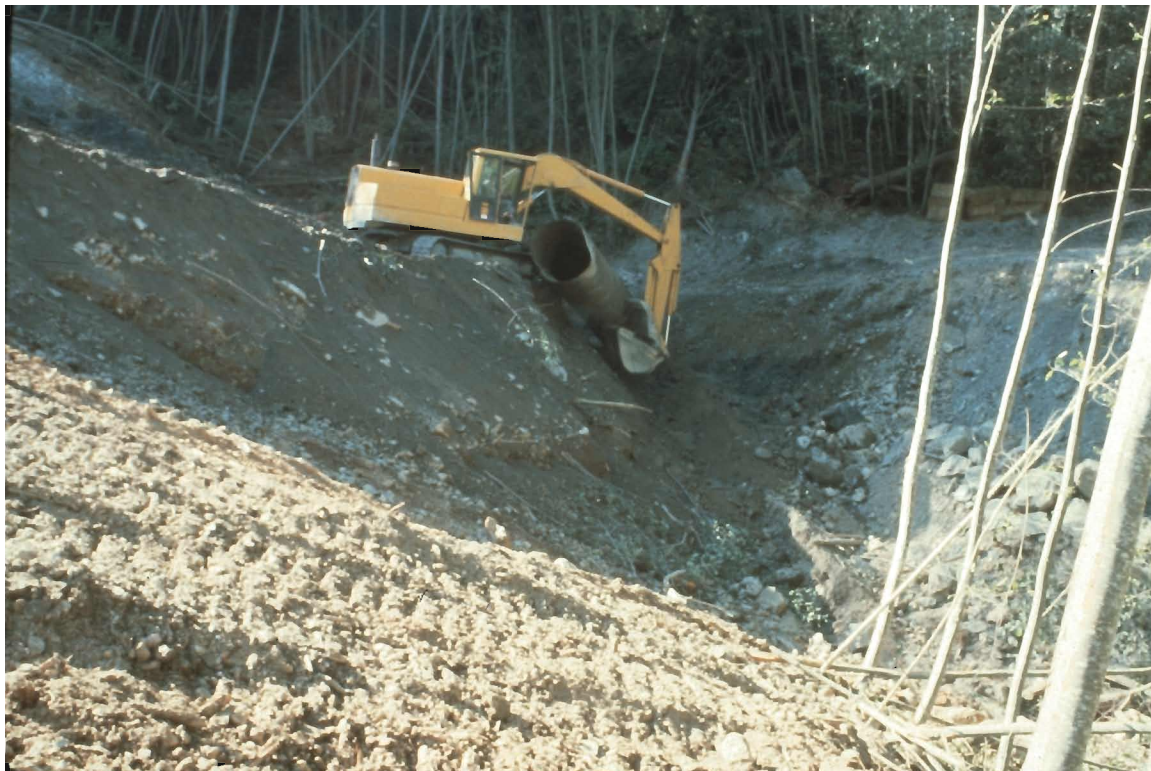
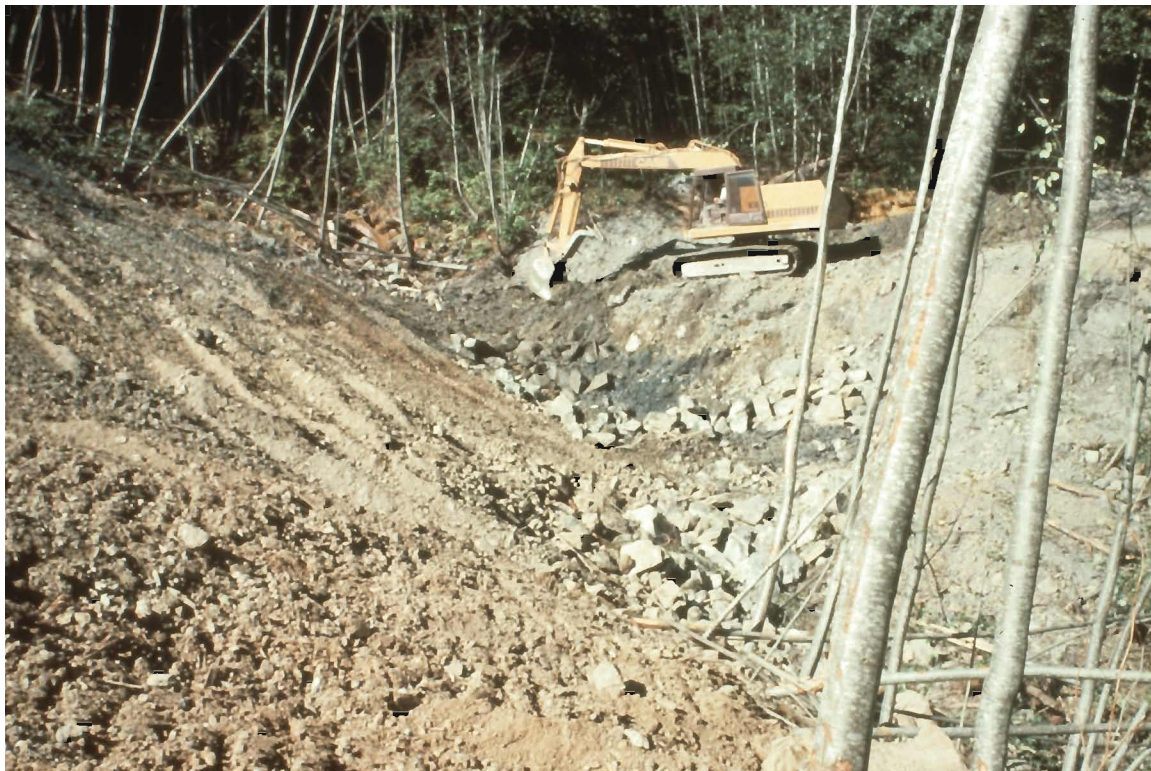
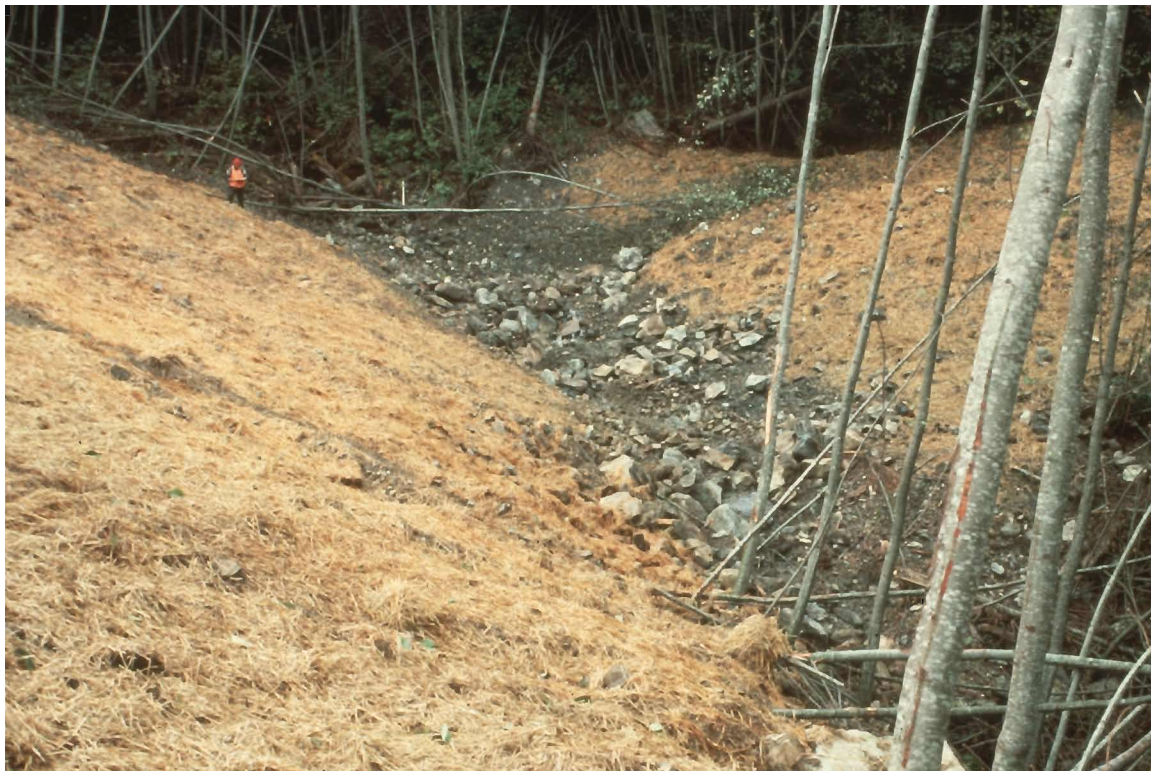
Unit: 86-4 Date: 10-6-1986,PP5 M-6-1 RX-1 from stump below 1+60, 35mm, (GB)

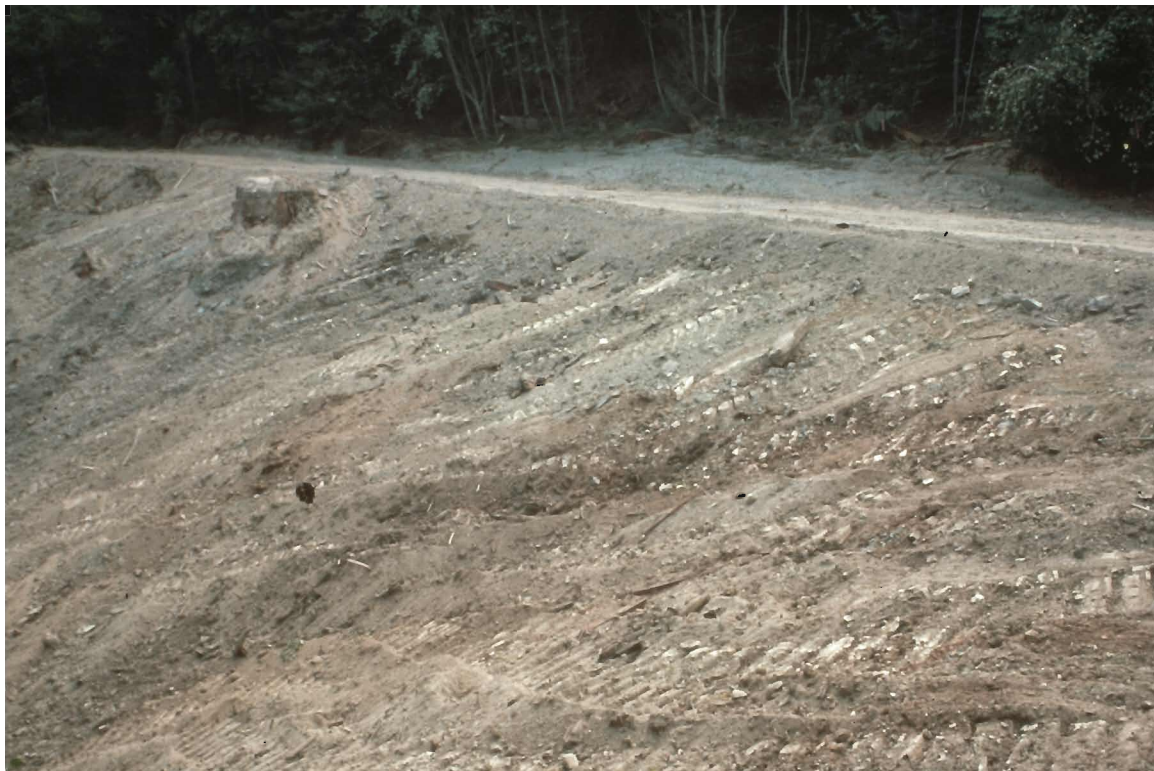
Unit: 86-4 Date: 9-9-1986,PP21B M-6-1 RX-3, 50mm, (GB)

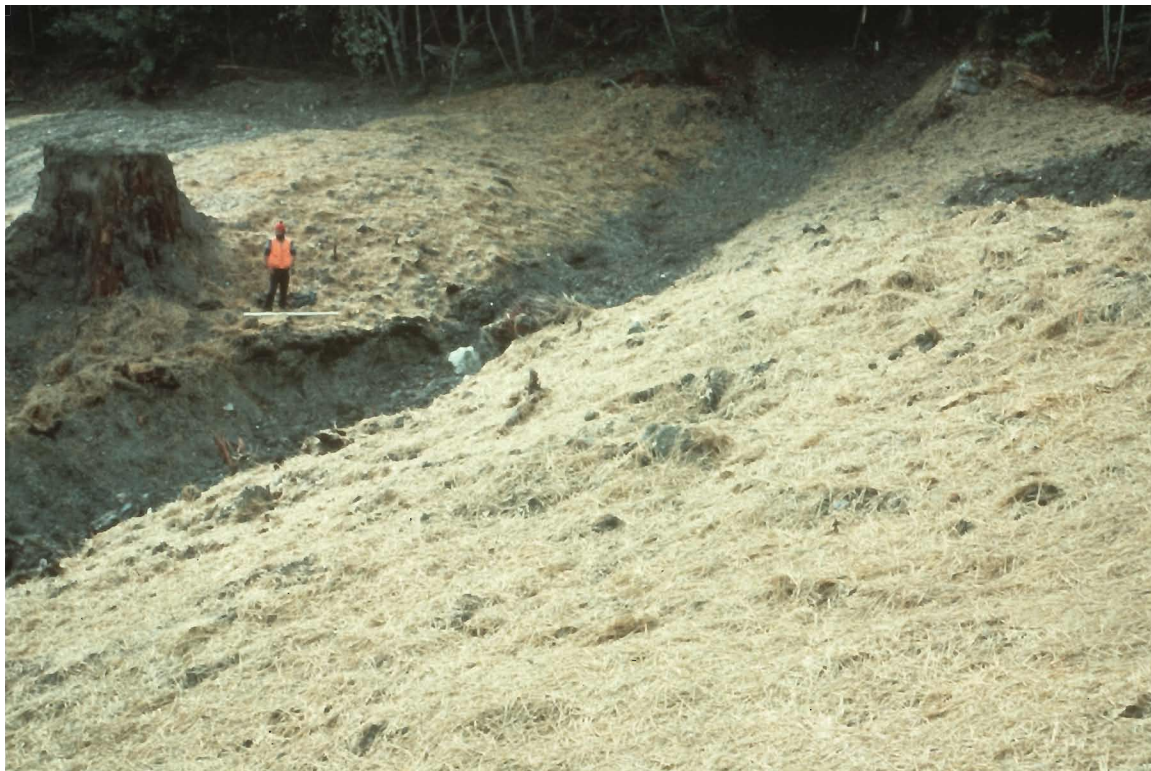
Unit: 86-4 Date: 10-28-1986, PP21B M-6-1 RX-3 from BM stump, 50mm, (GB+DLS)

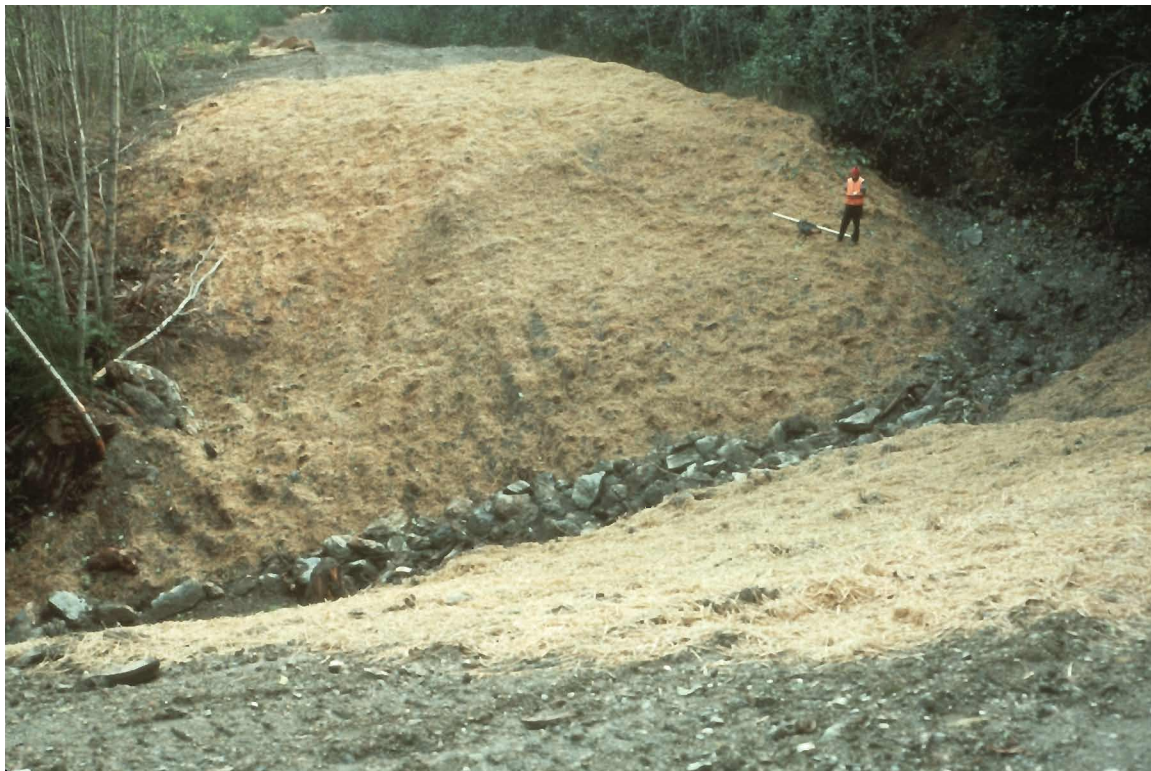
Unit: 86-4 Date: 10-28-1986, PP27 M-6-1 RX-6 from CB above fillsite, 50mm, (GB+DLS)

<sup>5</sup>The 1150 and 690 each spent 1hr. placing 30yd<sup>3</sup> of rock into the completed stream excavation.
