**Summary Report**

**Erosion Control Work Performed on  
The Fortyfour Creek Rehabilitation Unit  
84-5**

**by  
Gregory J. Bundros and David Burns**

**November, 1984**

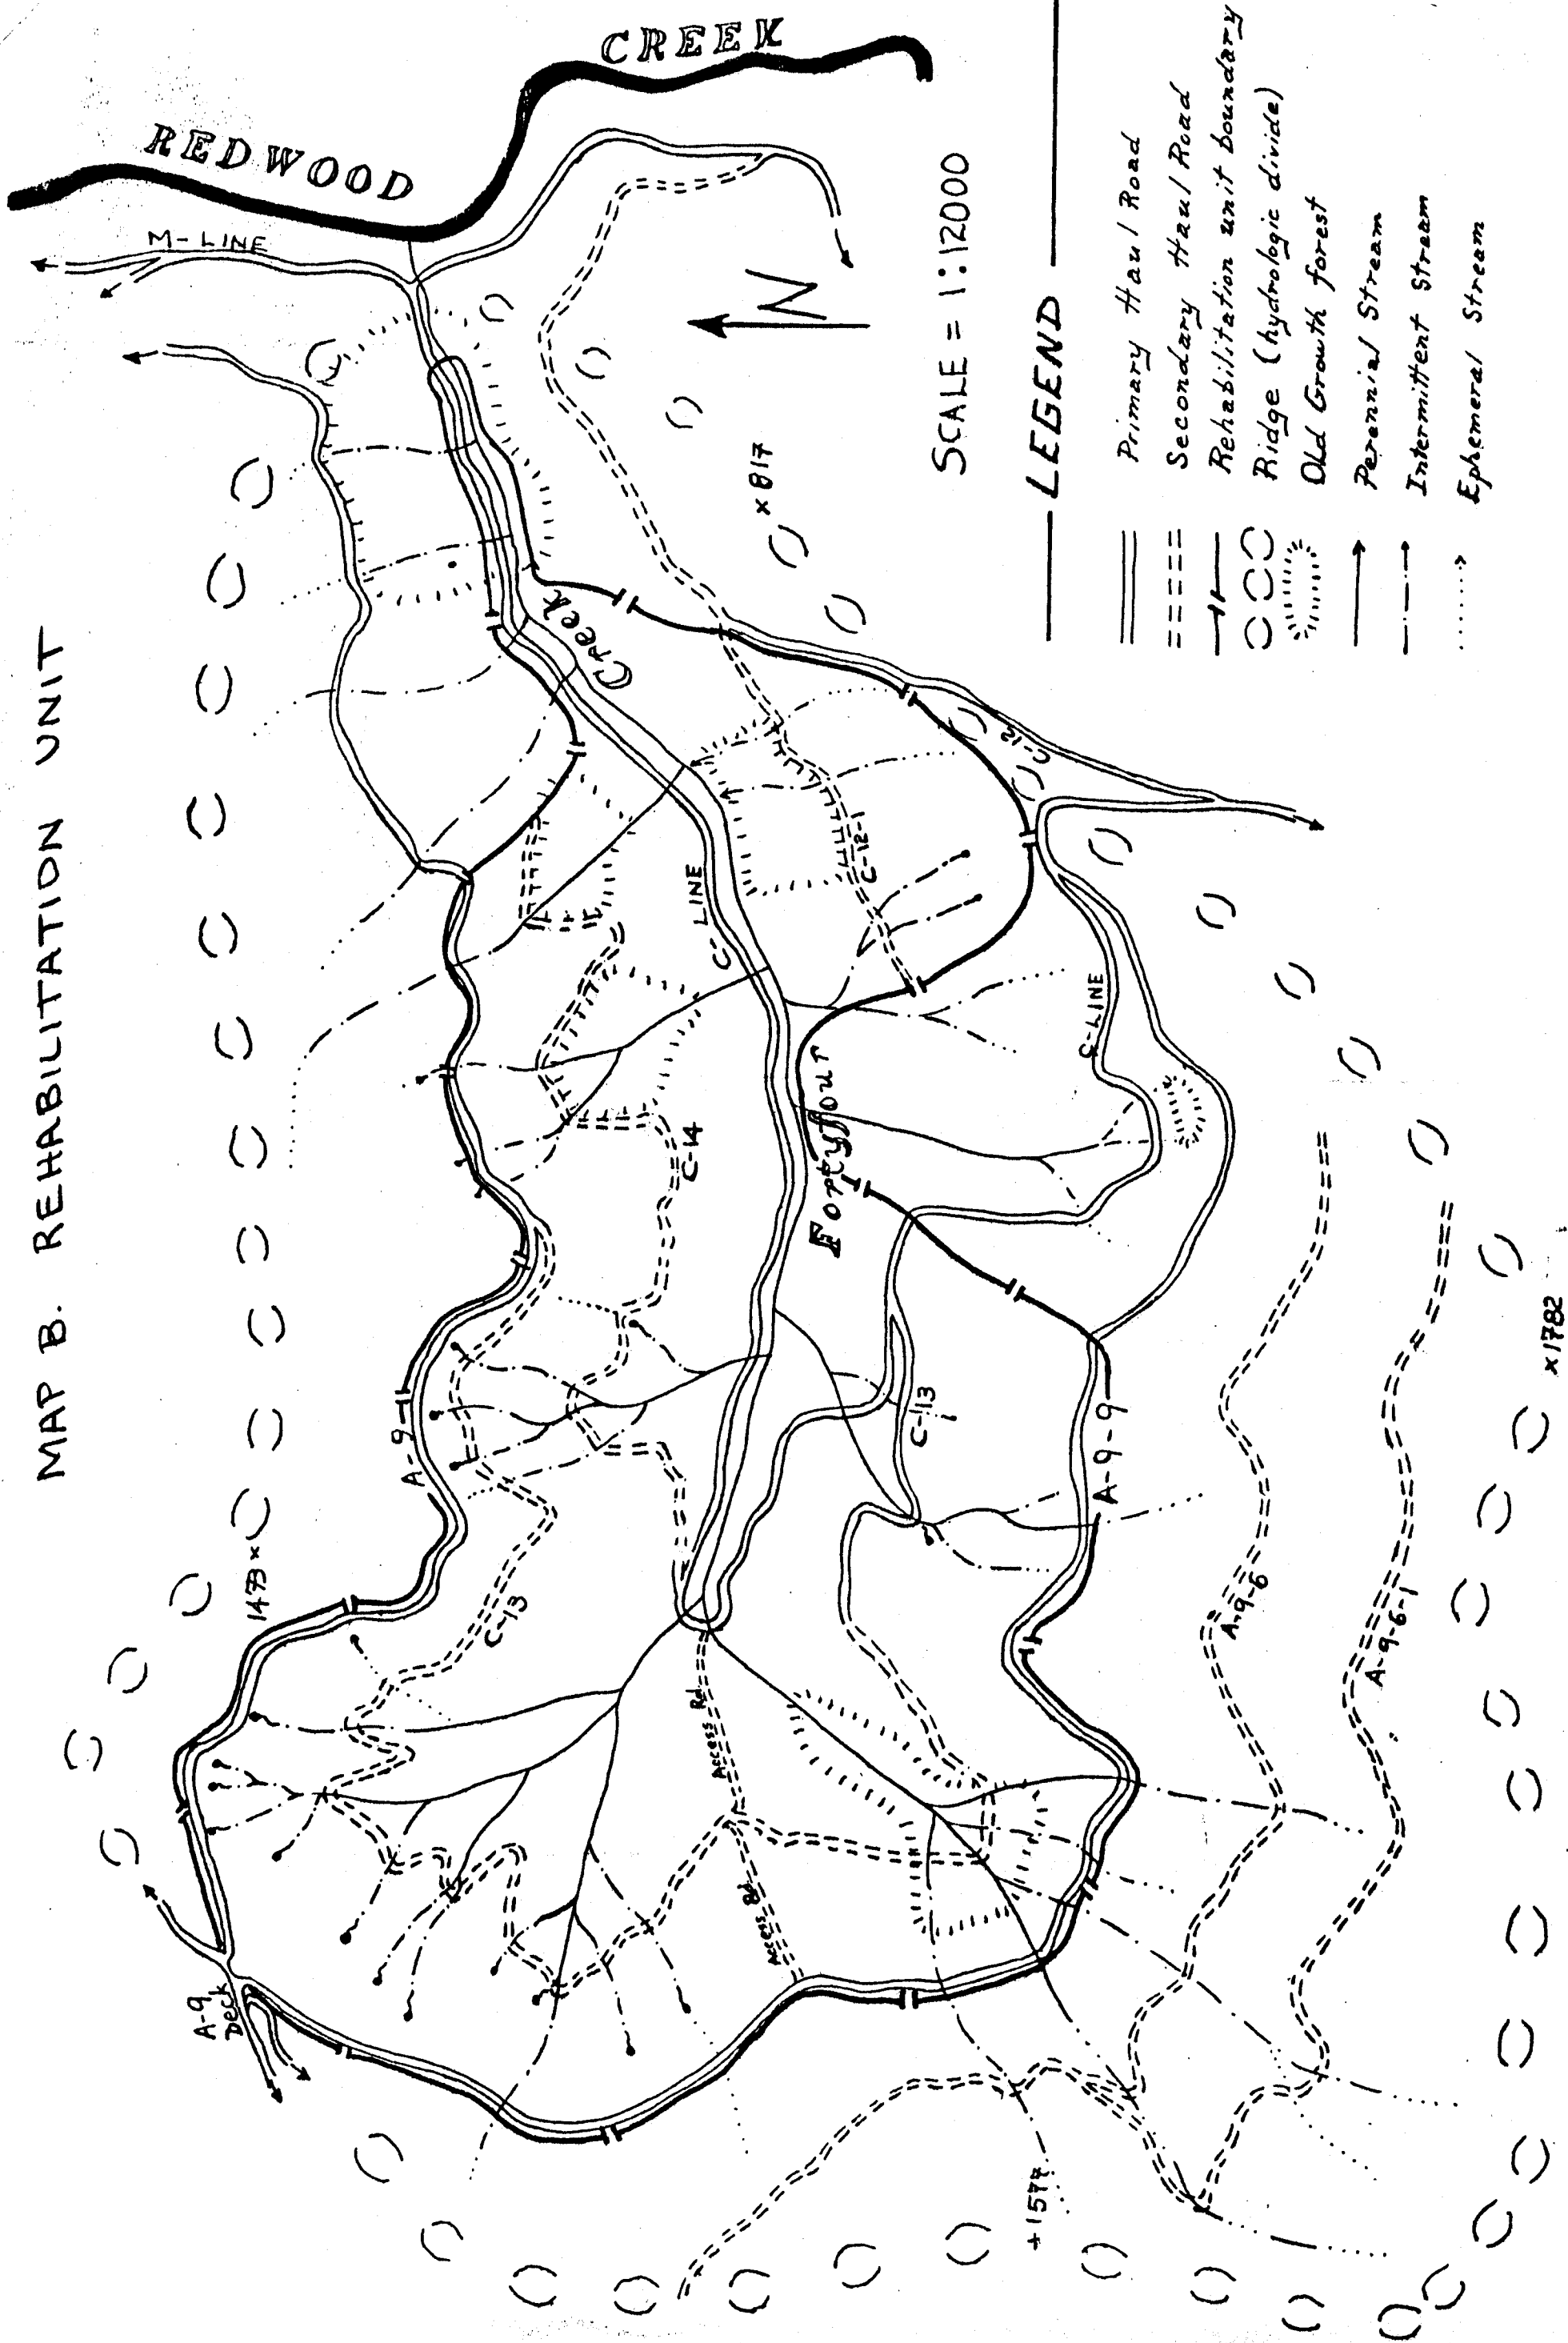
MAP B. REHABILITATION UNIT

The Fortyfour Creek Unit, 84-5 is located approximately six miles upstream from Orick, and drains the west side of Redwood Creek. The unit extends downslope from the A-9 and A-9-9 roads to the valley bottom. The unit contains 890 acres and seven miles of logging haul roads, including the C-12-1, C-13, and C-14 roads in their entirety, and that portion of the C-line, downslope from the C-line/C-13 road intersection (map A & B).

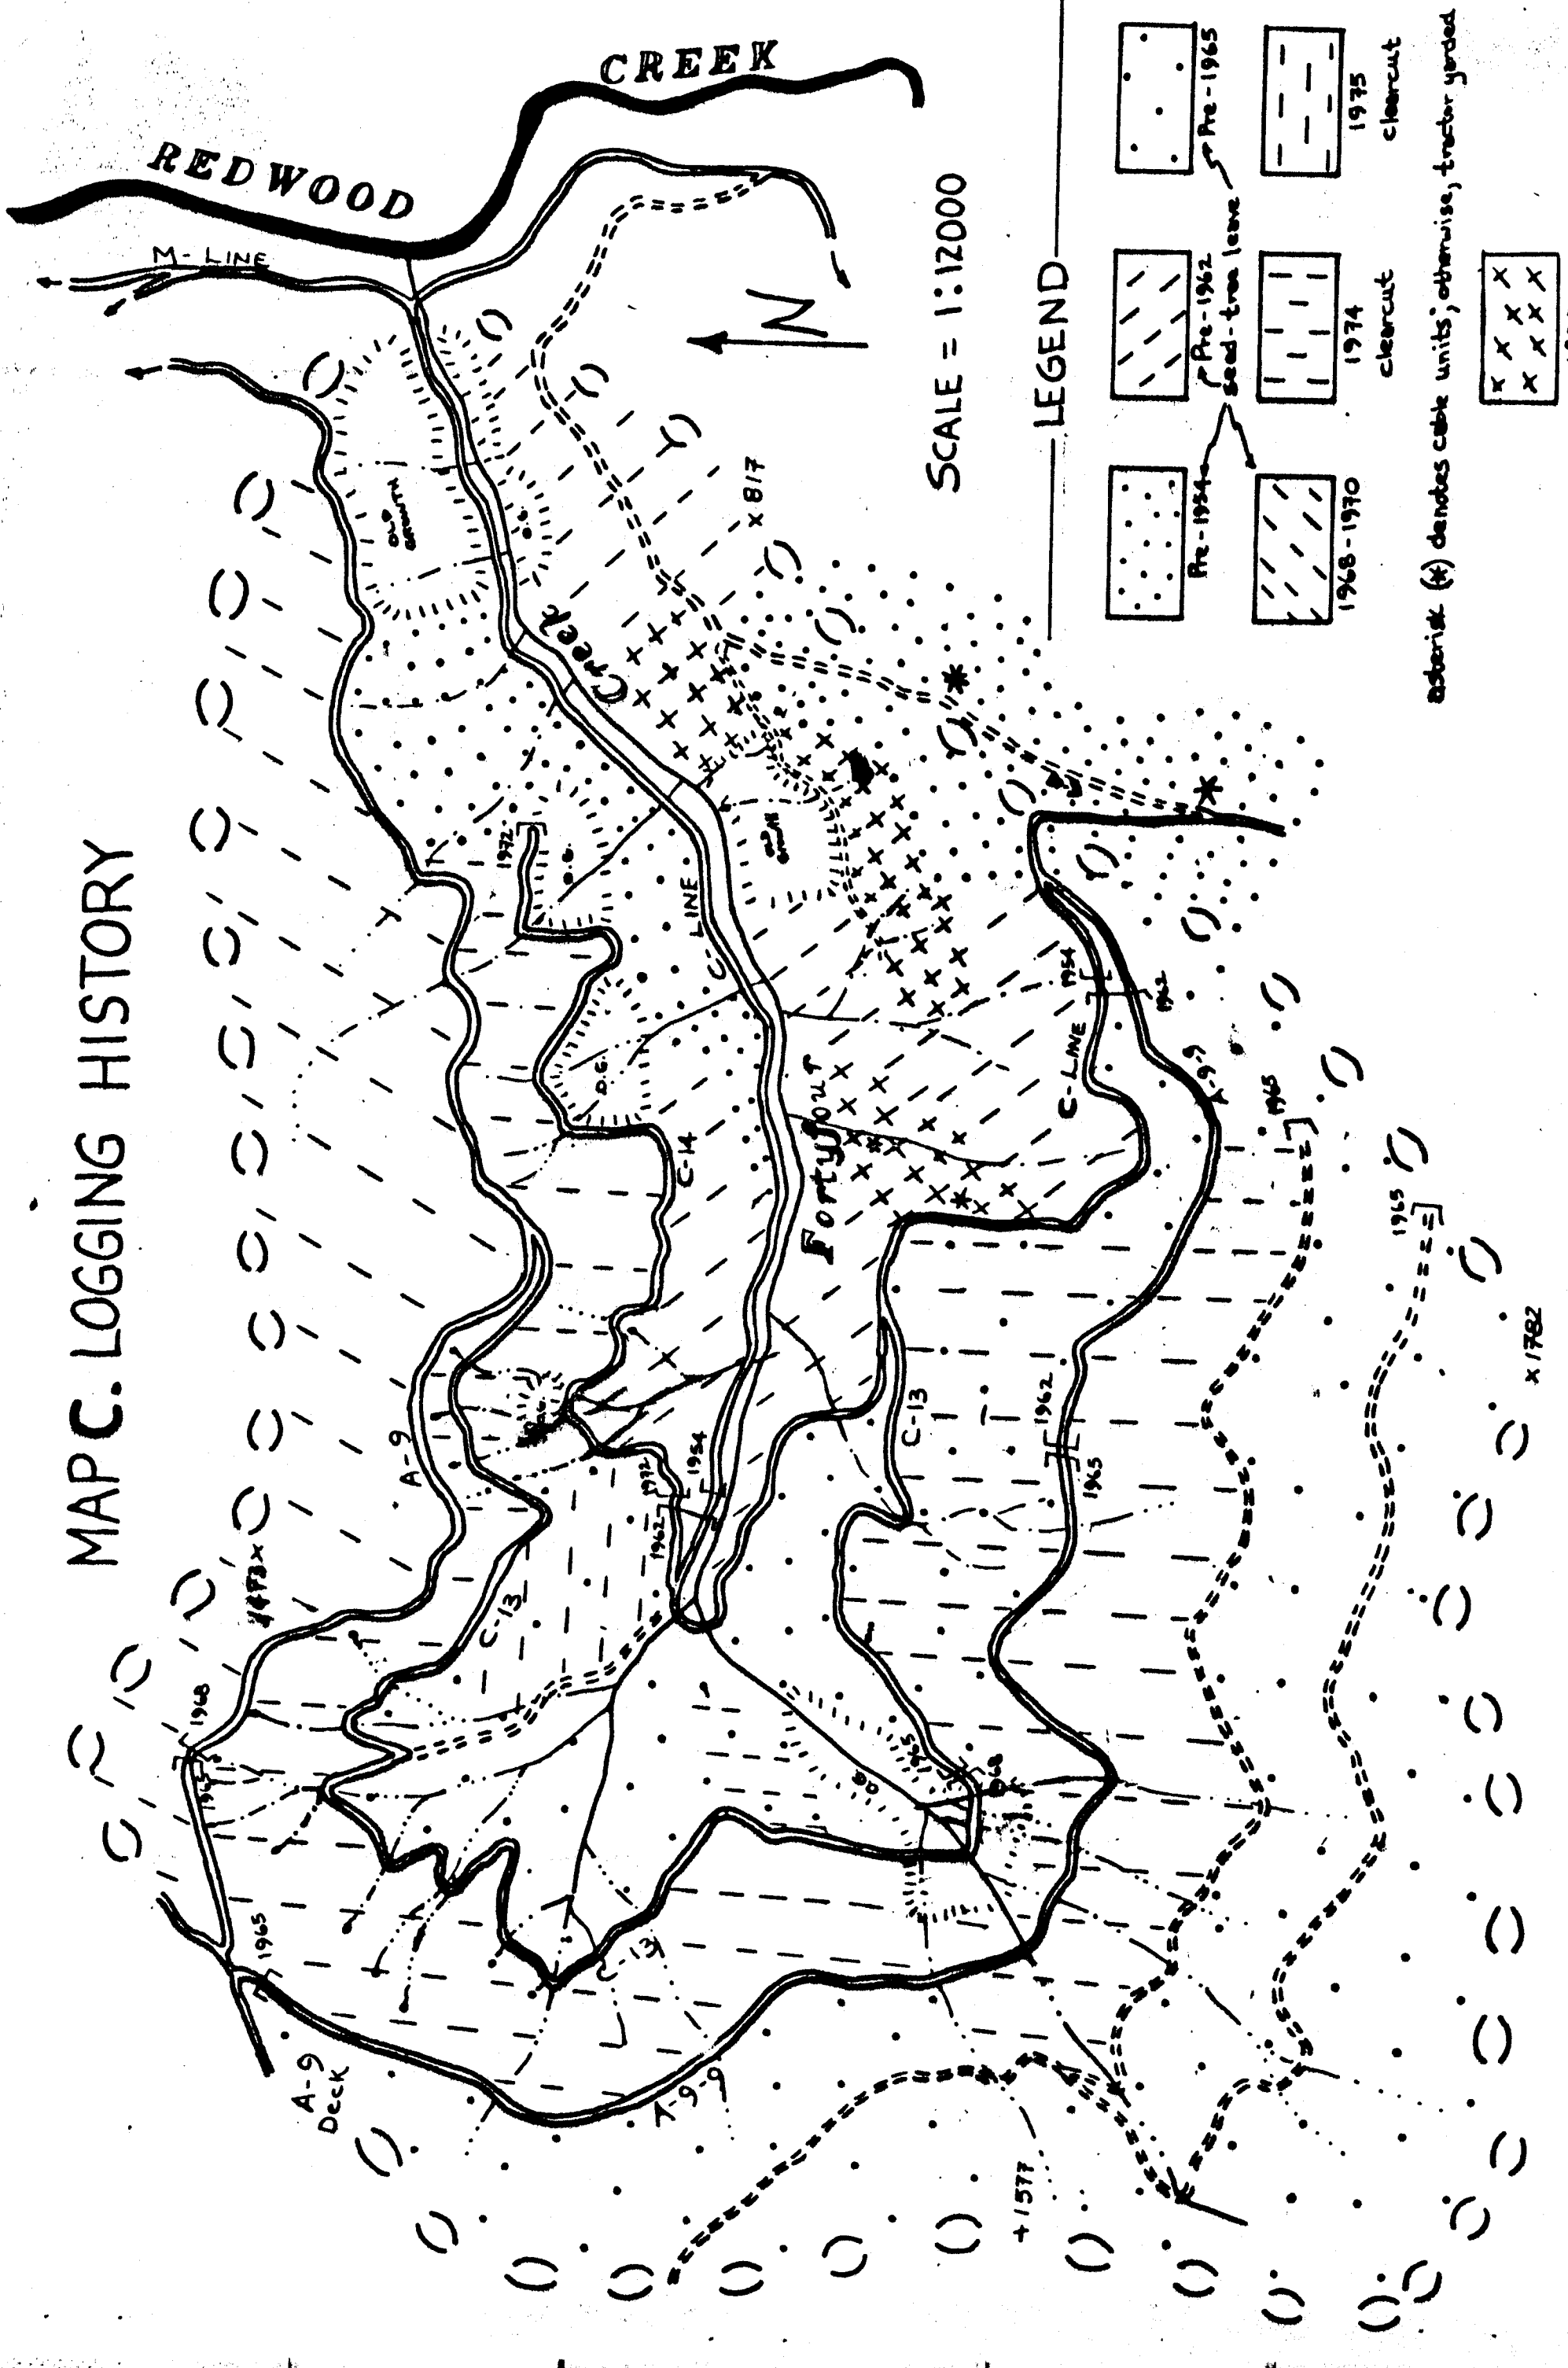
# MAP C. LOGGING HISTORY

As can be seen from Map C, timber harvest and road construction began in the early 1950's and continued until 1975. A major thrust in timber harvest took place in 1974. Essentially 99 percent of the harvested area was tractor yarded. As evidenced on this unit, tractor use was indiscriminate with little or no concern for soil and/or water resources. Numerous skid trail crossings were constructed on every stream channel, and, in many cases, tractors utilized the actual stream channels as skid trails. The confluence of the north fork tributaries provides a classic example to the indiscriminate tractor use in this basin. In 1975, during a seed-tree harvest, a log landing was constructed in the confluence of these 2- and 3- order perennial streams. Tractors re-shaped the valley bottom to suit their needs. They erased entirely all geomorphic features expressing the stream environments, and completely buried these channels with soil and organic debris. In John Pitlick's study, "Sediment Routing in Tributaries of Redwood Creek", he identifies a disproportionate amount of stored sediment in Fortyfour Creek relative to the amount of sediment contributed by streamside landslides. Based upon our field mapping and observations, the balance (almost 2x) of stored sediment was introduced directly to streams by tractor activity and subsequent fluvial erosion.

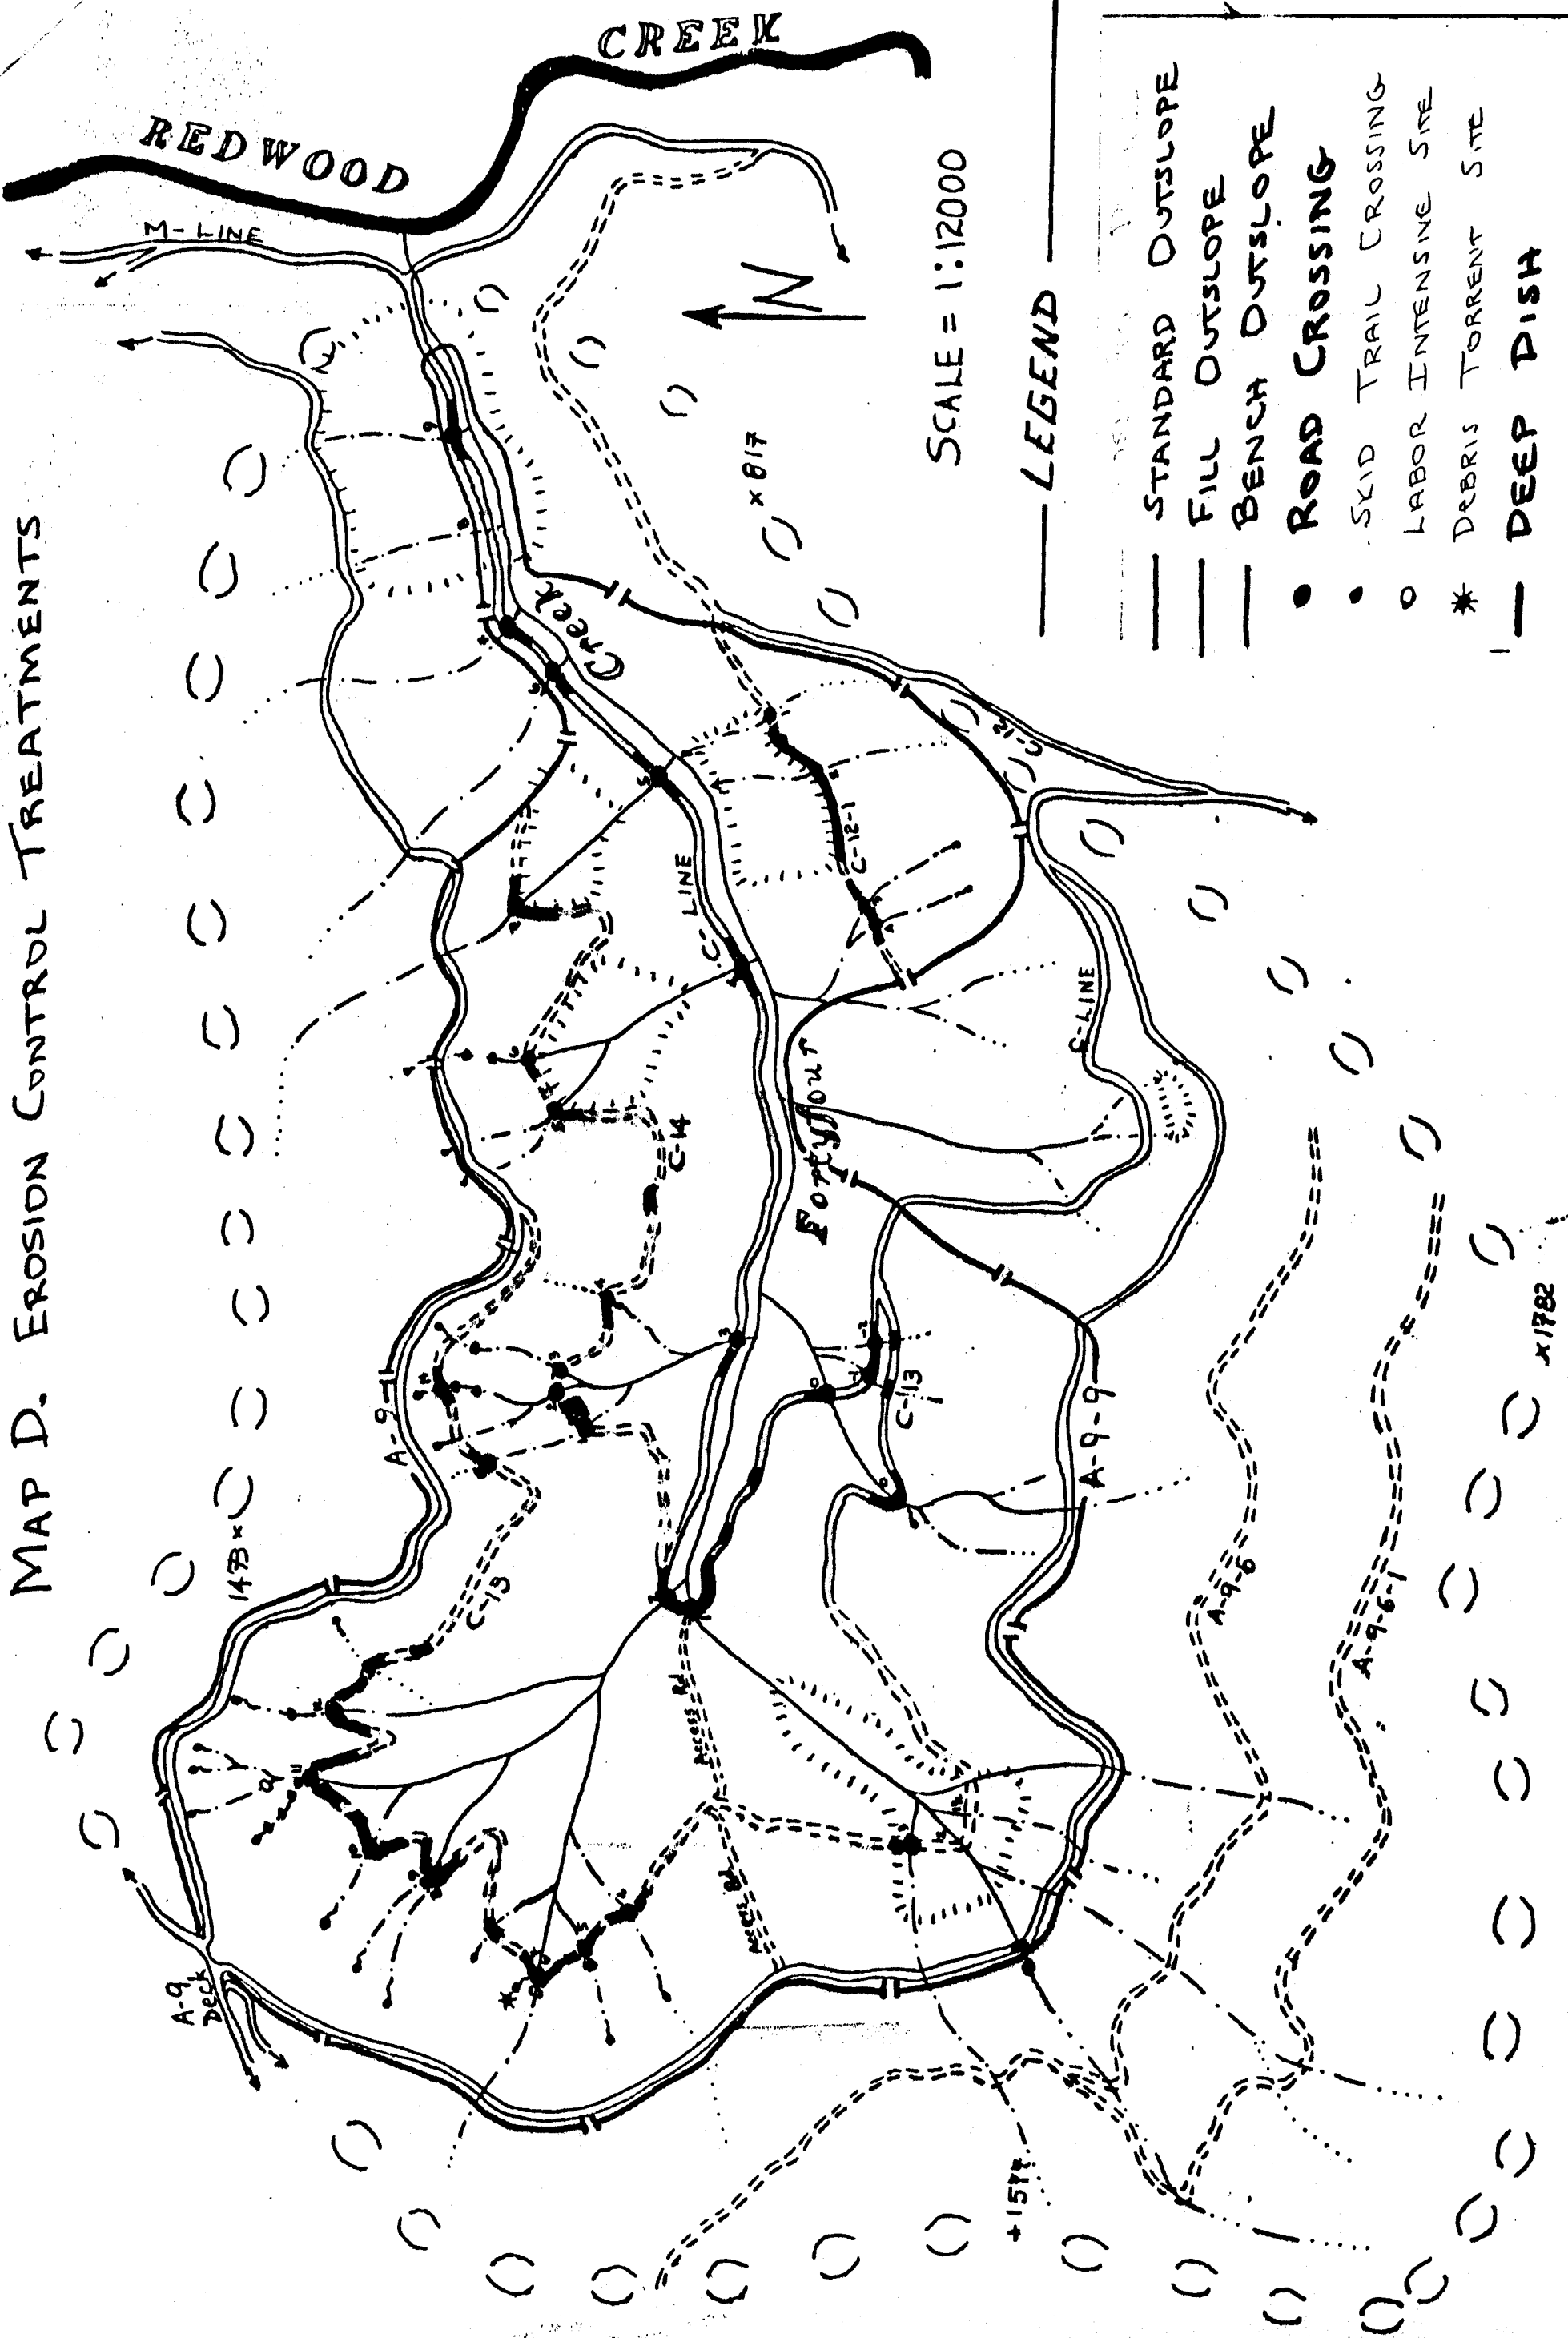
MAP D. EROSION CONTROL TREATMENTS

Erosion control treatments focused only on features capable of delivering sediment directly to streams. For example, skid trail crossings varied considerably in age and most had experienced at least one flood producing storm event since construction. As a result, most skid trail crossings had eroded beyond cost-effective treatment. Therefore, only those skid trail crossings capable of diverting streamflow or exhibiting debris torrent potentials were treated. All worksites are located on Map D, with unit costs listed in Table 2.
