SUMMARY REPORT

EROSION-CONTROL WORK PERFORMED ON  
THE UPPER SLIDE CREEK REHABILITATION UNIT,  
Site 81-3

By  
Gregory Bundros and Teri Huber

March 1982

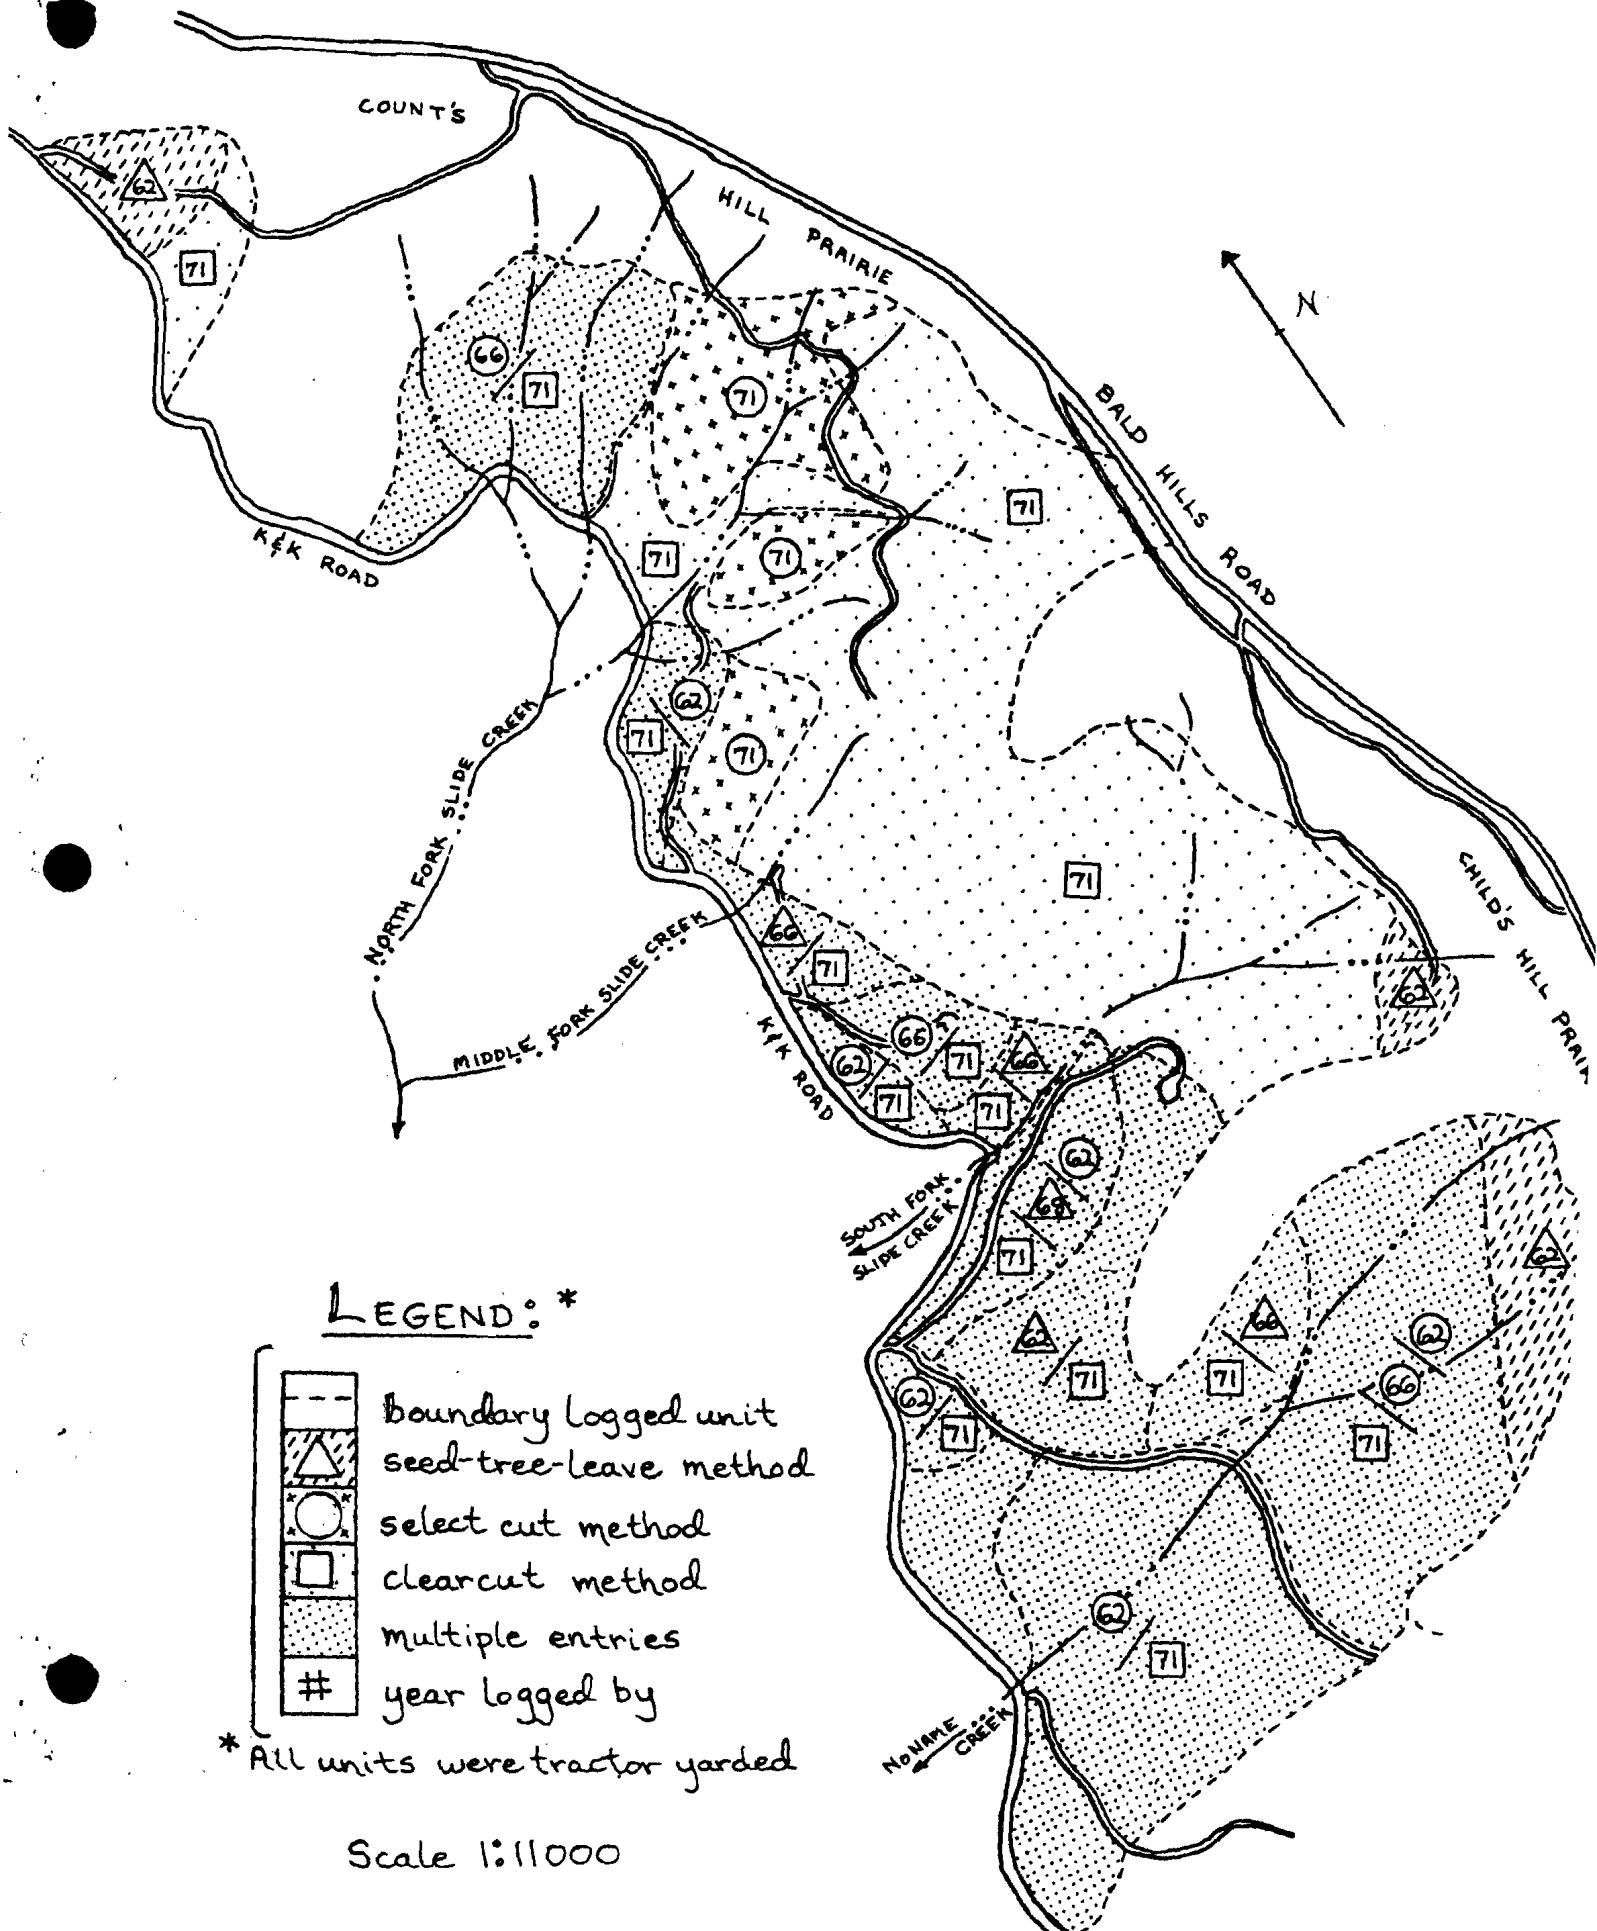
# MAP B: LOGGING HISTORY

Within the Upper Slide Creek Unit, all 405 acres of forested land had been logged by 1971 (see Map B). Of this total acreage, approximately 66 percent (267 acres) was initially harvested by seed-tree-leave and/or selective cutting methods during the seven year period between 1962-1969. By 1971 all but 48 acres of this area had been re-entered and clearcut. The remaining 34 percent (138 acres) of unlogged forested land was clearcut during 1970 and 1971. All harvested areas within this rehabilitation unit were tractor yarded.

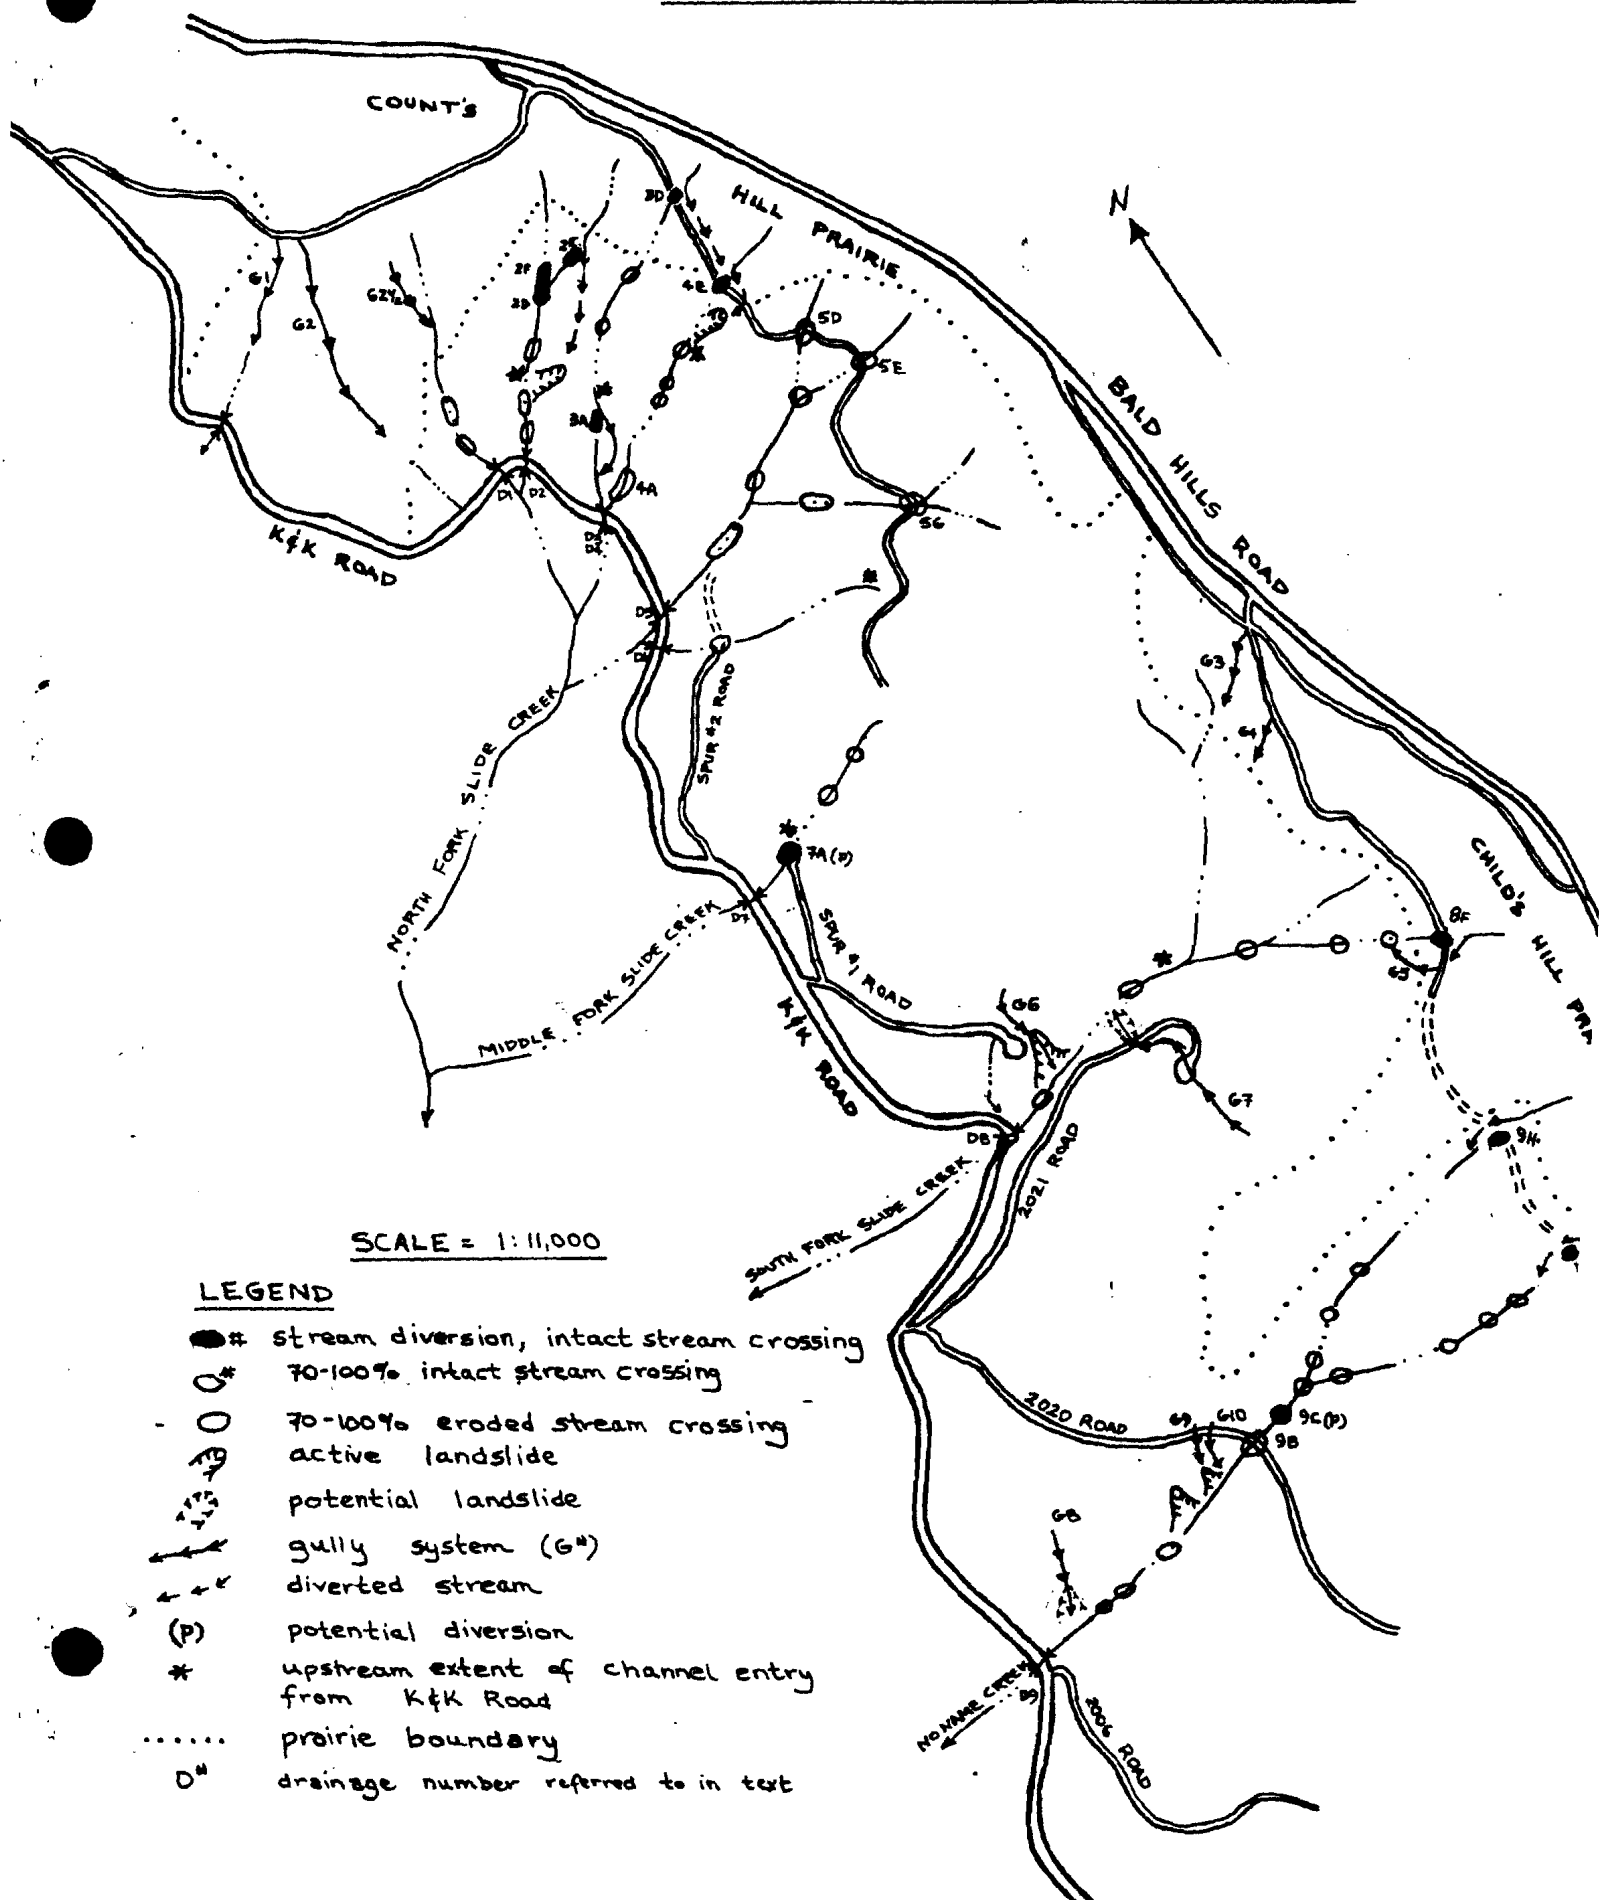
# MAP C. EROSION FEATURES

The types of erosion features found on the Upper Slide Creek Unit ranged from rills to large streamside landslides. This discussion will summarize only the major erosion features and sediment sources found on this unit (see Map C). Complete erosion inventory maps (1:1200) are on file in Orick and Arcata for more detailed reference.

The three main types of erosion features found on this unit were: 1) gullies formed by poor road drainage, 2) gullies and landslides caused by diverted stream courses, and 3) eroding skid trail and haul road stream crossings. Roads on Count's Hill and Child's Hill prairies were deficient or void of culverts, and road maintenance had seldomly been performed. Winter ground-

water and storm runoff had concentrated on these prairie roads, eroding approximately 2100 yd<sup>3</sup> from the prairies with the formation of gullies #1-#5 (G1-G5). G1 and G3 were fully formed by 1962 as a direct result of concentrated road runoff. The remaining gullies developed in response to the 1964 storm events and, at the time of mapping, had downcut to fairly stable basement material; however, gully banks remained vertical. At this point, the gullies on Count's Hill and Child's Hill prairies were seen as eye sores more than as significant sediment sources.

Five large gully-landslide features had developed on this unit that were caused by stream courses which had been diverted by skid trail and haul road stream crossings. In drainage #2, a small (8 acre) intermittent-ephemeral stream had been diverted at site 2E. The diverted stream traveled along a skid trail and eventually down steep (60 percent) hillslopes which had been heavily impacted by recent tractor activity. Initiated in 1972, this shallow, translational landslide produced approximately 800 yd<sup>3</sup> which entirely buried the channel below. The erosion potential for this feature remained high at the time of mapping. In the headwaters of drainage #4, surface and groundwater flow had been diverted by prairie road construction. The runoff produced from approximately 10 acres discharged onto steep (60-75 percent), unstable slopes adjacent to the stream channel. The combination of gully-landslide processes eroded approximately 600 yd<sup>3</sup> from the hillslope. This feature initiated in response to 1972 storm events, continued to enlarge in response to the 1975 storm, and remained active up to the time of mapping. In drainage #8, skid trails intercepted storm runoff and groundwater from the headwaters of a small (9 acre) ephemeral stream. As a result, skid trails directed storm runoff onto a log landing which had been constructed on a colluvial bench immediately upslope from the main channel. A large gully-landslide (G6) developed in 1975, delivering approximately 3800 yd<sup>3</sup> to the main channel below. Finally, two adjacent gully-rotational landslide systems (G9, G10) had developed in drainage #9 in response to the 1975 storm event. The cause of development is not entirely clear. It appears that the stream crossing at site 9B (which had failed twice since 1962) had plugged and before failing, diverted stream-flow down the 2020 Road and onto the lower hillslopes. Approximately 1000 yd<sup>3</sup> were eroded by gully development and, as erosion continued, both gullies breached their original courses. At the time of mapping, G9 no longer fed its original landslide but, instead, fed the adjacent landslide originally fed by G10. Likewise, G10 established a new course on a skid trail, bypassing its original landslide. The most upstream landslide, fed by G9, remained active and had the highest potential for further erosion. Gullies #7 and #8 were smaller features which also directed flow onto potential landslide areas adjacent to streams. Both gullies originated from groundwater discharge areas on hillslopes which had been impacted by tractor activity.

Since the fill and debris contained within stream crossings represents a potential sediment source to stream channels, each stream crossing has been located on Map C. A total of 47 crossings were identified on this unit, of which 7 were haul road stream crossings and 40 were skid trail or skid road stream crossings. Each haul road crossing contained 75-600 yd<sup>3</sup> of fill with an average of 450 yd<sup>3</sup> per crossing. Skid trail crossings contained 75-900 yd<sup>3</sup> and averaged 150 yd<sup>3</sup>. The years 1970 and 1971, a period of extensive road building and logging activity, were followed by major storm events the succeeding year. The 1972 storms initiated skid trail and haul road stream crossing erosion and, by 1981, approximately 68 percent of all crossings had lost

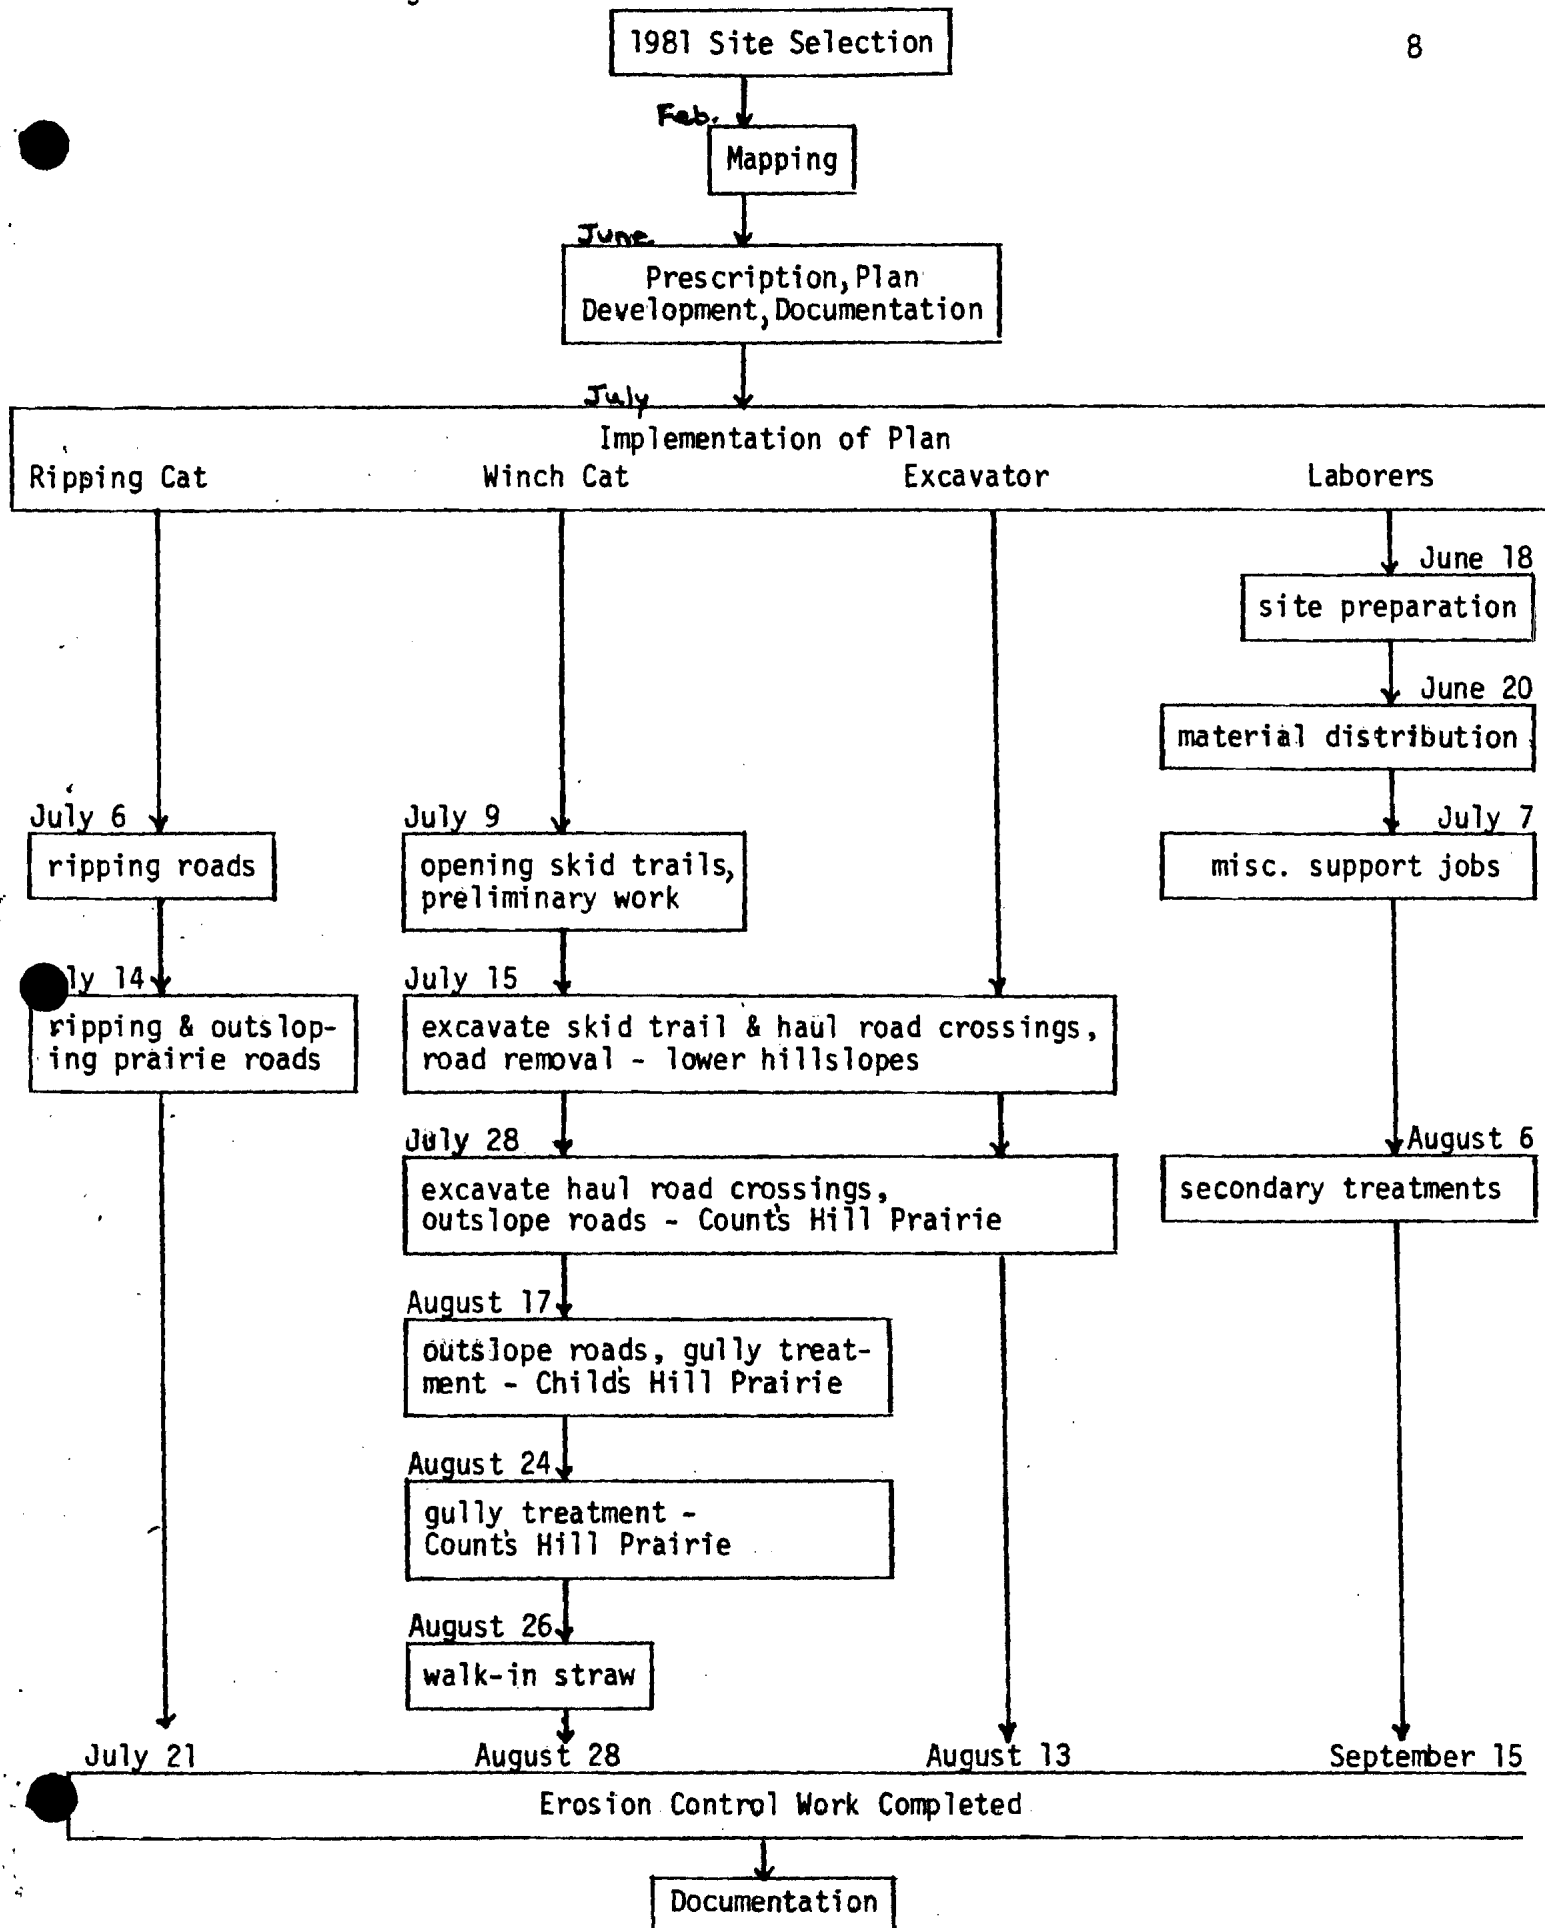
Figure 1. REHABILITATION PHASES AND WORK SEQUENCE

Heavy equipment work - excluding rock quarry and delivery - was performed by three pieces of equipment. Equipment work began July 6 and ended August 28 (see Figure 1, page 8). Tom Coy (owner) operated a Caterpillar D8 ripper tractor (\$80/hr). Whitey Brown (contractor) provided a John Deere 750 crawler tractor with winch and 6-way blade (\$70/hr) and a John Deere 690B hydraulic excavator (\$78/hr). Bill Campbell and David Felt operated the two pieces, respectively. With the exception of the first week, equipment worked concurrently until the D8 completed its work and was released.

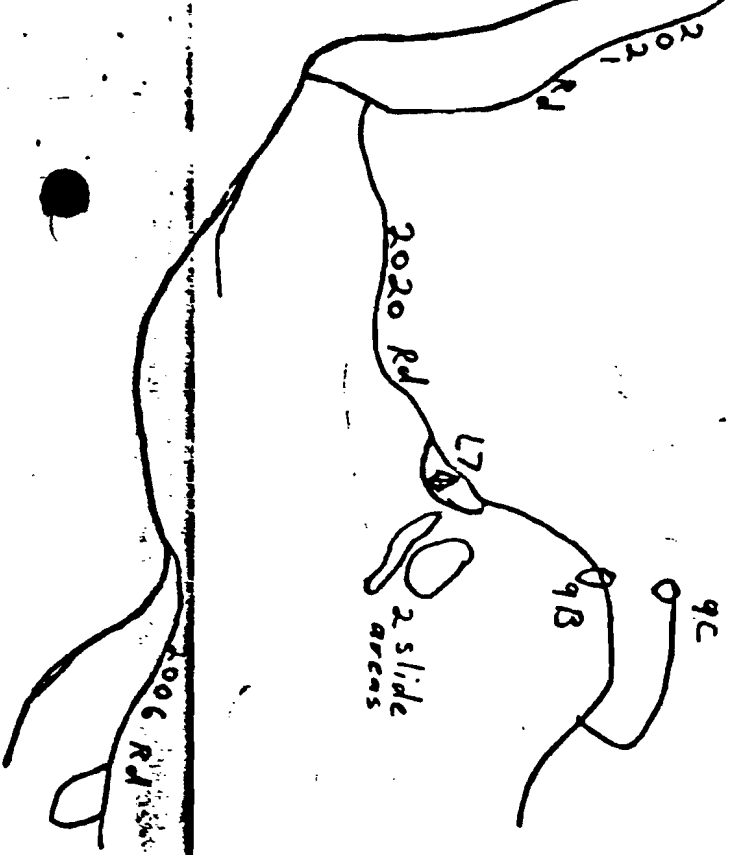
## VEGETATION TREATMENT LOCATIONS

◆ indicate test plot locations

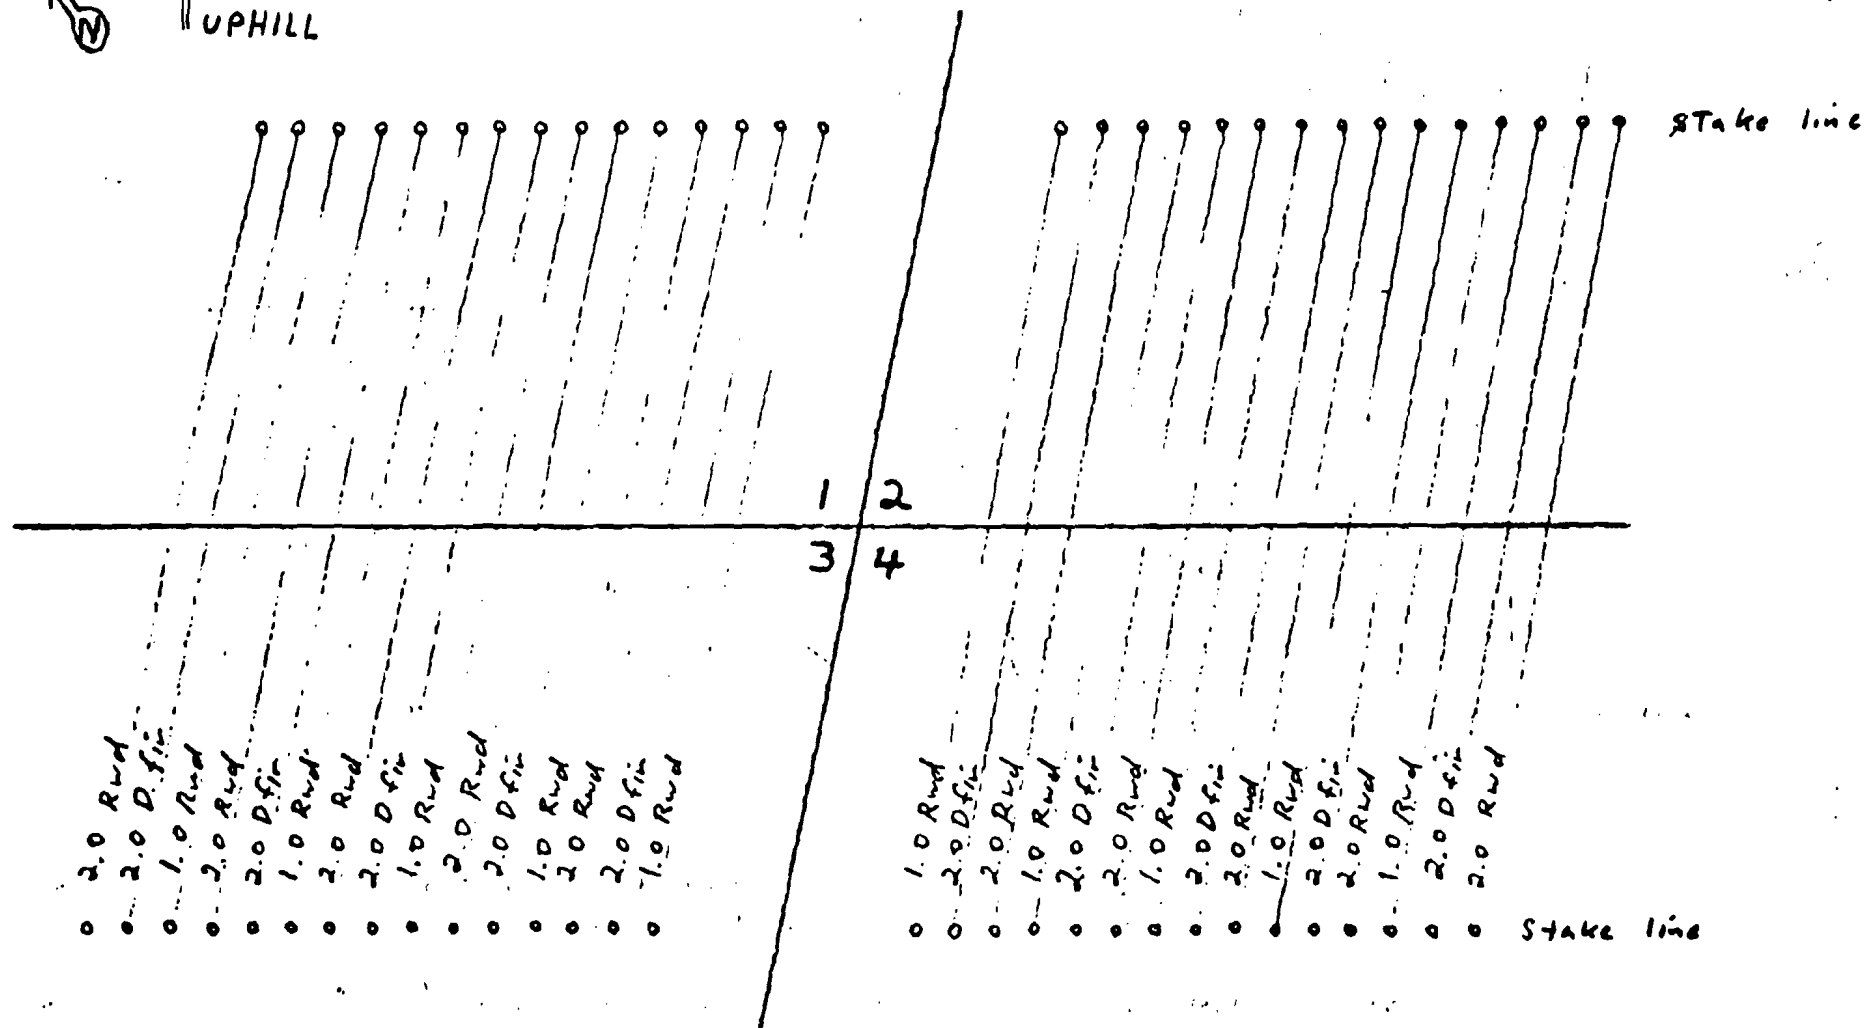
Sections 1 and 4 = Unfertilized

Sections 2 and 3 = fertilized

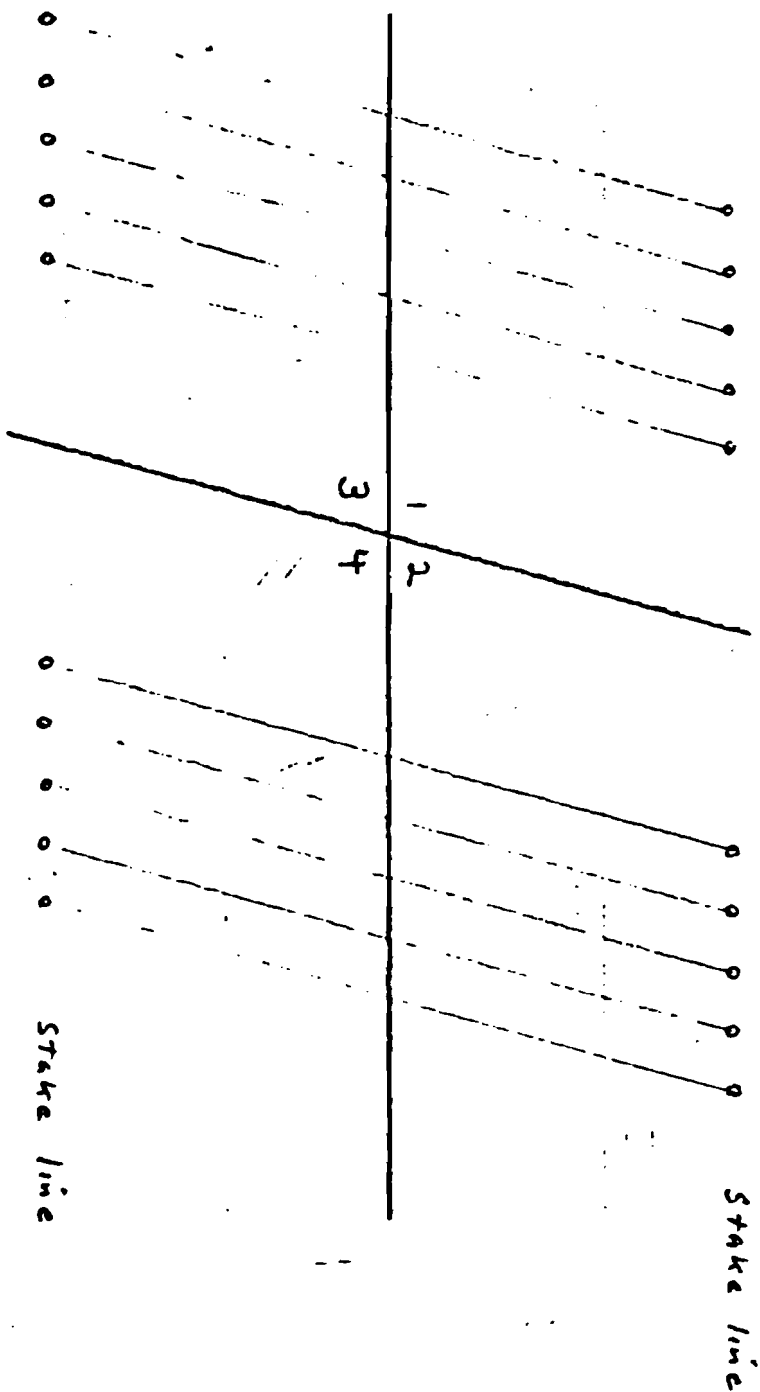
Quadrants 1 and 4 were fertilized  
Quadrants 2 and 3 were unfertilized

Each row consists of ten trees divided between  
two quadrants.
