Summary Report of Work  
Performed on Rehab. Unit 83-3,  
Bridge Creek

by  
Gregory Bundros & David Burns

November, 1984

## 83-3: M-3/M-4 Rehabilitation Unit Revegetation Report

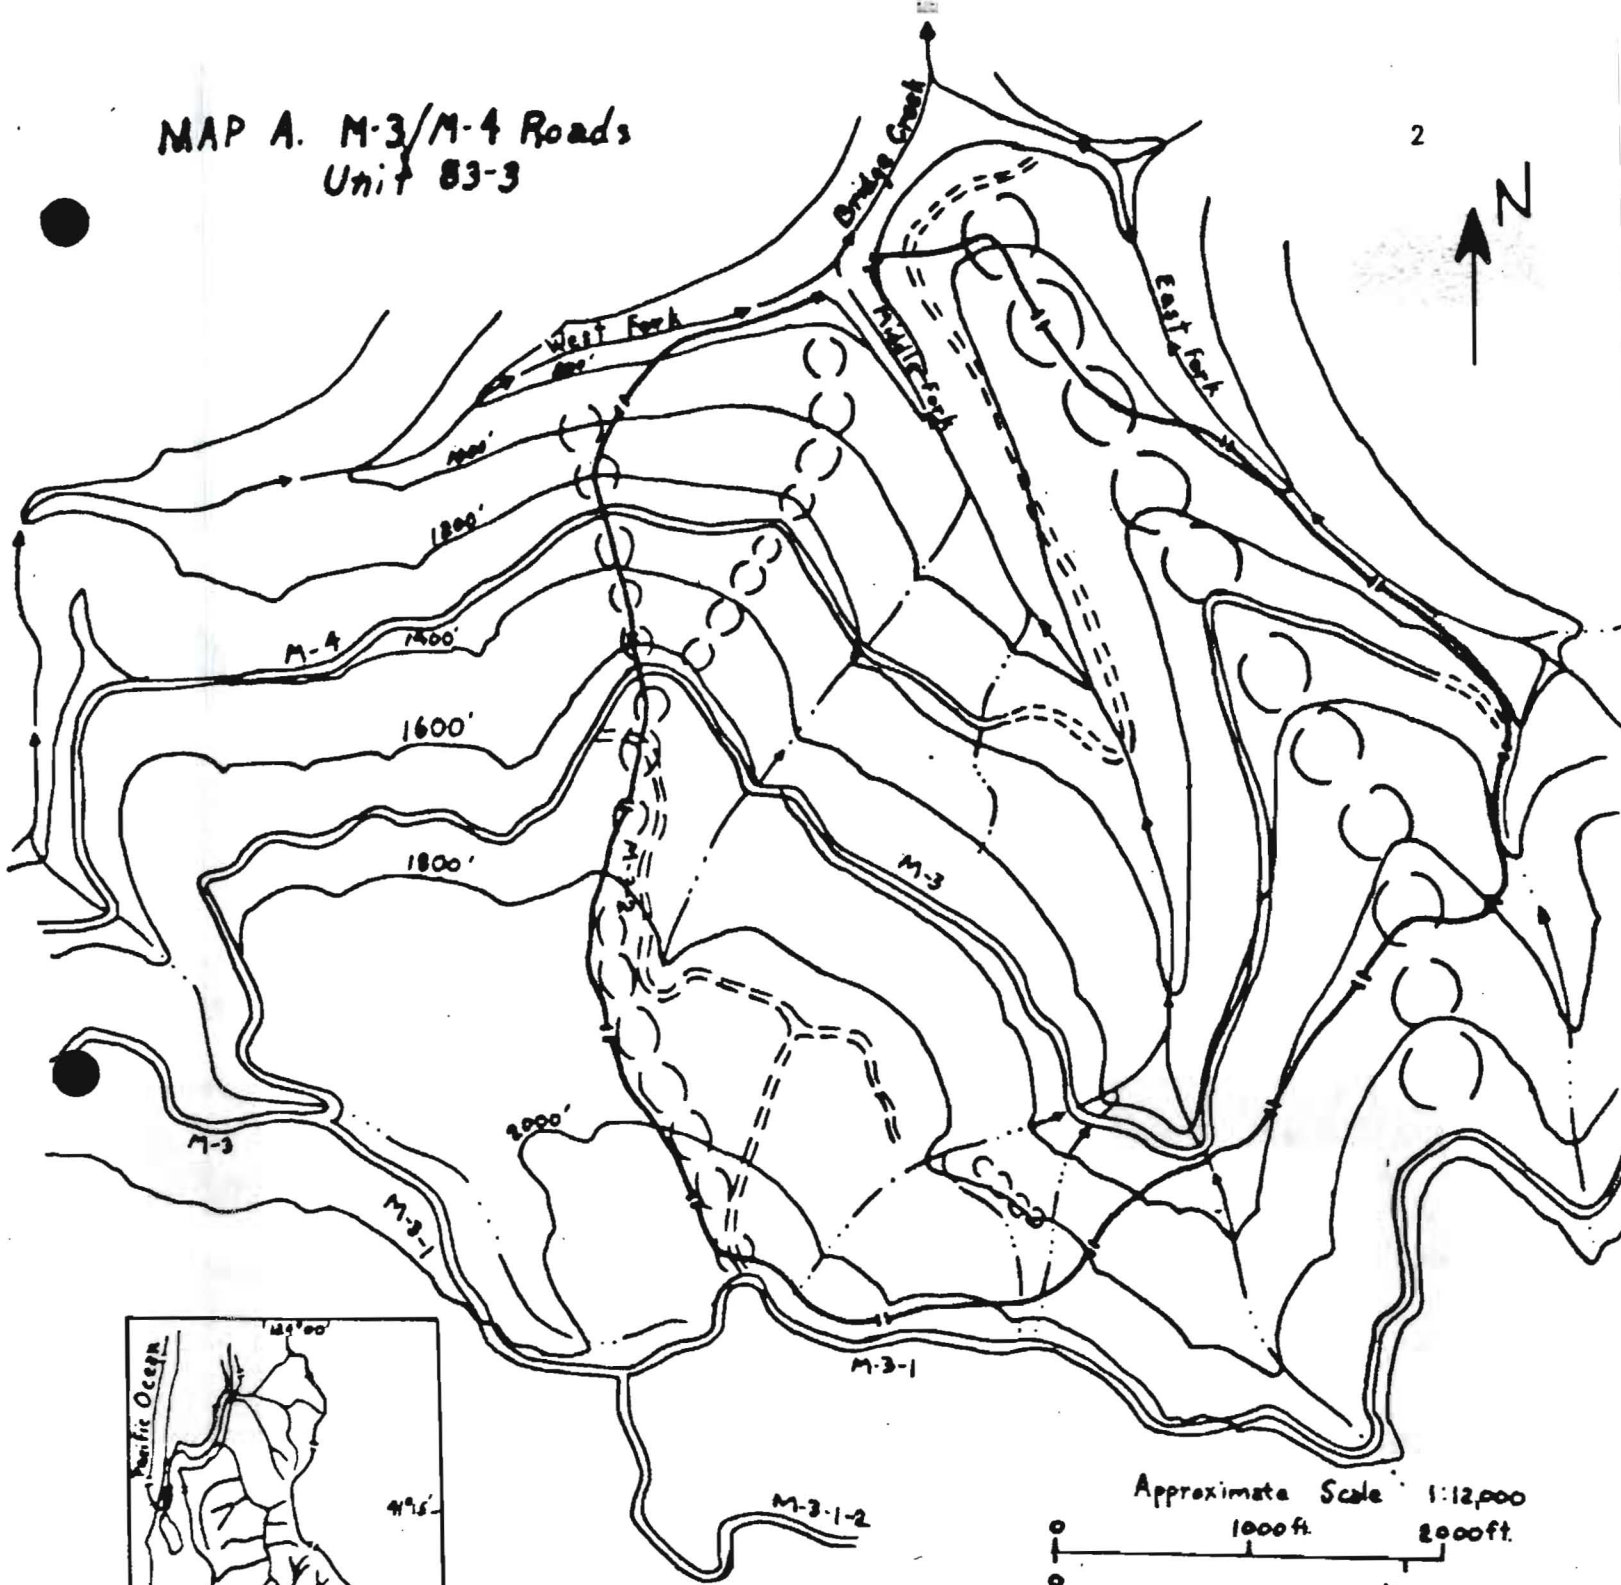
# MAP A. M-3/M-4 Roads Unit 83-3

The M-3/M-4 Rehabilitation Unit, 83-3, is located on the west side of Redwood Creek, roughly 15 miles upstream from Orick. The unit encompasses 490 acres of the eastern headwaters of Bridge Creek (refer to Map A). It is bordered to the east by the east fork of Bridge Creek, to the south by the M-3-1 Road, and to the west by a major divide.

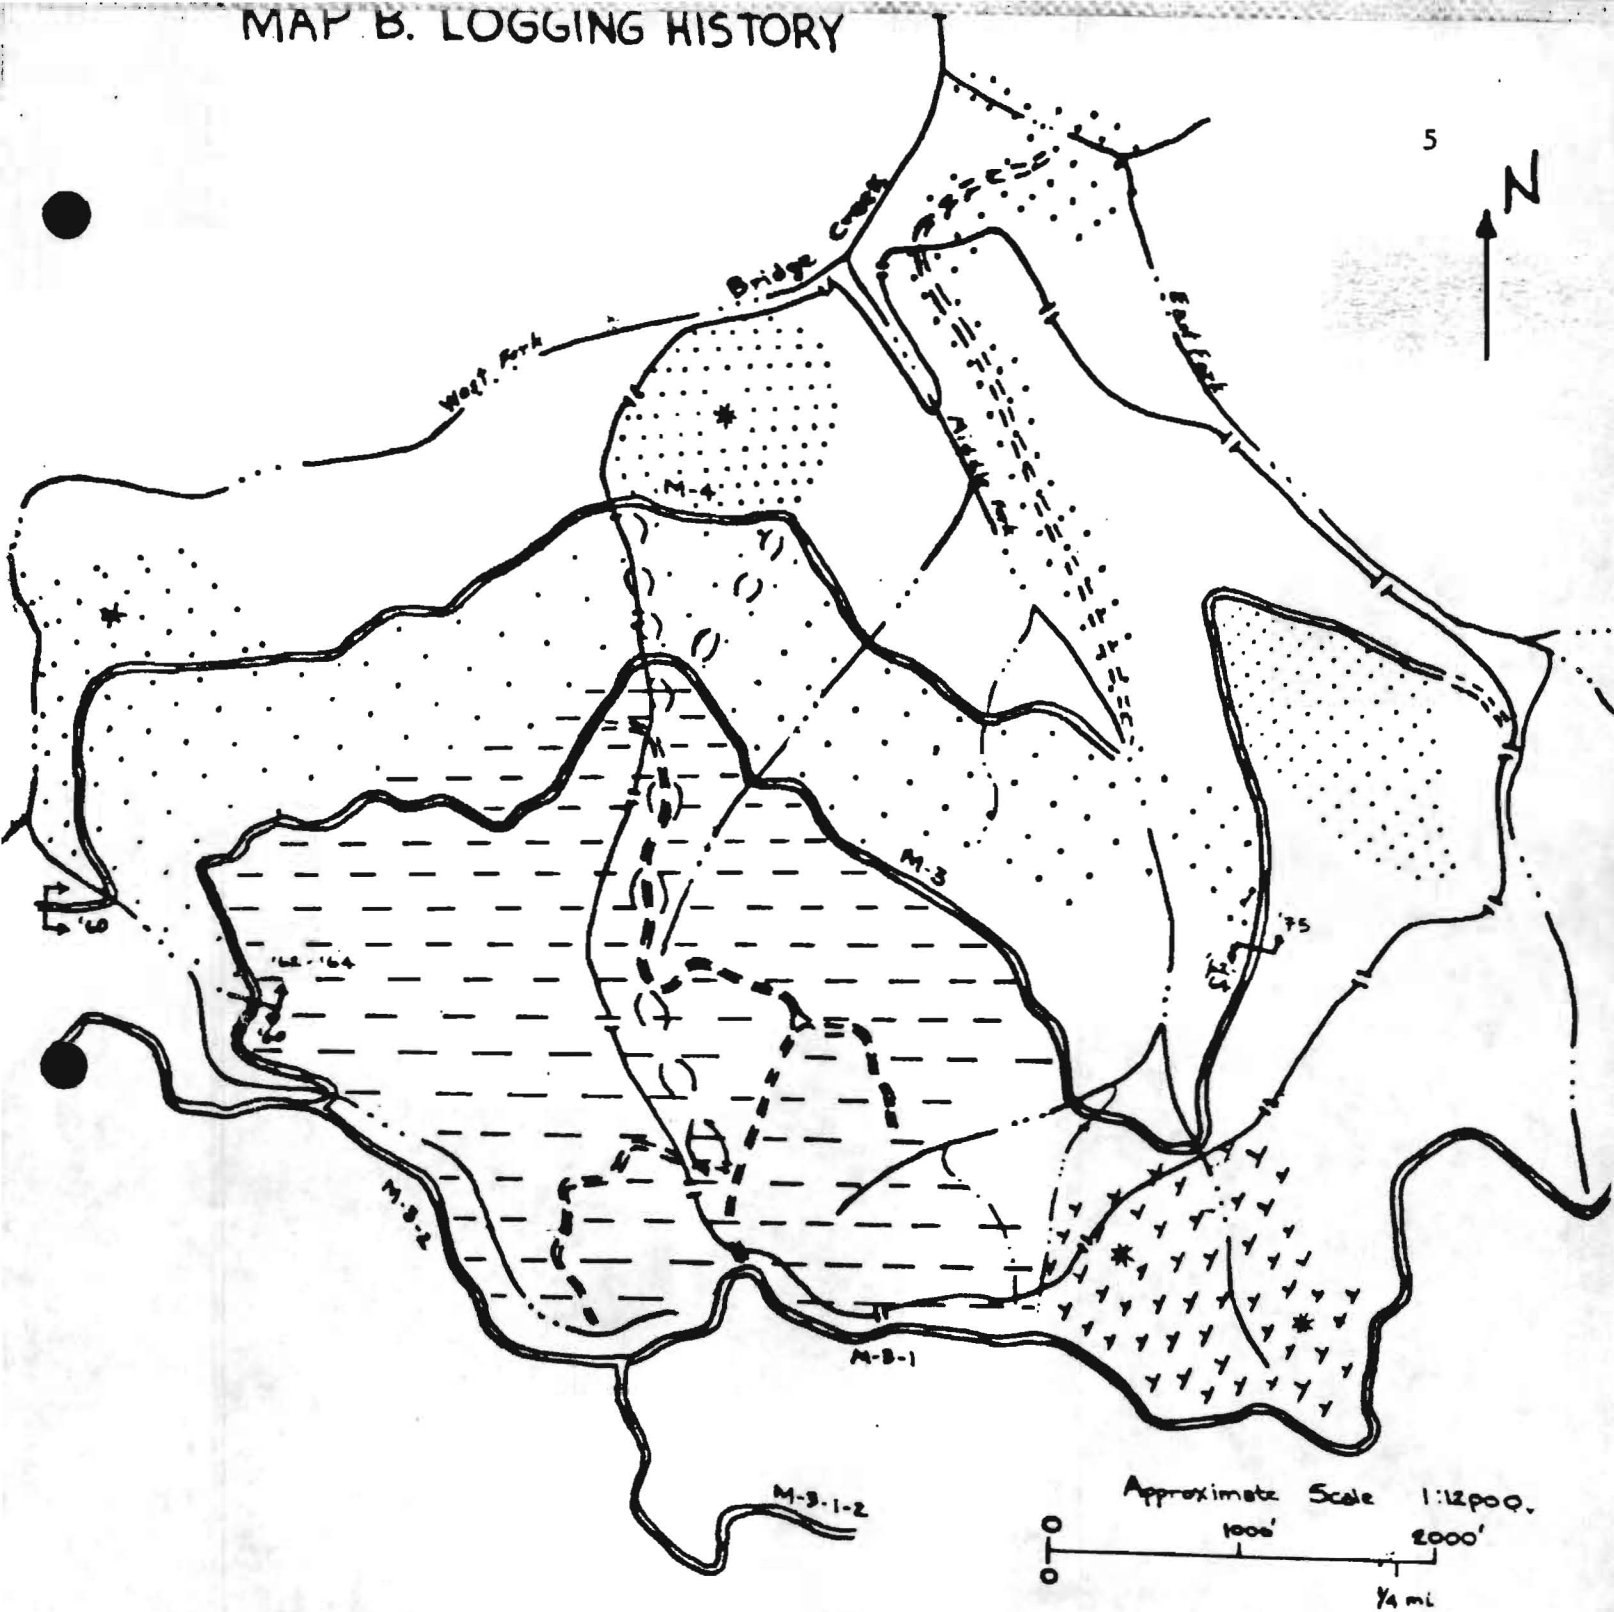
# MAP B. LOGGING HISTORY

Based on early aerial photographs, this headwater region of Bridge Creek remained undisturbed up until 1954. By 1960, the M-4 Road had been constructed across the lower portion of the hillslope. An unrocked road, the M-4 extended from the M-Line to the middle fork of Bridge Creek. Once across the middle fork, it crossed low on the hillslope, extending to the easternmost fork of Bridge Creek. This later portion of the M-4 appeared to be a major skid road rather than a fully developed haul road. Hillslopes above the M-4 and west of the middle fork were harvested by seed-tree-leave methods and tractor yarded. This cut extended up the hillside to the future location of the M-3 Road (refer to Map B). During this same period, a 40-acre unit located immediately upstream and east from the middle fork crossing was also harvested and tractor yarded. The middle fork crossing served as a log landing for this timber unit.

The M-3 Road had been constructed by 1966. It was initially constructed to the middle fork and pioneered approximately 500 feet beyond the crossing. At this time, the upper middle fork crossing was only a tractor crossing. A drainage device had not been installed. The M-3 Road provided access to the hillslopes above the road, and timber was harvested with seed-tree-leave, tractor yarding methods. Typical to this era of timber harvest, stream protection was not considered. Streams were crossed numerous times; earth and organic debris were sidecast into channels.

A quiescent period followed until 1973. At this time, the hillslopes between the M-3 and M-4 were relogged, removing the seed trees left during earlier timber harvest. In 1975, road crews upgraded the M-4 Road just beyond the westernmost boundary of this rehabilitation unit, and extended the M-3 an additional 0.8 mile. A cable unit below the M-4, along with a tractor unit above the M-3 were clearcut in 1976. The Water Quality Control Board of California halted further construction of the M-3 Road in 1977.

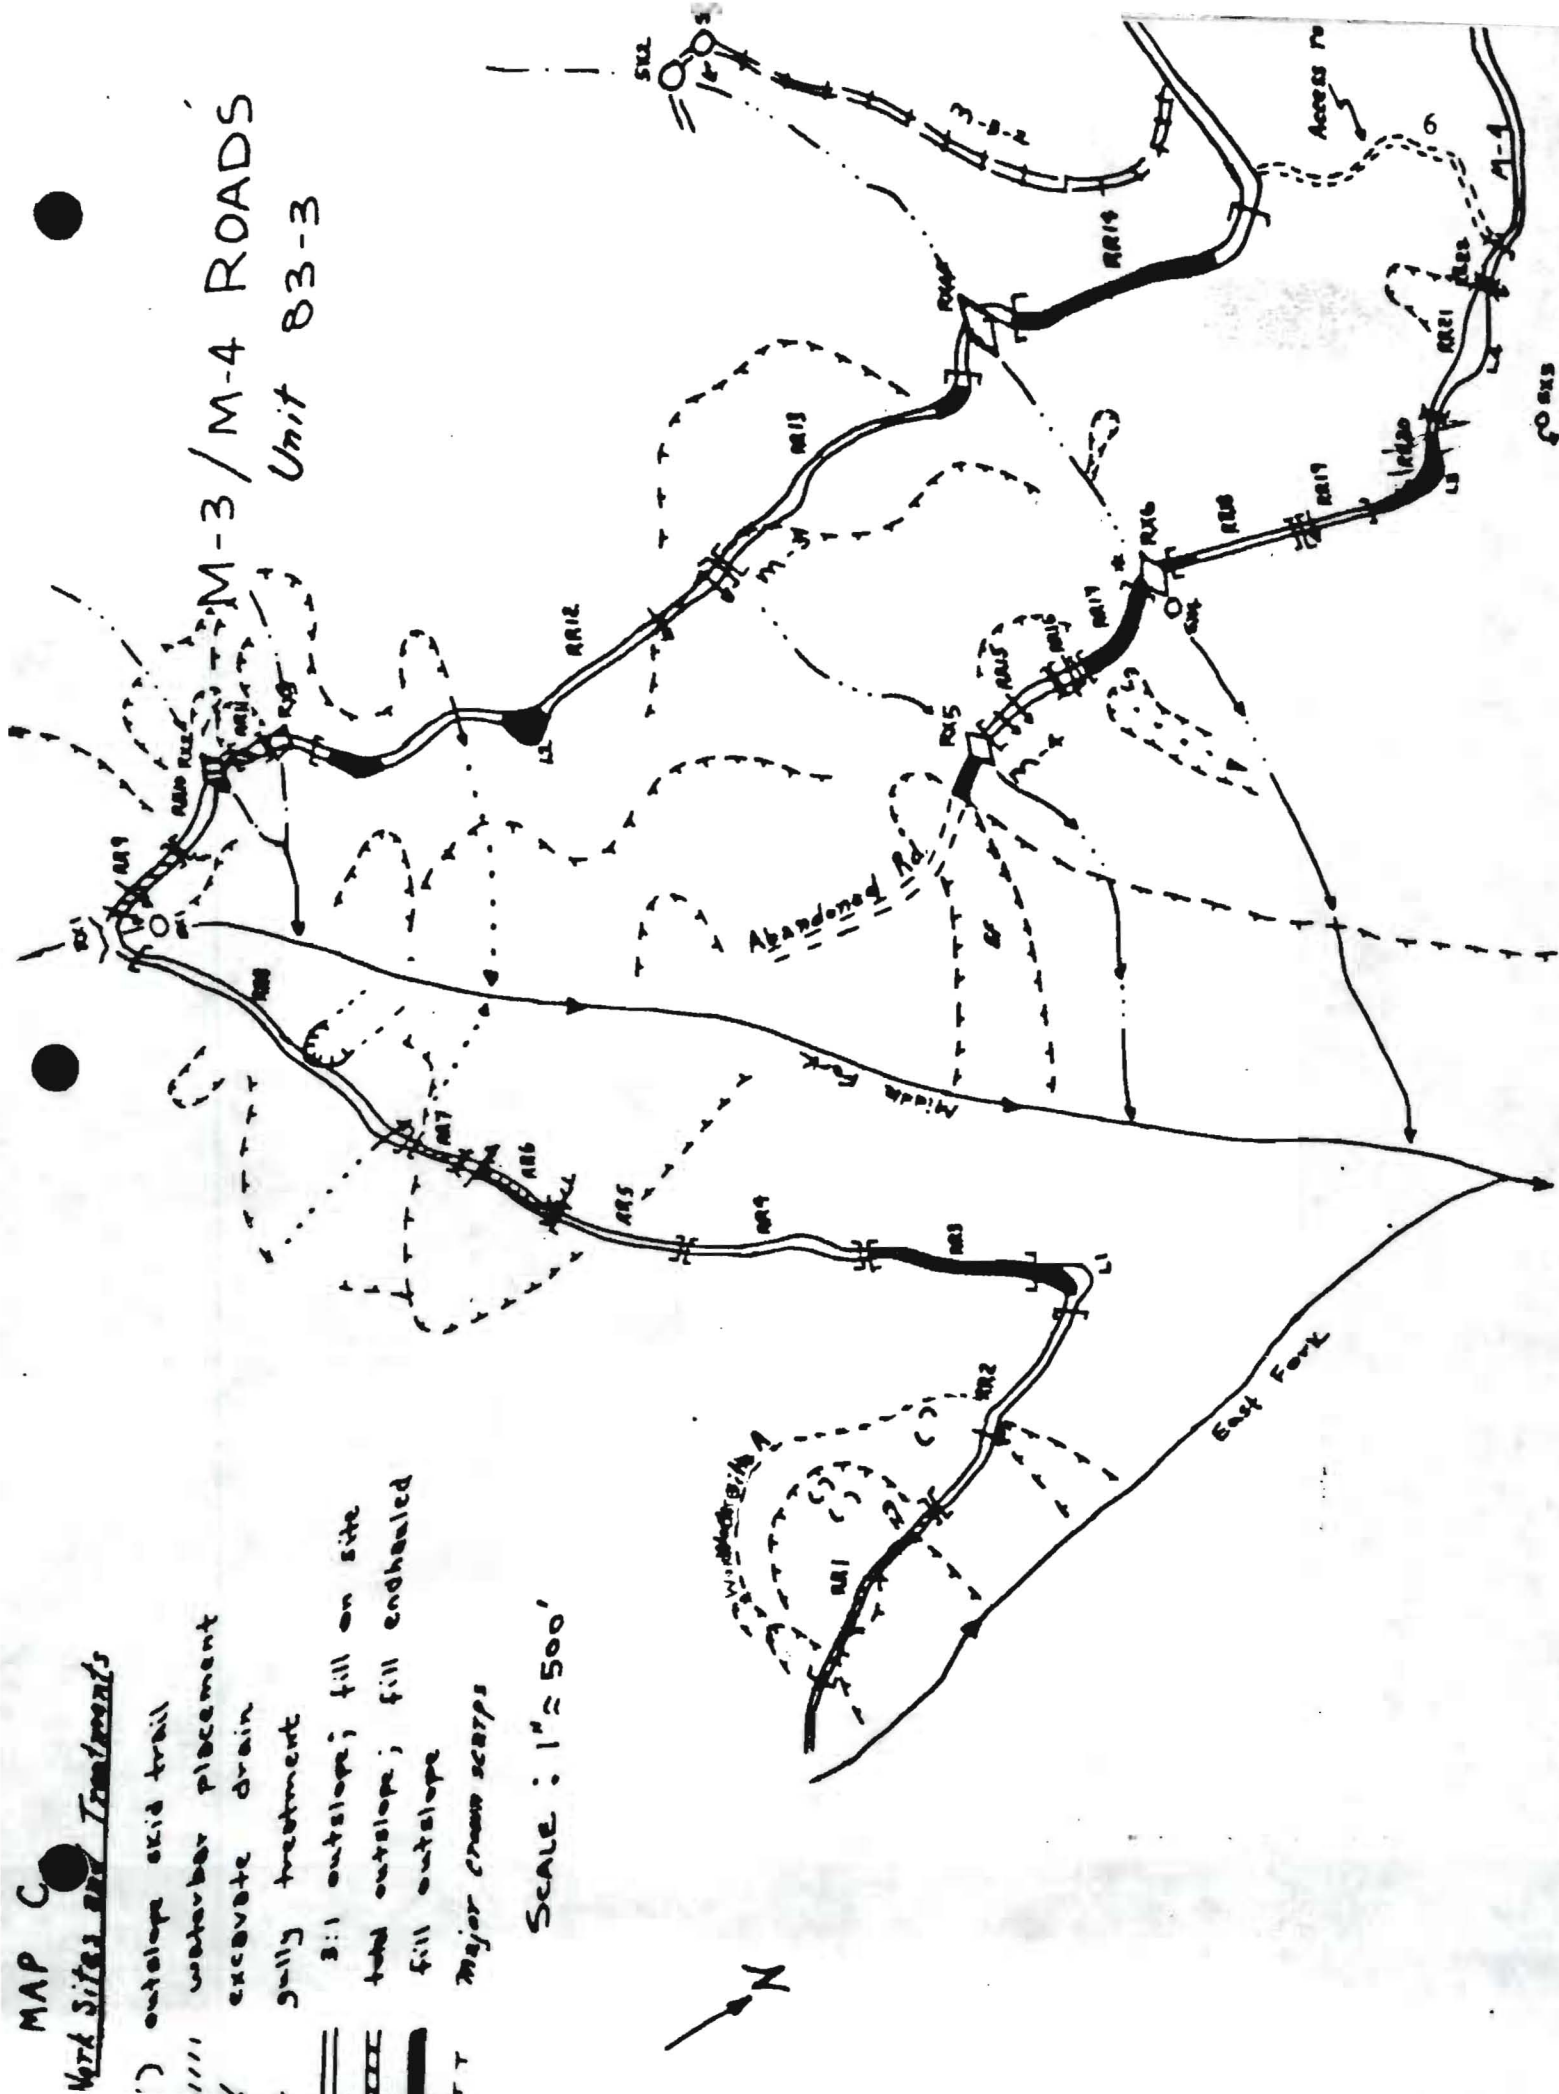
# MAP C

## Work Sites and Treatments

At the time of mapping, mass movement features capable of delivering sediment directly to streams included R1 (worksite A), R9, R10, and earthflow, gully, and landslide features below RX5 and RX6. R1 and adjacent hillslopes contained a recent debris torrent which originated from a network of skid trails above the M-3. Its potential for continued erosion remained high, by virtue of steep hillslopes, dense skid trail networks, and disrupted surface drainage. Below the M-3 and immediately above the east fork, the uncut hillslope displayed active, complex landslide characteristics.

R9 and R10 were unstable road segments located immediately above a second-order, perennial stream. Translational slides had already occurred in R9 (and remained active); R10 displayed similar potential. R8 contained a rotational landslide in an uncut forest. Its movement initiated in 1978, and advanced significantly in 1982-1983.

The objectives of rehabilitation were to eliminate active and potential sediment sources to stream channels, and to encourage vegetation as the ultimate form of erosion control. Erosion features which would store their eroded material as slope deposits were not a concern. The reader is referred to Map C which locates all work sites on this unit.

Work site A, R7-R10 fell under the first category of processes. A total outslope was prescribed for these road segments as well as the skid trails crossing the upper hillslope of work site A. The goals of these treatments were to remove as much of the potential sediment source as possible and to improve surface drainage on these hillslope areas.

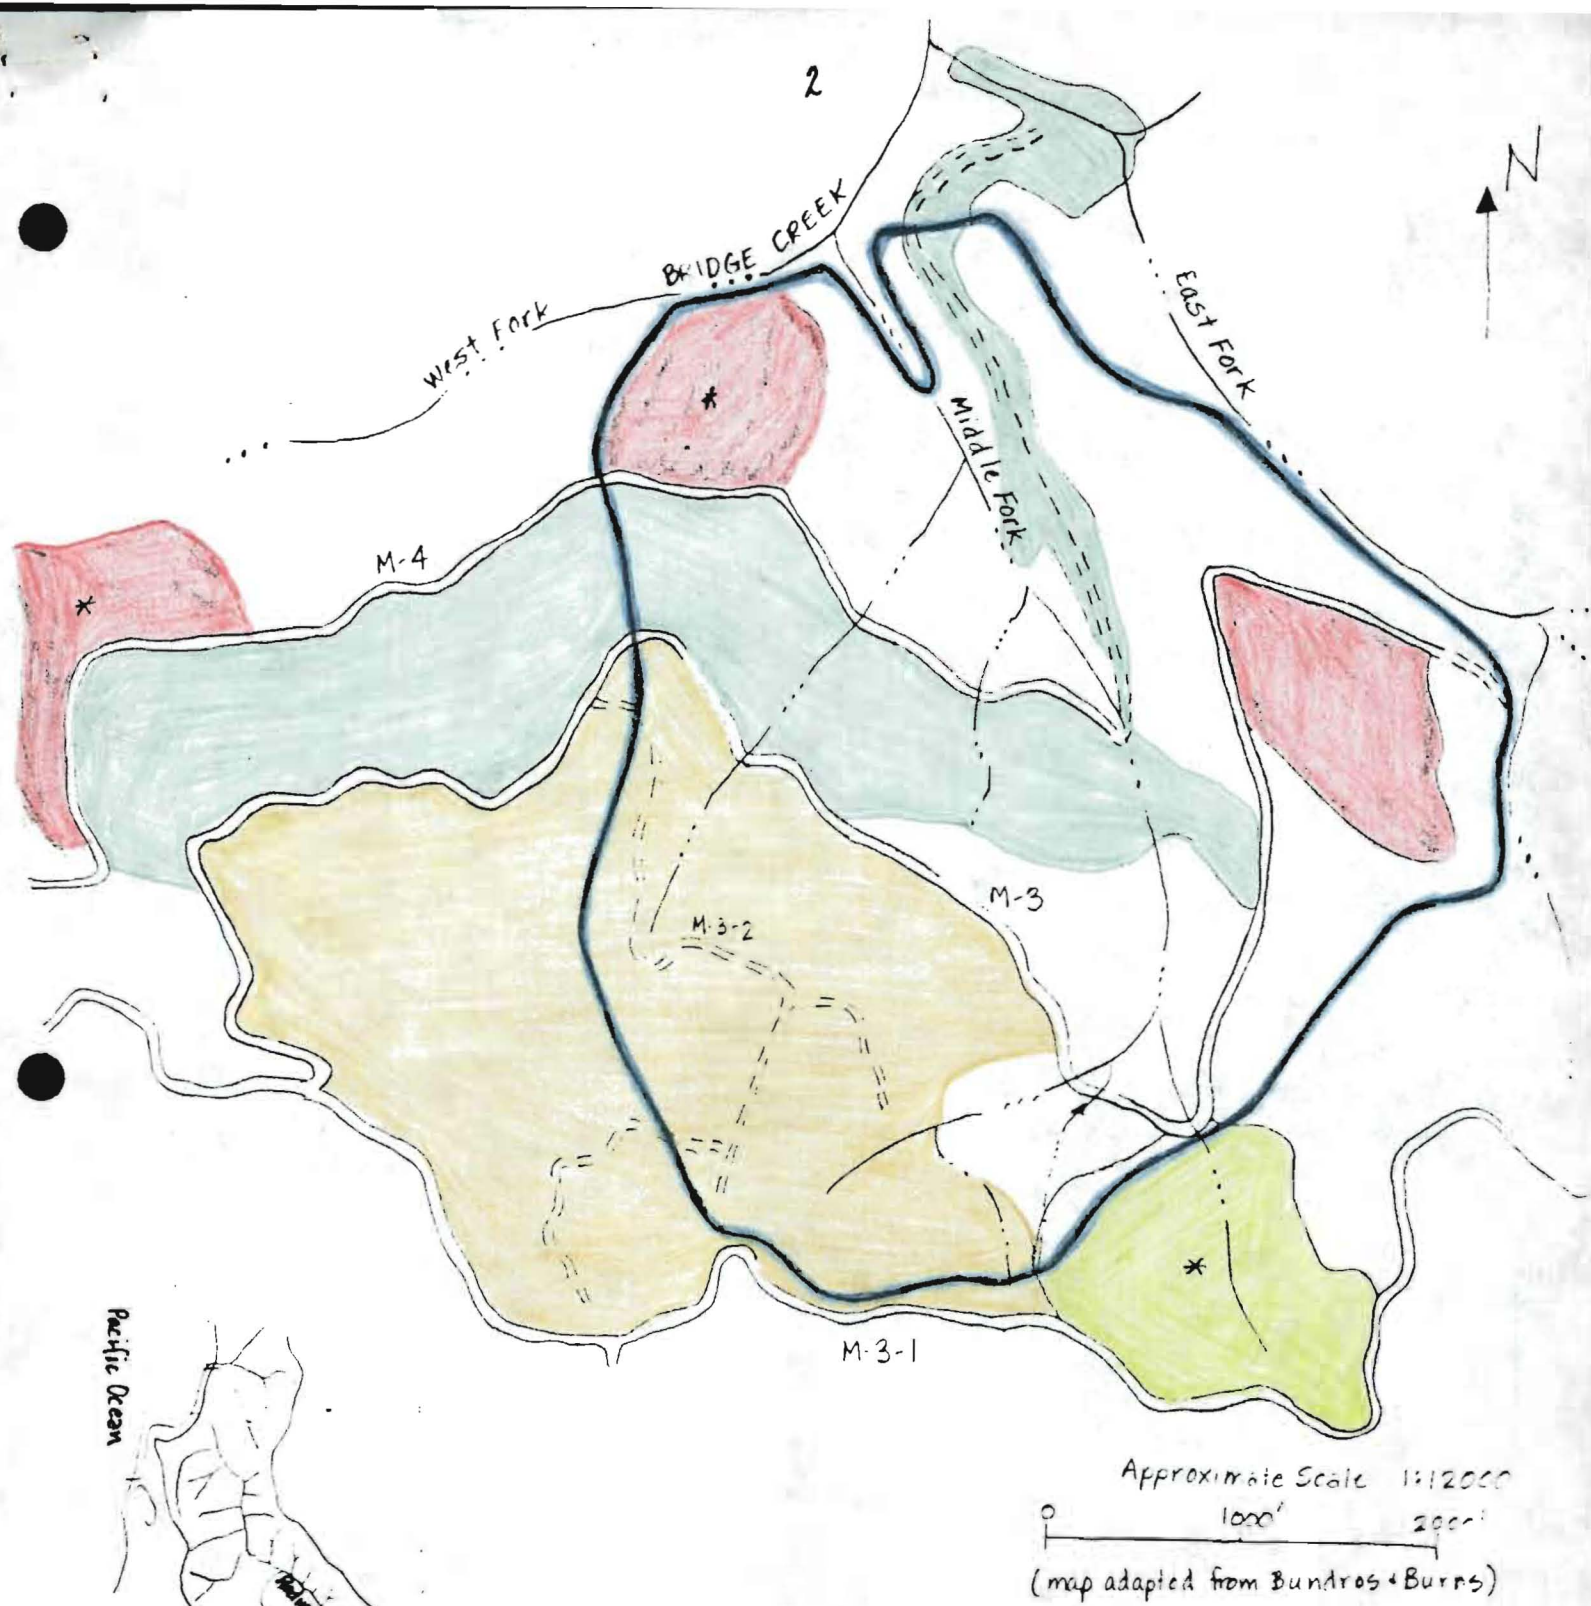
Figure 1

The M-3/M-4 Rehabilitation Unit is located on the west side of Redwood Creek about 17 miles from the Orick Operations Center via the Westside Access Road (Figure 1). The unit encompasses 490 acres in the eastern headwaters of Bridge Creek. Elevation ranges from 800 feet to 2,150 feet in a low to mid-slope position. The upper boundary of the unit lies 350 feet below the basin divide. The general aspect is northwestern and slopes average 45 percent. The site is generally favorable with lower portions remaining moist all summer.

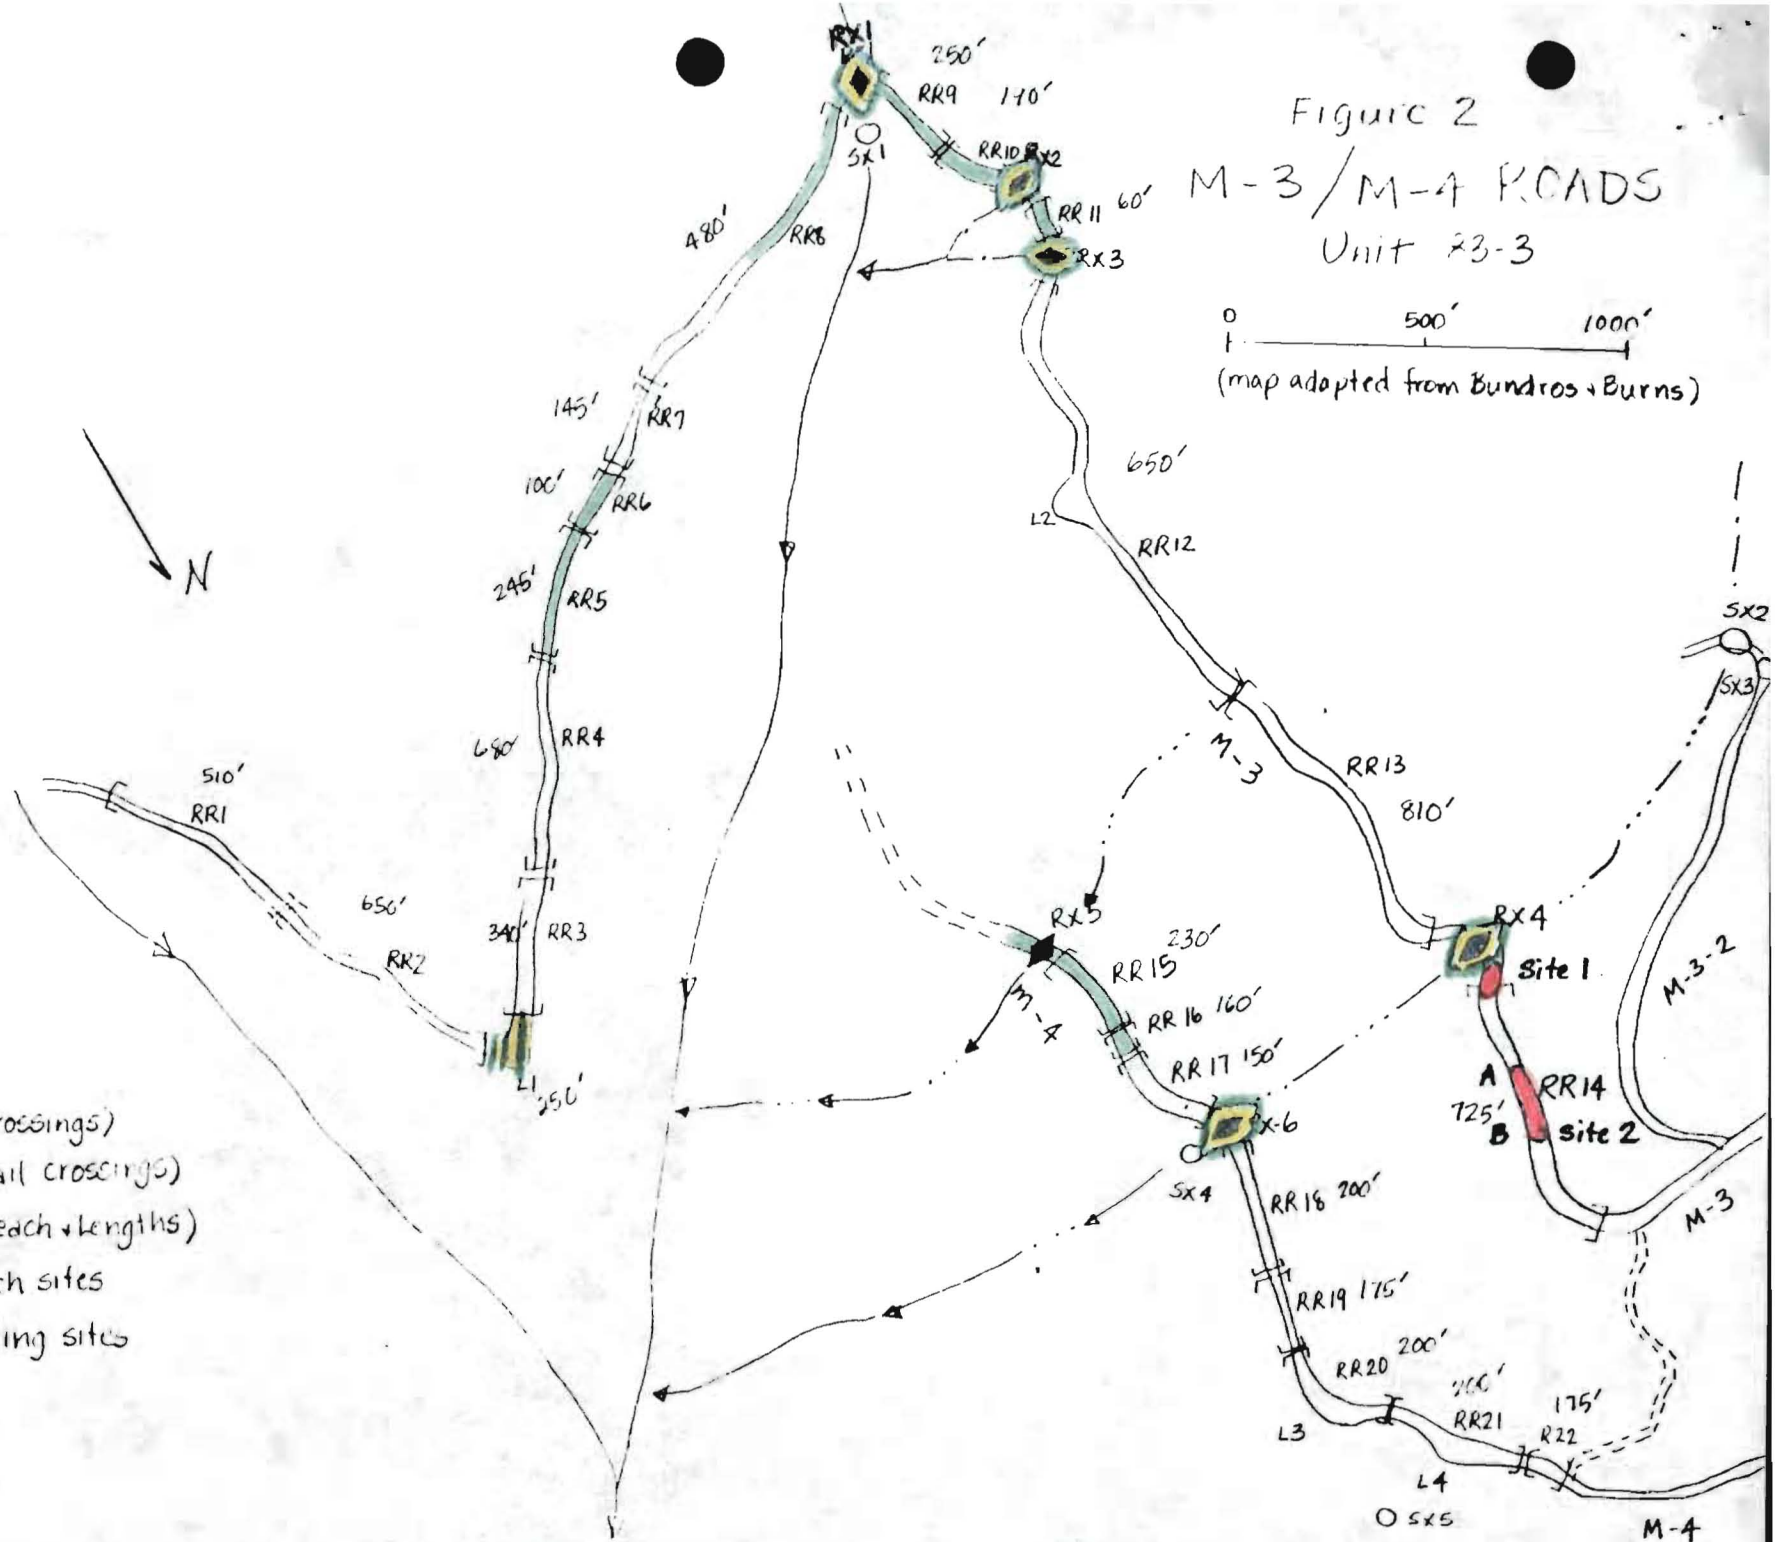
- ◆ RX (Road Crossings)
- SX (Skid trail crossings)
- [ ] RR (Road Reach + Lengths)
- Straw mulch sites
- Alder planting sites
- Test Plots

Since the site was formerly dominated by redwood and conditions still present are favorable to redwood, the goal of revegetation is to re-establish redwood as quickly as possible. Natural redwood regeneration is variable by year and frequently very slow. Little redwood might be established for a number of years if seedlings were not planted. Redwood seedlings were planted along the entire

lengths of both the M-3 and M-4 roads and at crossings. Since Douglas-fir is a more rapid colonizer and an abundant seed source is available, no Douglas-fir seedlings were planted. Alder seedlings were planted at crossings to provide rapid vegetative cover, in wet areas along outsloped roads to help provide slope stability and at L1 to provide shade for redwood seedlings<sup>(Fig. 2)</sup>. Natural seeding of alder along the roads is expected to be heavy in many areas and may benefit planted redwood seedlings by excluding the less shade-tolerant Douglas-fir seedlings resulting in a higher percentage of redwood. Skid trails and the M-3-2 road were narrow and did not require treatment.
