Summary Report  
WATERSHED REHABILITATION UNIT 88-2  
LOWER K&K ROAD AND SLOPE

David L. Steensen  
Redwood National Park

April, 1989

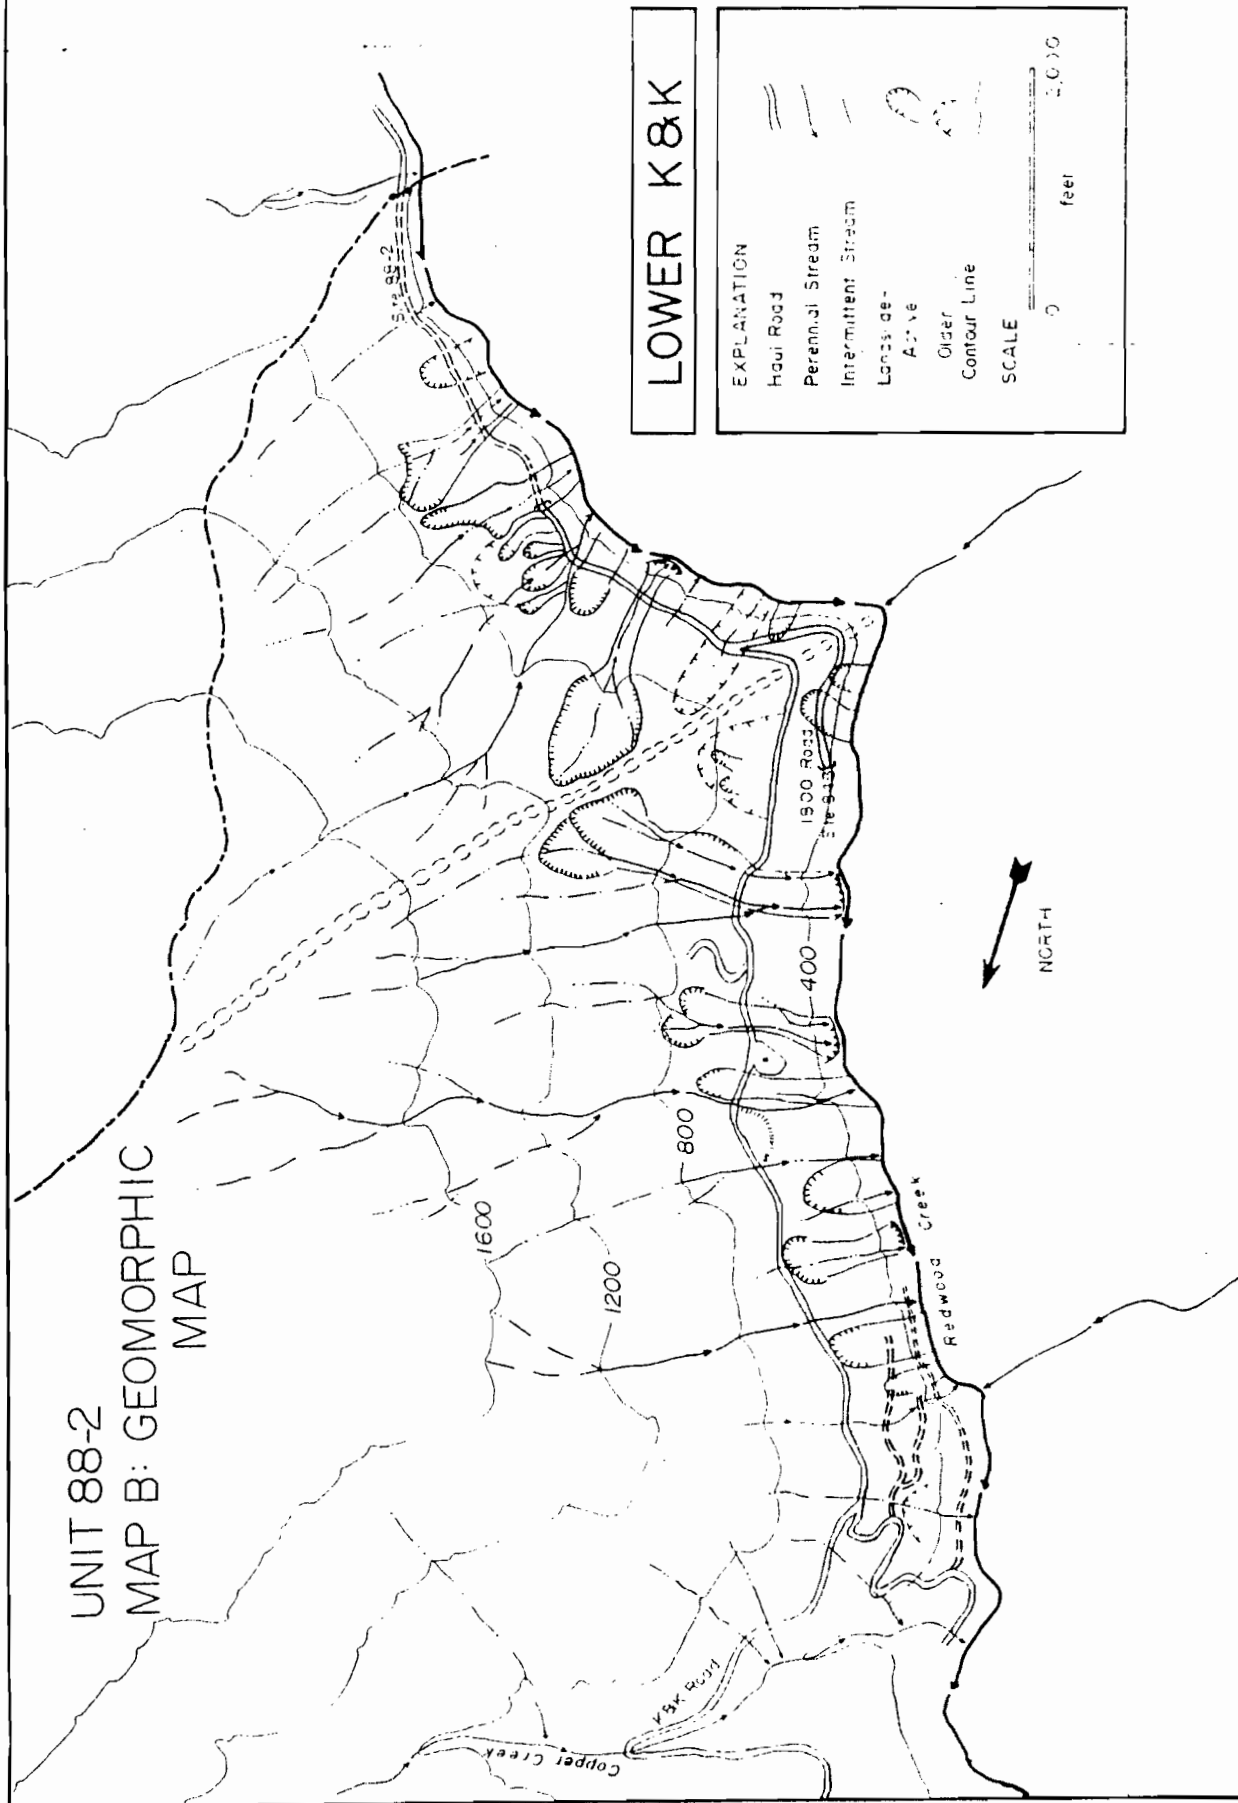
# UNIT 88-2 MAP B: GEOMORPHIC MAP

The site has a southwesterly slope aspect and has moderate relief from 400 feet to about 800 feet in elevation (Map B). Streams generally occupy poorly to moderately incised valleys and amount to nothing more than large gullies when they flow through landslide terrain. Stream gradients are mostly steep although quite variable in the tread/riser topography of the active landslides.

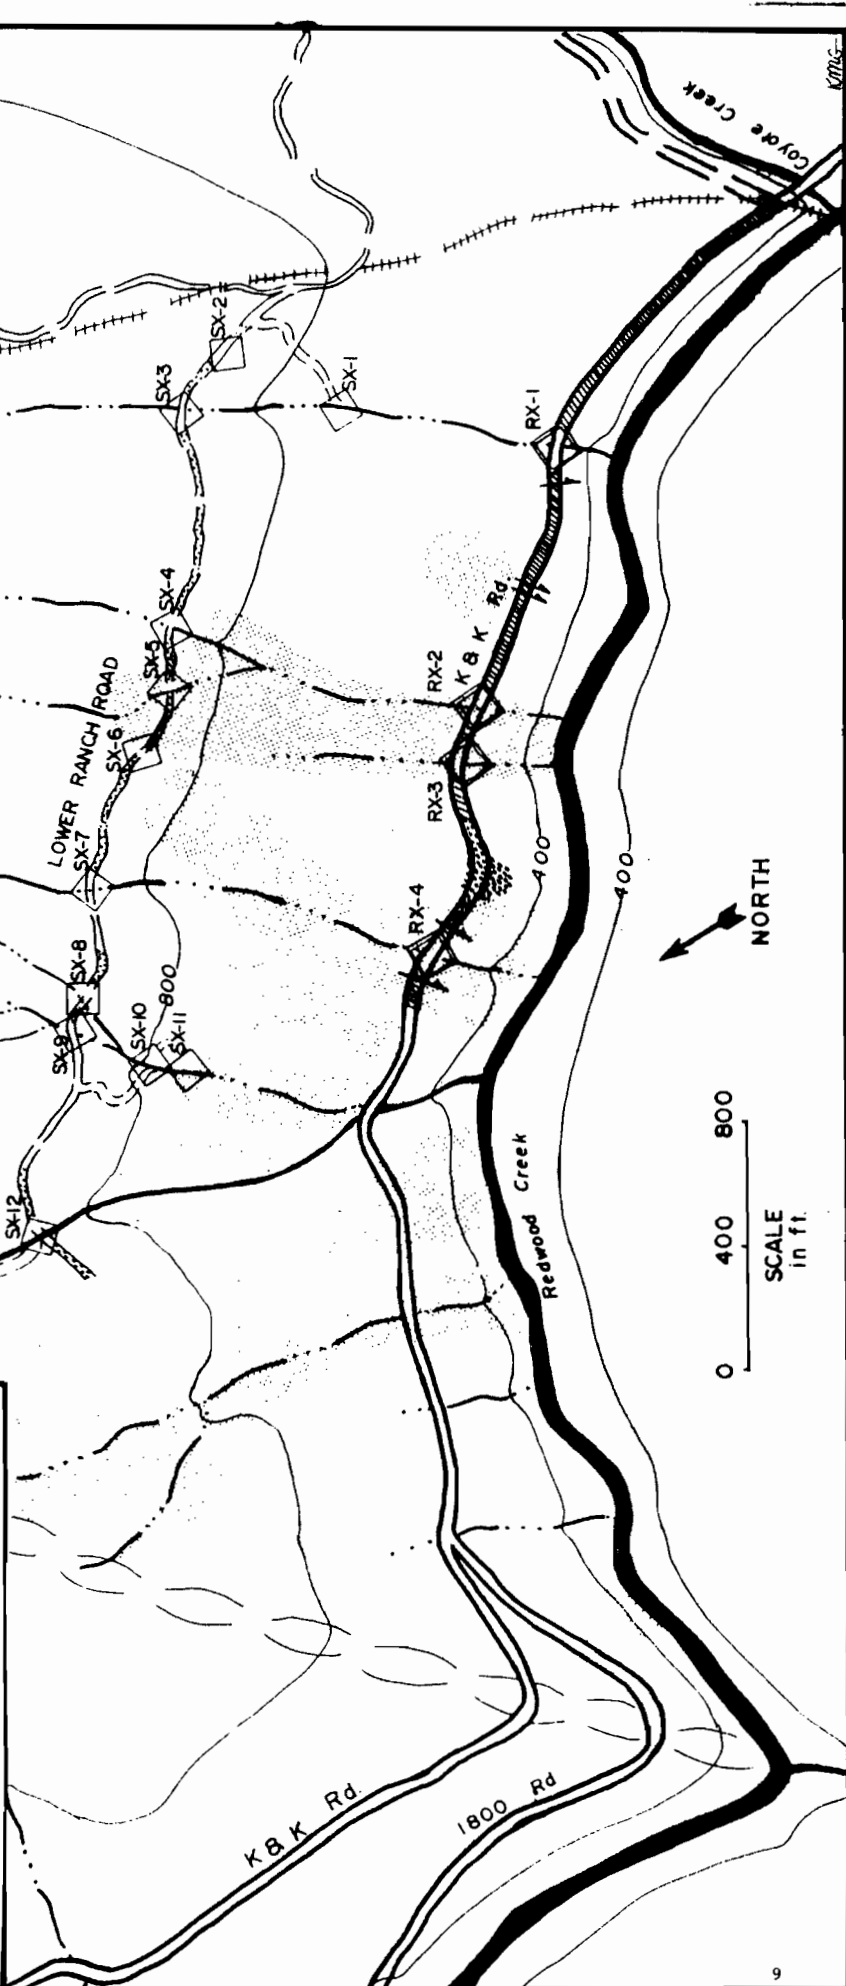
MAP D: TREATMENT MAP

Primary rehabilitation treatments included excavation of 4 haul road stream crossings, 2,550 feet of exported outsloping (truck-enhauled), and 255 feet of outsloping on the K&K Road. Treatments on the Lower Ranch Road (slopework) included 7 skid trail crossings and 2,700 feet of outsloping. Secondary treatments included placing rock channel armor in 3 of the 4 haul road crossings, and applying straw mulch to the finished slopes of the entire unit. Table 2 summarizes heavy equipment costs for 88-2. Refer to Map D for locations of individual worksites.

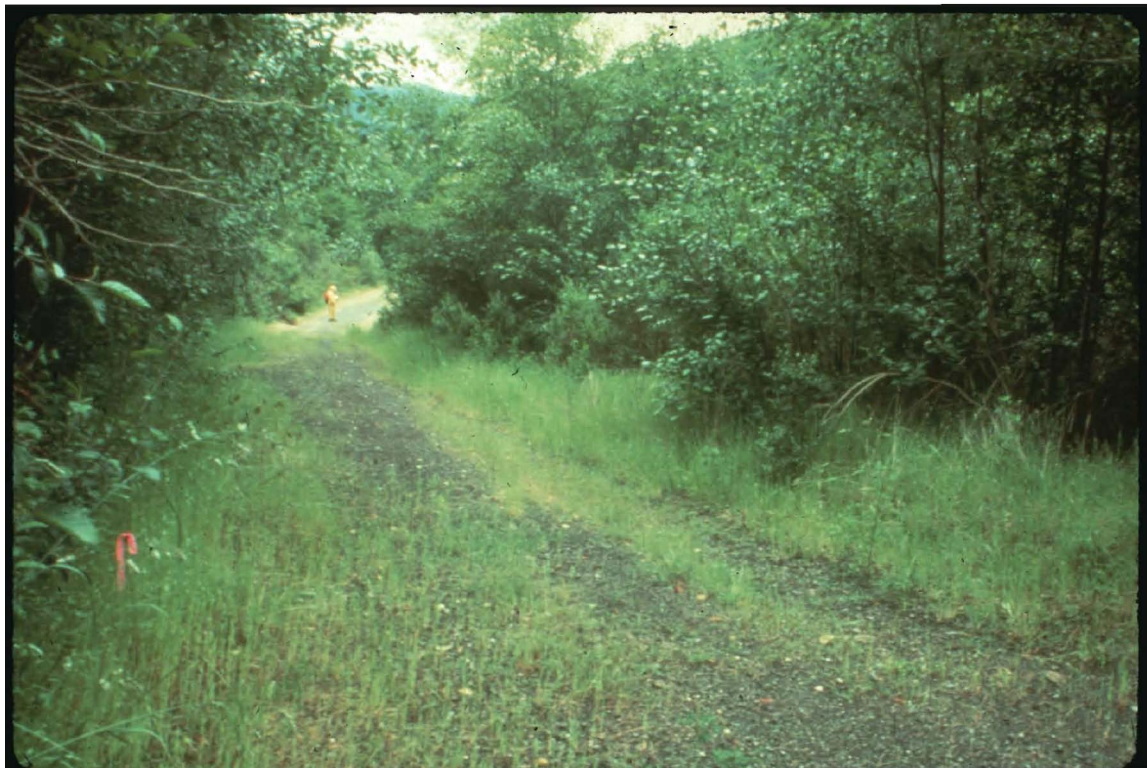
Unit: 88-2 PP4a Dwnstm. Rd STA 8+18 6-6-88 MH& RK 35mm

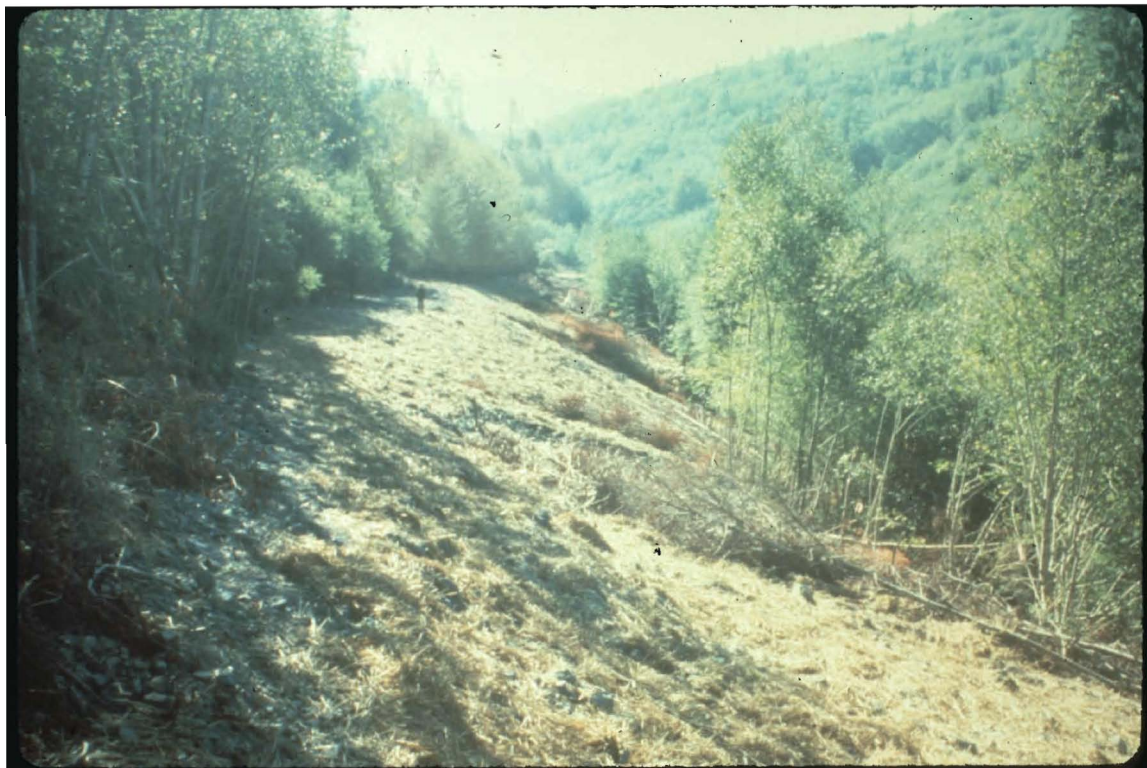
Unit: 88-2 PP4a K and K EOS 0+00 Sta 8+18 10-19-88 DLS & MMH 35mm

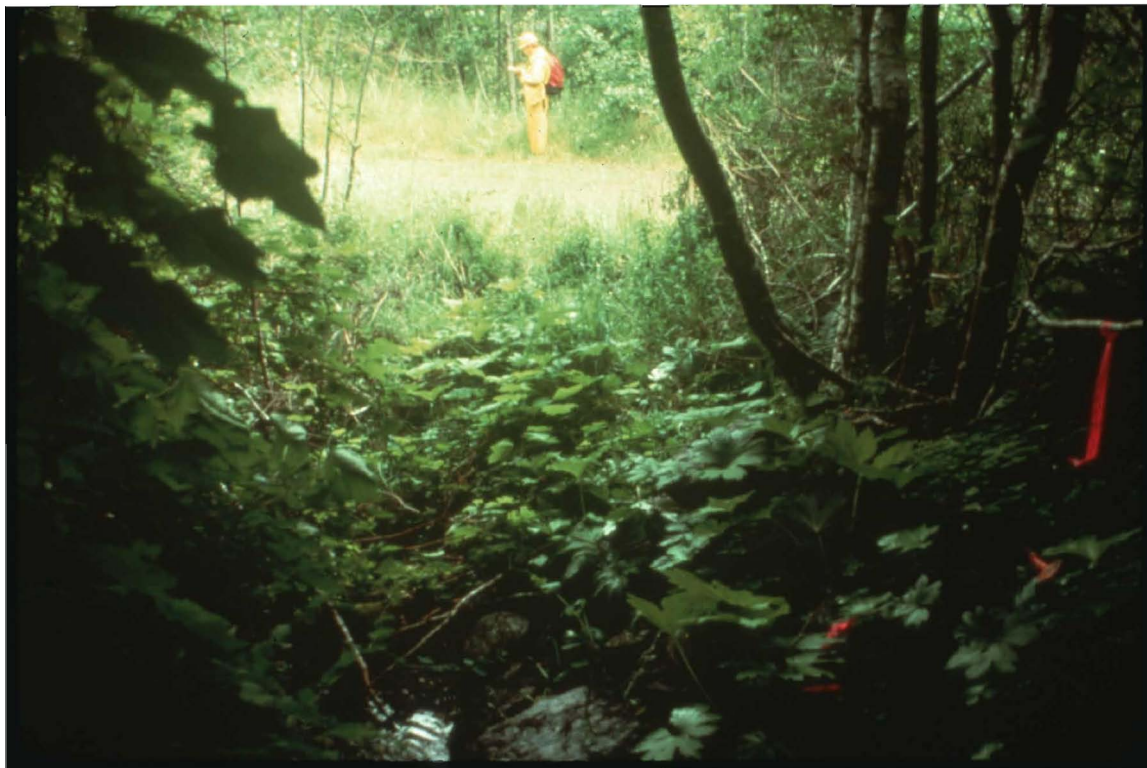
Unit: 88-2 PP5 dwnstm sta 8+52 RX-1 6-6-88 MH + RK 35mm

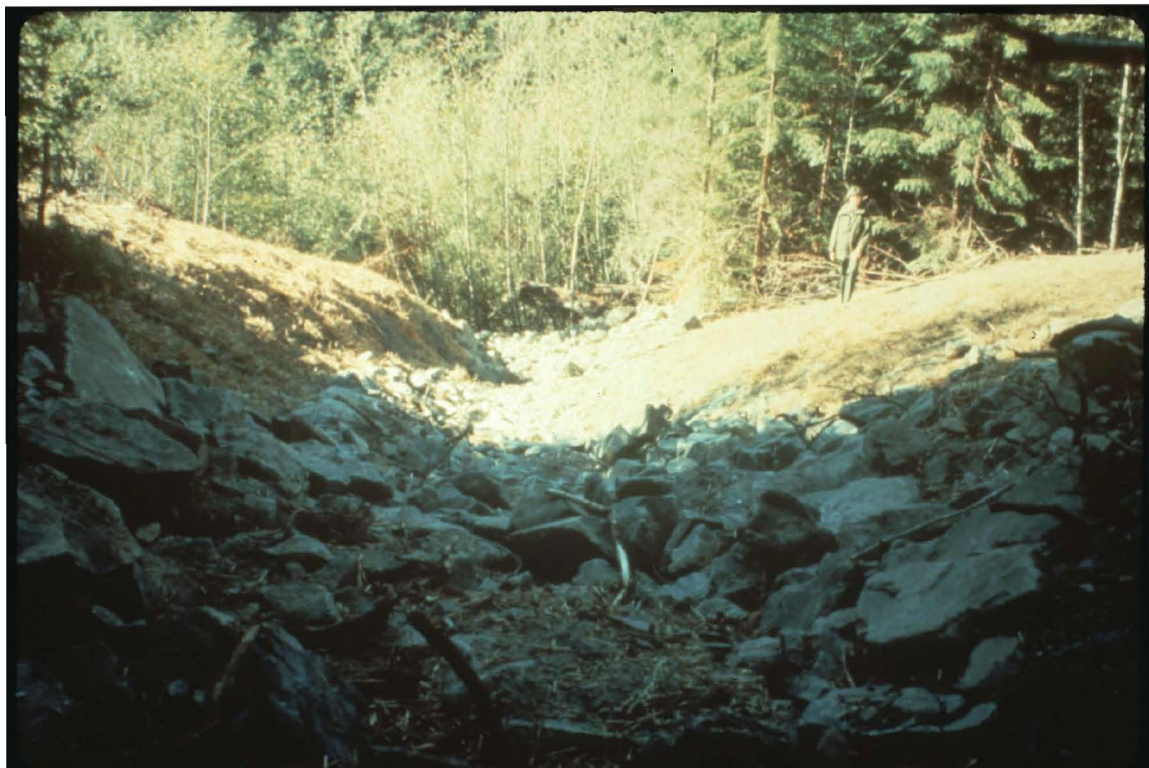
Unit: 88-2 PP4a K and K RX-1 Top Sta 8+52 DLS & MMH 35mm

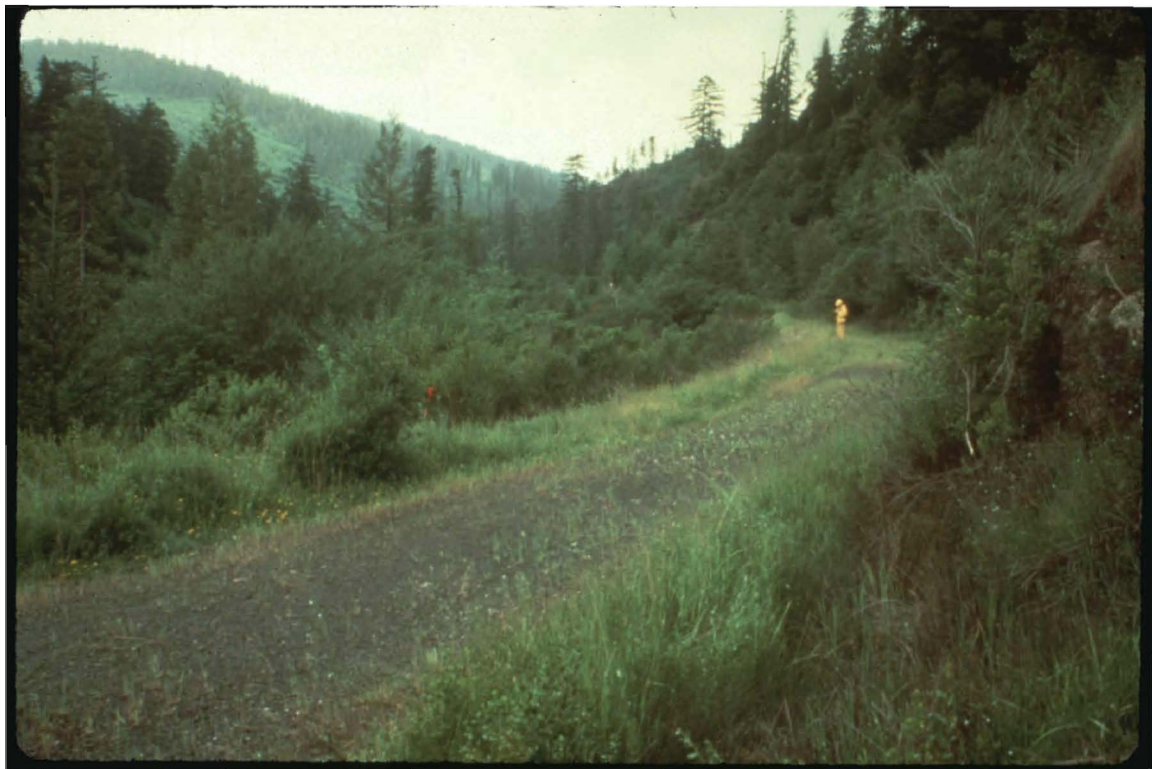
Unit: 88-2 PP8b Upsta Rd. STA 14+50 6-6-88 MH & RK 35mm

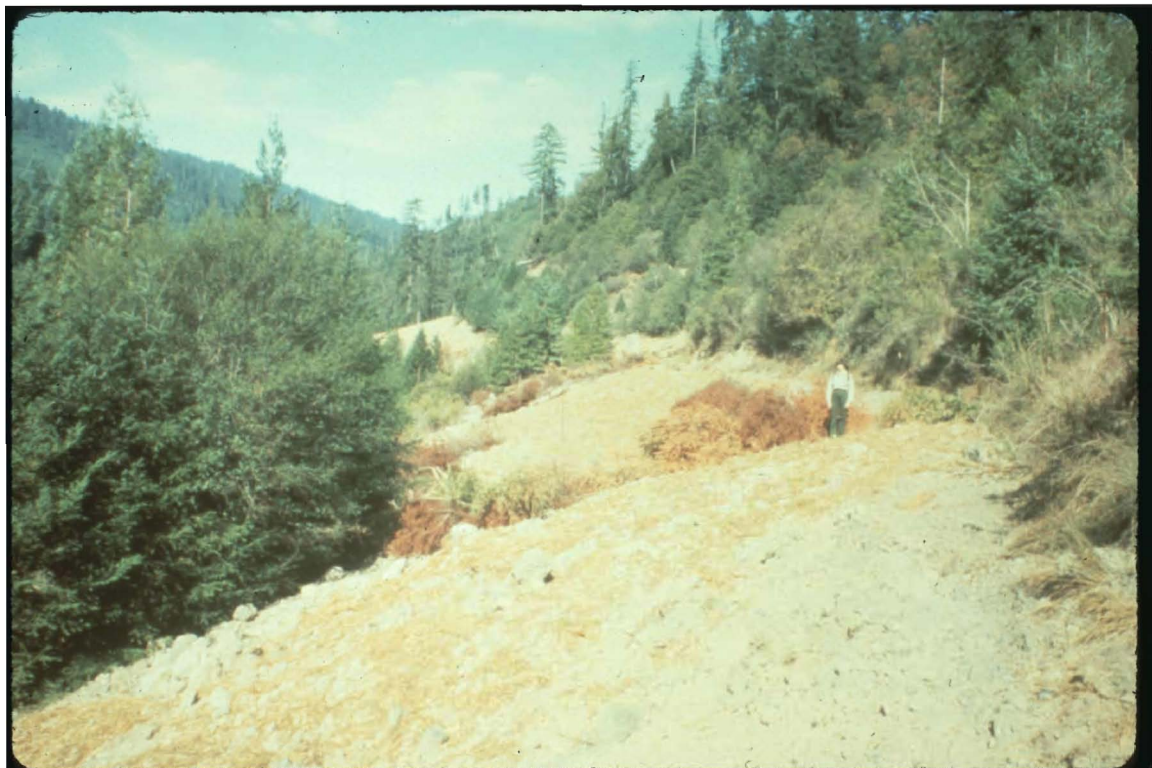
Unit: 88-2 PP8b K+K EO58+77 STA 14+50 DLS & MMH 10-19-88 35mm

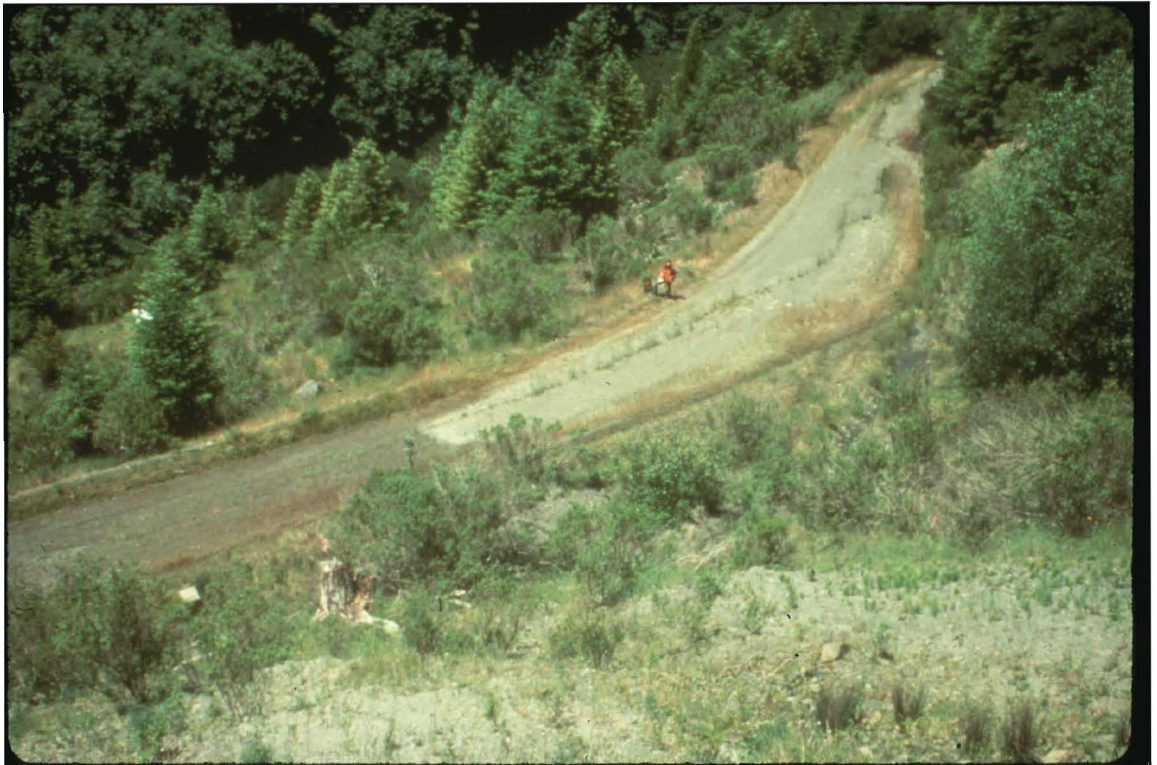
Unit: 88-2 PP15C Upstm RX3 STA 21+00 6-13-88 MH+KG 35mm

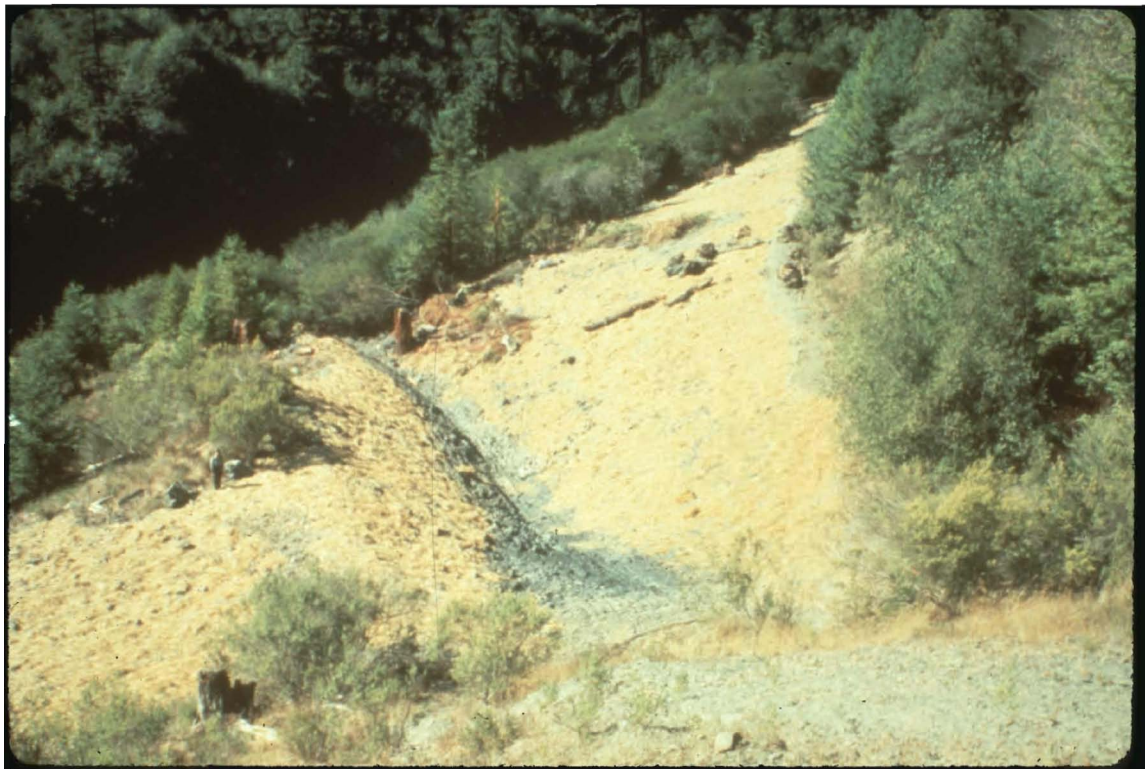
Unit: 88-2 PP15C K+K EO5 19+47 RX-3 STA 21+00 DLS & MMH 35mm

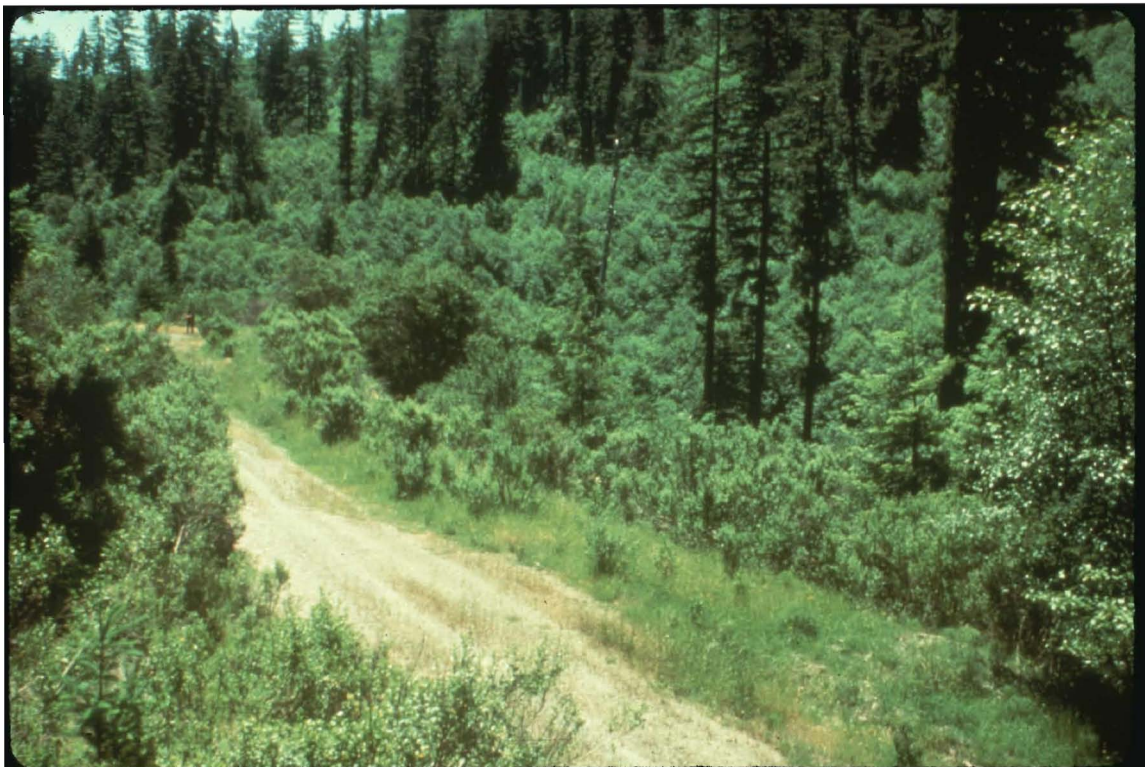
Unit: 88-2 PP17a Dwnstm Rd. STA 27+27 6-13-88 MH & KG 35mm

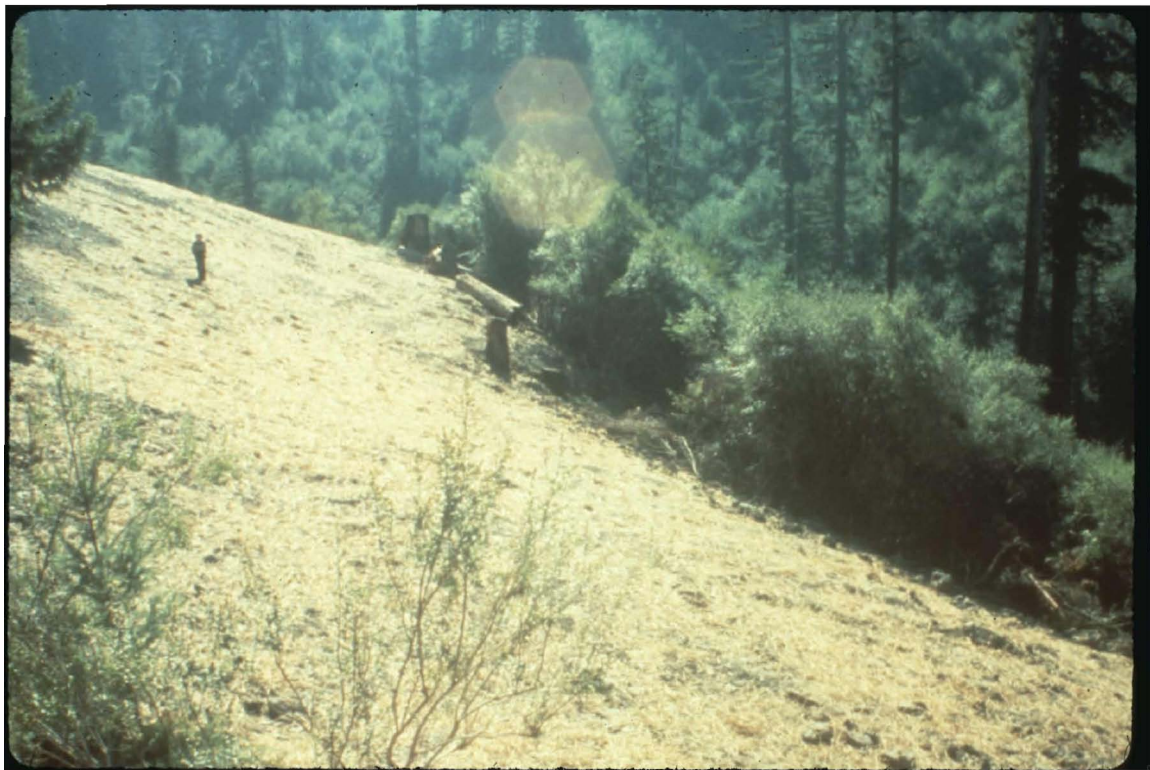
Unit: 88-2 PP17A OS 25+00 K&K Eos 27+00 Sta 27+27 10-19-88 DLS&MMH 35mm
