# BEACH NOURISHMENT PROJECT

CAPE HATTERAS, NORTH CAROLINA

## POST-PUMPING SUMMARY

BEACH NOURISHMENT: BUXTON, NORTH CAROLINA

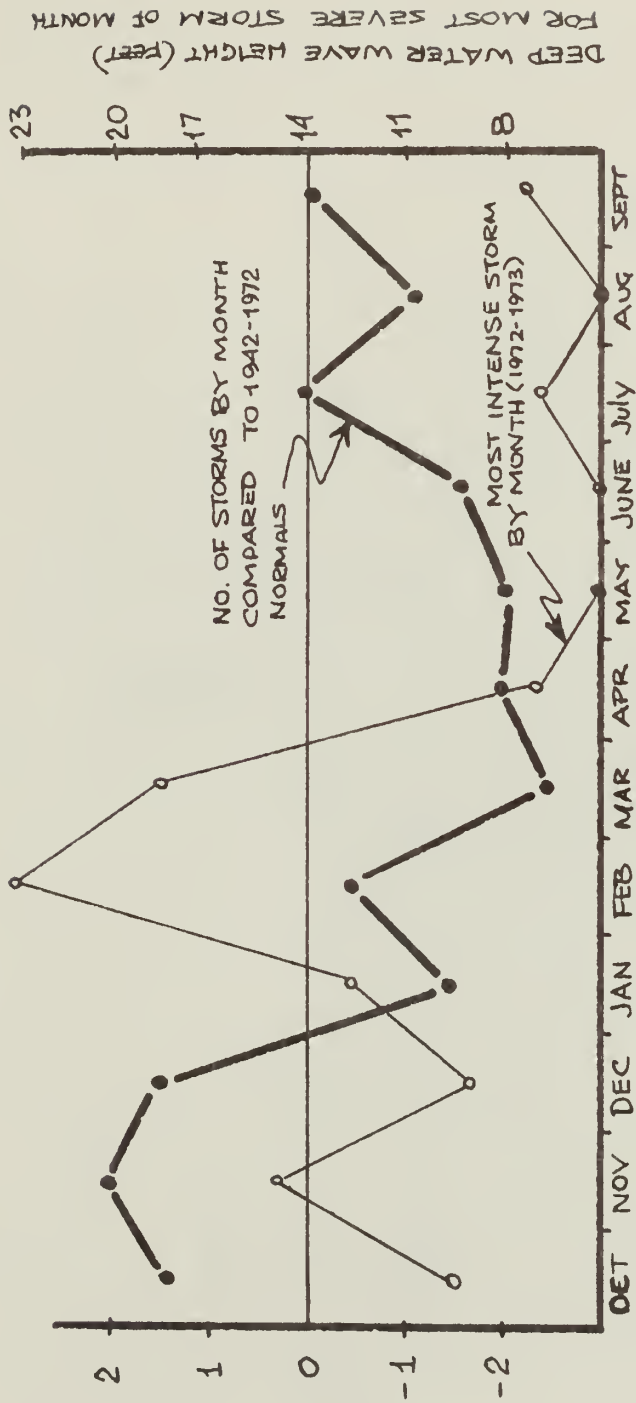
Fig. 1. Storms by Month (Oct. 1, 1972 - Sept. 31, 1973)  
Compared to the (1942-1972) 30 year normals.

1. What storm and wave conditions have characterized the pumping period? Were the storm and wave conditions significantly different than similar months of recent years?

Answer: The storm and wave conditions that occurred during the period of beach nourishment may best be characterized as consisting of two widely differing periods. The first period, up to the end of March, was considerably stormier than the average for the last three decades. The second period, extending from April 1 to October 1, was the calmest equivalent time period in the last 30 years (see Fig. 1). Of the seven times on which overwash in the Buxton area was observed, two occurred prior to the start of pumping and five occurred during the early stormy phase (January through March). The storm of February 9-15, 1973, was the most severe storm during the pumping period and the recurrence interval for storms of its magnitude is once in twenty-eight years. In spite of the severity of storms during the January through March period, the number of storms were few by comparison with the 30 year average (1942-1972).

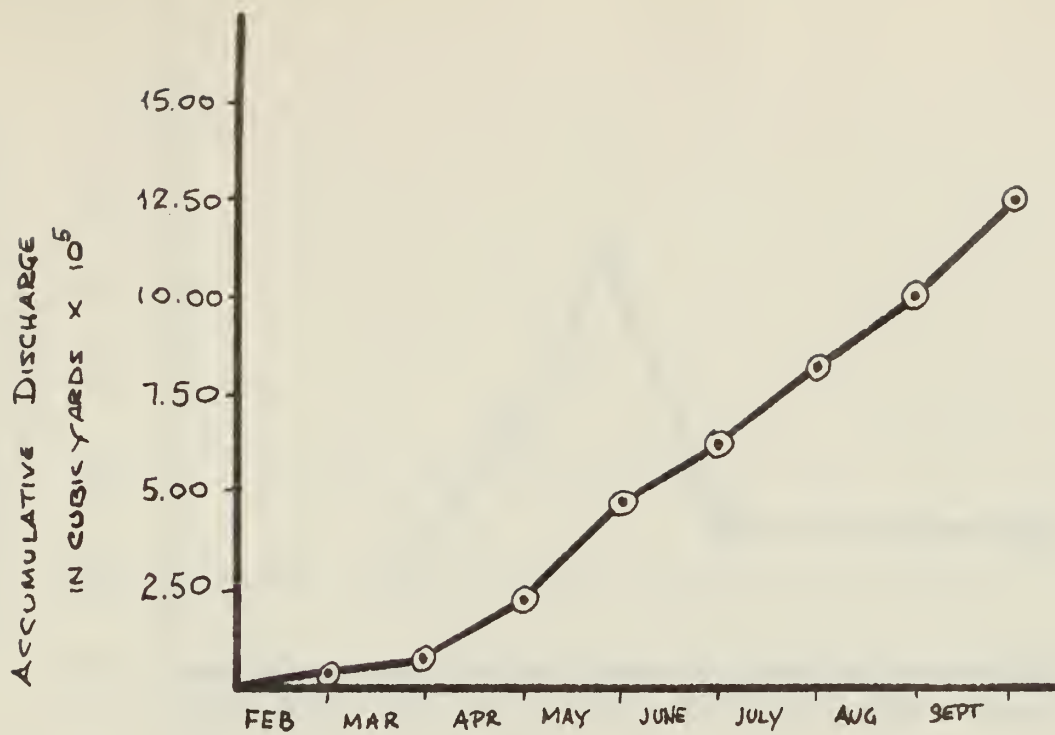
Fig. 5. Accumulative discharge volume by month.

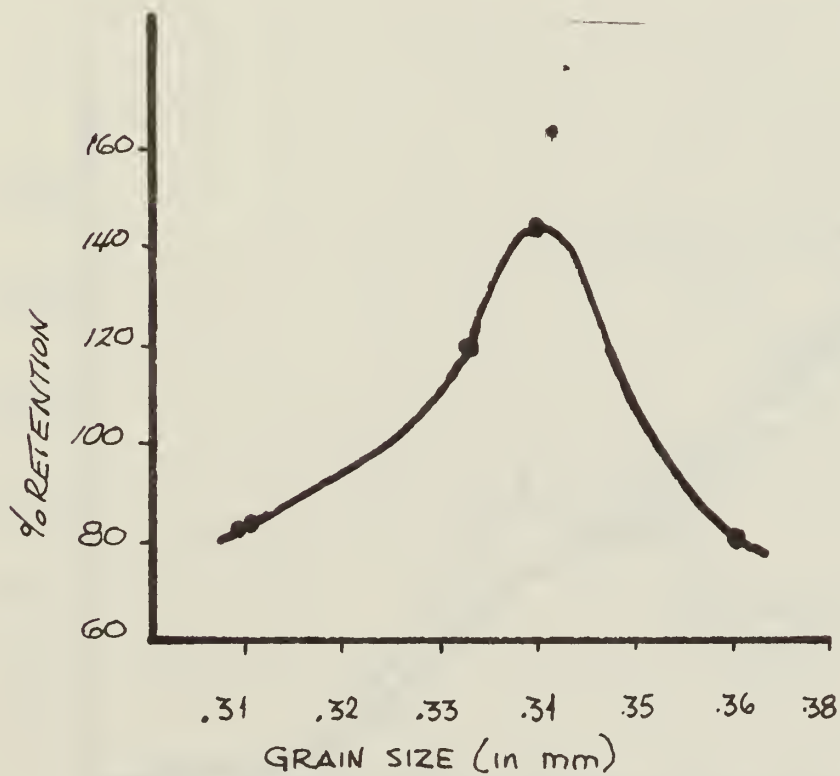
Fig. 6. Percentage retention of fill by grain size of discharge material.

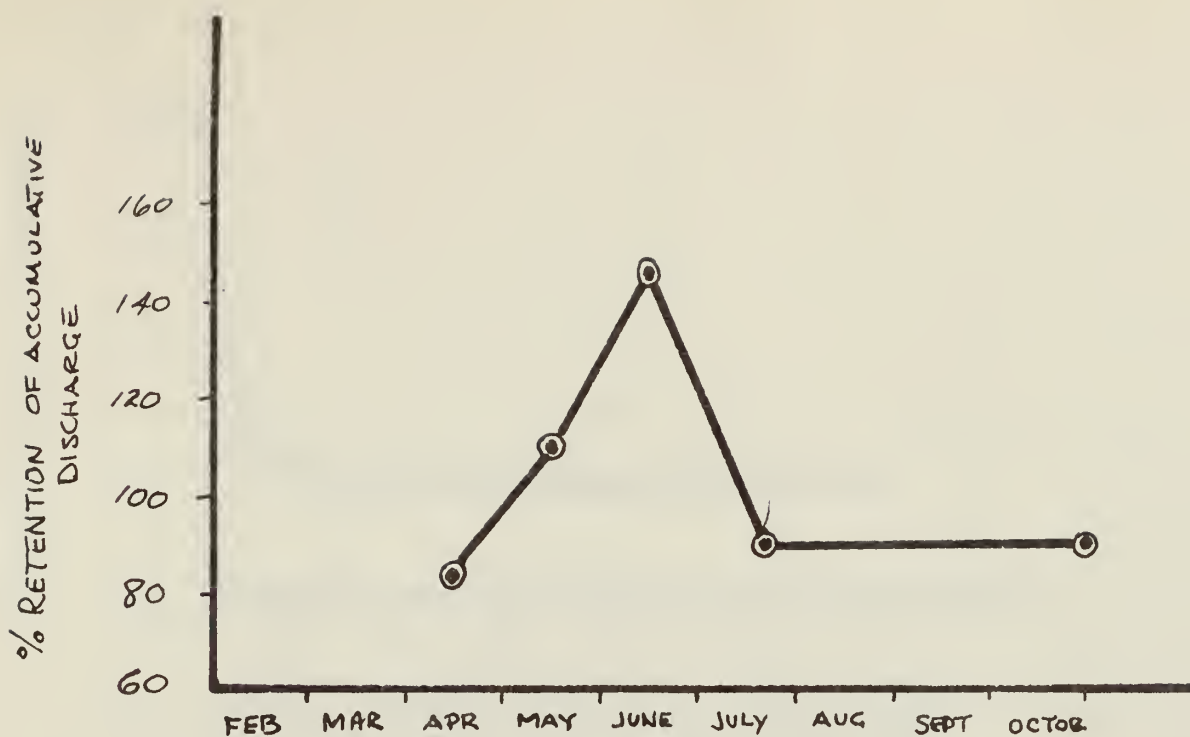
Fig. 7. Accumulative percentage retention of the fill for five intervals during the pumping period.

Based upon surveyed beach profiles and fathometer traverses across the inshore zone, retention figures approach 90% for the entire project. In Figure 7 the accumulative retentions at five intervals during the pumping period are illustrated. It should be noted, however, that loss may not constitute total loss from the system. During the period mid-April to mid-June calculated percentages of retention exceeded 100% and undoubtedly reflects natural beach building processes over and above the discharge additions. At the conclusion of the pumping, approximately 90% of the 1,250,000 cubic yards of sand discharged was in place. Based upon retention estimates the volume of sands in place on the beach system was calculated for five times during the pumping. A comparison of discharge volumes and volumes in place during the pumping period is illustrated in Figure 8.

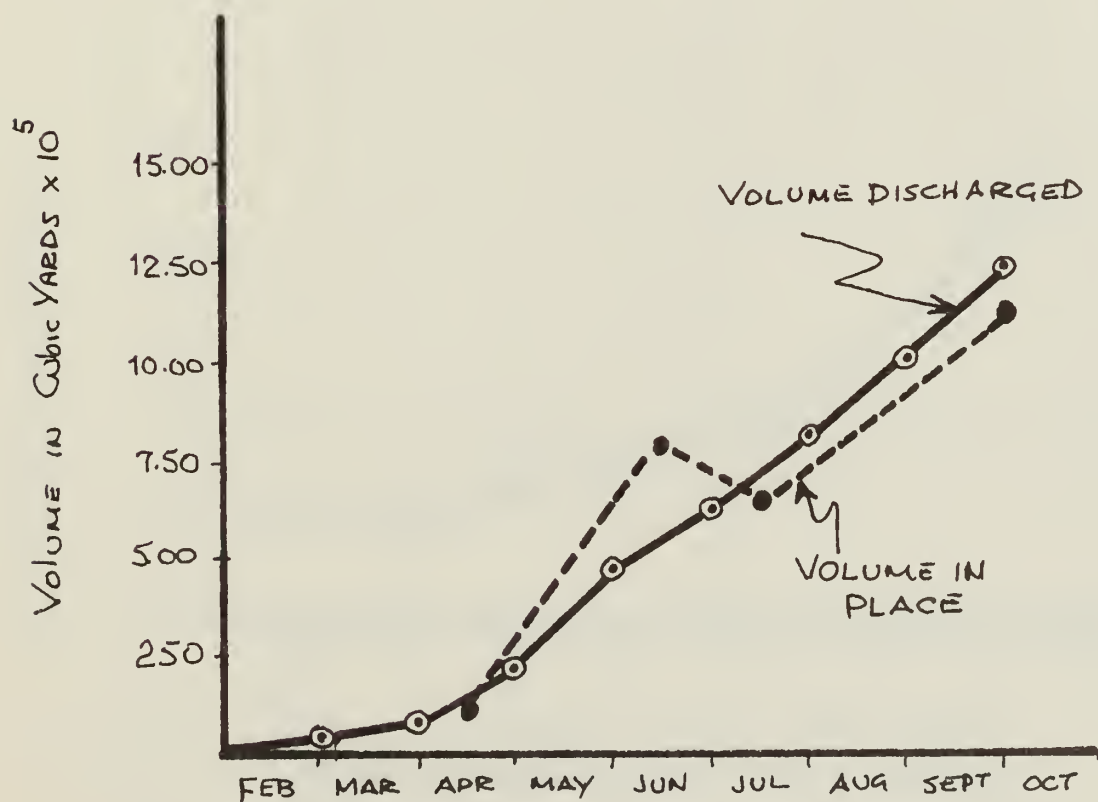
Fig. 8. Discharge volume corrected for percentage retention of the fill.

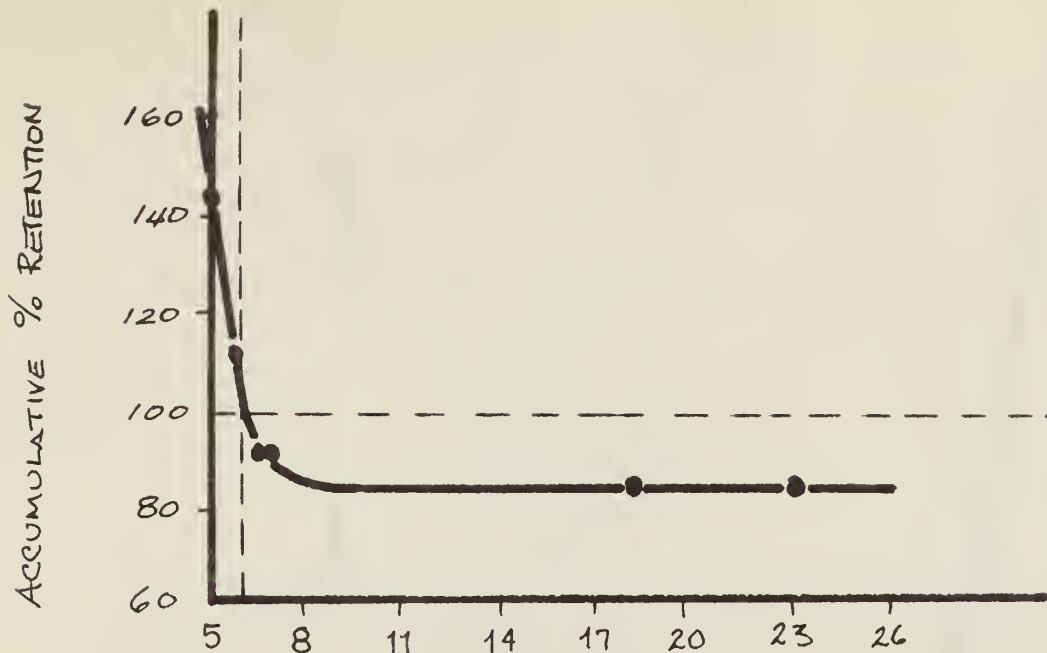
HIGHEST DEEP WATER WAVE HEIGHT (IN FEET)  
FOR PERIOD PRIOR TO RETENTION ESTIMATE

Fig. 9. Accumulative percentage retention of the fill for various wave height environments.

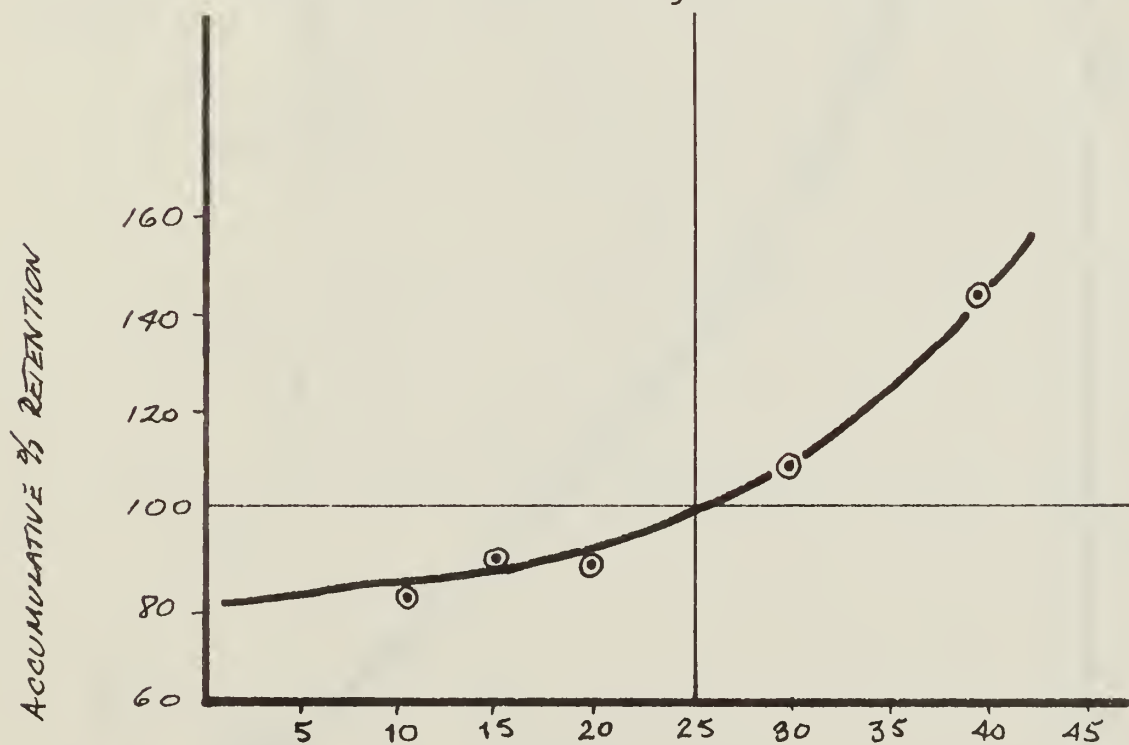
RETURN INTERVAL IN DAYS FOR STORMS  
GENERATING DEEP WATER WAVES IN EXCESS  
OF 7 FEET.

Fig. 10. Fill retention percentages by return interval of storms generating waves in excess of 7 feet during 1973.

The return interval for storms generating deep water waves in excess of 6 feet, calculated for the discharge period by intervals for which retention estimates were made, was plotted against the retention estimates (Fig. 10). On the basis of this analysis, retention percentages equal to or greater than 100% would be expected only during months when the return interval for 7 ft. or greater storms is less than once in 25 days. Under normal climatic conditions of Cape Hatteras this would only be expected during June, July and August. During 1973 four months (May, June, July and August) met these calm conditions. For retentions greater than 80%, five months normally would have return intervals for 7-foot or greater storms. In 1973, seven months were sufficiently calm to permit retentions in excess of 80%. Clearly

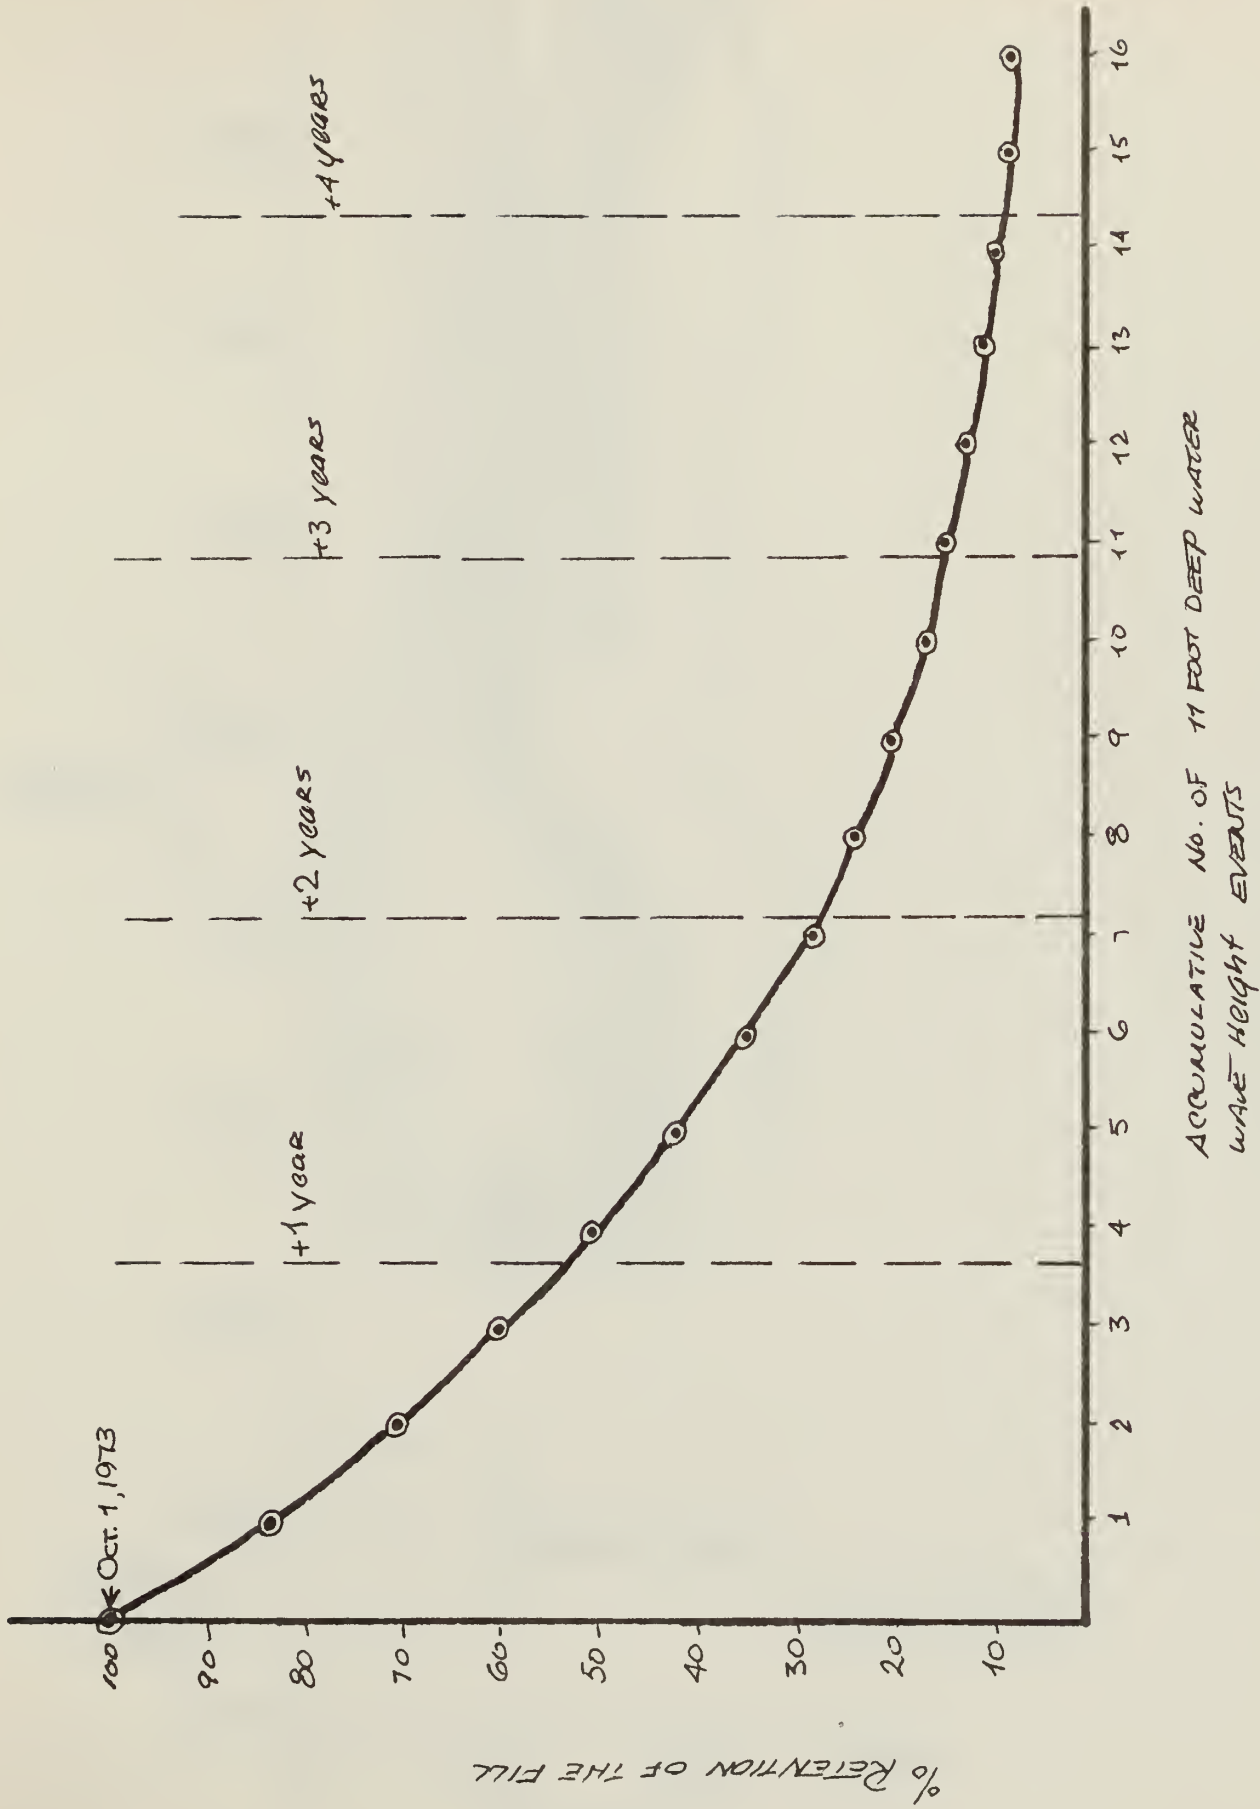
Fig. 11. Estimated retention of the fill for the next five years based upon climatic normals of storms generating 7 foot and greater waves.

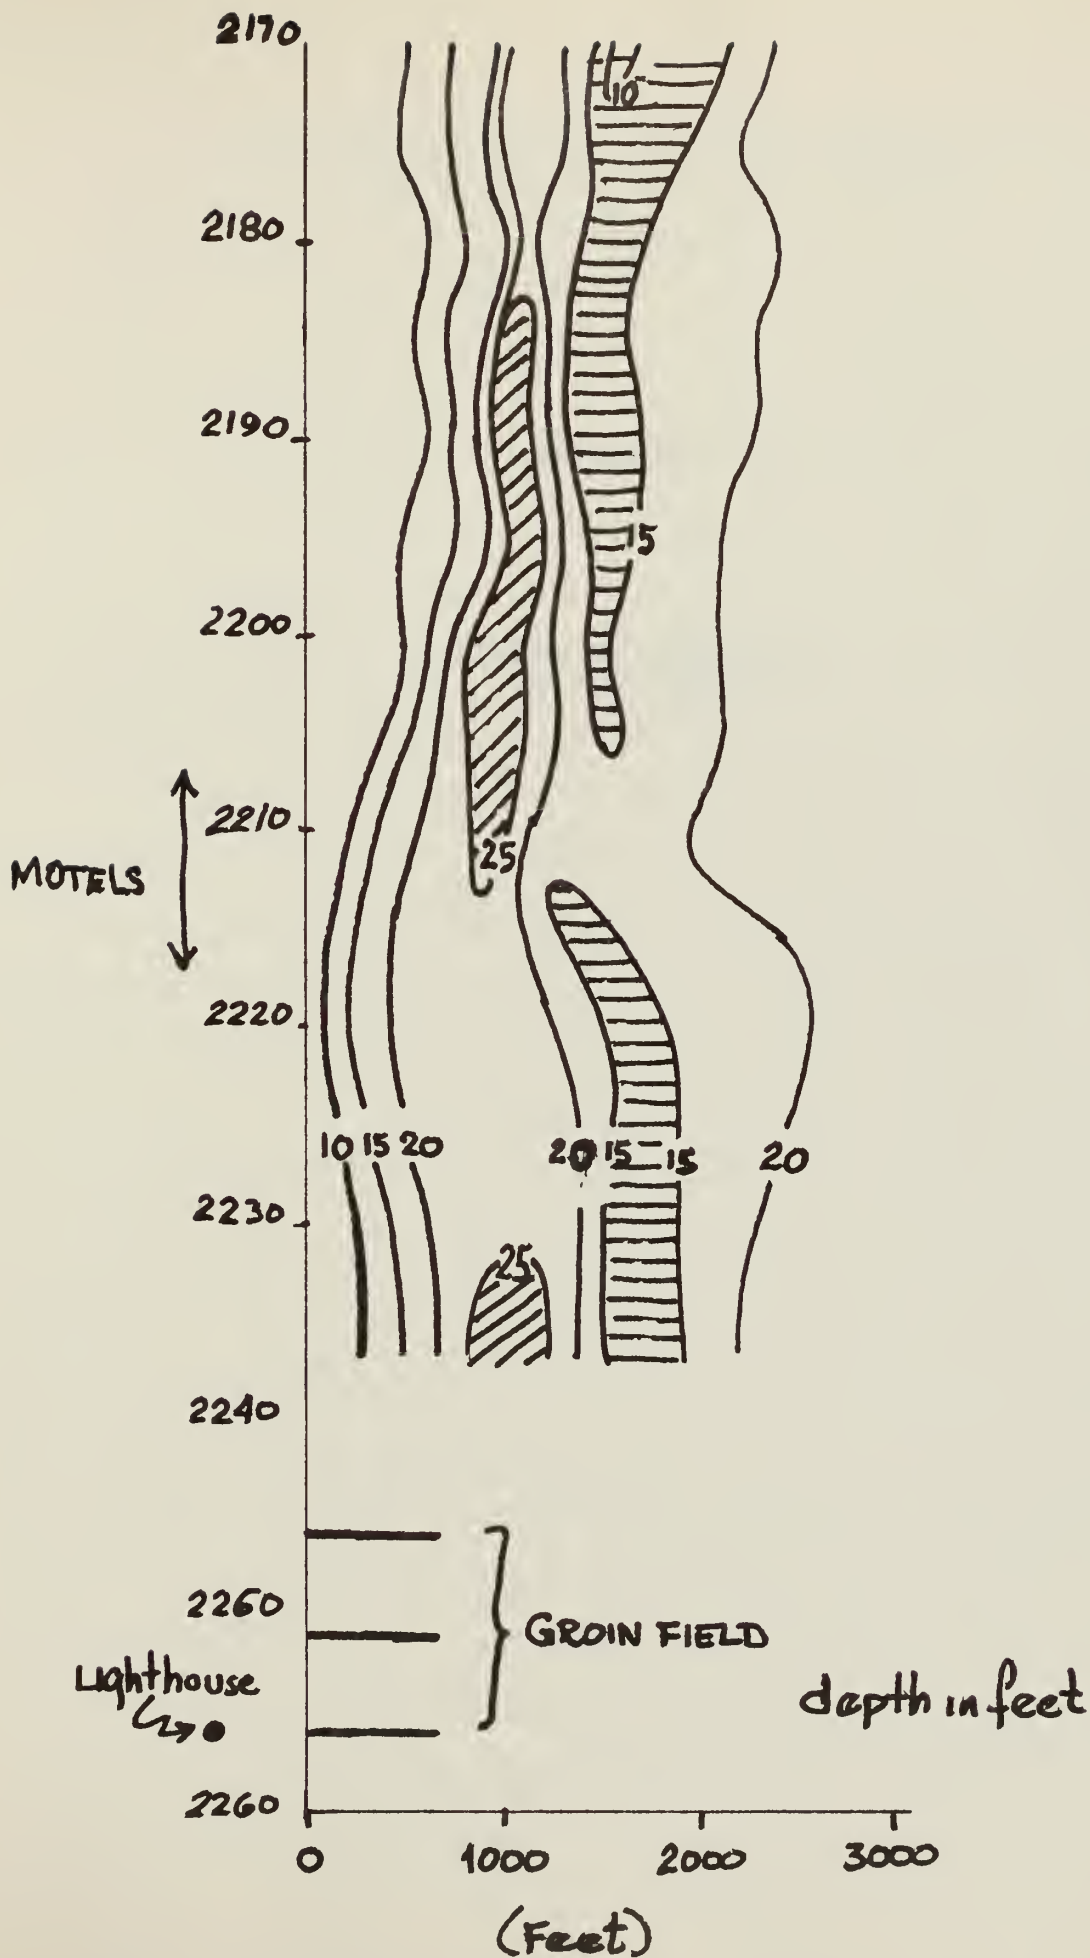
Fig. 12. Nearshore bathymetry in the nourishment area.

Answer: The nourishment program produced significant alterations in the inshore region; however, its effect upon the outer bar appears insignificant. The nourishment program had two primary effects on the inshore zone landward of the trough. The net profile was shifted seaward by the fill. This necessitated a steepening of the profile slope in this region. No inner bar development was noted, but since this bar is most likely due to storm-induced sand transport and since no major storms occurred after March, its absence is natural.

The detailed fathometer surveys during the monitoring period provided an understanding of the reason for the severe erosion at the Buxton motels in particular. A gap in the outer bar 1000 to 2000 feet long directly offshore of the motels allows high waves to reach the shore before breaking (Fig. 12). A more detailed report of this problem is included as Appendix II. During the period April to September no appreciable modification has been observed in spite of the massive nourishment program. As long as this bar gap remains the motel area will be subjected to overwash and erosion stresses during storms.

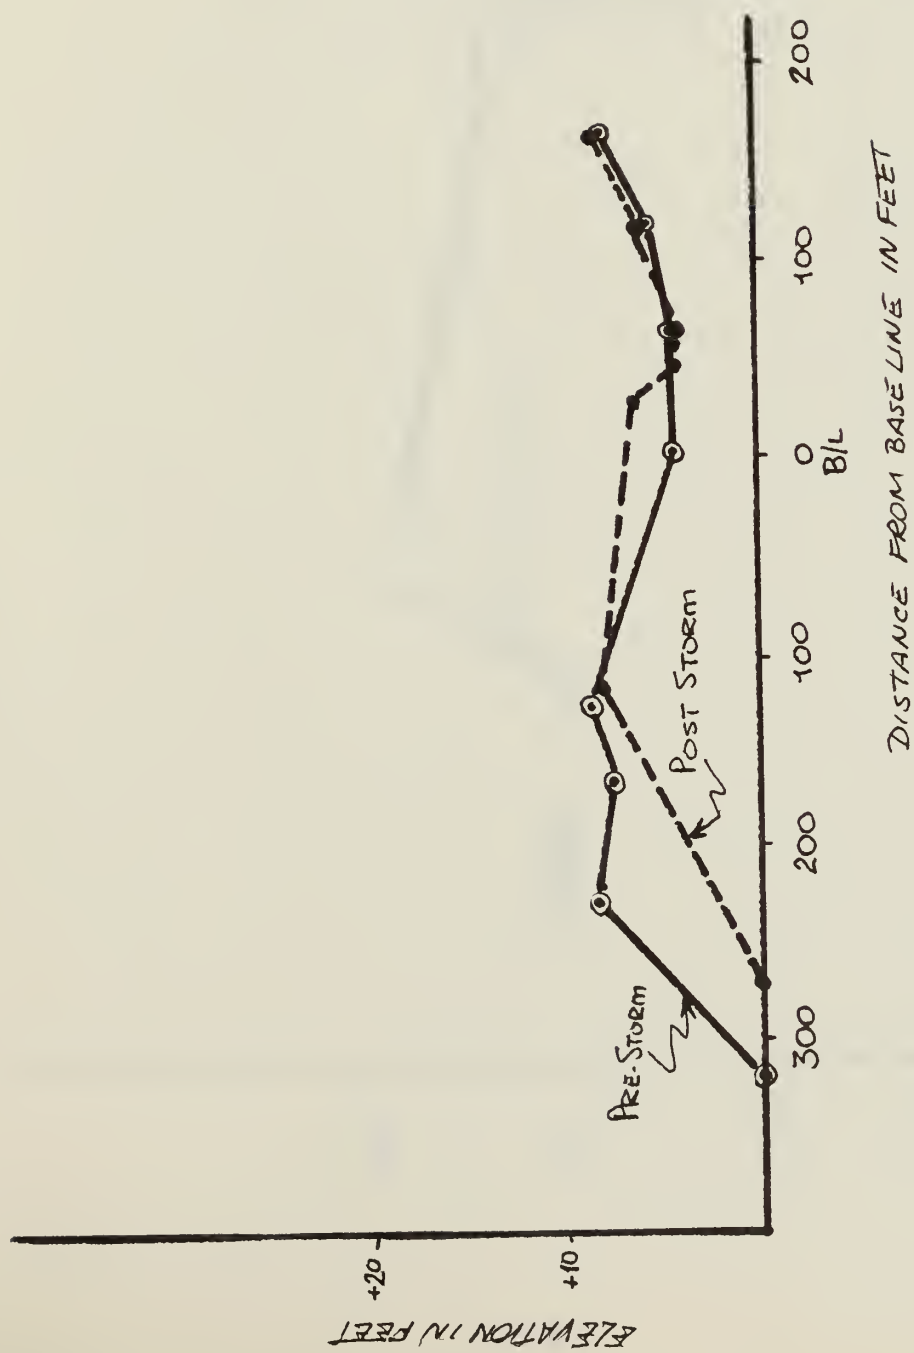
Fig. 1. Generalized changes in beach profiles in the nourishment area.

Beach Face Response: As expected, the initial response of the beach face to the high energy conditions was to assume a long, relatively flat slope (Fig. 1). This adjustment lead to a significant loss of fill seaward of the fill crest, some lowering and retreat of the top of the fill, and a narrowing of the beach.

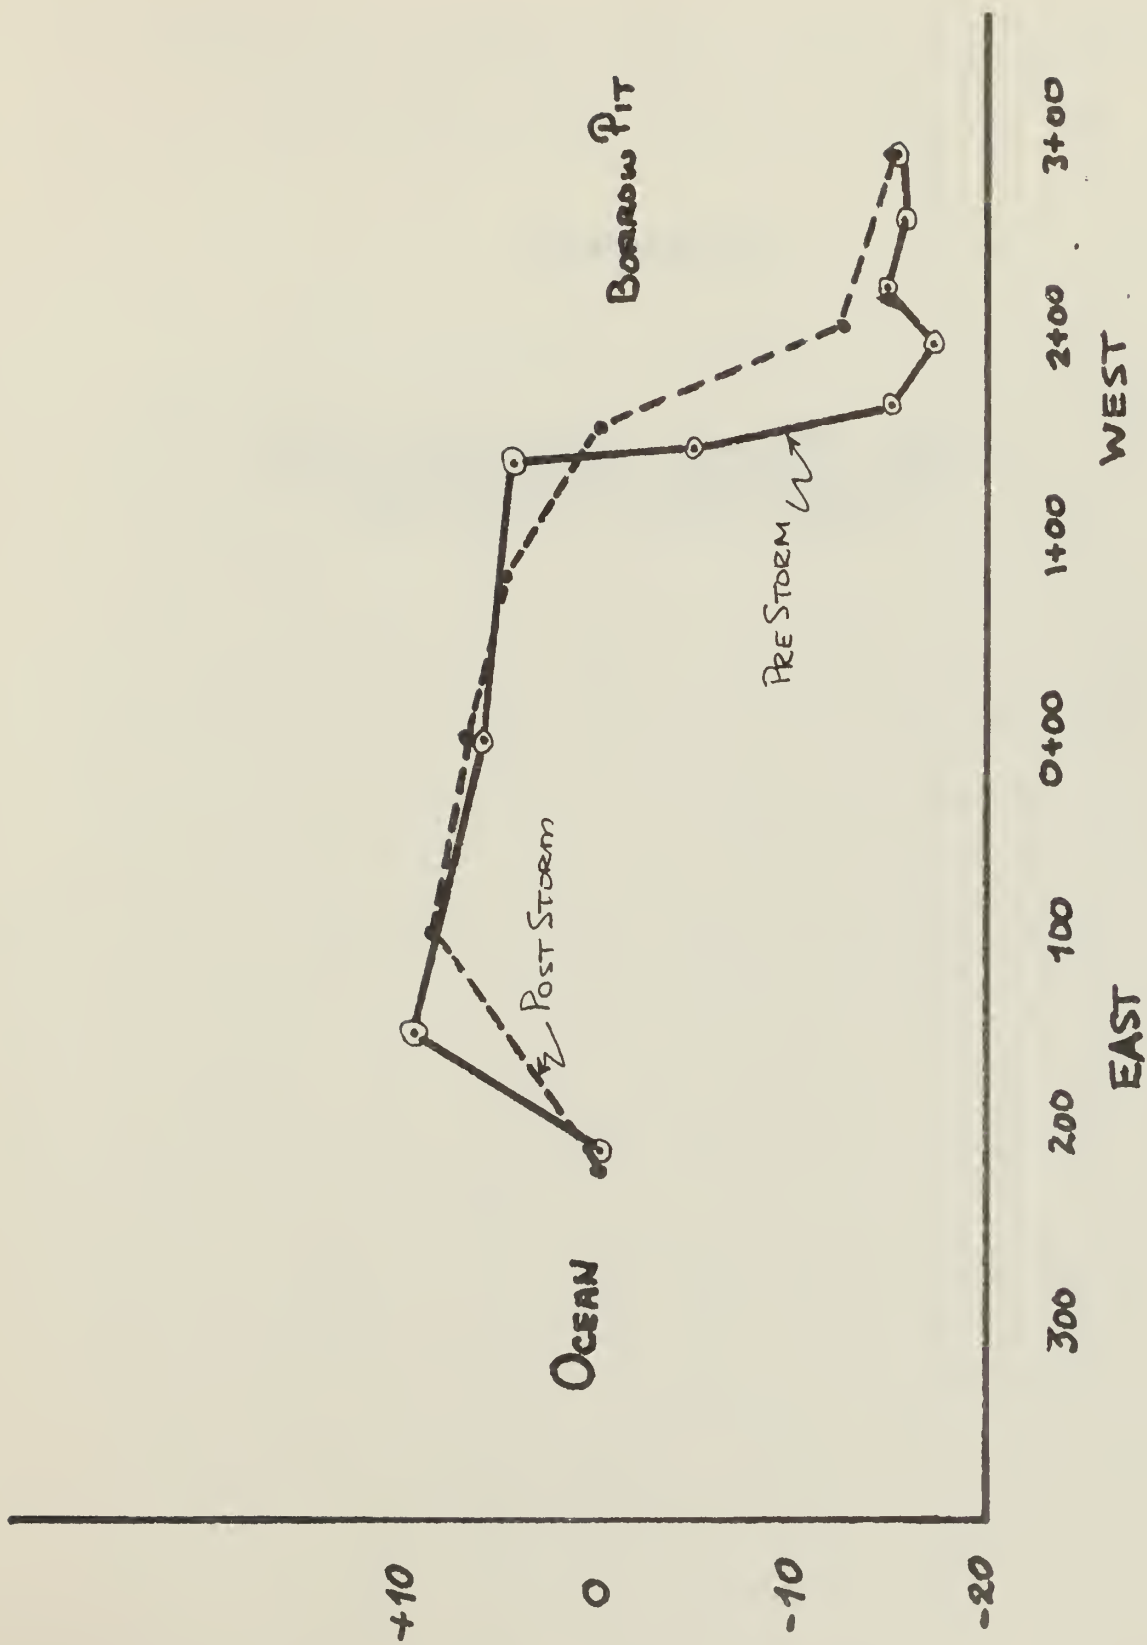
Fig. 2. Generalized changes in the Borrow Pit along the east line between stations 25 + 00 and 18 + 00.

Borrow Pit Response: Overwash into the borrow pit area lead to some deposition. Most of it was concentrated in the southeast corner where overwash was severest and where the borrow pit is nearest to the ocean. Between 1 to 2 feet of sand was deposited on the back side of the beach leading to the borrow area (Fig. 2).

Deposition decreased away from the storm berm and stopped before the excavated area was reached. Erosion of the flat borrow area took place, accounting for some of the sand deposited in the pit. However, some of the sand was pushed into the pit when the steep banks were graded after the pumping terminated. Although no figure on the amount of eroded sand versus the amount of bulldozed sand deposited in the bottom of the pit has been reached, a net increase in the volume of sand indicates that some storm deposition also occurred. Roughly 750 yards were added per 100 feet along the east line from Station 25+00 north to Station 18+00. Some deposition likely occurred along the south side of the borrow pit with some minor deposition in the northeast corner.

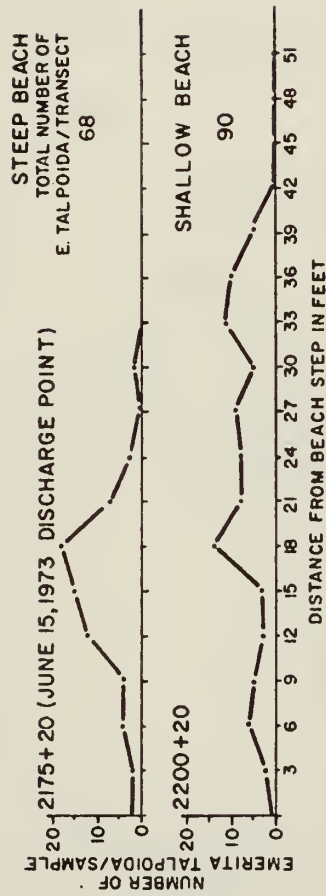
FIG. 4.--Results of Beach-face Samples Analysis

these analyses are presented in Figure 4. On the steep beach a single population-density maximum was observed approximately 18 feet from the most seaward sample point. On the flat beach, a population-density maximum was observed in the same vicinity; however, two lesser maxima were also observed which undoubtedly relate to the complexity of approaching waves as reflected in distinct swash areas in the shallow beach. In order to assess the impact of beach nourishment on *E. talpoida*, it was decided that samples should be taken in the center of the most active swash area of the beach. While fewer organisms were found on the shallow beach than on the steep beach, density at the point of population maxima differed little.

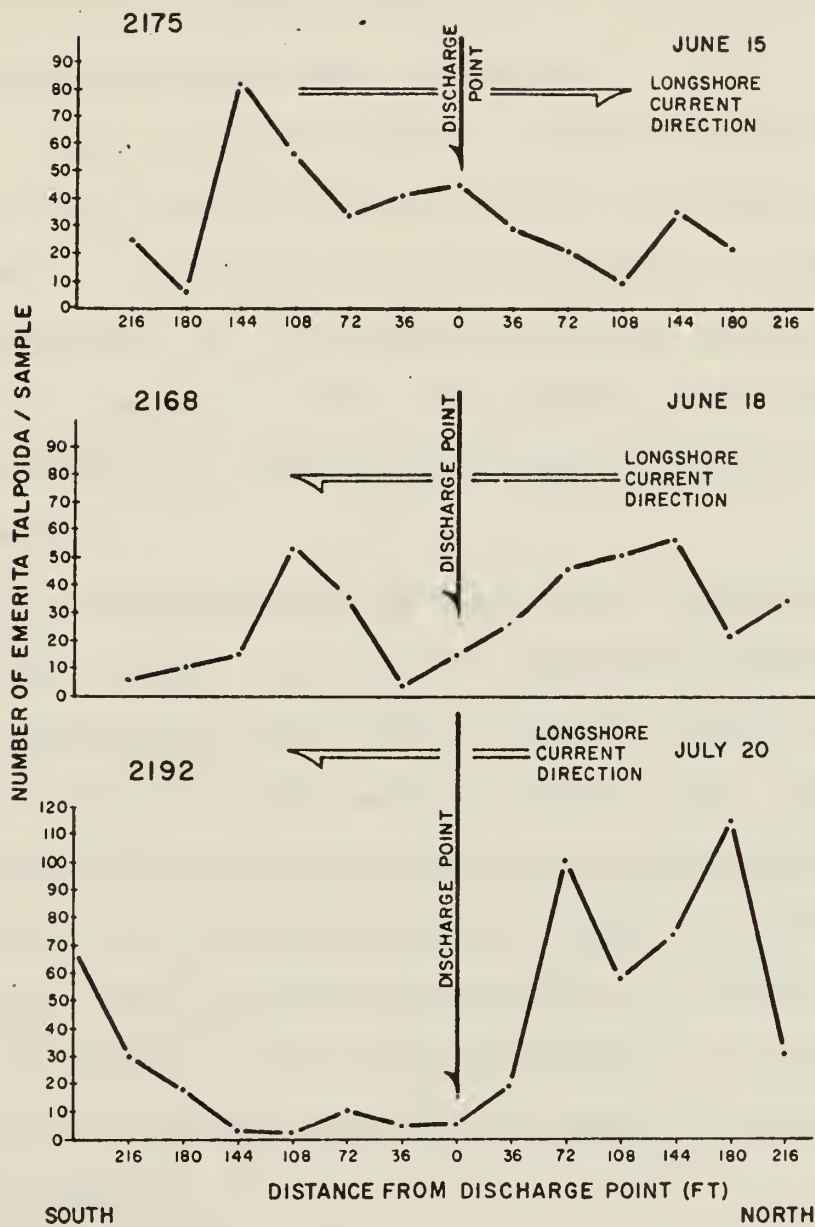
FIG. 5.--*Emerita talpoida* Densities Along the Beach  
Adjacent to Sand Discharge Locations

points, the population densities were depressed to the south of the discharge sites while at the June 15 site, population densities were depressed on the north side. On the days preceeding the June 18 and July 20 samples, waves were from the northeast with a southward longshore current. On the days preceeding the June 15 samples, the waves were out of the southeast and the longshore current moved to the north. Thus, the impact on *E. talpoida* was restricted to the down-current side of the point of sand discharge.

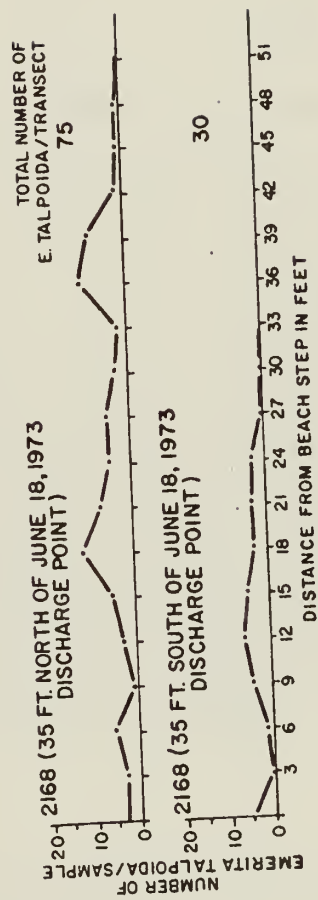
FIG. 6.--*Emerita talpoida* Densities Across the Beach Adjacent to Sand Discharge Point

In order to insure that the observed impact along the beach was not due to sampling error with respect to population positions across the beach, transects at three-foot intervals across the beach were taken 36 feet north and south of the July 20 discharge point. At the time of the July 20 discharge, the longshore current was out of the

It was noted that the population structure was unimodal to the south of the discharge point and trimodal to the north. In spite of this difference, the depression in population density on the down-current side of discharge was clearly evident and is illustrated in Figure 6. While the total number of organisms observed on the impacted south side was 30, 75 were observed on the north side. The 40% reduction in population density is consistent with the 53% observed for the along-the-beach sampling procedure.

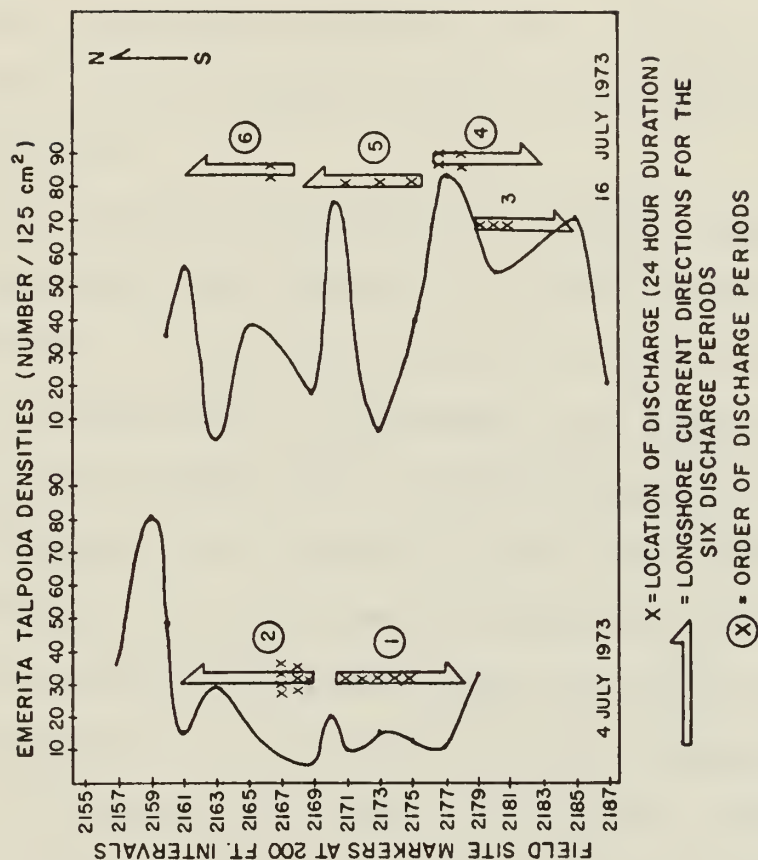
FIG. 7.--*Emerita talpoida* Densities Along the Beach Following Consecutive Times of Discharge

be detectable. Samples taken at 200-foot intervals suggest that this movement may be actual. The results of these analyses are illustrated in Figure 7.

On six occasions sand discharges were accompanied by high population densities approximately 600 to 1,000 feet down the beach from the point of discharge. In three of the six instances, northeast waves and southward longshore currents occurred at the time of discharge; and, in the remaining three cases, southeast waves and northward longshore currents took place. In all six cases, the elevated numbers of *E. talpoida* observed were in the down-current direction at a distance of between 600 and 1,000 feet. This dimension is consistent with sand-wave shoreline meanders in the area and suggests that the mode of transport and re-entry onto the beach face may be the response of the bar system to the prevailing longshore current.
