**ANALYSIS OF CHANNEL GEOMORPHOLOGY AND  
HABITAT FORMING PROCESSES FOR  
FEASIBILITY ASSESSMENT OF  
RIP-RAP REMOVAL,  
MUIR WOODS NATIONAL MONUMENT  
MILL VALLEY, CALIFORNIA**

**Final Report**

The National Park Service,  
Muir Woods National Monument,  
And the  
Golden Gate National Recreation Area

May 2002

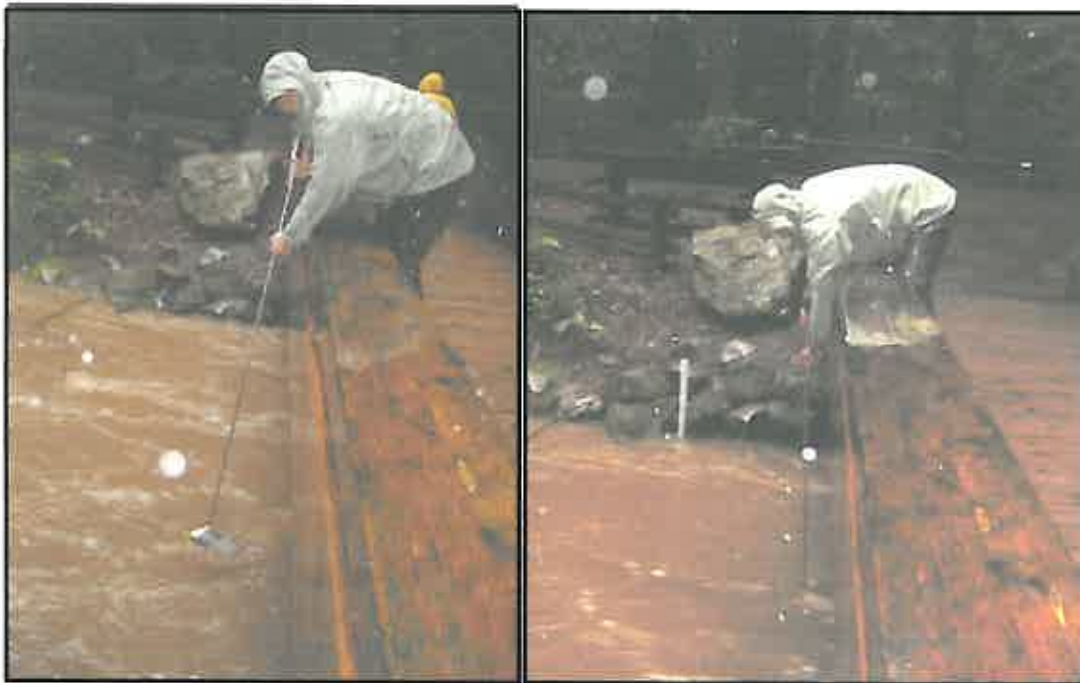
Figures 2 and 3. Suspended sediment sampling. Lowering and raising a DH-48 sampler into the flow across the channel and a temporary gage on left bank.

Suspended sediment samples from Redwood Creek were collected during storm flows to support a sediment budget for the watershed and to put estimated sediment influxes from riprap removal and post-removal bank erosion into perspective. I collected four suspended sediment samples during heavy rains on February 19, 2002 according to the method described in (Beschta, 1996). I lowered a DH48 (Depth-integrated Handheld) suspended sediment sampler from the upstream side of Bridge 2 (Figures 2 and 3) moving across the flow from the left bank to the right bank. I lowered and raised the sampler in even motions so it was in contact with the water for the same amount of time at each spot. I repeated this at intervals of about two feet moving across the creek. Samples will be analyzed by NPS and the data used in decision making about riprap removal.

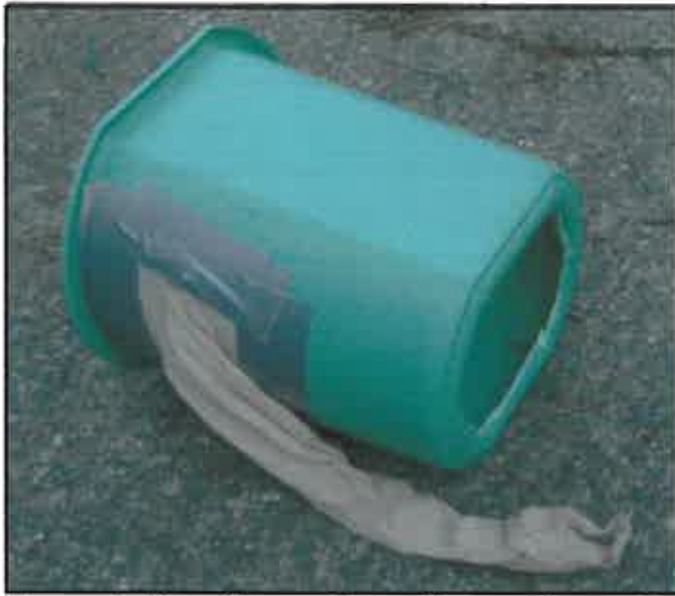
**Figure 4.** Hess-like sampler used to sample aquatic insects in Redwood Creek. A plastic garbage can with a 0.5 ft opening and a nylon stocking to catch the sample.

I collected samples of aquatic insects at five sites on Redwood Creek in Muir Woods by using a modified Hess sampler (Figure 4). The mouth of the sampler had a 0.5 ft<sup>2</sup> (0.046 m<sup>2</sup>) opening area, which I placed over the substrate to achieve a known sampling area. I taped a nylon stocking around the hole in the side of the bucket to act as a sieve and catch the sample. For each site, I took samples from three strata: the surface of riprap in water, a natural bank in water, and the bed (Figure 5). I placed the sampler over three areas per sample and disturbed the substrate to put any insects into the water column and then into the collection net. For example, at one riprap site, I sampled three different 0.5 ft<sup>2</sup> (0.046 m<sup>2</sup>) areas for one minute each, giving a total sampling time of three minutes and a total sampling area of 1.5 ft<sup>2</sup> (0.14 m<sup>2</sup>) for one riprap site. This method allowed for a more representative sample to be collected from each site. I repeated the process for a natural bank and a bed area within 100 feet to achieve somewhat constant conditions.

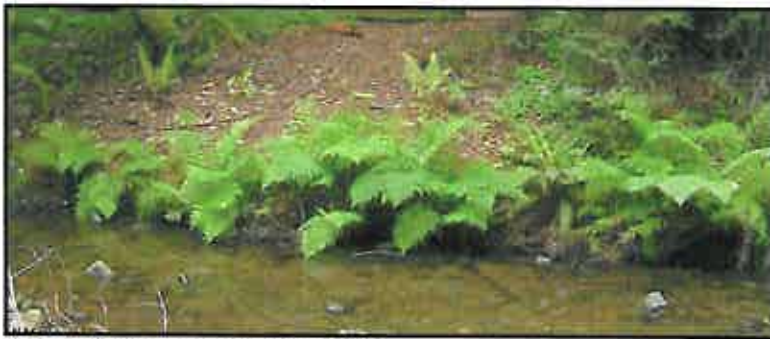
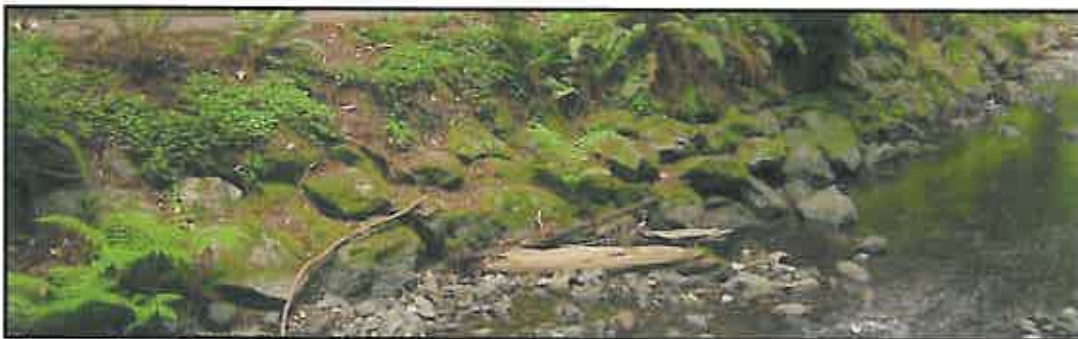
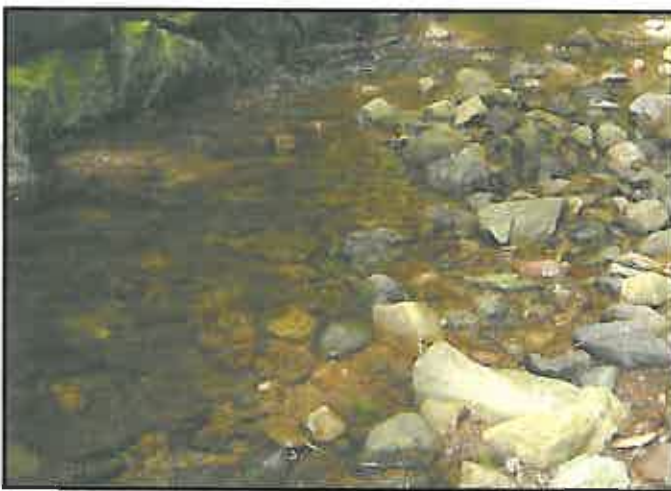
Natural Bank Strata Example

Riprap Strata Example

Bed Strata Example

**Figure 5.** Examples of the three strata samples for aquatic insect abundance and diversity.

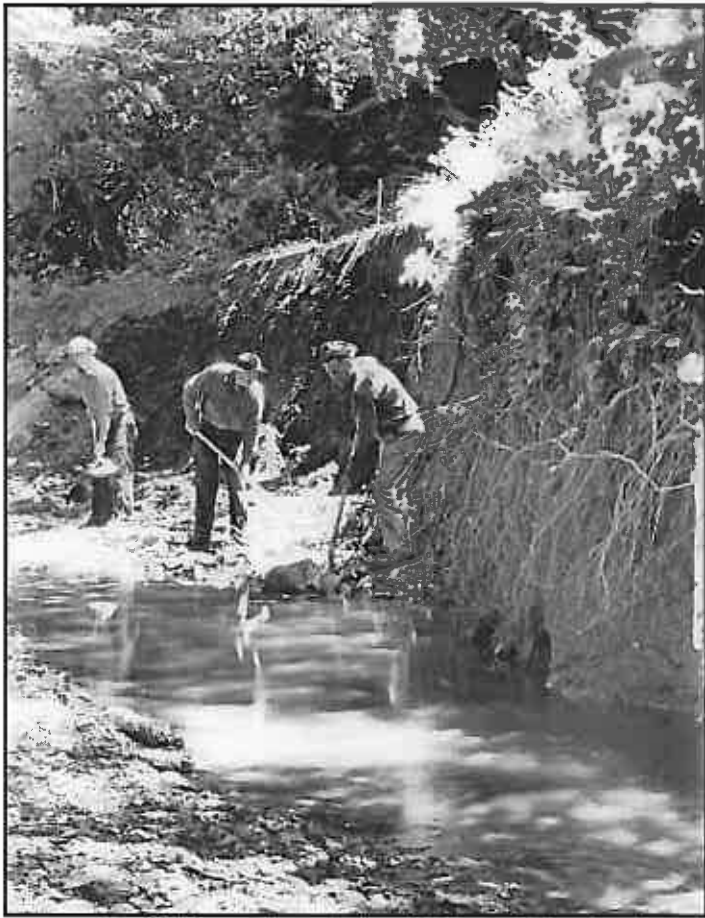
**Figure 6.** CCC workers in the Redwood Creek channel. Note the height of the bank in relation to the men and the roots exposed from scour (from NPS Archives).

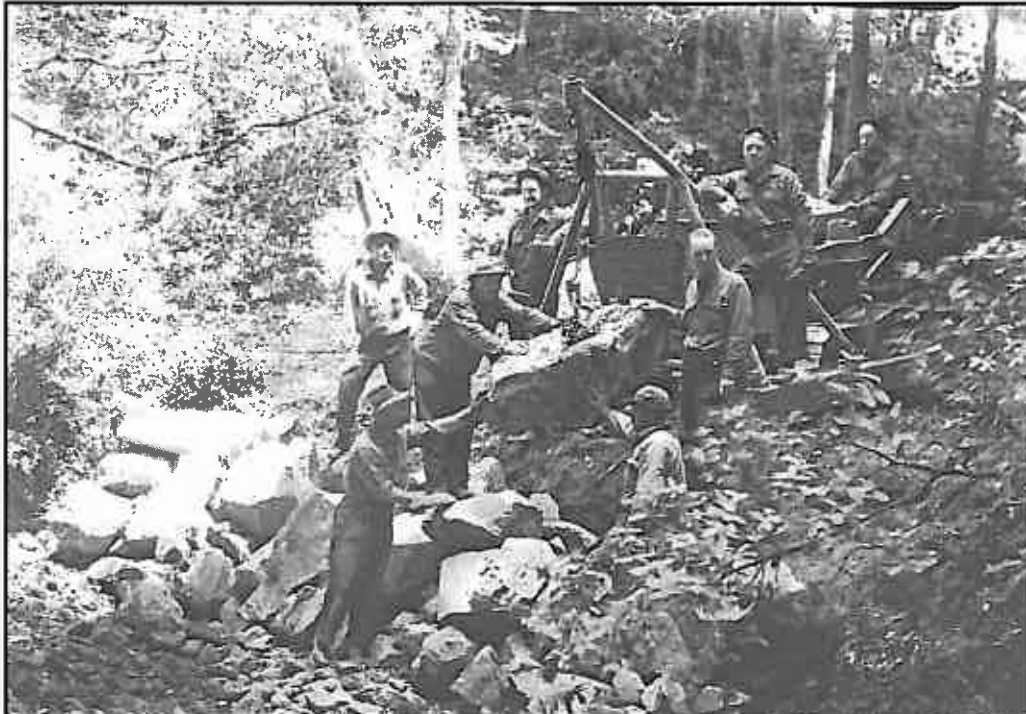
**Figure 8.** CCC workers placing large boulders on Redwood Creek in Muir Woods ca. 1934 (from NPS Archives).

Following the initial attempts at stream bank revetments and the concern over what were seen as unstable banks, the CCC installed 26 sections of boulder riprap on the banks of Redwood Creek and 2 sections on Fern Creek (a tributary) from 1933-1938. Length of the riprap sections ranged from 13-540 ft (4-165 m) and rock size ranged from about 1-3 ft (0.3-1 m) in diameter (Figure 8).

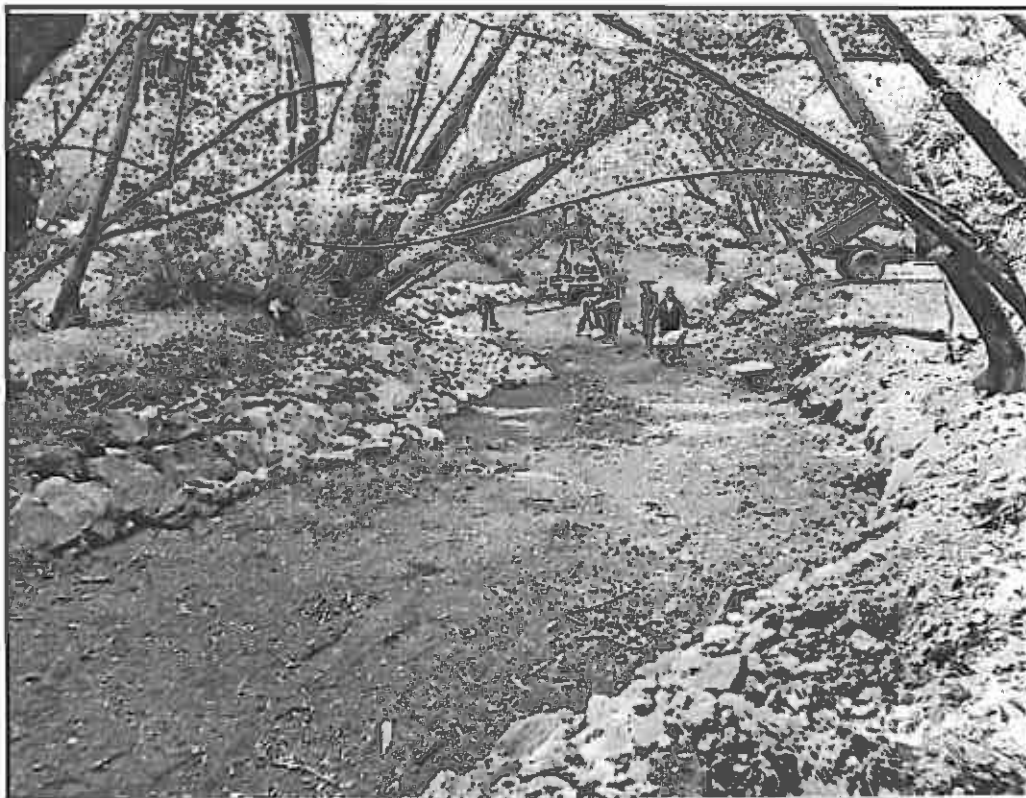
**Figure 9.** CCC workers installing rock riprap along the banks of Redwood Creek. Note the lack of bank vegetation and the truck on the bank, showing bank disturbance, also the machinery in the creek. ca. 1934 (from NPS Archives).

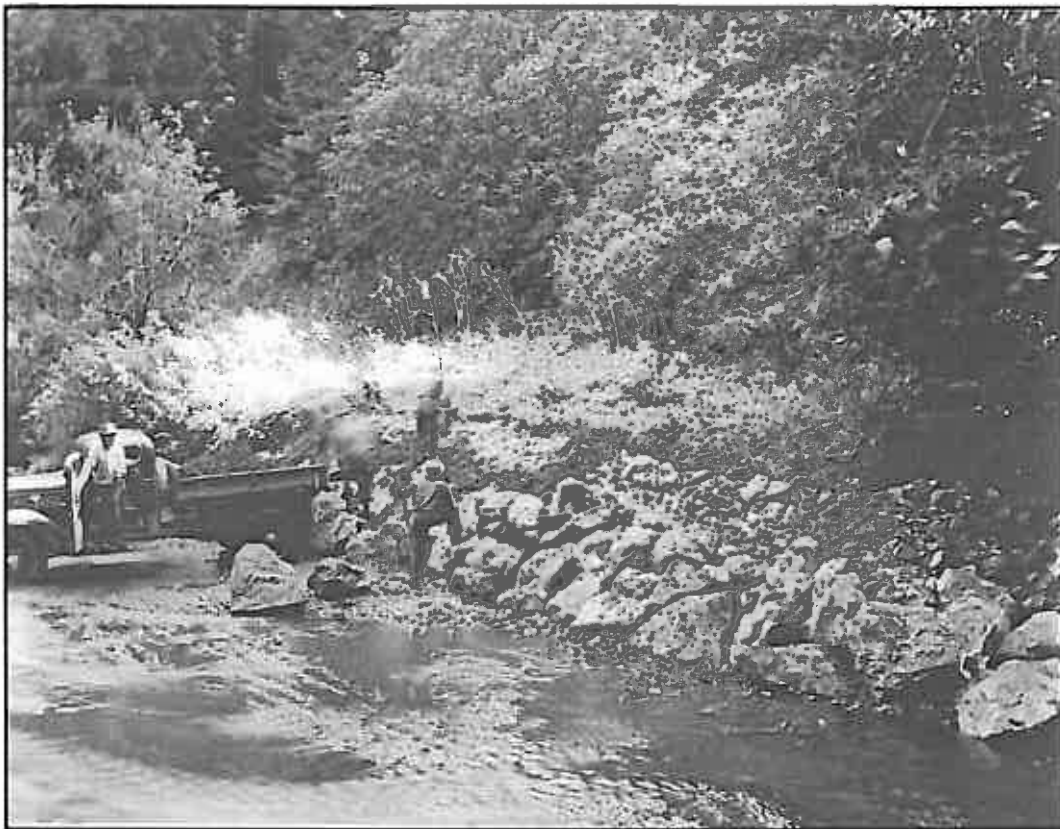
**Figure 10.** Equipment working in streambed during CCC riprap construction ca. 1937, note the bed and bank disturbance (from NPS Archives).

Trucks and heavy equipment were driven in the creek bed to excavate parts of the bed for the riprap and check dam installations (Figures 10,11) (Haynes, 1936), however it is not clear whether the bed was excavated and then filled in after rock placement, or if the material was moved elsewhere, leaving the bed wider or lower than previously, or even if the channel was straightened as part of the project<sup>1</sup> (Figure 12).

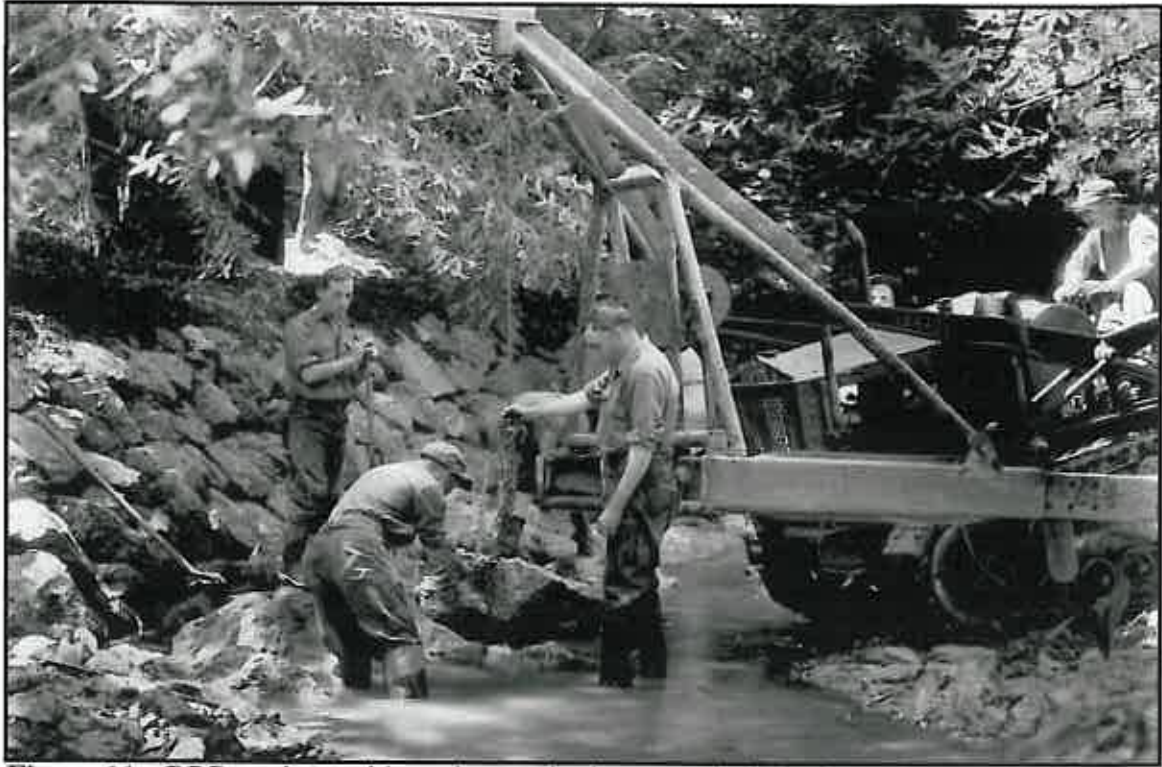
**Figure 11.** CCC workers with equipment in the streambed placing rock ca. 1936 (from NPS Archives).

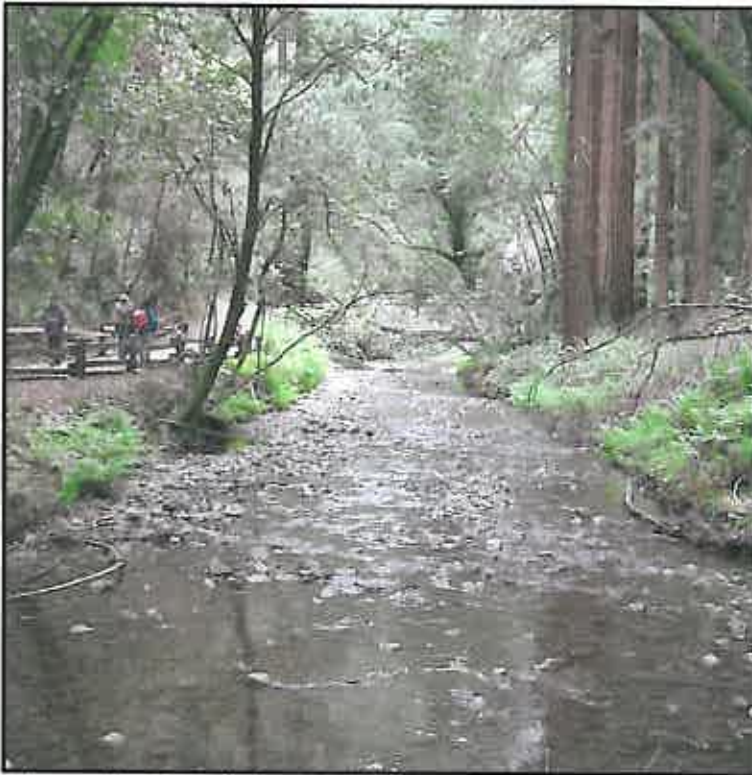
**Figure 12.** Reach that appears unnaturally straight and could have been straightened during CCC construction.

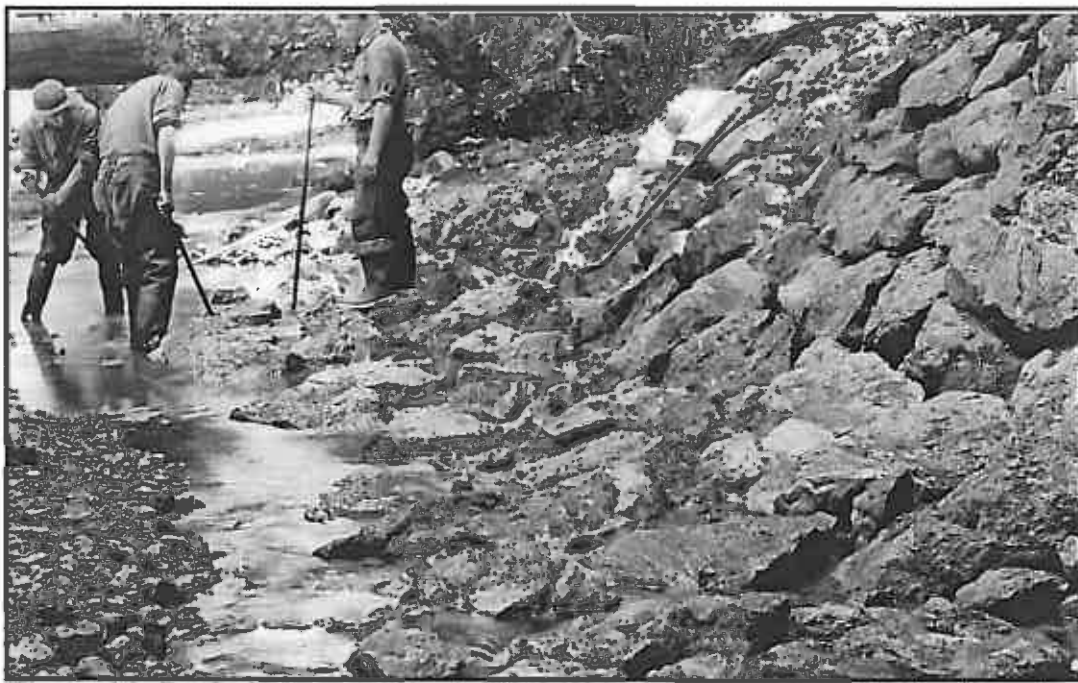
**Figure 14.** Rock riprap armoring the stream bank and extending into the channel as depicted in Figure 13 (from NPS Archives).

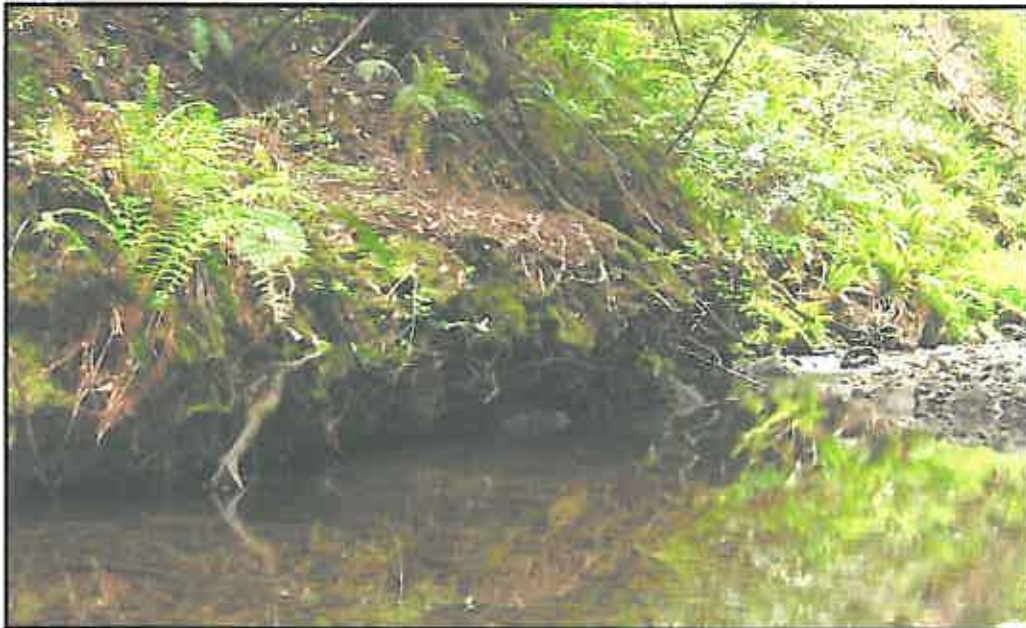
**Figure 15.** Undercut bank with pool on a non-riprapped meander bend in Muir Woods. Tree roots and ferns and a bedrock outcrop stabilize the bank.

Riprap now armors the outside banks at 19 out of 29 bends, and along seven straight reaches, resulting in a flatter channel cross section than would be expected because flow circulation cannot create scour pools and undercut banks on the outside of the meander bends as it can where banks are not armored (Figure 15). Cross sections of areas with riprap (Appendix 2) show flatter streambeds or, as in section L-11, a narrow channel adjacent to the riprap with a high gravel bar opposite the riprap. Without the ability to erode the outside bend and move in that direction, the channel also cannot create a point bar that grows and evolves as the channel moves.

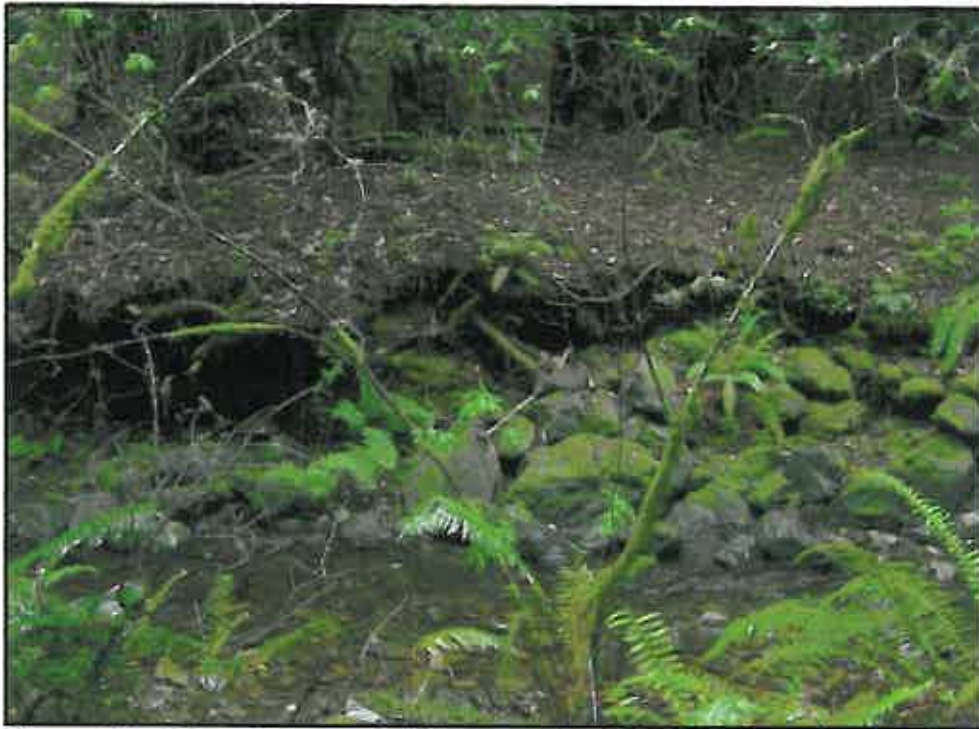
**Figure 16.** Downstream end of riprap section R9. Note the rock slumping into the channel and the bank scour on the left.
