## Condition of Bulkhead, Great Kills Marina

Prepared by: Norbert P. Psuty  
Tanya M. Silveira  
Daniel Soda  
Institute of Marine and Coastal Sciences  
Rutgers, the State University of New Jersey

Submitted to: Mark Christiano  
Gateway National Recreation Area  
Ft. Wadsworth

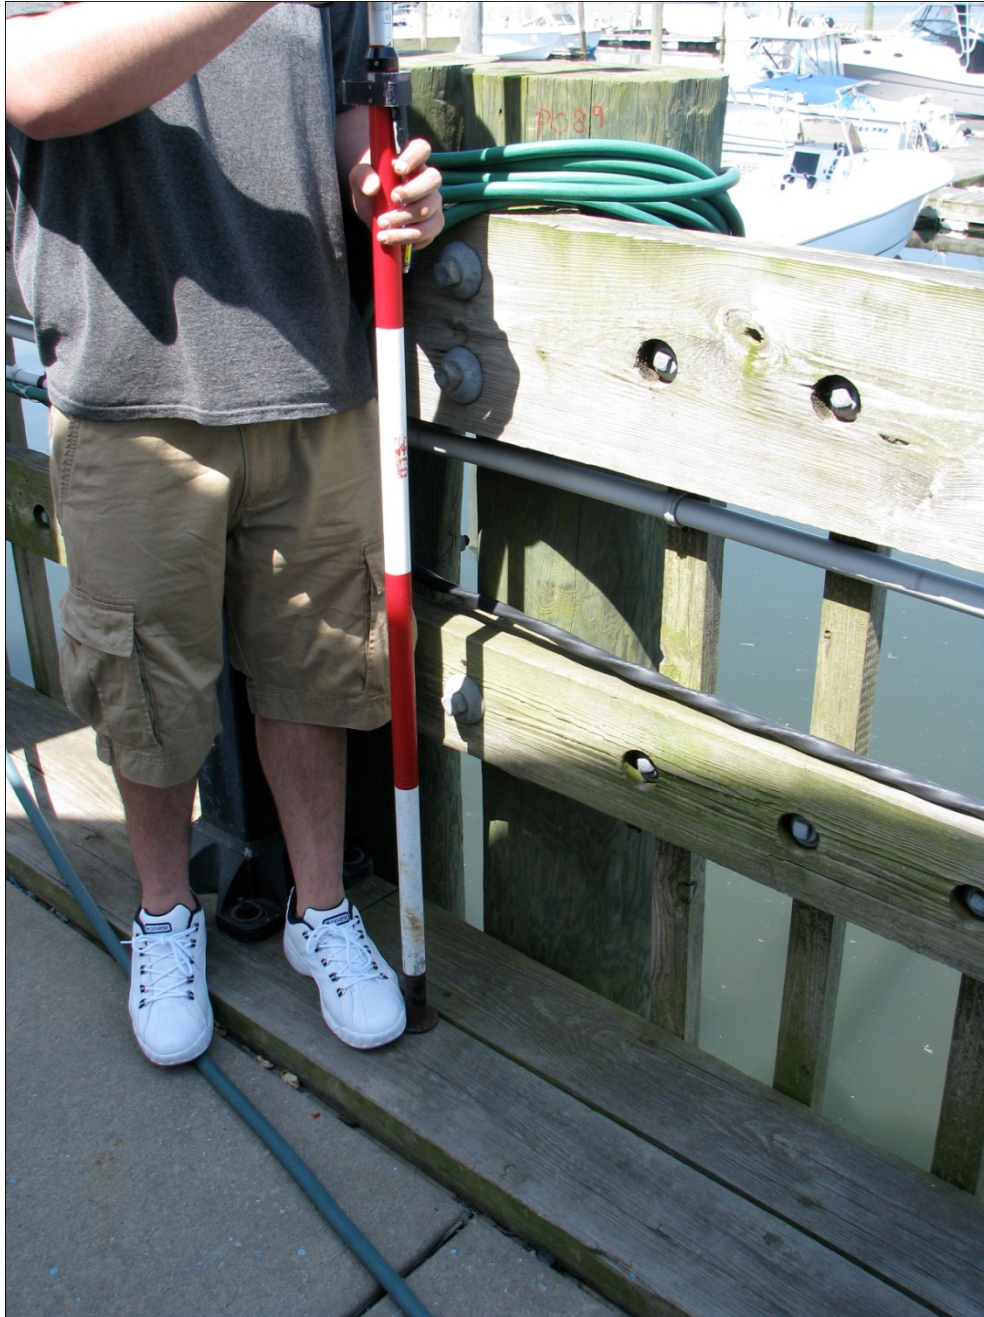
1. The land surface is lowering. At several locations along the inland margin of the line of pilings, there is evidence of a relative lowering of the sediment surface compared to concrete or wooden platforms. In some cases, the differences are minor, but in some cases the differences are on the order of 7-8 cm (Fig. 1).

Figure 1. Lowering of the concrete surface adjacent to the marina bulkhead, 7-8 cm. May 24, 2010.

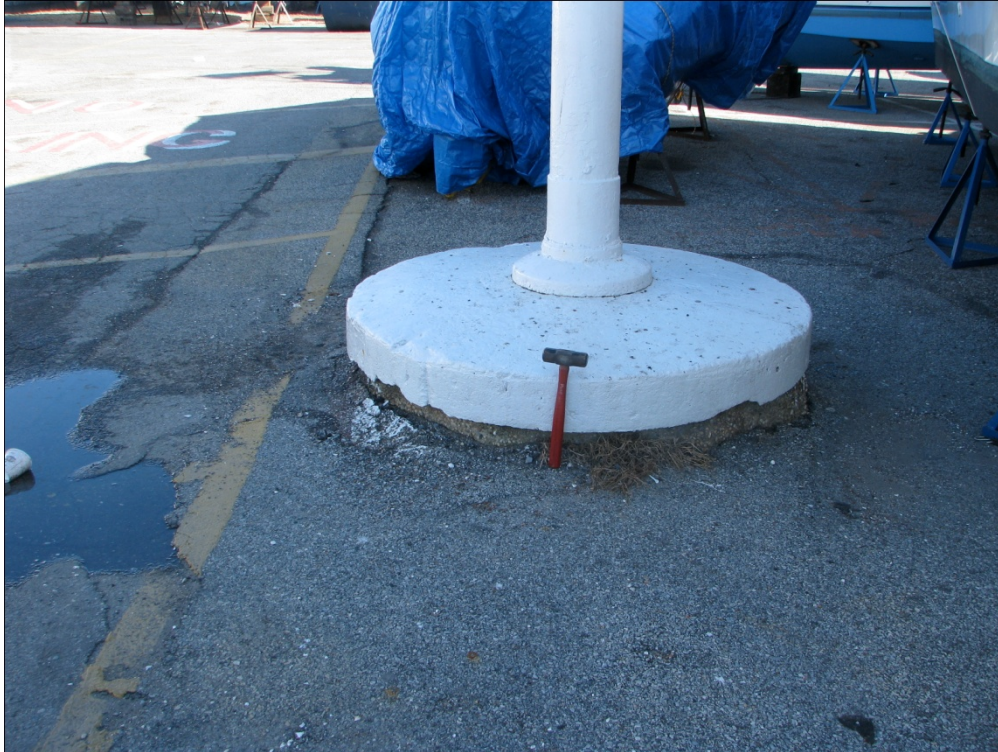
2. The land is lowering. At one case, at the base of a 'flag' pole in the parking area, the depression of the surface is on the order of 10-12 cm (Fig. 2).

Figure 2. Lowering of parking lot surface relative to flag pole, 10-12 cm. March 24, 2009

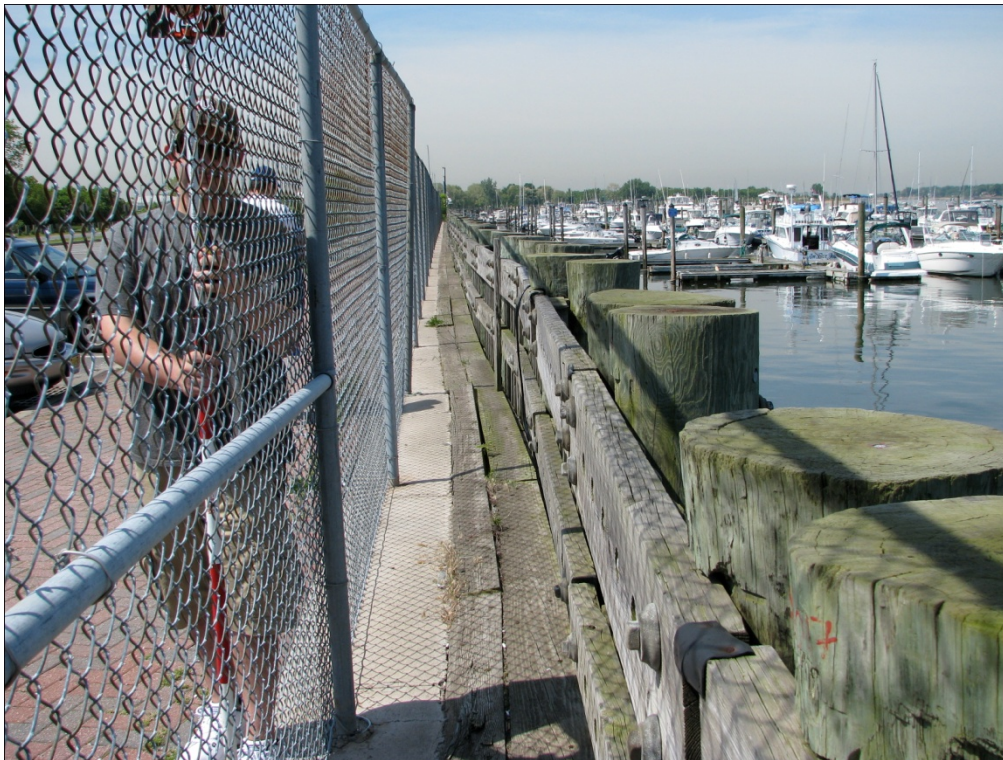
3. The land is shifting into the marina basin. In the northern portion of the marina, the displacement is less than 10 cm (Fig. 3). In the southwestern end of the marina, near the boat launch site, the pilings have shifted marineward about 25-30 cm. The pilings are leaning and there is a loss of land along the inland margin of the pilings. There are a few places where the pilings are shifting into the marina and the hole extends to the water level (Fig. 4).

Figure 3. Shift of bulkhead and pilings into marina, less than 10 cm. northern end of marina. May 24, 2010.

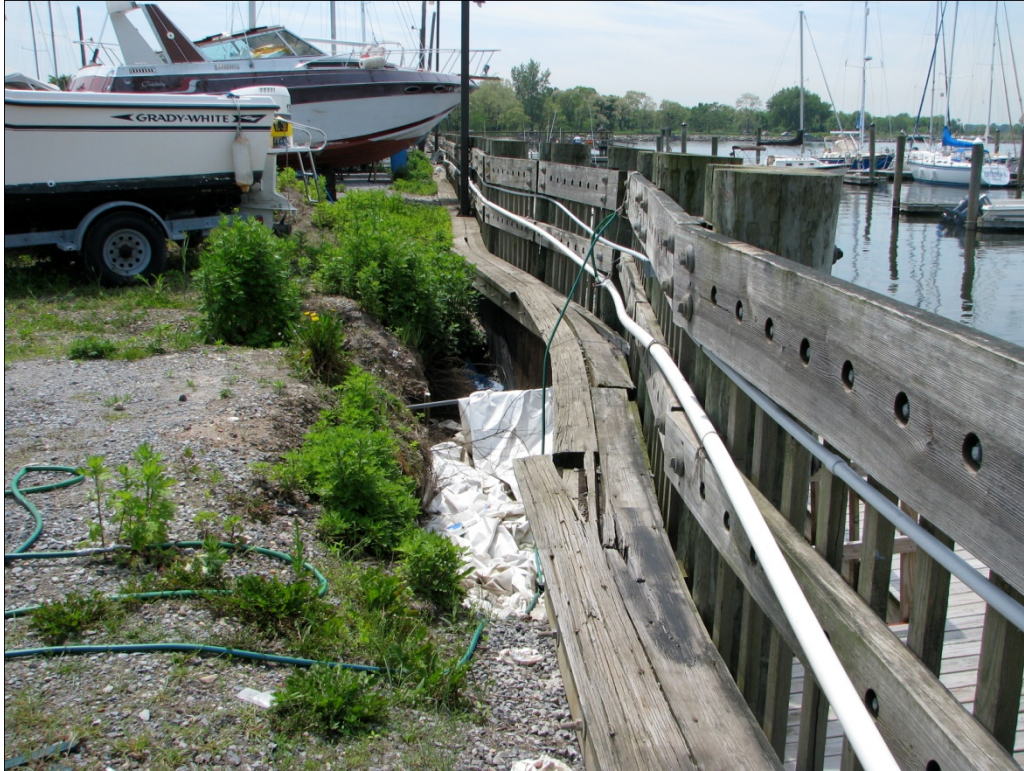
Figure 4. Major shift of pilings and bulkhead into marina, 25-30 cm, May 24, 2010.

Another situation is the general flow of the fill that is also displacing the pilings in the fill. In this instance the flow is of sufficient depth that the pilings are being dragged along. They are tilting, indicating that the flow is faster forward the surface (Fig. 4).

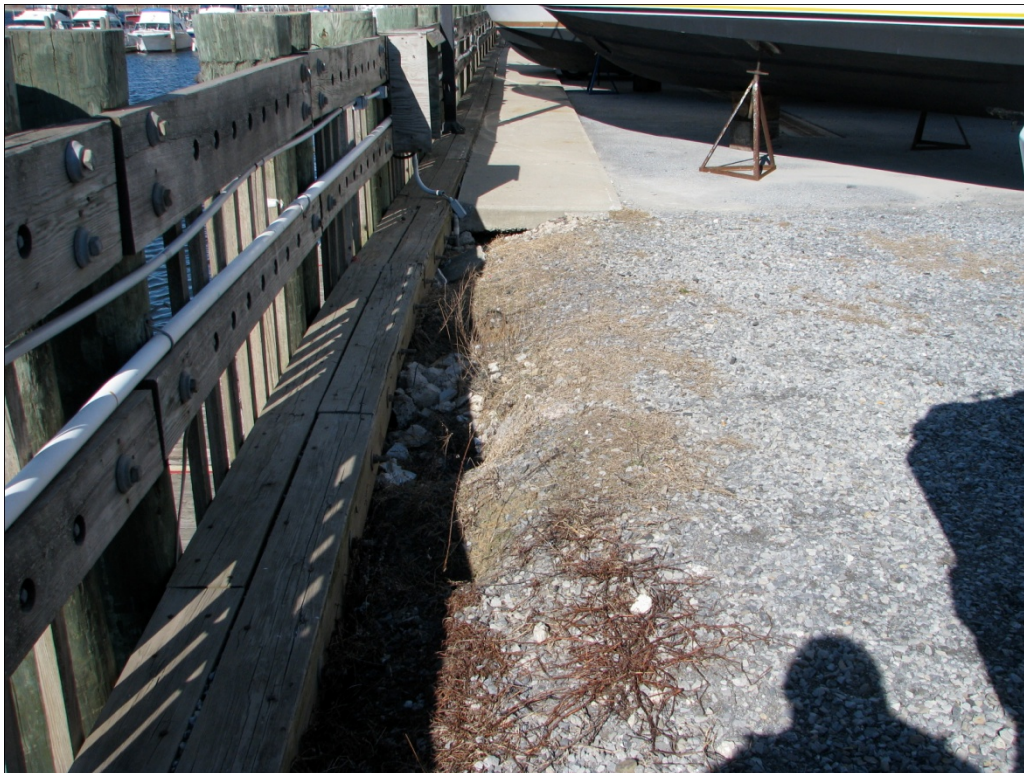
4. Sediment is flowing and gaps are being created at the inland margin of the line of pilings in the marina (Fig. 5).

Figure 5. Sediment lost at inland margin of bulkhead, some gaps 10s of cm deep. March 24, 2009.

However, there are gaps and holes that are more indicative of flow and a loss of mass as material is removed and voids are created. In these cases, the sediment is being transferred and is causing voids to develop along the margins of the fill (Fig. 5).

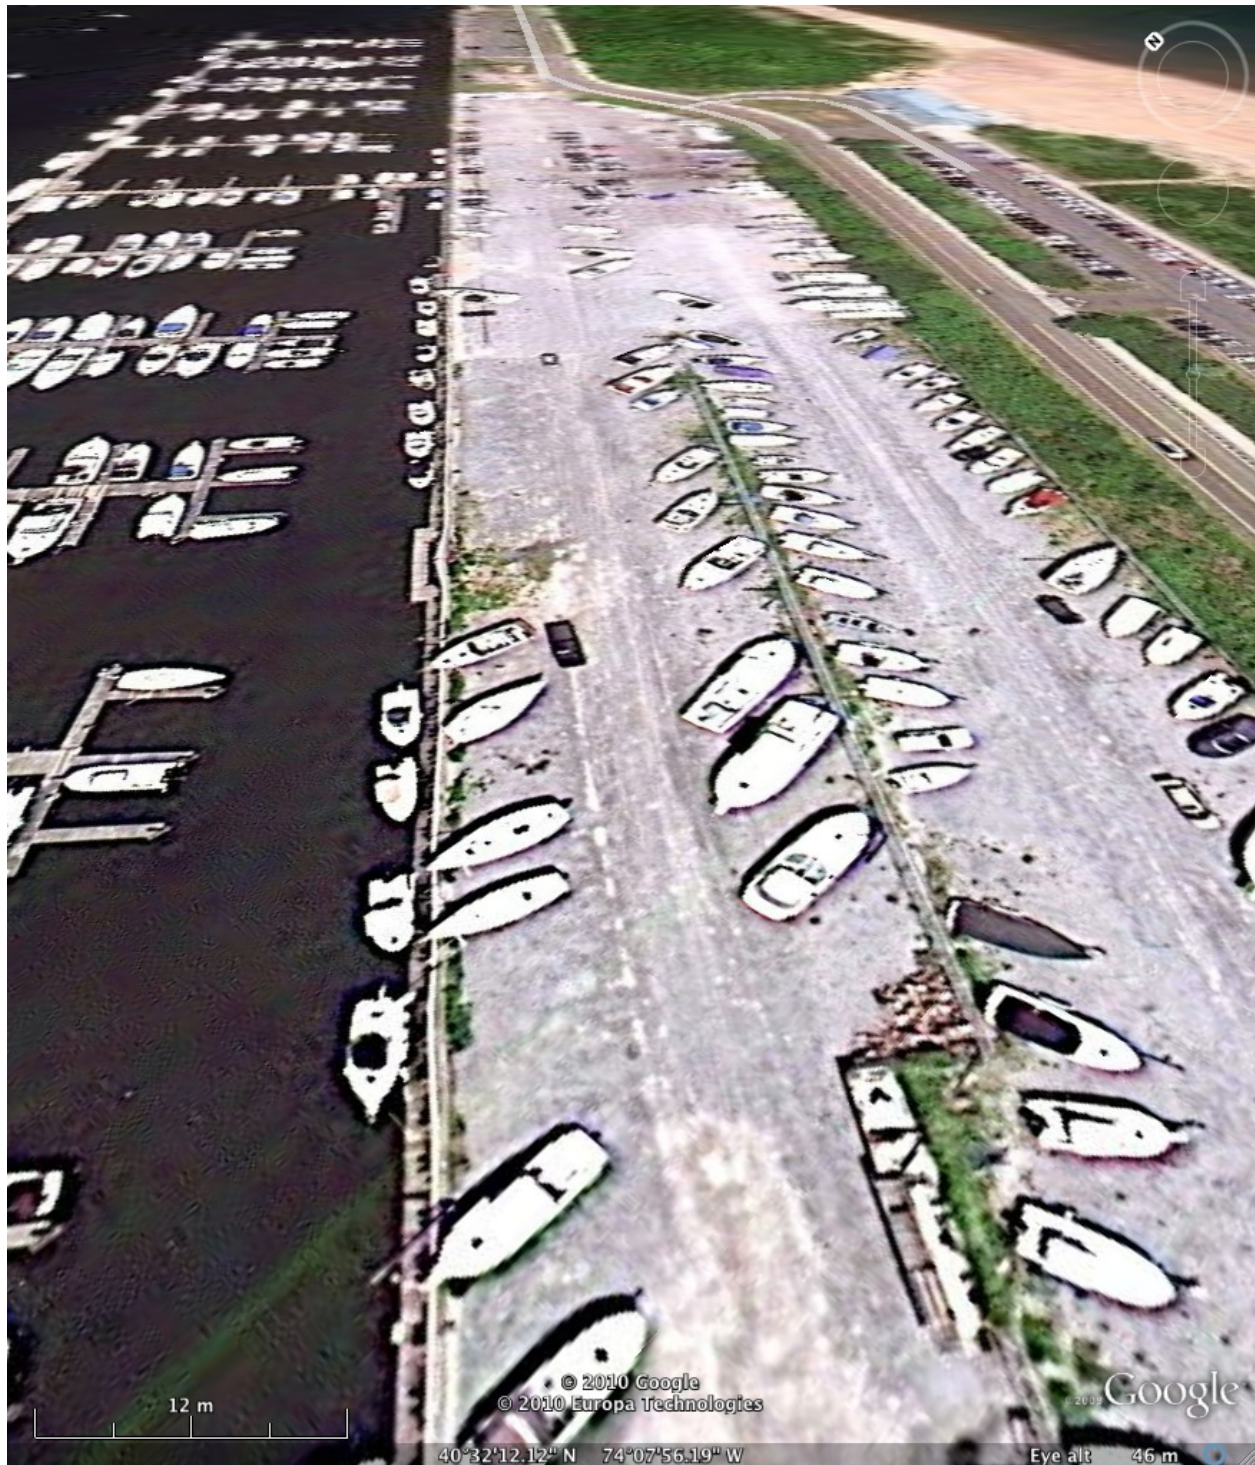
Whichever the cause, there is evidence that differential displacement is occurring along parts of the bulkhead of the Great Kills Marina (Figs. 6 and 7).

Figure 6. The shifts of the bulkhead and its pilings toward the marina basin are evident in the foreground of this photo and in the middle ground. Date of photo is unknown.
