## **2009 ORV Monitoring Results: Pyramid Peak Trail, Windy Creek Trail, and Cantwell Creek Floodplain Route**

*Cantwell Traditional Use Area, Denali National Park and Preserve*

Natural Resource Data Series NPS/CAKN/NRDS—2010/092

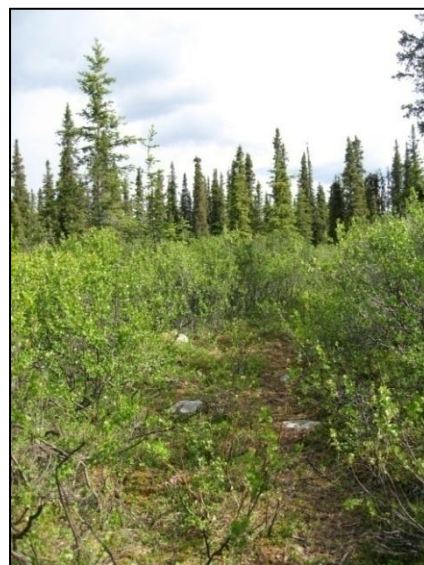
**Figure A3.** Windy Creek Repeat Photo Point 3. Vegetation cover has increased over time. Photos from 2007 and 2009 are not available.

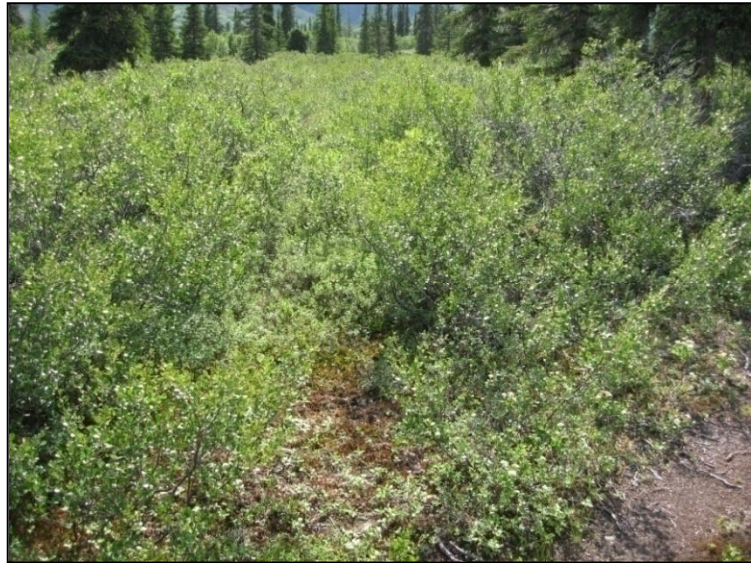
**Figure A4.** Windy Creek Repeat Photo Point 4. Vegetation cover has increased over time. Photos from 2009 are not available.

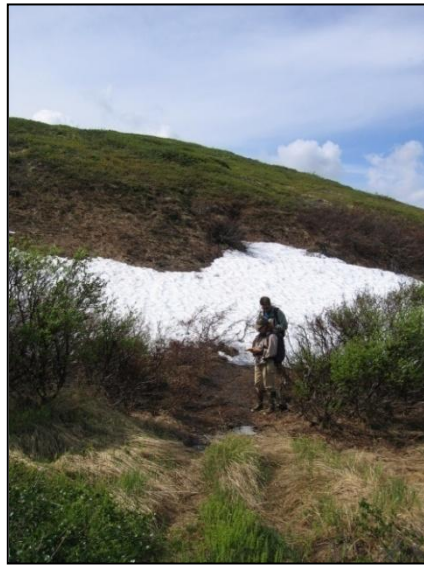
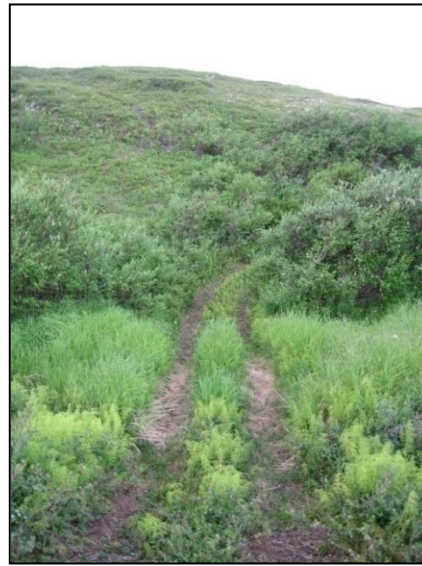
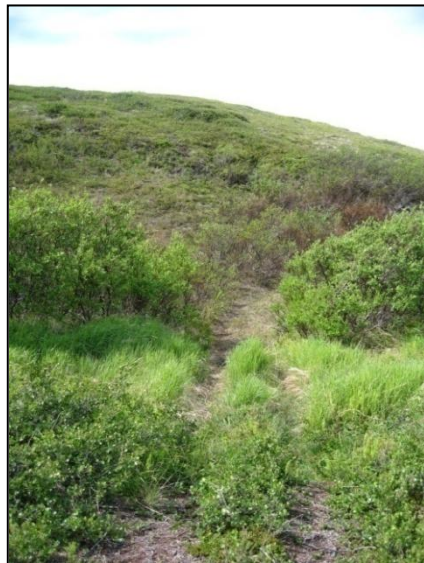
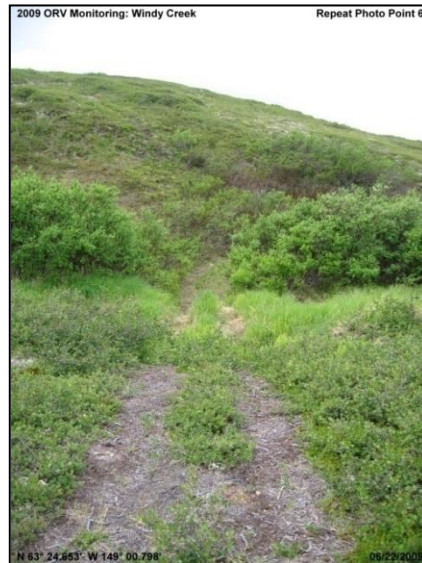
**Figure A6.** Windy Creek Repeat Photo Point 6. Vegetation cover and the degree of rutting have remained similar through time.

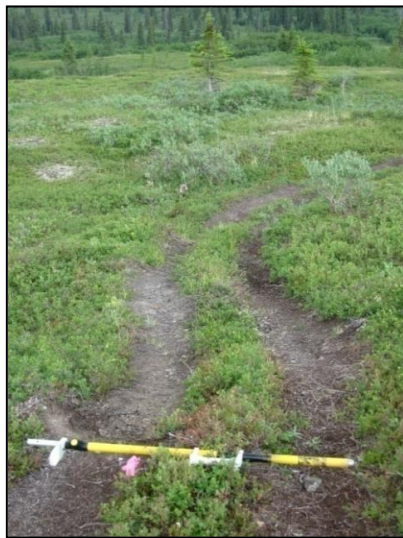
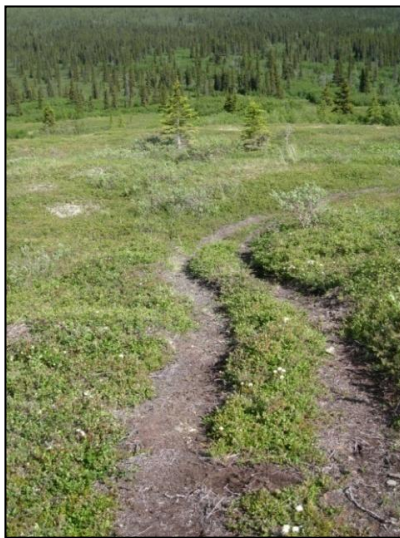
**Figure A7.** Windy Creek Repeat Photo Point 7. Vegetation cover and the degree of rutting have remained similar through time. Photos from 2005 are not available.

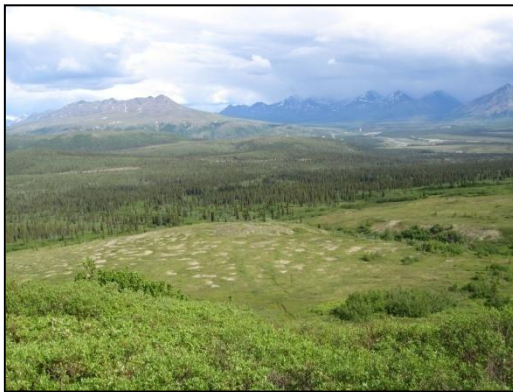
**Figure A8.** Windy Creek Repeat Photo Point 8. ORV Tracks in the meadow may be less prominent than in 2008. The photo point was established in 2008, thus photos from 2005 and 2007 are not available.

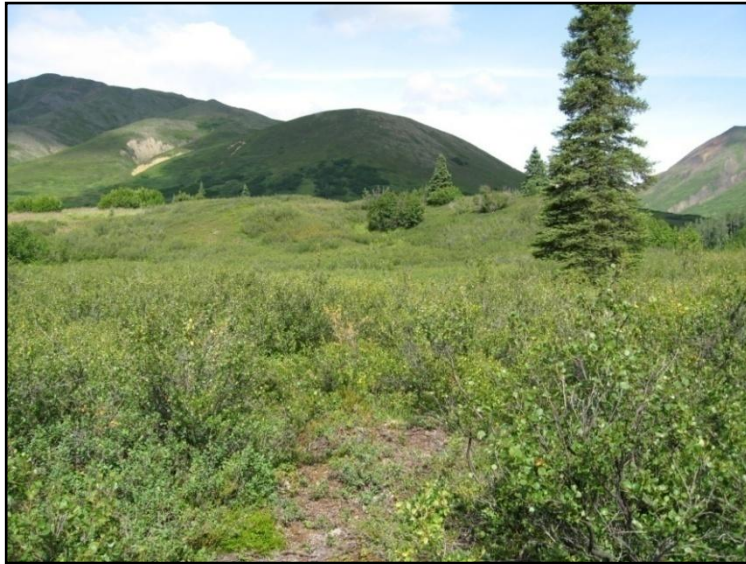
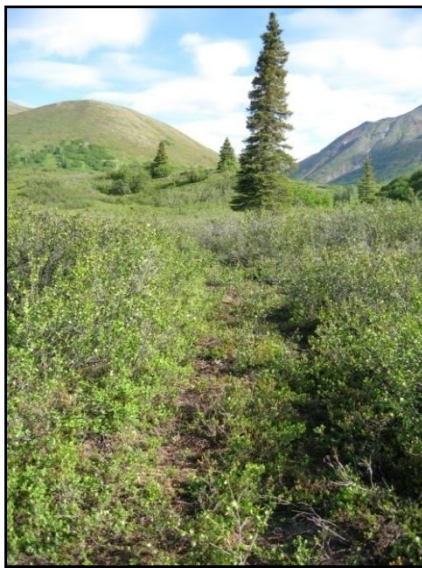
**Figure B6.** Pyramid Peak Repeat Photo Point 6. Conditions may have deteriorated over time.

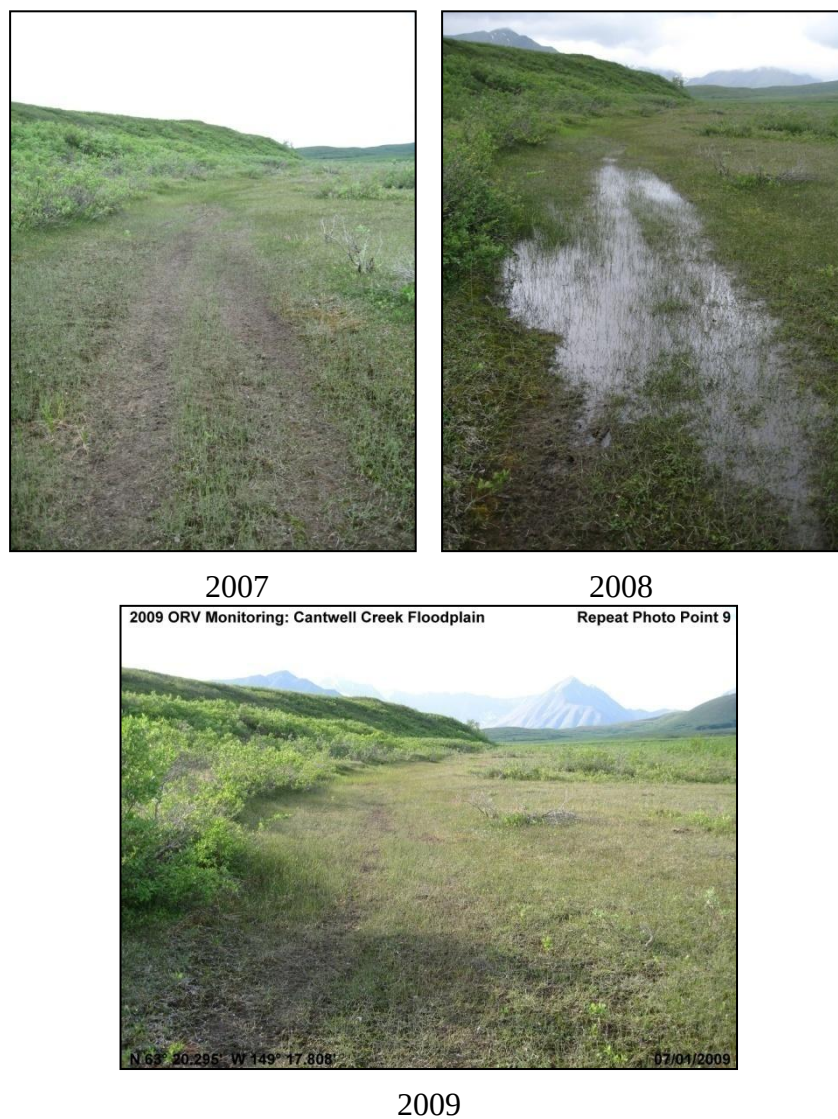
**Figure C6.** Cantwell Creek Floodplain Repeat Photo Point 9. Conditions may have improved, ruts appear less prominent.

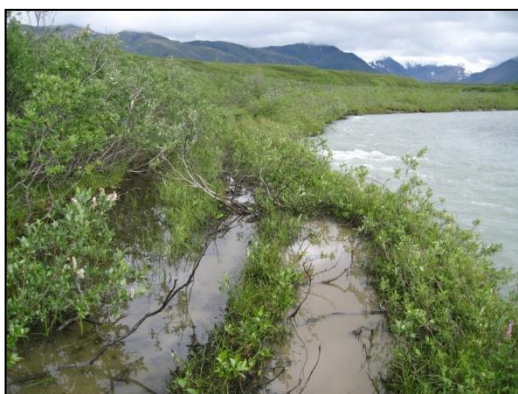
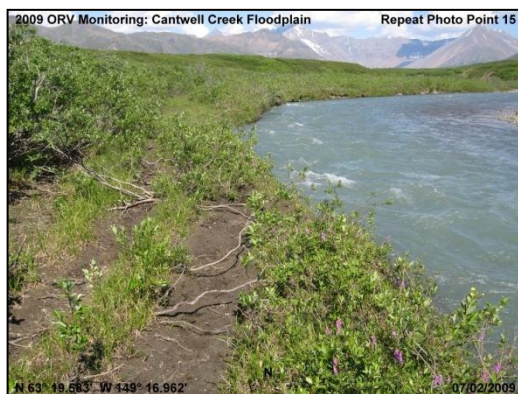
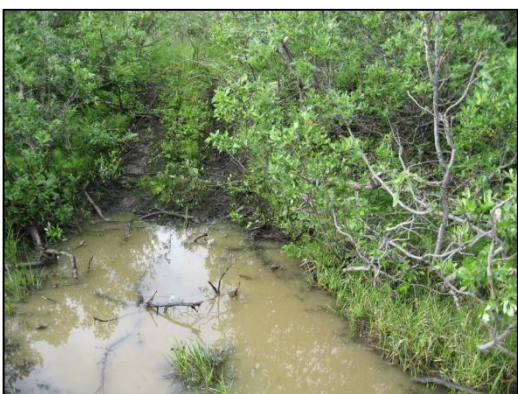
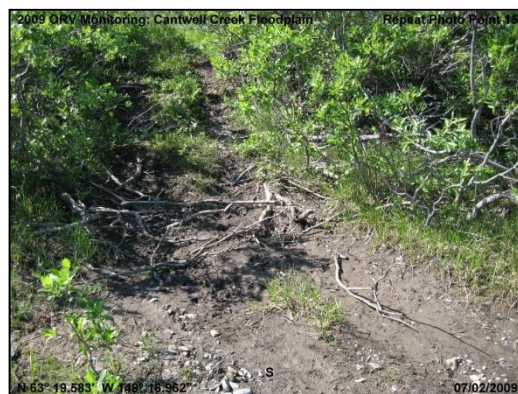
**Figure C11.** Cantwell Creek Floodplain Repeat Photo Point 15. Moisture status varies, but conditions appear similar.
