## 2008 Harding Icefield Trail Report

### *Kenai Fjords National Park*

Deborah Kurtz  
National Park Service  
Kenai Fjords National Park  
Seward, AK  
September 2008

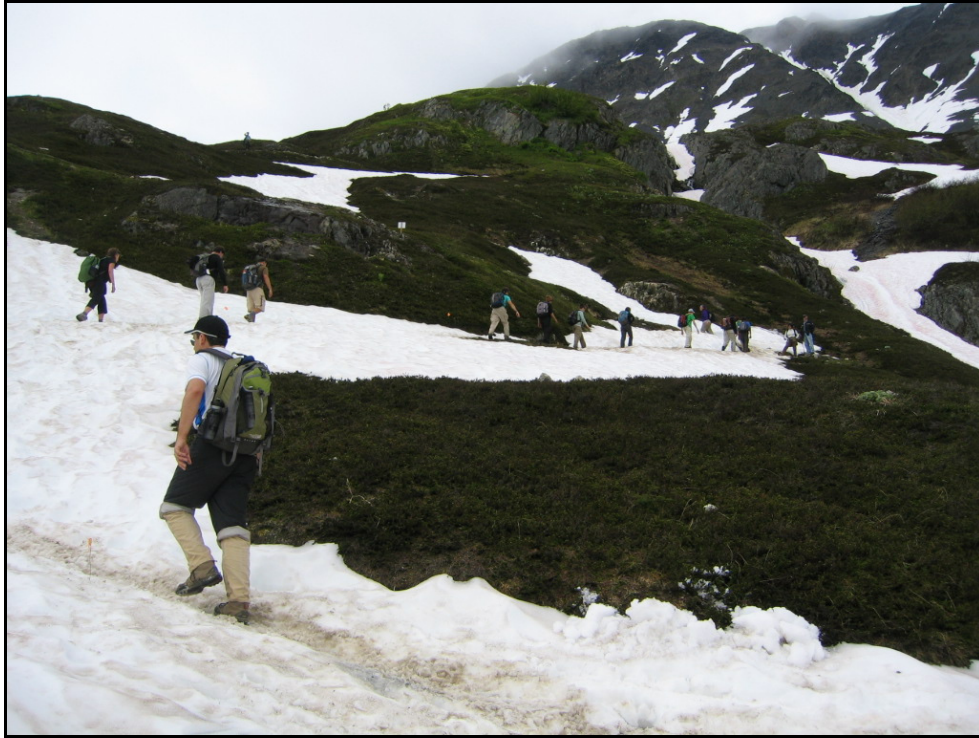
Figure 2. Hikers on the snow-covered Harding Icefield Trail.

persisted longer than usual and a one month delay of green-up (and no green-up in places that experienced perpetual snow cover this summer).

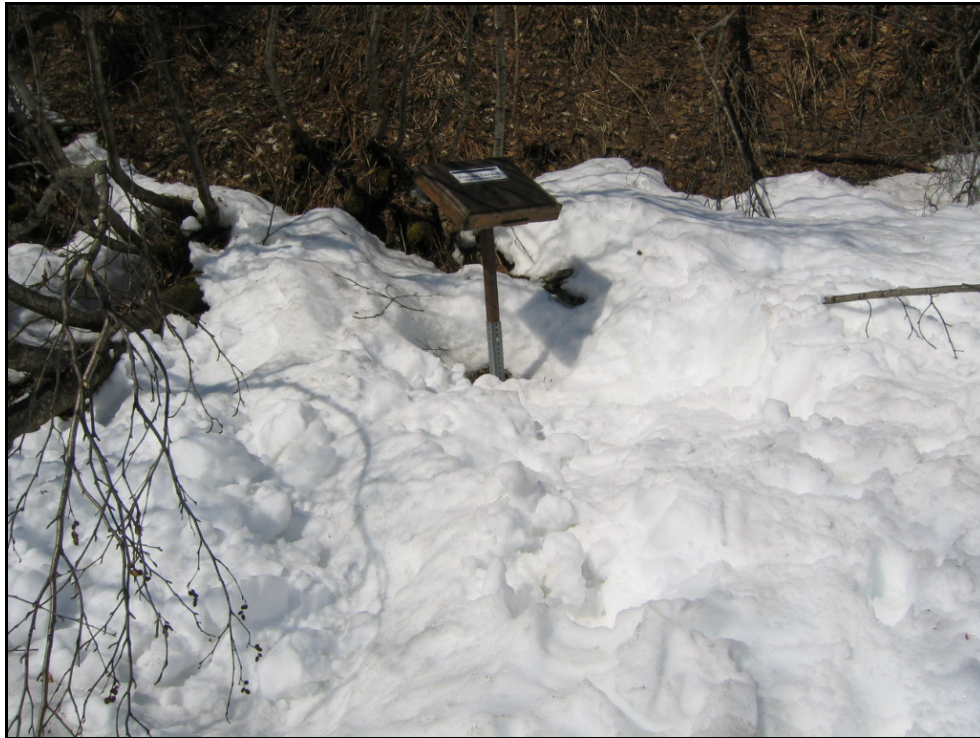
Figure 3. Deep snow levels during the winter 2007/2008 lead to a late spring in KEFJ. The Harding Icefield Trail register, located at 545 feet (166 meters) was still surrounded by snow on May 22, 2008.

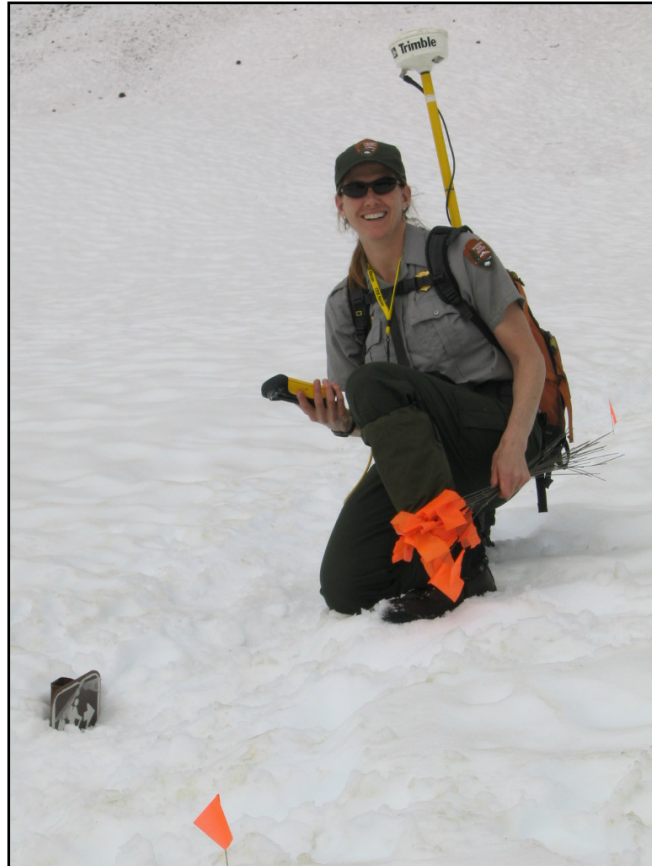
Figure 4. Deep snow persisted on the Harding Icefield Trail throughout the 2008 summer season. Notice the height of the trail sign in Marmot Meadows (mile 1.25) in this photo taken on June 19, 2008.

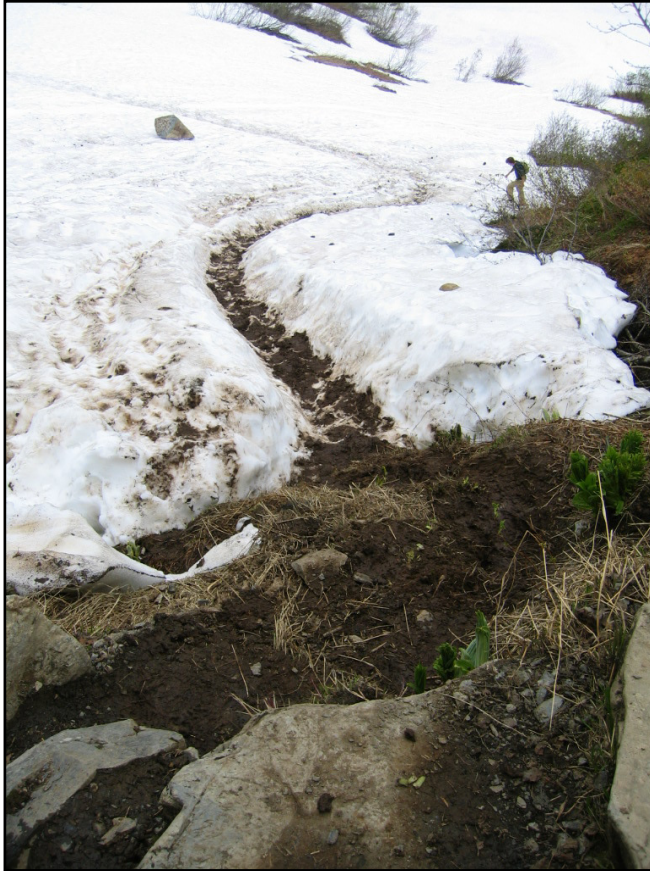
Figure 5. One of several half-pipe features that resulted from hikers cutting switchbacks and sliding down the slopes rather than hiking on the trail. In addition to sliding down, hikers were also choosing to hike up this particular path, located at the Bottom of the Cliffs. Once this shoot became overly muddy, the sliding ceased, but the damage to the vegetation was apparent. This photo was taken on July 8, 2008.

season progressed, hikers not only continued to slide in these tracks, but they also used them to hike up the slopes as well, as they provided a more direct route than the flagged switchbacks. As the snow pack got thinner, the underlying vegetation was trampled by both the hiking up and the sliding down. Short of standing next to the resultant half-pipes that formed and patrolling this activity, it seemed impossible to convince visitors to refrain from using these paths and stay on the trail (Figure 5).

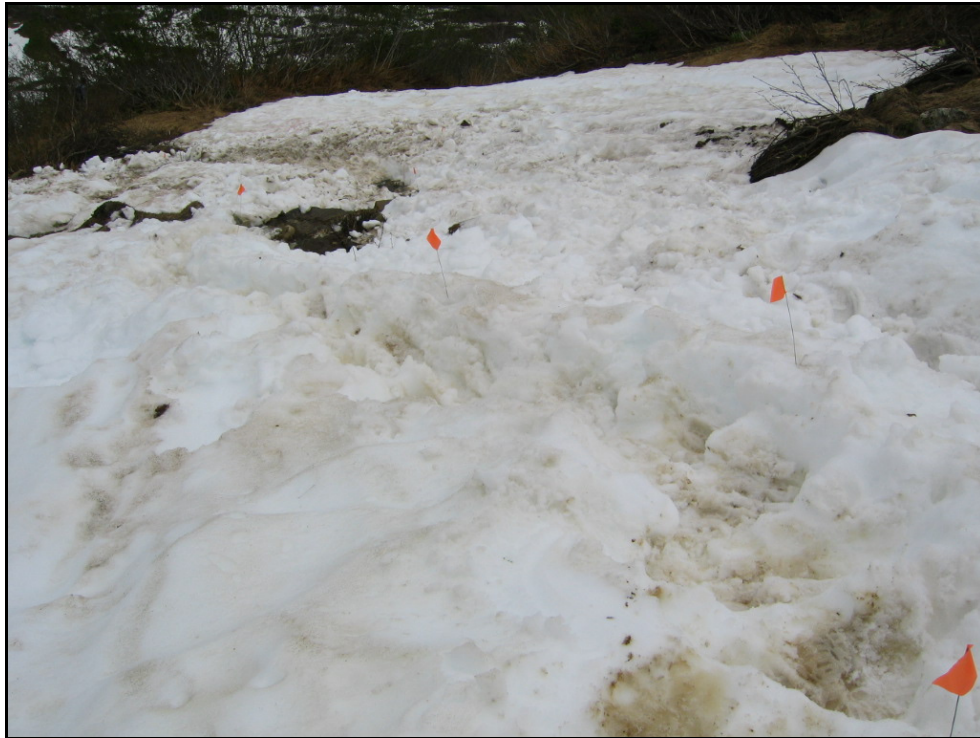
Figure 6. Orange flags marking the trail in an area of the HIT where hikers were making their own way. Photo taken 07/08/2008.

Cutting steps into hard-packed snow encouraged hikers to use the correct trail. We placed small, wire flags at intervals necessary to direct foot traffic to the correct trail (Figure 6). We adjusted the flag positions as the snow melted out and revealed trail features.

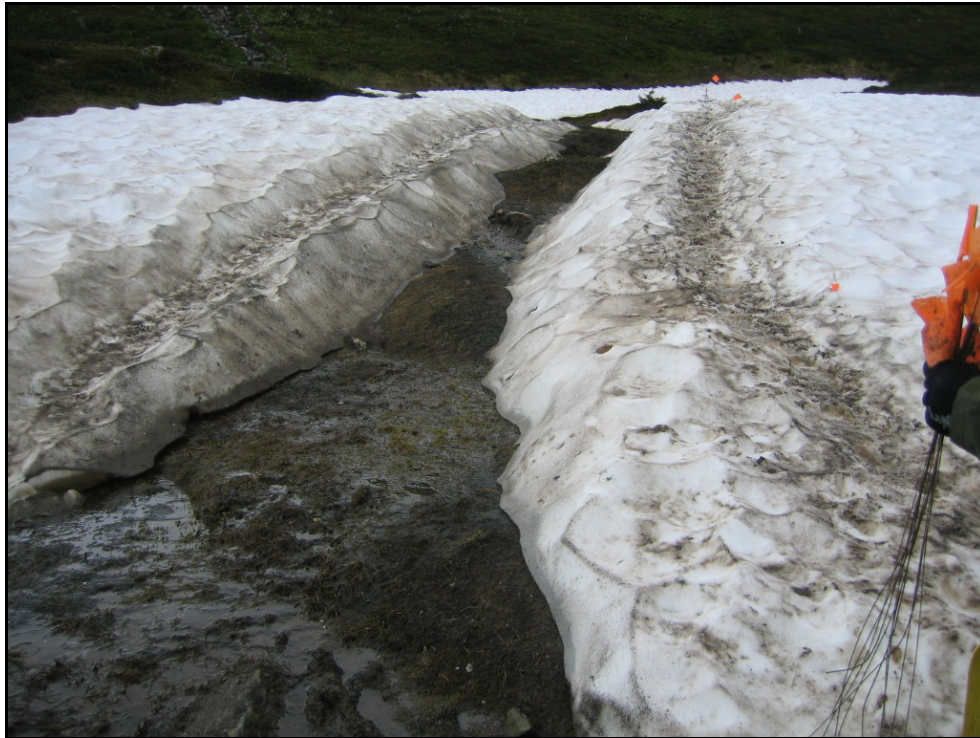
Figure 7. It can be nearly impossible to accurately locate and flag the HIT in the exact location for the entire extent of the trail as demonstrated by these three paths above the Top of the Cliffs Overlook (mile 2.25). Photo taken 8/15/2008.

Figure 7 illustrates the challenges of precisely marking the trail with the GPS. The combinations of errors in the original trail data that is used to navigate, and errors that may be introduced on the day of marking make it very difficult to mark the trail with accuracy and precision. This deems it necessary to continually monitor the trail as the snow melts and make adjustments by shoveling and reflagging to prevent trail-widening and/or the creation of social trails.

In an effort to more effectively and efficiently locate and mark the HIT in the early-season, resource management staff installed and buried seven metal pins in the center of the HIT to facilitate locating the trail with a metal detector. These pins were installed in areas of low satellite coverage or where there were no good landmarks to assist with trail location. Based on the success of this trial, more pins will be placed along the upper sections of the trail in the future.

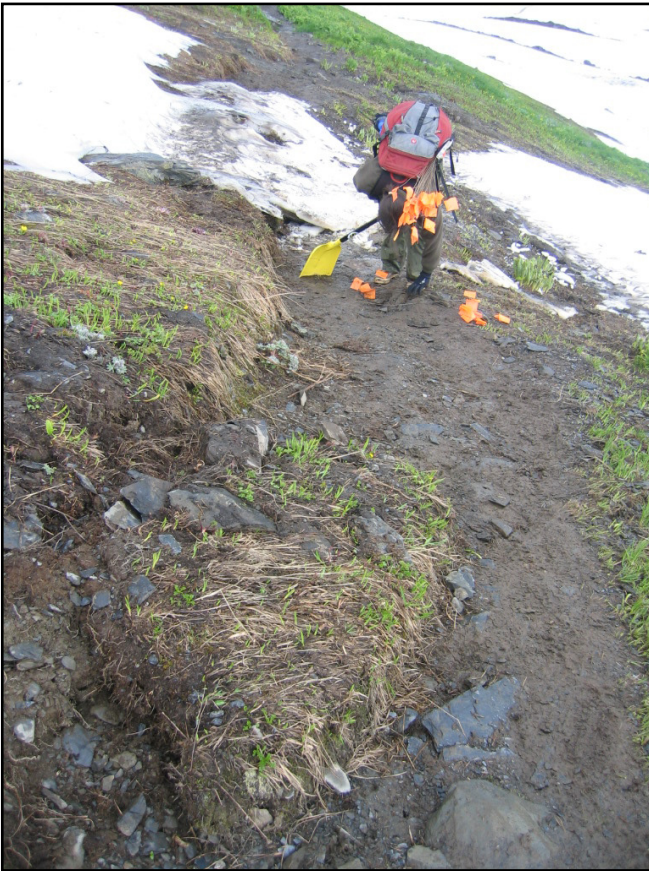
In addition to human impacts from trampling, the HIT is also subject to natural impacts such as slumping from saturated soil (Figure 8) and scouring from spring avalanche activities (Figure 9). Although the result of natural processes, these impacts can also lead to trail widening and increased damage to vegetation as hikers find new routes in response to these events.

Figure 8. Saturated soils resulted in vegetation slumping onto the HIT beyond the Top of the Cliffs Overlook (mile 2.25). Photo taken 8/15/2008.

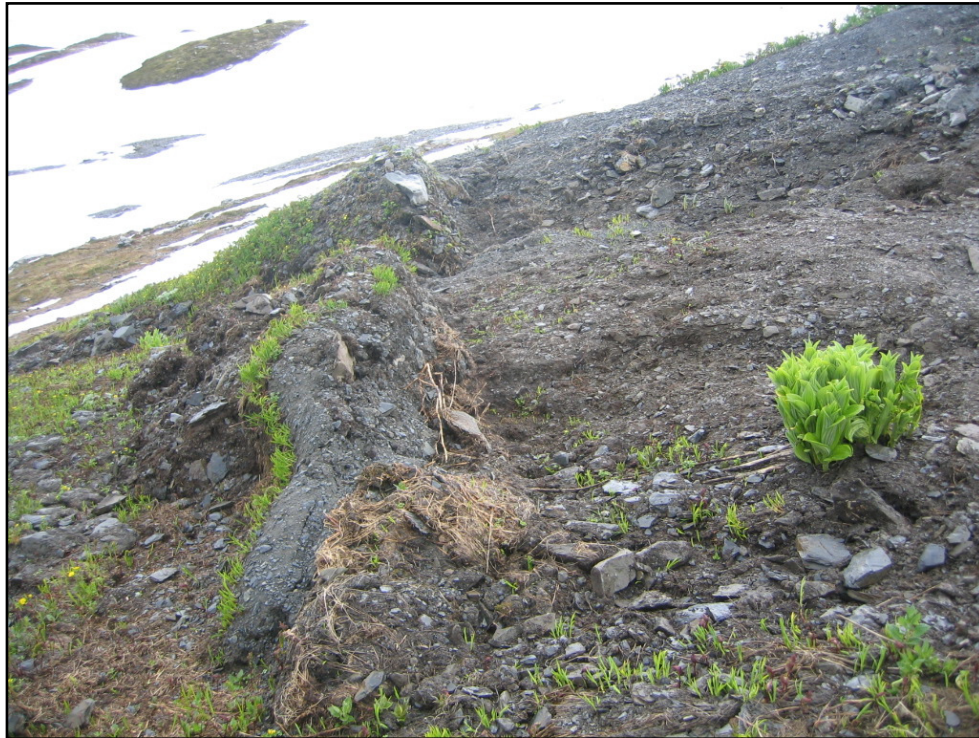
Figure 9. Spring avalanches plowed topsoil and vegetation right over the top of the HIT between the Top of the Cliffs Overlook (mile 2.25) and the Emergency Shelter (mile 3.6). Photo taken 8/15/2008.

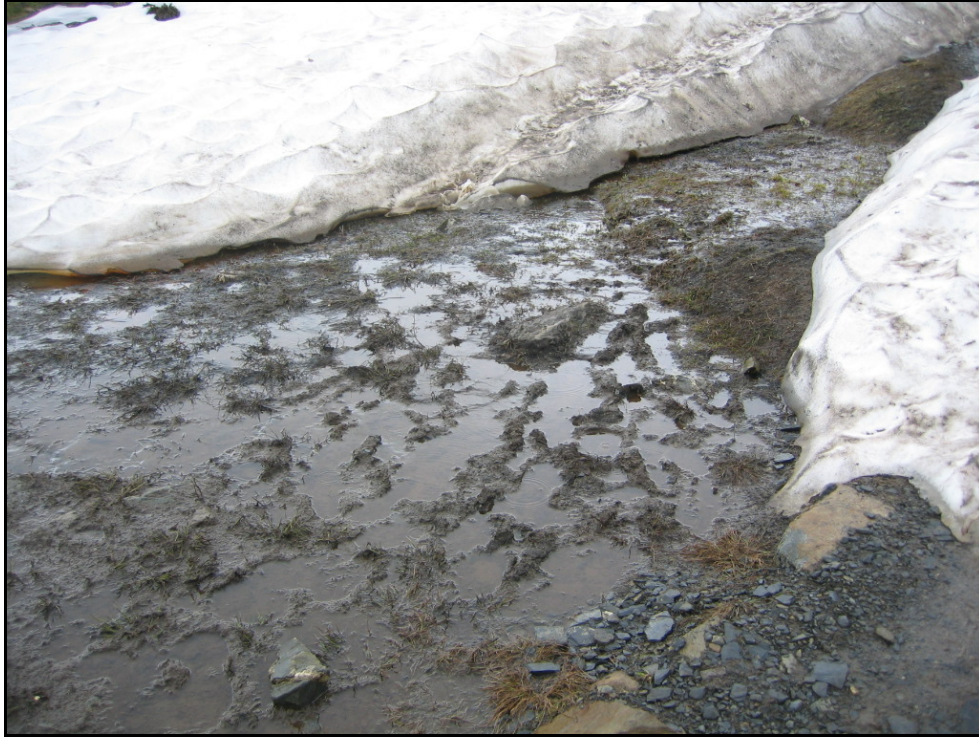
Heavy erosion and destruction of fragile tundra vegetation have worsened at the Top of the Cliffs Overlook (mile 2.25). This will persist until efforts are coordinated and executed to improve the trail and clearly designate boundaries and walking paths at the overlook area (Figure 10 and 11).

Figure 10. Persistent snow cover and muddy conditions result in widening of the trail and reduced vegetation on the trail at the Top of the Cliffs Overlook (mile 2.25). Photo taken 8/15/2008.

The “Proposal for Management of Two Heavily Impacted Areas on the Harding Icefield Trail” (Tetreau 2005) is still relevant and should be implemented to prevent further damage of the fragile tundra ecosystem at the top of the cliffs. The long-term considerations addressed in the proposal, such as plant restoration and construction of durable trails and viewing pads should be included in both resource management and maintenance projects. A maintenance project is identified in PMIS for this project and will begin when funding becomes available.

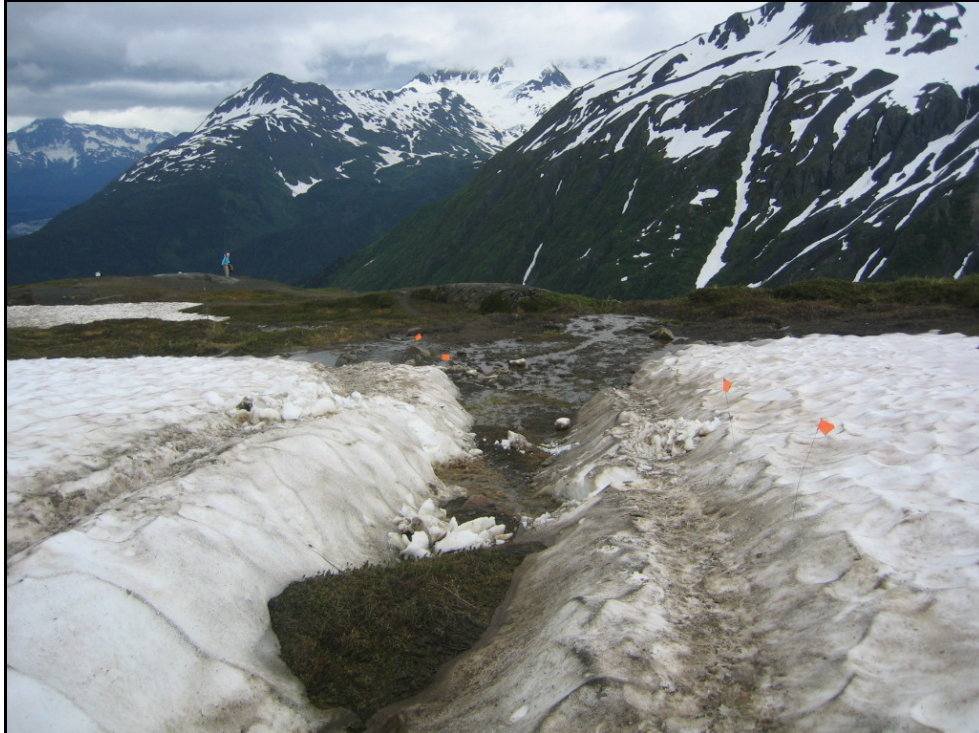
Figure 11. The spider web of trails at the Top of the Cliffs Overlook was a muddy mess most of the summer of 2008. Photo taken 8/15/2008.
