## **Harding Icefield Trail Impact Monitoring Report 2008**

**Christina Kriedeman  
Kenai Fjords National Park  
Resource Management Division  
P.O. Box 1727  
Seward, AK 99664**

**September 2008**

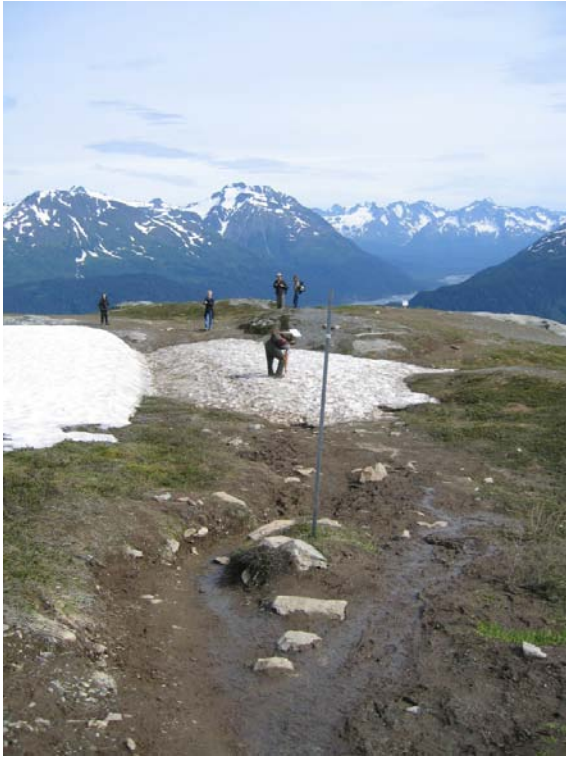
Photo 1.

As mentioned previously, snow stayed on the trail later than usual, and plant phenology was very far behind or completely covered in snow. This is why the survey was conducted a month later than usual, and two impacted sites were still covered in snow. The cool summer and late snow melt caused the vegetation to be far behind its usual stage of development. This made it difficult to compare the severity of impact and any changes that occurred from photos taken the previous year. The sites could appear more impacted than they really were, because less vegetation was visible and was at an earlier stage of growth. The survey had to be completed with these less than ideal circumstances since the summer season was coming to a close and field work needed to be completed before vegetation was wilted by frost or covered in new snow.

Snow covering a monitoring site August 21, 2008      Snow on the trail below the shelter Sept 22, 2008

Because the survey was conducted so late in the season, there was not enough time to repair impacted sites with a 2 or 3 impact rating as was done in previous years. Future actions were recommended on the survey data sheets for sites that were not improving, but most will have to be carried out in the summer of 2009. The only actions taken to repair impacts on the trail were at site 247. Hikers step off the trail at this site and have trampled the vegetation at this corner. Biotechs covered the site with large branches to keep hikers from walking on the area. Recommendations that needed trail work will be passed on to the Trail Coordinator.

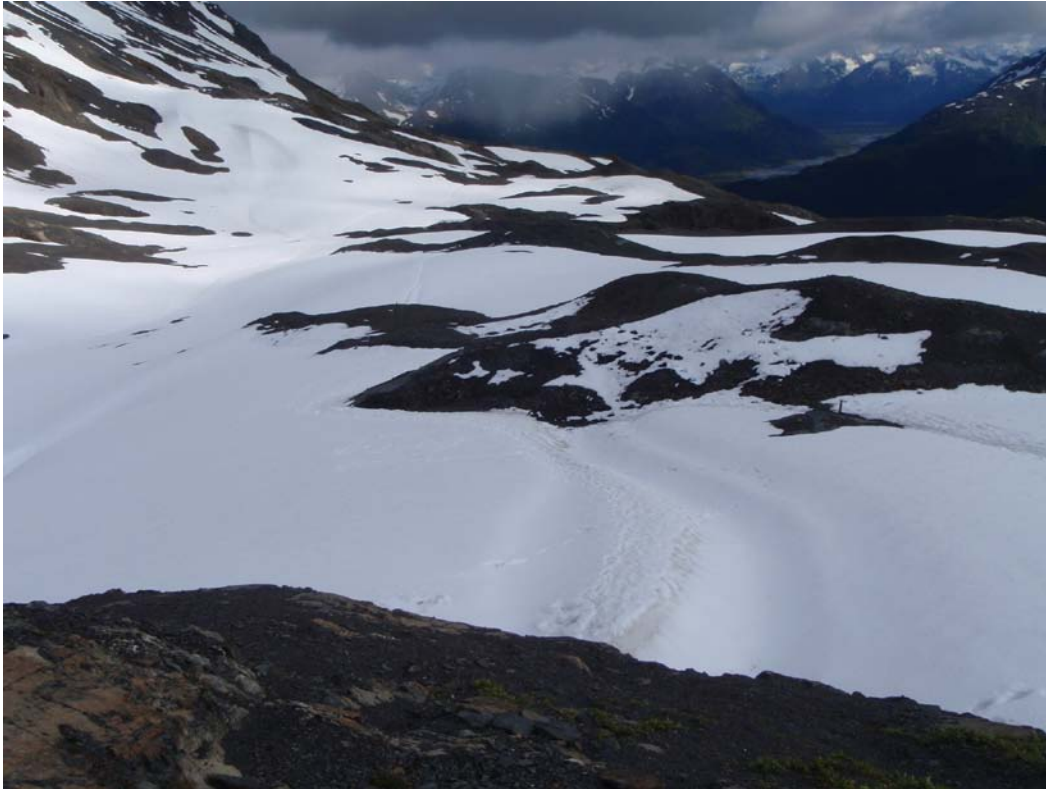
Photo 3.

I sent photos of the snow that never melted along the HIT to Mike Tetreau, a long time employee at Kenai Fjords National Park, and he commented that there hasn't been any significant snow left in that basin below the shelter at the end of summer for at least a decade; maybe even back to the early 1990's (see Photo 3 below). He said that the whole basin was filled with snow (maybe 100 ft. deep) up until 1990-91 or so, when the ash from Redoubt volcano had a significant affect on the perennial snow along the trail. It will be interesting to see if the snow continues to remain in the area or melts in the coming summer.
