**Flow monitoring technology and methodology assessment  
EPA region 7 grant: X7 97702501-0**

**Iowa Department of Natural Resources**

February 2011

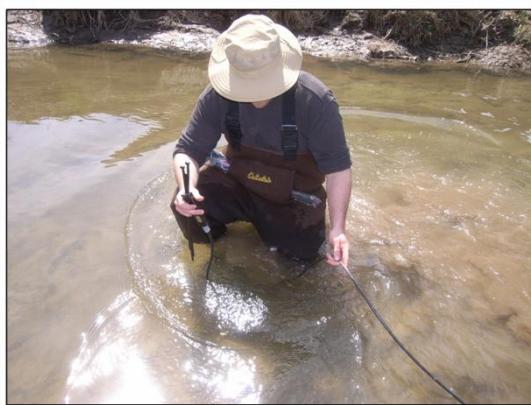
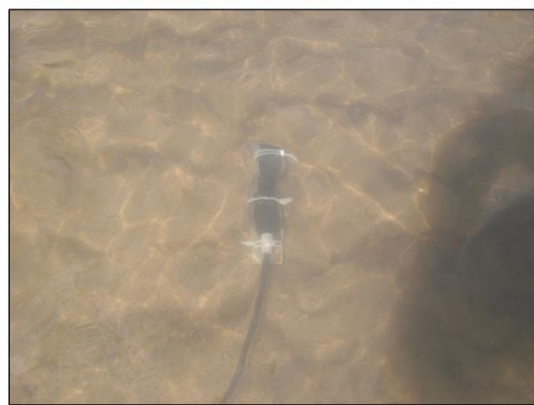
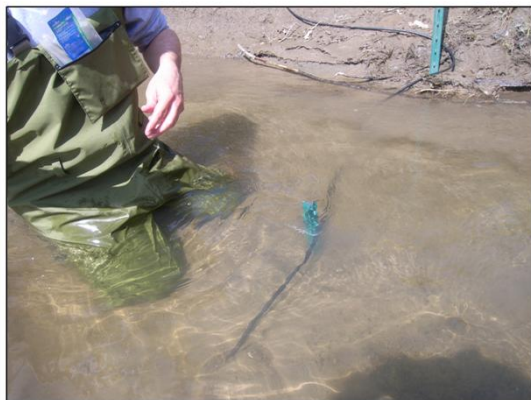
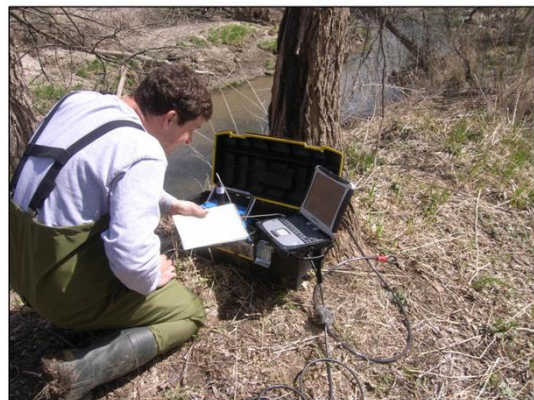
A: Installing sensor to stream bottom

B: AV sensor on stream bottom

C: Securing cable to T-post

D: Programming AVFM unit

**Figure 2-3 Initial 2150 AVFM installation photos**

Once a stable, trapezoid like cross section with minimal flow turbulence was identified the equipment was put in place. The AV sensor is connected to the control box and power supply by a long heavy gage cable and was anchored to the stream bottom using an auger style anchor that is screwed into the stream bottom (Figure 2-3-A). The length of anchor and width of auger necessary to hold the unit in place changes by substrate type. Armored clay or gravel bottoms required shorter anchors with smaller diameter augers while sandy bottom streams required long (36") shafts with 3" diameter augers.

The AV sensor was placed near the center of the channel where the thalweg was located and was positioned with the sensor facing directly into the main flow of the channel (Figure 2-3-B). The cable leading from the AV sensor to the control box was tethered to metal t-posts and was installed along the stream bottom behind the AV flow cross section (Figure 2-3-C). The control box and power supply were housed in a tool box and anchored to a structure above typical flood stage. Control and programming of the 2150 AVFM were achieved using a simple USB connection port to connect any Windows based operating system computer to the device (Figure 2-3-D).

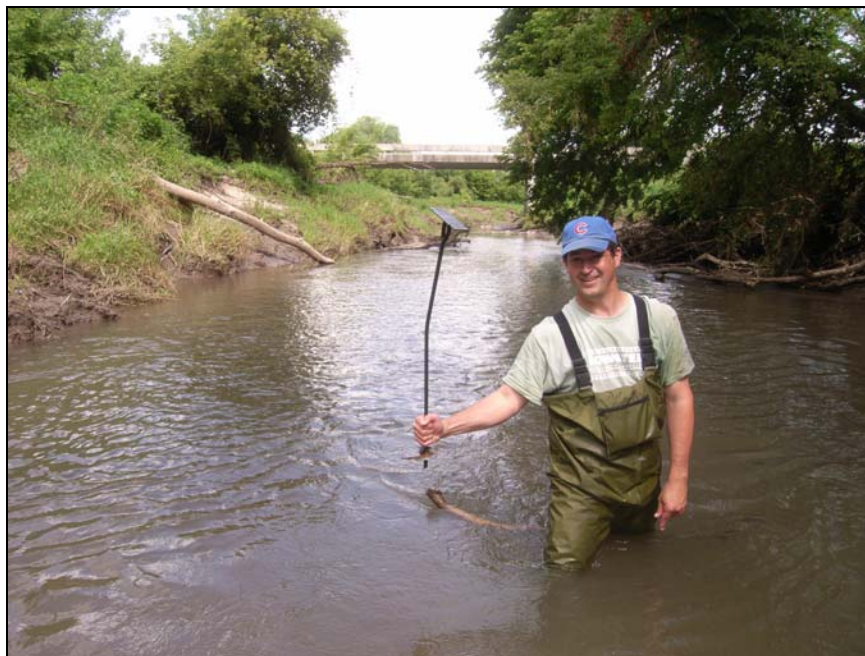
Figure 3-11 Photo of stream anchor damage at Clear Creek, June 2009

Problems anchoring the AVFMs flow sensor to the bottom of the channel could be an issue. The combination of a shifting sand bottom and high stream power at the Clear Creek gage site tested the limitations of the deployment methodology. The initial anchor system (three foot long) was adequate to hold the equipment in place during high flow events. However, during an event on June 20, 2009, the anchor system was likely struck by debris causing the anchor to bend (Figure 3-11). Instead of the sensor being aligned parallel with the flow, the sensor was reading the flow at an acute angle to the flow direction. This caused the AVFM to calculate lower than actual flows. The replacement anchor was only a foot in length and was easily dislodged by subsequent high flow events.
