**Dead Horse Bay, Spring Creek South & Hamilton  
Beach Restoration Sites**

***Land Disturbance History Maps***

Working Group Meeting  
Fort Wadsworth, Staten Island

June 25<sup>th</sup>, 2003

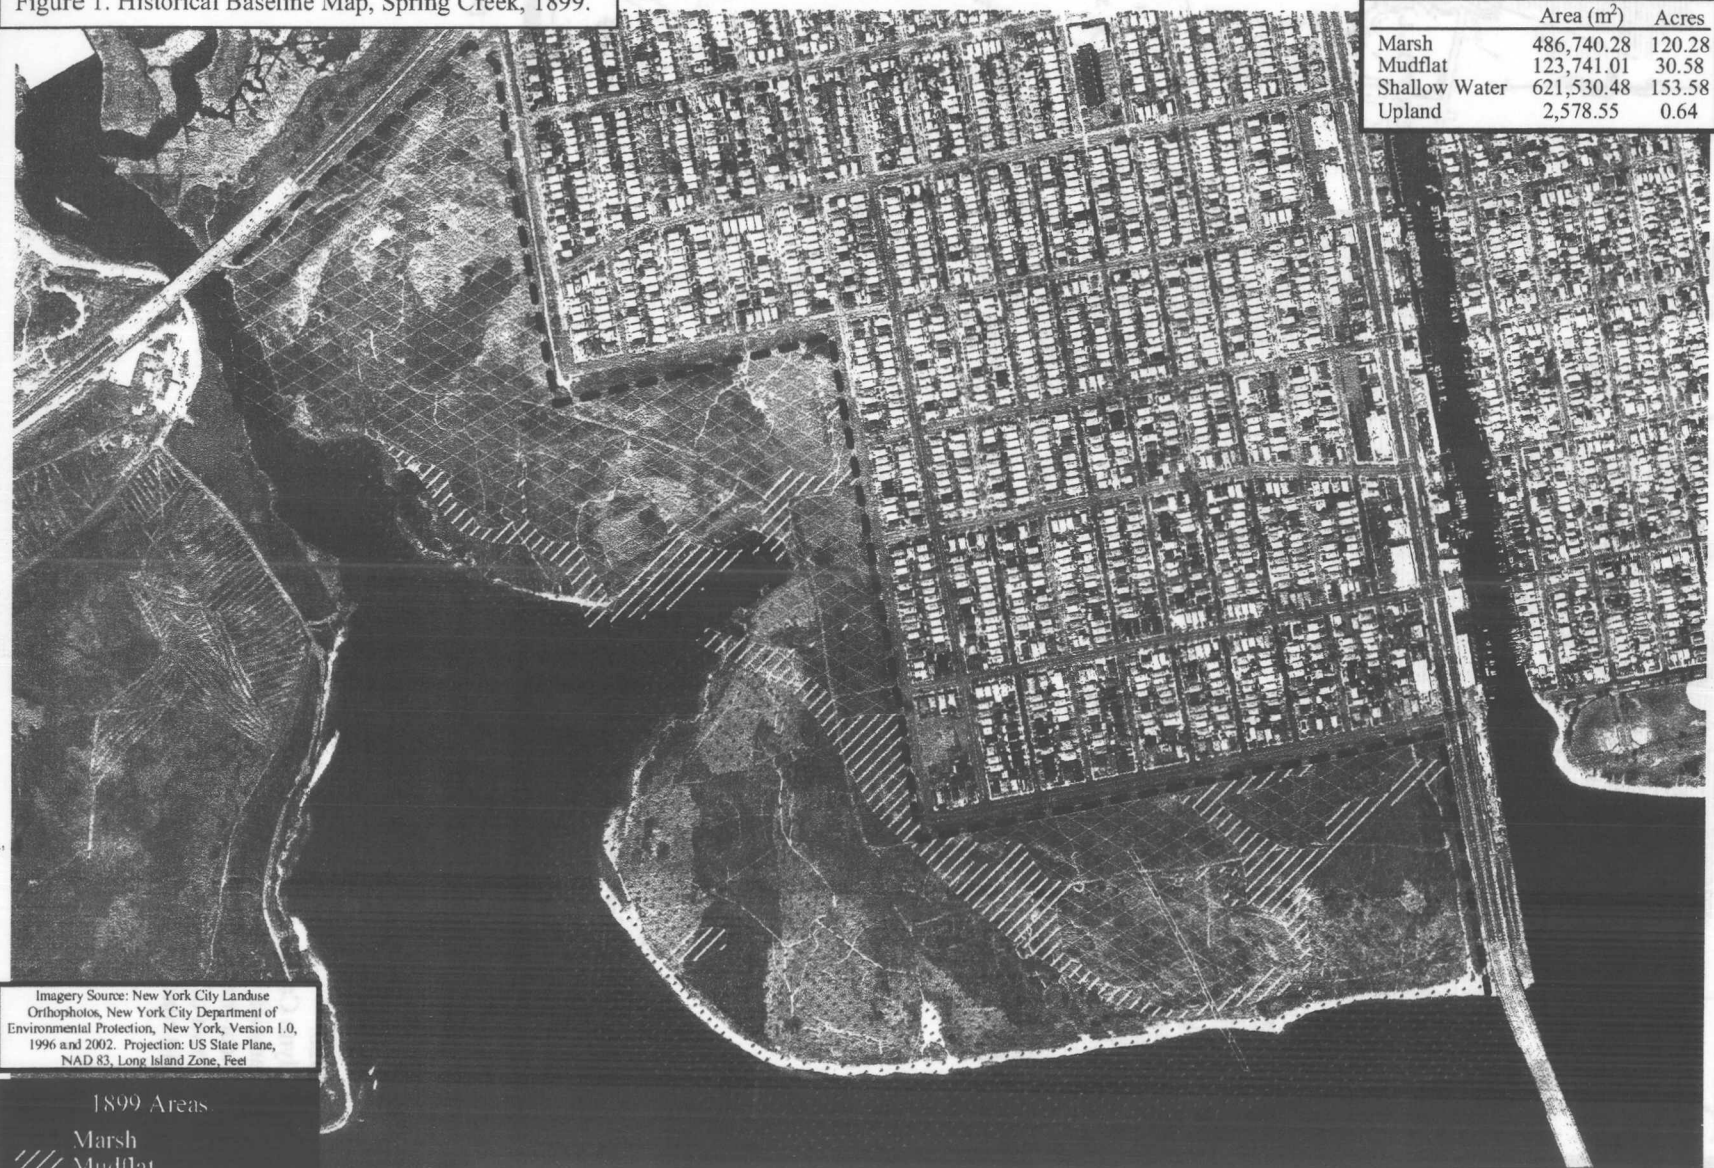
Figure 1. Historical Baseline Map, Spring Creek, 1899.

| | Area (m <sup>2</sup> ) | Acres |
| Marsh | 486,740.28 | 120.28 |
| Mudflat | 123,741.01 | 30.58 |
| Shallow Water | 621,530.48 | 153.58 |
| Upland | 2,578.55 | 0.64 |

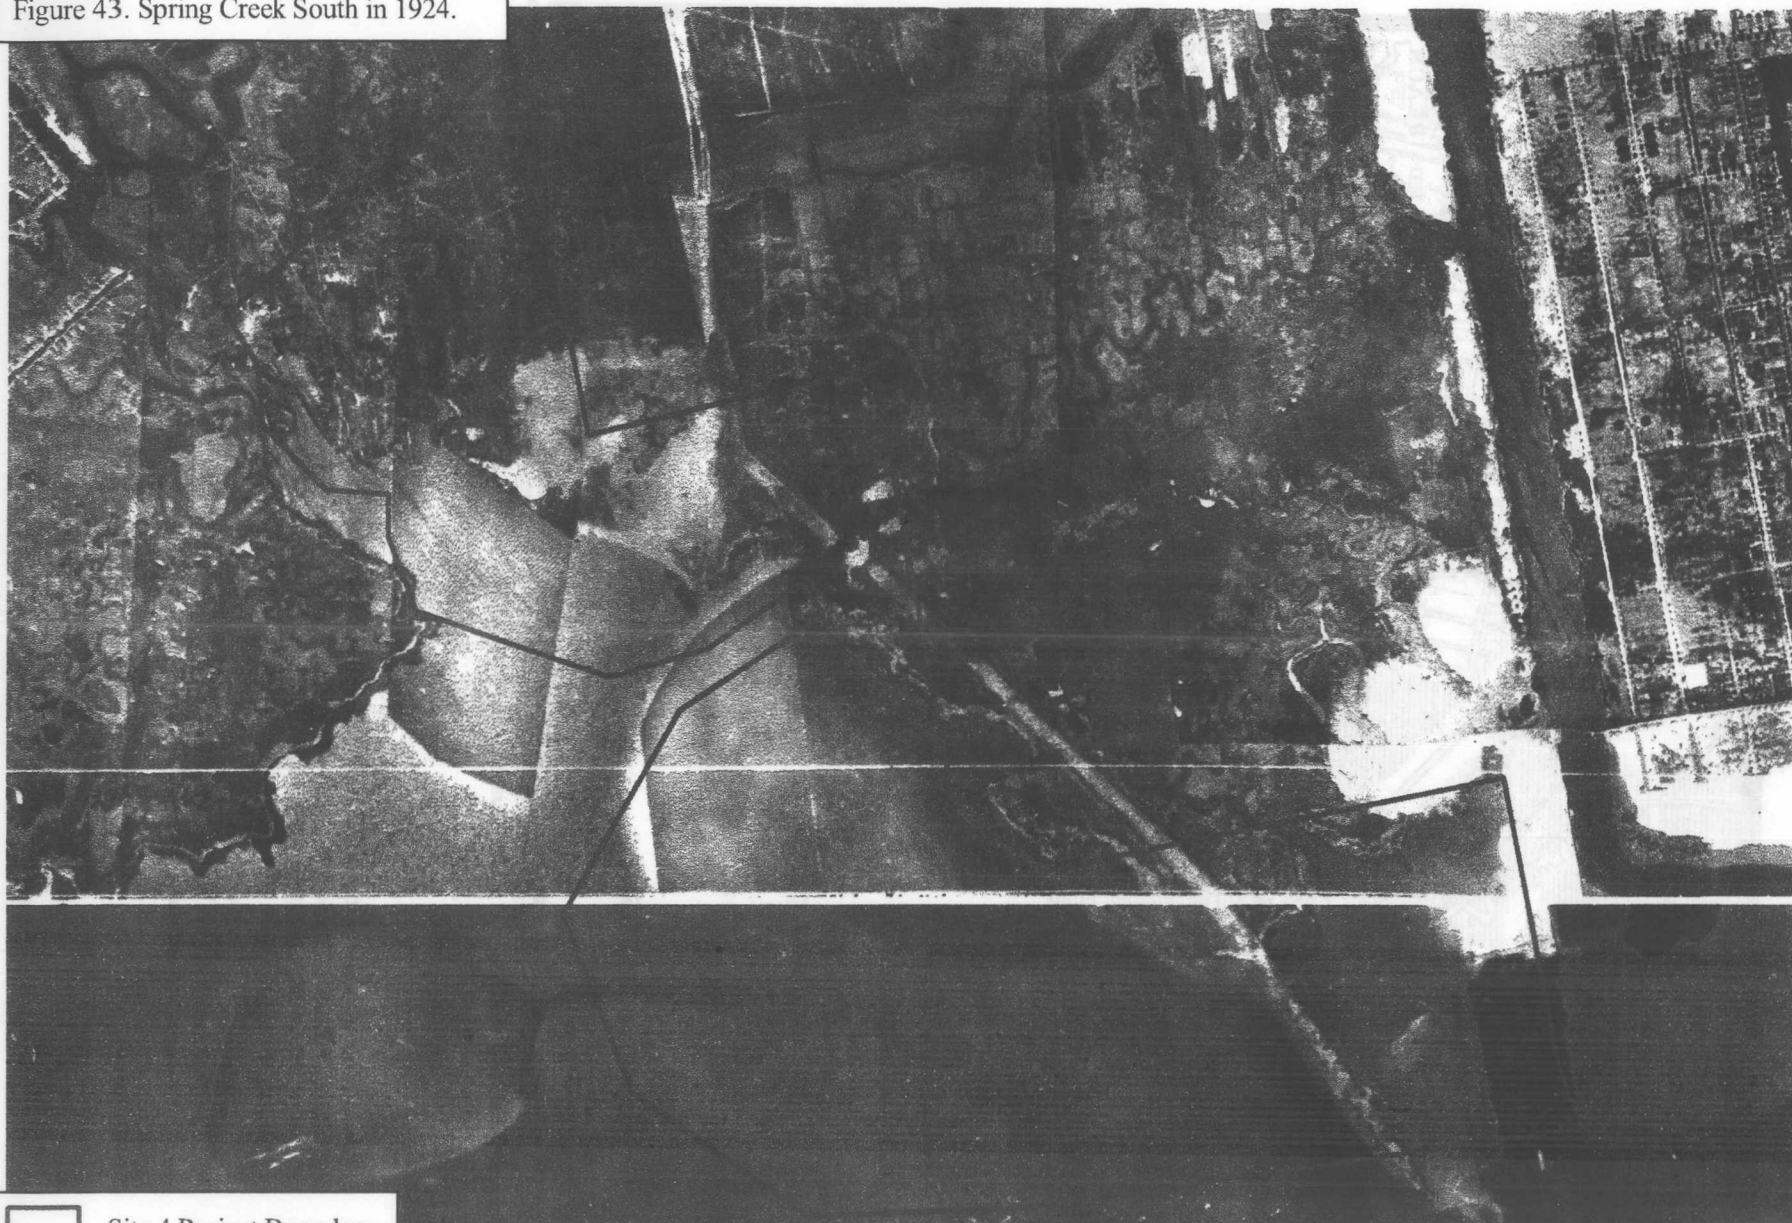
Figure 43. Spring Creek South in 1924.

Site 4 Project Boundary

Imagery source: New York City Fairchild  
Aerial Photography, 1924. Georeferenced  
to US State Plane, NAD 83, Long Island  
Zone, Feet

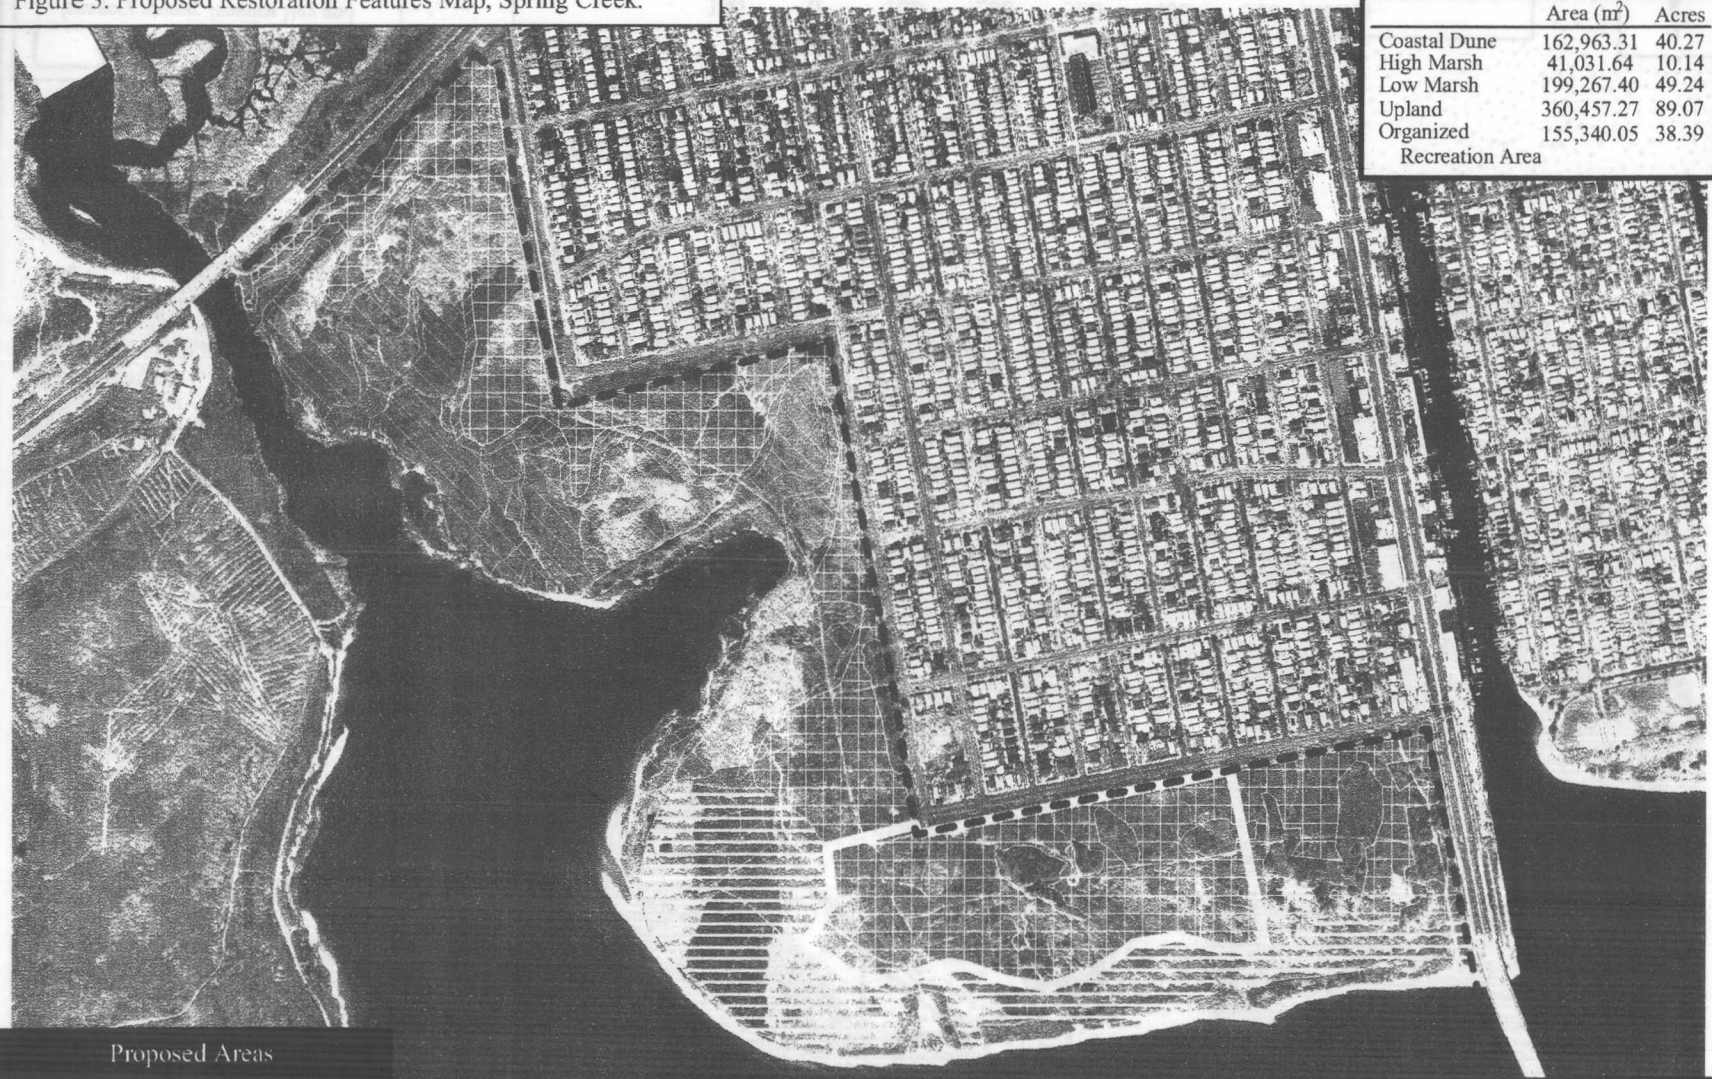
Figure 3. Proposed Restoration Features Map, Spring Creek.

| | Area (m <sup>2</sup> ) | Acres |
| Coastal Dune | 162,963.31 | 40.27 |
| High Marsh | 41,031.64 | 10.14 |
| Low Marsh | 199,267.40 | 49.24 |
| Upland | 360,457.27 | 89.07 |
| Organized Recreation Area | 155,340.05 | 38.39 |
