**Thompson Island Salt Marsh Restoration  
Feasibility Study**

**Thompson Island, Boston, Massachusetts**

**June 2004**

**Northern Ecological Associates, Inc.  
451 Presumpscot Street  
Portland, Maine 04103**

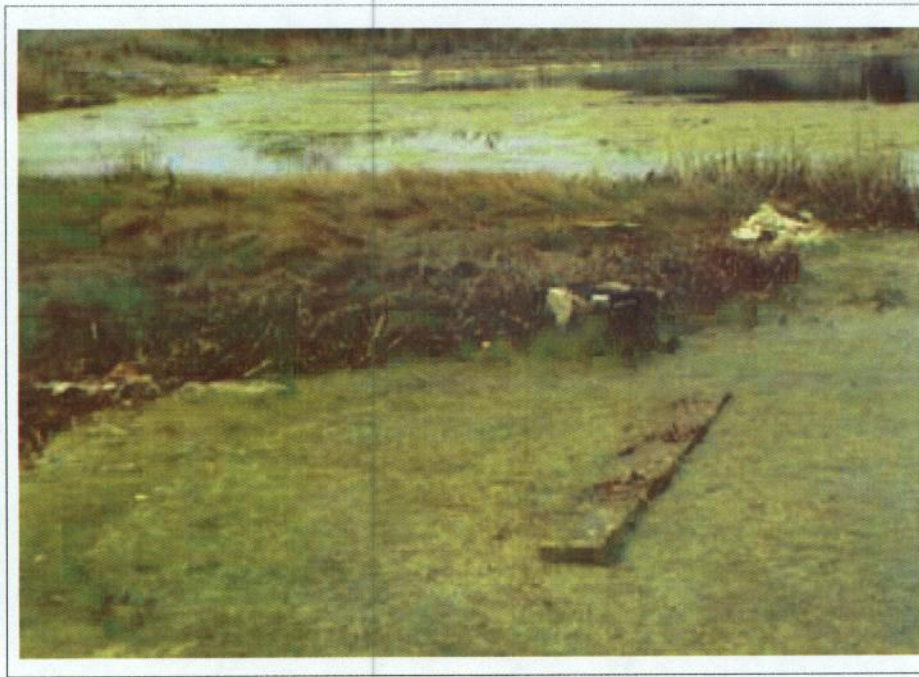
**Figure 3. Algae bloom in degraded salt marsh, May 2004.**

A preliminary hydrologic assessment was conducted by WRP in September 2003 during an eight (8) day period from the spring new moon tide to the neap first quarter moon tide of the tidal cycle. These data indicated that there was very little tidal influence on the subject salt marsh/pond, and although water may drain from the pond, seawater only enters the pond during the highest spring full moon tides and presumably during storm tides. Lack of daily tidal flushing has resulted in a stagnant waterbody with severe algae blooms that form thick green mats over much of the surface of the pond during the growing season (Figure 3).

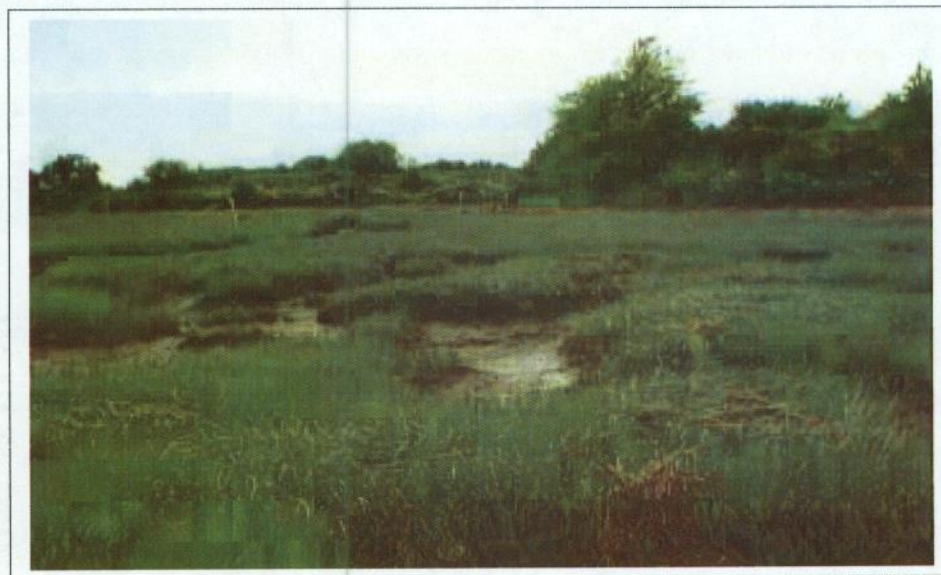
**Figure 5. Reference marsh located along southwesterly shore of Thompson Island.**

The potential for improvements to this estuarine ecosystem are evidenced by the existing high

value salt marsh ecosystem located on the southwest side of Thompson Island, and approximately 800 feet southwesterly of the subject degraded salt marsh/pond. This "reference marsh" is flushed by the tides twice daily, has substantial areas vegetated with *Spartina alterniflora* (smooth cordgrass), has mudflat areas that are exposed at low tide, and currently shows no signs of algae blooms or encroachment by invasive species (Figure 5). No isolated salt ponds were observed in the reference marsh, and salt ponds are rare in Boston Harbor. There is no reference salt pond habitat for comparison.

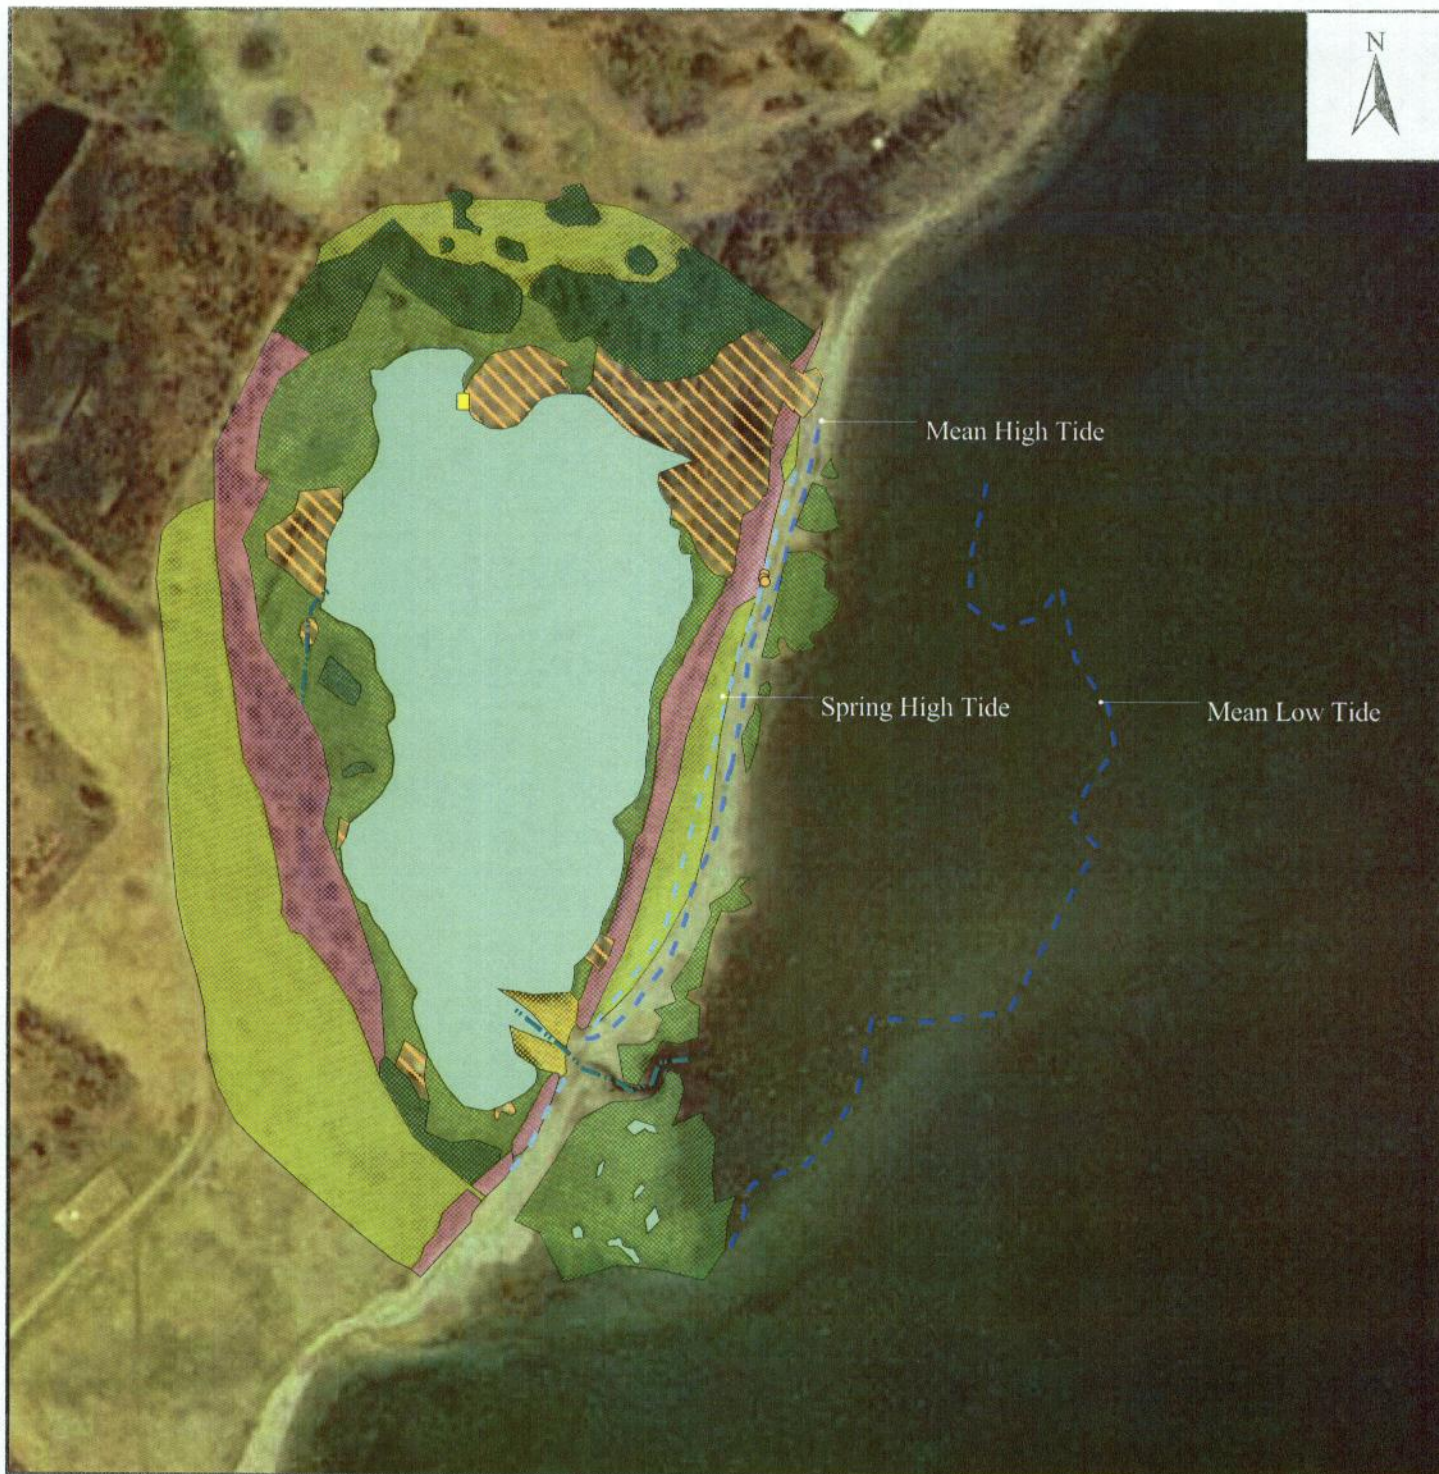
**Figure 14. Cover Type Map  
for Thompson Island  
Salt Marsh Restoration  
Feasibility Study,  
Boston, Massachusetts.**

A cover type map was prepared to document existing vegetation communities in the Study area (Figure 14). Vegetation was mapped from the existing dirt road located west of the pond, approximately 200 feet north and south, to mean low water (ocean) to the east (approximately 13.15 acres). Distinct vegetation community types include upland herbaceous, upland shrub-scrub, upland forested, wetland herbaceous (e.g., *Spartina patens* and *Spartina alterniflora*), and

wetland scrub-shrub. *Phragmites australis* communities were mapped separately in order to differentiate invasive species from native salt marsh communities. Green algae (e.g., *Enteromorpha* species and *Ulva* species) and submerged aquatic vegetation were present in the salt marsh/pond. During field activities in June 2004, green algae covered approximately 40% of the pond surface. Submerged aquatic vegetation, such as widgeon grass (*Ruppia maritima*), was present in the deeper sections of the pond. A species list by strata is presented in Table 2. In addition, disturbed areas such as the man-made berm separating the pond from the ocean and spoil material washed into the pond were mapped. Cover type boundaries were recorded using a Trimble TDC1 Global Positioning System (GPS) unit. Spatial data were georeferenced, and transferred to ARCView/ARC/INFO® GIS (Environmental Systems Research Institute, Inc. [ESRI] 1999, 2002) for figure preparation (Figure 14).
