**Overview Report of Coastal Processes and Hazards in Northeast Coastal  
National Parks and Recommendations for Addressing Coastal Hazard  
Issues**

Cheryl Hapke  
U.S. Geological Survey

July 21, 2006

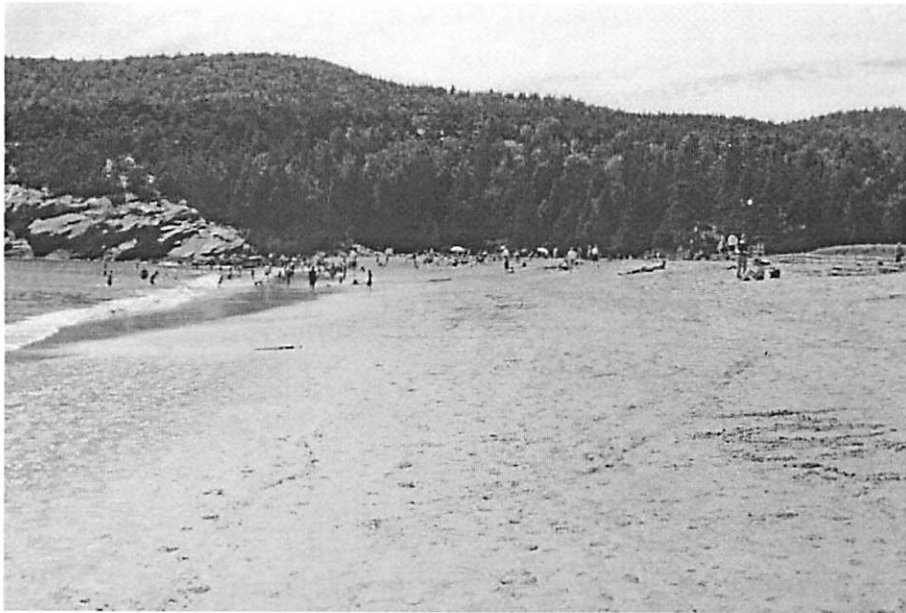
**Figure 1.** Sand Beach occurs at the mouth of a small river, which delivers enough sediment to keep this recreational beach in equilibrium.

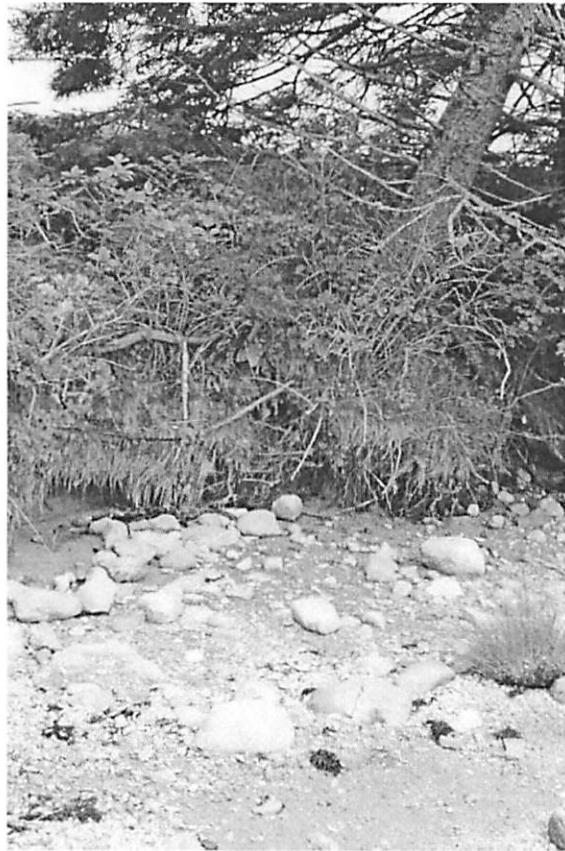
**Figure 2.** Undercutting of a bank along Somes Sound at The Narrows is causing some localized erosion. No park resources or infrastructure are threatened at this time.

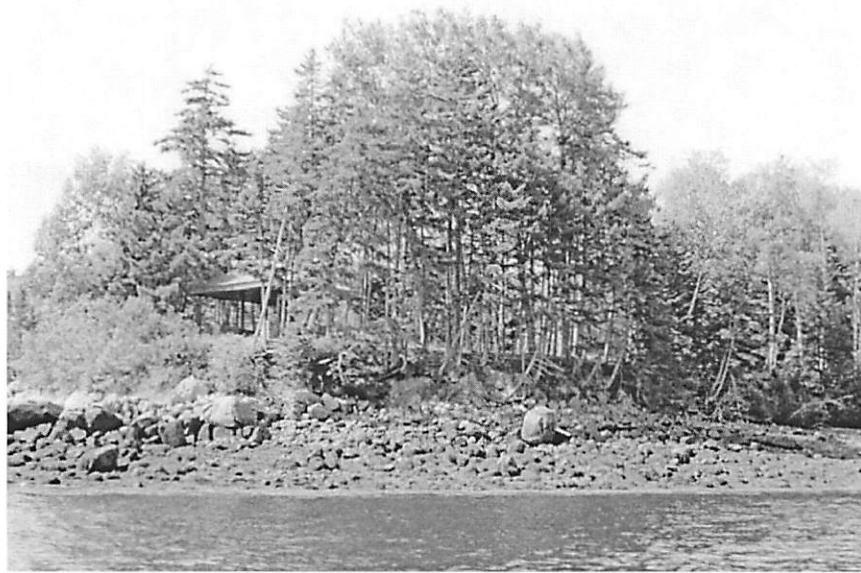
On the mainland, an interpretive trail runs along a small promontory in the river bank (Fig. 4). The exposed 2-3 m high riverine bluffs are composed of soft alluvial deposits. According to anecdotal

evidence, erosion rates have increased in the last 5-10 years. Riprap placed at the apex of the promontory 6 years ago attests to the perceived need by the park to mitigate this increased hazard. Little or no information has been compiled regarding rates of erosion on the mainland portion of the park. Both the interpretive trail and some of the structures are severely threatened by continued bluff retreat.

**Figure 4.** Low bluffs surrounding promontory, on which the SACR interpretive trails is built, are actively eroding. The apex of the promontory is now protected by riprap (large boulders in left foreground) but north side of promontory is eroding (note leaning trees just below bluff edge). The pavilion (in trees), which is a part of the interpretive trail, is threatened by bluff erosion.

It is recommended that a bluff retreat monitoring program be undertaken on the mainland portion of the park to evaluate threats from erosion to park infrastructure. A simple monitoring program that doesn't require specialized or high-tech equipment should be implemented to measure the distance from the bluff edge to permanent park structures. The monitoring can be carried out by local park personnel (with initial training by a field scientist). Since the interpretive trail area is quite small, a team of two should be able to conduct such surveys in a half-day or less. Initially the bluff edge position should be surveyed once per month, and after especially large rainstorms or tidal events.

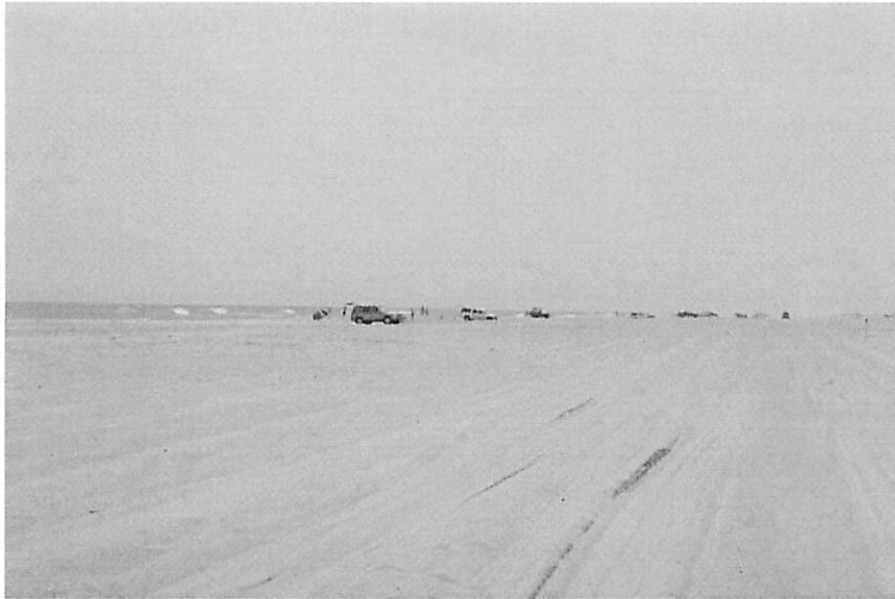
**Figure 7.** There is extensive off-road vehicle traffic in the central and southern portions of ASIS. Little is known about the impacts (if any) of such activity on the morphologic evolution of the beach/dune system.

Finally, it is recommended that an analysis of the impacts of driving on the beach to the park resources be undertaken. At Assateague, seasonal driving is permitted in the central and southern portions of island (Fig. 7). The impacts of extensive beach driving, such as at Assateague and Fire Island, are unknown in terms of changes to the beach geomorphology and disruption to sediment transport processes.

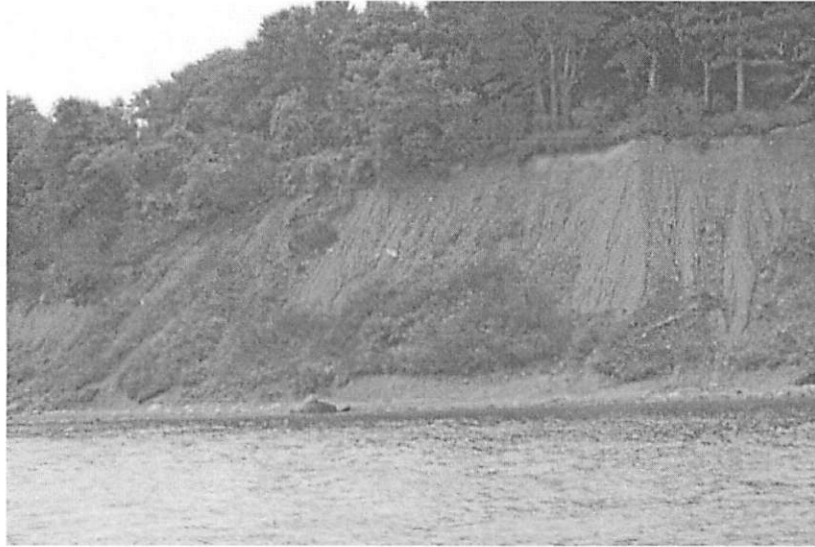
Tall bluffs flank much of the northern shoreline of Peddocks Island. The bluffs are composed of soft glacial till, and are eroding rapidly due to both marine (waves) and terrestrial (rain, overland flow) processes (Fig. 8). Recent analyses suggest that marine erosion may be accelerated by the wake generated by boats passing through the channels between islands. Currently a program is in place to conduct regular ground surveys of the eroding bluffs and study the impacts of boat wake on bluff

**Figure 8.** Tall bluffs on the northern end of Peddocks Island are undergoing rapid erosion. The rills on the unvegetated portions of the cliff face are indicative of erosion by surficial overland wash processes.

erosion processes and rates. Since the bluffs are heavily vegetated along the top edge, a topographic analysis using lidar data may be difficult but the feasibility of this should be explored.

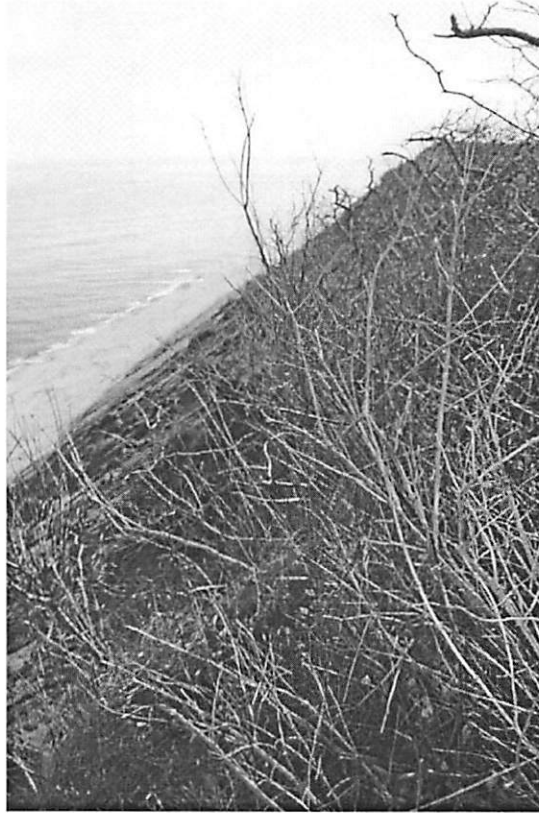
A shoreline monitoring program is well established in the park and this should continue on a regular basis. In addition, analyses of coastal bluff retreat have been primarily conducted using widely spaced profiles. Bluff retreat is perhaps the greatest coastal hazard in Cape Cod, as very tall cliffs erode (Fig. 9) episodically during large storms, threatening park infrastructure. Useful data for understanding the dynamics of bluff retreat would be to develop a time series of topographic models from existing lidar data to assess short-term changes to the beach/bluff system. Areas of concern in terms of beach erosion hazards include rapid erosion at a popular beach near Provincetown (Herring Cove Beach, Fig. 10), where some existing shore protection structures are being undermined and could

**Figure 9.** Bluffs as high as 50 m are formed in soft glacial till along the Cape Cod coastline.

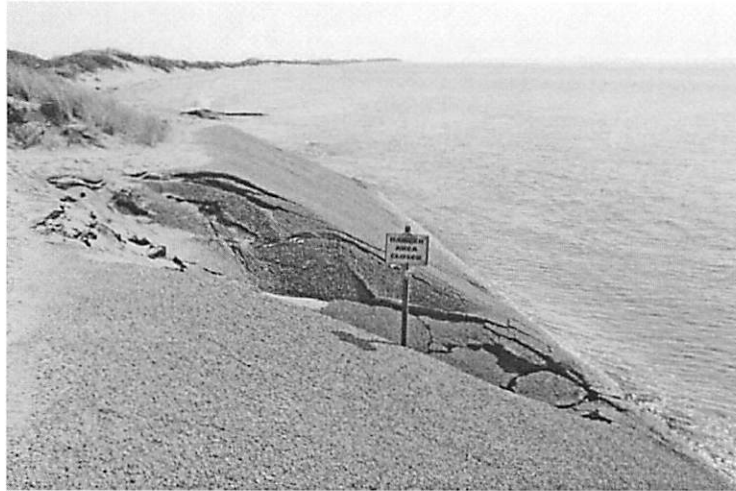
**Figure 10.** An asphalt bulkhead that lines a section of the foreshore at Herring Cove Beach is failing and may be unsafe.

make use of sections of the beach unsafe for park users. This site should be monitored and the park should consider the possibility of removing the asphalt bulkhead from the foreshore. Other areas of concern include issues related to management of the highly dynamic Monomoy Wildlife Refuge barrier island. Due to the dynamic nature of these islands, which are partly managed by the Fish and Wildlife Service and partly managed by the National Park Service, jurisdictional issues arise because boundaries (e.g. mean high water) are not stable.

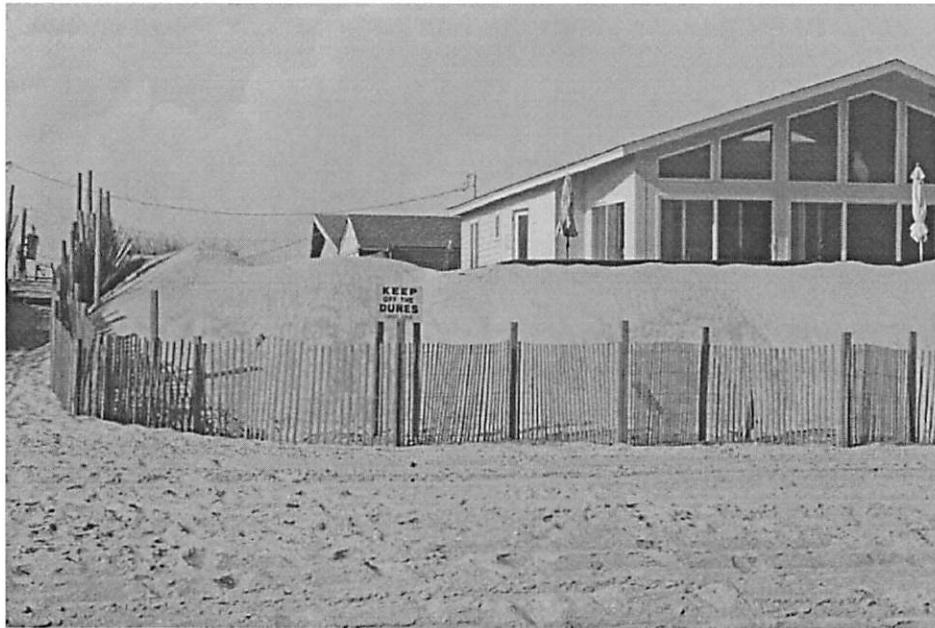
Coastal issues of most concern to park management include the impacts of beach scraping (Fig. 11) and nourishment, lack of data or information on nearshore sediment transport processes, need for better understanding of inlet formation and overwash dynamics, and how to address issues of bayside erosion (Fig. 12). The beach on Fire Island is also used heavily by vehicles (Fig. 13) except in restricted areas. There are very few studies to date on the impacts that driving on the beach may have on the long-term evolution of the beach.

**Figure 11.** Beach scraping to create artificial dunes for erosion mitigation is a common practice in the communities on Fire Island. Snow fencing is generally used in conjunction with scraping to help hold the sand in place.

It is recommended that studies be undertaken to look at the long- and short-term impacts of beach scraping on the morphology of the barrier island system. Analyses should include assessments of storm, seasonal and historical changes in beach morphology in scraped versus unscraped areas. This

analysis should include an assessment of how well scraping and nourishment mitigate erosion on a variety of scales. Complementary to this analysis would be a side-scan sonar survey to map the nearshore environment. Sidescan sonar does exist for the entire length of the island but does not extend closer to shore than 10m water depth. Sidescan data will provide some insight into the processes of nearshore sediment transport.

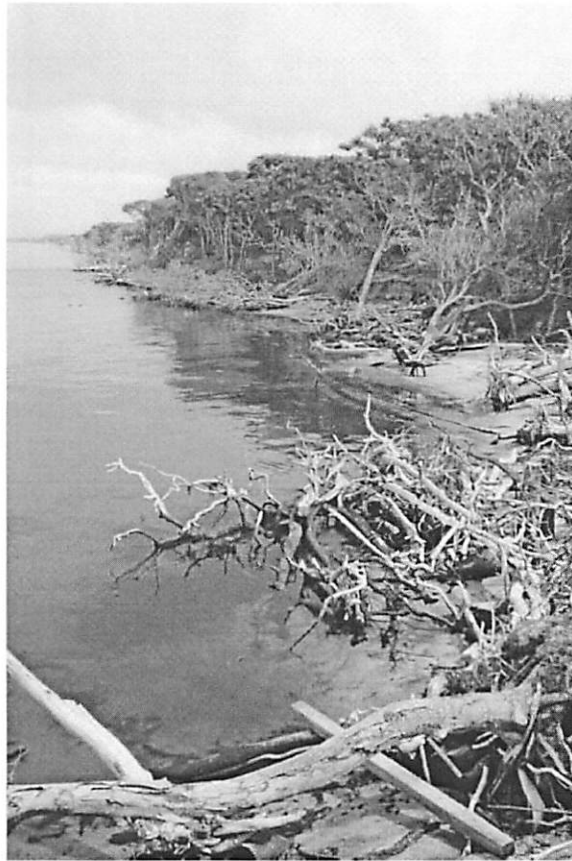
**Figure 12.** The edge of the maritime forest is no longer protected from waves by marsh or sand due to increased erosion, and the result is the dying out of the trees along the bayside edge of the of the island.

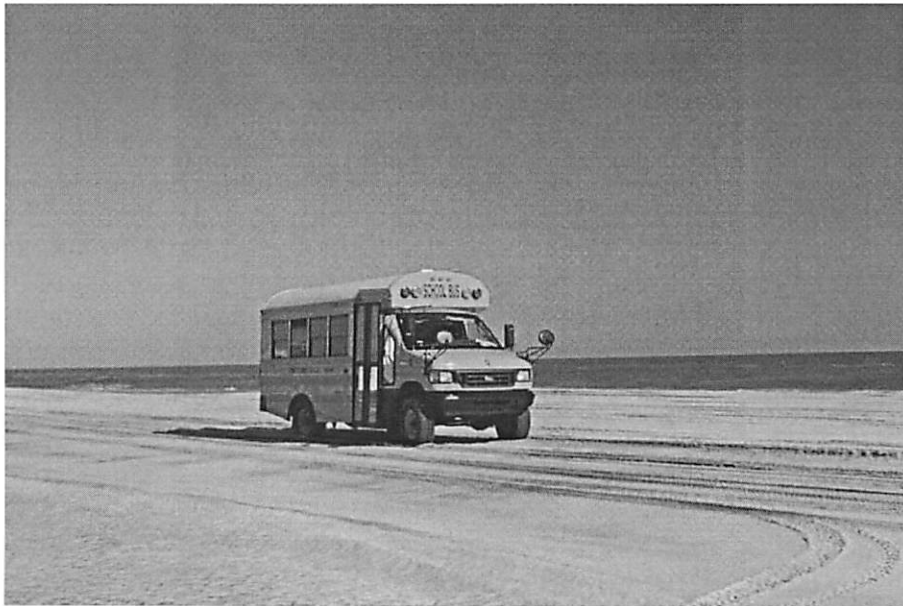
**Figure 13.** Vehicular use is heavy on Fire Island in the off-season. School bus routes and stops are actually on the beach.

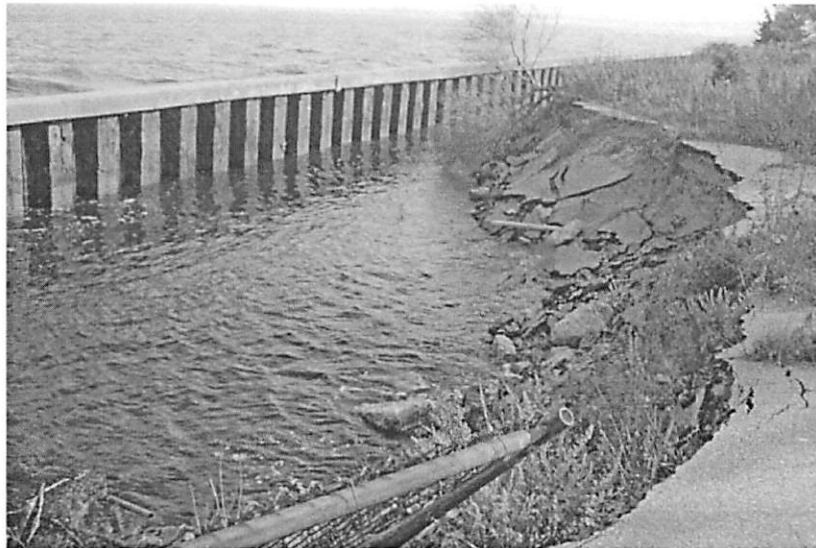
**Figure 14.** Erosion caused by scouring behind bulkhead at Floyd Bennett Field.

During a reconnaissance field trip, several specific areas of Jamaica Bay were discussed by park staff as those of coastal hazard concern. These include erosion around sections of Floyd Bennett Field, artificial ponds in the wetland marshes, Riis Park and Breezy Point. Floyd Bennett Field has a highly engineered and modified coastline, as it was once part of a Naval facility. Chronic erosion is occurring where a dilapidated bulkhead no longer provides shore protection from waves and tidal currents (Fig. 14). Ideally, all the old, non-functional structures should be removed and the shoreline restored to a more natural state. Currently the structures may be dangerous to park users. However, restoration would likely be prohibitively expensive. In the interim, the area should be monitored, and possibly closed to public use.

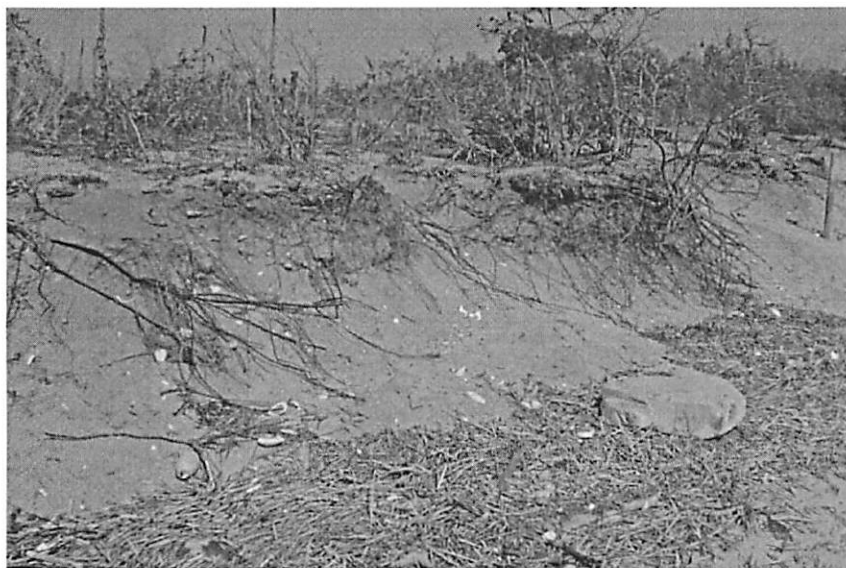
Artificial ponds were dredged in the Jamaica Bay marshes in the 1930s to create habitat in Wildlife Refuge. In order to preserve the dredged ponds, artificial sand levees were built and these levees are now rapidly eroding (Fig. 15). A long-term shoreline change analysis has been completed and beach profiling is underway to monitor additional changes. It is recommended that the monitoring be continued, and because of the value of the ponds to the natural resources of the park, they should be repaired or renourished as necessary.

**Figure 15.** Erosion of artificial sand levees around West Pond in Jamaica Bay.

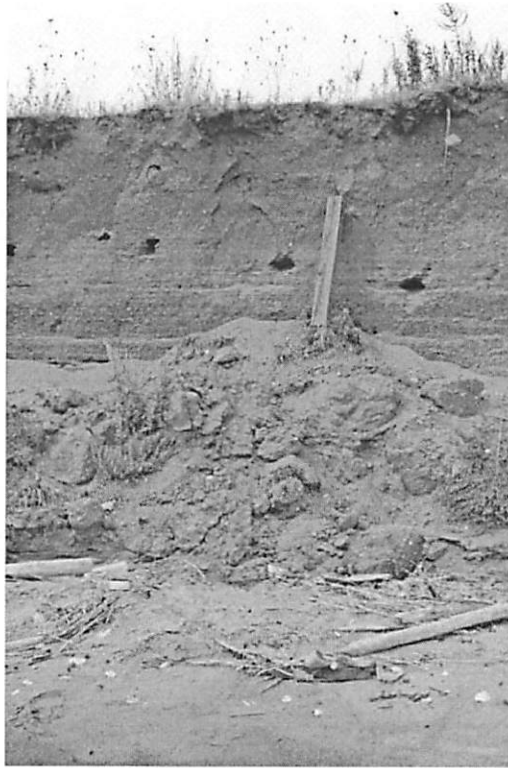
On the east side of Staten Island, coastal bluffs are formed in the soft glacial outwash deposits. Very rapid erosion of the moderate-relief (~5m) bluffs is currently threatening to destroy a bathhouse; continued erosion may lead to damage of other park infrastructure (Fig. 17). Additionally, rapid erosion of the marsh in front of the bluffs may be related to erosion hotspots in that the marsh may provide some bluff-toe protection from waves. The erosion of both the marsh and the bluffs may be exacerbated by a large groin at the northern end of the bluffed section of coast. It is recommended that a historical aerial photographic analysis of this area be conducted to quantify the erosion rates and investigate the reasons for the high erosion in this area. The groin to the north may be trapping sediment from upcoast, resulting in reduction of the marsh and erosion of the natural protective beach

**Figure 17.** Rapid erosion of bluffs composed of soft glacial outwash deposits is threatening a bathhouse in Great Kills Park.

at the base of the bluff. It would be useful to park management to have a spatial inventory of what infrastructure may be threatened in the future as a result of rapid bluff erosion.

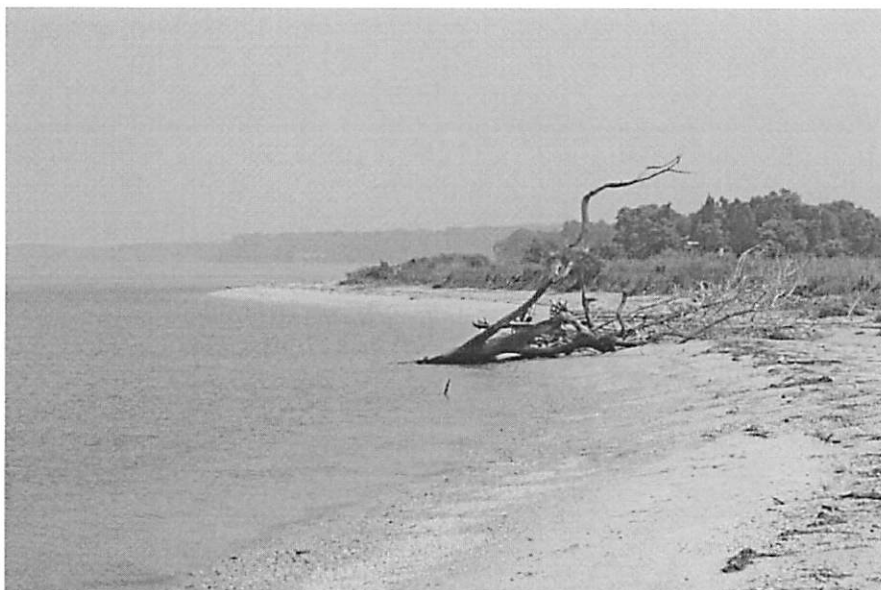
This National Monument is situated adjacent to a dynamic river estuarine setting, Pope's Creek Estuary, which feeds into Potomac River (Fig. 18). The estuarine environment includes a migrating sand spit and tidal marsh developed on flood tide delta. Moderate-relief bluffs (5-15m) are formed in Miocene sediments just north of the estuary mouth (Fig. 19). The bluffs are actively eroding, and act as a continual source of sand for the barrier spit system. The rapid, episodic bluff erosion does present a threat to park resources (Fig. 20) but there is very little known about the rates of erosion, including the spatial and temporal variations. Some data on sandy shoreline change already exists, and there is active monitoring of coastal processes by USGS scientists from the Earth Surface Processes Program in Reston.

**Figure 18.** Looking south along barrier spit at mouth of Pope's Creek Estuary. Body of water on left side of photo is the Potomac River.

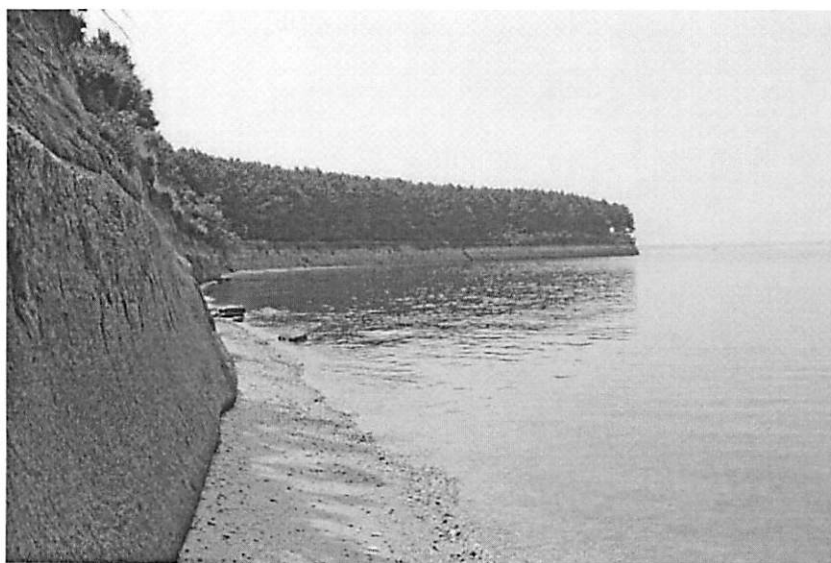
**Figure 19.** The coastline north of Pope's Creek Estuary is characterized by poorly lithified, moderate-relief bluffs. Photo is looking north.

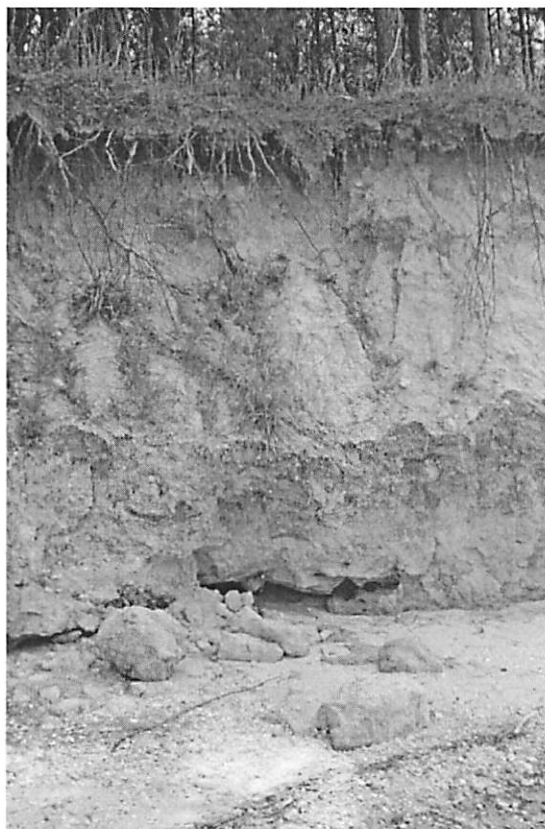
**Figure 20.** Bluffs are actively eroding through processes of undercutting and subsequent slumping. This photo shows the undercut bluff as well as debris (boulders on beach) left from an earlier failure. The numerous tree roots exposed at the top edge of the bluff are evidence that the bluffs are actively eroding.

It is also recommended that an analysis be undertaken to examine and understand the spatial and temporal distributions of bluff erosion. Some of the same data sources used for the shoreline change study can be used for the bluff erosion analysis. Existing lidar data could be used to quantify short-term bluff erosion rates and historical maps and/or aerial photography can be used to determine the long-term rates. In addition, it would be useful to develop a program to monitor shoreline change

and collect profiles of the bluff on a bi-annual basis, using GPS (preferably RTK). These data should be incorporated into the coastal change GIS database to monitor the change in relation to park resources.
