## **Characterization of Sediment Storage and Remobilization in Valley Creek, Valley Forge National Historical Park**

Technical Report NPS/NER/NRTR—2007/095

Lisa M. Fraley, Andrew J. Miller, and Claire Welty

September 2007

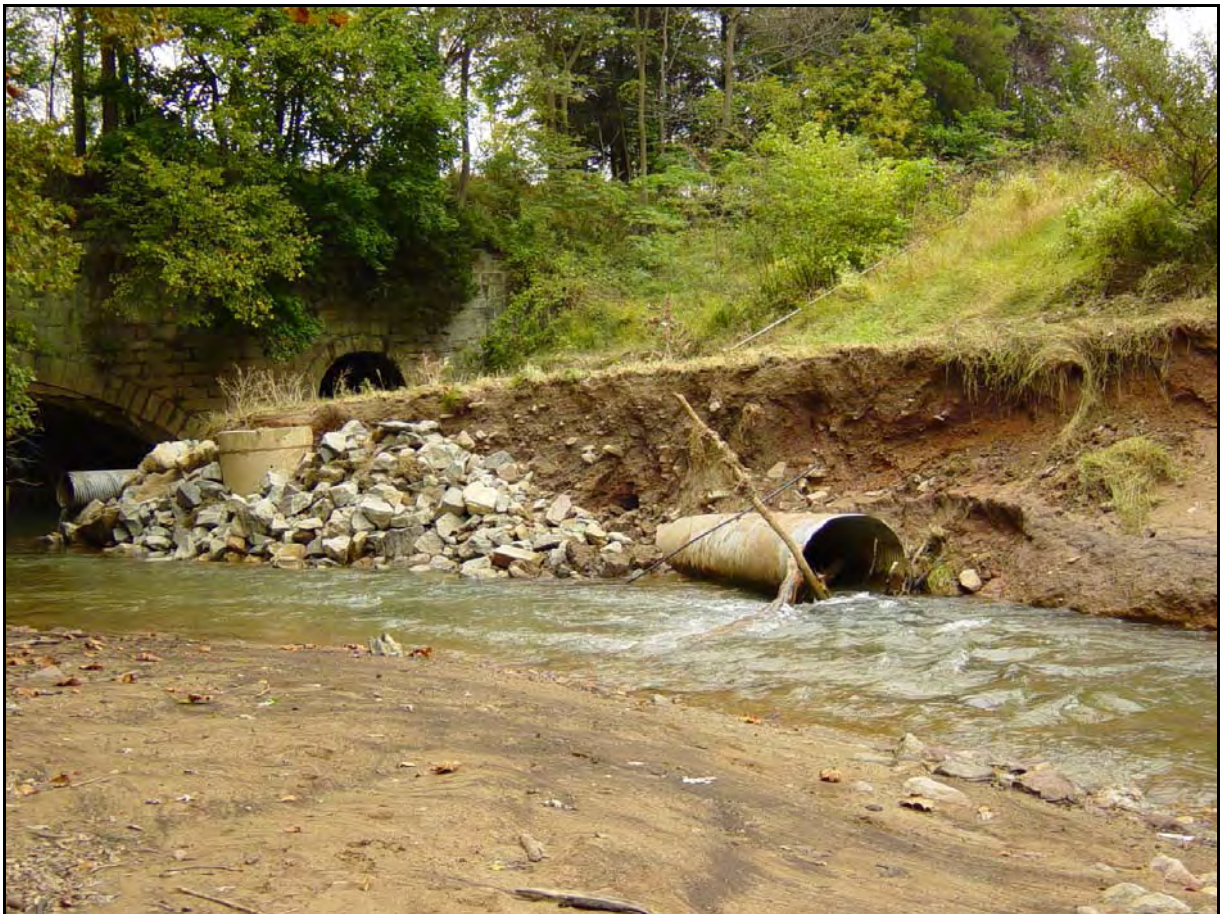
**ON THE COVER**

Eroded section of Valley Creek in front of Washington's Headquarters in Valley Forge National Historical Park.  
Photograph by: Lisa M. Fraley.
