## **Project Summary**

### **Quitobaquito Pond Water Supplementation**

### **March 23 – 27, 2009**

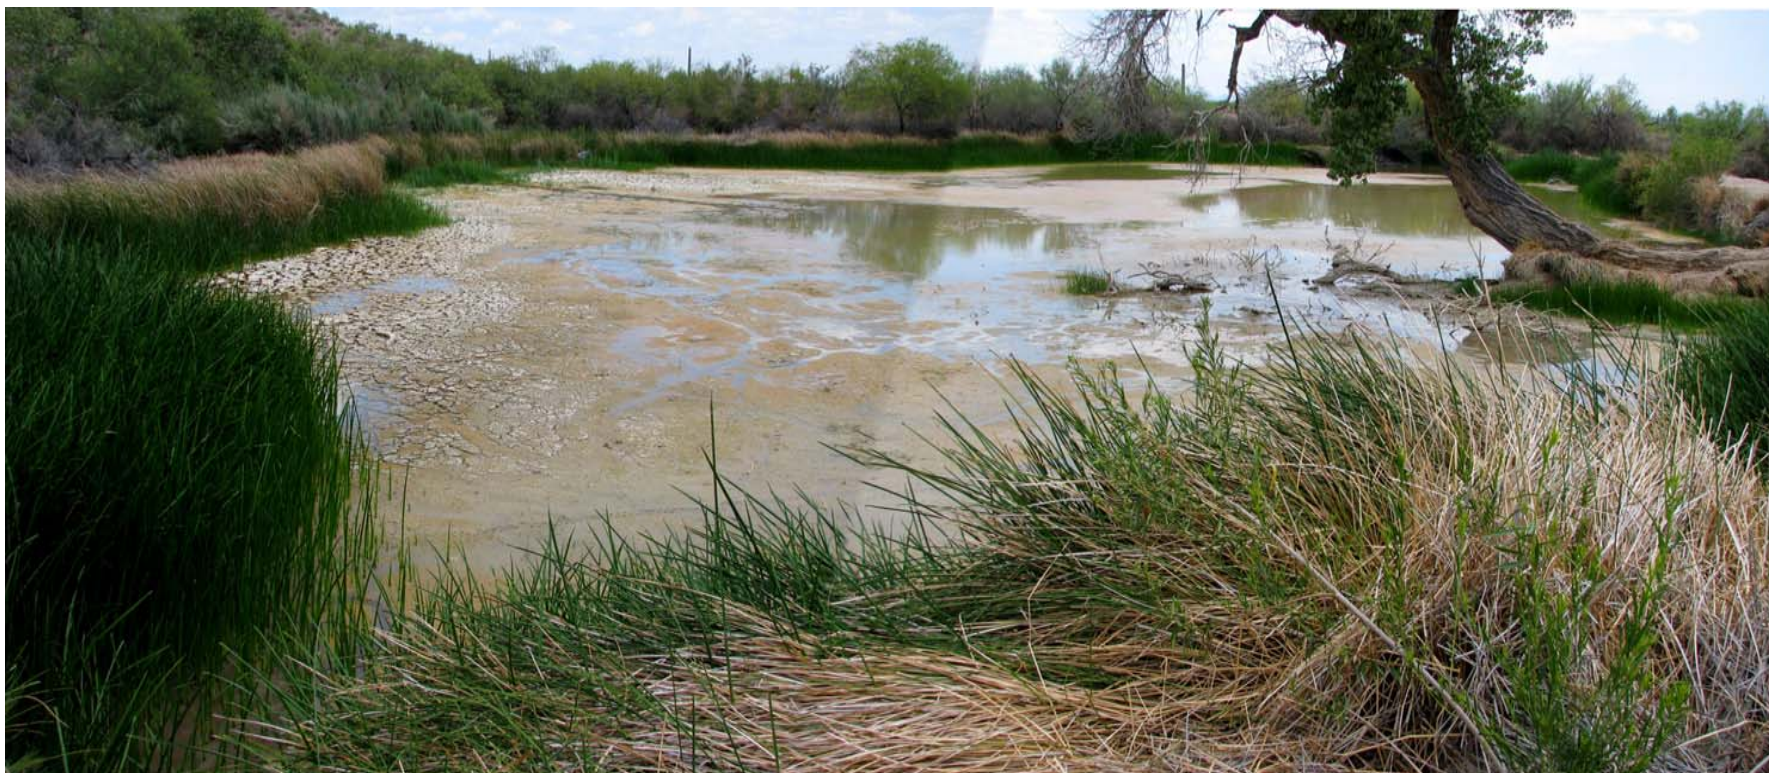
Figure 2. Quitobaquito Pond, view east from west bench, July 26, 2008. Pond level is minus 28.0 inches. Photograph is prior to major bulrush encroachment in August-September along north (left) and east (opposite) shores. Note exposed mudflats in all areas of pond except far right.

The appearances of the pond at its lowest level, - 28.0" (July 26, 2008) is illustrated in Figure 2. The condition on March 27 is illustrated in Figure 3. The net increase of 13.5" between the two views is the result of hauling 83,500 gallons of water between July and December 2008, rainfall input (4.76" from July 2008 through March 2009), reduced winter evaporation loss, 28,000 gallons added in early 2009, and the 190,200 gallons added during this project.

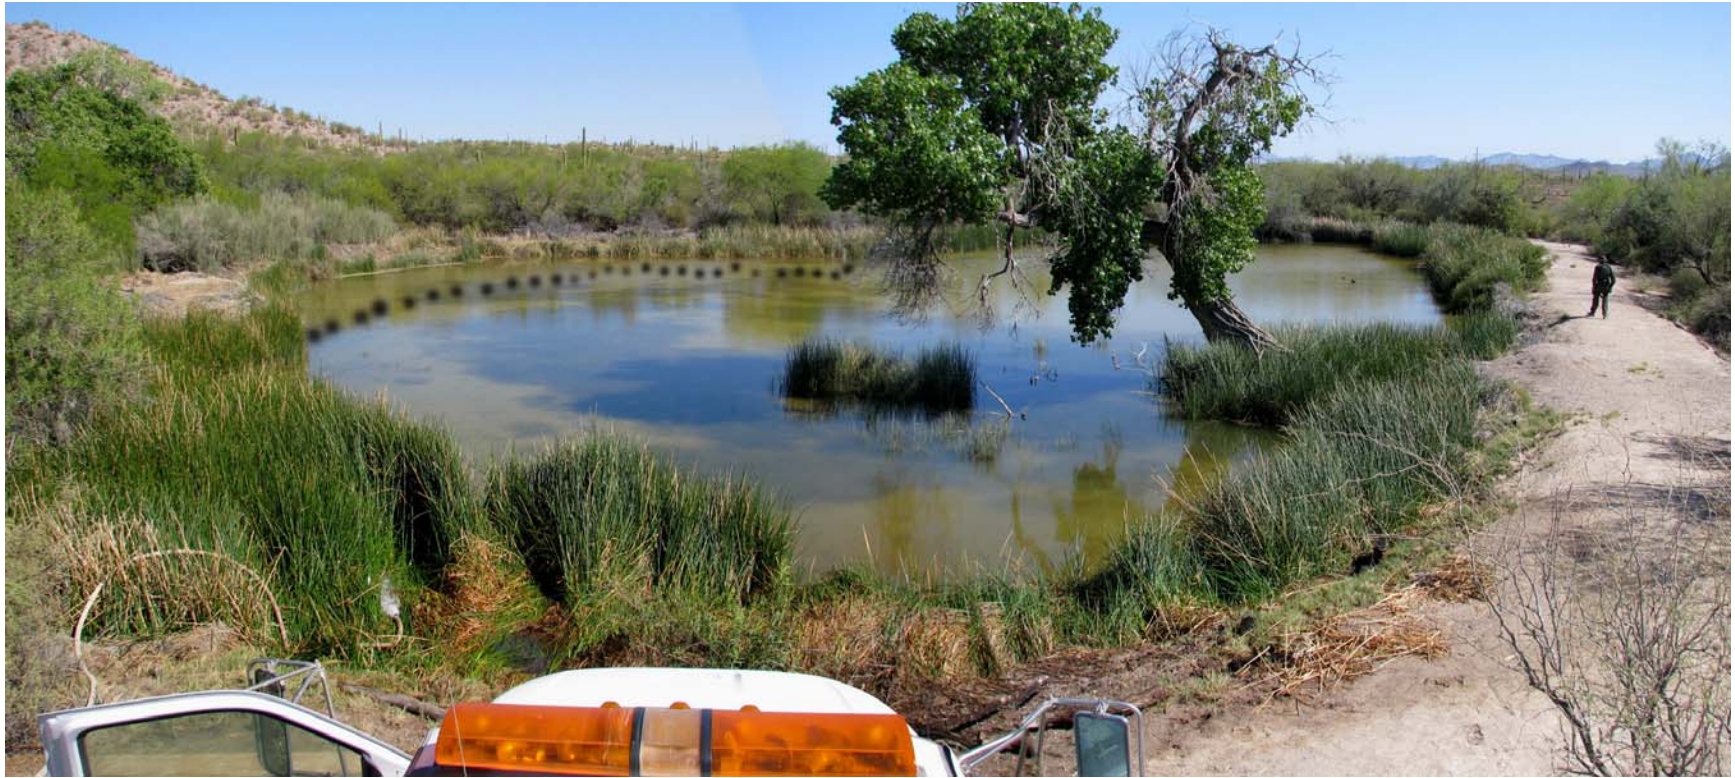
Figure 3. Quitobaquito Pond, elevated view east from west bench, March 27, 2009. Pond level is minus 14.5 inches. Line of black dots at northeast shore (left rear) indicates area of bulrush removed in winter 2008-2009. Note enlarging bulrush island under cottonwood tree, in comparison with Figure 1.

In winter 2008-2009, ORPI staff also manually removed extensive growths of bulrush (*Schoenoplectus americana*), with assistance from Southwest Conservation Corps crews. With the low water levels of 2006-2009, bulrush had encroached up to 25 feet from the former pond edge, toward the pond center. Encroachment was most extensive at the shallow north side of the pond. In that area, the combination of extreme low water and dense bulrush stands had created "new" land so substantial that seedlings of mesquite and tamarisk were abundant within the bulrush, in what was recently open pond. In winter 2008 and early 2009, we manually cleared approximately 1,400 square feet of bulrush stands, down to and including the root masses (Figure 3). An increasing island of bulrush beneath the cottonwood tree could not be removed due to presence of Africanized honeybees in the cottonwood.
