# Gulf Coast Network Water Quality Report

## *Status of Water Quality of Vicksburg National Military Park*

Natural Resource Technical Report NPS/GULN/NRTR—2012/548

February 2012

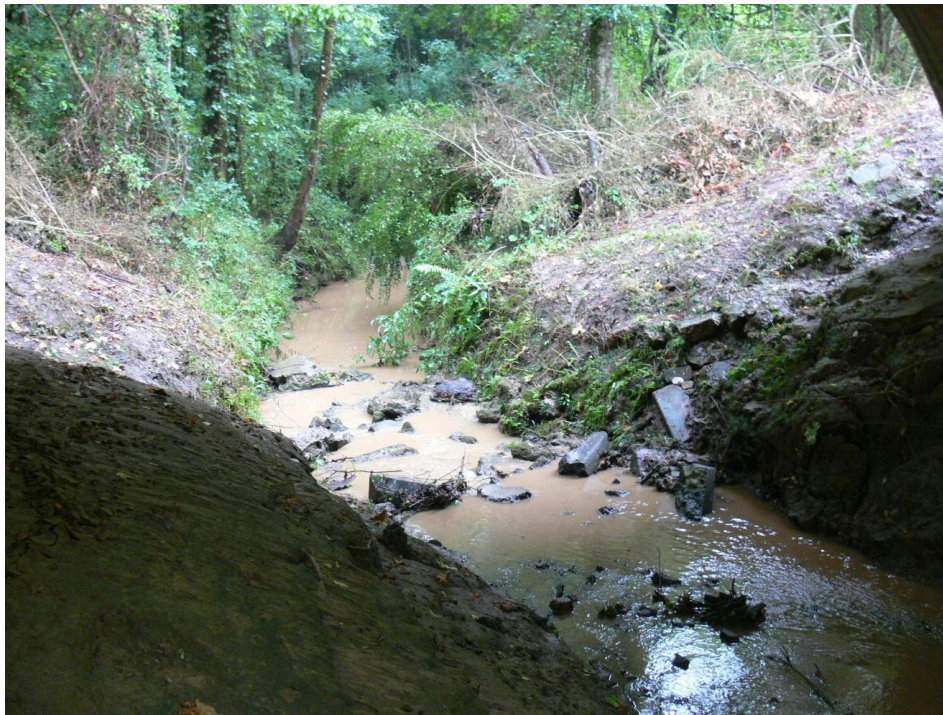
Figure 4. Durden Creek, facing downstream, August 10, 2006.  
Note high turbidity in response to brief local shower during the site visit.  
Photograph by Joe Meiman.

**Durden Creek (UADC):** Durden Creek is sampled where it leaves the park as it crosses under Union Avenue (Figure 4). The watershed upstream of the monitoring station is fully contained within the park and should reflect water quality of undisturbed lands, with the exception of the park's headquarters, visitor center, and maintenance yard, which lies approximately 200 meters (656 feet) upstream of UADC. The site is accessible in all conditions.

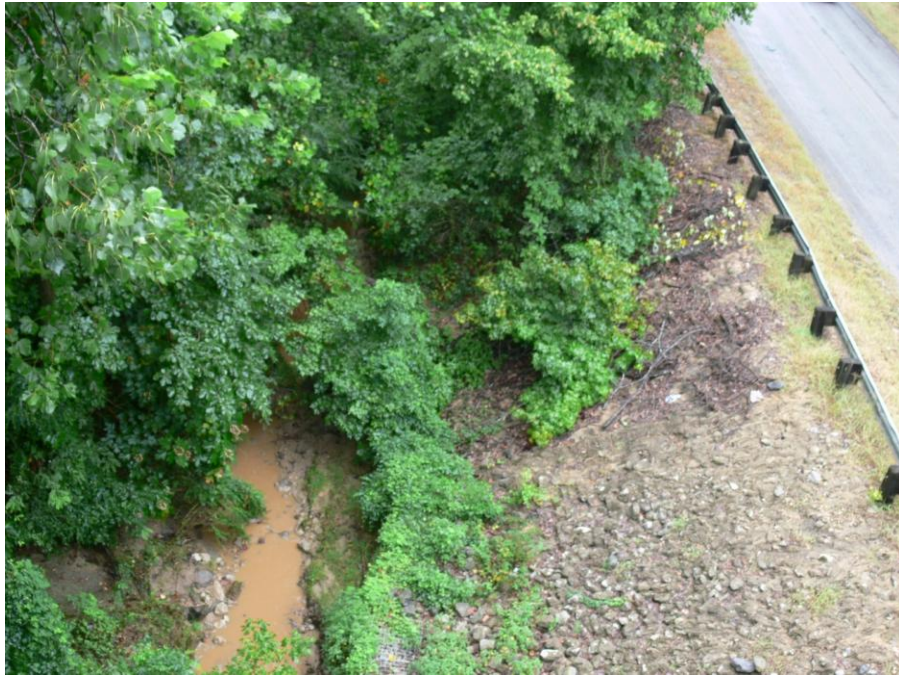
Figure 5. Glass Bayou adjacent to Jackson Road below Union Avenue, facing downstream, August 10, 2006. Note high turbidity in response to brief local shower during the site visit. Photograph by Joe Meiman.

**Glass Bayou (UAGB):** Glass Bayou is sampled where the stream enters the park along Jackson Road as it crosses under Union Avenue (Figure 5). Glass Bayou transects the park for approximately 850 meters (0.5 mile), flowing from light urban and commercial uplands to the Yazoo River in downtown Vicksburg. Site access is moderately easy and safe at all times.
