# Cumberland Piedmont Network Water Quality Report

## *Cumberland Gap National Historical Park*

# **Cumberland Piedmont Network Water Quality Report**

January 2009

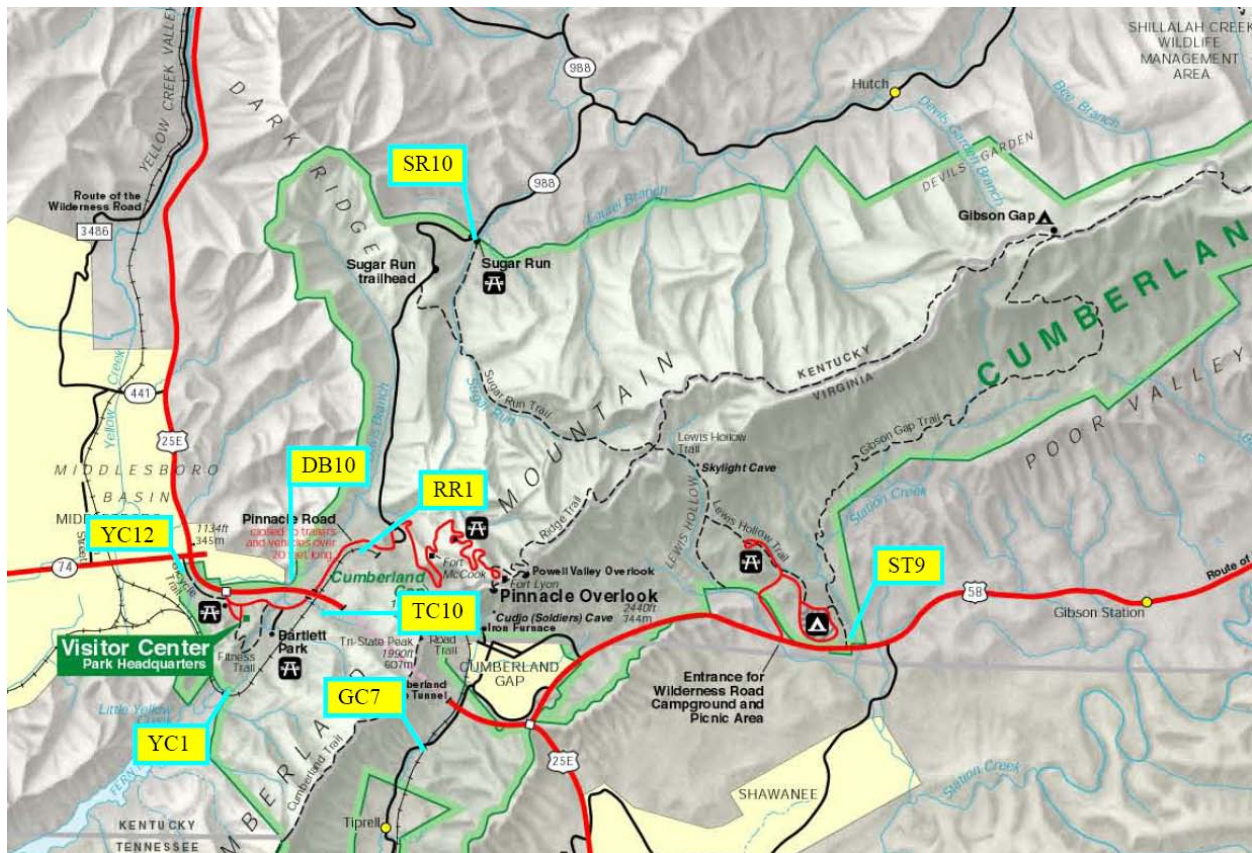
Figure 1. Map of water quality sampling sites in the eastern portion of CUGA.

Below is a map of water quality sampling sites at CUGA. During each monthly sampling round each site was visited and an additional Quality Assurance-Quality Control sample was extracted. Monthly sampling commenced in October 2006 and continued until September 2008, for a total of 24 sampling events. As all of these sites had been previously sampled by CUGA, we simply adapted their existing naming convention – two characters denoting the stream followed by a number designating its relative position within the watershed, with 1 as the headwaters and 10 at the base of the watershed or where the stream leaves the park.

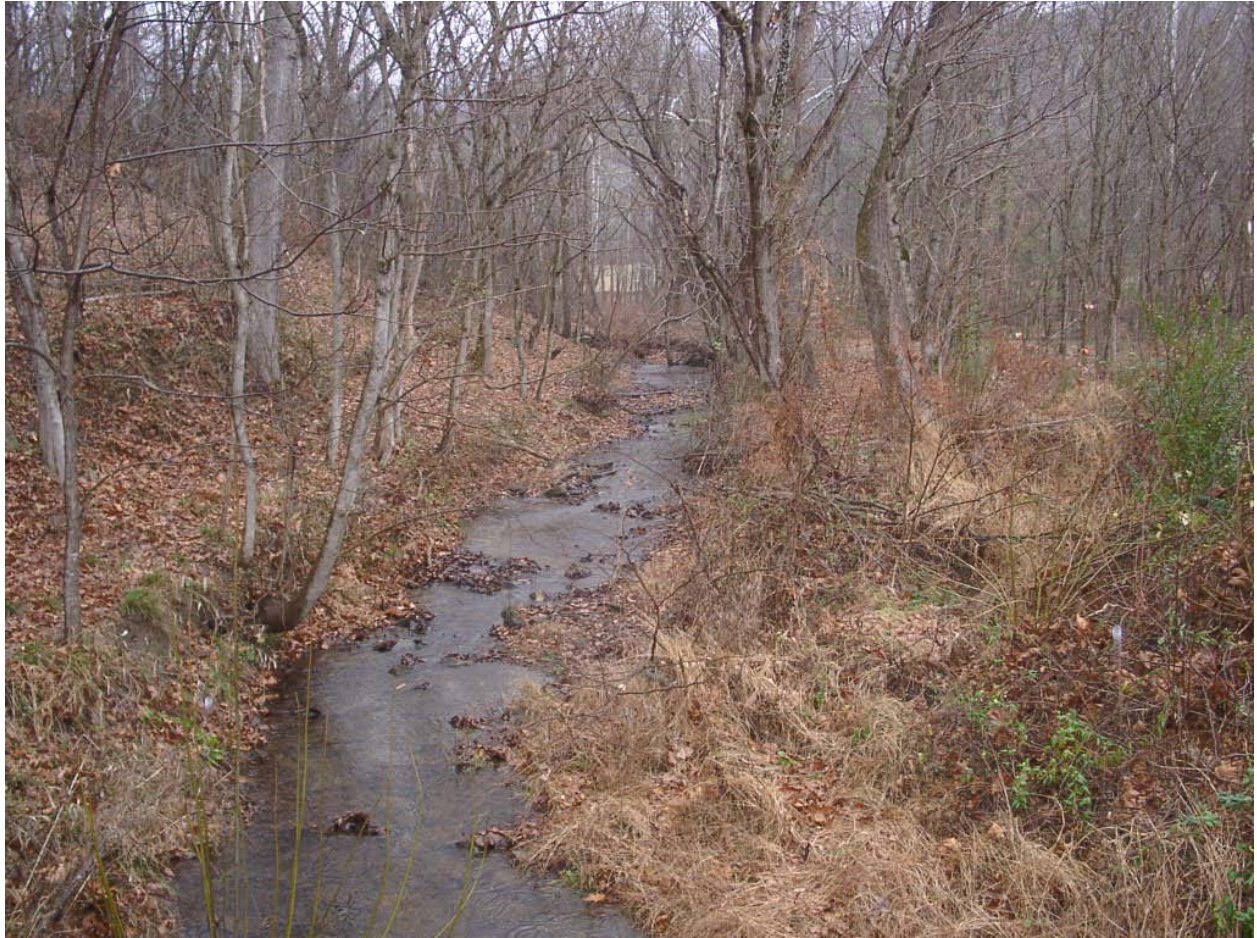
Located where Davis Branch leaves the park, immediately upstream of the city of Middlesboro Kentucky.

Figure 3. Davis Branch, looking upstream, as photographed November 20<sup>th</sup>, 2001 by Joe Meiman

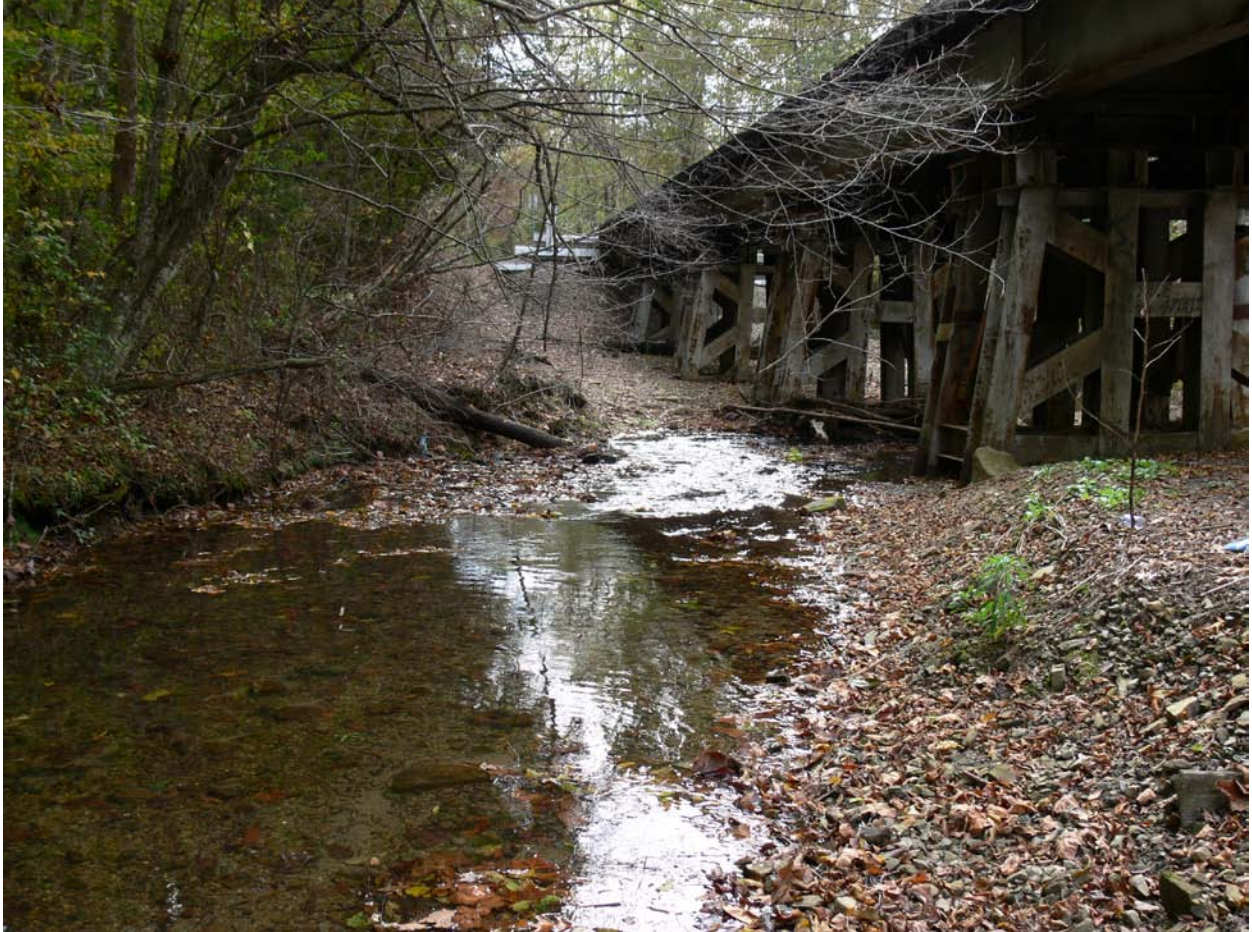
Located at the railroad bridge and downstream from the town of Cumberland Gap, Tennessee and the town's waste-water treatment plant. This site is recharged by a combination of drainage from the tunnel, Giles Spring (fed by the tunnel cave), Gap (formerly Cudjo) Cave, and runoff from the town.

Figure 4. Gap Creek, looking downstream as photographed October 10<sup>th</sup>, 2006 by Joe Meiman

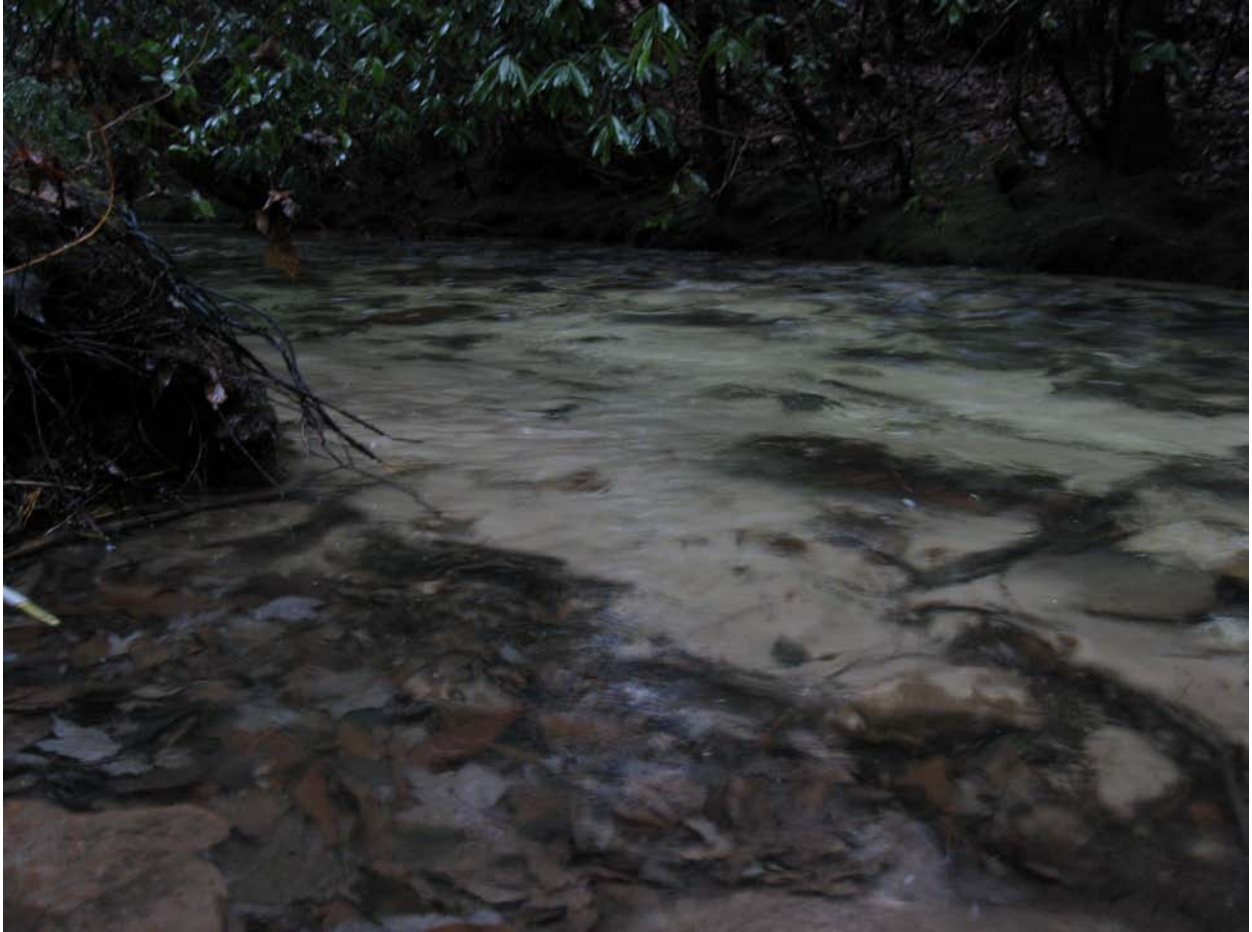
***Martin's Fork (MF5)***

Figure 5. Martin's Fork as photographed December 19<sup>th</sup>, 2008 by Joe Meiman.

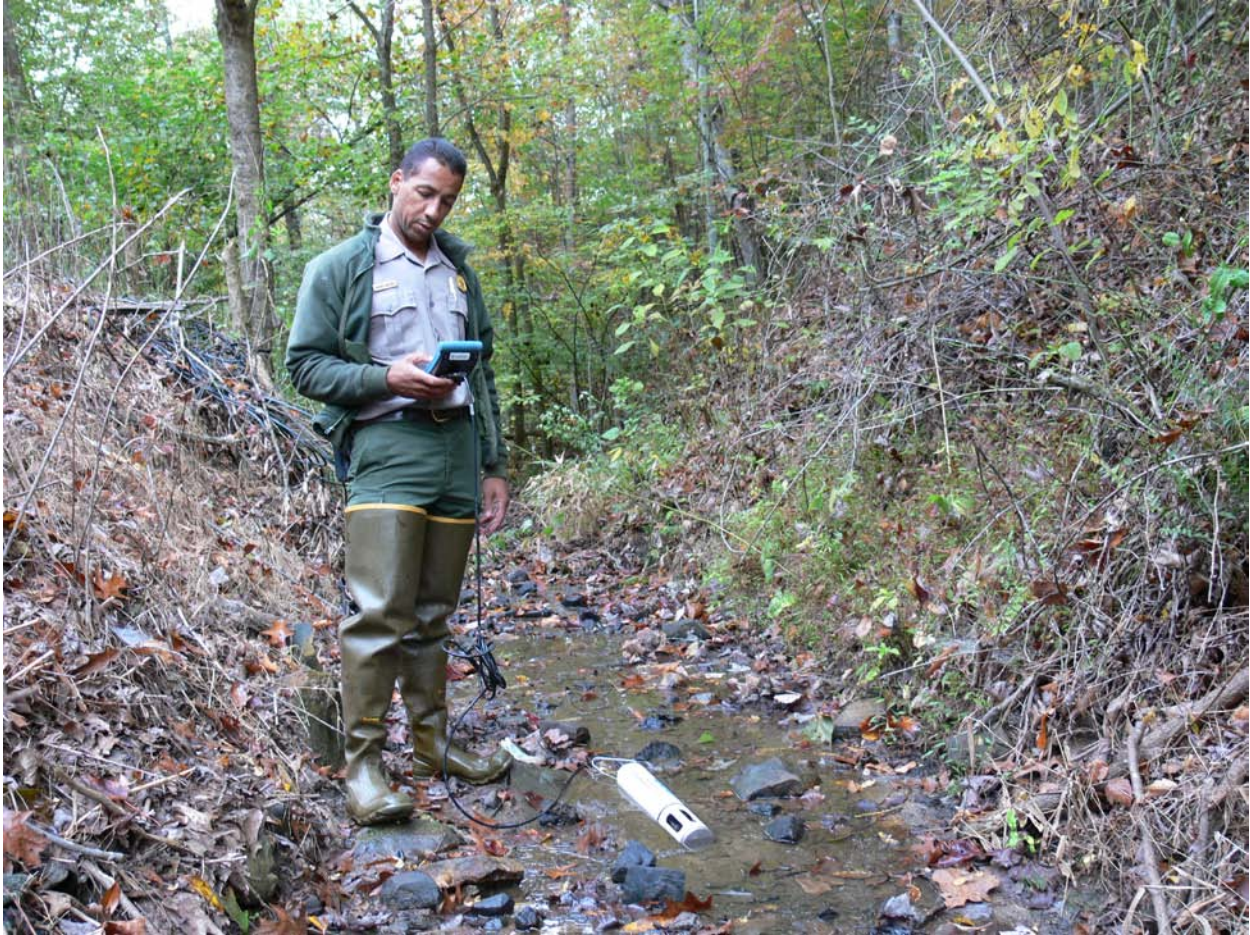
Located just off Pinnacle Road, this small perennial stream receives flow from the railroad tunnel as well as runoff from the restoration project area along the Wilderness Road. This stream discharges into Davis Branch.

Figure 6. Rodney Martinez monitors Rail Road Creek as photographed October 10<sup>th</sup>, 2006 by Joe Meiman

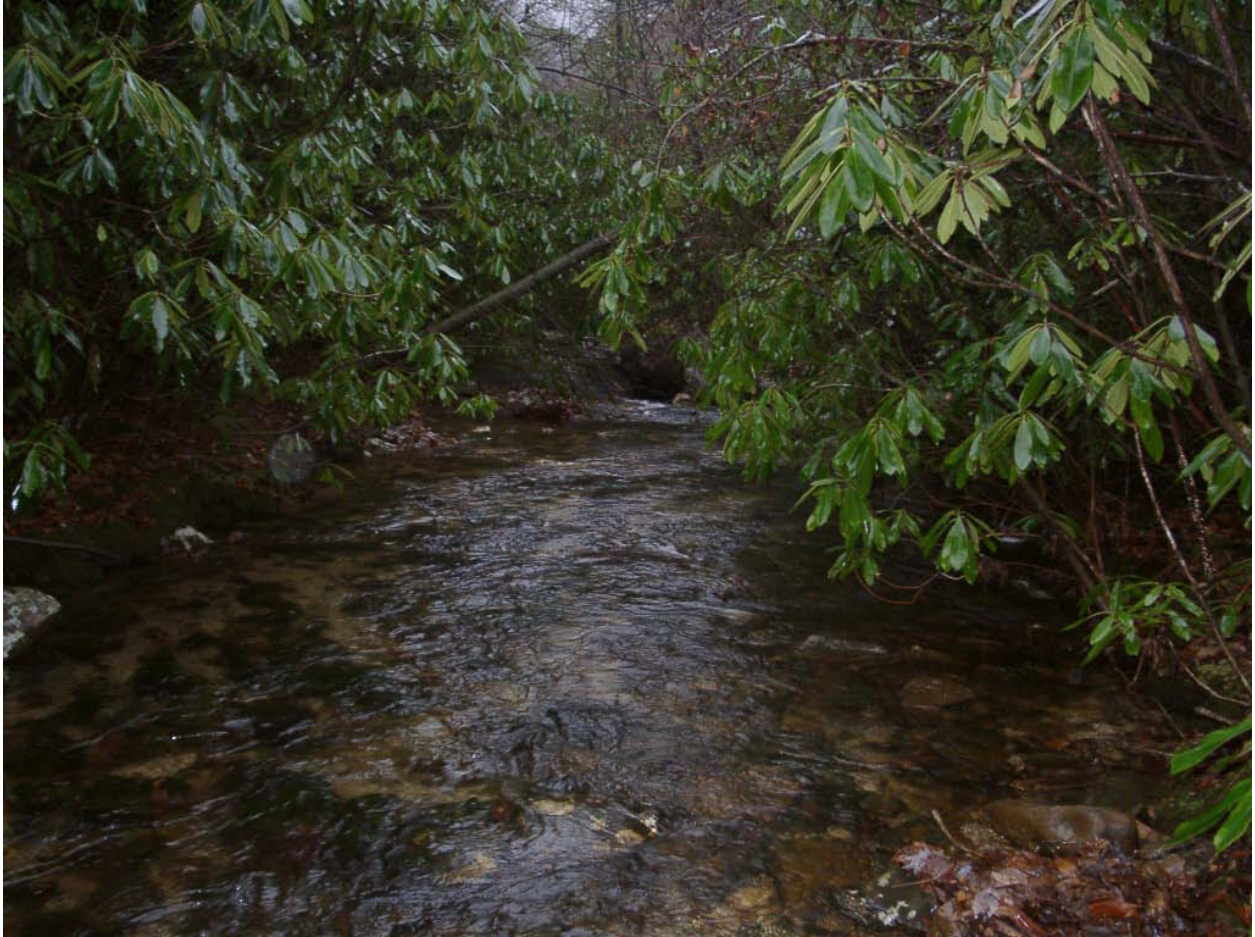
Primary sampling site where located as the stream exits the park and enters Kentucky Wildlife Management Area. This stream is very high gradient as it falls over large boulders as it flows down the western slope of Cumberland Mountain. It is headed at the Hensley Settlement.

Figure 7. Shillalah Creek as photographed November 20<sup>th</sup>, 2001 by Joe Meiman

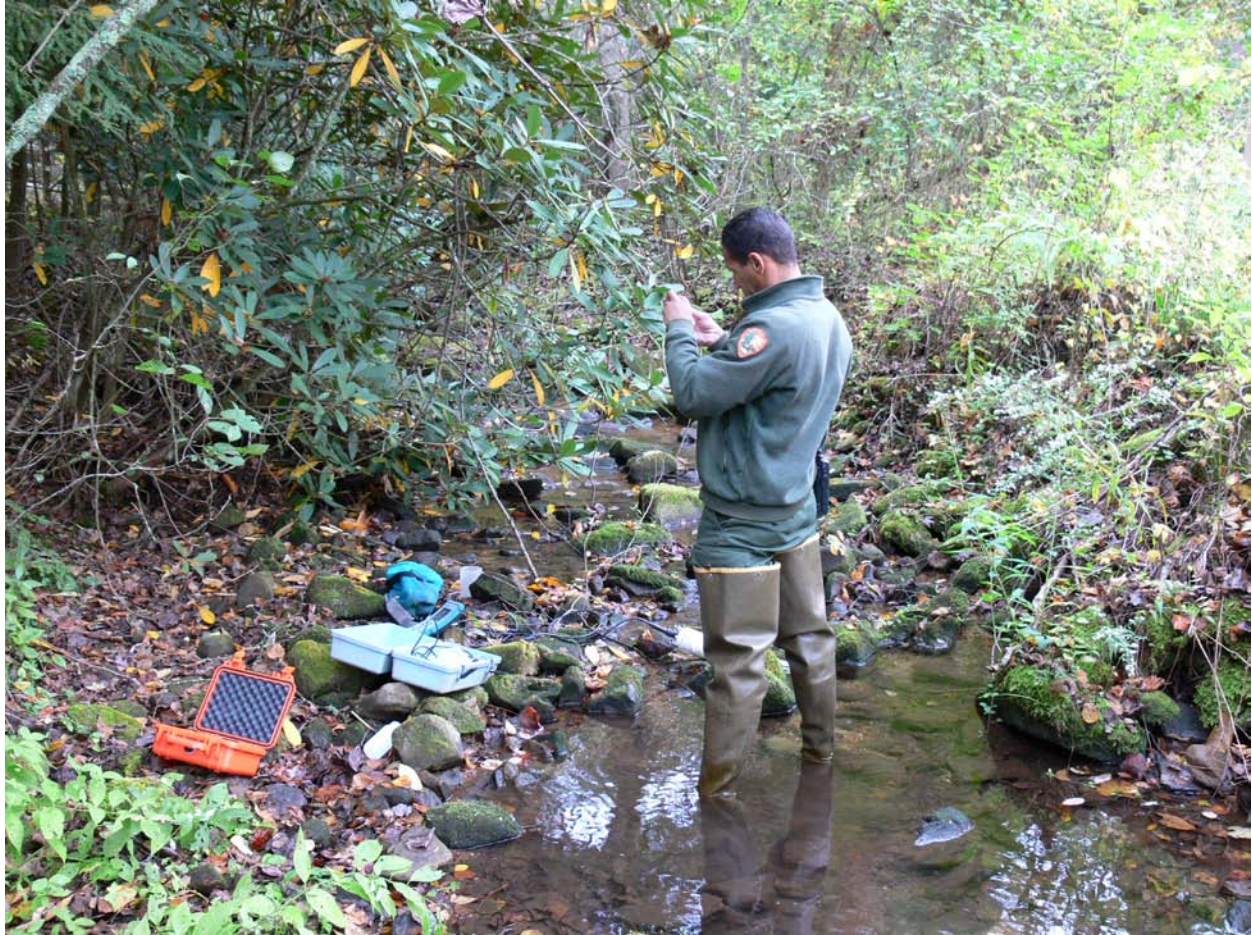
Draining park lands, this perennial stream flows along Sugar Run Trail and is adjacent to a picnic area. The main stem of Sugar Run is a dense corridor of Eastern Hemlocks and its watershed is entirely within the Commonwealth of Kentucky.

Figure 8. Rodney Martinez monitors the water quality of Sugar Run as photographed October 10<sup>th</sup>, 2006 by Joe Meiman

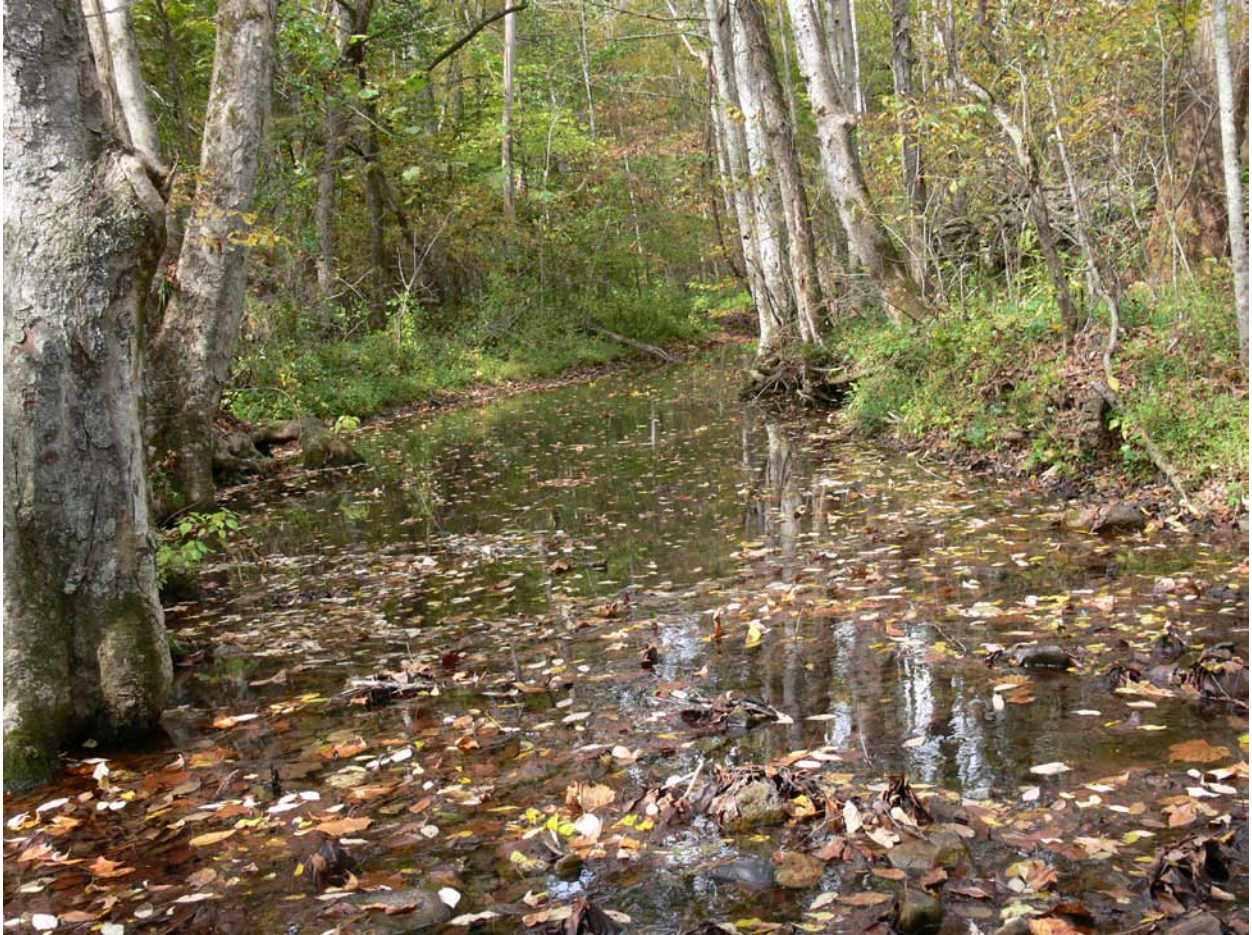
Located as Station Creek leaves the park and passes under SR58, this stream is recharged by rural private lands and park lands, including the park campground (septic system). This is the only site located in Virginia.

Figure 9. Station Creek, looking upstream, as photographed October 10<sup>th</sup>, 2006 by Joe Meiman

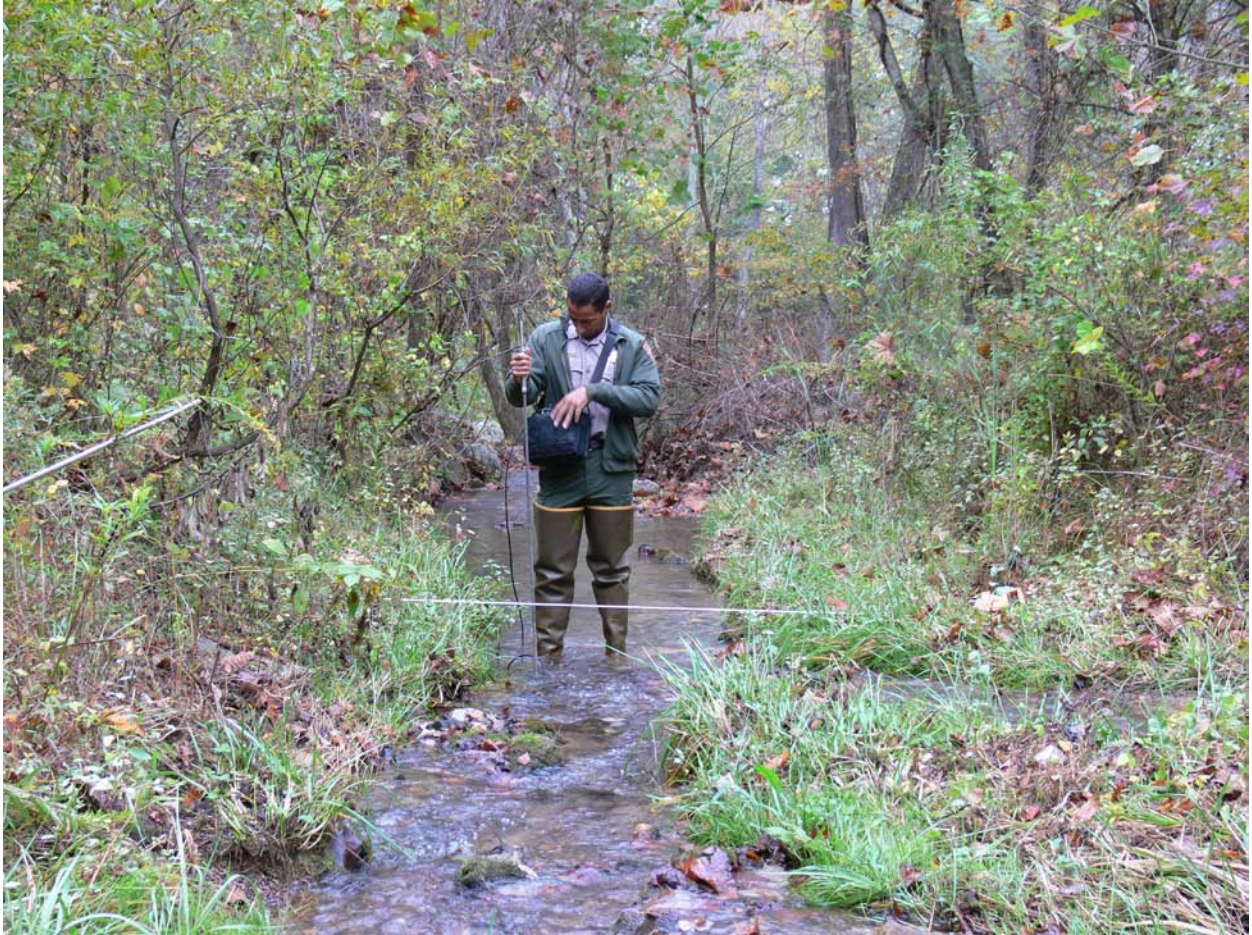
Located along Pinnacle Road, this perennial stream, which prior to the construction of the tunnel was a seasonal stream, receives recharge from US25E leading to the tunnel as well as drainage from the Kentucky side of the tunnel.

Figure 10. Rodney Martinez monitors Tunnel Creek as photographed October 10<sup>th</sup>, 2006 by Joe Meiman

Water temperatures of CUGA are considered to be within range to support native aquatic life. The compressed temperature range at Tunnel Creek (TC10) is caused by the exclusive recharge of this site by groundwater drained from the tunnel. While Kentucky has designated both Martin's Fork and Shillalah Creek as "Coldwater Aquatic Habitats", there is not a specific temperature requirement, only that they will not "be increased through human activities above the natural seasonal temperatures".

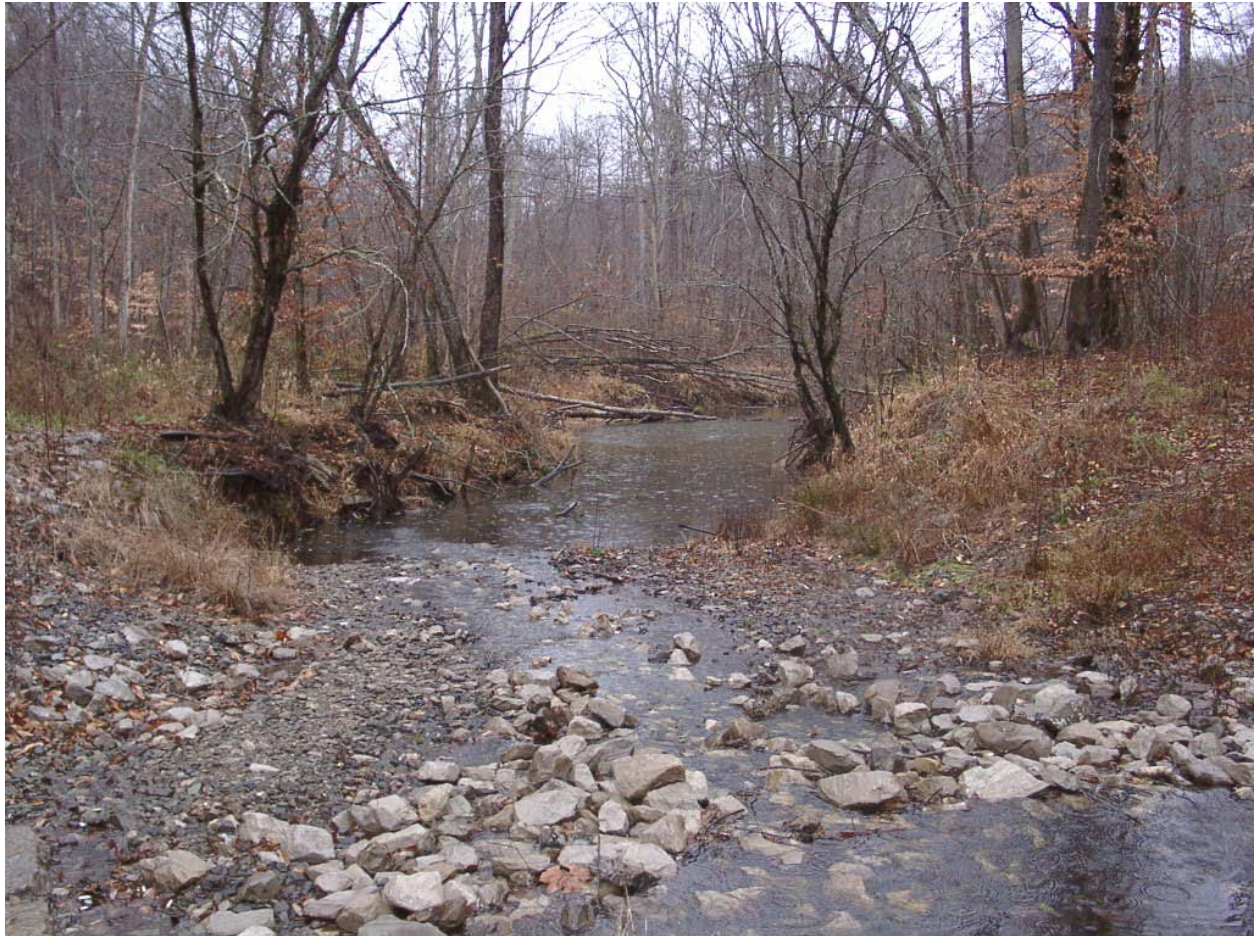
This site is located where Little Yellow Creek enters the present park boundary. It is just downstream from Fern Lake Dam (public drinking water supply for Middlesboro Kentucky). The majority of the watershed is forested with several abandoned strip mines (coal). Through acquisitions by the Trust for Public Lands, the park now protects 1620 hectares of the Yellow Creek watershed above Fern Lake.

Figure 11. Upper Little Yellow Creek as photographed November 20<sup>th</sup>, 2001 by Joe Meiman

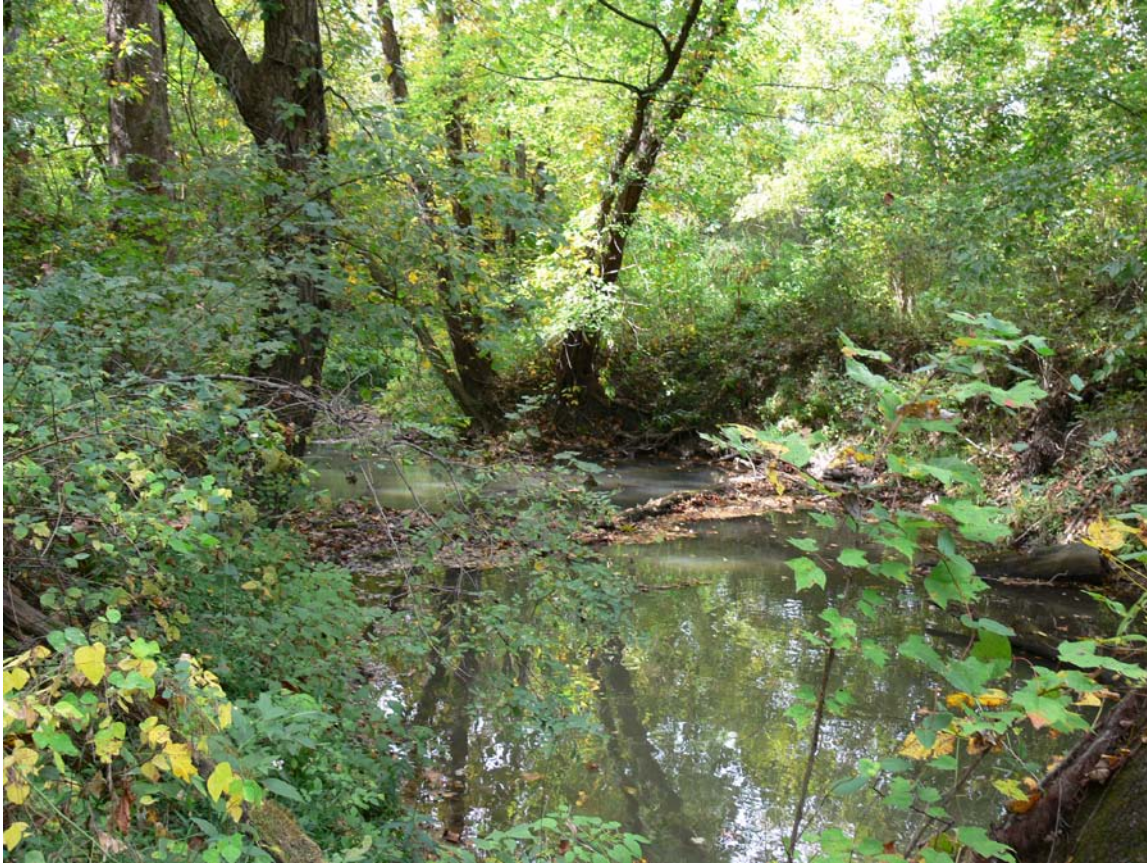
Downstream from the confluence of Davis Branch, this site also receives runoff from a small portion of Middlesboro as well as the park's maintenance, headquarters and Visitor Center areas. This site is where Little Yellow Creek exits the park at the intersection of US25E.

Figure 12. Little Yellow Creek, looking downstream, as photographed October 10<sup>th</sup>, 2006 by Joe Meiman

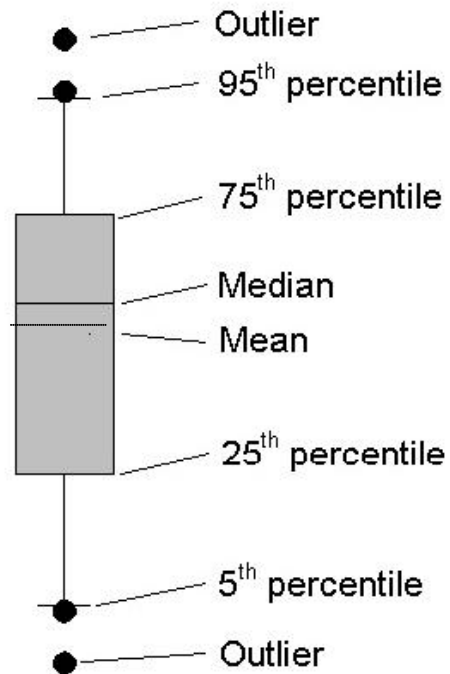
Figure 13. Structure of a box-plot

The following graphs are a composite of 24 consecutive monthly rounds of sampling at CUGA. Data are represented in the graphs below as box-plots. Here is a key to understanding the structure of a box-plot:

Note that there will be no outliers plotted for Martin's Fork as there are only nine data points for this site (a minimum of 10 points are required for outlier plotting).

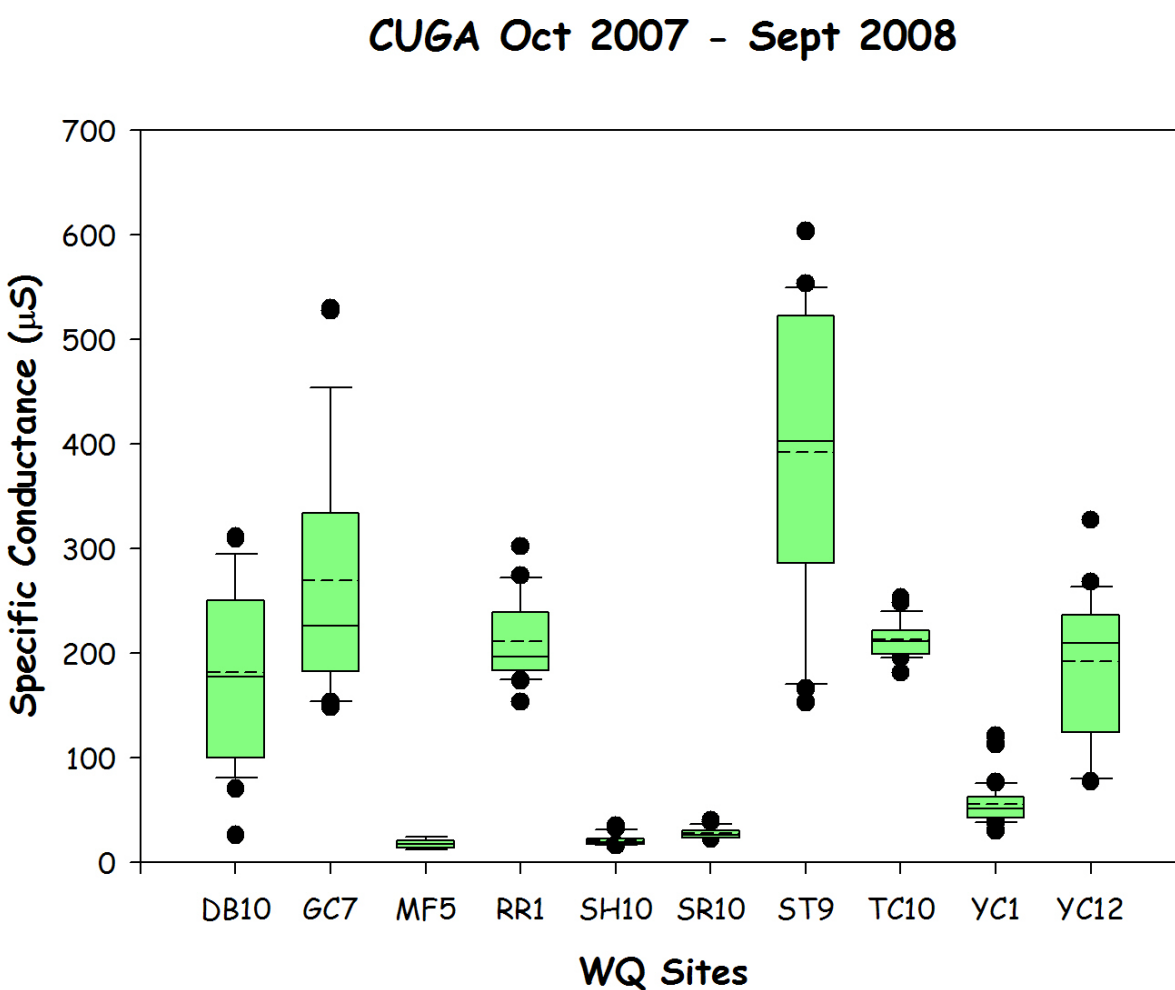
Figure 15. Specific Conductance at GUGA

The distribution of specific conductance (SpC) of CUGA is reflective of the amount of dissolved solids, which is primarily controlled by lithology and residence time. The tight pattern of low SpC values at Martin's Fork (MF5), Shillalah Creek (SH10), Sugar Run (DR10), and Upper Little Yellow Creek (YC1) are consistent to limited contact with carbonate strata. On the other end of the range, Gap Creek (GC7) and Station Creek (ST9) are recharged by watersheds containing ample carbonates (limestone); Lower Yellow Creek (YC12) is a mix of YC1 and Davis Branch (DB10). The range of values is due to flow condition. Following a rainfall event, waters are typically low in dissolved ions – quick flow having little interaction time with the rock. The inverse is true for low flow periods. There are no state standards for SpC.

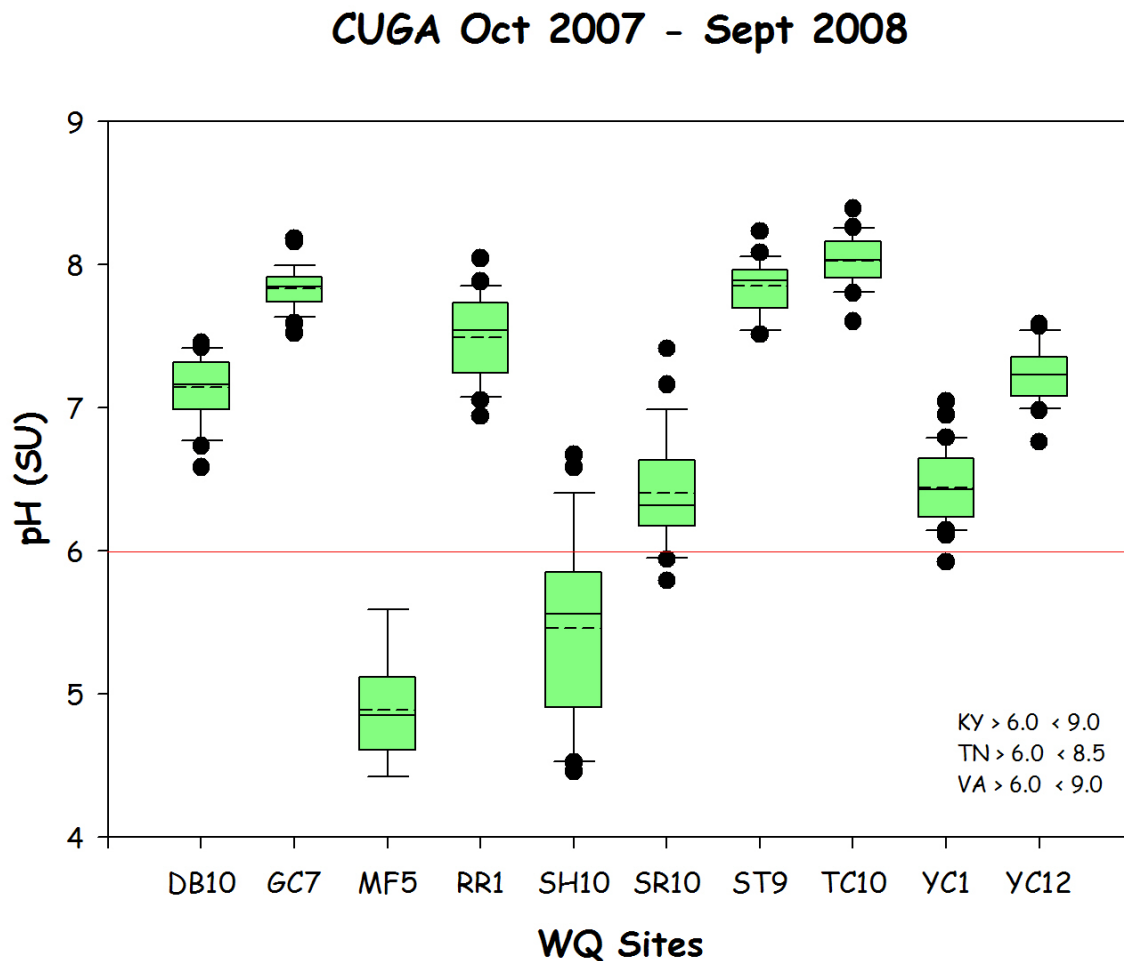
Figure 16. pH at CUGA

The pH of CUGA waters is summarized by the geology of specific watersheds: If carbonates are present, pH is buffered towards neutral to basic (7 and above); if not, pH is acidic (below 7). Rainfall is naturally acidic (about 5.6 to 5.8 SU), combined by natural humic acids (from soils and leaf decay), pH tends to remain low unless the water contacts carbonate strata. The dissolution of carbonate rock, such as limestone, liberates calcium ( $\text{Ca}^{+}$ ) and bicarbonate ( $\text{HCO}_3^{-}$ ) ions, the latter is an alkaline and comprises the bulk of a water's capacity to neutralize acid.

MF5 was always below, SH10 almost always below, and SR10 and YC1 sometimes below the Kentucky pH lower limit of 6.0 SU. This, however, may not constitute violations of state water quality standards. Section 10 (2) of 401 KAR 5:031 (Exceptions of Criteria for Specific Surface Waters) states: "The analysis shall show that the water quality criteria cannot be reasonably achieved either on a seasonal or year-round basis due to natural conditions..." Results of CUPN monitoring and published USGS geologic maps indicate that low pH values are to some degree natural. There are no carbonate rocks within the watersheds upstream of the Martin's Fork or Shillalah Creek sites, and very little upstream of Sugar Run and Upper Little Yellow Creek. Additional CUPN monitoring is presently making this determination.

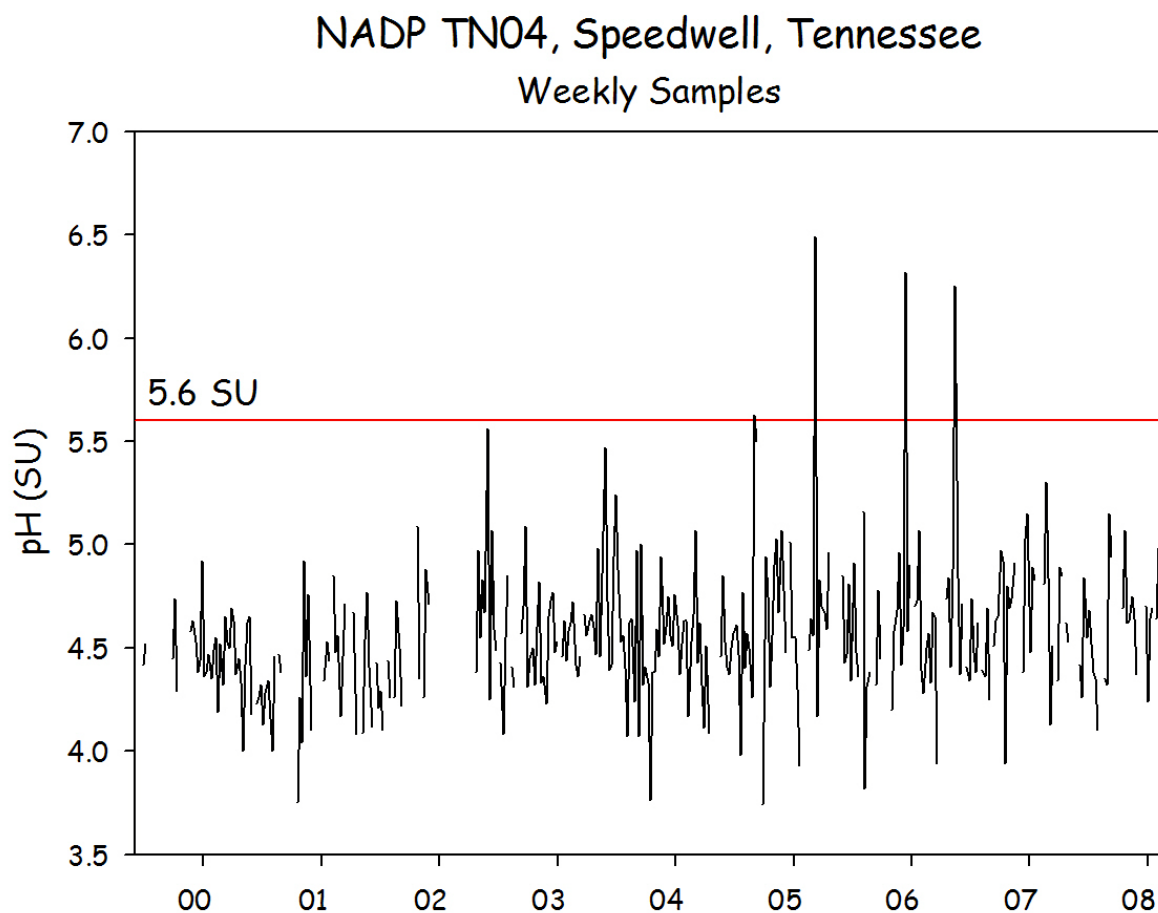
Figure 17. pH at NADP site in Speedwell Tennessee.

As mentioned above, data and geology support the claim that Martin's Fork, Shillalah Creek and Sugar Run have naturally depressed pH. This is due to a combination of facts that 1) rainwater is naturally acidic, and 2) there are no carbonate rocks within their watersheds to provide a pH buffer. Natural rain has a pH of about 5.6 SU, mainly because in the in-gassing of atmospheric carbon dioxide ( $\text{CO}_2$ ) as the raindrop forms and falls, producing carbonic acid ( $\text{H}_2\text{CO}_3$ ). The addition of sulfur and nitrogen oxides (mainly from emissions of coal combustion and vehicles) form sulfuric ( $\text{H}_2\text{SO}_4$ ) and nitric ( $\text{HNO}_3$ ) acids in the atmosphere and are brought to earth in rainfall. The nearest National Atmospheric Deposition (NADP) program site is located in Speedwell, Tennessee – some 35 km from the Hensley Settlement, the common watershed boundary between Shillalah Creek and Martin's Fork. Weekly pH readings at Speedwell (July 1999 – February 2008) show an average of 4.56 SU, maximum of 6.48 SU and a minimum of 3.74 SU. On only four occasions was the pH of rainfall collected at this NADP site above what is generally considered natural rainwater pH of 5.6 SU.

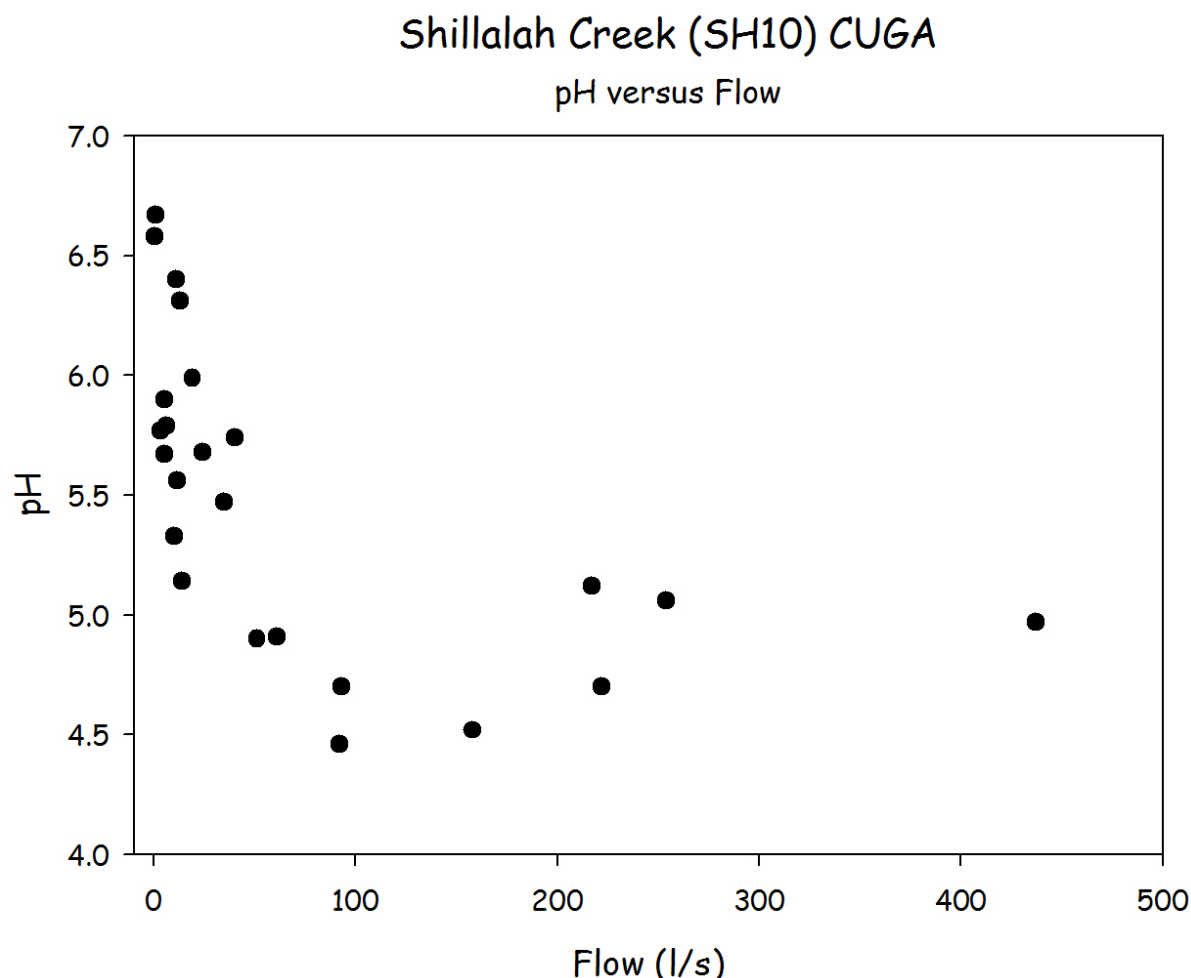
Figure 18. pH versus flow at Shillalah Creek.

This relationship can be seen in Figure 18 as pH is plotted against flow at Shillalah Creek. During times of high flow (sampled during or immediately after a rainfall event), stream pH is at its lowest. As flow decreases, and recharge is generated from bank-stores and groundwater, pH increases. Finally, at very low flows, where 100% of the flow is from groundwater, pH is at its highest.

All flow in the mountain streams (Shillalah Creek, Martin's Fork and Sugar Run) originate from rainwater. Some rainwater, during and immediately following a precipitation event, runs off into the streams as "quick-flow". Quick-flow has almost no residence time – that is contact with the soils and strata. Some precipitation soaks into the soils and fluvial deposits adjacent to the streams as "bank-storage" and gradually seeps into the streams. Bank-stores may be retained in these near-surface environments for several weeks or months. A portion of the rainwater eventually enters the fractures and bedding planes of the bed rock and becomes groundwater. Groundwater may be months, years, or even decades old. The longer water is retained, the longer it is in contact with rock and soil, the more opportunity it has to dissolve these materials.

If one were to examine a general hydrograph beginning with a rainfall event and ending with a drought, the proportion of flow from each of these three provinces would vary in the extreme. During and immediately after the rains, quick-flow may comprise 90% of the flow, 9% from bank-stores and perhaps 1% (if that much) from groundwater. A week after the rain, there would be 0% quick-flow, 95% bank-stores, and maybe 5% groundwater. Months after the rain, even the bank-stores will dry as eventually 100% of the stream flow is from long-residing groundwater. It is groundwater, slowing dissolving components of the bedrock during its long storage, which sustains flow during droughts. One such component is bicarbonate, even it minute quantities in the bedrock, is dissolved and buffers the groundwater that is slowly released into the streams.

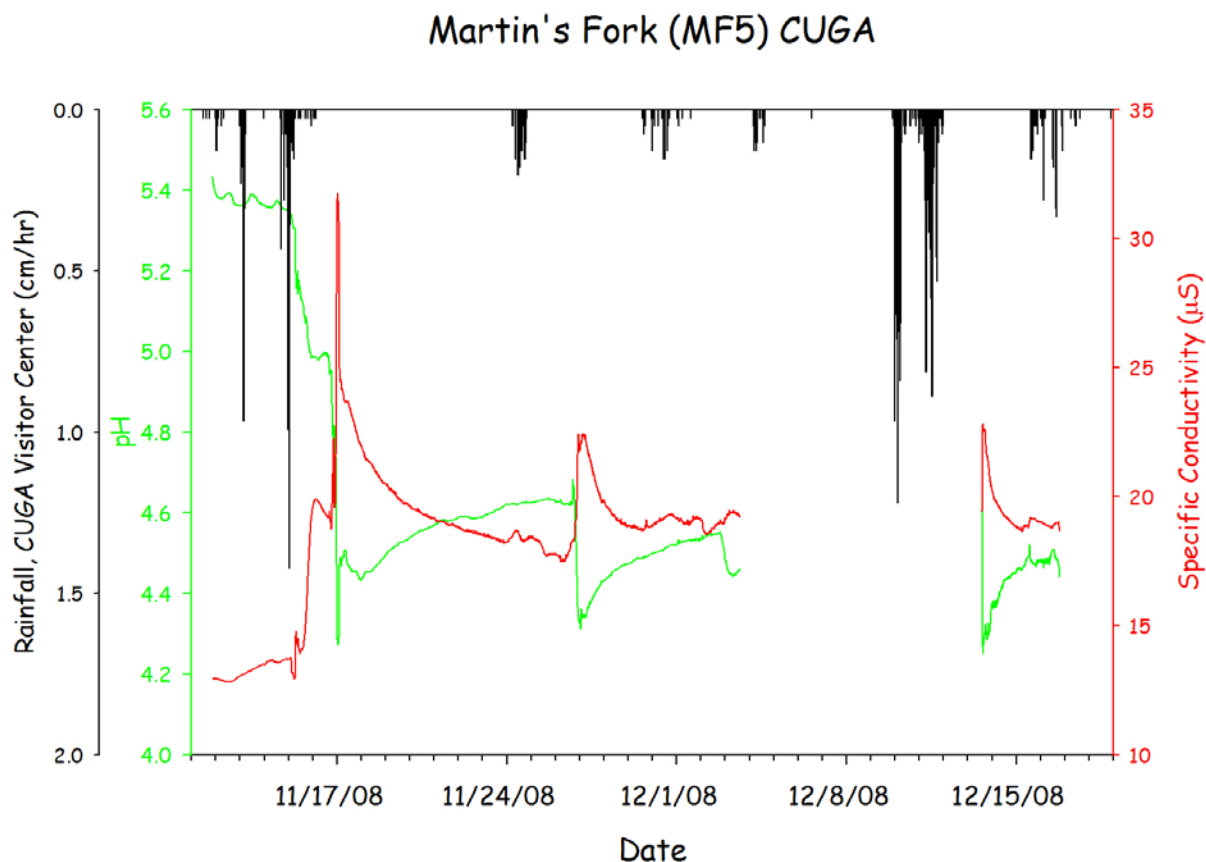
pH and SpC data shown in Figure 19 were collected every 15 minutes at Martin's Fork (MF5) during November and December 2008. The large gap in early December was caused by the datasonde being washed up on the bank during a large rain event. Data collection resumed during a subsequent rainfall when the stream rose to meet the sensors. Rainfall data are hourly totals from the nearest meteorological station, at the CUGA Visitor Center, some 23 km from the MF5 site. While rainfall and stream response do not match for all events due to precipitation variances between the sites, what is obvious is a decrease of pH and an increase of SpC following every dose of rainfall. pH at the beginning of the record, while the stream was at base flow (it had not rained in over one month) was at 5.4 SU, it ended one month later at 4.4 SU. As

the pH scale is logarithmic, this is decrease of ten fold with respect to hydrogen ion concentration. Each rainfall event lowered the pH a bit more. The frequency of rainfall events keeps pH depressed – this is common throughout the winter and spring months as the asymptotic recovery of pH is interrupted by rainfall events. As the stream has no buffering capacity, stream pH eventually approximates the rain. Recall the average pH at the NADP site in Speedwell (July 1999-February 2008) was 4.56 SU.

SpC is plotted to further indicate the arrival of a precipitation event. Its response is opposite to pH, in that the quick-flow component has a higher dissolved load than bank-stores. The average SpC of rain at the Speedwell site was 21.8  $\mu\text{S}$ . Examination of additional time-series data may explain this phenomenon.

Figure 19. pH and SpC response to rainfall at Martin's Fork,
