# Cumberland Piedmont Network Water Quality Report

## *Cumberland Gap National Historical Park*

# **Cumberland Piedmont Network Water Quality Report**

January 2009

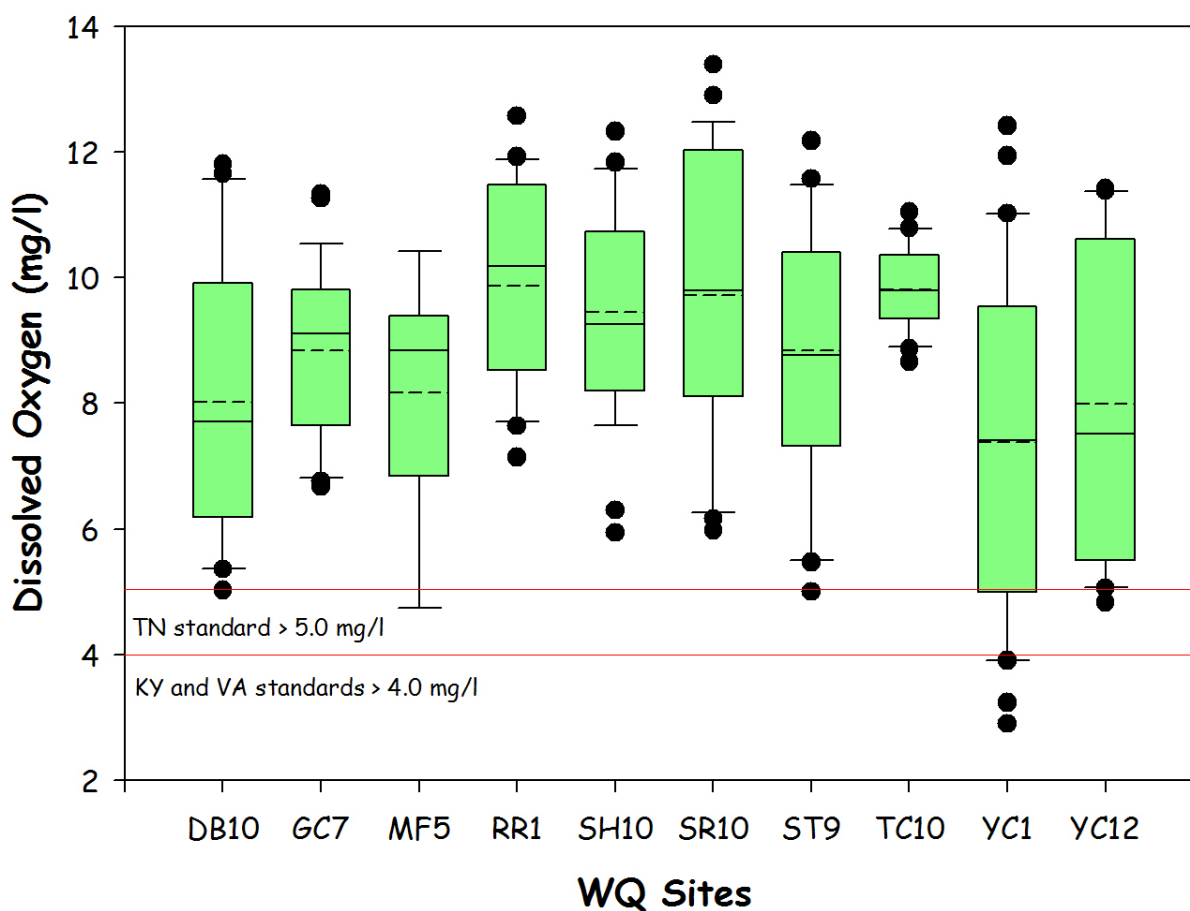
Figure 20. Dissolved Oxygen at CUGA

All Tennessee and Virginia waters met state dissolved oxygen (DO) standards of 5.0 and 4.0 mg/l, respectively. There were two occasions (September 11, 2007 and June 10, 2008) where the DO levels at Upper Little Yellow Creek (YC1) dropped below the Kentucky warm water standard of 4.0 mg/l, and one occasion (September 26, 2007) where Martin's Fork dropped below the cold water standard of 5.0 mg/l. These sampling events were coincident with very low flows (little aeration) and at times of higher temperature – warm water holds less dissolved gases, including oxygen, than cold water. A combination of low flow and high temperature was the likely cause of depressed DO levels. At this time there is no reason to believe that CUGA has a DO problem, as these rare events coincide with exceptionally low flow conditions.

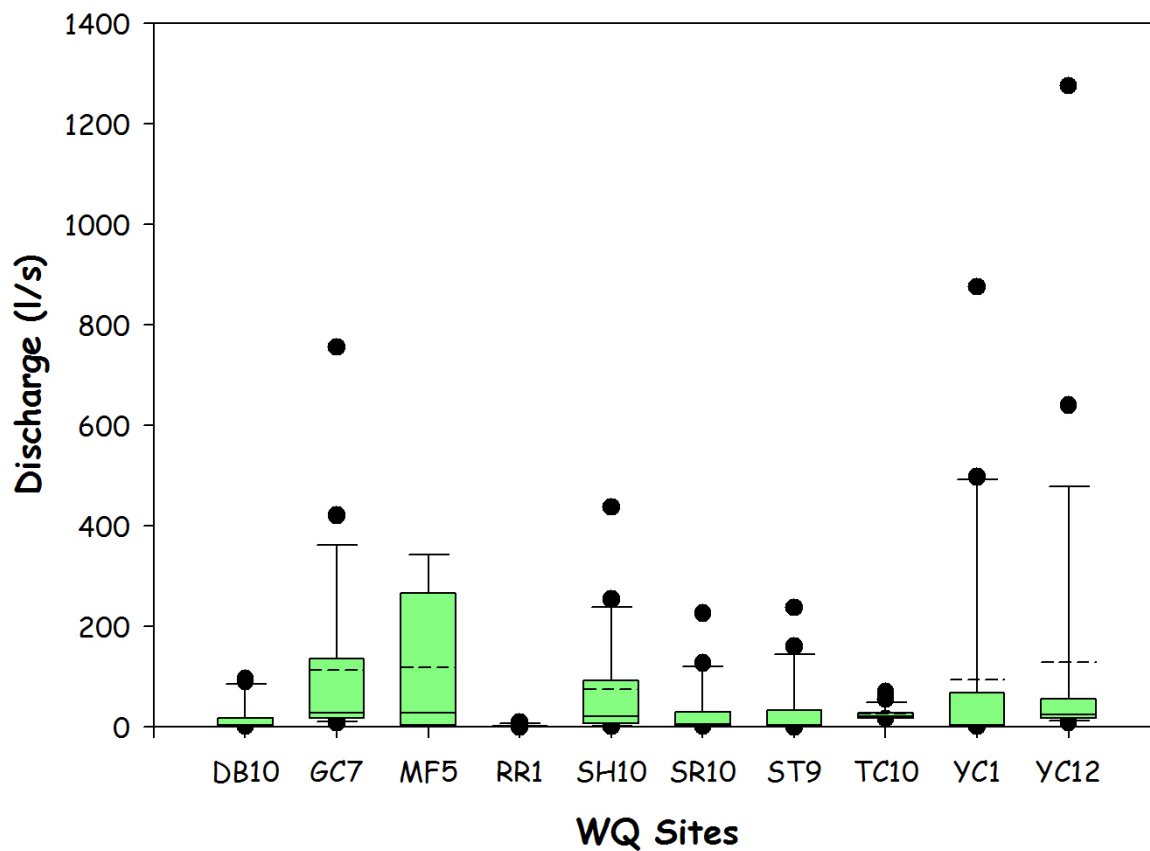
Figure 21. Discharge at CUGA

Discharge, or flow, helps put all water quality into context. As will be presented later in the bacteria discussion, discharge relative to parametric concentration can greatly assist interpretation of results. All sites, with the exception of TC10, are centered low with high outliers, as most sampling rounds were during low flow, with the occasional high-flow event. Tunnel Creek's flow is nearly exclusively groundwater and is far less variable.

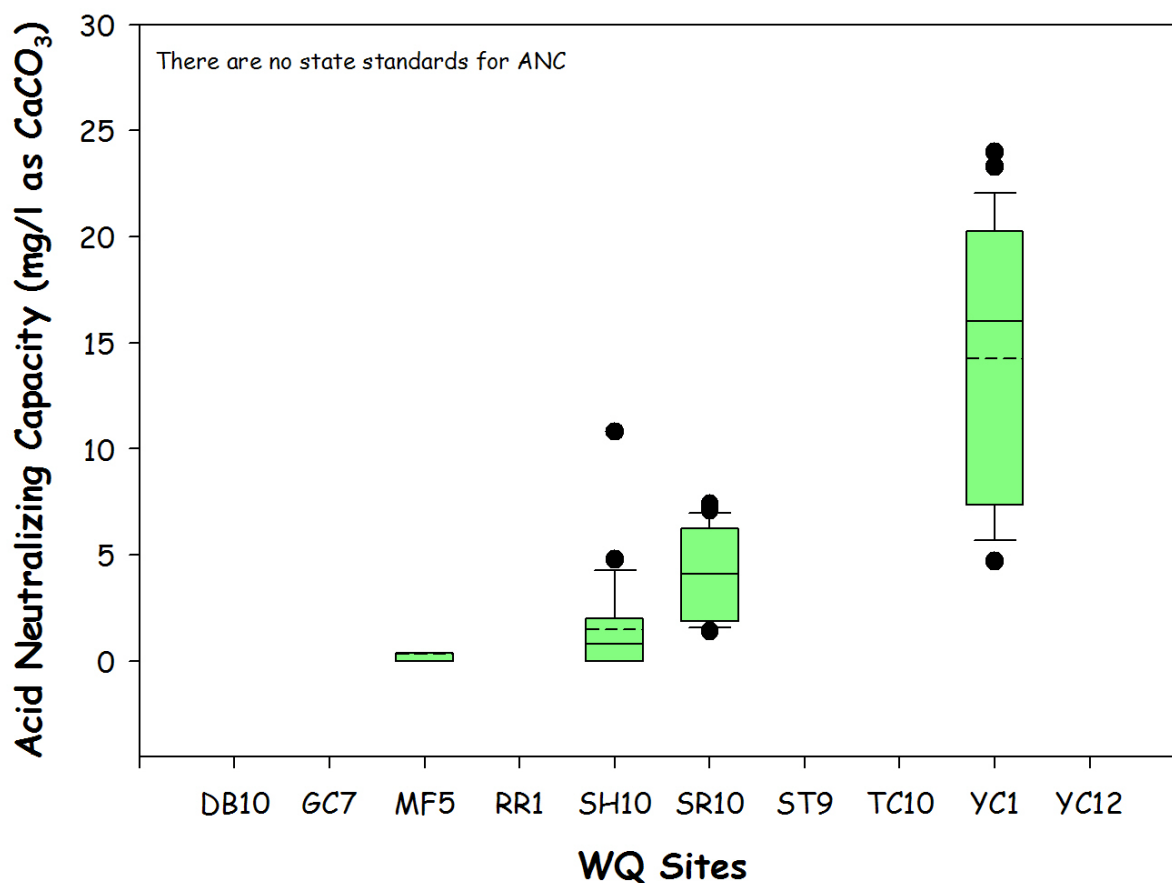
Figure 22. Acid Neutralizing Capacity at CUGA

One of the main values of monitoring ANC is that it gives insight into related water quality issues. Kentucky has a provision that a water is not considered in violation if it comes by it naturally. ANC results show that there are little or no bicarbonates to buffer pH at MF5, SH10, and perhaps SR10. Secondly, as this well may be a natural condition, results help explain the presence or absence of aquatic species.

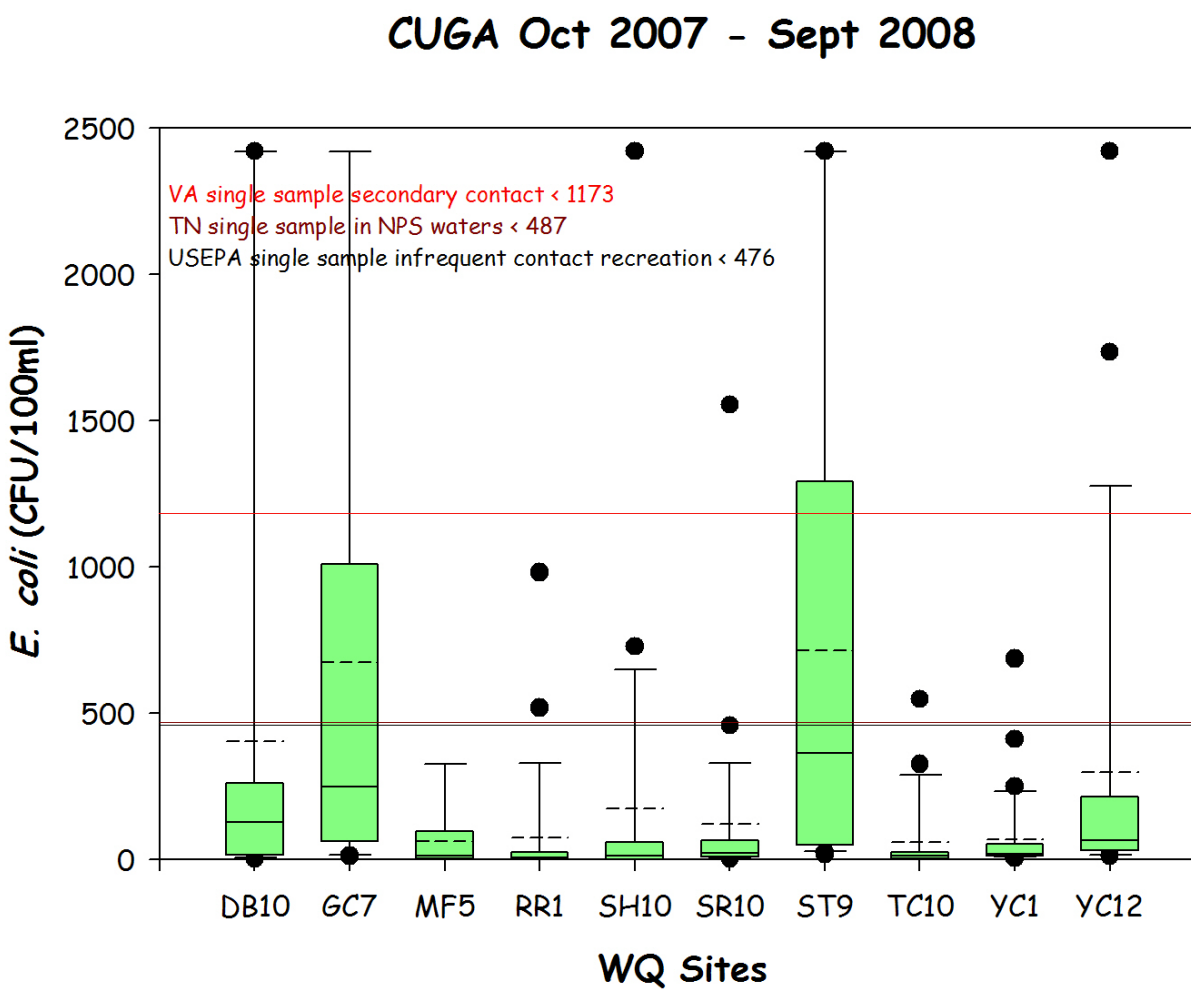
Figure 23. *E. coli* at CUGA

With the exception of MF5 (which may be simply an artifact of a smaller sample size), every water monitored at CUGA exceeded state WQ standards for *Escherichia coli*. This should not necessarily alarm the resource manager as high levels are associated with rainfall events, thus a non-point source is the likely contributor. Consider the pristine watershed of Shillalah Creek or Sugar Run. While devoid of development, there are times, immediately after rainfall, where the USEPA single sample limit of 476 Colony Forming Units (CFU)/100ml is exceeded. This is a natural condition. A bear, like many animals, does indeed defecate in the woods. It is likely that the occasionally elevated levels in Davis Branch (DB10) are due to the high beaver activity immediately upstream of the sampling site. It also appears that there is no impact of the facilities at the Sugar Run picnic area to the adjacent stream.

What may be of use to park management are the bacteria levels found at Station Creek (ST9) and Gap Creek (GC7). These sites commonly exceeded state standards – mean values of Gap Creek topped the Tennessee limit for National Park waters of 487 CFU/100ml, while the Virginia single sample standard of 1173 CFU/100 ml was exceeded over 25% of the time in Station Creek. These two sites exhibit point and non-point source contamination signatures to be further explored in the following figures.

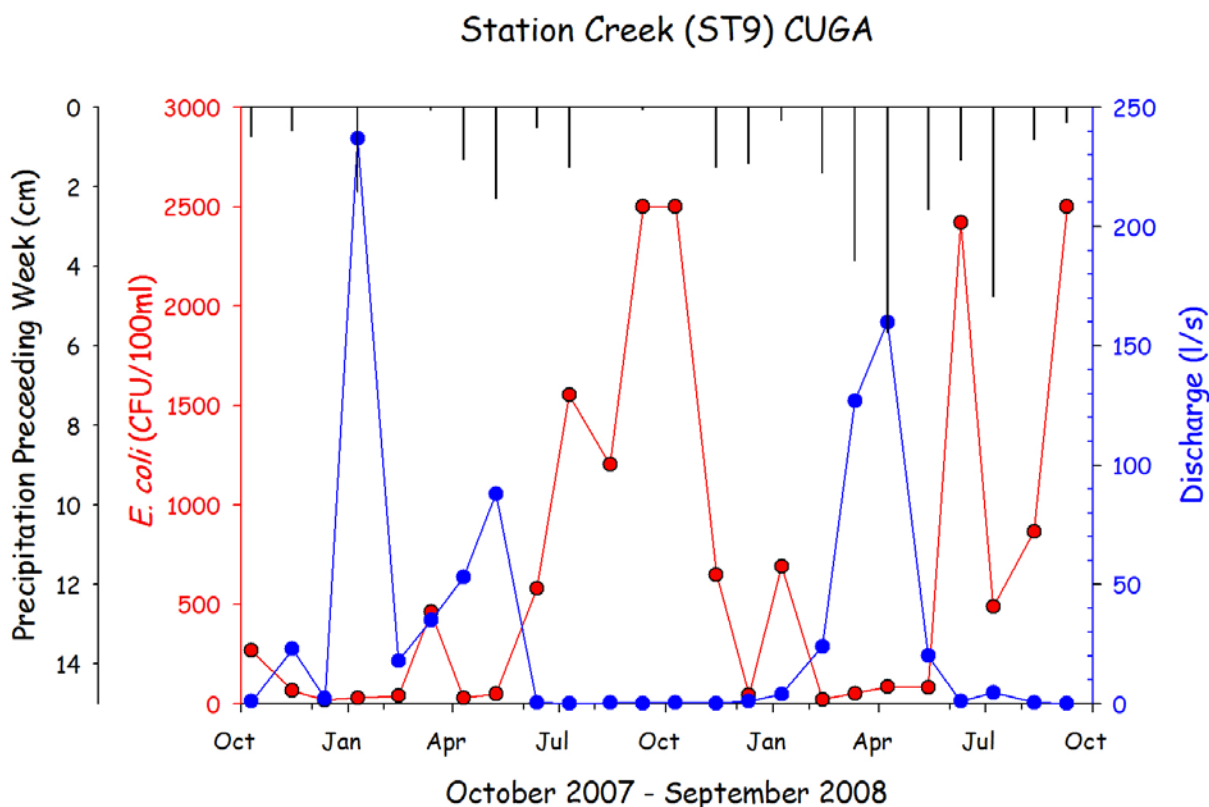
Figure 24. *E. coli* at Station Creek

Station Creek displays a point-source contamination signature. There is no correlation between rainfall events and high bacterial loads, rather *E. coli* levels are the highest when flow is the lowest – rising in late spring, peaking through the summer and trailing off in the autumn. Higher flow periods in the winter months are coincident with low *E. coli*. There are two possible sources: either animals defecating directly into the stream (as seen where livestock is given access) or failing/overwhelmed septic fields. The park has begun to take additional samples to isolate the source.

The high bacteria found in Station and Gap Creeks both warrant additional, concise monitoring. It is possible that *E. coli* levels in Station Creek are due to a failing or overwhelmed septic system at the park's campground. Additional samples taken above and below the campground, during high and low flow should determine the source. Approximately 20 sample events would be needed. Gap Creek should also be similarly sampled and partitioned above and below the town of Cumberland Gap's wastewater treatment facility.

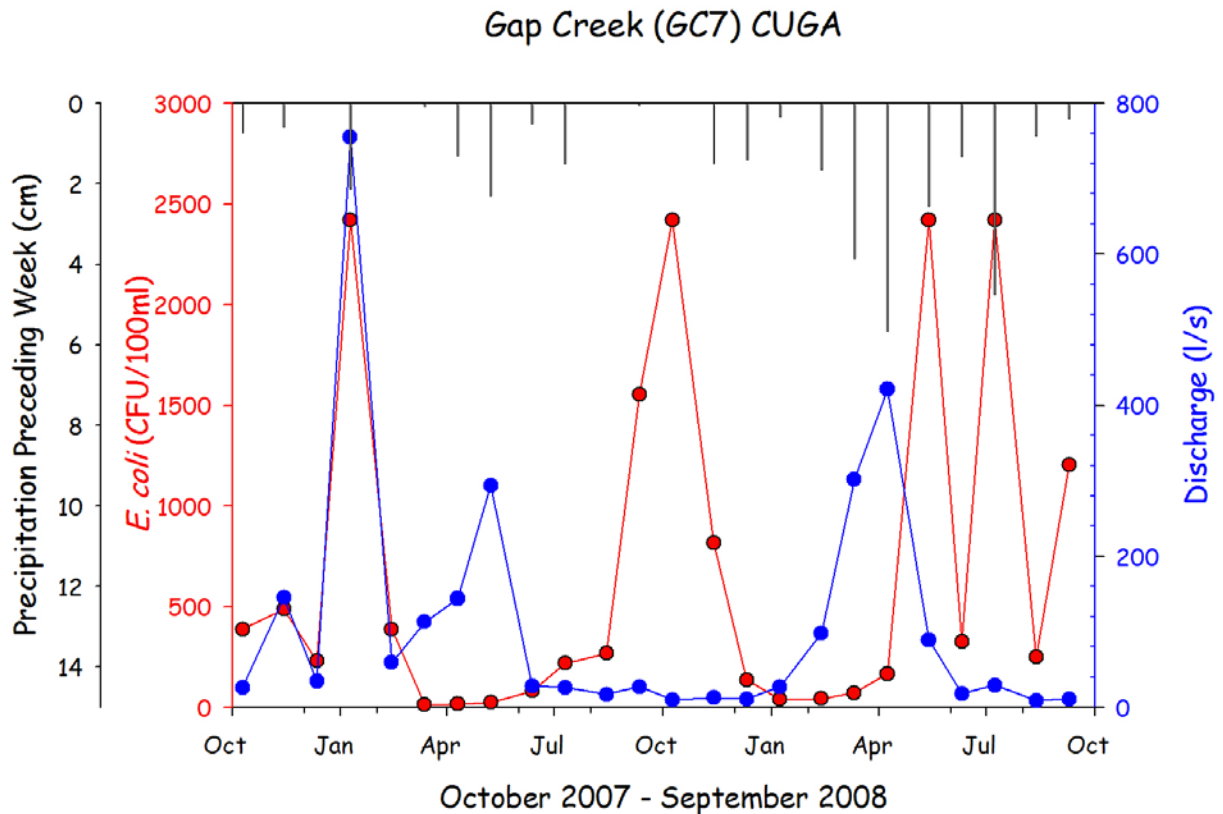
Figure 25. *E. coli* at Gap Creek

*E. coli* data at Gap Creek (GC7) show both point and non-point source contamination. Several times, January 2007, May and July 2008, bacteria counts were above quantification limits of the test (>2419 CFU/100ml). The exceedences of the later two dates may have been compounded by construction at the Cumberland Gap wastewater treatment plant. This facility, which was found to be discharging untreated effluent into Gap Creek by Park Ranger Justin Cully, has had a history of poor operation. Rodney Martinez brought the situation to the attention of the Tennessee Water Commission and was told of planned improvements, which occurred during the late spring and summer of 2008.

While there was no rainfall the week prior to the September 9, October 9, and November 11, 2007 rounds, it is likely that non-point sources are the main contributors as these events took place during or immediately following rains the day of sampling. It should be noted that not every high flow is met with high bacteria, as this relationship is dependent also upon the distribution, intensity, and timing of rainfall events prior to sampling, which are not necessarily represented in the course scale of the graph.

It is also quite possible that during high flow times, which are coincidental with high infiltration rates of gravity-collection sewers, that the capacity of the Cumberland Gap waste-water treatment works is exceeded. A simple sampling effort taking samples above and below the facility would effectively partition the creek and determine the source. A series of samples should be taken above and below the facility, and during low and high flows.

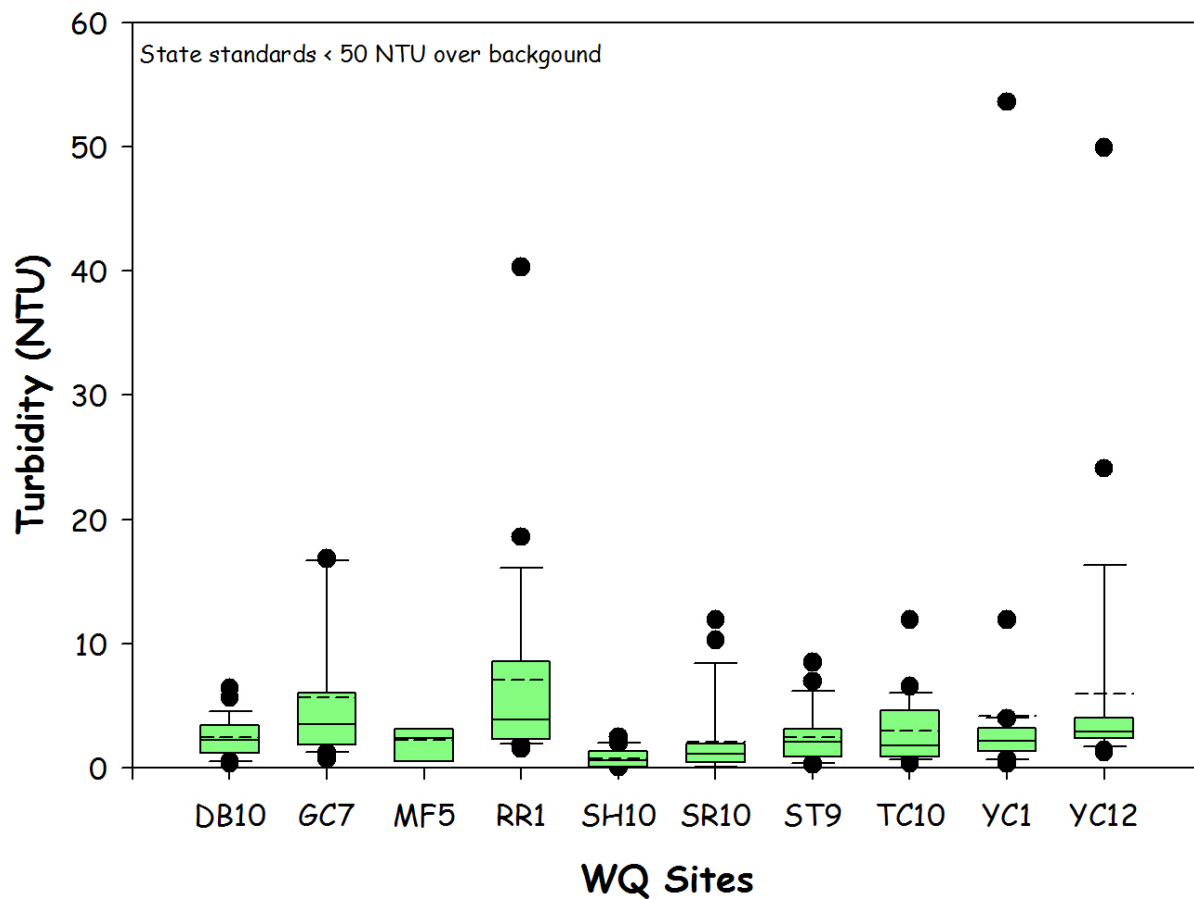
Figure 26. Turbidity at CUGA

Turbidity is a general measure, or approximation of the amount of suspended material in the water. It is not directly correlative to suspended solids as particle size, shape and color all play a role in the transmission of light through the water column. In general, the higher turbidity values are associated with muddy or turbid waters. In general, waters of CUGA were clear to slightly turbid. This range is due to sample collection in respect to rainfall events –high turbidity associated with high flow. Turbidities 50 NTU (Nephelometric Turbidity Units) above background are considered violation of state standards. There are three outliers at RR1, YC1, and YC12. A possible cause for the former two is sediments being disturbed in sample collection, while the later was localized near the Middlesboro Kentucky Fried Chicken which is adjacent and just upstream of YC12.
