National Park Service  
Cultural Landscapes Inventory  
2005

Pennyfield Lock  
Chesapeake and Ohio Canal National Historical Park

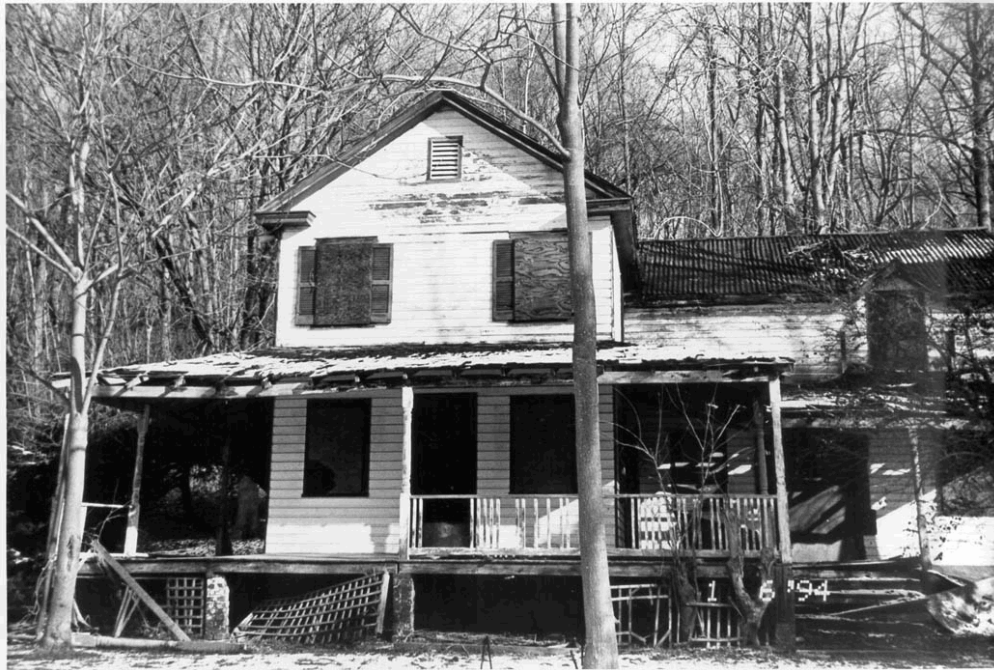
*Pennyfield House c. 1994. Substantial damage had occurred by this time. (NPS/NCR)*

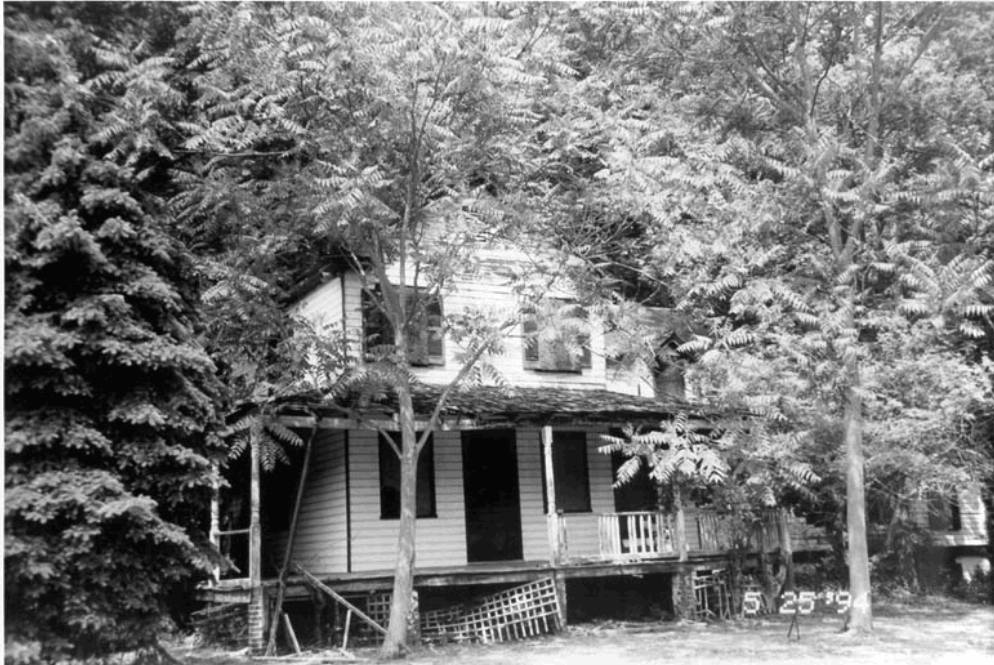
*Ailanthus trees (since cleared) had sprung up along the perimeter of Pennyfield House, 1994. Tree to the left is a planted fir or spruce of uncertain vintage. (NPS/NCR)*

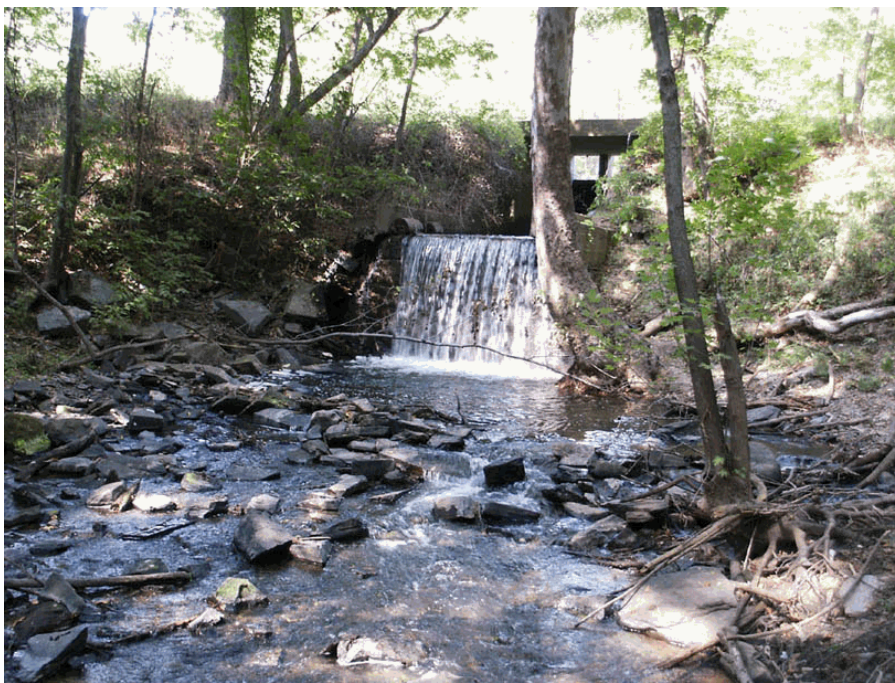
*Overflowing water from the canal upper level through the waste weir has carved a small stream in the floodplain. (2002, M. Gerdes)*

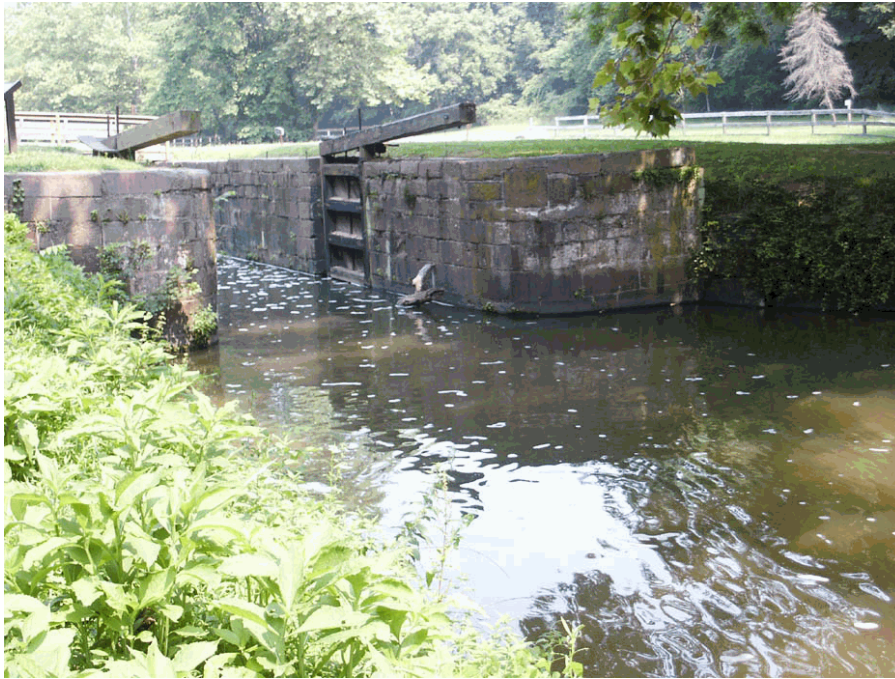
*Lock walls, including lock extension walls and headwalls, seen from lower level. Fence at upper right encloses grass field by Pennyfield House. (2002, M. Gerdes)*

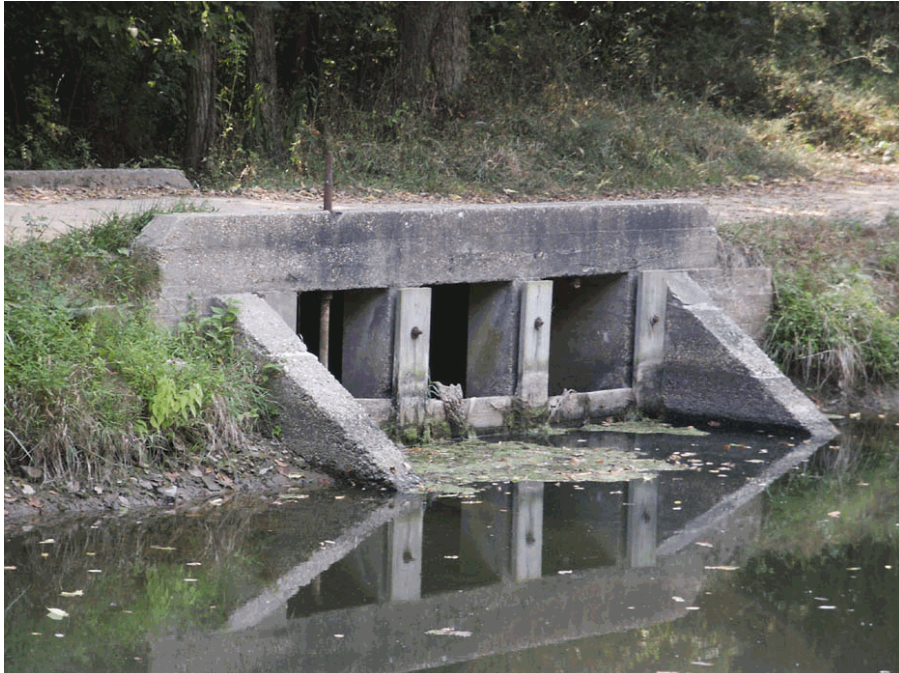
*Concrete waste weir inflow on upper level of canal, with towpath crossing it. Waste weir was built c. 1909. Before that, there seems to have been an informal overflow a little farther upstream. (2002, M. Gerdes)*

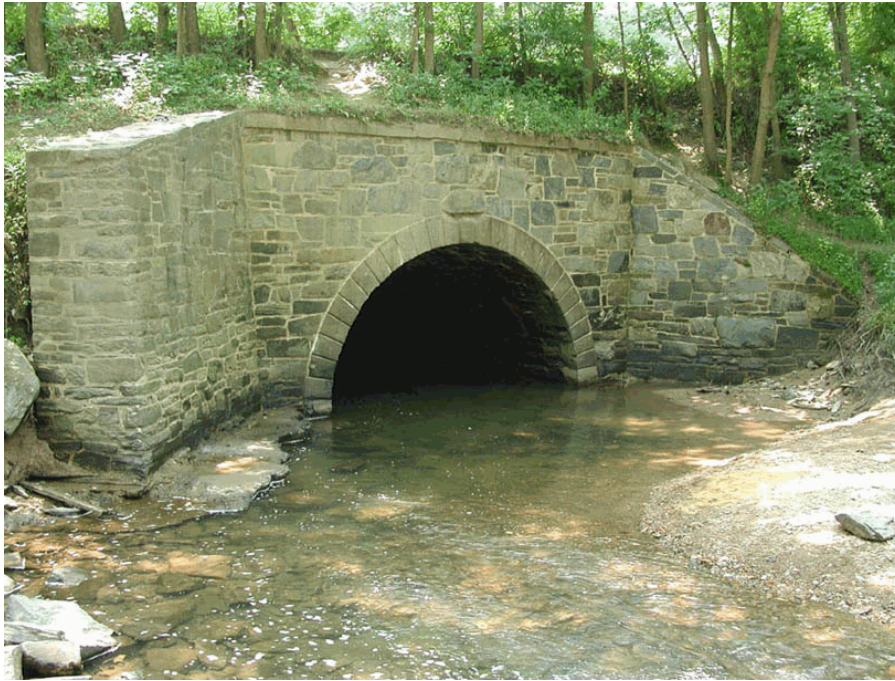
*Headwalls of Muddy Branch culvert on inland side. (2002, M. Gerdes)*

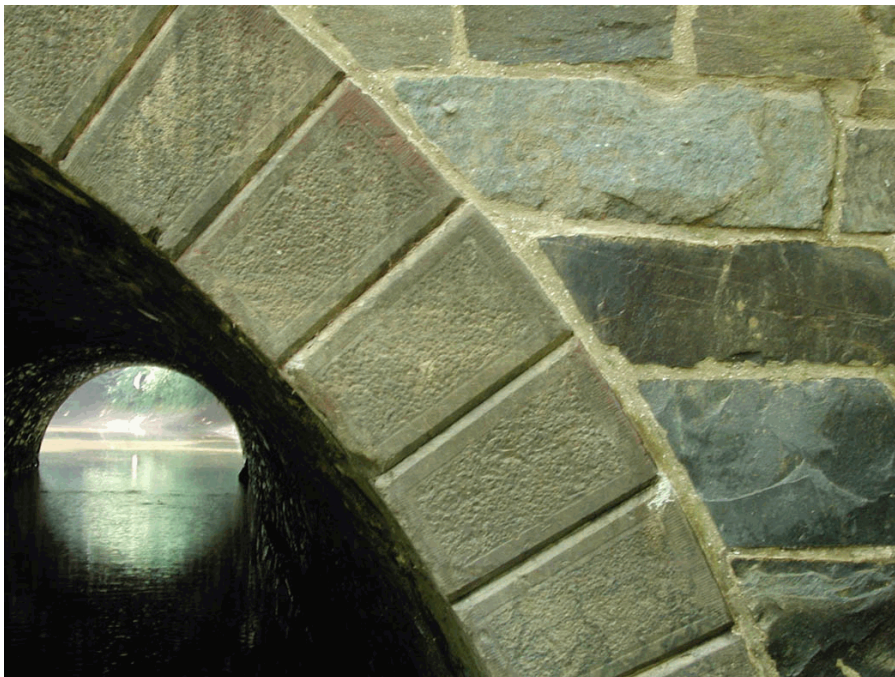
*Closeup view of stonework of arch ringstones. View through culvert to other side. (2002, M. Gerdes)*

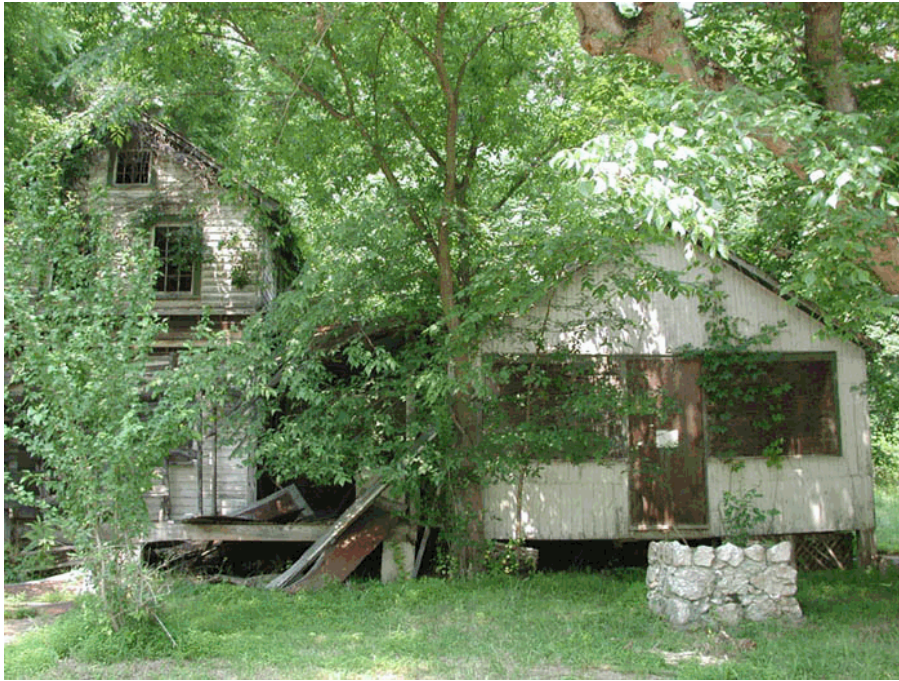
*Secondary (daughter's) house and store. Masonry feature in front may be remains of well.  
(2002, M. Gerdes)*

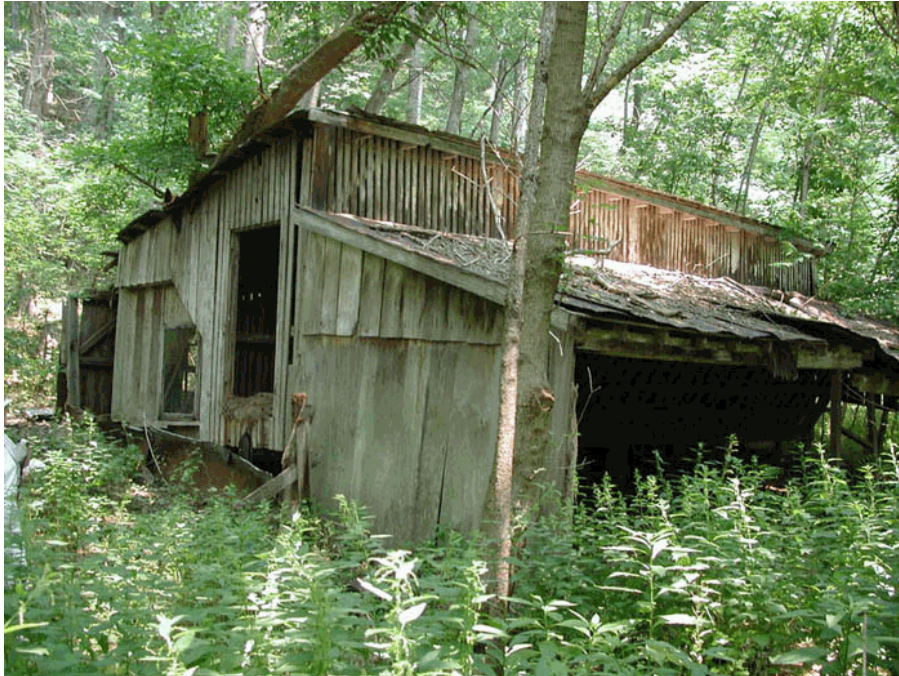
*Corncrib and loafing shed combined, part of agricultural landscape at lock, now hidden in  
successional growth. (2002, M. Gerdes)*

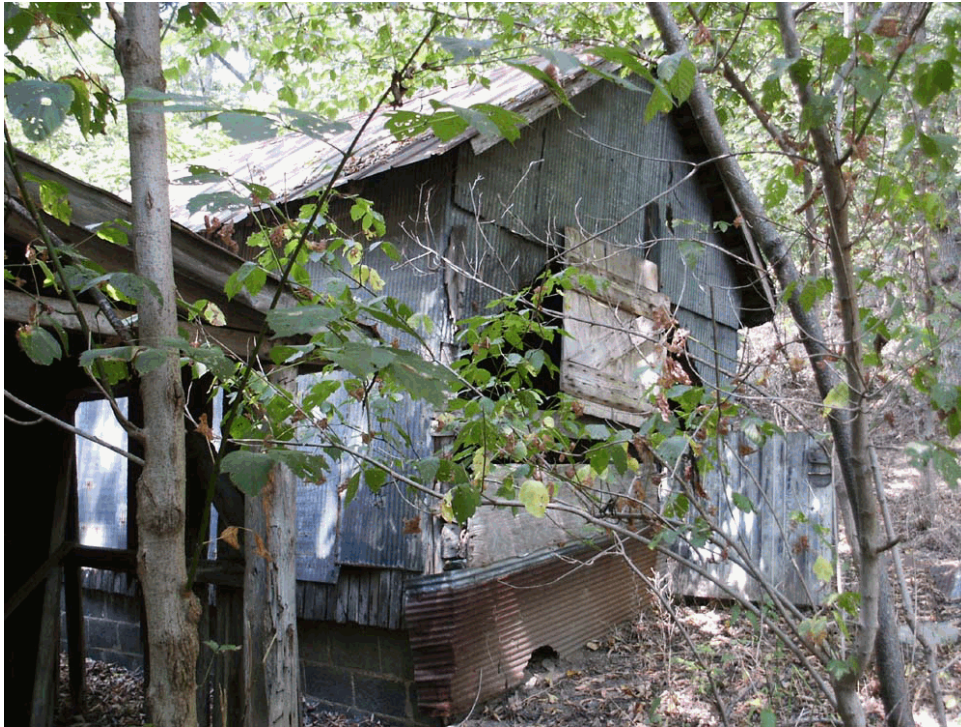
*Tin-sided one-car garage still standing. Some of the dilapidated structures have handhewn beams. (2002, M. Gerdes)*

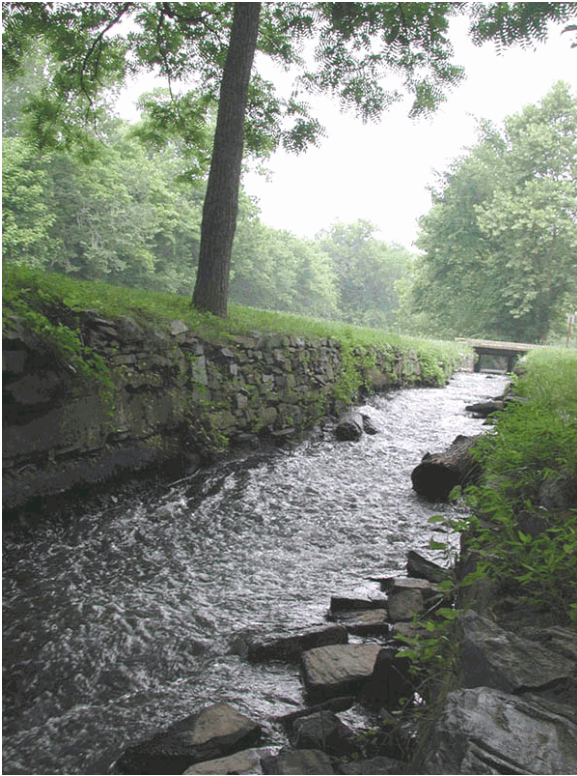
*Bypass flume. Water cascades on riprap "tumble" and banks are secured with dry masonry. Feature is discussed in Buildings and structures." (2002, M. Gerdes)*
