National Park Service  
Cultural Landscapes Inventory  
2003

Linnaean Hill  
Rock Creek Park

## Inventory Unit Summary & Site Plan

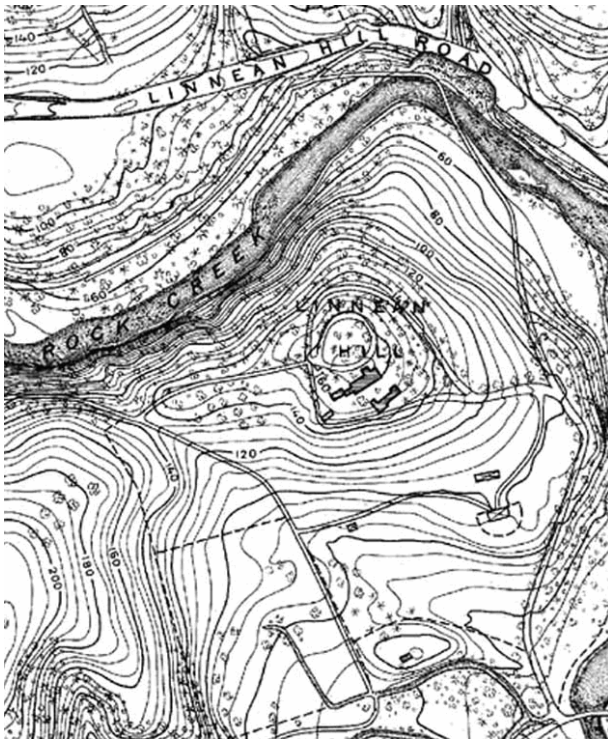
*The U.S. Coast and Geodetic survey published in 1893 indicates a simplified circulation pattern and an increase in vegetation on the north side of the house.*

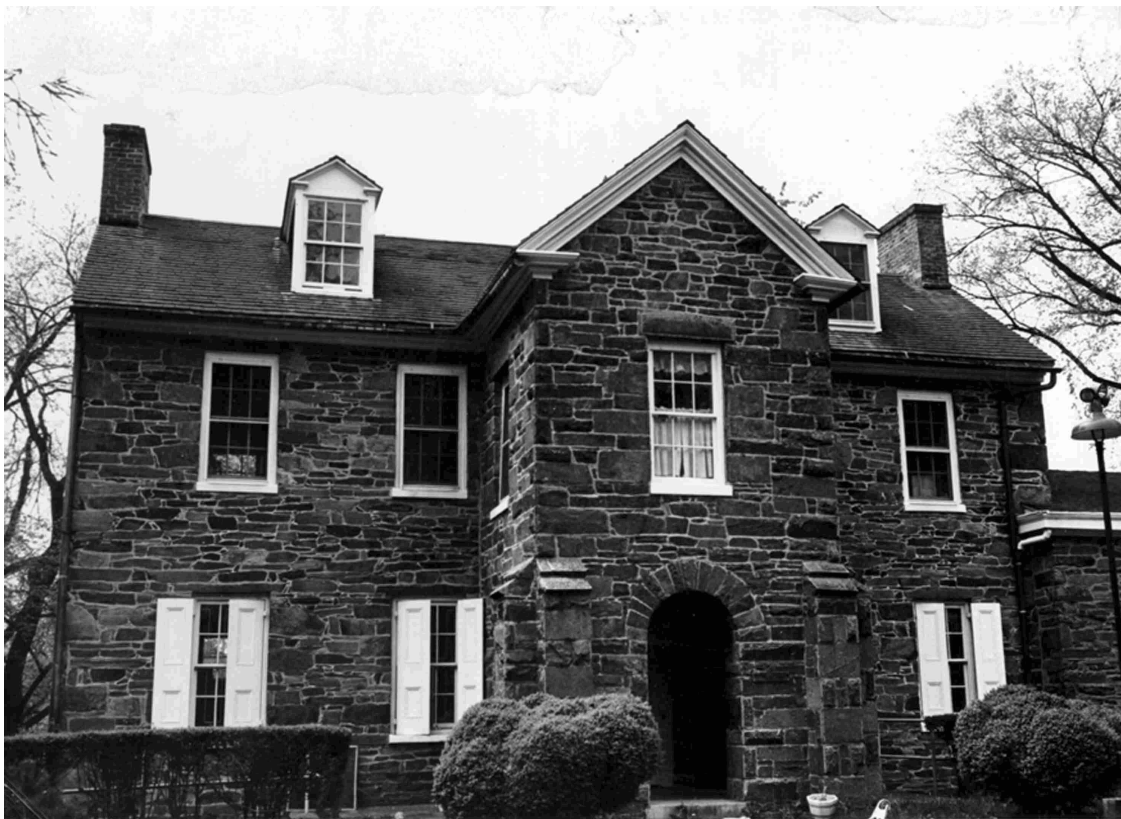
*This photograph of the northern façade of the house was taken after the 1936 rehabilitation. Characteristics typical of the Colonial Revival style include the shutters and foundation plantings.*

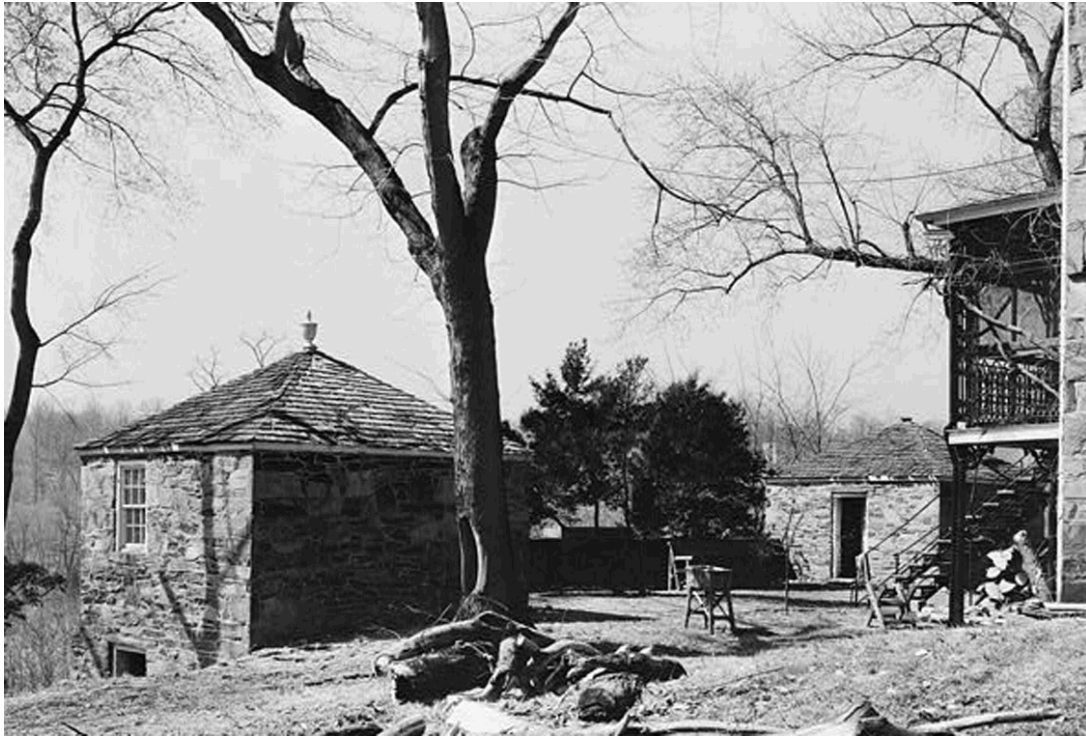
*The two stone outbuildings and the south side of the house created a utilitarian outdoor service area. From circa 1935 Historic American Buildings Survey photograph.*

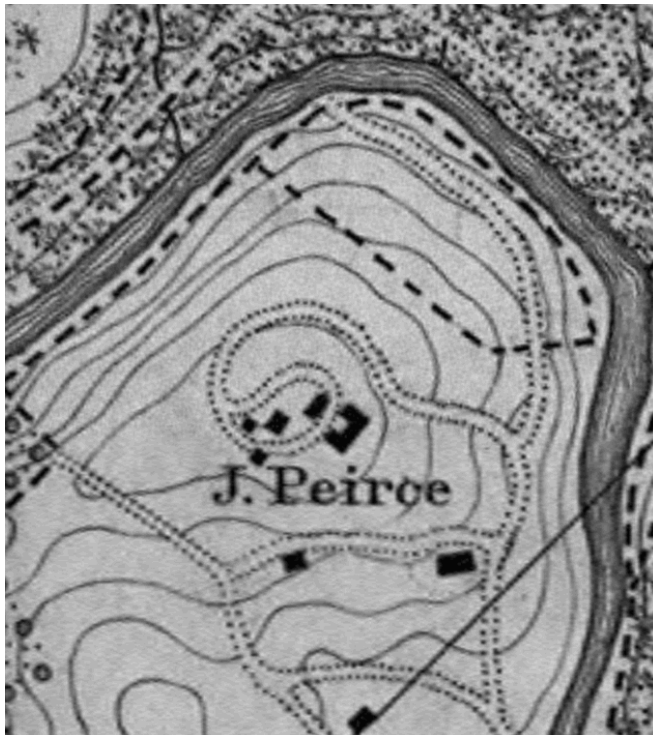
*Boschke map of Linnaean Hill, showing U shaped arrangement of dependencies behind the main dwelling.*

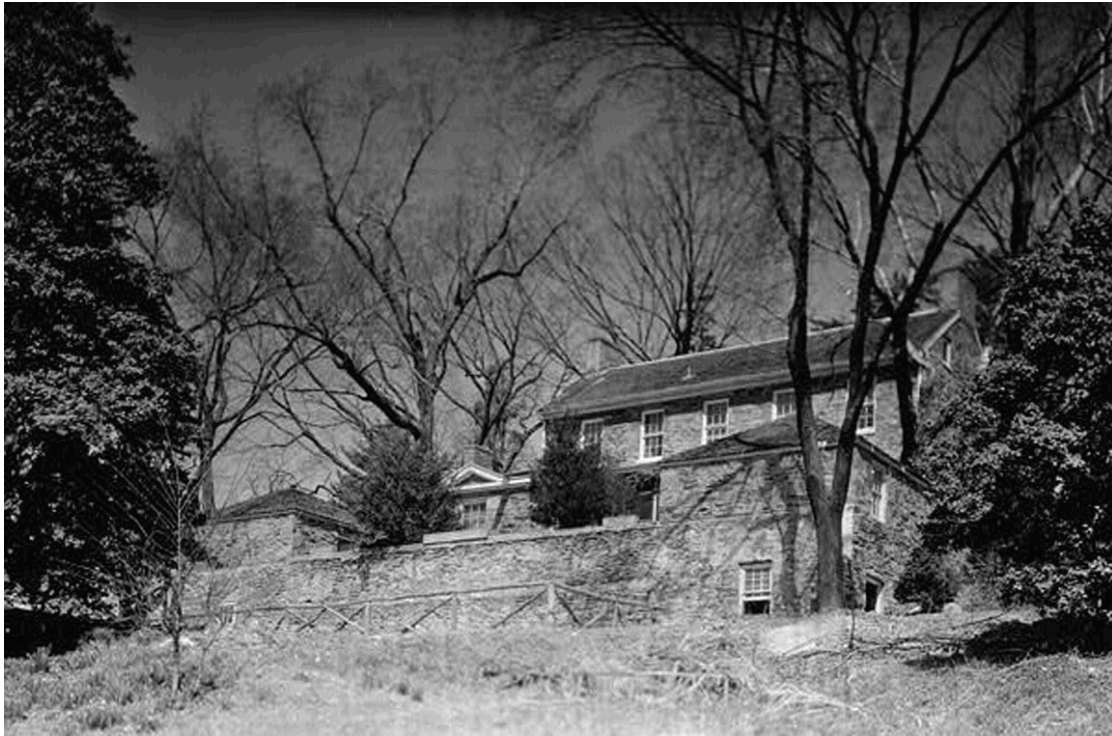
*Circa 1935 Historic American Buildings Survey photograph of retaining wall formerly serving as rear wall of greenhouse, which had been removed by this time.*

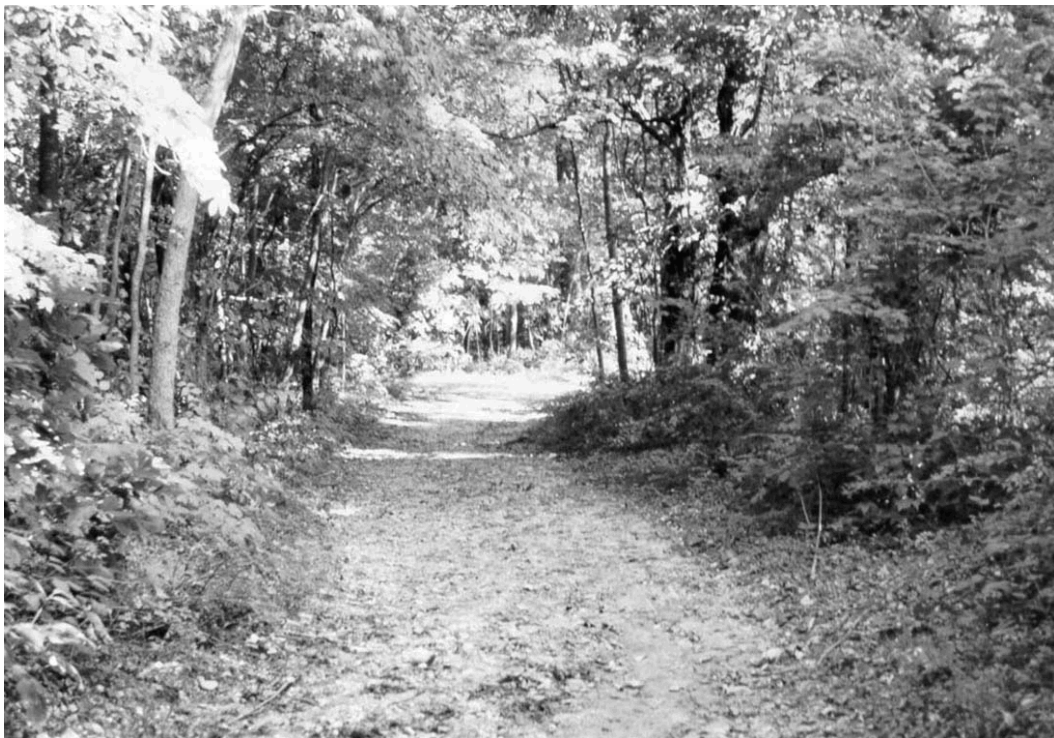
*This abandoned entry drive, 1993, dates to the early nineteenth-century and functions as a trail today.*
